Maryland Inventory of Historic Properties number: CAR-296

Name: MD 328 OVEP - TUCKANOKE RIVER.

MHT No. CAR-296

SHA Bridge No. 5012 Bridge name MD 328 over Tuckahoe River

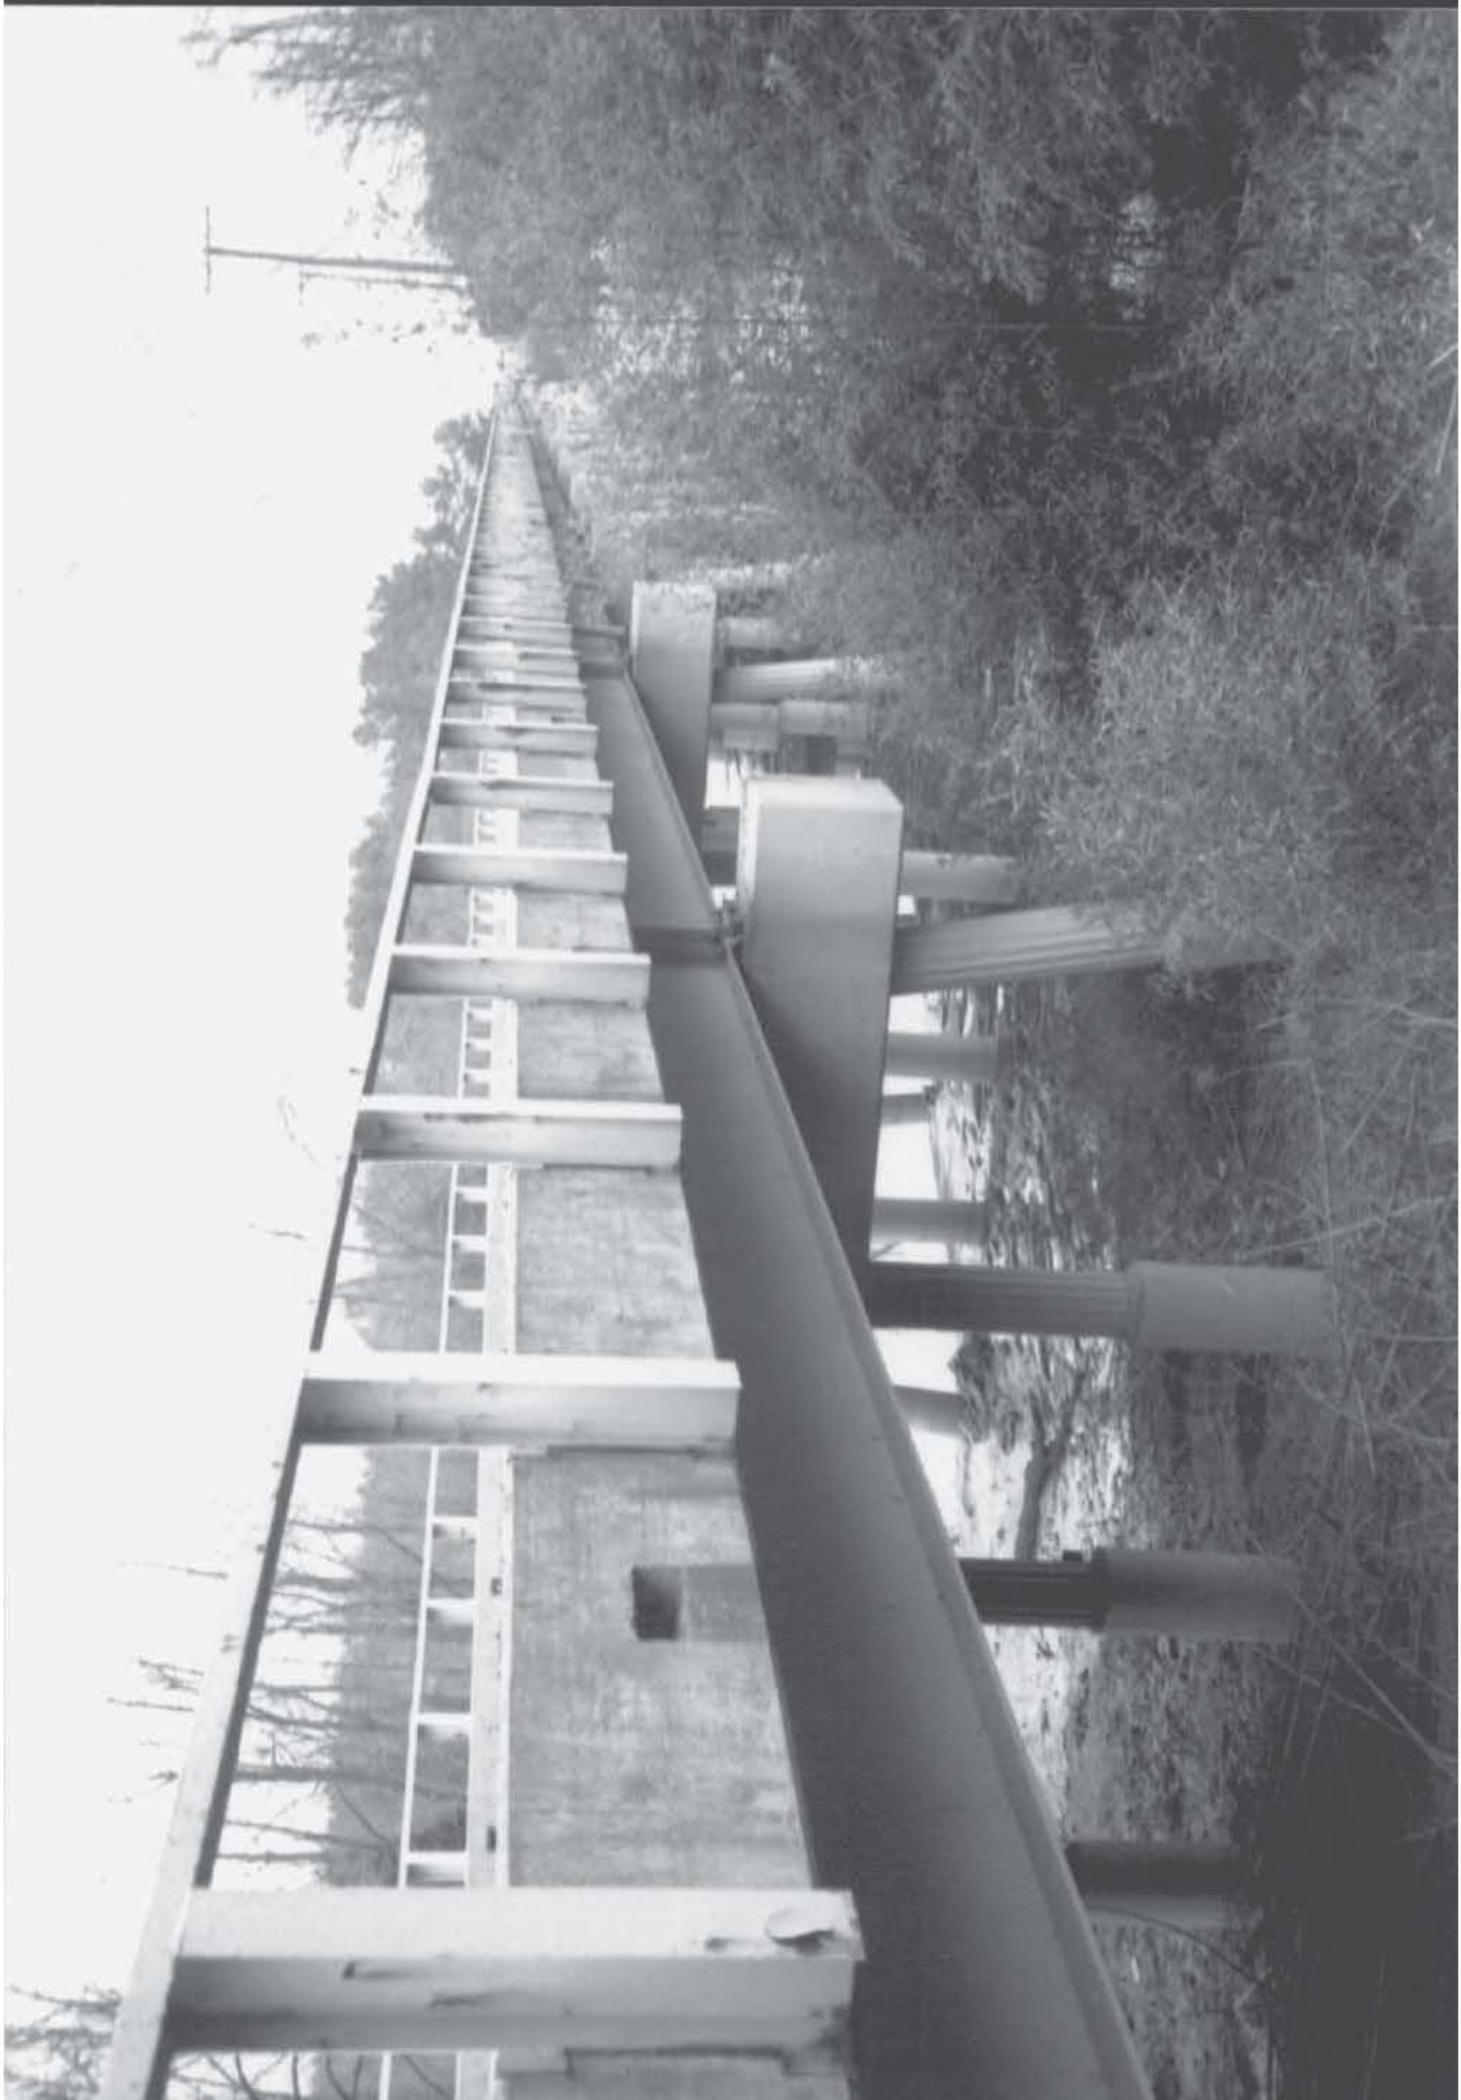
The bridge retains some character-defining elements of its type, as defined by the Statewide Historic Bridge Context, including rolled longitudinal I-beams and a metal railing. The concrete pile bents have been concealed with fiberglass jackets.

1. CAE-296
2. MD 328 over Tuckahoe Creek.
3. Caroline Co., MD
4. Caroline Hall
5. 3/97
6. MDS4PB
7. detail of substructure
8. 6 of 6

Substructure repairs were performed after a 1982 inspection revealed severe deterioration to the steel monotube pile shells and the concrete fill material. In 1984, Bent 9, pile 5 was repaired and the deck in spans 1, 2, 5, 6, and 9 was replaced. In addition, all concrete end diaphragms and sliding plate joints were replaced with compression seals. In 1994, the piles were encased with fiberglass protective jackets.
