CAR-38
Harry Nuttle Brick House
Andersontown
Private

Fourth Quarter 18th Century

INVENTORY FORM FOR STATE HISTORIC SITES SURVEY

Harry Nuttle Brick House

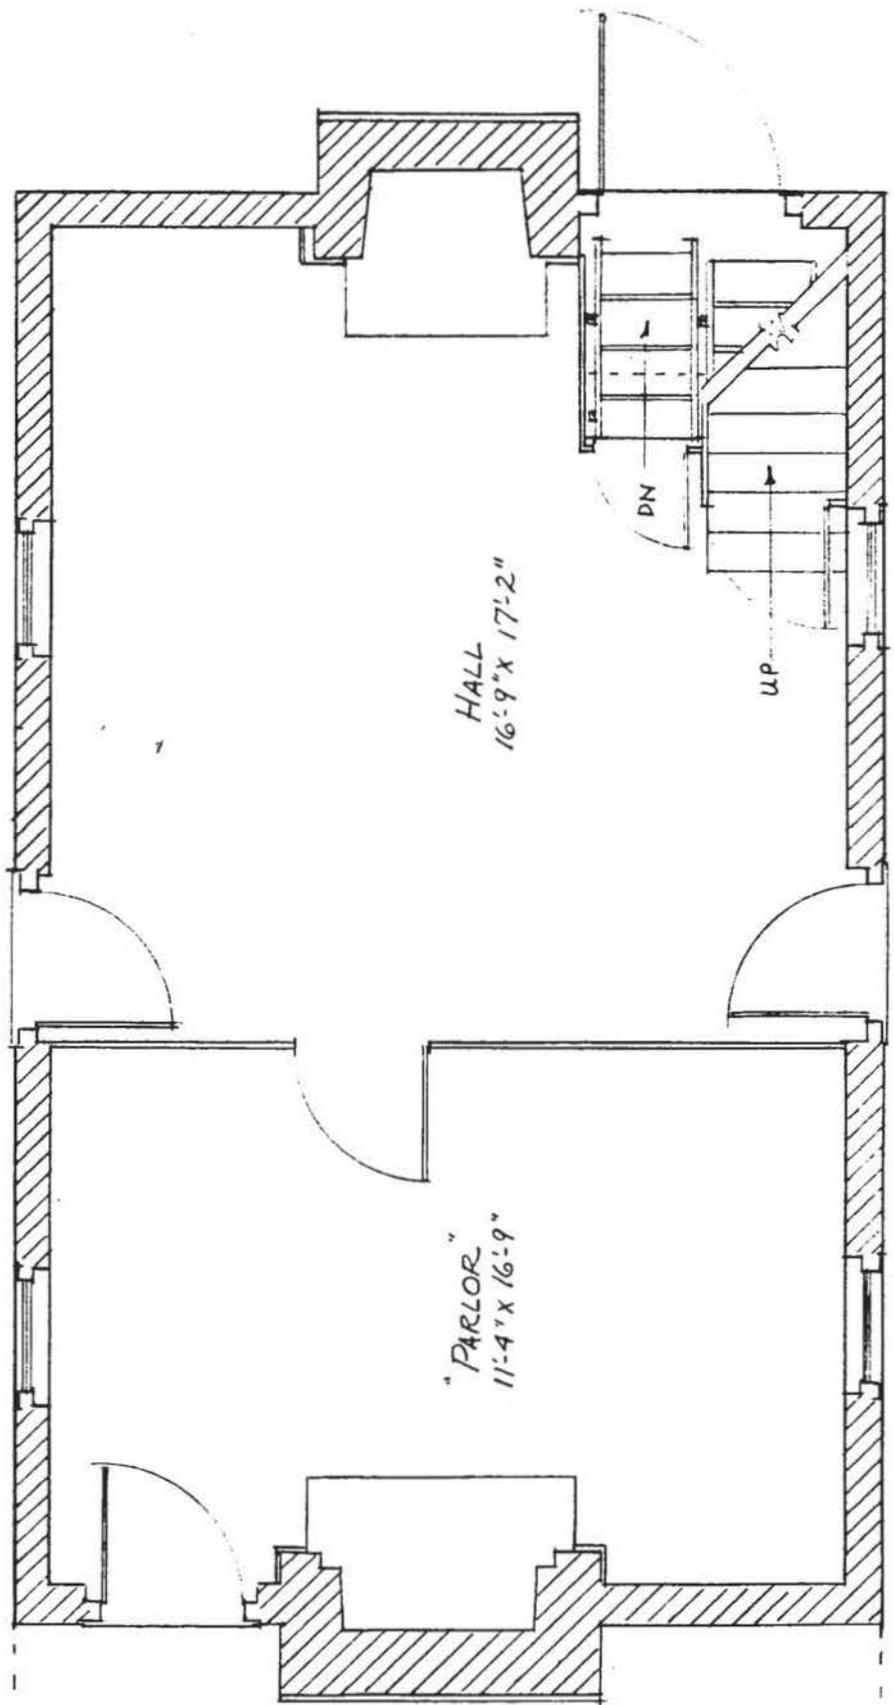
FIRST FLOOR PLAN

The interior has a two room plan with plaster walls. There is a through passage provided by the doors in the middle bay of the north and south facades. The staircase is in the northwest corner of the house. The house also has a cellar whose exterior entrance is on the west gable end. There is a two bay clapboard addition on the east gable end.
