CARR-1006

3126 Old Westminster Pike, Finksburg Vicinity

Maryland Historical Trust State Historic Sites Inventory Form

Survey No. CARR-1006

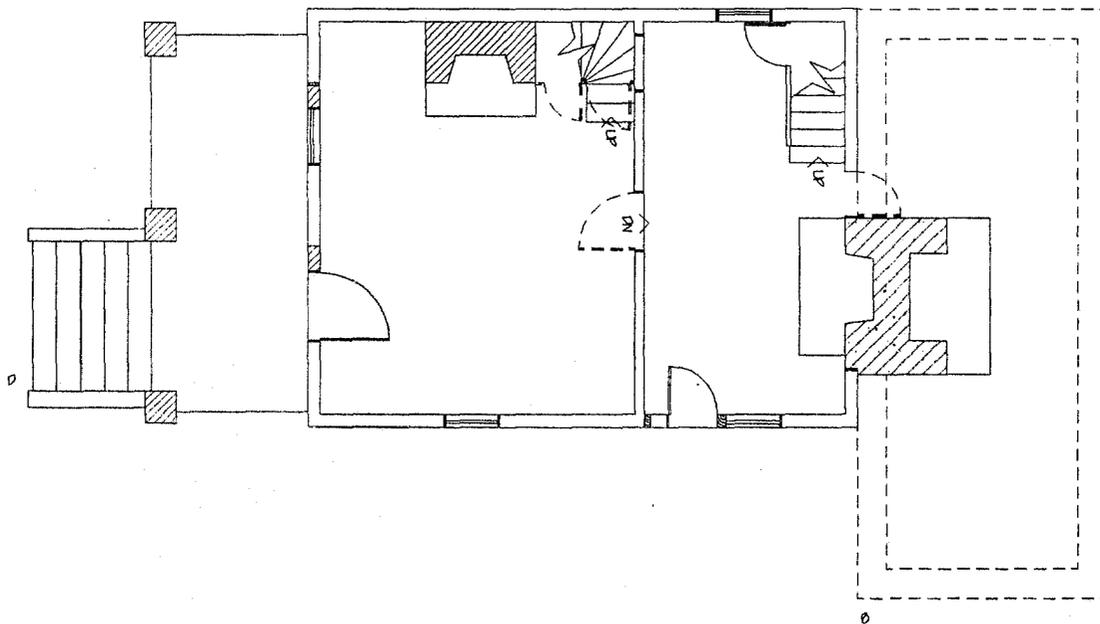
FIRST FLOOR PLAN

- A ALL MEASUREMENTS MADE AFTER INTERIOR LATH AND PLASTER REMOVED
- B ORIGINAL WING CONFIGURATION BASED ON REMAINS OF FOUNDATION
- C EXISTING WALLS OF V-NOTCH CORNER LOGS
- D PORCH STEPS CAST CONCRETE

The first story is a three-room plan, with one room in the front, or south, another room in the center, and a third room in the rear, or north. The south room architrave is symmetrical, with a pyramidal moulding in the center and with plain corner blocks. The logs were white washed and later vertical riven lath was fastened with cut nails, then plastered. The lath passes behind the baseboard, suggesting it was added at a later date. There is a brick fireplace with splayed jambs and a plastered surround on the west elevation. The mantel has been removed but reportedly had pilaster strips identical to the architrave. There is an enclosed winder stair in the northwest corner, but the door to it is gone. There is a closet underneath that is also missing its door. The stair is enclosed with plain tongue-and-groove boards. The stairway covers over a doorway on the north wall, at the west corner, that led to the center room. The logs in this corner are whitewashed below the later lath and plaster, and there is no ghost of anything here. It would thus appear that the stairway was added at a later date, forcing the doorway to be moved to the center of the north wall. The north wall has a center doorway. The door is gone, but the door frame has thin boards nailed to the log ends and appears to be a later opening. This north wall has several puzzling logs. A log just below the top of the door has notches on top of it. One of these notches holds a joist in the center room. The rest of the center room joists are set on top of this log, not in the notches. Thus, it appears that the joists were replaced. The log above this notched log also has notches on the top. These notches are filled with chunks of used brick that have mortar and black soot on them, and also have new mortar helping to fill the spaces. The corresponding log on the front wall, however, has no notches. This could be because it was

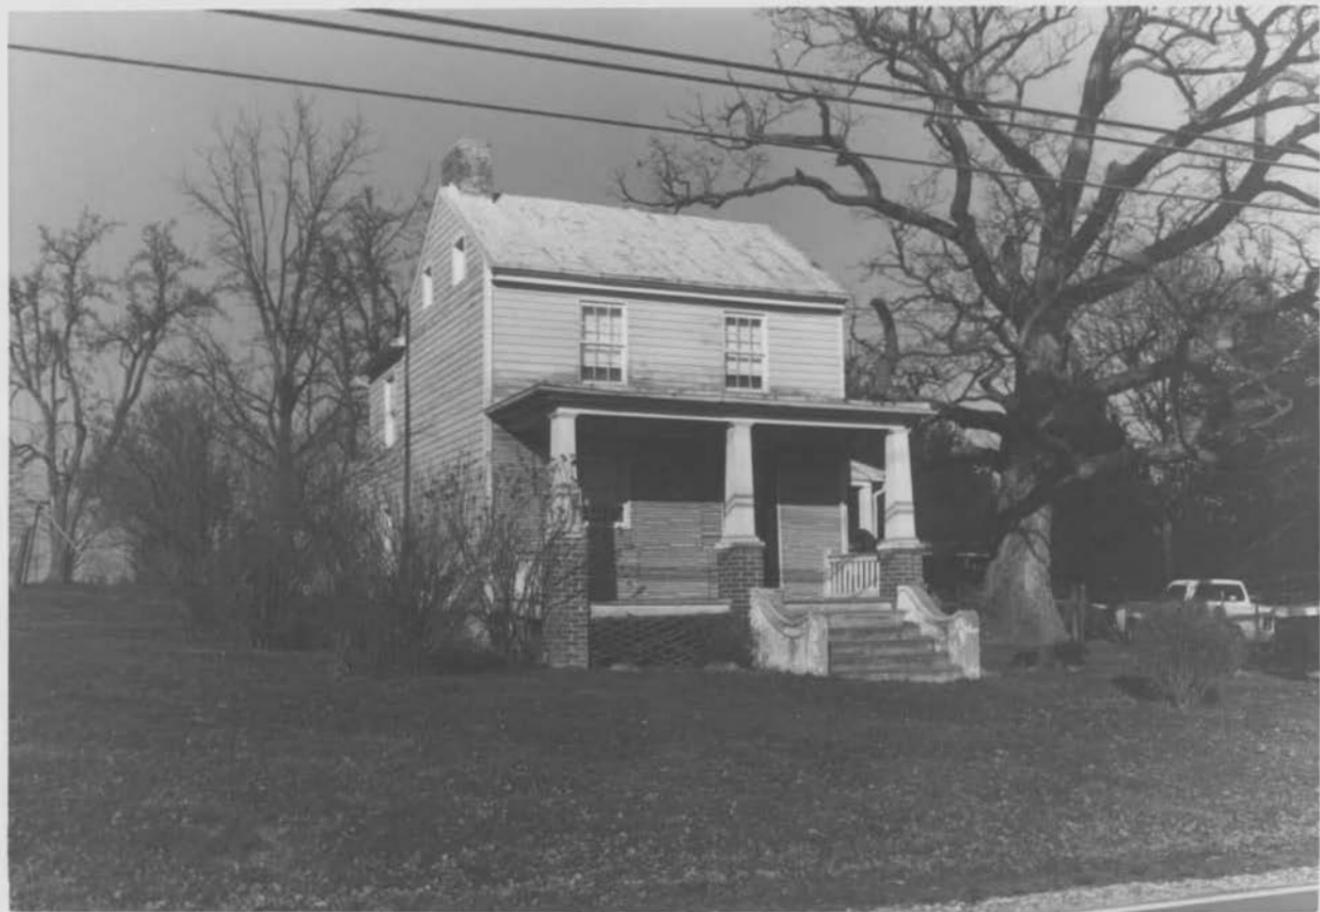
1. CARR-1006
2. Carroll County, Maryland
3. Joe Getty
4. December 1984
5. Maryland Historical Trust, Annapolis, Md.
6. North elevation (camera facing south)
7. 1/1
