**NATIONAL REGISTER OF HISTORIC PLACES
REGISTRATION FORM**

historic name Shaffer, Jacob F., Farm

**Jacob F. Shaffer Farm
Carroll County, Maryland**

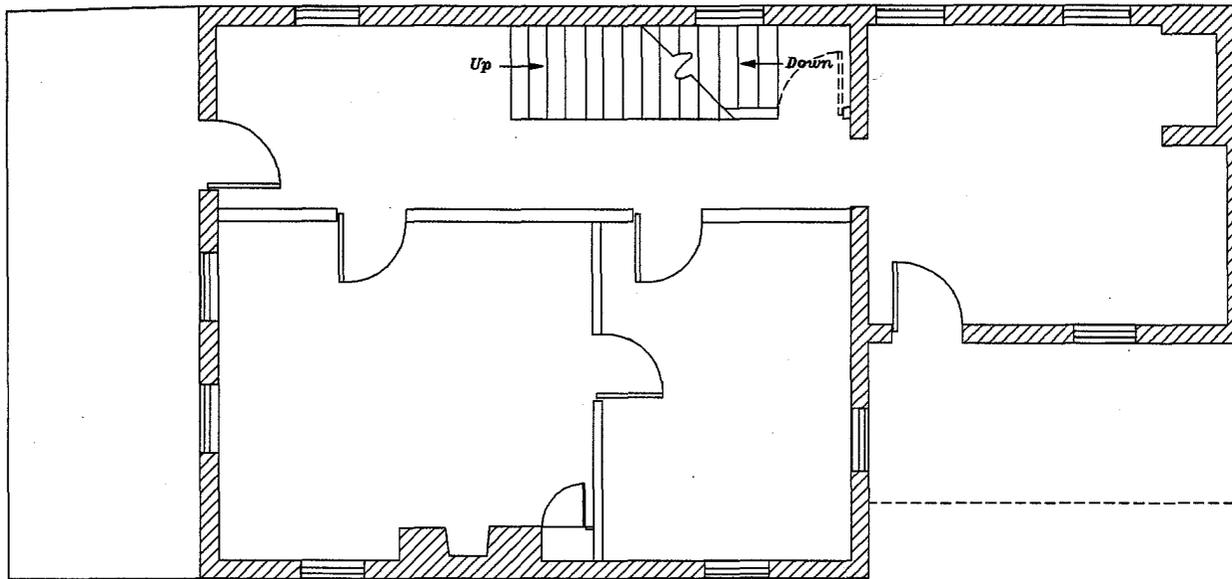
CARR 1148	Jacob F. Shaffer Farm-House	First Floor Plan	April 1992

The house is a two-story, three-bay wide, banked brick structure with Flemish Bond on the east facing front and 5-1 common bond on the other elevations. The house has a double-pile side-passage plan with a rear kitchen ell. All of the windows, which have been replaced, are 1/1 with snap-in muntins, but an old photograph in the possession of the owner shows 6/6 sash. Above the windows are splayed jack arches. While most of the foundation is stone, the east foundation wall is exposed and is of brick. It is three bays, with a six-panel

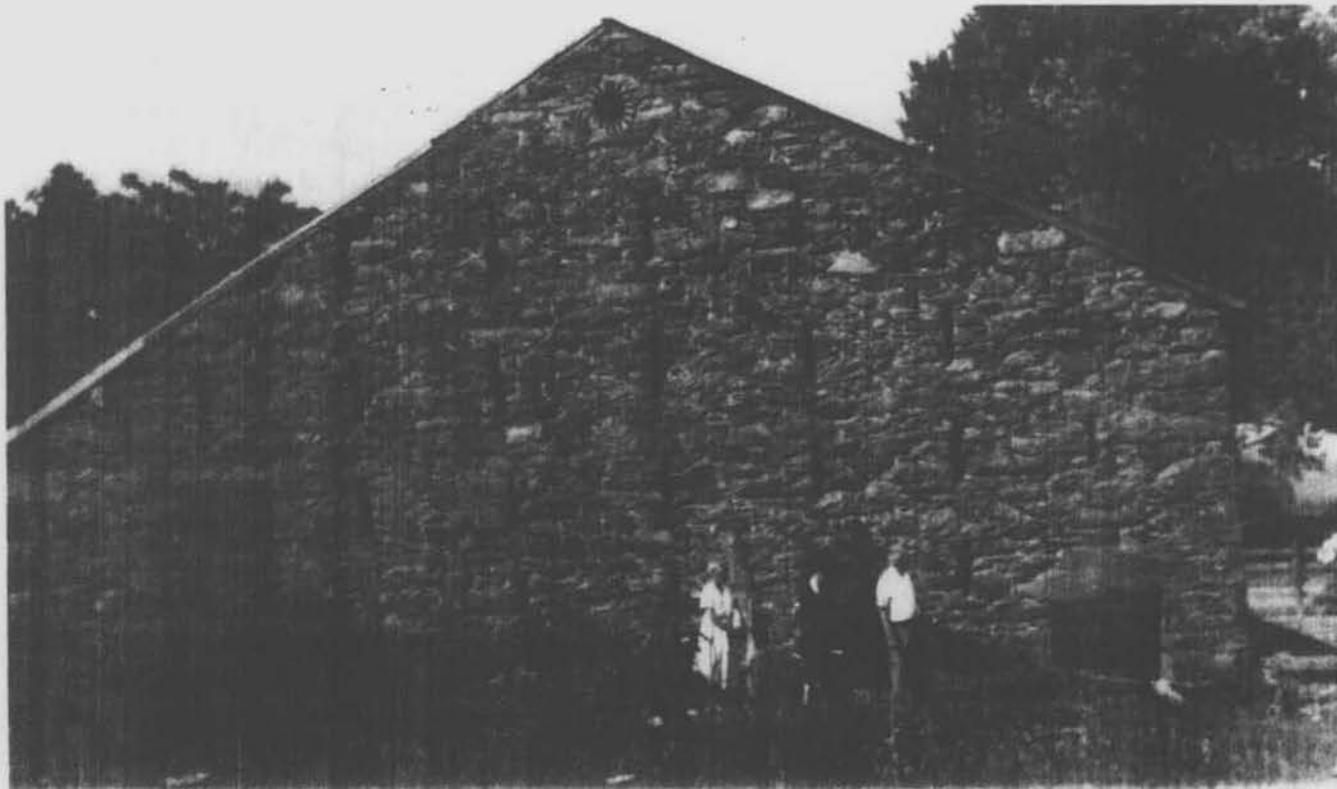
The stone barn on the old Frederick Place near Lineboro is an excellent example of slit ventilators which give the end walls a medieval appearance.

Joe Getty demonstrated that in 1798 stone barns were rare in Carroll County. They continued to be built throughout the first half of the nineteenth century, at least, but always remained rare. Carroll County apparently retains five, including the Shaffer Farm example. With few examples standing it is dangerous to make broad conclusions, but some features can be noted. These barns have both frame forebay end walls, such as the Pfoutz Mill Farm (Carr-1384) barn that was built before 1798, and stone forebay end walls, as with the Shaffer Farm barn built c. 1850-1865. Both of these barns, like most stone examples, have slit vents on the upper story that are splayed on the interior. The Richards-Feezer Farm barn (Carr-1389), on the other hand, has wood louvers set in large rectangular openings.

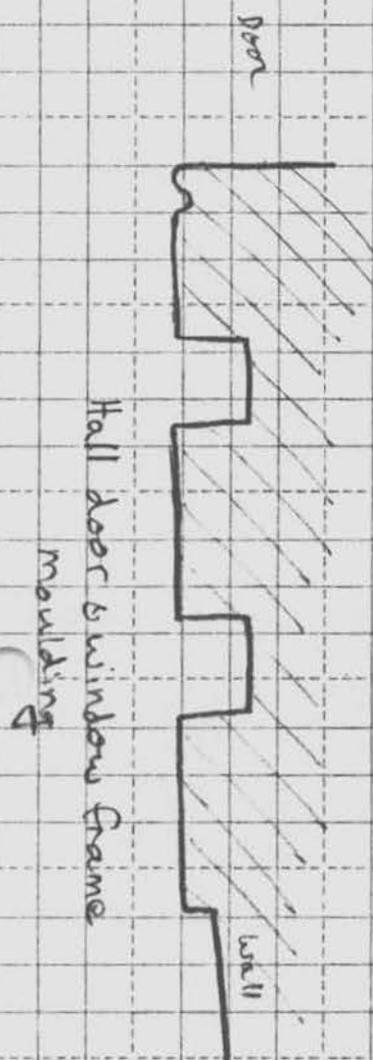
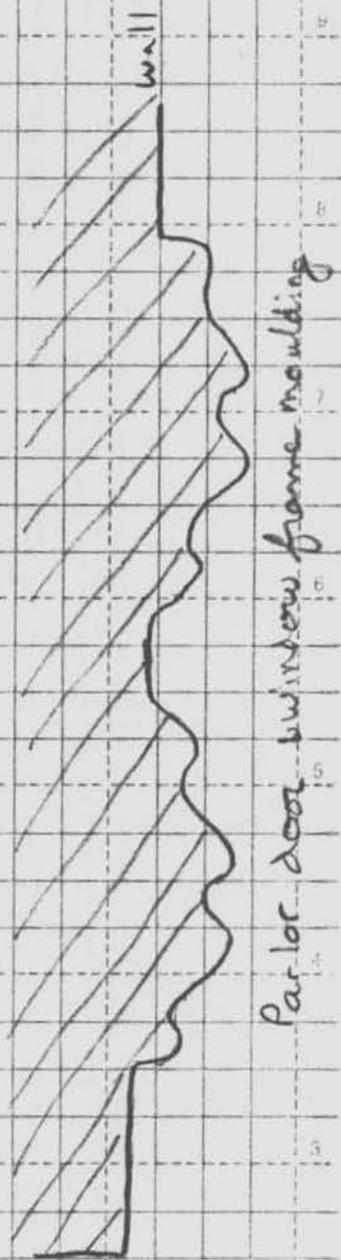
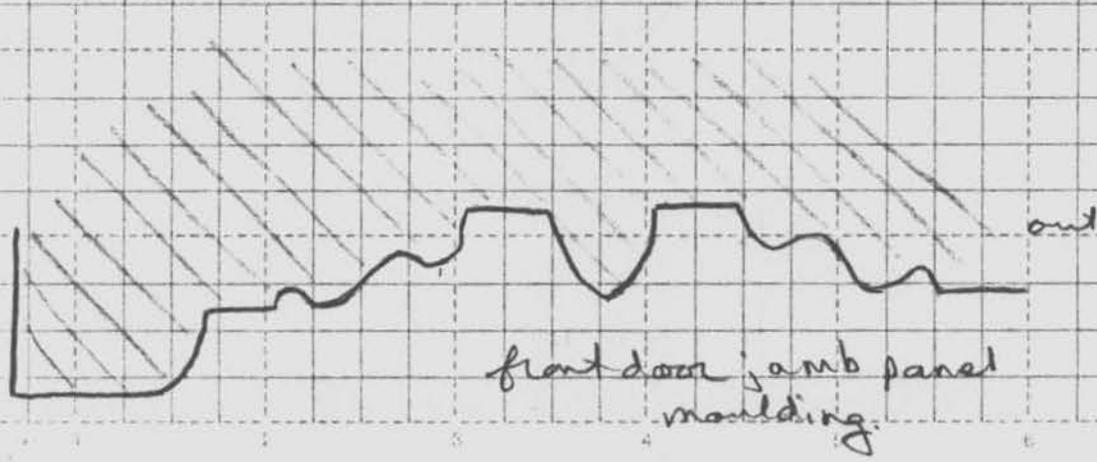
4758 Schalk Rd #1 CARR-1148
Moulding Profiles

door in the north bay. The first story has a door that has six square panels over two vertical ones and a four-light transom in the south bay. The jambs and soffit are paneled, with ogee panel moulds and a raised, lanciform moulding in the field. There is a raised, one-story shed roof porch with wood shingle roof, square posts, and a railing of square-in-plan, vertical balusters above a horizontal board rail. The north elevation of the main block is two-bays deep, with a single window in the east bay of the foundation and two small 2/2 sash in the gable end. Between these is a datestone with a carved shell above and "J.[A?].S. A.D. 1854" below. The north elevation of the kitchen ell is set back from the plane of the main block, is two bays, and has a door in the east bay that has two horizontal panels at top, two square panels in the center and two vertical panels at the bottom. The setback is filled with a new one-story porch. The old photograph shows a one-story porch here, too. The west elevation of the ell is a C.1985 addition. The south elevation of the main block matches the north, but with a door in the foundation that contains a large glazed light above two horizontal panels. The datestone has a six-petal rosette flanked by two small six-point stars, all above "J.F.S. A.D. 185[4?]" The ell is two-bays deep and flush with the main block, with no break in the brickwork. There is an interior brick chimney in the southwest corner of the ell. There is a brick dentil cornice on the east and west elevations of the main block, with a wood shingle gable roof and a rebuilt internal brick chimney centered on the ridge of the north end. The ell has a gable roof, but this originally was a shed roof sloping from south to north, and judging from the historic photograph continued out over the porch.

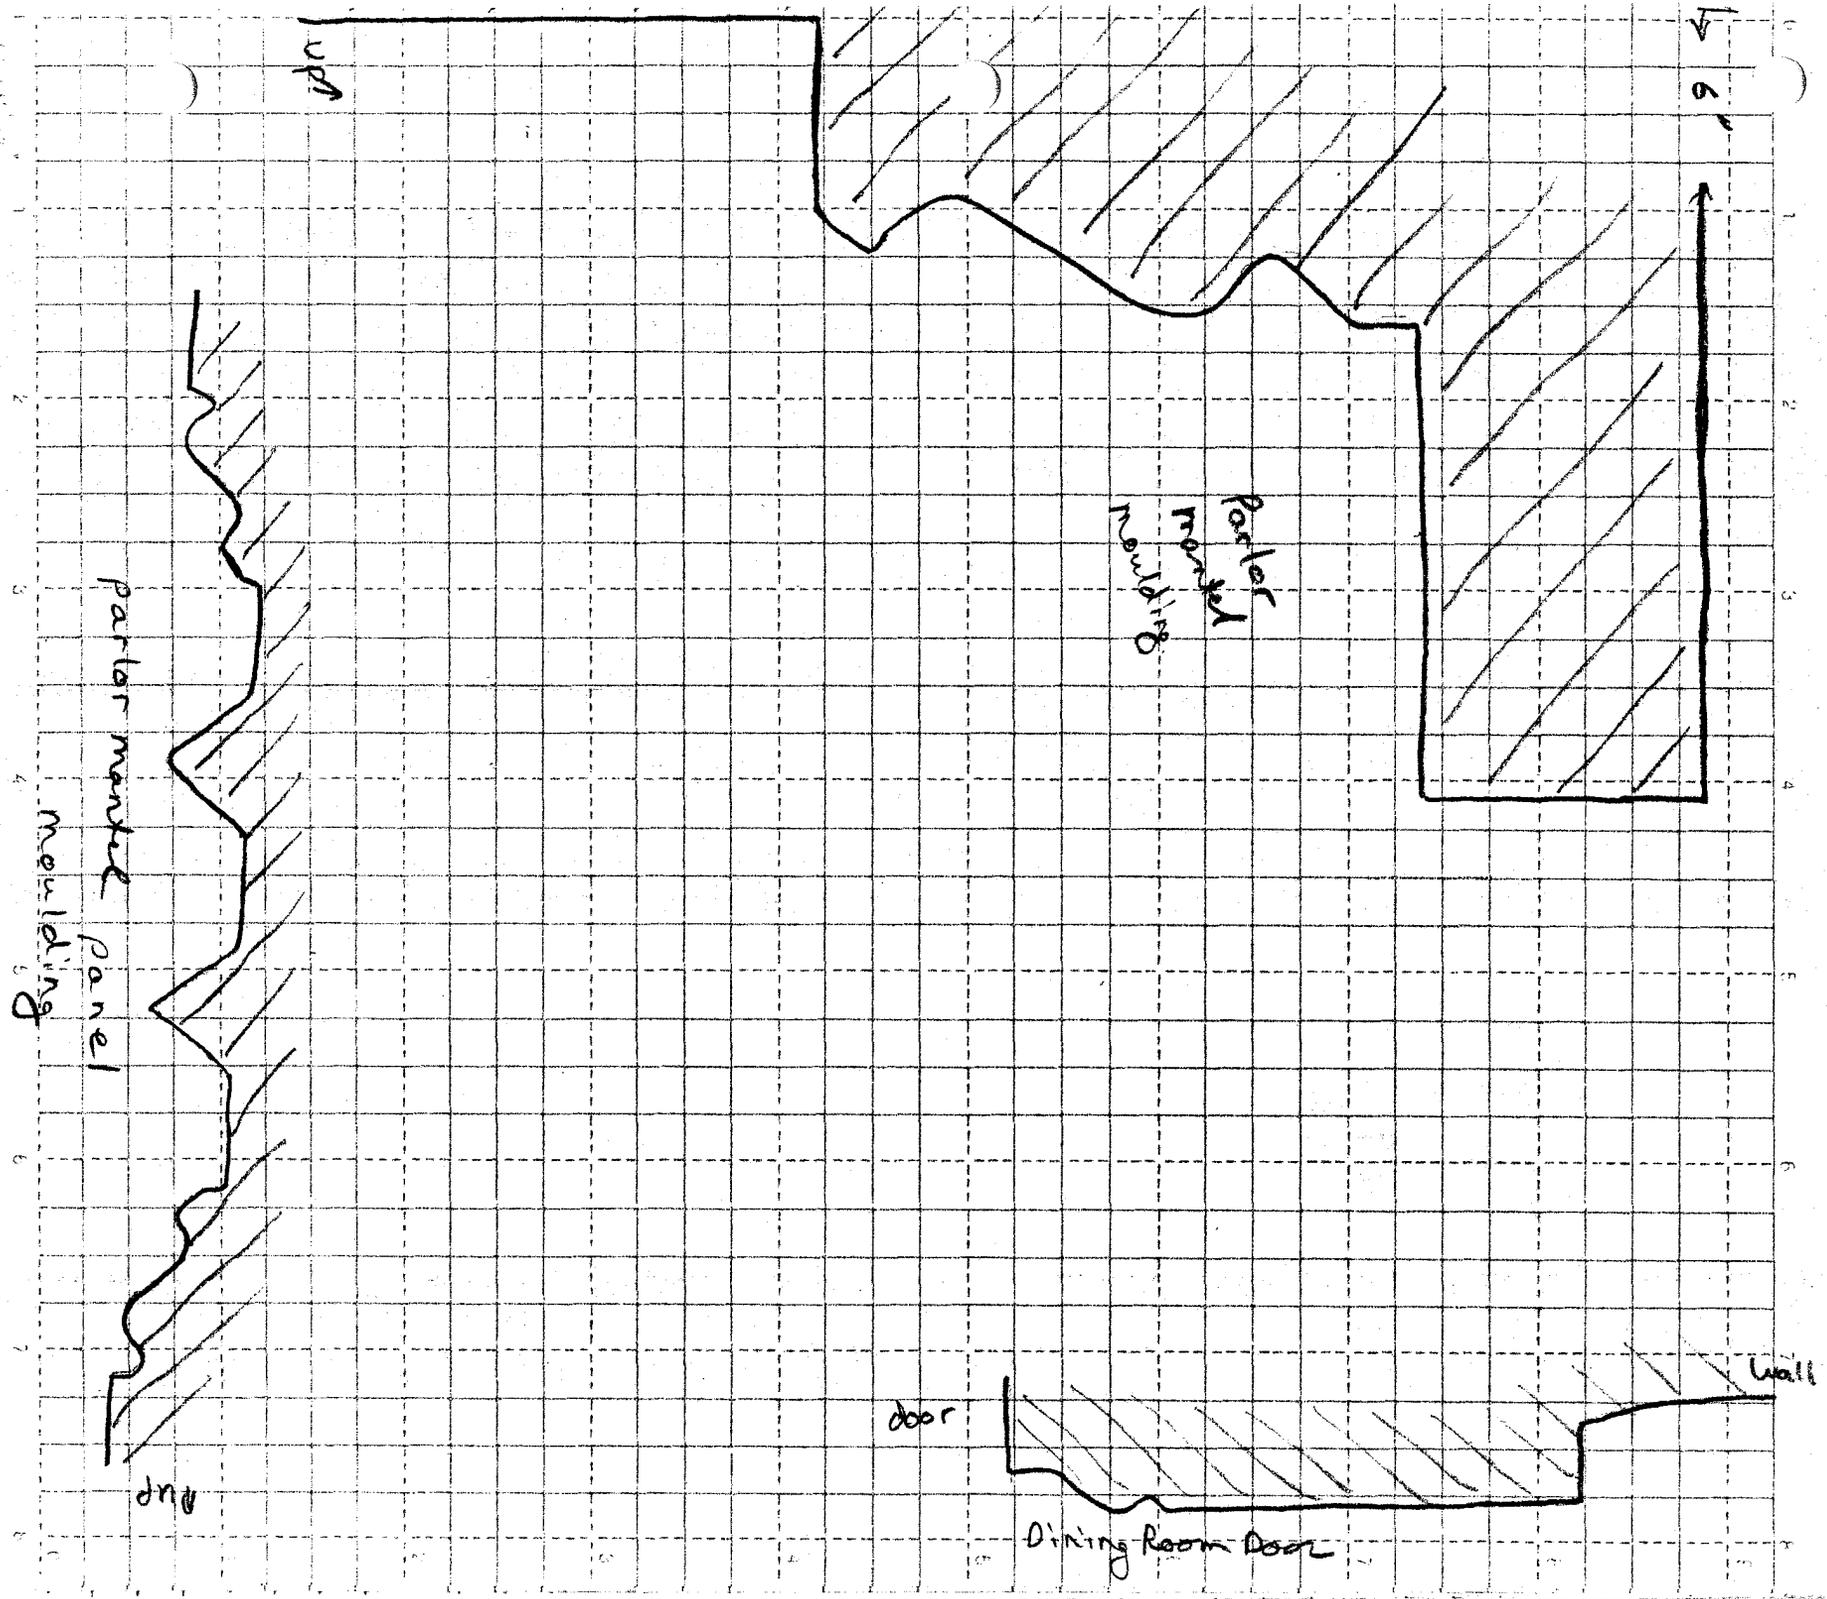
4758 Schalk Rd #1
Moulding Profiles
CARR-1148

Parlor
moulding
profile

door
Dining Room Door
