CARR - 1162

7576 MIDDLEBURG ROAD

FIELD SHEET--HISTORIC RESOURCES SURVEY

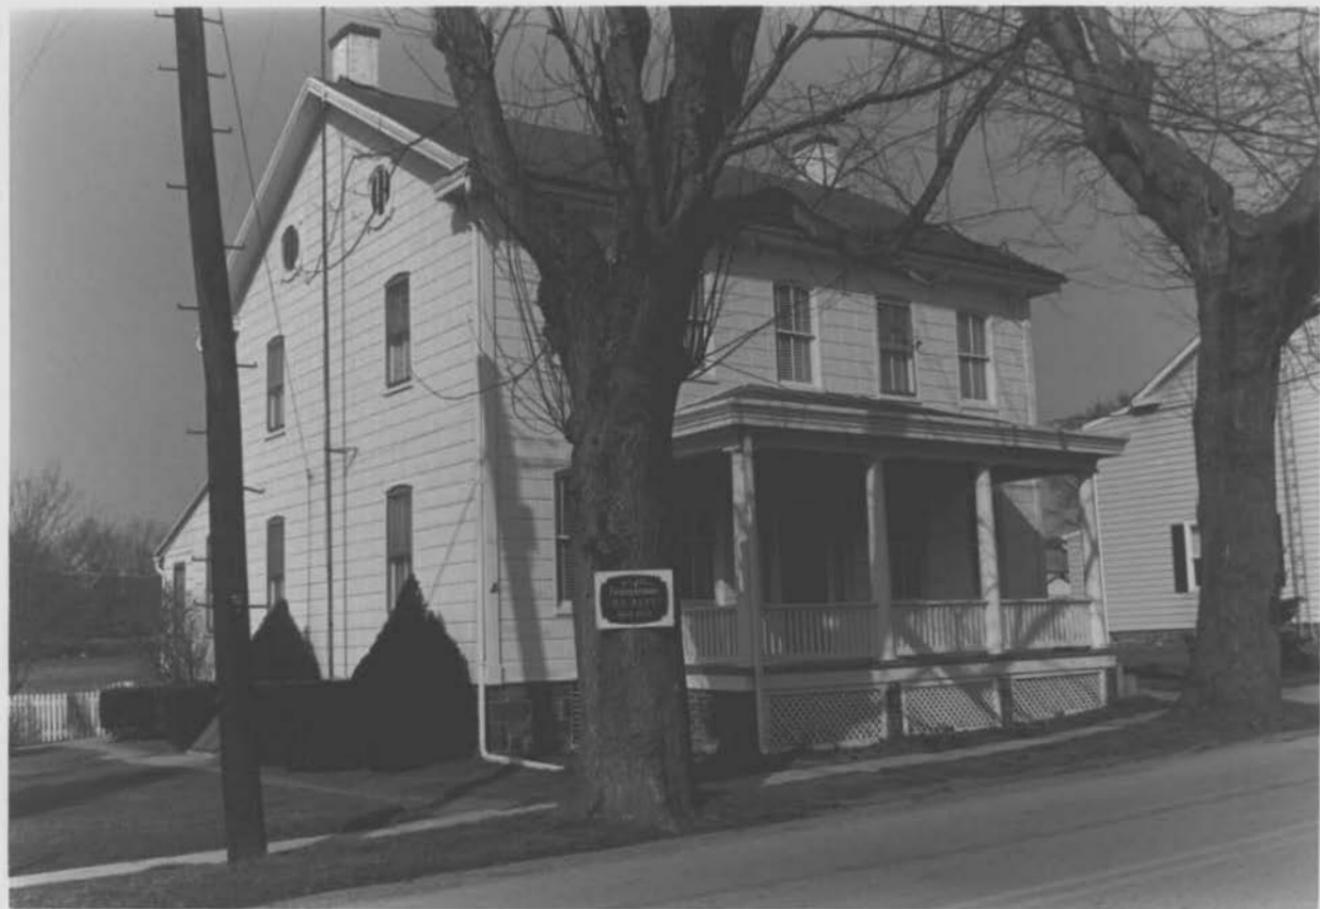
1. CARR-1162 7576 Middleburg Rd
2. Carroll Co., Md.
3. Joe Getty
4. April 1986
5. Md. Hist. Trust, Annapolis, Md
6. S & W elevations
7. 1/1

The frame house at 7576 Middleburg Road depicts the regional house type under the influence of nationally popular Victorian ornamentation. These details include the wood siding scored to imitate stone usually associated with the Italianate style, arched window frames, a wide arched door frame, three-bay front porch, and circular windows in the gables.

Regional house type showing influences of rural Victorian ornamentation, such as the imitation stone wood siding, arched window frames, 3-bay one-story porch, and circular windows in the gable ends.
