CARR - 1165

7573 MIDDLEBURG ROAD

FIELD SHEET--HISTORIC RESOURCES SURVEY

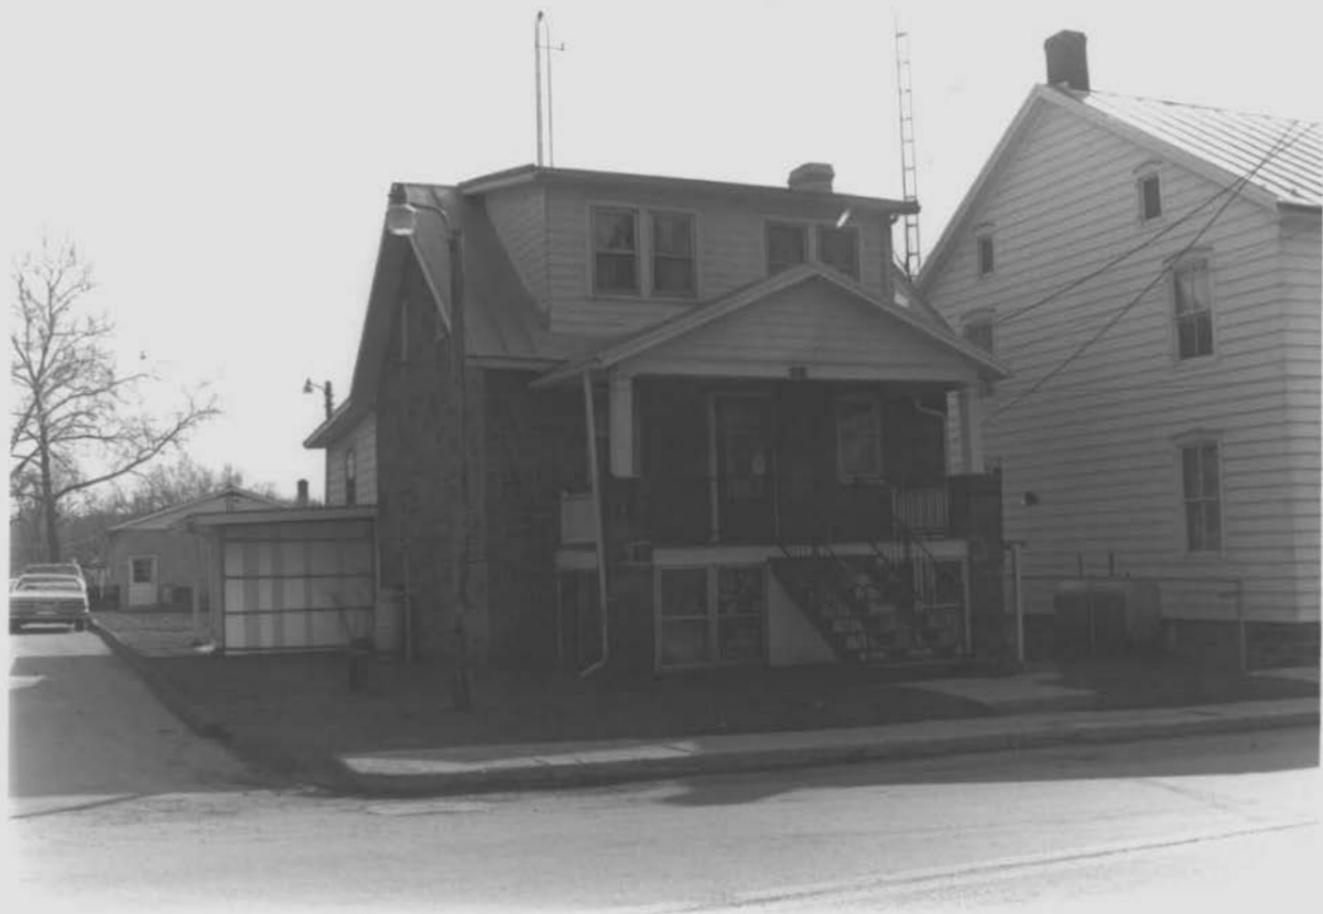
CARD-1165

Vernacular style stone structure that has 20th century additions (shed roof
 dormer and gable roof porch) that give it a bungalow style appearance.

1. CARR-1165 7573 Middleburg Road
2. Carroll Co., md
3. Joe Getty
4. April 1986
5. Md. Hist. Trust, Annapolis, Md
6. N & E elev. (Camera facing sw)
7. 1/1
