CARR-1237

Horse Barn

Springfield Hospital Center

# Maryland Historical Trust State Historic Sites Inventory Form

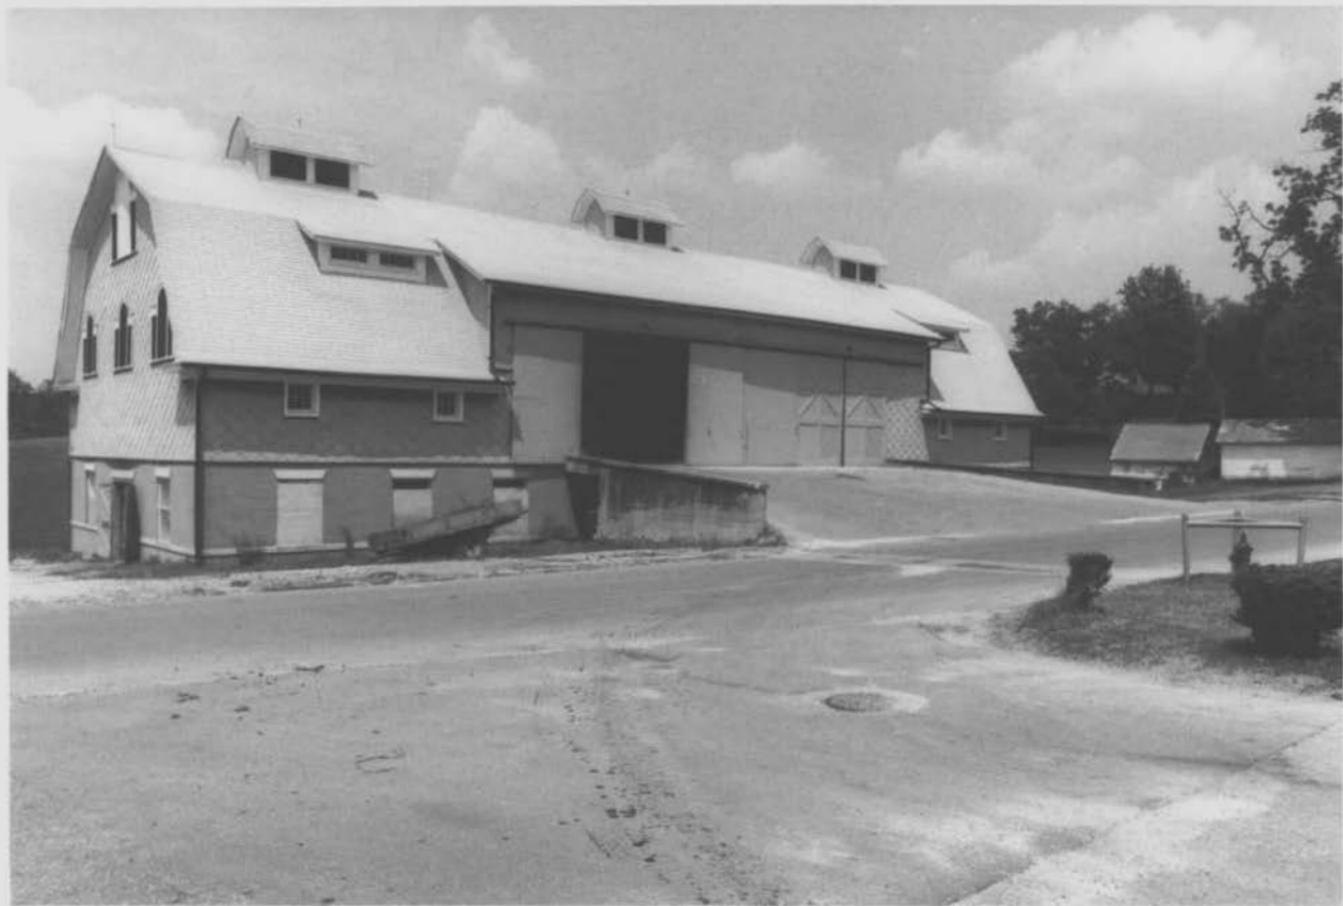
East

The main distinction on the east wall is the large entrance. The east wall is interrupted by a slightly projecting shed roof which extends from the fourth bay to the eighth bay. The shed roof allows for three large sets of double doors which slide open on a track.
