CARR-1238

Dairy Barn

Springfield Hospital Center

# Maryland Historical Trust State Historic Sites Inventory Form

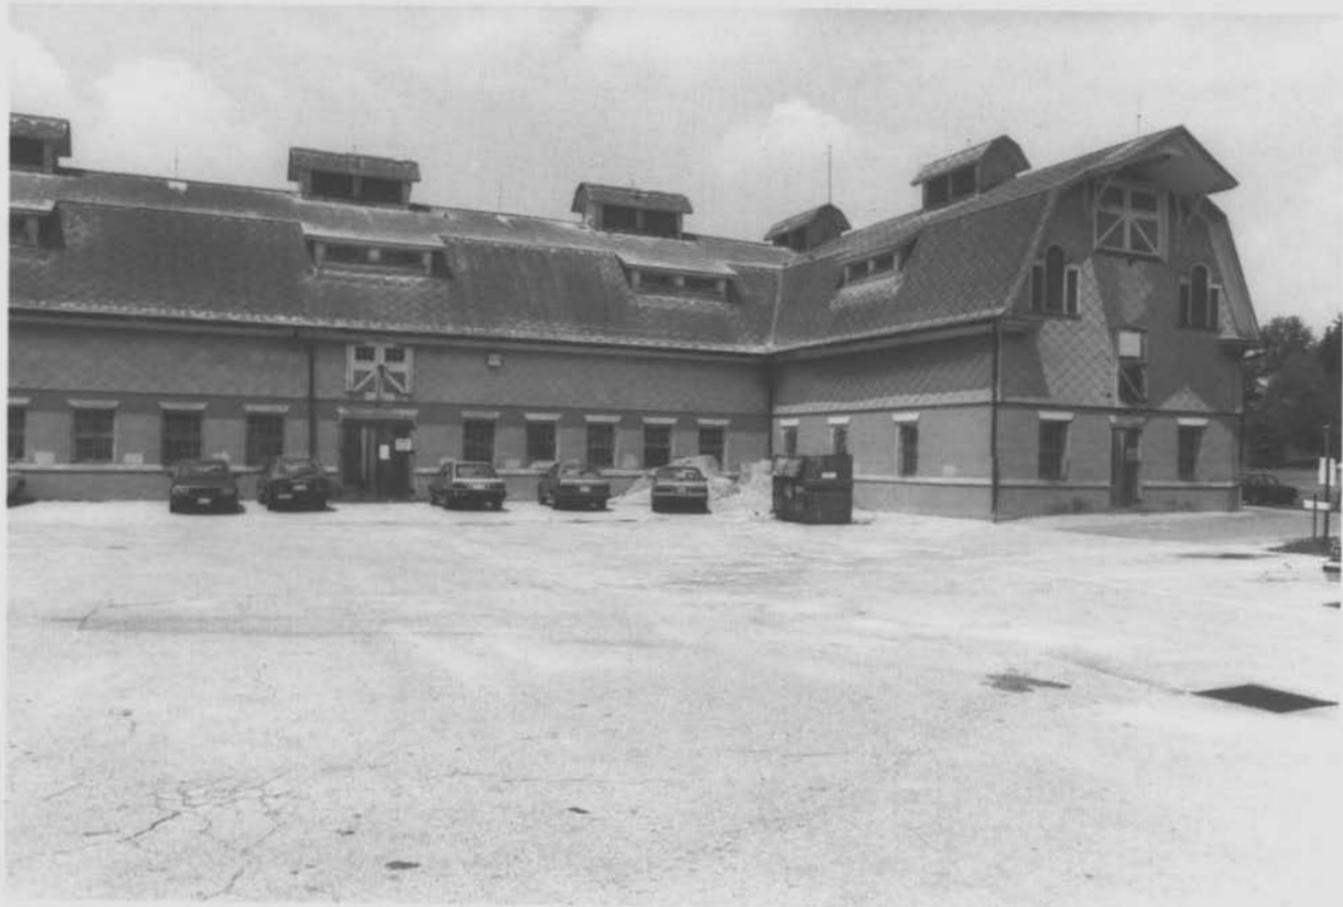
East

The east and west gambrel ends exhibit return eaves and plain projecting verges. The windows on the gambrel ends are Palladian with louvered faces. The surrounds of the windows are wooden. The gambrel ends also display a third floor, barn door. The double wooden door is located below the peak of the roof. The roof overhang shelters the door. The overhang itself is supported by brackets.

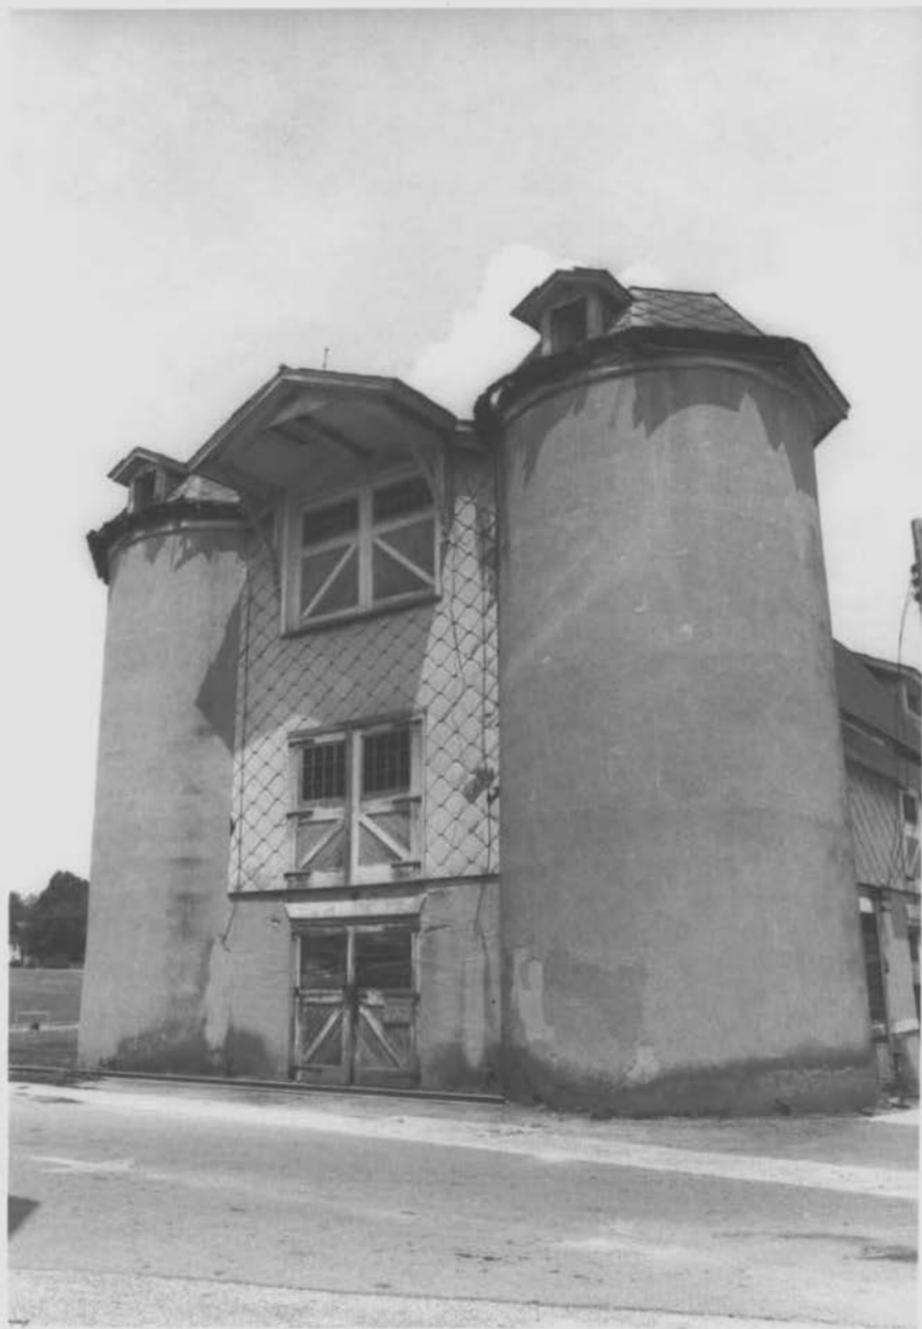
South Walls

The southern wall of the T projection does not end in a gambrel. The corners of the building are embellished by two silos constructed of stucco over cast concrete. The silos rise the three stories of the barn and are capped by a bellcast tower roof. On the southern portion of the silo roofs, there is a gabled dormer. The roof of the dormer mimics the large overhang of the other roof. This southern wall between the two silos does not reveal any Palladian windows but instead a wooden door occupies the central bay on each floor.
