Maryland Historical Trust State Historic Sites Inventory Form

historic South Gatehouse (Springfield Hospital)

and/or common Staff House #15

CARR-1252
South Gatehouse (Springfield Hospital)
7283 Cooper Drive

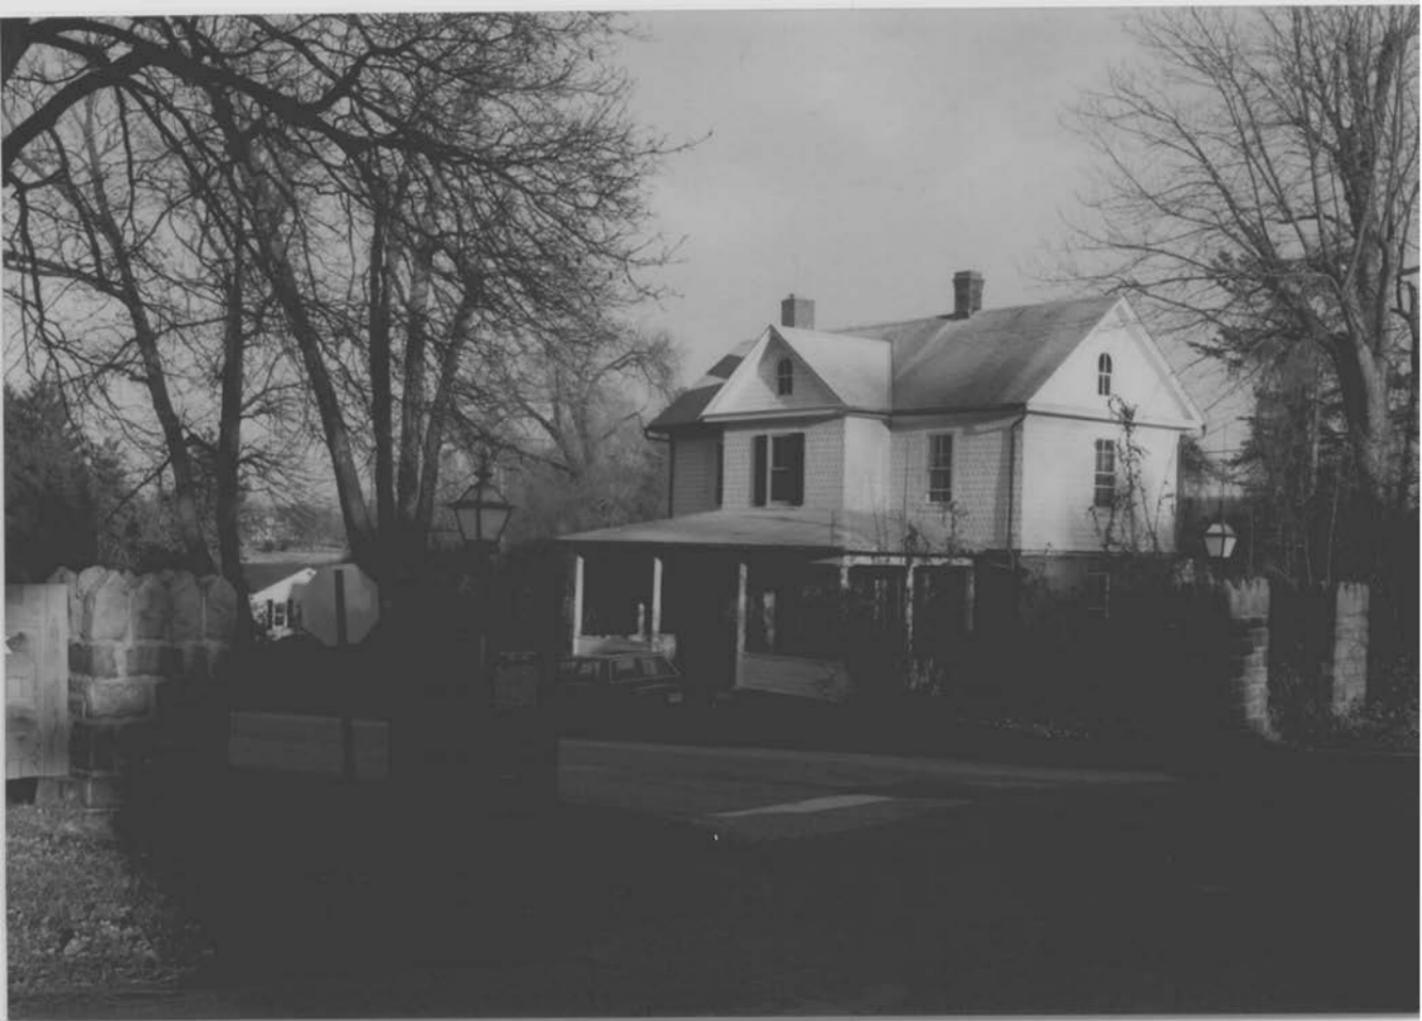
1/4

Neg. Loc.: Maryland Historical Trust
 gate & gate house - NW & SW elevs.

About 25 feet west of the gatehouse is a gateway consisting of two pairs of random ashlar piers that are widely spaced between the pairs. The top stones of each pier are set vertically and pointed. The inner two piers are topped with metal lanterns. There were apparently gates between the narrow openings in each pair of piers, as some portions of iron hinges and latches survive.

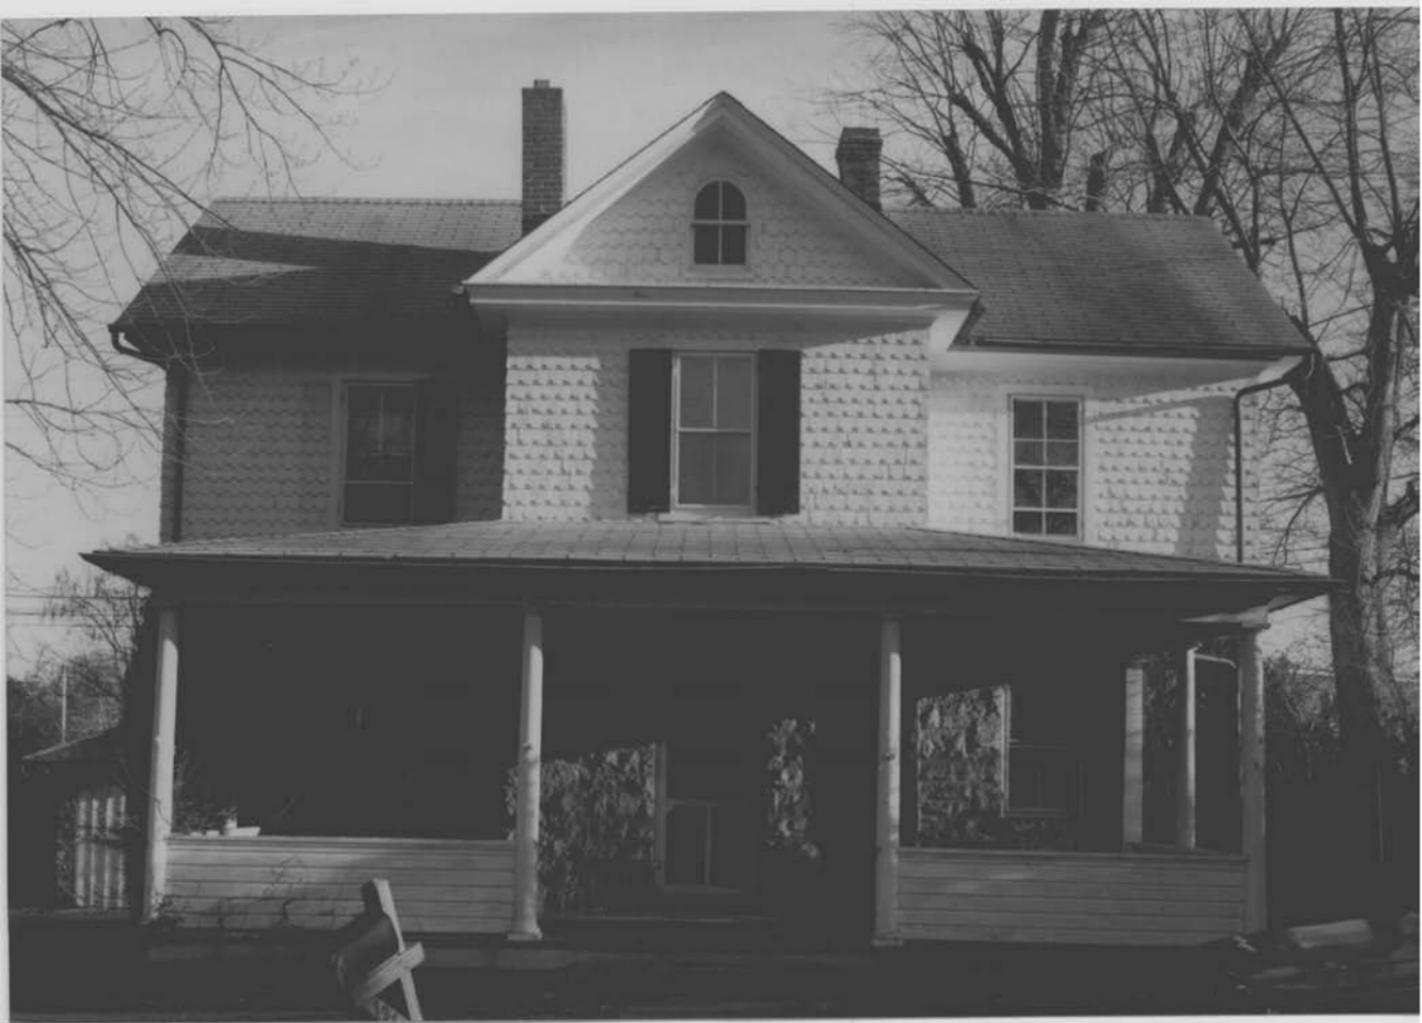
2/4

NW elev.

The northwest elevation on the first story has a center entrance with one light over one lying panel in the center, and two panels at the bottom. The panels have sunk fields and ovolo panel moulds. There is a two-light transom above. The door is set in a bullnose-

moulded frame. On either side is a single 2/2 sash in a bullnose-and-cavetto-moulded frame. These windows had shutters. On both the northeast and southwest elevations of the projecting bay are single 1/1 double-hung sash in identical frames. There is a one-story, three-bay porch with a wood deck set on stone piers. It has wood Doric columns and a balustrade of German siding on the exterior, and beaded-edge-and-center vertical boards on the interior. The porch has a hip roof with asphalt shingles. The second story has three 2/2 sash with shutters, and a beaded-interior-edge architrave. The break between the wood of the second story and the stone of the first story has a kick with an ogee moulding below it. The wood box cornice has an ogee bed mould and an ogee cymatium. The center bay has a pediment that is filled with the same shingles and cornice and has a semicircular-arched 2/2 sash. There is an interior brick chimney between the center bays and the end bays on each side.

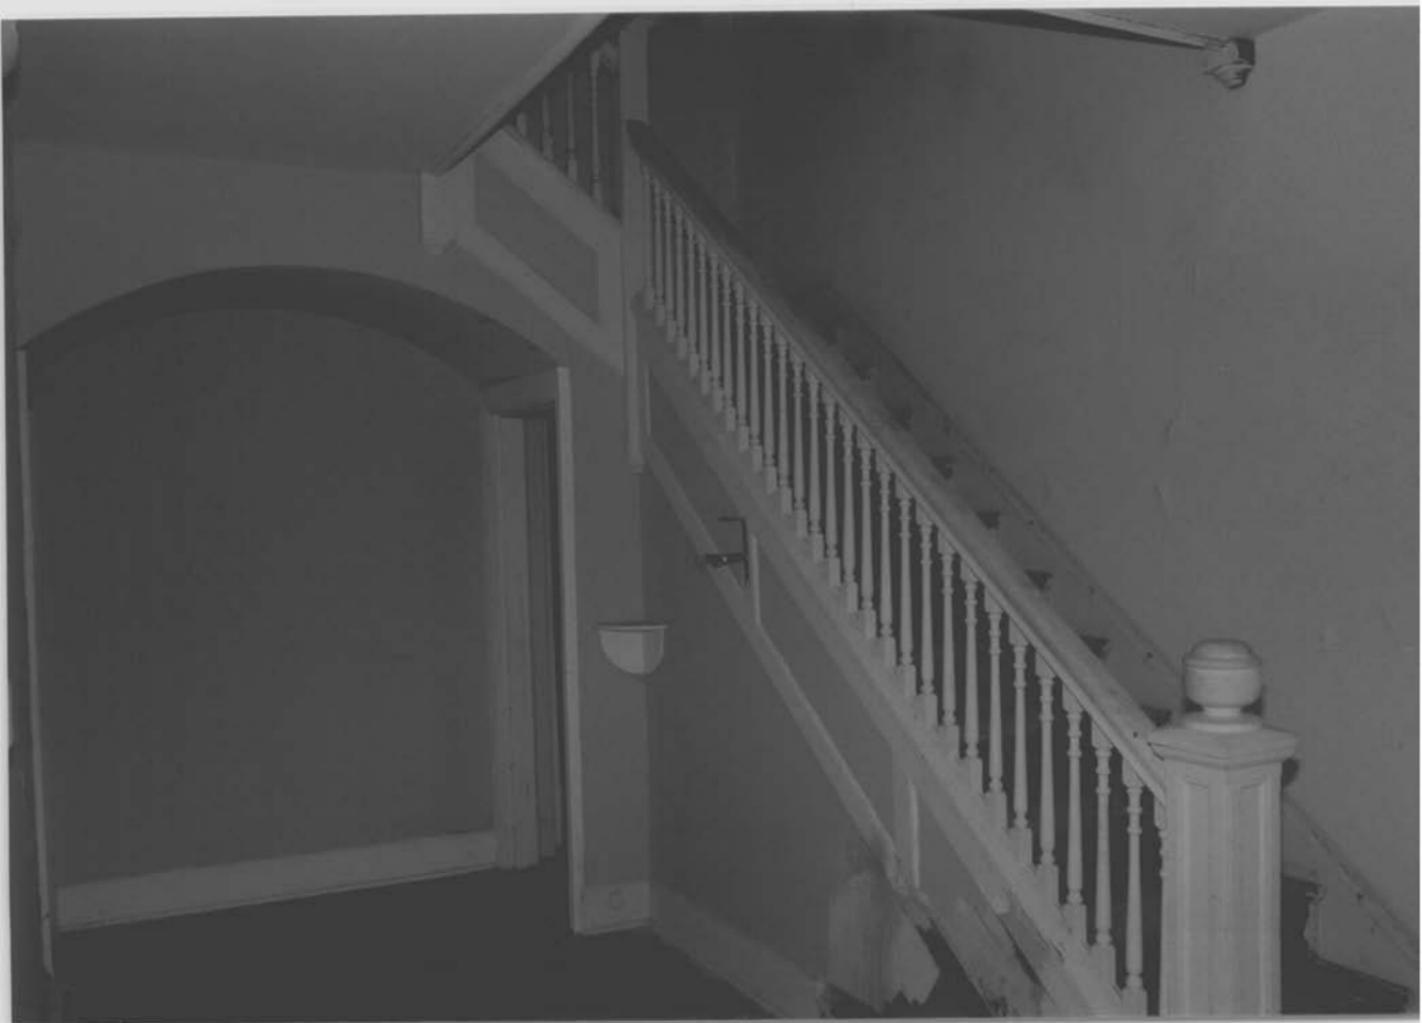
Stairway - view South

The first story has a center-passage, single-pile plan with a pantry at the southeast end of the passage. All of the woodwork throughout the house appears to have originally been varnished, but is now painted. The architrave in the passage is identical to that in the cellar. There is a closed-stringer, two-flight stair along the southwest wall. The stringer is paneled, with flat sunk panels that have ovolo and cavetto panel moulds. There are turned balusters and a handrail that is moulded on both sides. The square newel has flat sunk panels with egg-and-dart panel moulds. It also has a bead-and-reel moulding at the corners and an acorn finial. It appears to be of oak. The southeast end of the passage is narrower because of the stairs and the ceiling under the stairs is segmentally arched. The baseboard in the passage has a torus with a bead above it. The windows have sash weights and latches on the top rail of the bottom sash.

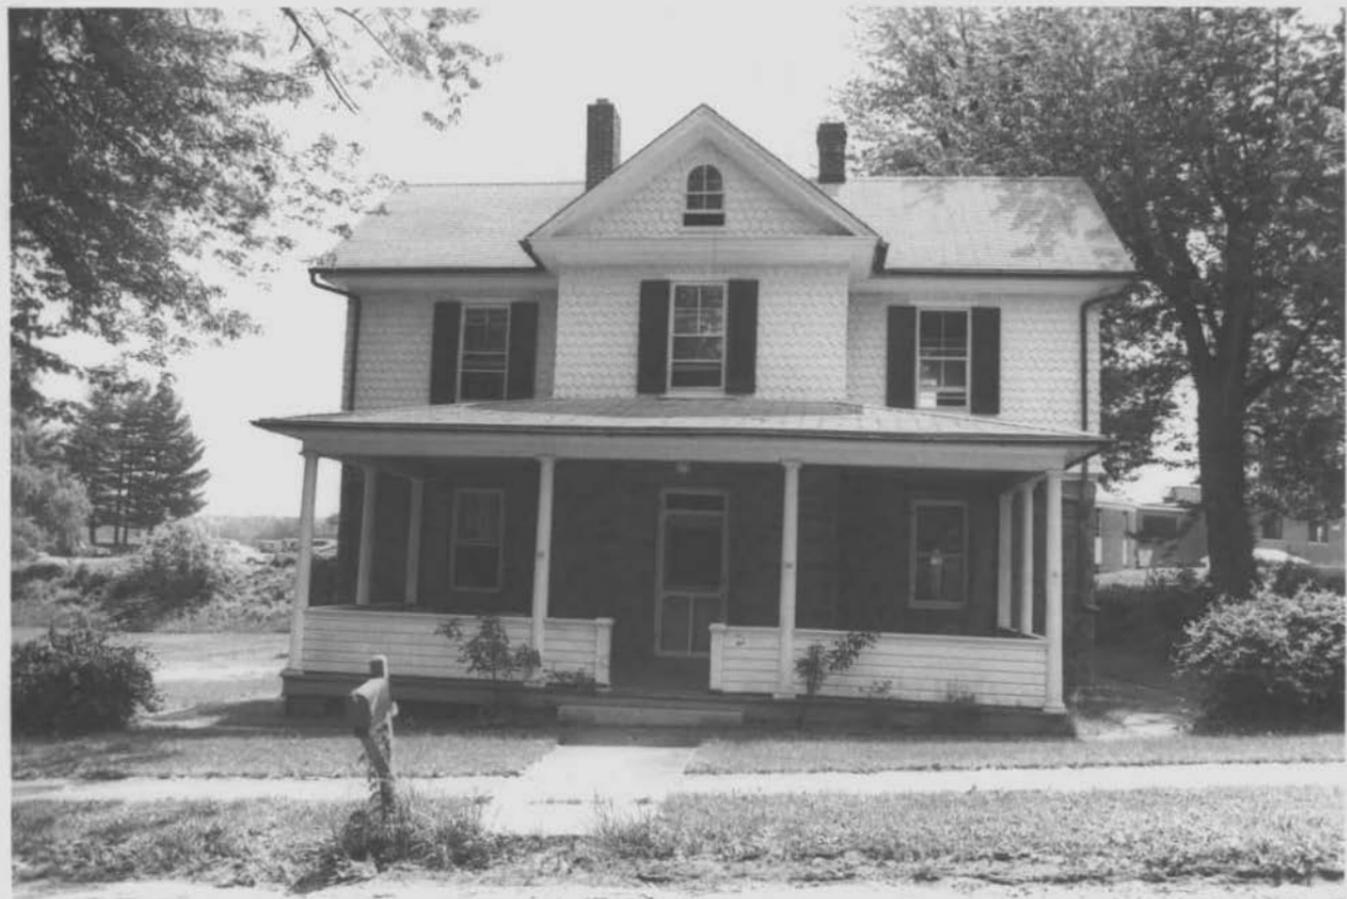
NO 4-113
CARR-1252

Negatives at MHT
North

The north wall is three bays wide, consisting of two bays flanking the central bay of the projecting gable. A wooden porch extends the length of the north facade. Stone piers support the wooden porch. Tongue and groove flooring, plain columns, and a shiplap railing characterize the shed roof porch. On the first floor, two windows flank the projecting gable. The windows are recessed with a 2/2 double-hung sash. The windows display stone sills and lintels and the only distinction which distinguishes them as such is the thinner cut of the granite. This sill and lintel pattern repeats on the front door located at the middle bay. The single, wooden door exhibits an inverted cross pattern and a two pane transom.

On the second floor of the north wall, the building is covered by octagonal shingles. The second floor fenestration repeats the 2/2 sash but adds wooden shutters to the windows. The wooden surround functions as the sill and lintel. The pediment gable displays plain projecting verges and a rounded arch window of 2/2. Two central interior brick chimneys protrude through the roof line. One breaks the ridge of the roof while the second chimney appears on the slope of the roof.

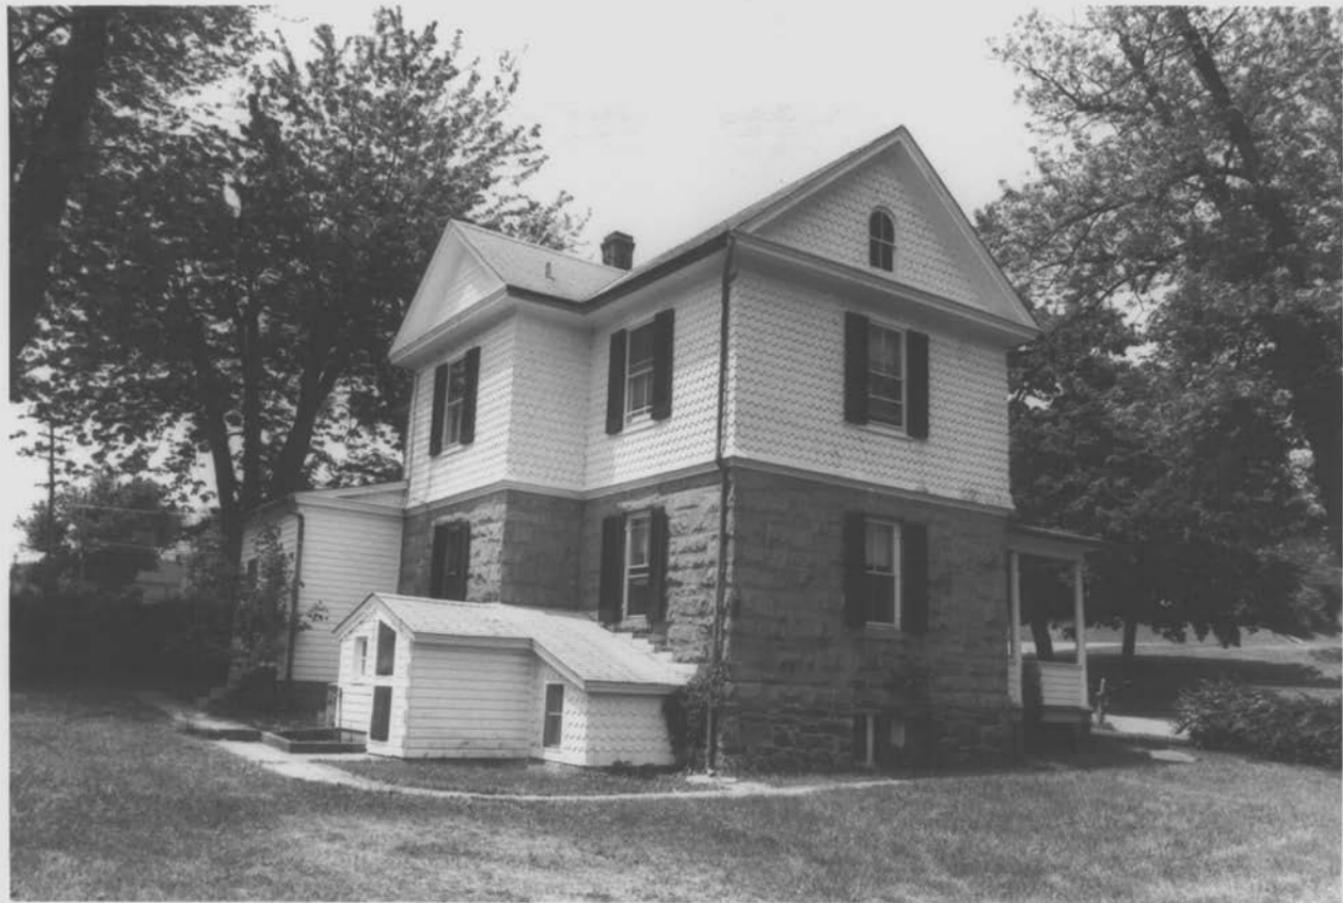
South and East

The east and west walls of the dwelling share similar appearances. The rubblestone foundation is slightly exposed on these walls. The east wall displays a single casement window on the ground level. The remaining wall space on each face repeats the fenestration and construction material patterns established on the north facade. The pediment gable shows plain projecting verges.

The south wall displays two wooden additions constructed of shiplap siding. The east addition is a half story tall attachment that provides access to the basement. The second addition attaches to the western portion of the wall and measures one bay by one bay. The one story addition exhibits a shed roof, an 1/1 window, and single door.

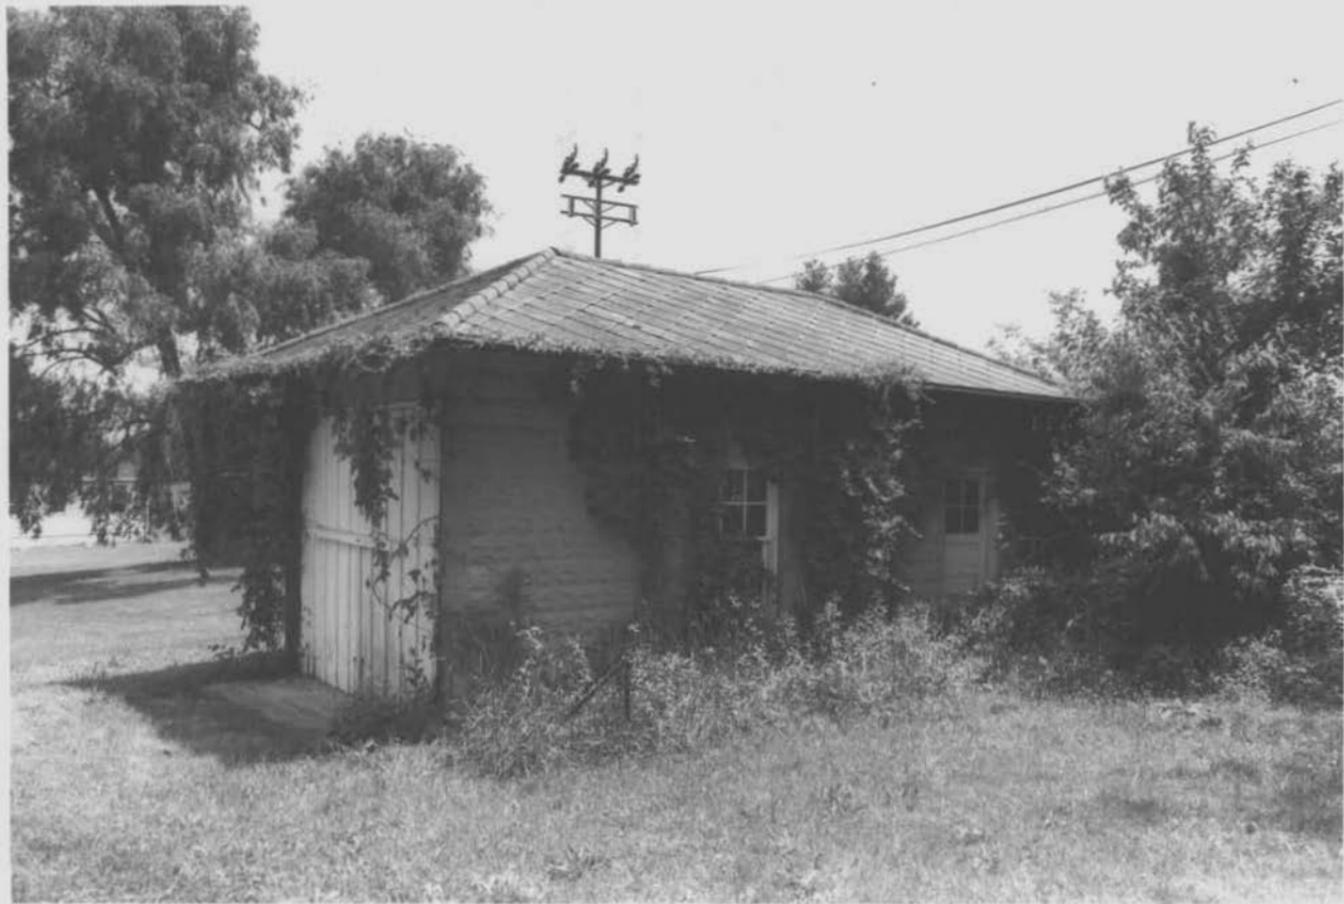
Staffhouse #15 Garage

West and North

A one story, cement block garage lies just southeast of the residence. It measures one bay deep and two bays wide with a hipped roof. A double door constructed of board and batten appears on the north wall.
