CARR-1300

3831 Lineboro Road
Lineboro (vicinity)

Maryland Historical Trust State Historic Sites Inventory Form

name/title Kenneth M. Short, Historic Planner

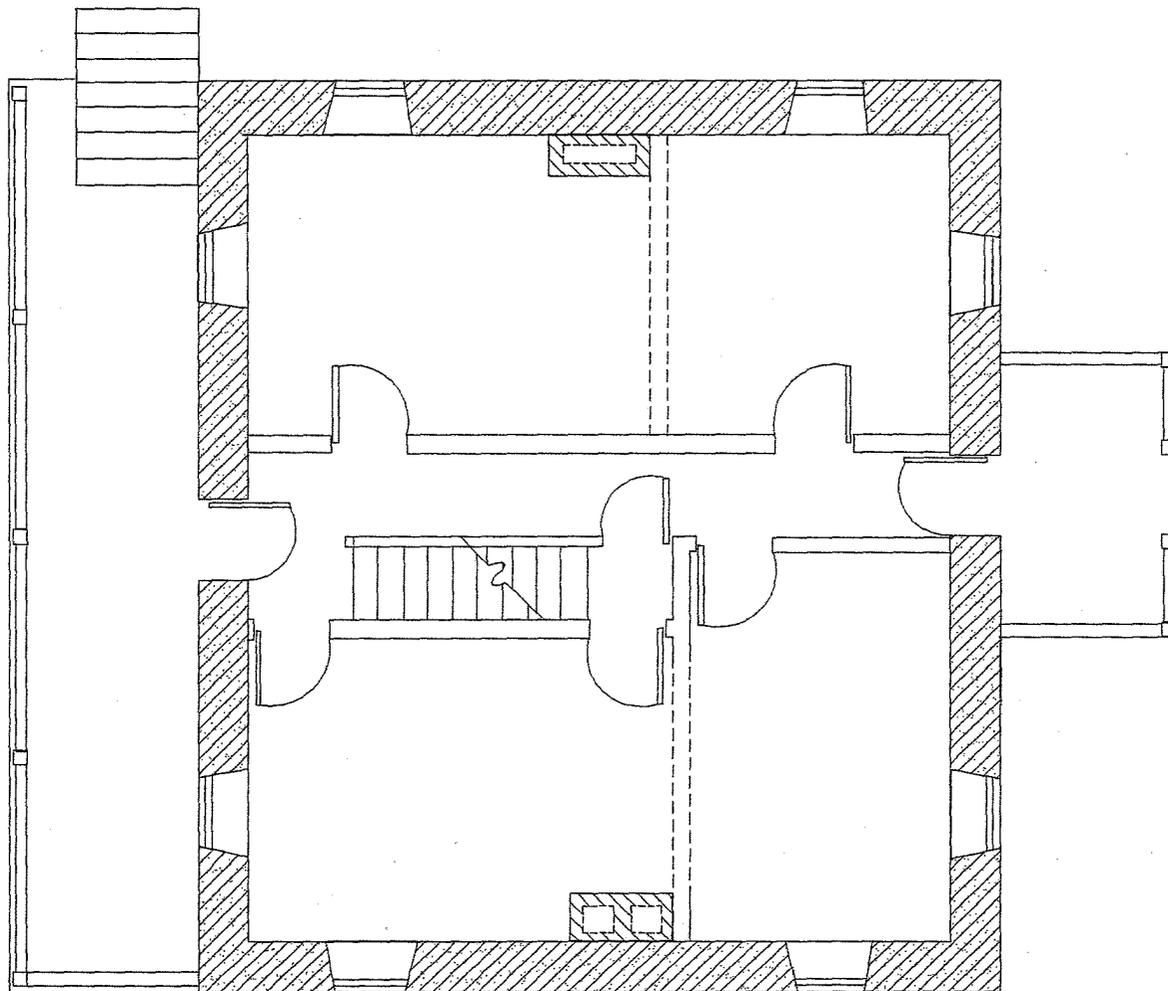
First Floor
Plan

The plan of the house has a central passage with stair hall on the southwest wall toward the northwest end of the house. The open-stringer stairs have a turned baluster and newel. The passage is narrower to the southeast in order to make the south room larger. This room has been altered, but was originally entered from the passage. The west room can be entered from either the foot of the stairs or under the stair landing. There is evidence that the northeast room was originally divided in two, the north half being larger. None of the rooms had fireplaces, although it is likely that the north and west rooms had stoves, since they have brick chimneys. The cellar contains a brick wall in the center, running northwest to southeast. The joists are sawn, as are the rafters.

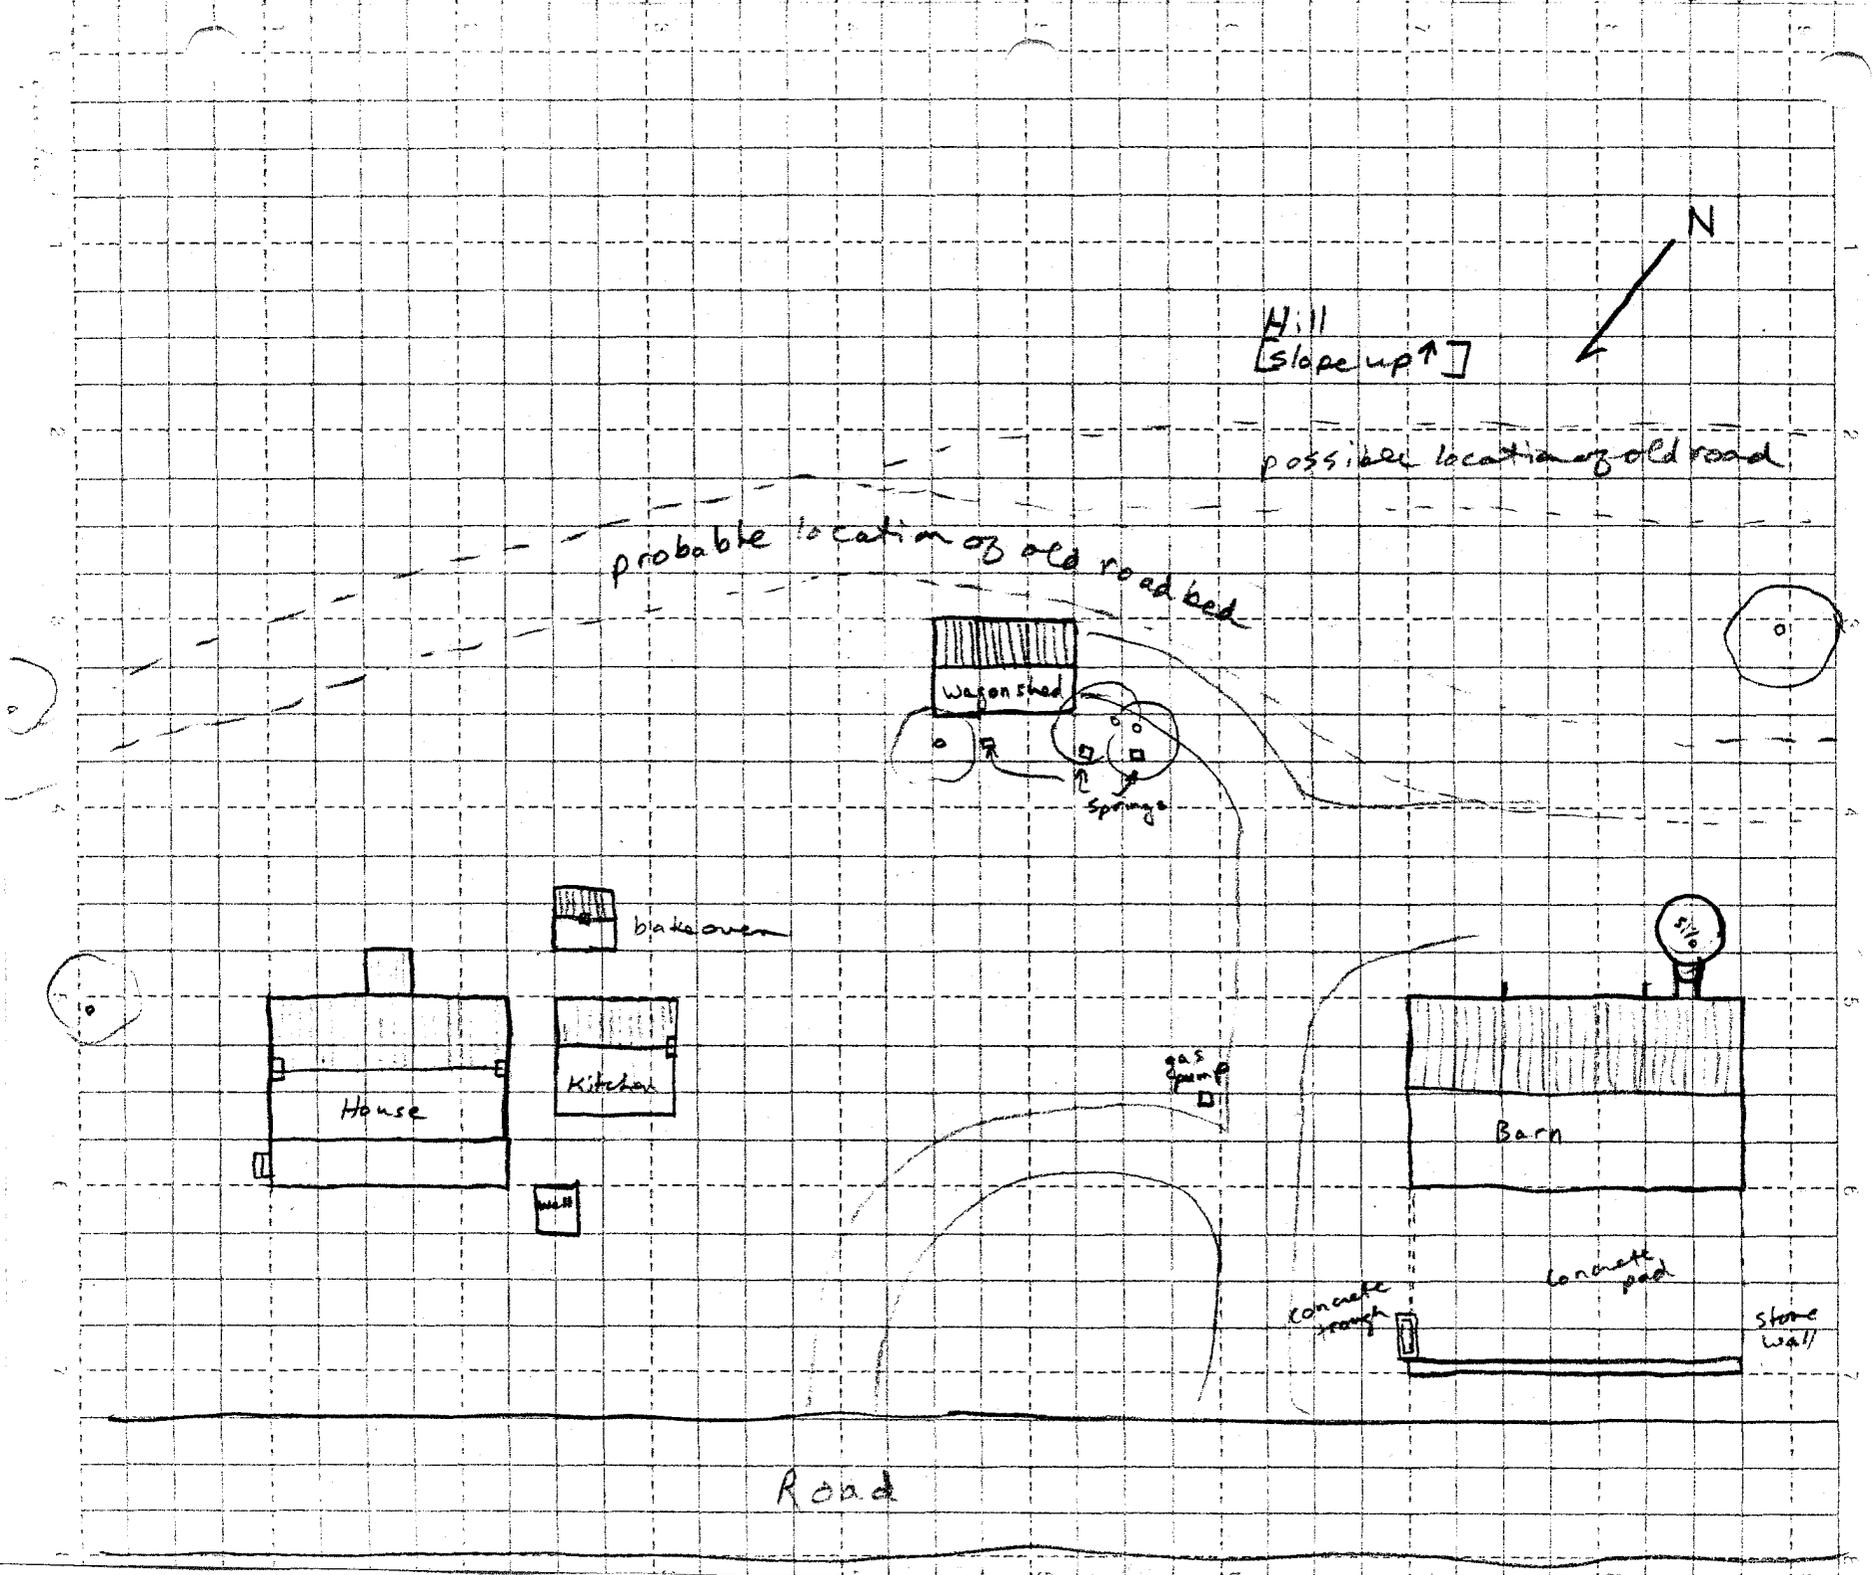
3831 Lineboro Road
Site Plan
ARR-1300

The property at 3831 Lineboro Road is located on the southeast side of the road approximately one mile southwest of Lineboro. It is located in the middle of a low ridge, close to Lineboro road, which has been moved. Formerly, Lineboro Road was located east of the buildings and was very close to the barn. The complex is laid out on a linear farm plan and consists of a stone house, stone summer kitchen, log and brick smokehouse/bakeoven, frame wagon shed and frame bank barn.

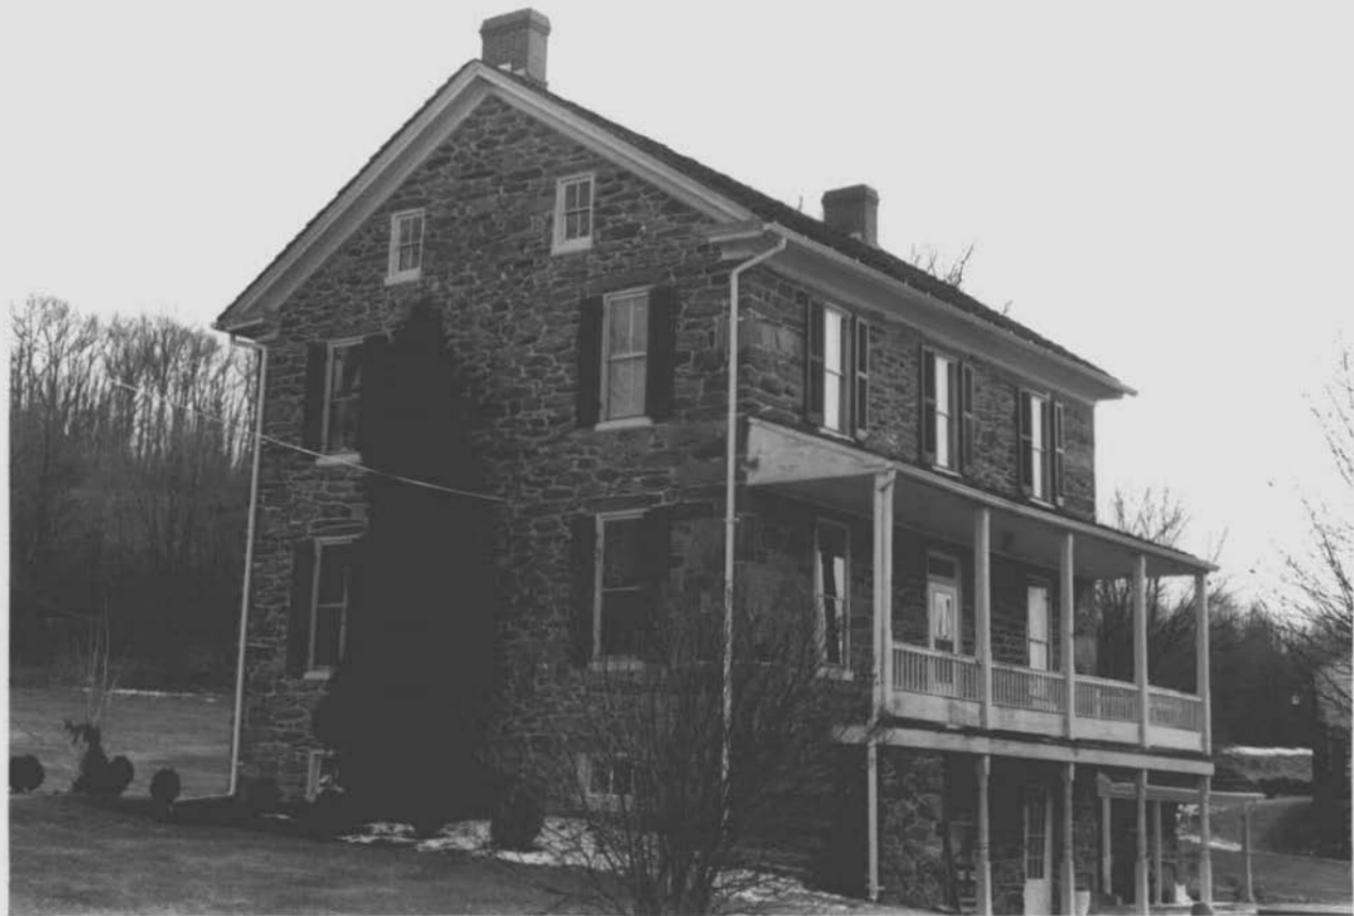
1/11

The house is two-stories high and three bays by two bays. It is built of rubble fieldstone, with quoins. The gable roof has wood shakes, although there is evidence that the roof covering was formerly slate. The house is banked on the southeast, with the cellar of the northwest elevation exposed. This wall has doors at either end with a window in the center bay. The house has predominantly 2/2 double-hung sash with wood sills, stone lintels, and blinds. Several windows have been replaced with 1/1 sash. The first story of the northwest elevation has a center entrance with two-light transom. There is a raised, shed-roof porch on the first story supported by a stone pier on the north end, and four turned posts, at the cellar level. Above are five chamfered posts and a balustrade of square-in-plan vertical balusters above a horizontal board rail. The stairs are on the northeast end of the porch. Two extend beyond the porch and the remaining six are within the porch proper, running alongside the stone pier under the porch roof. There is a box cornice and an internal brick chimney at each end. The northeast

elevation has two two-light sash in the cellar and two small 2/2 sash in the gable end. The southwest elevation contains a 1/1 sash in the west bay of the cellar and two small 2/2 sash in the gable end, as well. The southeast elevation has a center entrance with a two-light transom and a one-story, one-bay, shed-roof porch on stone piers. It has four chamfered posts and a balustrade that matches the northwest porch.

House - northeast & northwest elevs.

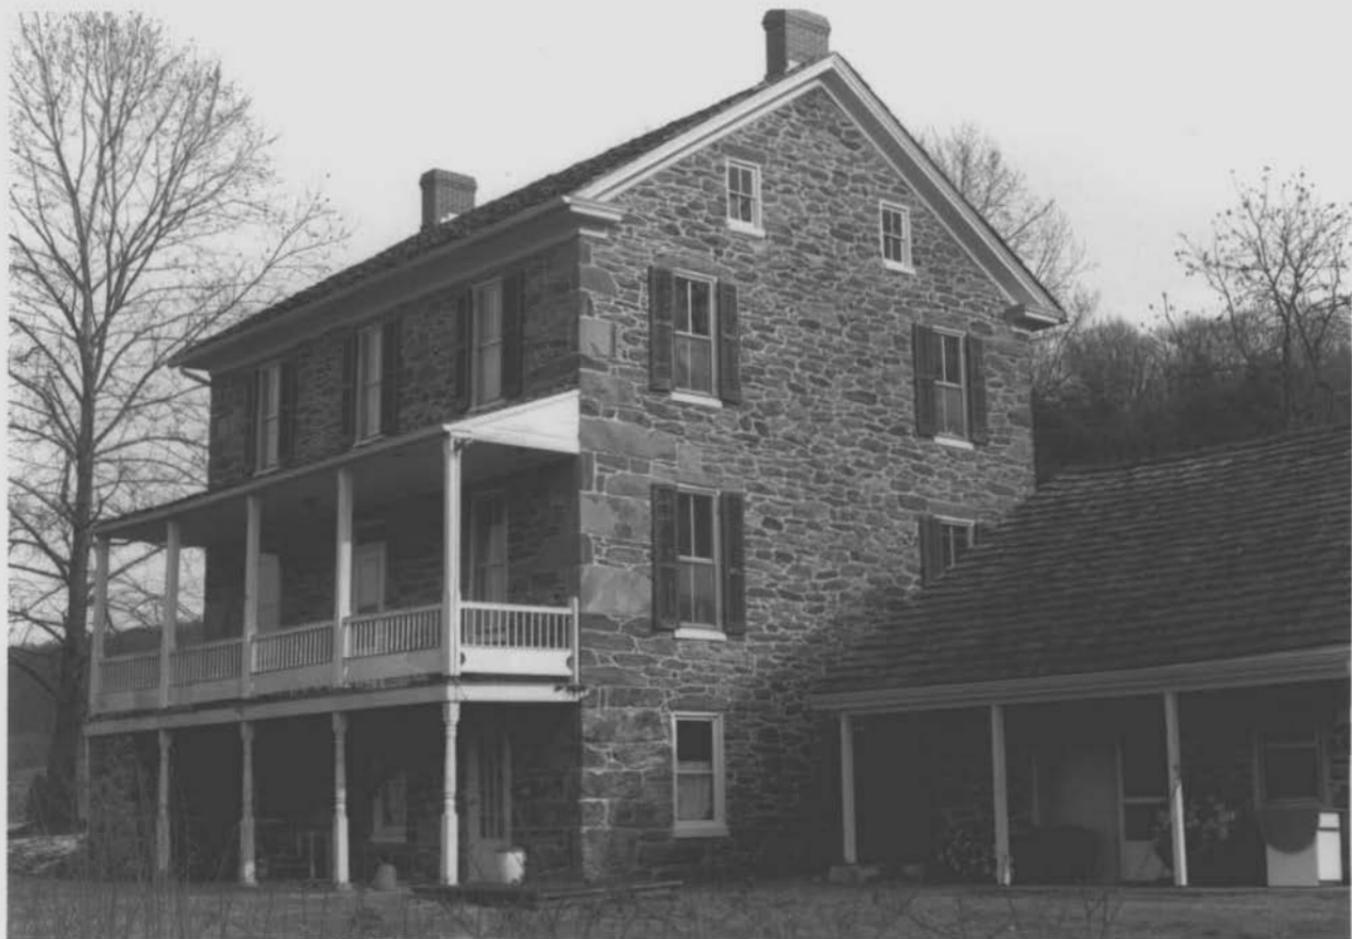
2/11

House - northwest & southwest elevs.

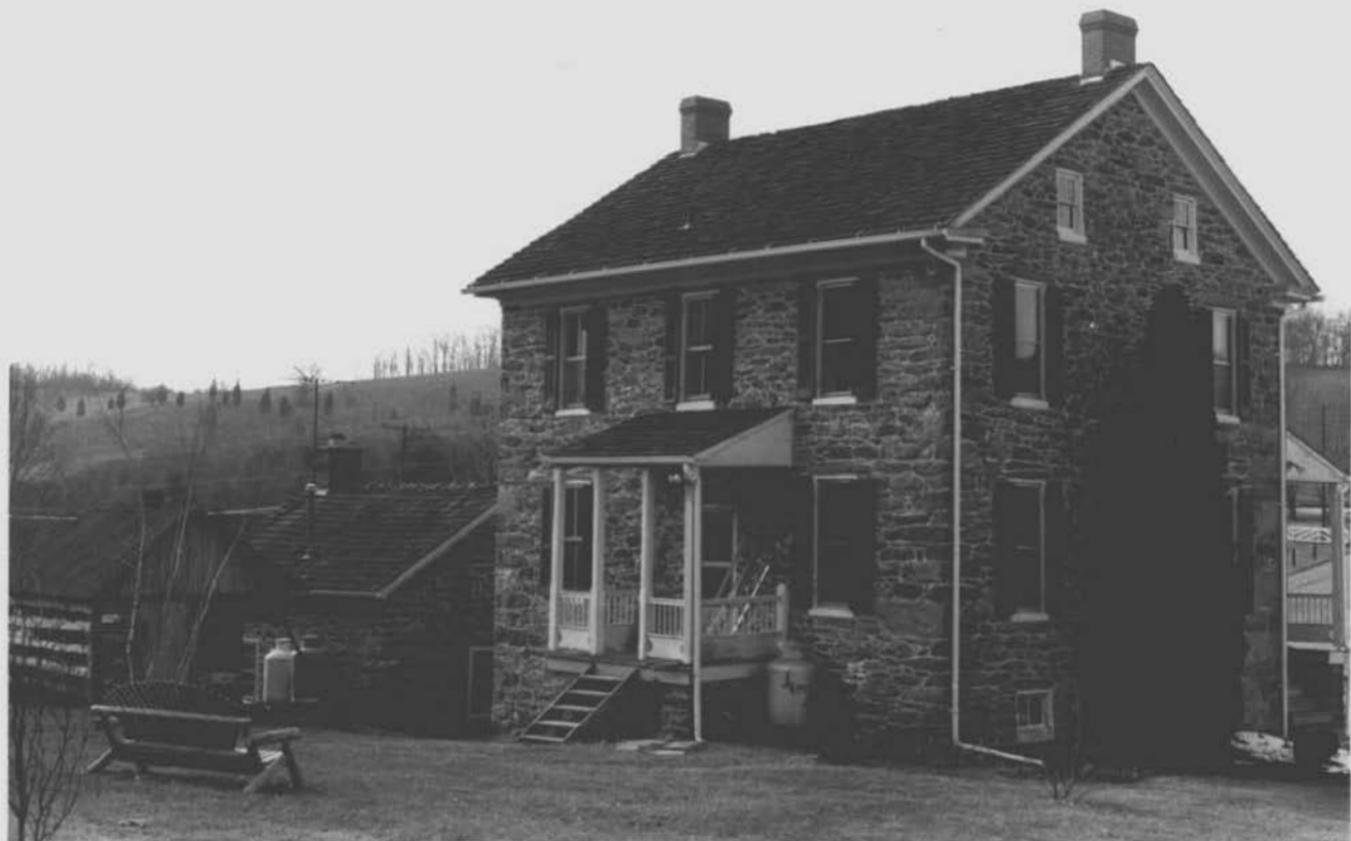
3/11

Bake house, Summer Kitchen, & House - southeast & northeast elevs.

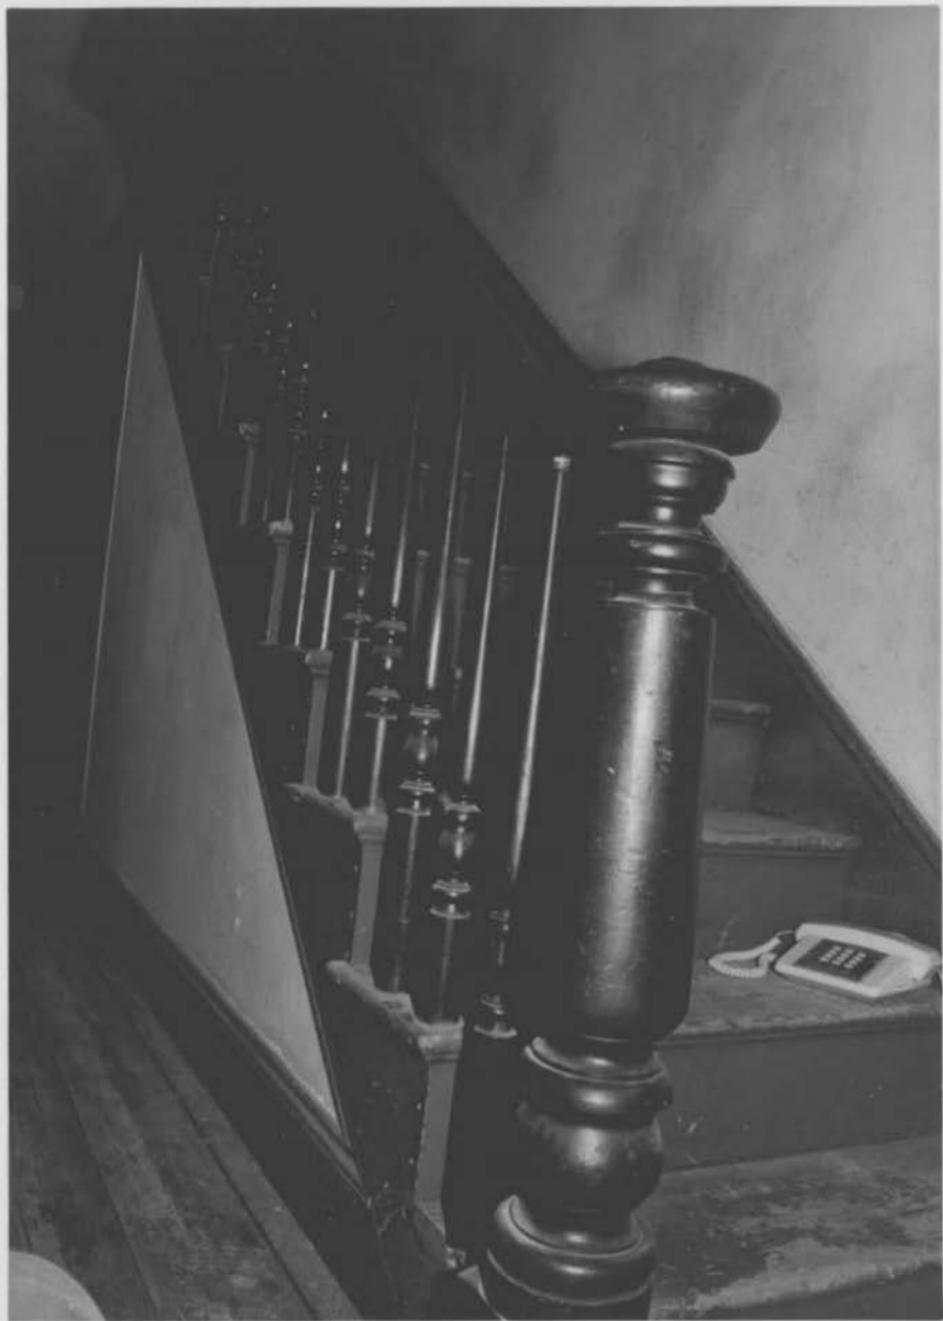
#11

Stairway

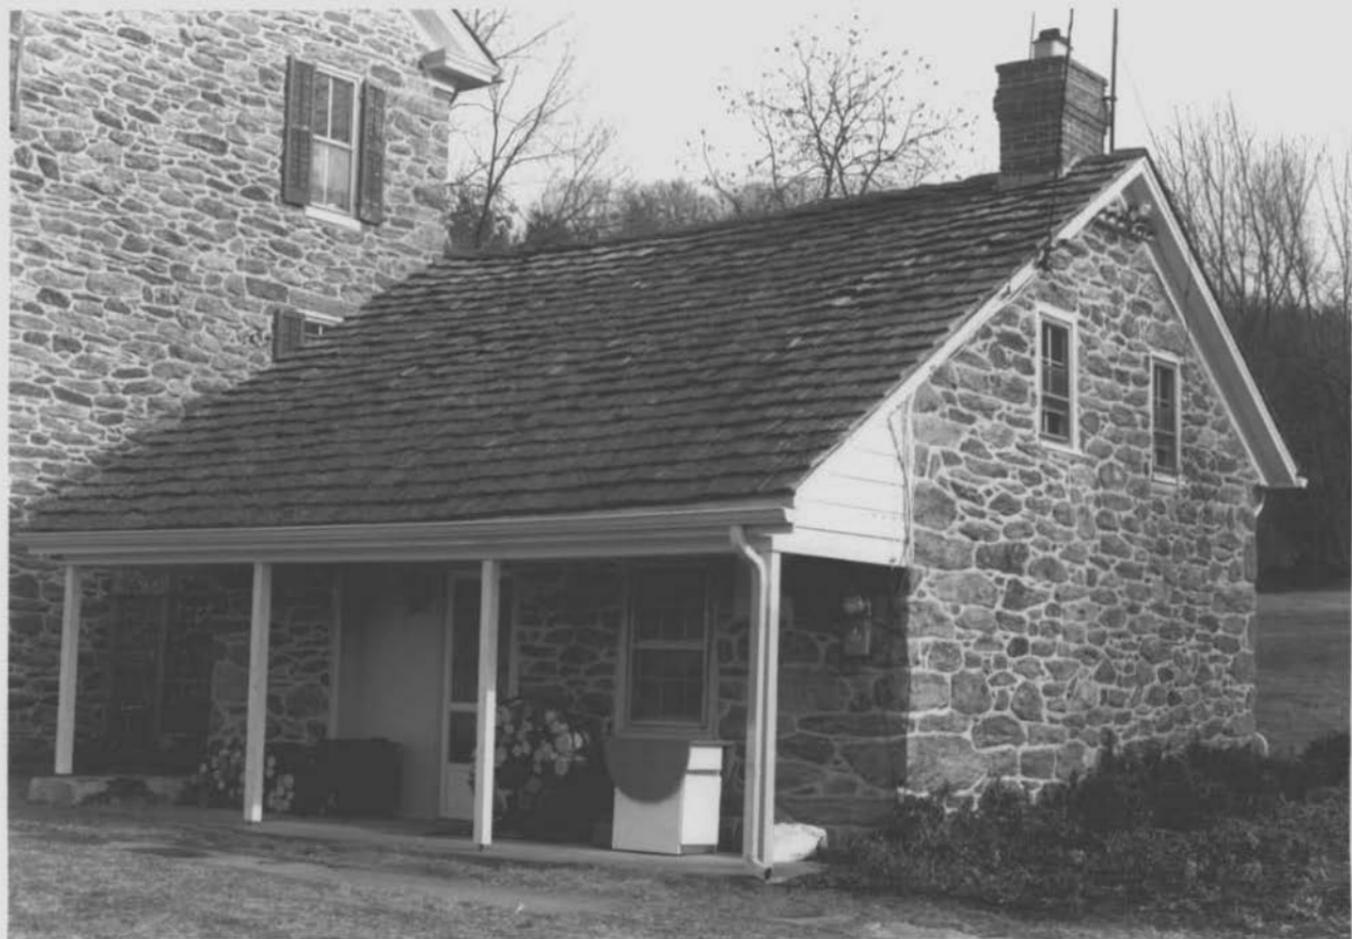
5/11

Southwest of the house is a one-story rubble stone summer kitchen. The gable roof has wood shakes and is carried beyond the eave on the northwest to form an integral porch supported by four square posts. There is an internal brick chimney on the southwest gable end. The northwest elevation is two bays, with a recent door and wood infill in the north bay and a 6/6 sash in the west bay. The southwest elevation has two 4/2 sash in the gable end. The southeast elevation has a 6/6 sash in the south bay. There is a single 6/6 sash centered on the northeast elevation.

Summer Kitchen - northwest & southwest elevs.

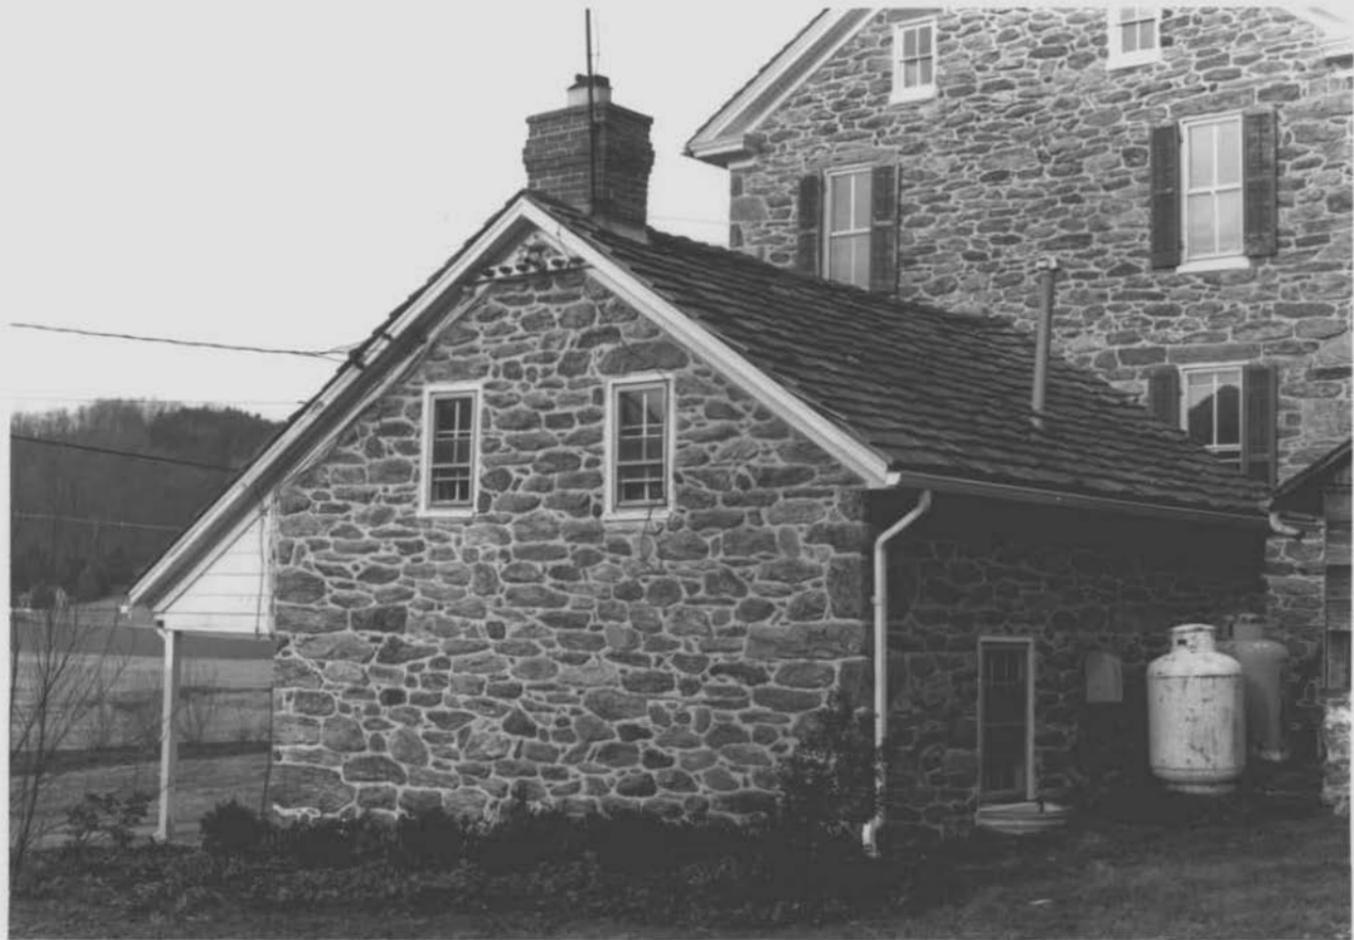
6/11

Summer Kitchen - southwest & southeast elevs.

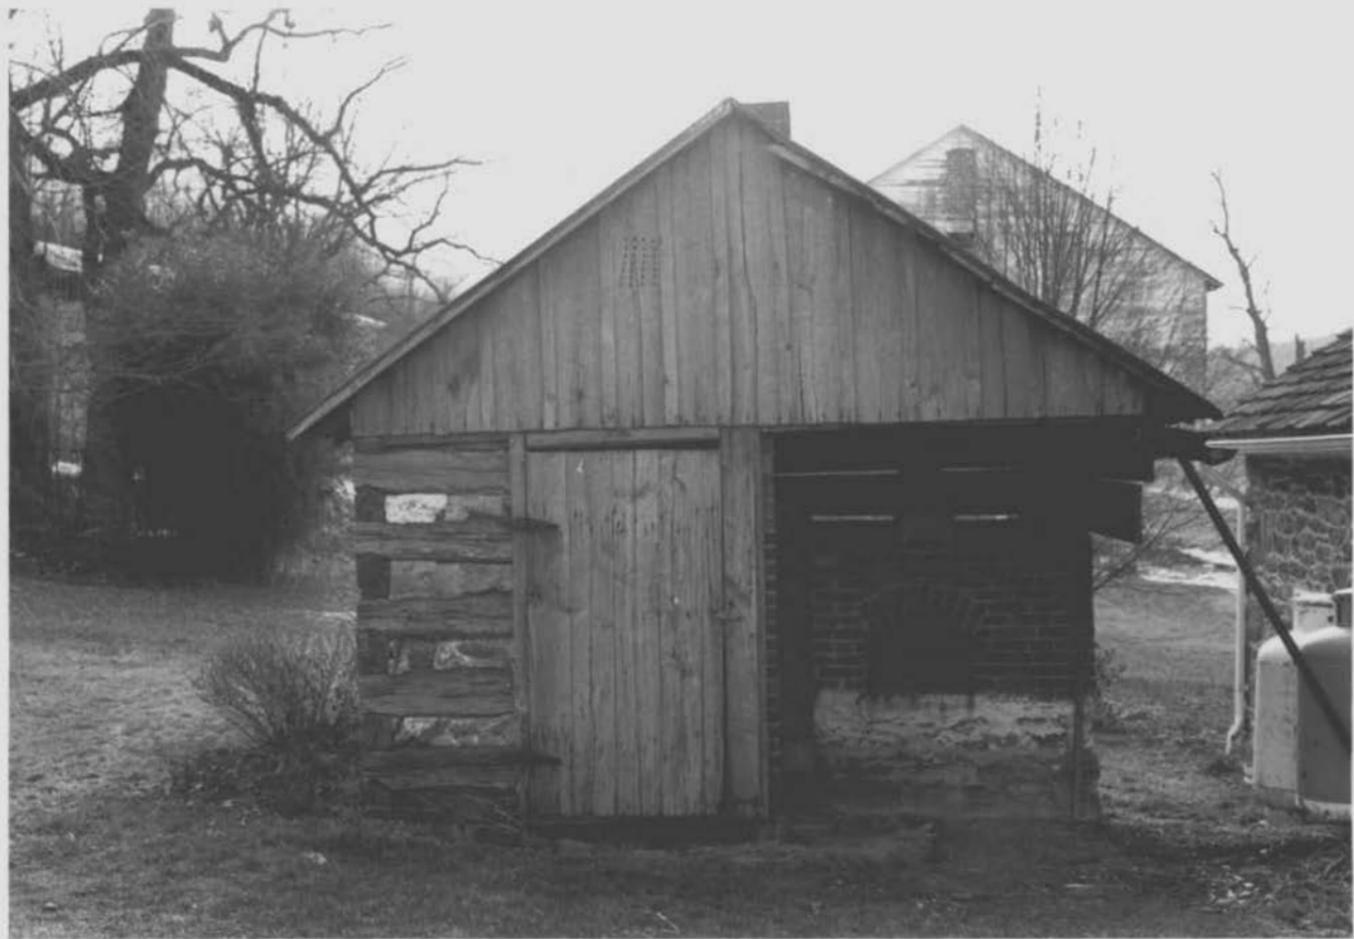
7/11

Southeast of the summer kitchen is a one-story square smokehouse/bakeoven with a corrugated metal gable roof and a rubble stone foundation. The building is divided in half by a brick wall that runs northeast to southwest under the roof ridge. The southeast half is built of V-notched log with diagonally-laid stone chinking set in mortar, and is the smokehouse. The brick firebox is in the south corner, with an opening in the southwest wall. The northeast elevation has a vertical board door. The smokehouse has four beams that rest on the end girts and parallel the brick wall. Two of them have metal hooks and two have wood pegs on the sides. The northwest half of the building contains the squirrel-tail-flue bakeoven. The brick oven is set on a stone base to the southwest and fills less than half the space. The arched opening to the oven is on the northeast. The opening to the fire pit is at ground level on the southwest side. There is a wood post in the south corner, and was formerly one in the north corner that supported the plate and roof rafters. Some of the clapboard siding on the southwest and northwest elevations of the bakehouse survives. The entire northeast gable end of the bakeoven is open below the girt for access. Both gable ends of the structure are covered with board and batten siding. The chimney of the bakeoven exits the oven at the top front, above the oven door. It rises several feet straight up, then turns southeast on a forty-five degree angle,

Bakehouse - northeast elev.

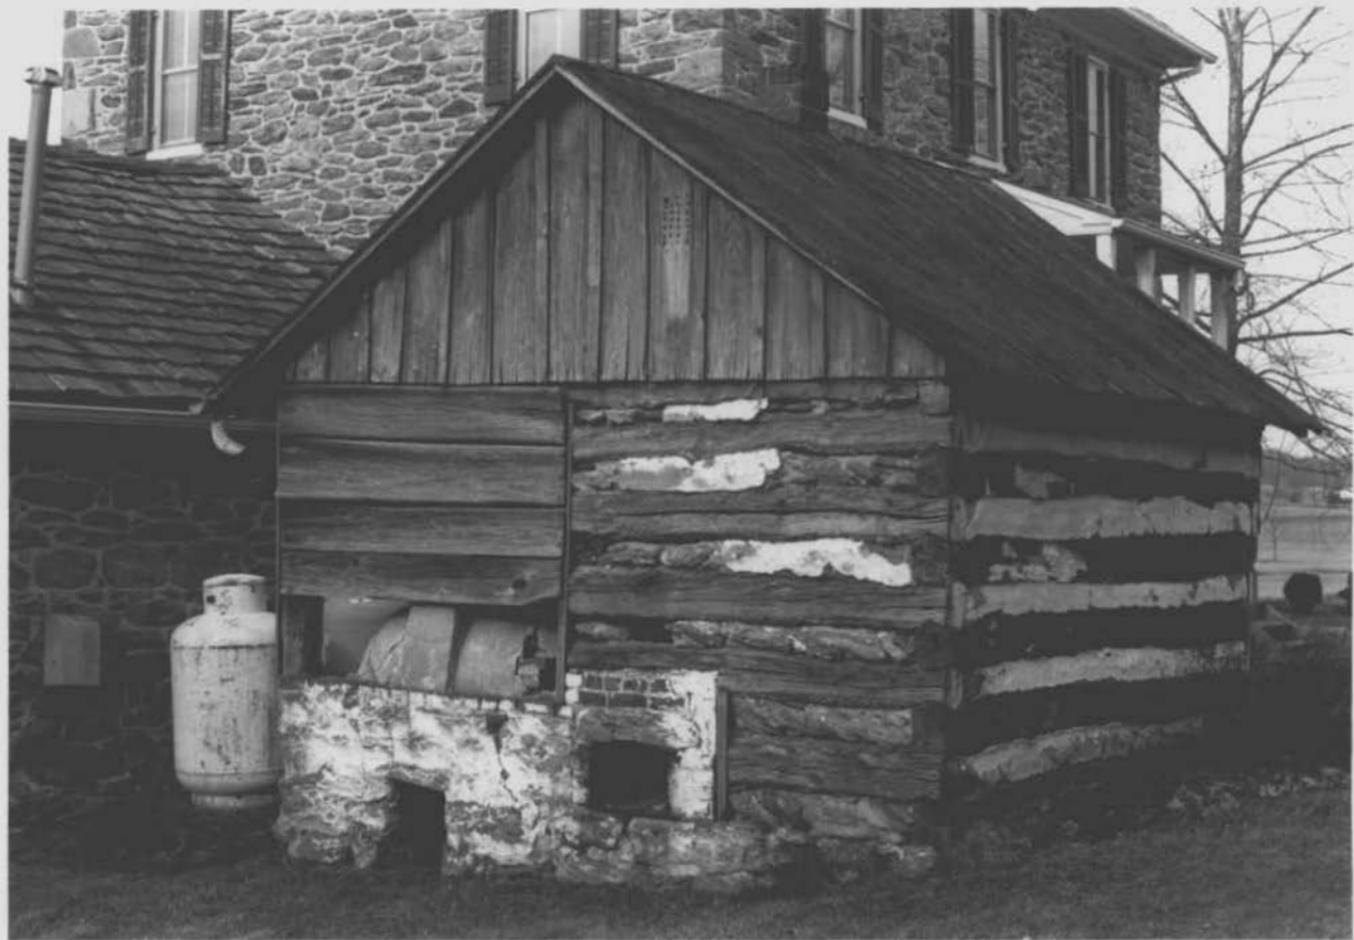
8/11

supported by a board, until it reaches the brick center wall, where it turns upright again and exits through the roof.

Bakehouse - southwest & southeast elevs.

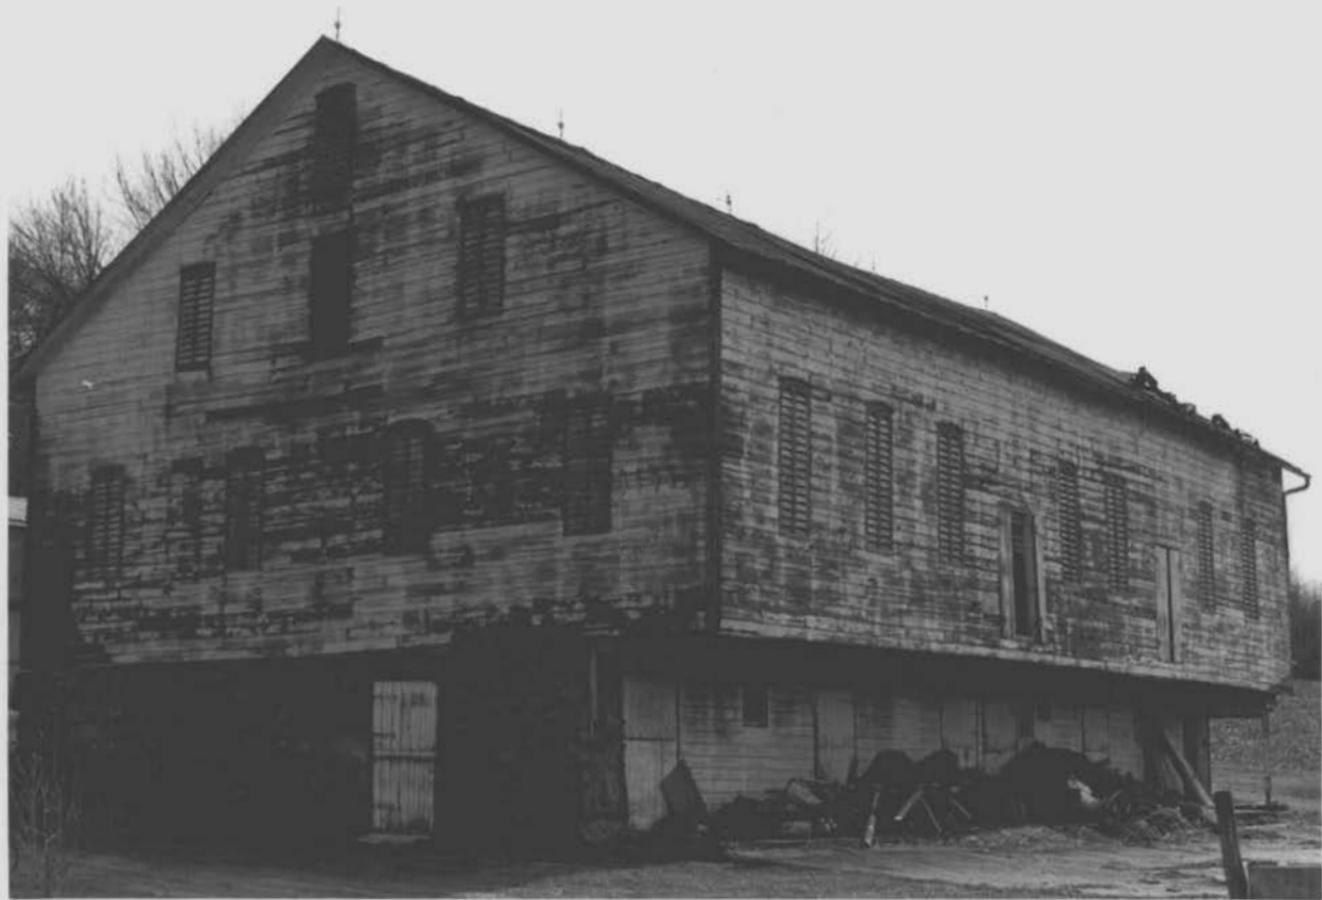
9/11

Southwest of the house is a large, frame bank barn with clapboard siding and a rubble stone foundation with quoins. The southeast side is banked. The northwest elevation of the lower story has clapboard siding, as well. Carved in it are "H of D Mar. 19, 1921" and "HWK? AD 1919". This elevation has a beaded-edge-and-center vertical board dutch door to the north, a four-light sash in a reduced opening, a matching door, a boarded opening, two matching doors, a four-light sash, a partially-boarded four-light sash, another matching door, a wood vent, and a matching door to the west. The upper story has three wood louvered vents, double doors, two vents, a second set of double doors, and two more vents to the west. The northeast elevation has an opening in the east bay of the lower story and a matching dutch door on strap hinges in the north bay. The upper story has an opening at the east corner, with the door now missing. There is a row of four vents, a row of three above, and one in the gable end. The southwest elevation is similar, but with two openings in the lower story.

Burn - NE & NW elevs.

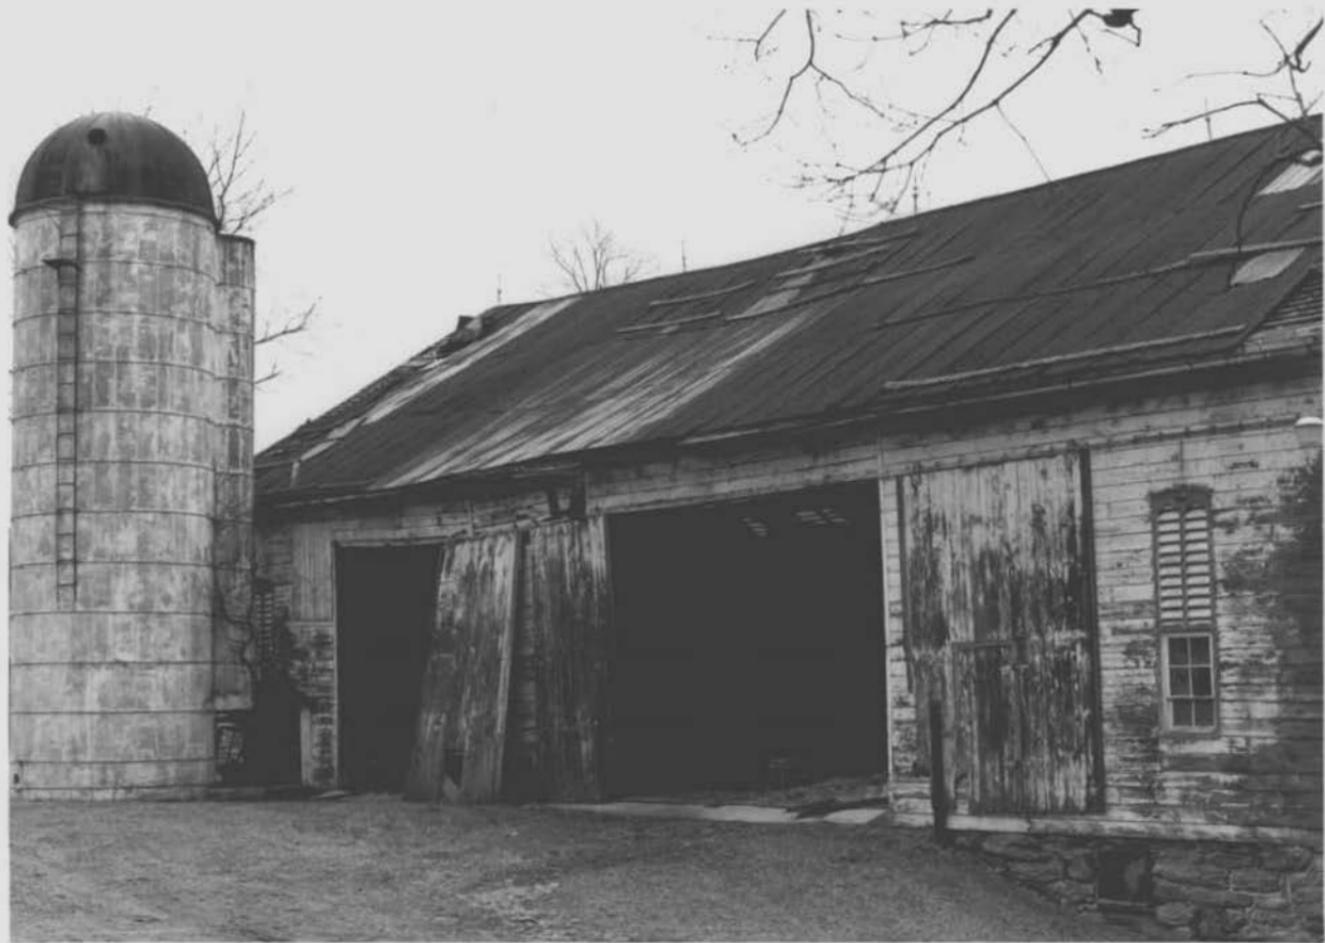
10/11

The southeast elevation has an opening in the east bay of the lower story. The center of the upper story has a pair of doors on rollers to the east and a single door on rollers to the west. All the doors are of vertical, beaded-edge-and-center boards. On either side is a wood vent. The vent on the east has 4/2 sash below it. There is a concrete, wire-bound silo, with metal dome roof, attached to the south bay. Part of the stone barnyard wall survives northwest of the barn, paralleling the road. The interior of the lower story is deteriorated but virtually intact. There are pens at both ends, with an aisle on the interior side of each, and two pens in the center. The upper story has two side-by-side threshing floors, with a hay mow at each end and a granary in the east corner. There are four queen-post-truss bents, with braces fashioned out of reused timbers. Some 3/4 round log rafters survive, but most have been replaced by sawn 2x4's butted at the peak.

3831 - SE elev.

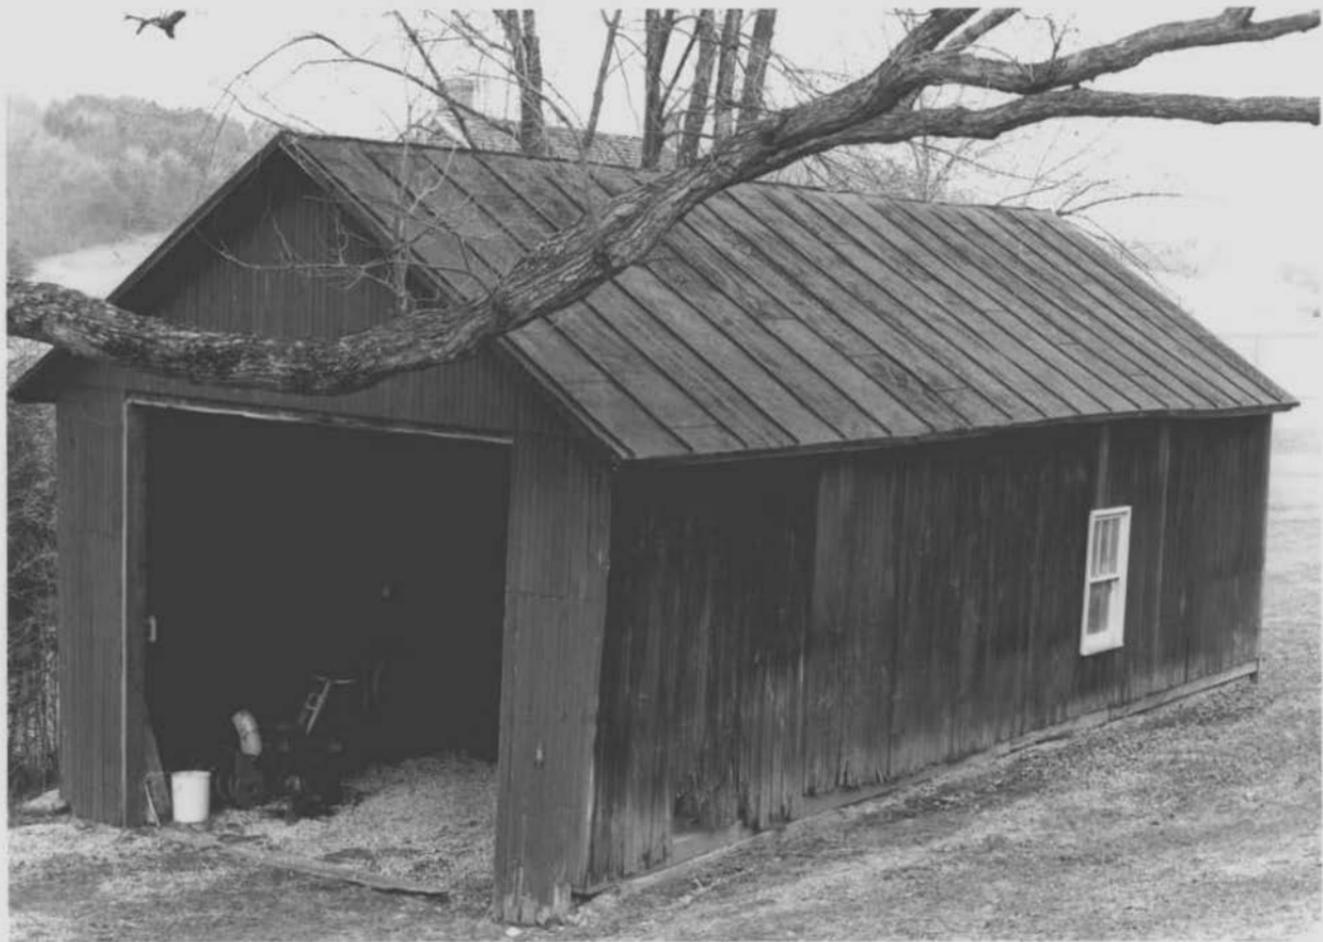
1/1

East of these buildings is a wood frame wagon shed. It has beaded-edge-and-center vertical board siding on the northwest, southwest, and southeast, with plain vertical boards on the northeast. The frame is sawn and nailed and the gable roof has standing seam metal. The southwest gable end has a large opening, the southeast elevation has a 3/1 sash east of center, and the northeast elevation has a four-panel door against the east corner.

Neg. Loc.: Maryland Historical Trust
wagon shed - S.W.: SE elevs.
