CARR-1302

Abraham Krumrein Farm
4833 Wentz Road
Melrose (vicinity)

Maryland Historical Trust State Historic Sites Inventory Form

MARYLAND INVENTORY OF
HISTORIC PROPERTIES

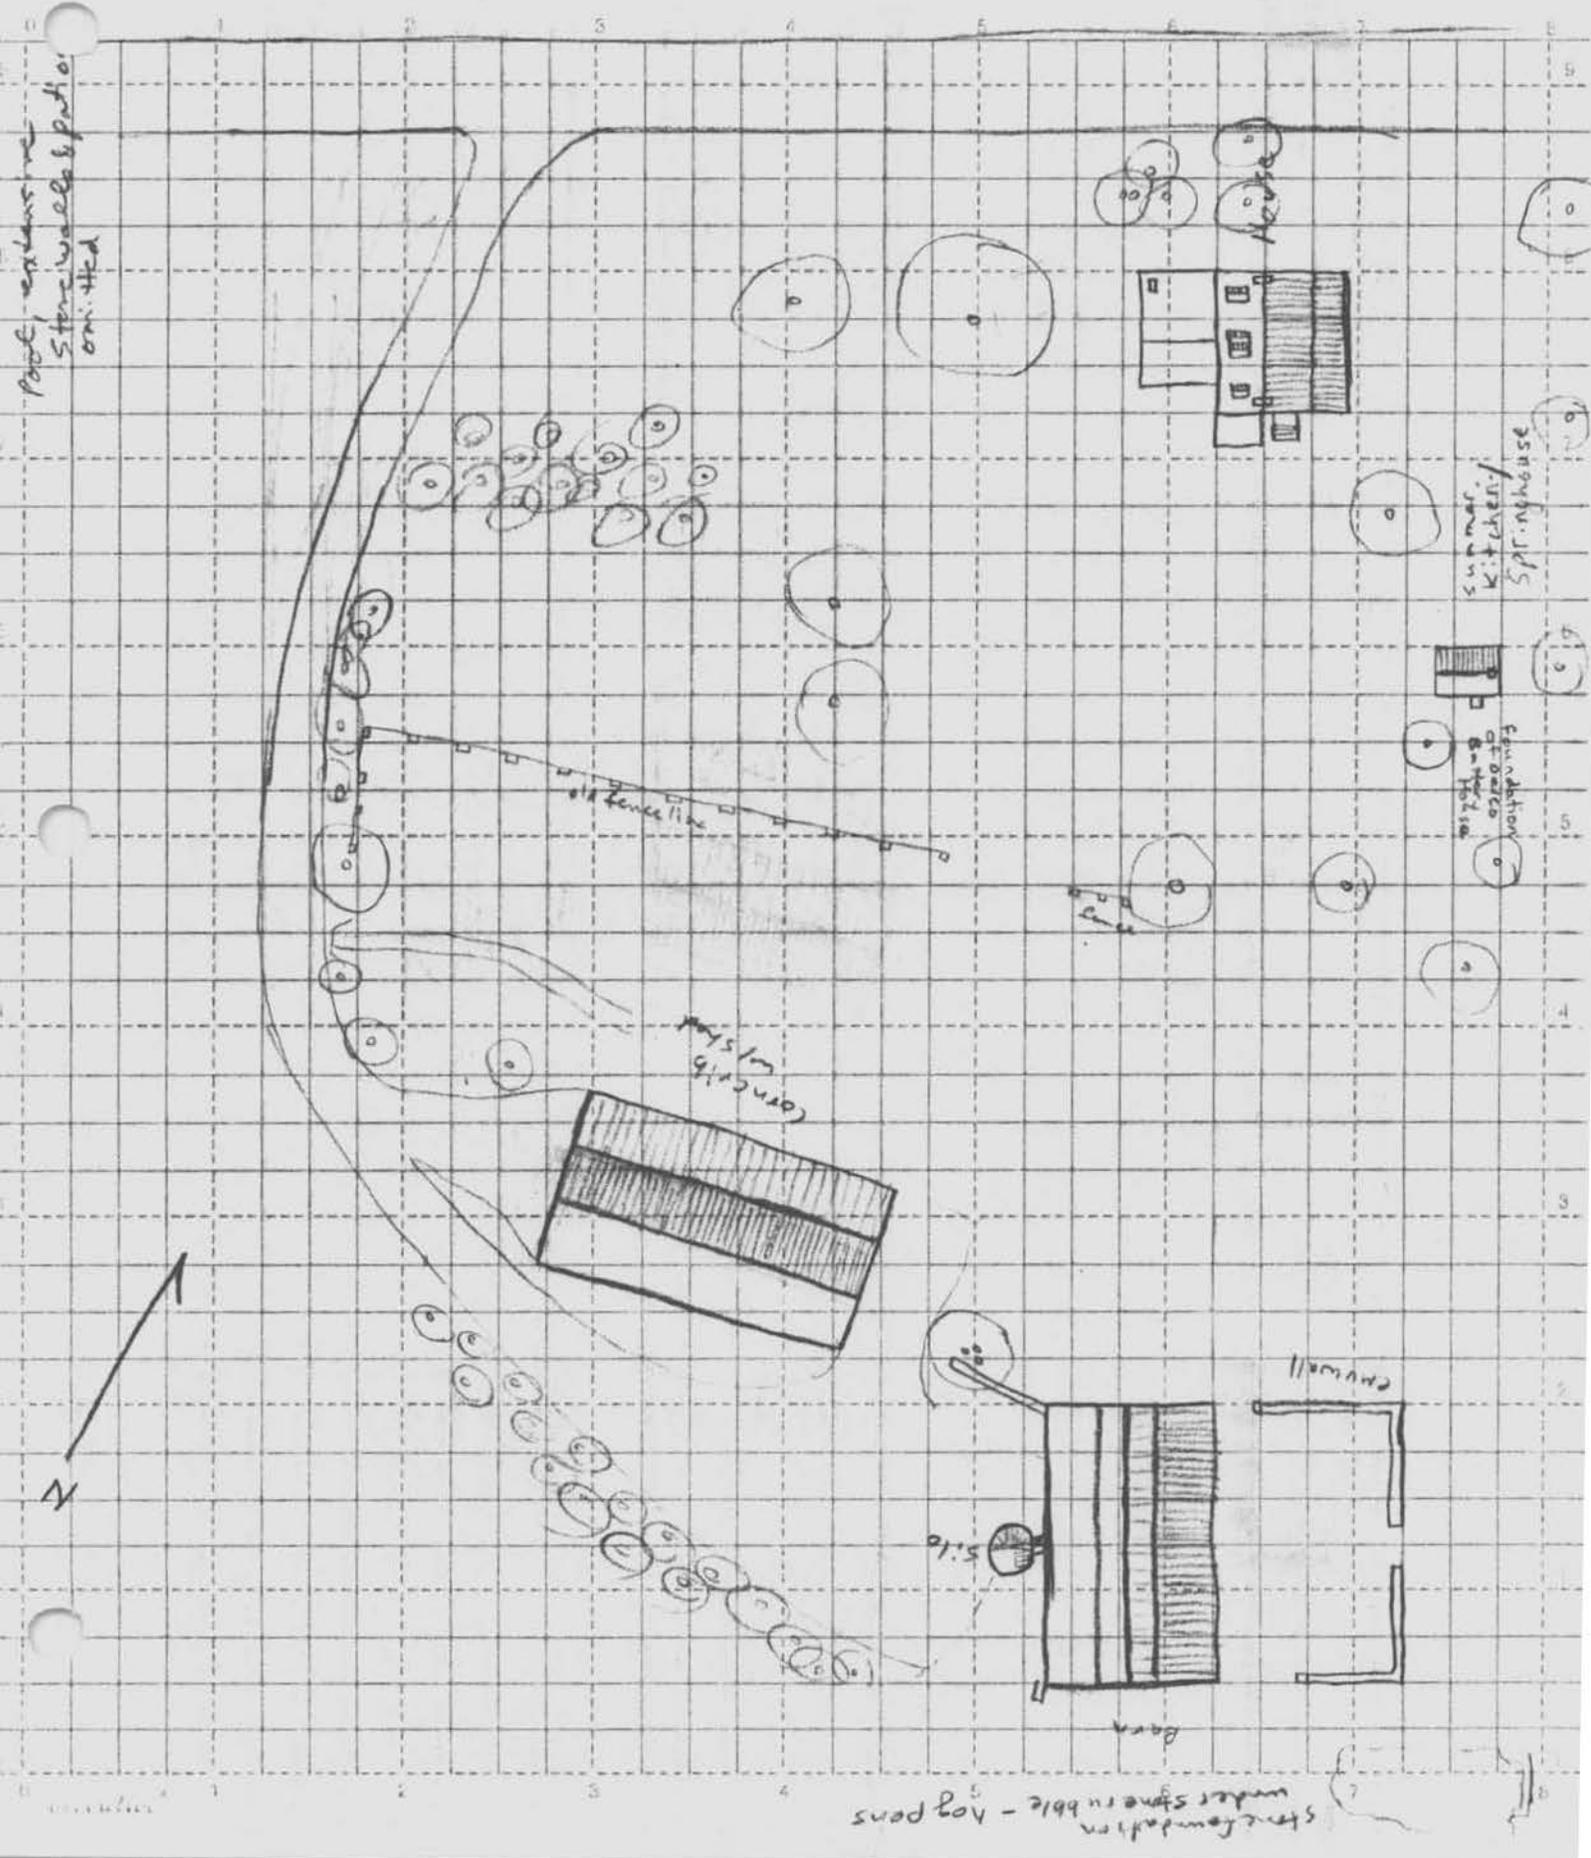
Site

stone foundation - hog pens
under stone rubble

churnwell

old fence line

Kitchen/
Springhouse

Foundation
of patio
for horse

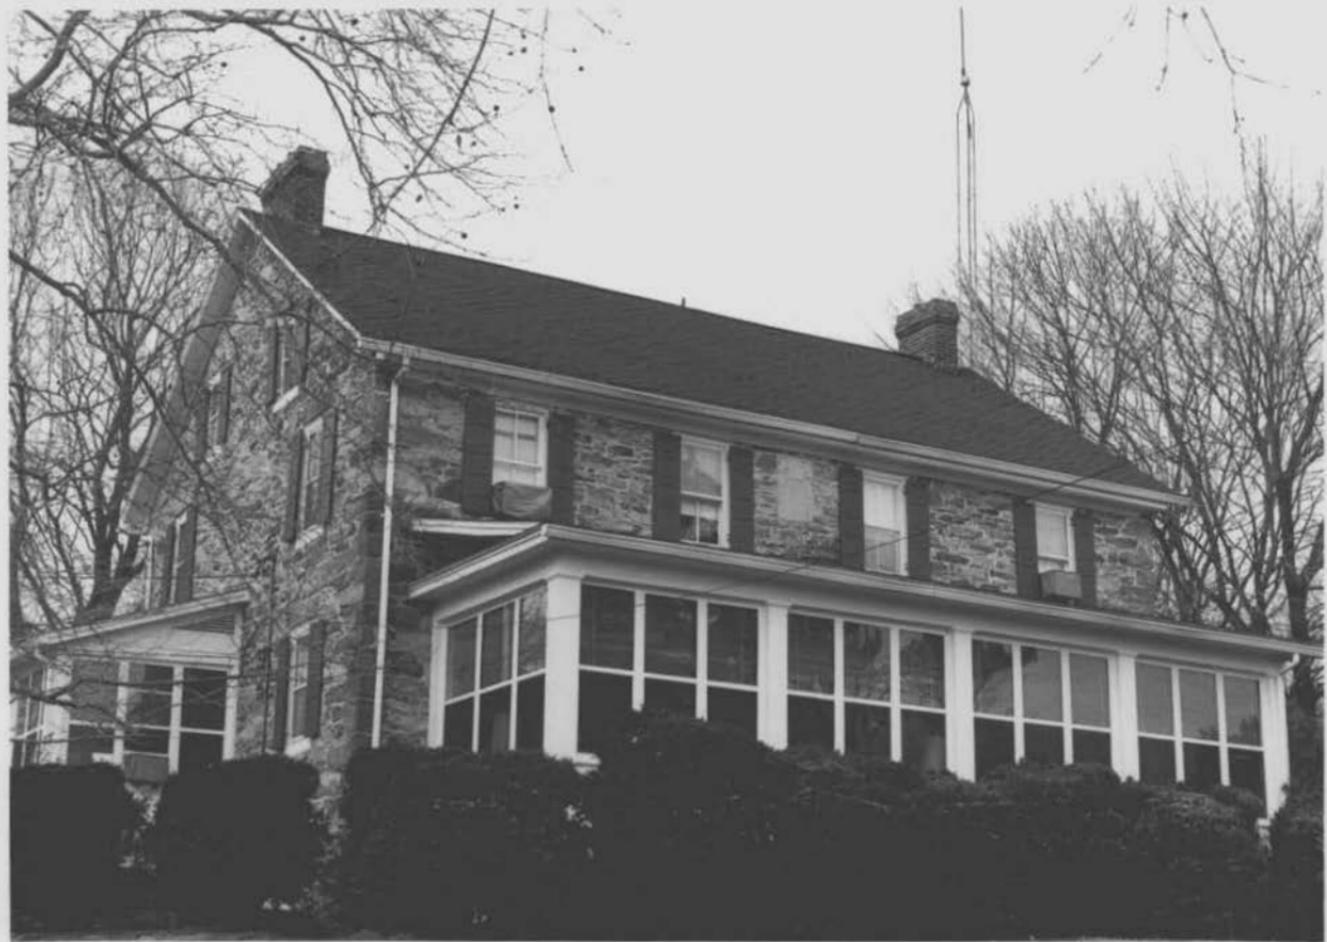
1/12

House - SE & NE elevs.

The Abraham Krumrein Farm is located on the southeast side of Wentz Road about one- and one-quarter miles north-northeast of Melrose and almost one mile south of the Maryland-Pennsylvania border. The 1798 stone house is set on a raised foundation on the top of a low ridge and faces northeast. The house is built of rubble stone with quoins and a gable roof of asphalt shingles. It is two-and-one-half stories, and four bays by two bays, with a one bay square stone wing on the west corner. The northeast elevation has 2/2 double-hung sash with a pair of four-panel shutters and wood sills. The first story has a door in the north-central bay with eight panels, two small over two large, then two small and two large. There is a four-light transom and panelled soffit and jambs. In the center of the second story is a date plaque marked "1798 ABRAHAM KRUMREIN BAUHER JUDITH KRUMREININ BAUFRAU GEORG KRUMREIN HAD DIESEN BAU GEMAURED." The box cornice has a bed mould with an ovolo

The southeast elevation of the main block has a door in the south bay, with a three-light transom above. The wood frame does not appear to be original. The east bay of both stories has a 2/2 sash with four panel shutters, wood sills, and stone jack arches. The south bay of the second story is a 6/6 sash, but otherwise is the same. The gable end has two 6/6 sash with three-panel shutters, wood sills, and stone jack arches. The east bay of the cellar has diagonal, beaded-edge board double doors in a mortised, tenoned and pegged frame, with splayed jack arch. They open in on interior strap hinges. There are four new steps down to the door. The south bay of the first story is covered by a one-story shed roof porch supported by three square posts. Each half of the porch contains three 1/1 sash above vertical tongue-and-groove, beaded-edge-and-center siding. The southwest end of the porch has three lights on each side of a two-light and one-panel metal door, with a two-light transom above. The northeast end has three 1/1 sash with the same siding above and below.

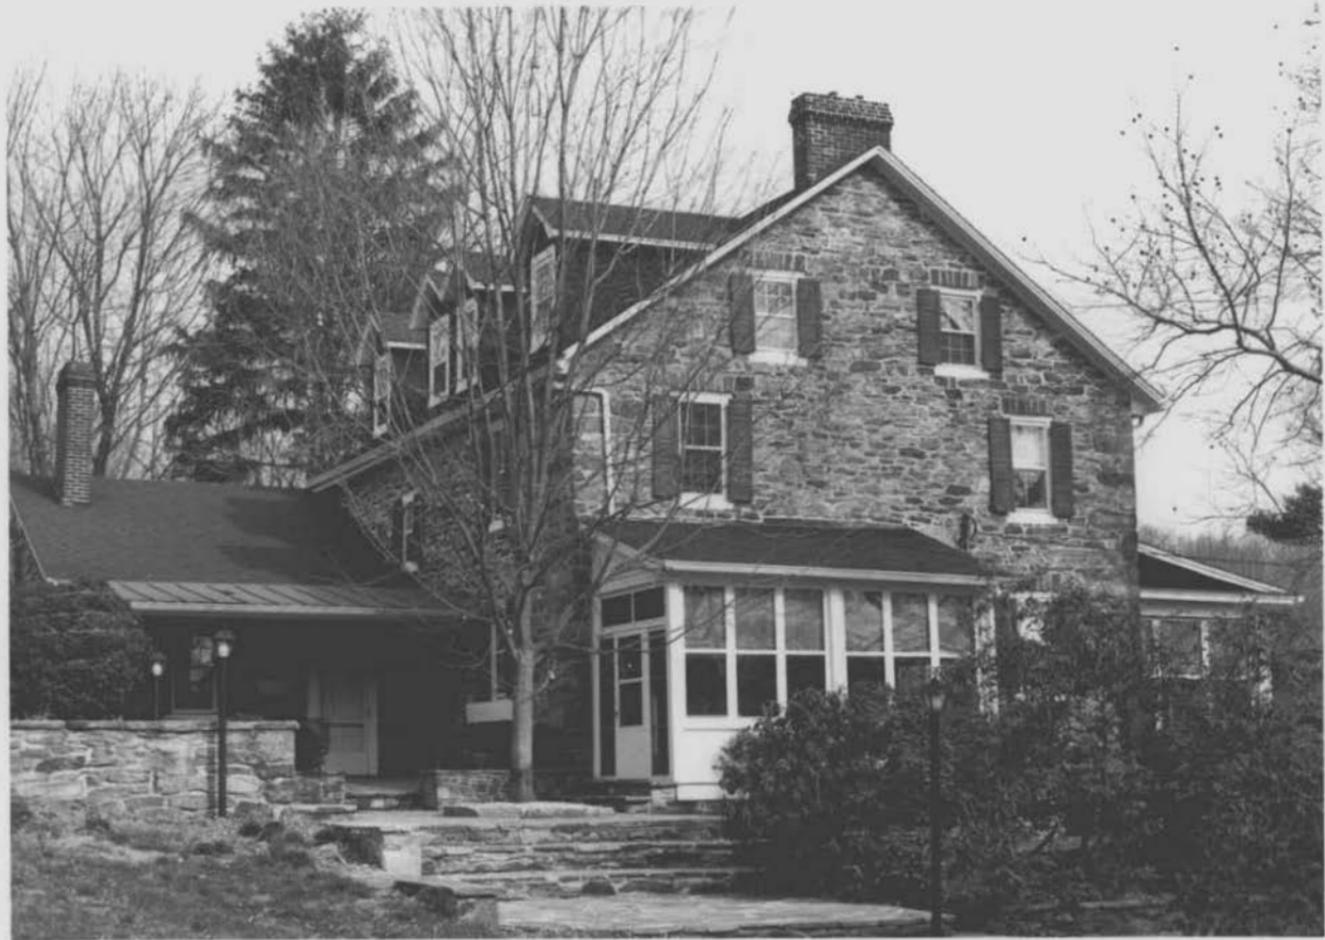
2/12

Neg. loc.: Maryland Historical Trust
House - SW; SE elevs.

The western half of the southwest elevation of the main block is covered by the wing. There is a single 6/6 sash with three-panel shutters and wood sill in the center of the house, between the first and second stories. The south bay has a 6/6 sash with four-panel shutters and wood sills in each story. The box cornice has no bed mould. There are four gabled dormers with 6/6 sash. The center two are paired.

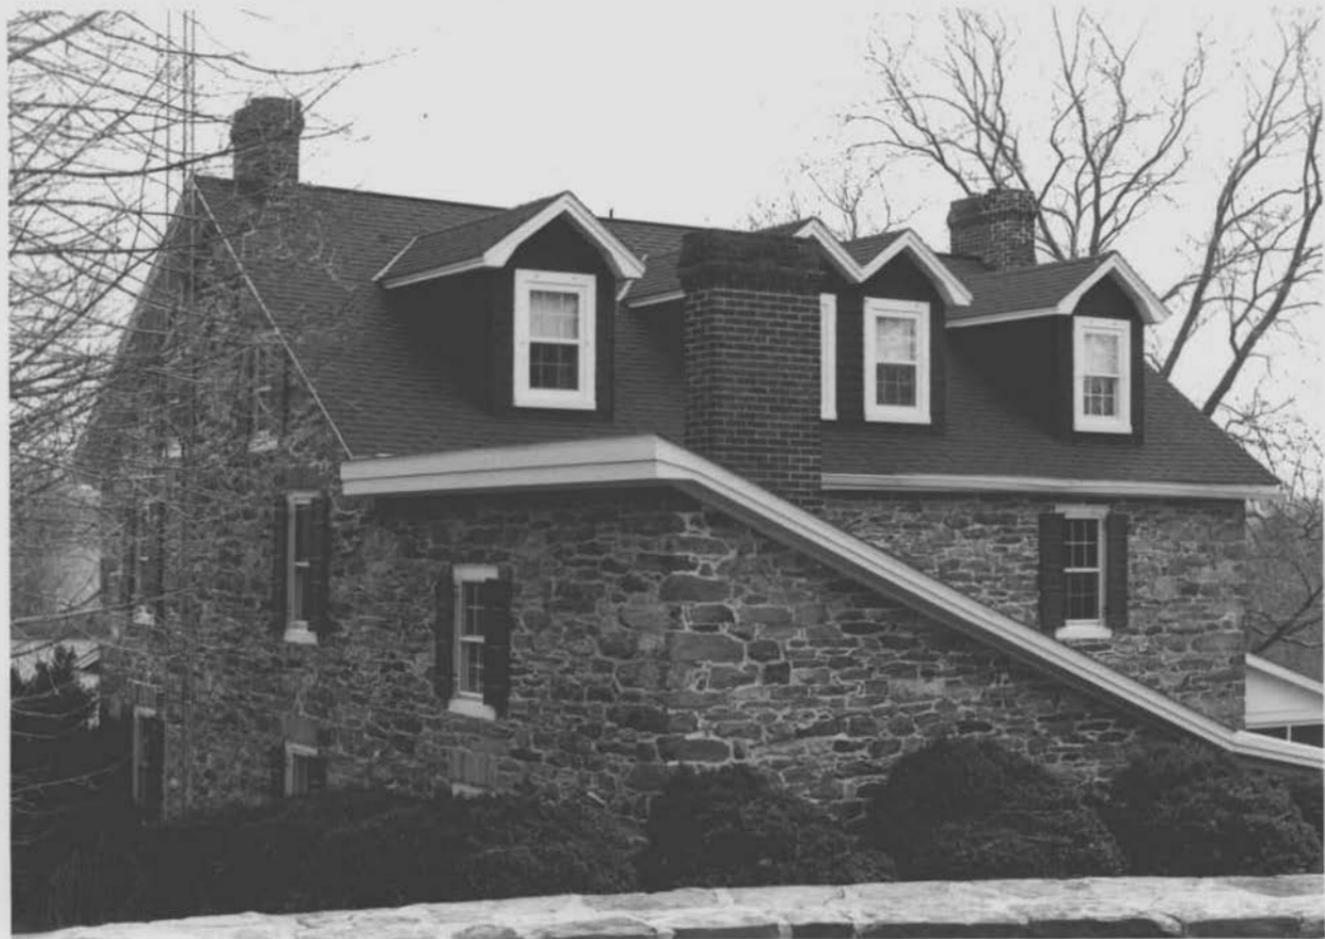
3/12

House - NW & SW elevs.

The northwest elevation also has 2/2 sash with shutters and splayed stone jack arches. The wood frames are mortised and tenoned and pegged, with an ovolo moulding between fillets. There are also two 6/6 sash with a pair of three-panel shutters in the gable end. The northwest elevation of the wing is two stories, with no break in the stonework. There is a single 6/6 sash with wood sill in each story. The first story has a pair of four-panel shutters and the second has three-panel shutters. The ell has a shed roof that slopes to the southeast. There is an internal brick chimney in the west corner. The southeast elevation of the wing is two bays, with a 6/6 sash to the south and a six-panel wood door to the east. The frame is mortised, tenoned, and pegged, but the bottom half has been cut out and replaced. There is a standing-seam roof porch addition on the southeast.

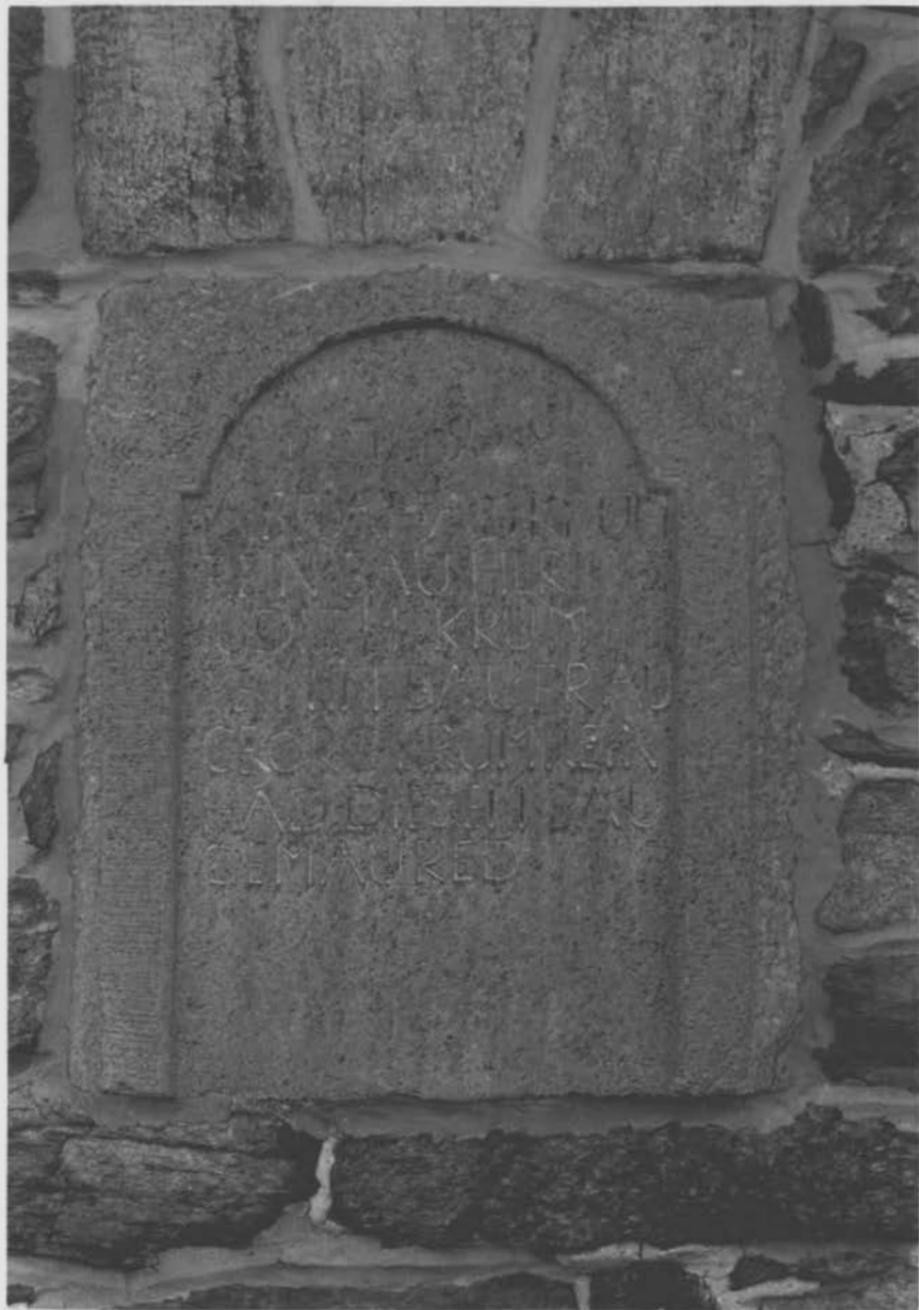
7/12

House - NE elev. datestone

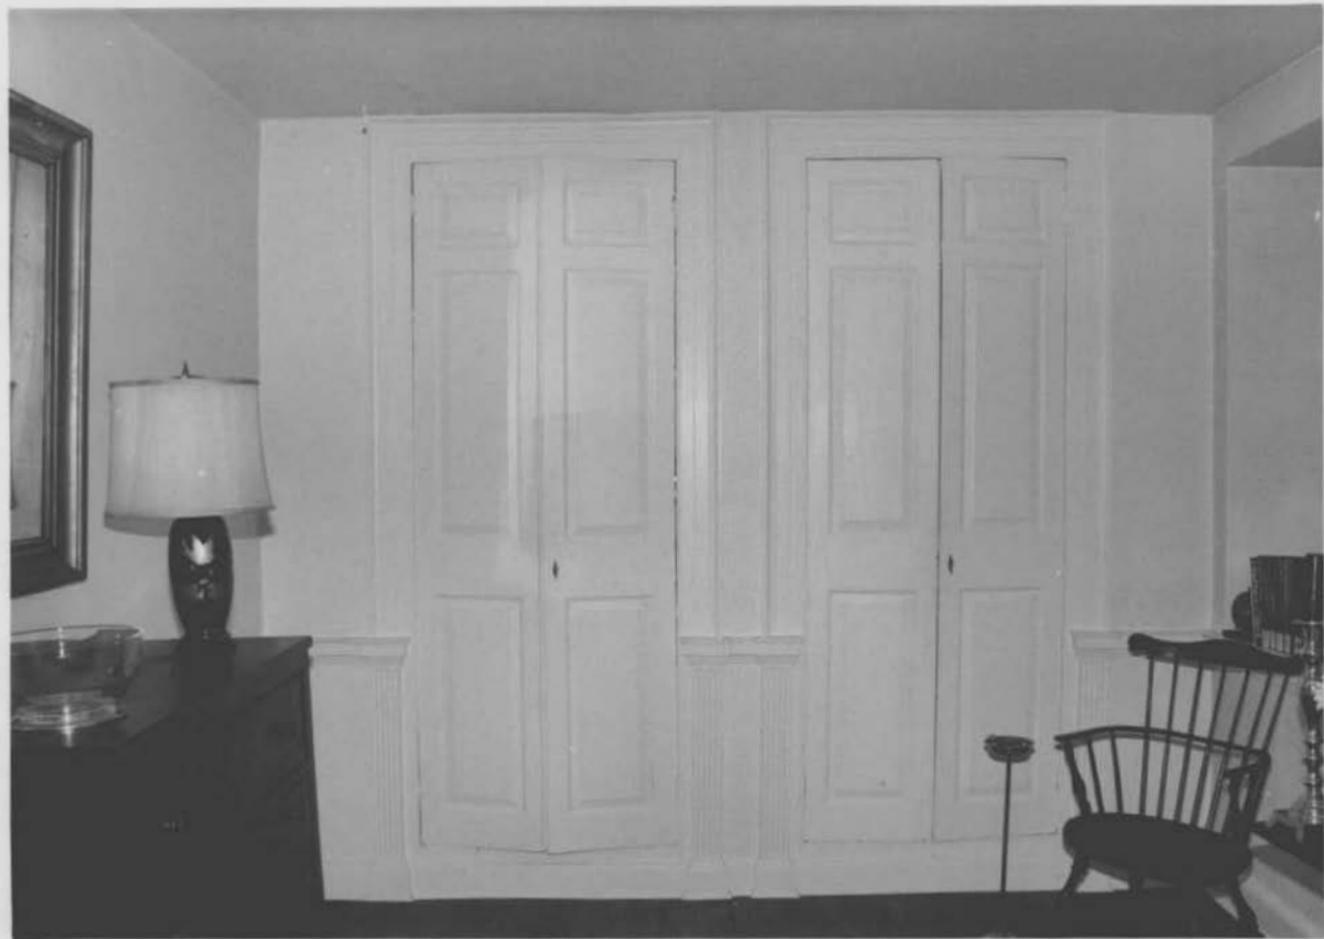
2/12

House - nw room, sw wall elev.

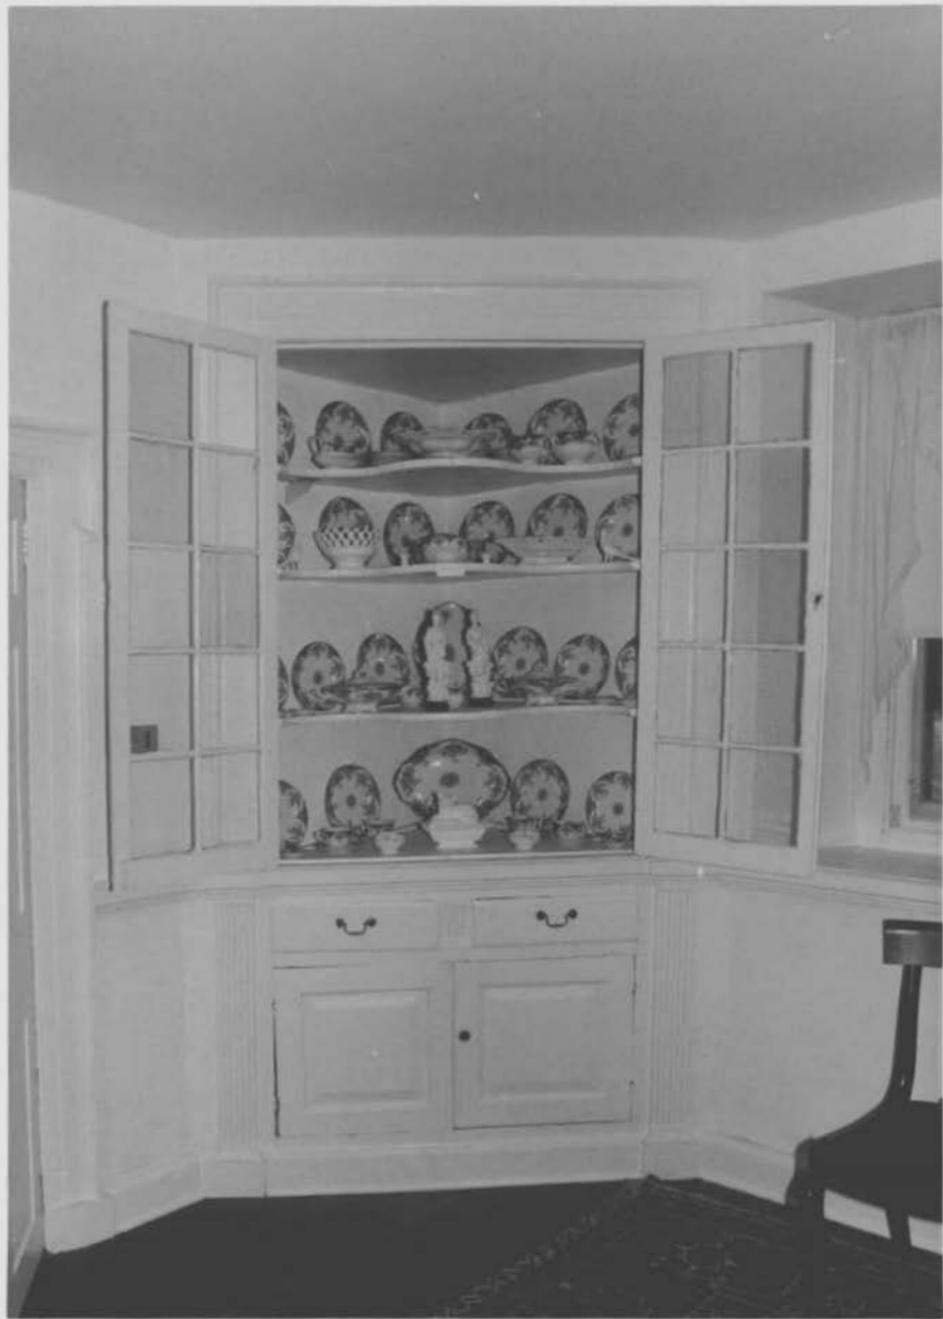
E/12

House - SF room - corner cupboard in N.

The first-floor plan has a central passage stairhall with one large room on the northwest and two rooms on the southeast. The passage leads back to a one-room rear wing with stone kitchen fireplace on the southwest wall that has had some alterations. The open well, two run stairs have an open stringer, balusters that are square in plan, and a tapered newel. According to a long-time associate of the owners, the stairs originally had short flights off both sides of the landing as well, but they were removed in the 1930's renovations. The stairs are open to the attic. The passage has a chair rail with an astragal above a fillet and cavetto, a plain field, and an ogee moulding below the field. The baseboard has a cavetto and fillet above an astragal, a plain field, and a cavetto and fillet at the floor. The doors have crosstetted architraves with a cavetto at the outer edge, a broke-field fascia, and a beaded interior edge. The doors are all six panels. The flooring is tongue-and-grooved oak 2¼" wide. The wall between the passage and the northwest room has been opened up to give a wide semicircular entrance. This room has a fireplace centered on the northwest wall. The mantel has fluted pilasters, fluted frieze, and a dentil cornice with a cavetto above an astragal under the mantel shelf. The chair rail and baseboard mouldings match that in the passage. On the southwest wall are two closets, each with double doors of three panels each. There are fluted pilasters below the chair rail on each side of the closet. The west side closet has two rows of peg rail inside, while the south side closet has been altered. The east room has a matching chair rail and baseboard, and a cupboard in the north corner. The cupboard has fluted pilasters beneath the chair rail, as well as two drawers above panelled double doors. At the top of the cupboard are double doors with ten lights each. The scalloped shelves

have triangular slots for cutlery. The stone fireplace on the southeast wall is rebuilt. The mantel is crossetted and matches the door architrave in profile. The southwest wall retains a peg rail. The south room has been completely altered as a modern kitchen.

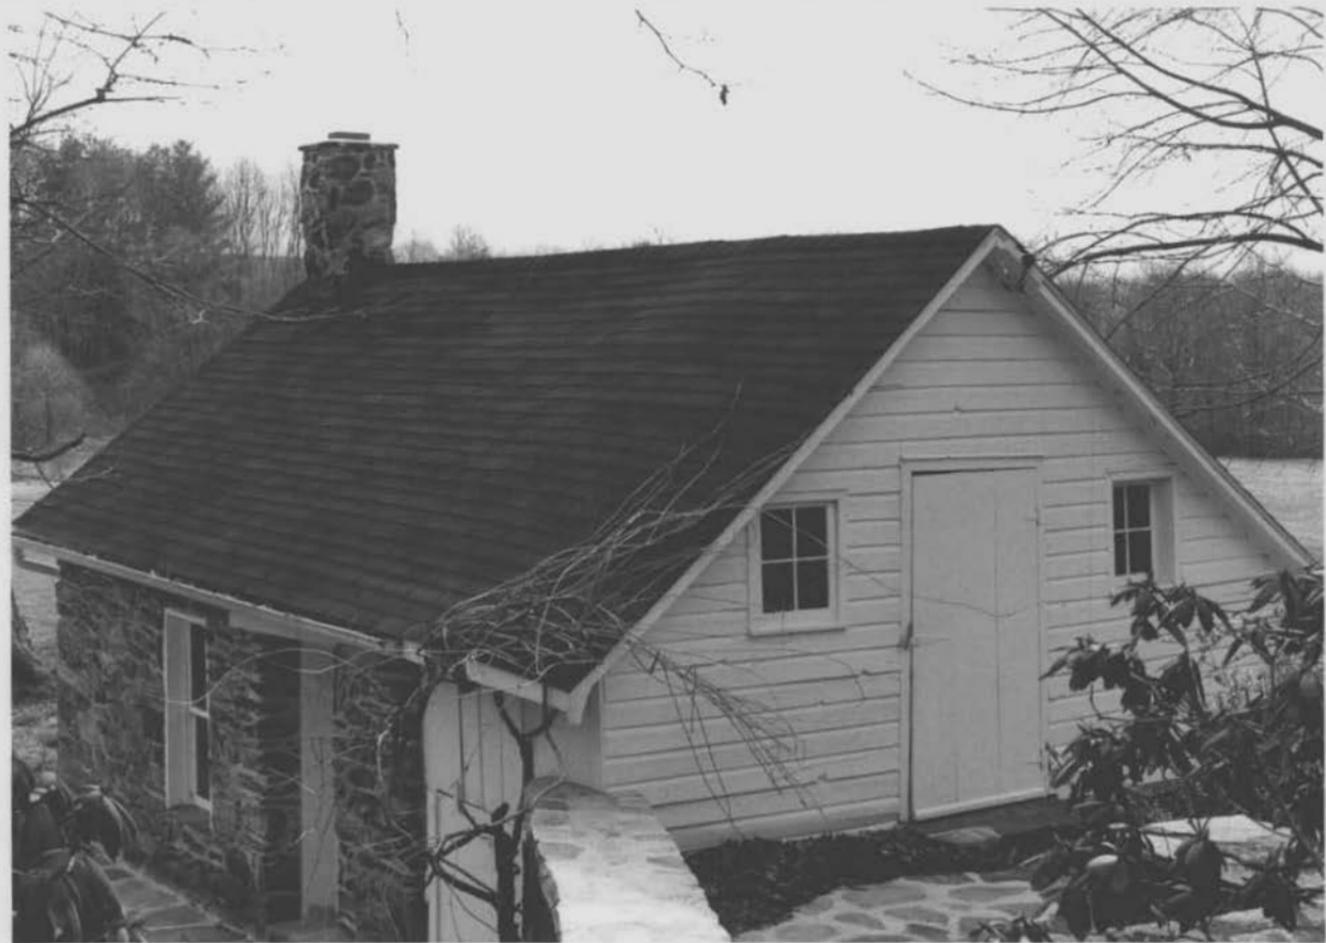
9/12

Neg. Loc.: Maryland Historical Trust
Springhouse - NW; SW elevs.

East of the house is a one-story rubble stone springhouse/summer kitchen with an asphalt shingle gable roof. The southwest elevation has a cantilevered frame attic section with German siding. There is a central vertical board door with flat, mitered surround and drip mould above. It is flanked by a four-light sash on both sides. There is an original stone wall that rests below the plane of the southwest attic wall. This wall and the ground around have been raised so that the attic wall is now at ground level. The northwest elevation has a 2/2 double-hung sash in a nailed frame, and vertical board door with a wood lintel and nailed frame. The cantilevered attic end has vertical board siding, with an infill below of a plywood door. This heads down several steps to a concrete floor and a well. The southeast elevation has stone infill below the cantilevered attic. The attic section has vertical board siding with two two-light casements added to it. The floor of the lower section is new concrete and stone. There is a new stone fireplace and chimney inside the northeast end. An old photograph shows a brick chimney where the stone one now is. The attic floor used to be set into the stone wall at the level of the bottom of the overhang, but the original joists have been removed and new ones placed on top of the wall. The rafters are sawn 2x4's except over the cantilevered section, which retains half-round log rafters with central tenons. The plates are exposed and are hewn. There is a new vertical board double door in the southwest stone wall, inside the cantilevered attic section, set in an original mortised, tenoned, and pegged wood frame. The attic flooring is now plywood.

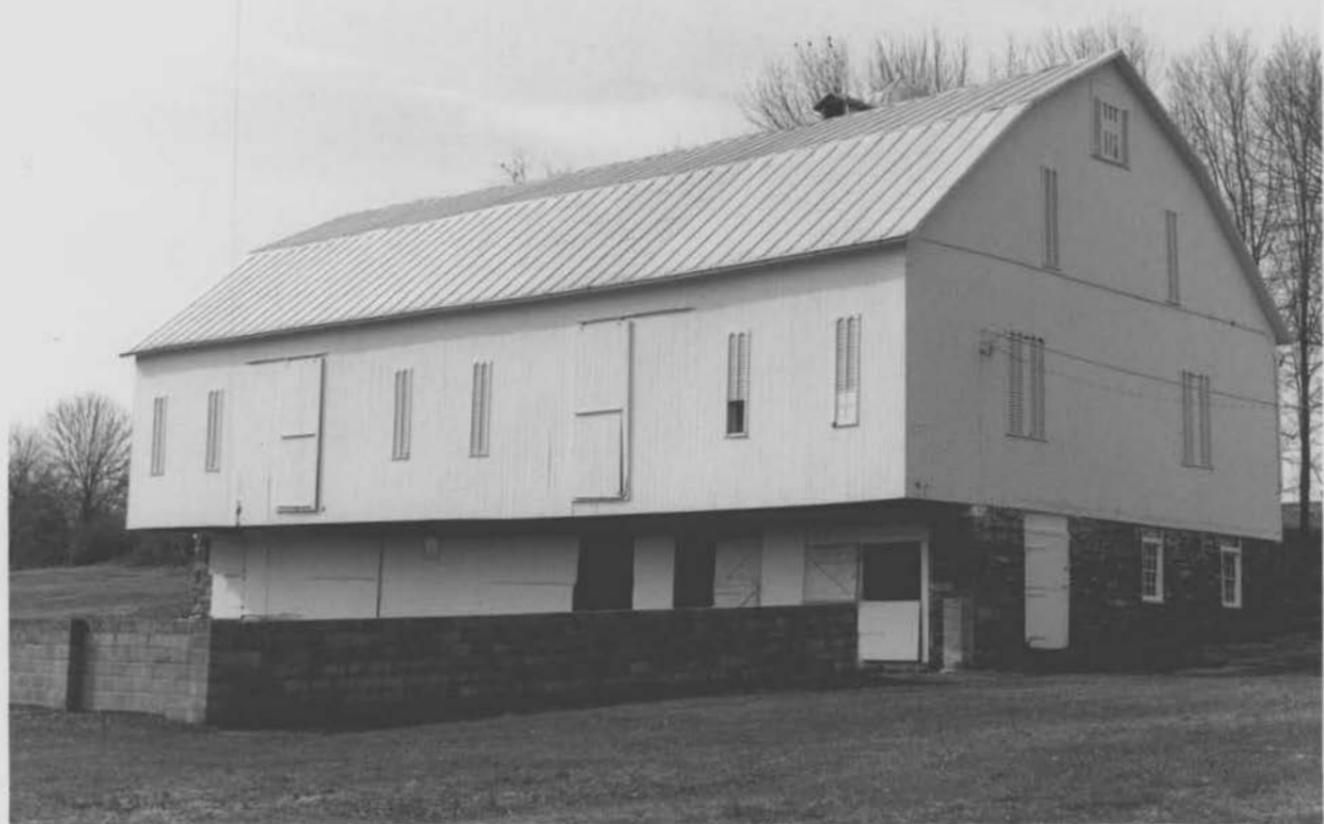
10/12

Barn - NE: NW elevs.

Southeast of the house is a frame bank barn with forebay that faces northeast and ramp on the whole southwest side. It has a rubble stone foundation with frame wall on the lower story of the northeast side covered by horizontal beaded-edge-and-center boards. There is tongue-and-grooved beaded-edge-and-center vertical board siding on the upper story and a gambrel roof with standing seam metal covering. The lower story of the northeast elevation has a dutch door on strap hinges, a four-light window, a door on rollers, two one-light windows, another roller door, another dutch door, a four-light window, and a dutch door with four-light transom. All the doors on the barn match the

vertical siding. The upper story has two vents, a door on rollers, two vents in the center, another roller door, and two vents with four-light sash at the bottom. The northwest elevation has a dutch door on strap hinges, with a five-light transom, and two 6/6 sash with wood sills and three-light transoms in the lower story. The upper story has a row of two pair of vents, a row above of two vents, and in the gable end two vents flanking an opening. The upper story of the ramped southwest elevation has two vents with boarded-up openings at the bottom, double roller doors with a smaller inset door, a terra-cotta tile silo on a stone foundation with standing seam metal dome roof and lightning rod, then another pair of roller doors and two vents with boarded openings below. All the vents have a gabled surround at the top and applied mullion down the center. The southeast elevation has a six-light sash and a 6/6 sash with the bottom sash missing in the lower story. Above is a flush door at the south corner, and is otherwise identical to the northwest elevation. The barnyard is enclosed with a CMU wall.

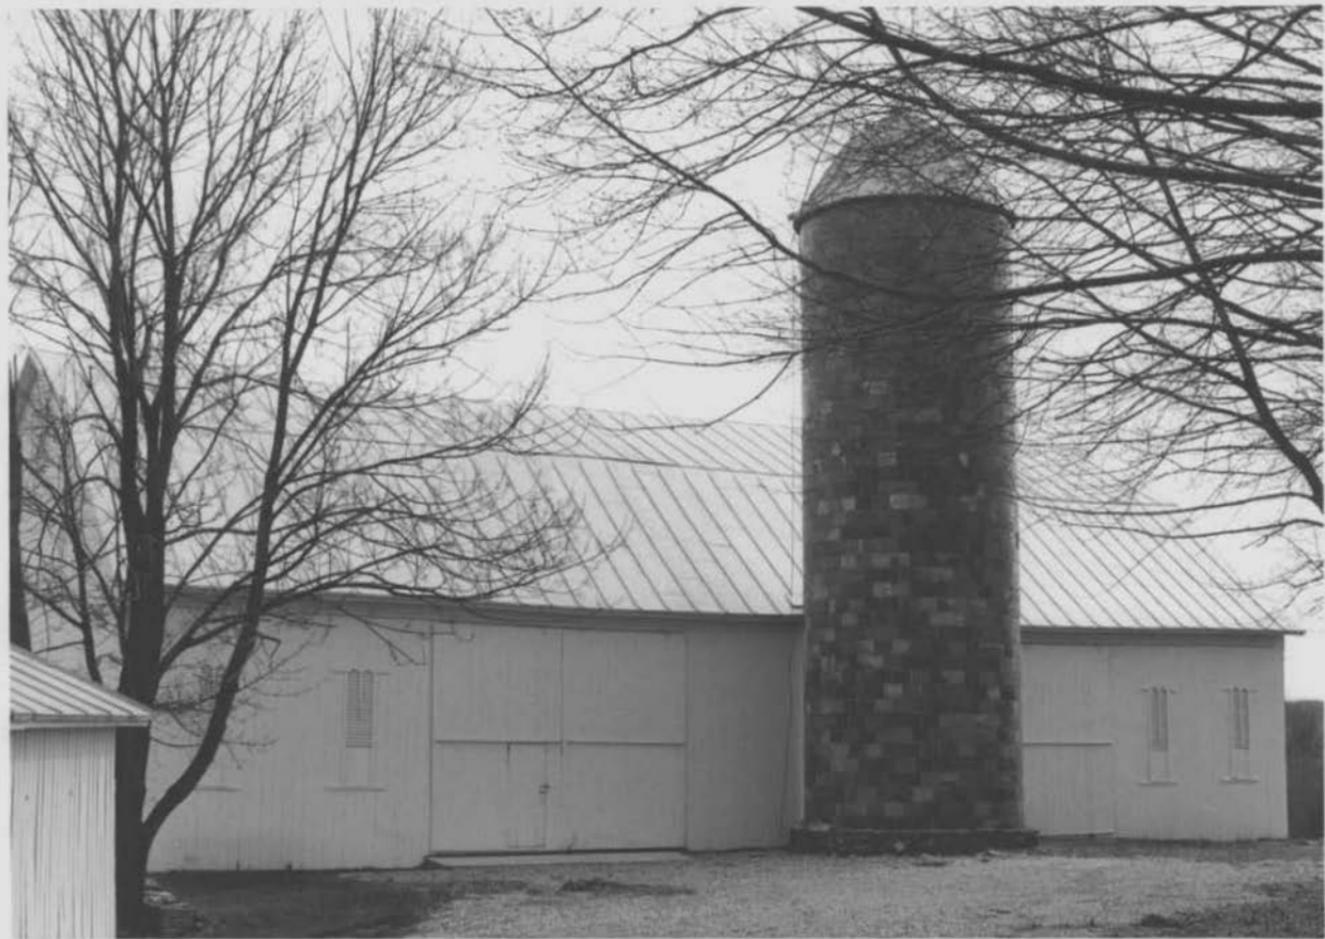
1/12

Barn - SW elev.

The lower story of the barn has been altered. It has two sets of circular-sawn summer beams supported by circular-sawn posts. The circular-sawn joists support a diagonally laid subfloor. There is an opening in the center of the southwest wall to a room under the ramp. The upper story has two threshing floors, with end and center hay mows and three granaries, in the north, west, and south corners. The bents are circular-sawn and mortised and tenoned. They are a simplified version of the typical queen post truss. The sawn rafters support lath, but old, undated photos show only metal roofing.

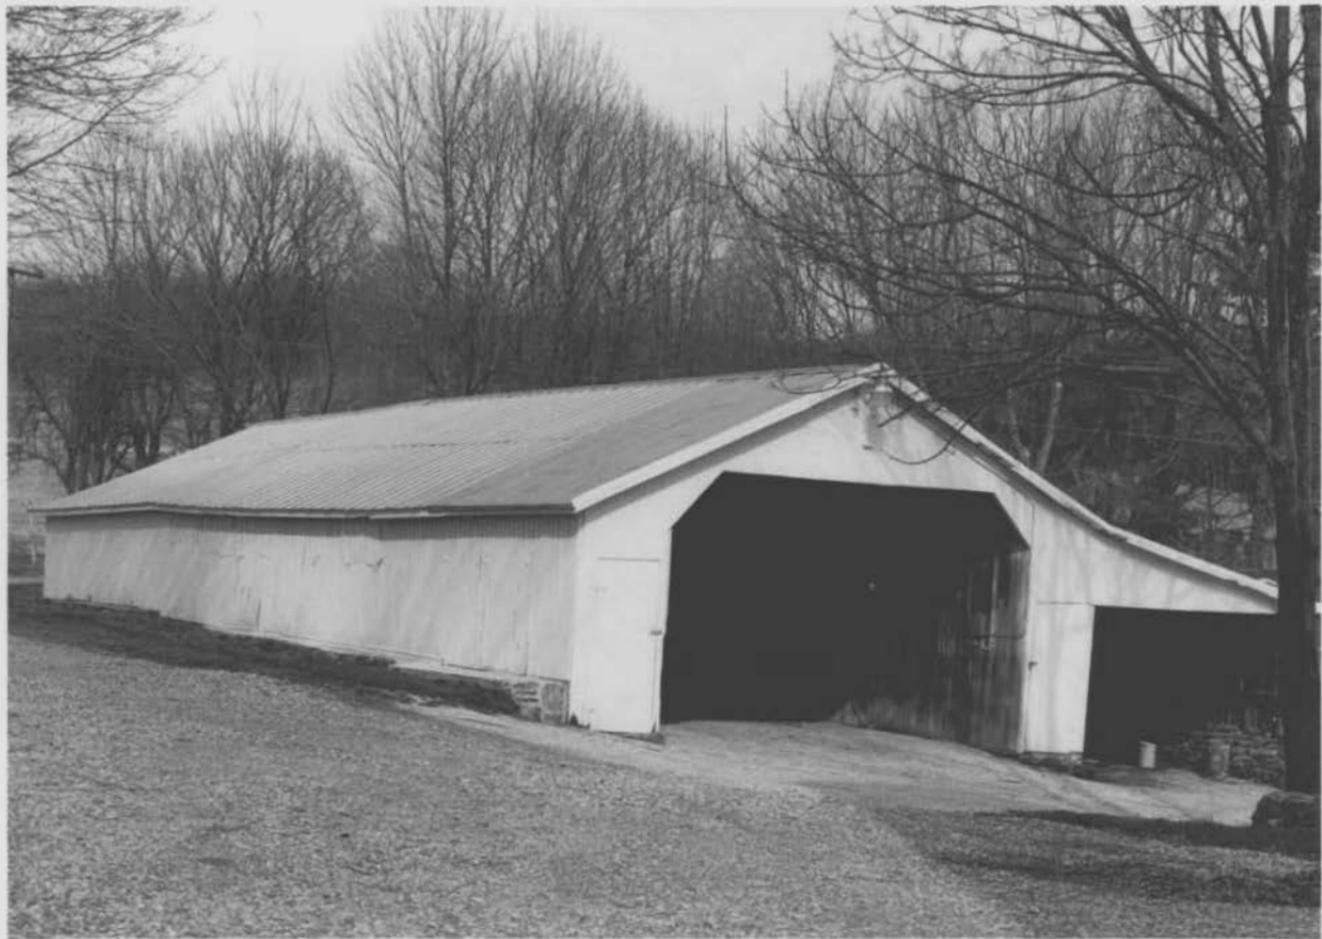
12/12

Neg. Loc.: Maryland Historical Trust
corn crib - SE & NE elevs.

West of the barn is a wagon shed with corn cribs on both sides. It has a stone foundation, is open on both ends, with a gable roof. The frame is sawn and nailed 2x4's. The building has been virtually doubled in length by the addition of the extension on the southwest end. There is a frame shed addition on the northwest side.
