CARR-1303

John Werner Farm
4400 Watertank Road
Manchester

c. 1850

Maryland Historical Trust State Historic Sites Inventory Form

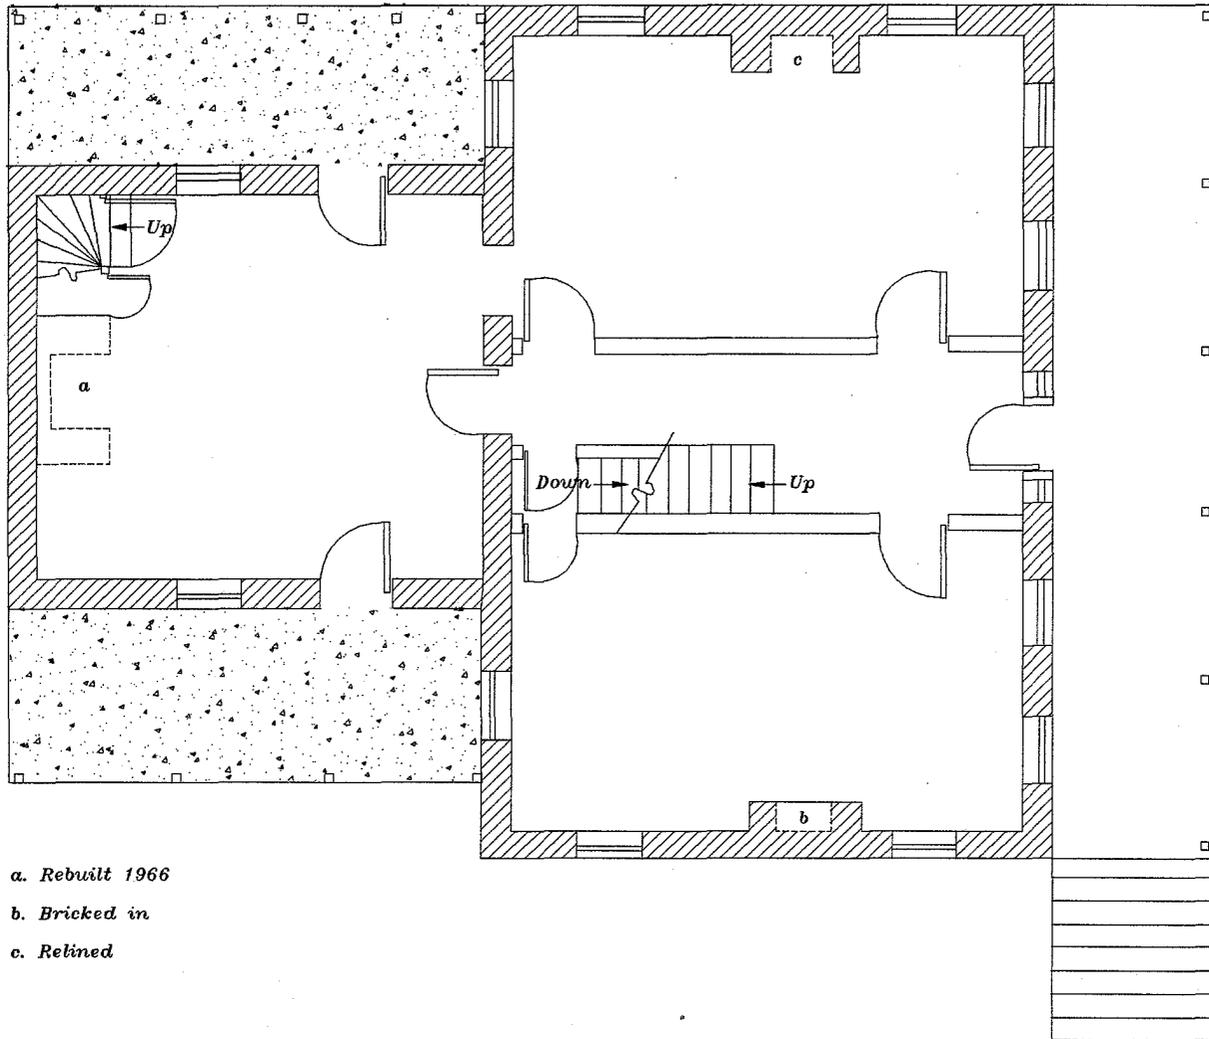
CARR 1303	John Werner Farm-House	First Floor Plan	February 1992

- a. Rebuilt 1966
- b. Bricked in
- c. Retined

The interior has a central passage stairhall with the stairs along the southwest wall. The passage is flanked by two rooms, each with a fireplace that is southeast (toward the front) of the center of the room. This suggests the possibility that the rooms were subdivided originally, but there is no evidence to confirm this. The windows and doors in both rooms and the hallway have elaborate panelled architrave moldings with ogee panel molds and a beaded inside edge, as well as bullseye corner blocks. The hallway also has a chairrail with ogee molding. Beneath the windows are panels with ogee panel molds and a horizontal double bead in the center. All the moldings have Greek profiles. At the end of the passage is the addition, which was probably the kitchen. It is a single open room with a large rebuilt brick fireplace on the northwest wall and original boxed winder stairs in the north corner of the room. The cellar has arched brick piers that support both chimney stacks. They are of plastered and contain wood shelves within the arches.

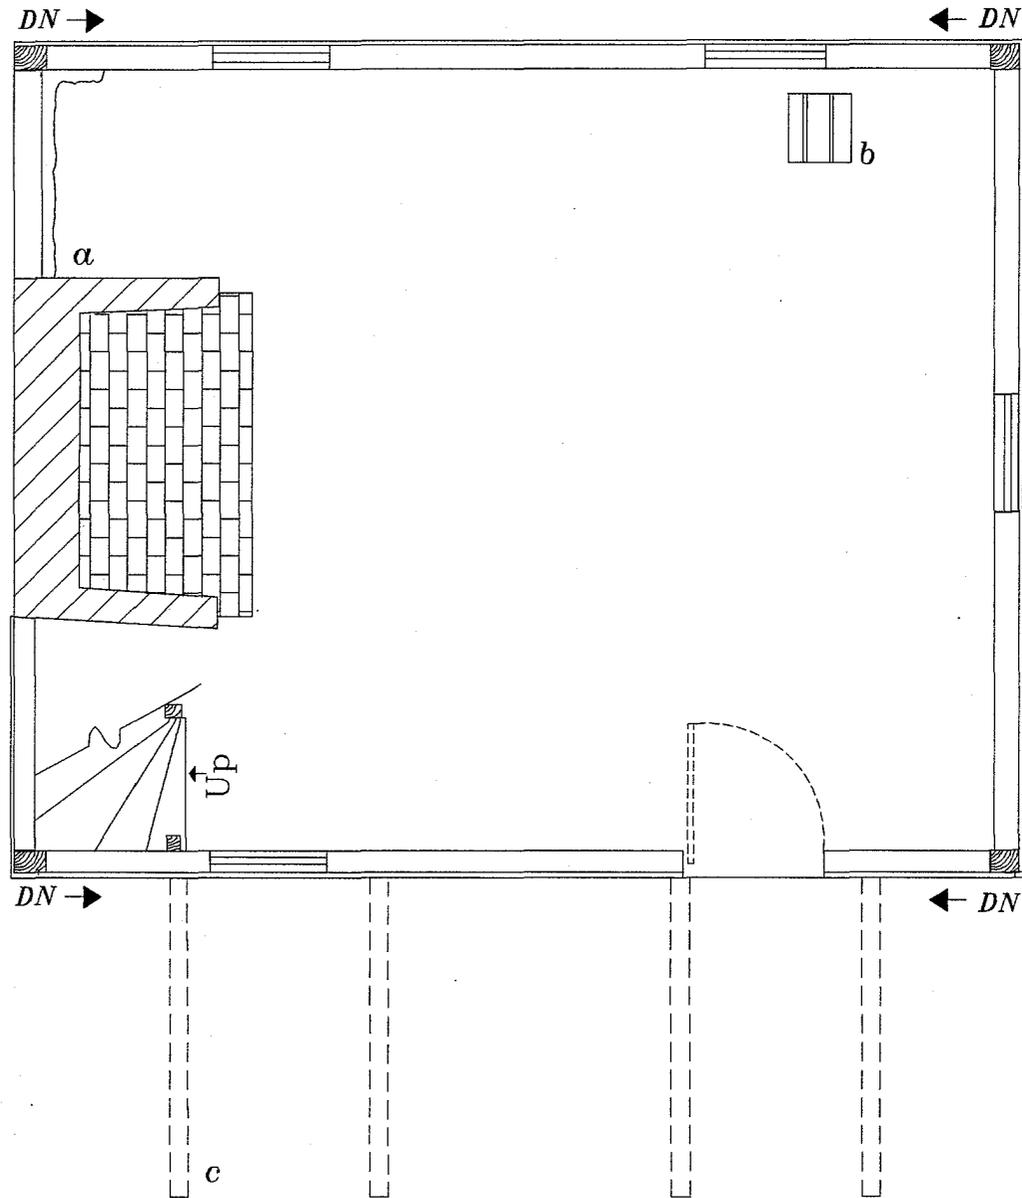
John Werner Farm - Log Summer House
4400 Water Tank Road

- a. Brick Wall Rubble
- b. Wood Drain Under Removable Floor Board Trap Door
- c. Reflected Plan of Deteriorated Porch Beams
- DN → Corner Braces

The tenant house/summer kitchen is a one and one-half story hewn log structure with mortised corner posts for the tenoned and pegged log ends, and down braces on the northwest and southeast sides. The braces are approximately one and one-half inches thick and set into mortises in the logs so as to be flush with the front wall surface. The logs have stone rubble chinking laid diagonally and set in mortar. The building rests on a rubble stone foundation. The northwest elevation has a 6/3 double hung sash in the north bay, with one board shutter surviving. The west bay has a door opening. Inside the building is a tongue and grooved vertical board door that is probably what originally hung in the opening. Projecting from the wall at the attic floor level are portions of several joists that were probably part of a one-story porch .

fireplace flush with the outside wall, which flush brick chimney centered on the ridge of the gable roof. There is a single 3/3 sash west of the chimney in the loft that lights the winder stairway in the north corner of the single-cell-plan building. The gable roof is covered with corrugated metal on wood laths. The building is deteriorating and is now exposed to the elements, and is quickly becoming in danger of collapse.

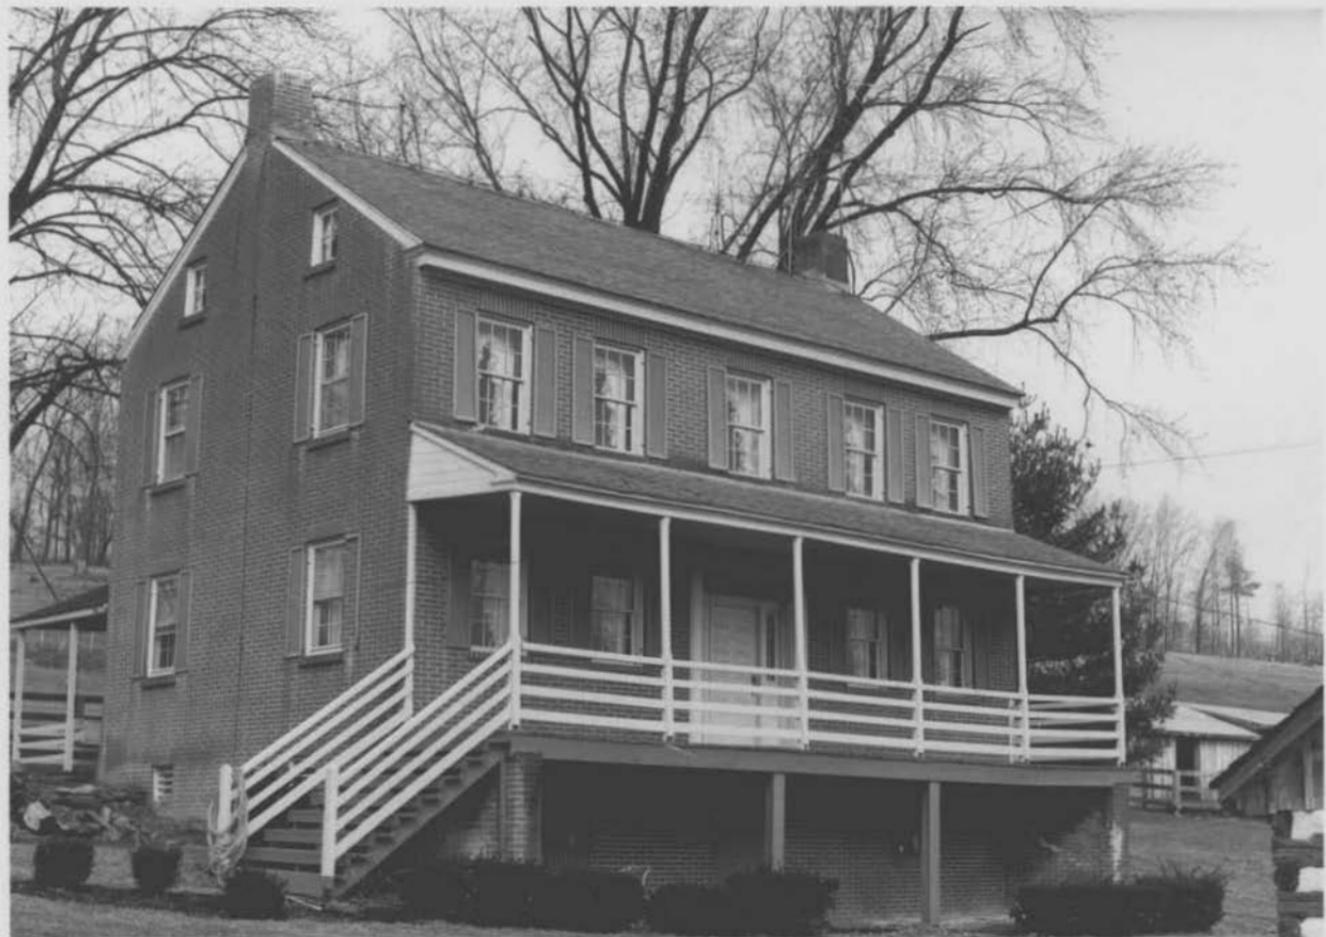
1/13

SW & SE elevs.

The brick house is a two-story, five bay central passage plan building, now covered in a brick-pattern stucco. It is banked into the hillside, with an exposed foundation wall on the southeast facade. This wall has a central vertical board door flanked on each side by a single 6/3 double-hung sash centered between the windows in the story above. The first and second stories have 6/6 double-hung sash with applied exterior blinds, though the hardware for earlier exterior blinds survive. The central entrance on the first story contains a transom and sidelights of multiple lights, with panels at the bottom half of the sidelights and a panelled soffit and jambs. The door has six square panels above two vertical rectangular panels. The doorway is framed with an architrave molding with corner blocks. There is a one-story porch with shed roof supported by end walls of masonry and two wood posts at foundation level, and by six chamfered posts at the first story. Currently the balustrades are four horizontal rails, which are not original, with eight wood steps on the southwest end of the porch.

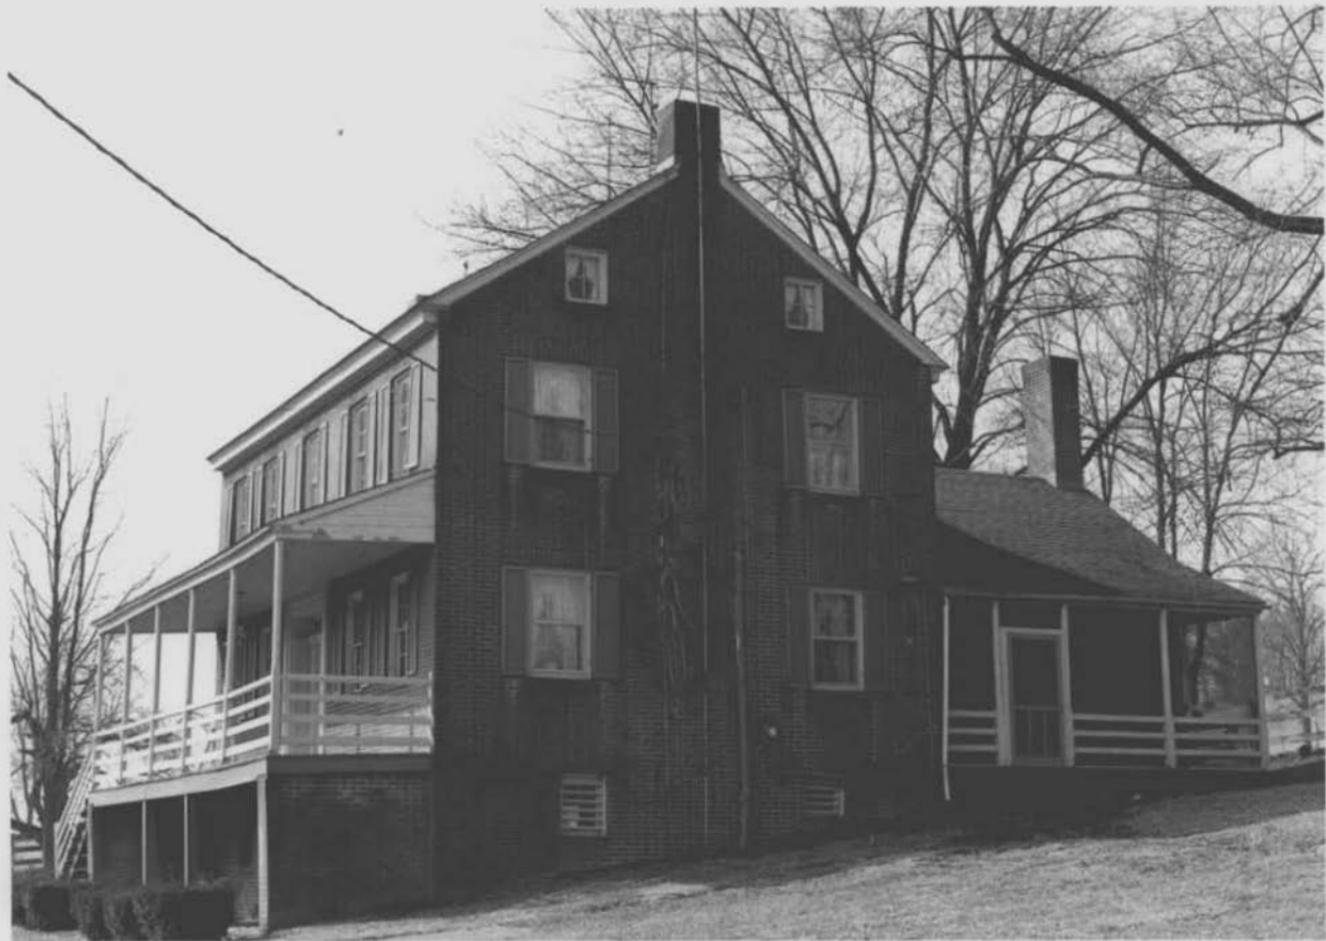
2/13

NE elev - House

The house has a boxed cornice with crown mold on the fascia and bedmold below the soffit. There is a gable roof with asphalt shingles and a flush brick chimney centered on the ridge at either end. The southwest and northeast elevations have tapered rake boards at the eave, with two four-light sash in the gable end, two 6/6 double-hung sash

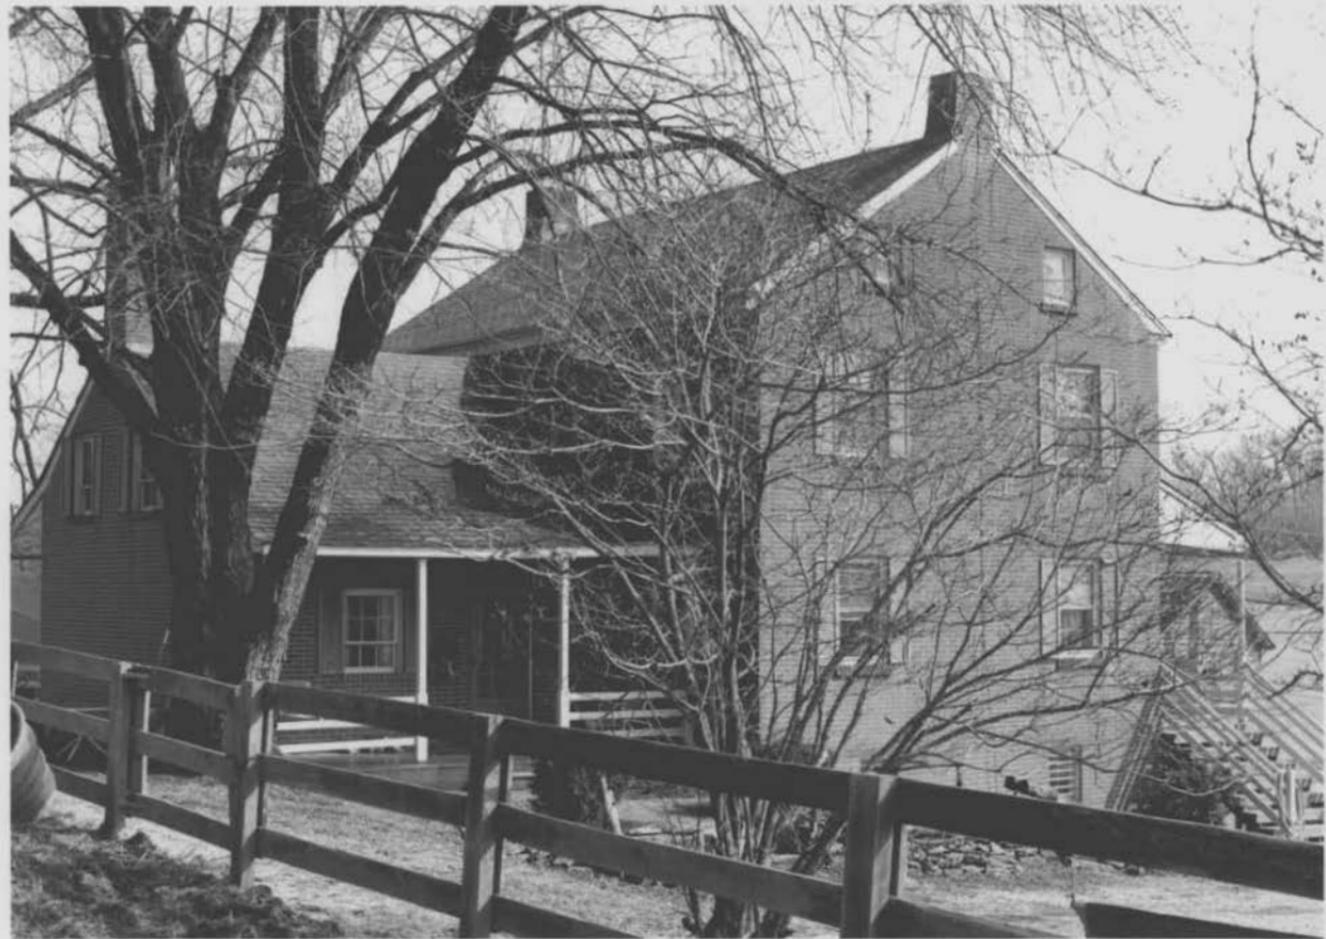
3/13

House - NE elev.

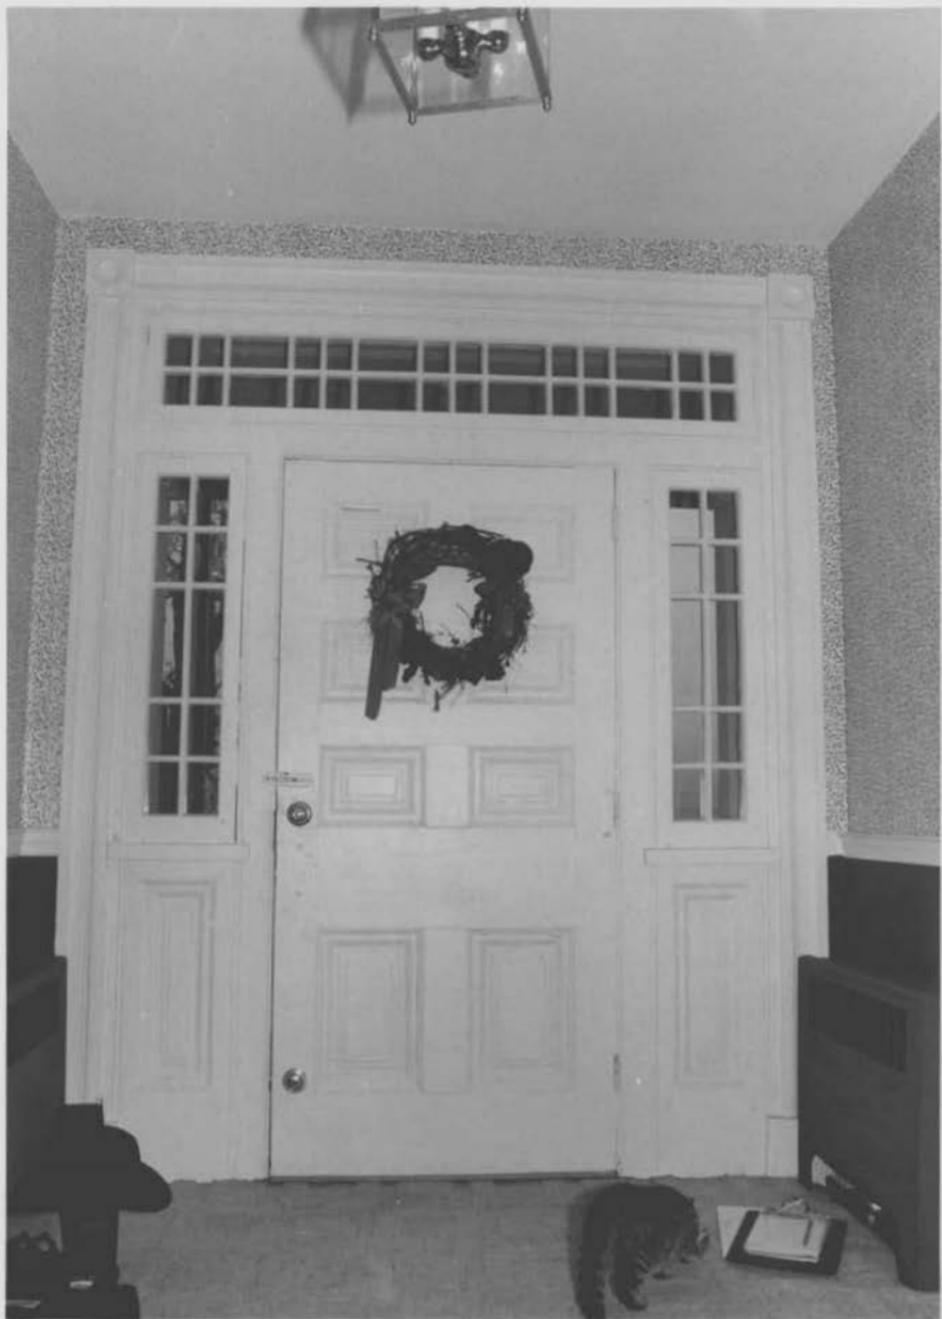
4/13

House - SE door, interior

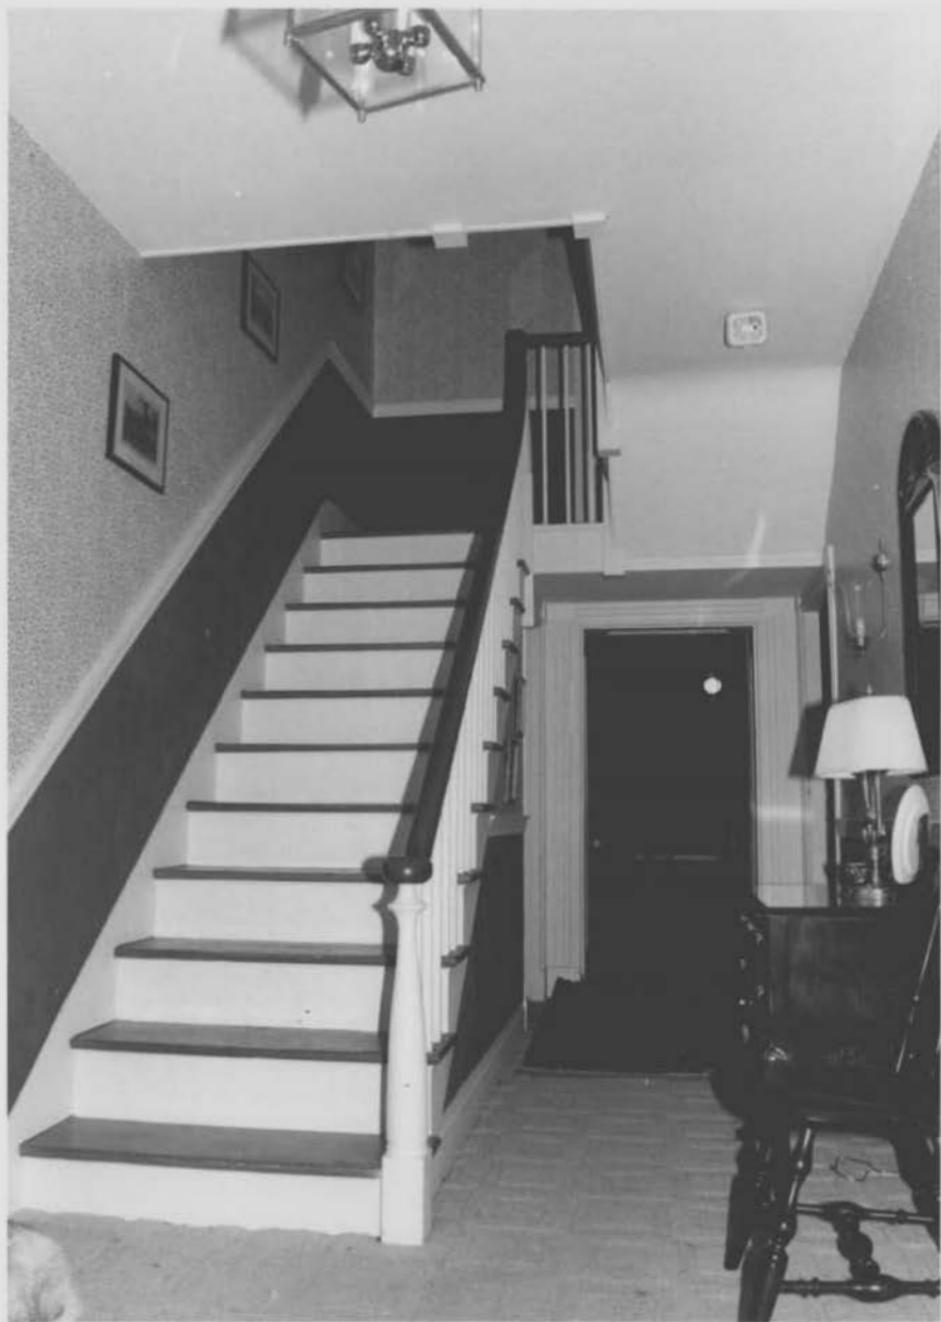
Neg. Loc.: Maryland Historical Trust
House - Starbuck - view northwest
7/13

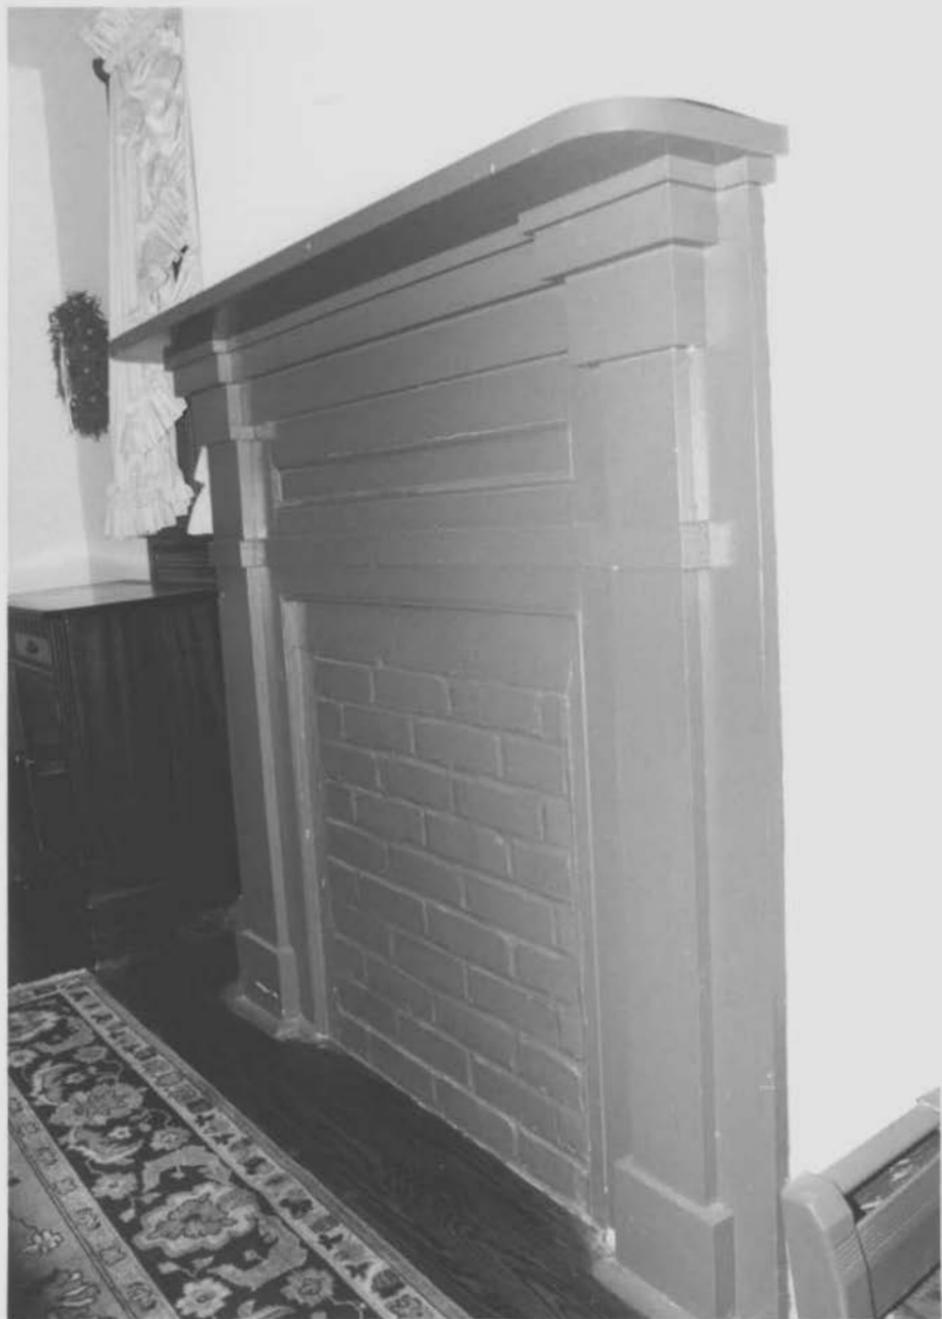
6/13

House - South west, room mantel

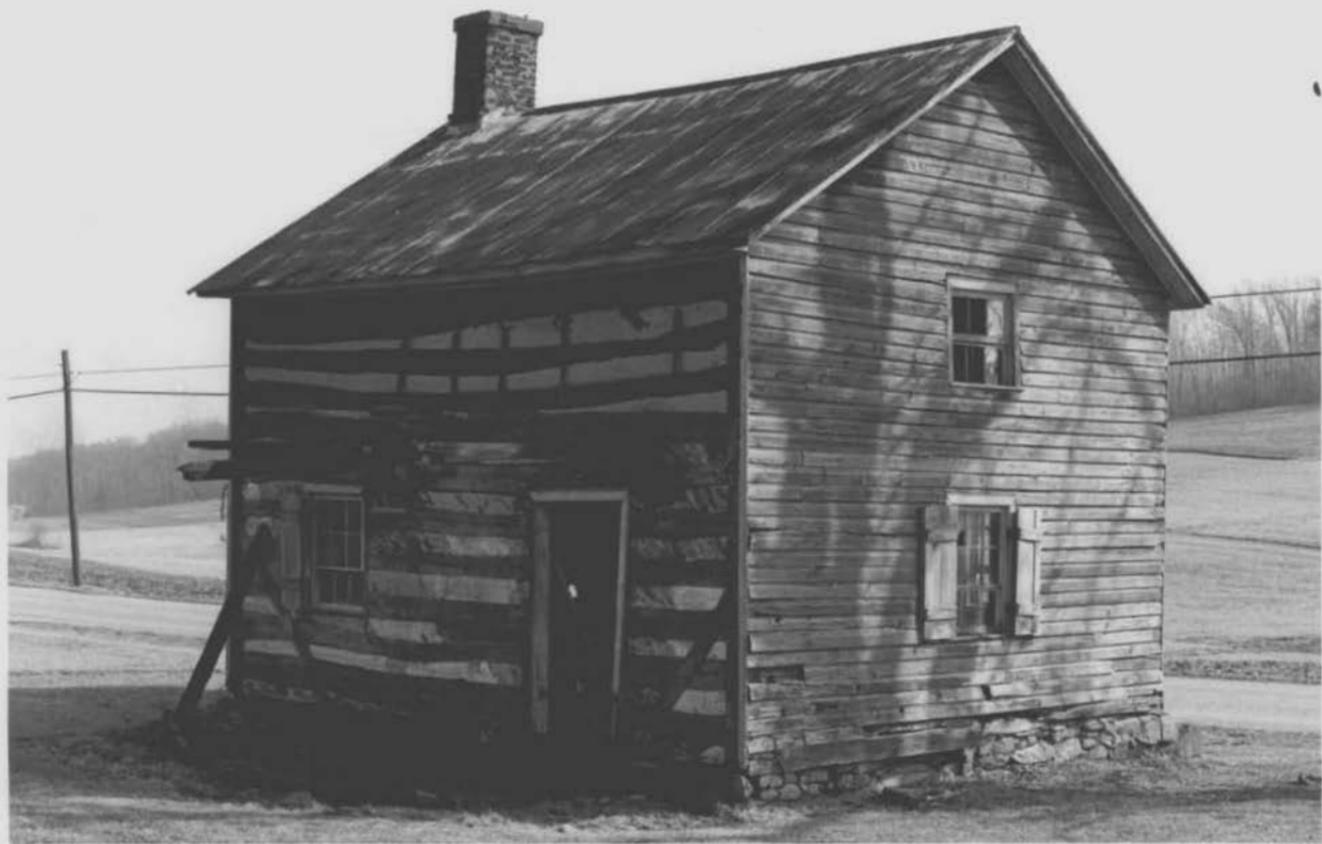
7/13

Neg. Loc.: Maryland Historical Trust
Summerhouse - NW & SW elevs.

The southwest elevation is covered by German siding and has one 6/3 double hung sash with board shutters on the first story and a 3/3 sash above. The southeast elevation copies this arrangement, but is two bays. The northeast elevation has an exposed brick

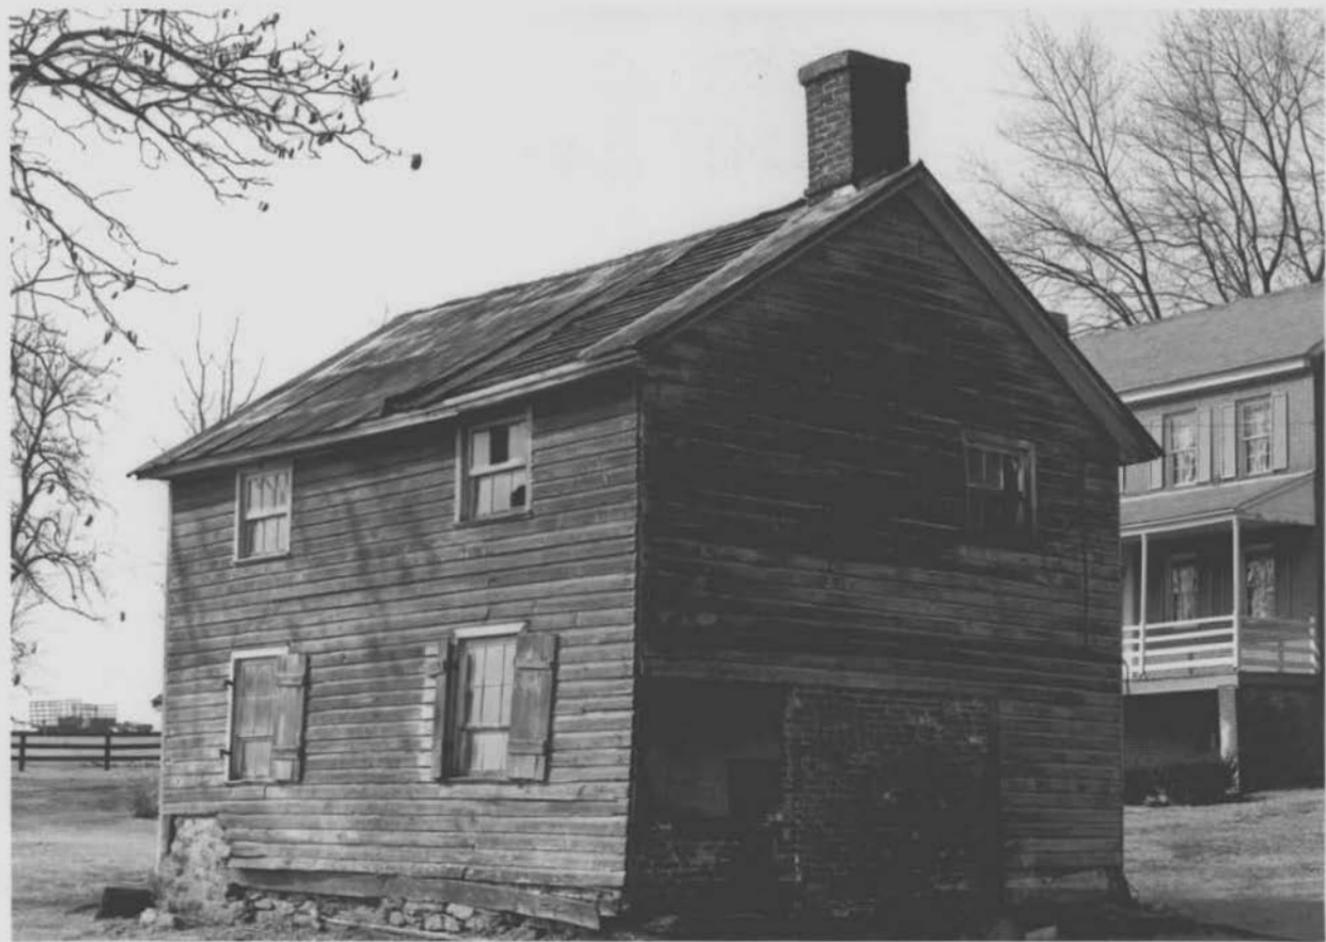
8/13

Summerhouse - SE & NE elevs.

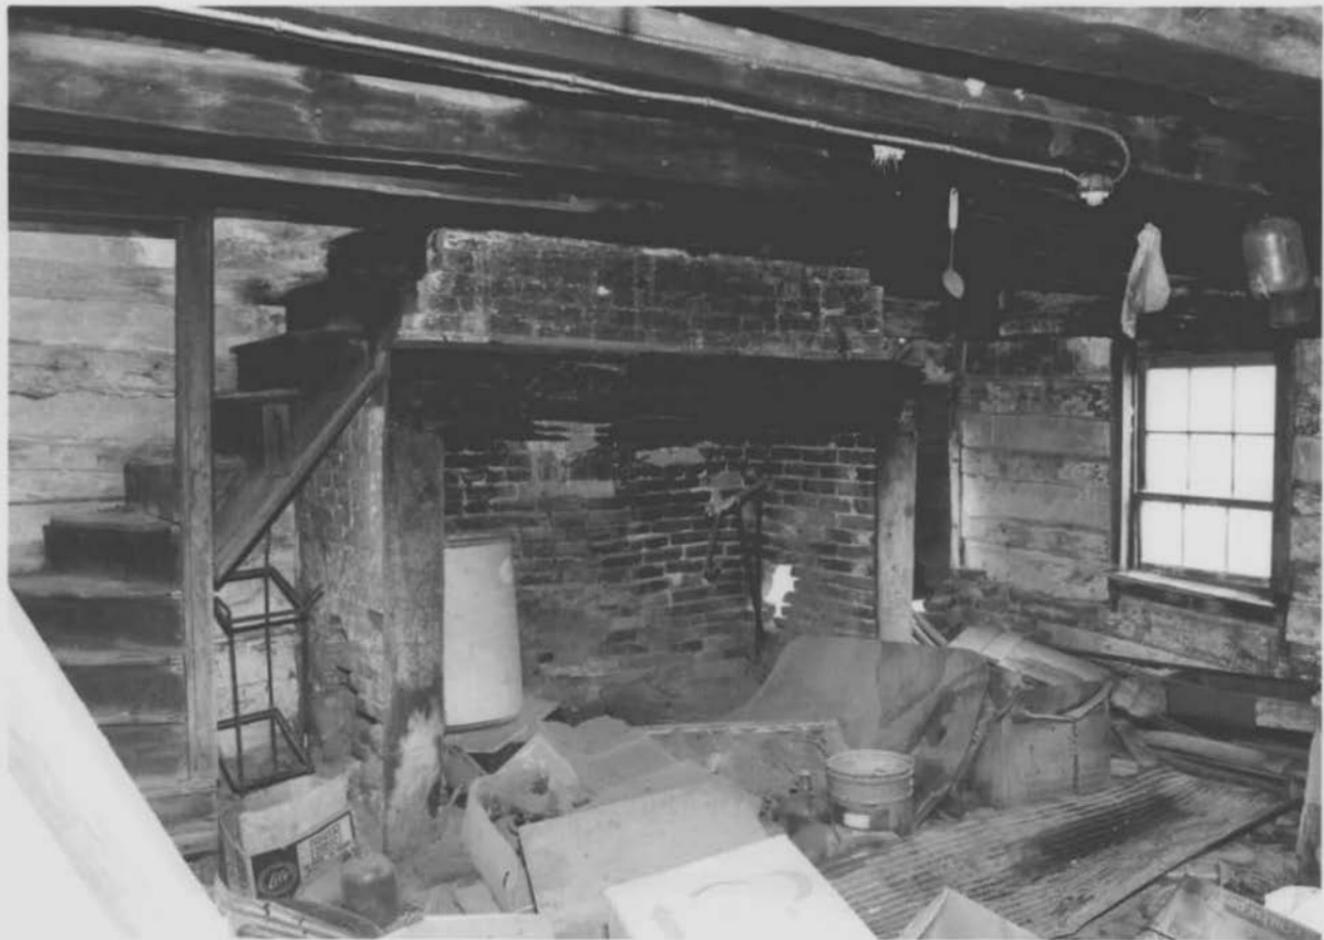
1/13

Summer kitchen, interior, view east

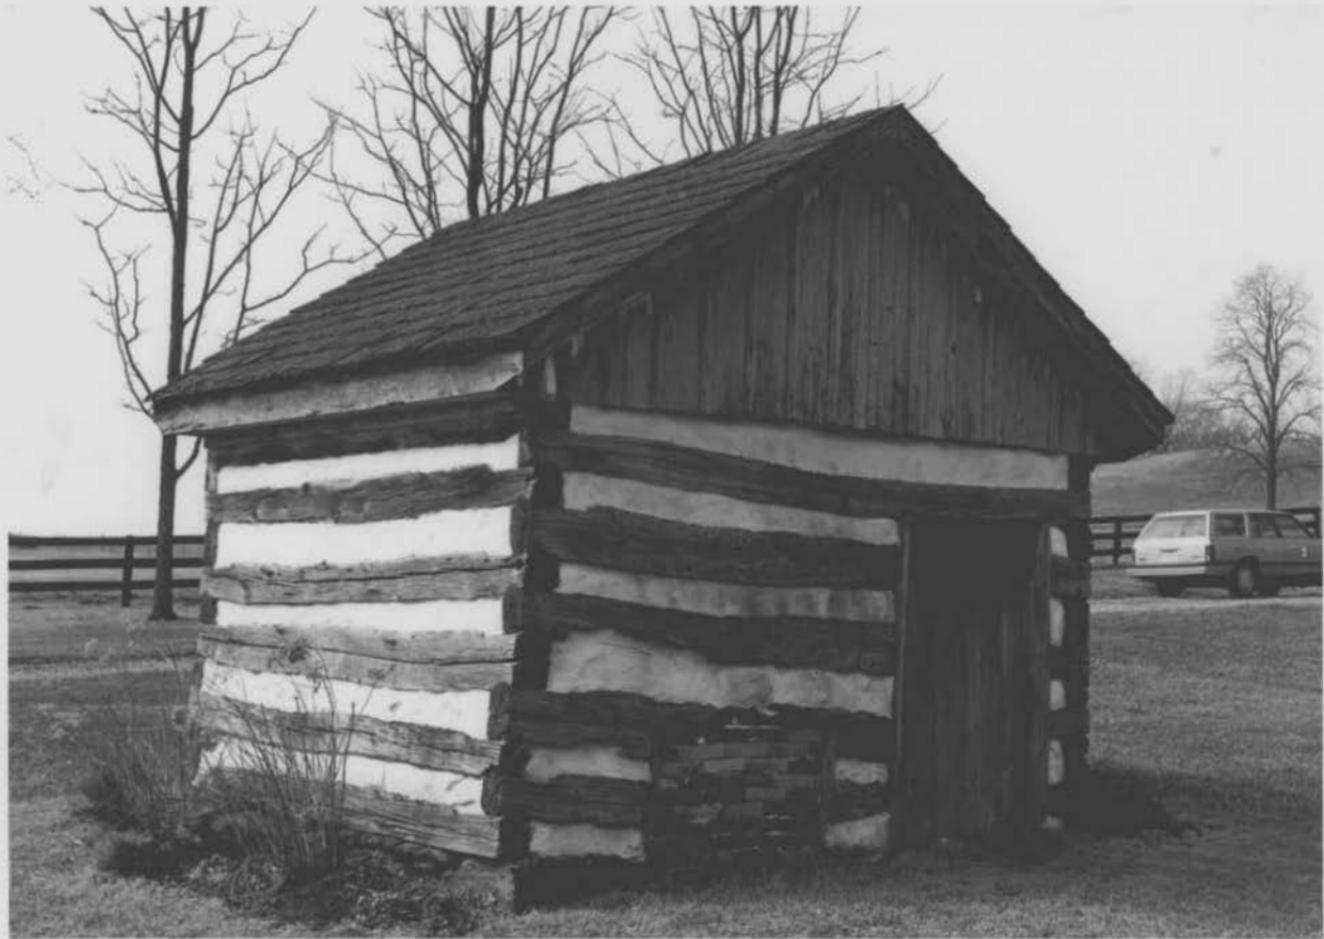
10/13

Smokehouse - SE : NE elevs.

The smokehouse is a V-notched log structure on a stone foundation, with a wood-shingled gable roof and board and batten siding in the gable ends. The battens have tapered sides. The northeast elevation has a vertical board door in the west bay and the rebuilt brick remains of the firebox exposed in the bottom of the east bay.

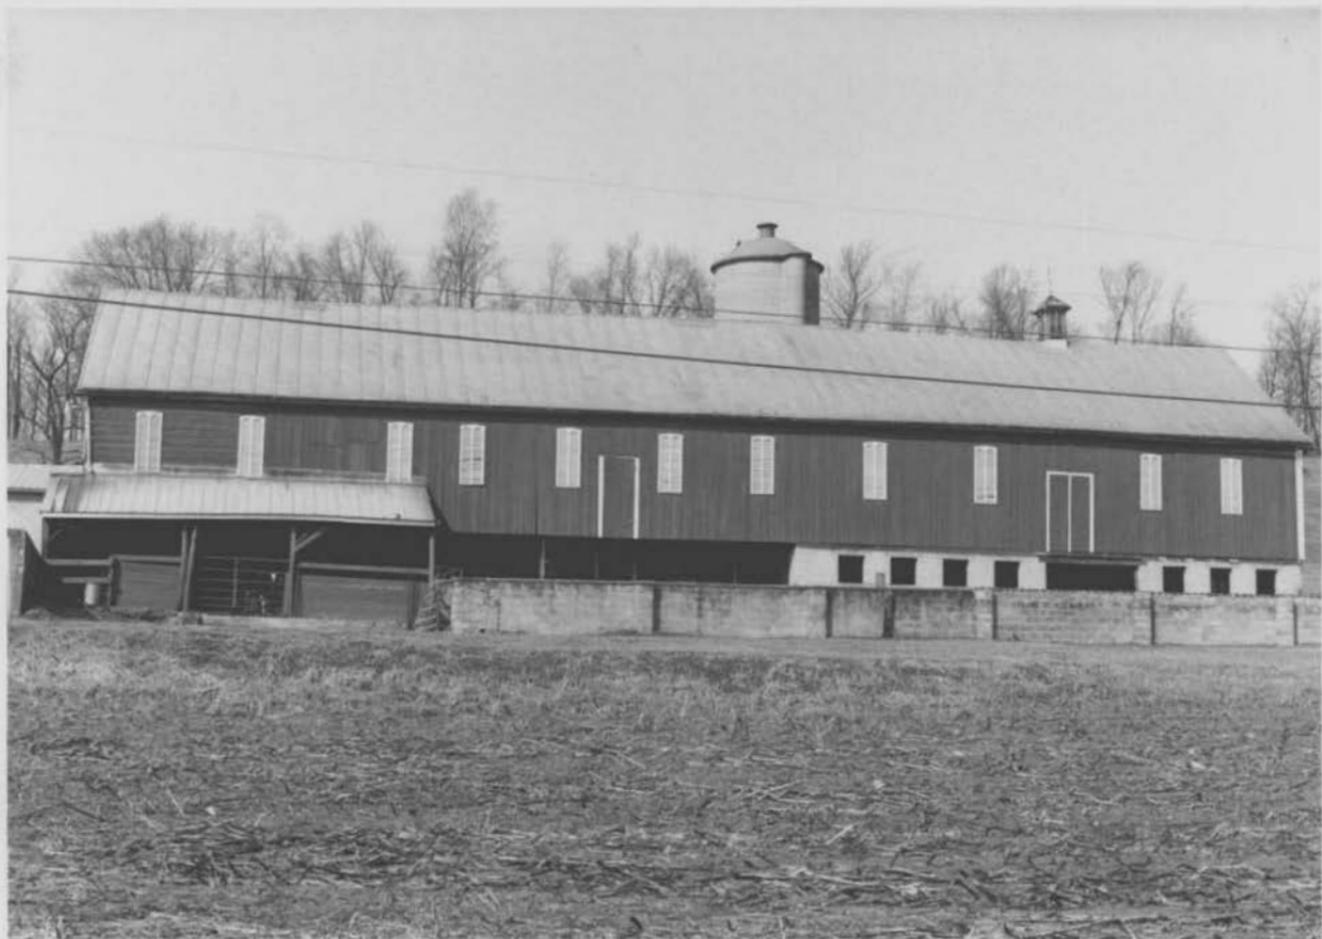
11/13

Barn - SE elev.

The barn is a banked structure with cantilevered forebay facing southeast. The basement wall under the forebay has been altered and has a later block wall to the north, but several bays in the middle contain their original vertical board dutch doors between horizontal board wood siding. The forebay wall has, from south to north, two wood vents with horizontal board siding, then vertical board siding with a vertical board door, three wood vents, another door, four vents, double doors, and two vents. The ends of the barn have a single vent in the gable. The northwest elevation is complicated. From south to north it contains a wood vent above a 4/2 window in what was probably a granary, then a pair of double doors on strap hinges recessed about six feet back from the wall plane, with a single wood vent between them. Then there is possibly a second granary in line with the first, then a wood vent, a pair of double doors on strap hinges that project forward about six inches, with a low cross gable roof and two wood vents in the gable end above the doors, and finally another wood vent in the northernmost double doors. There is a freestanding concrete silo with metal domical roof centered along the northwest wall of the barn.

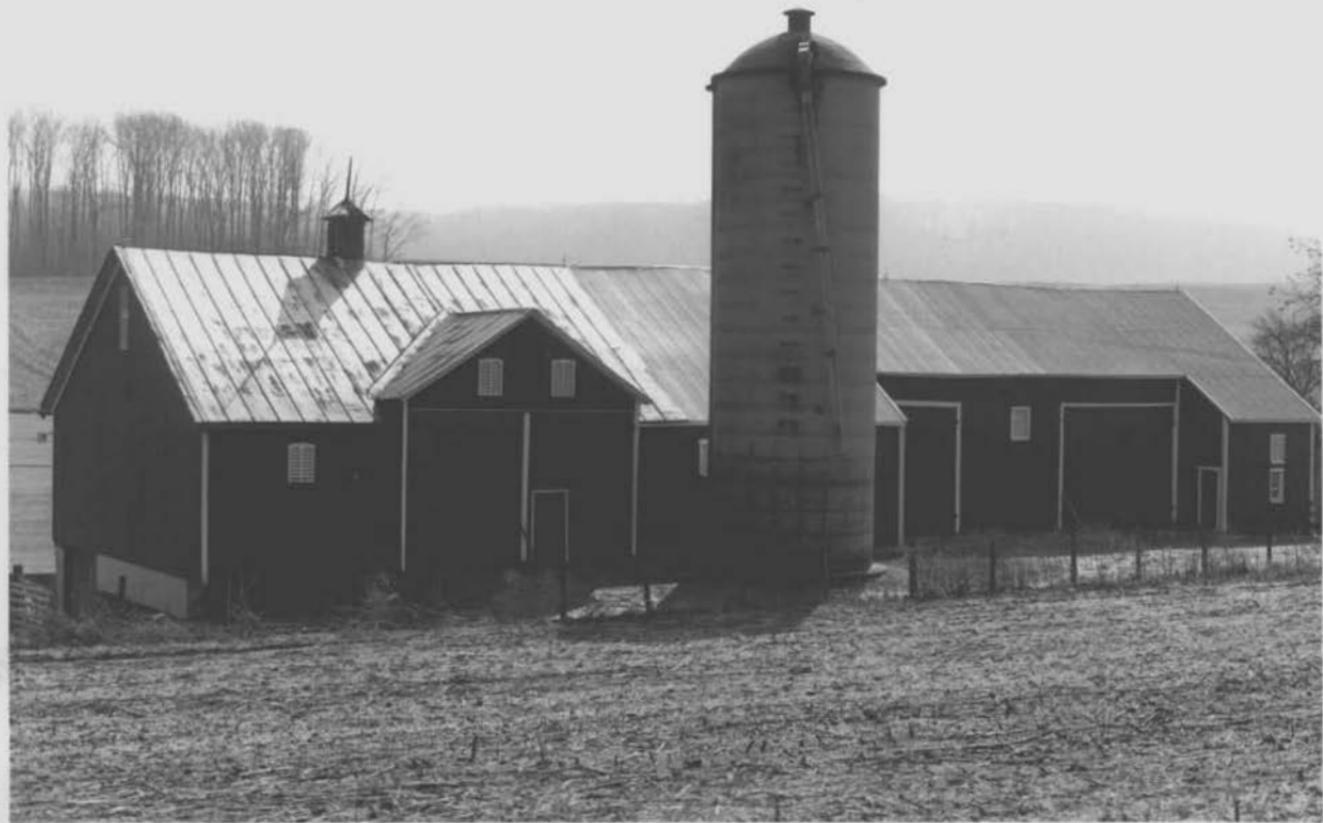
12/13

Burn - NE of Newelers.

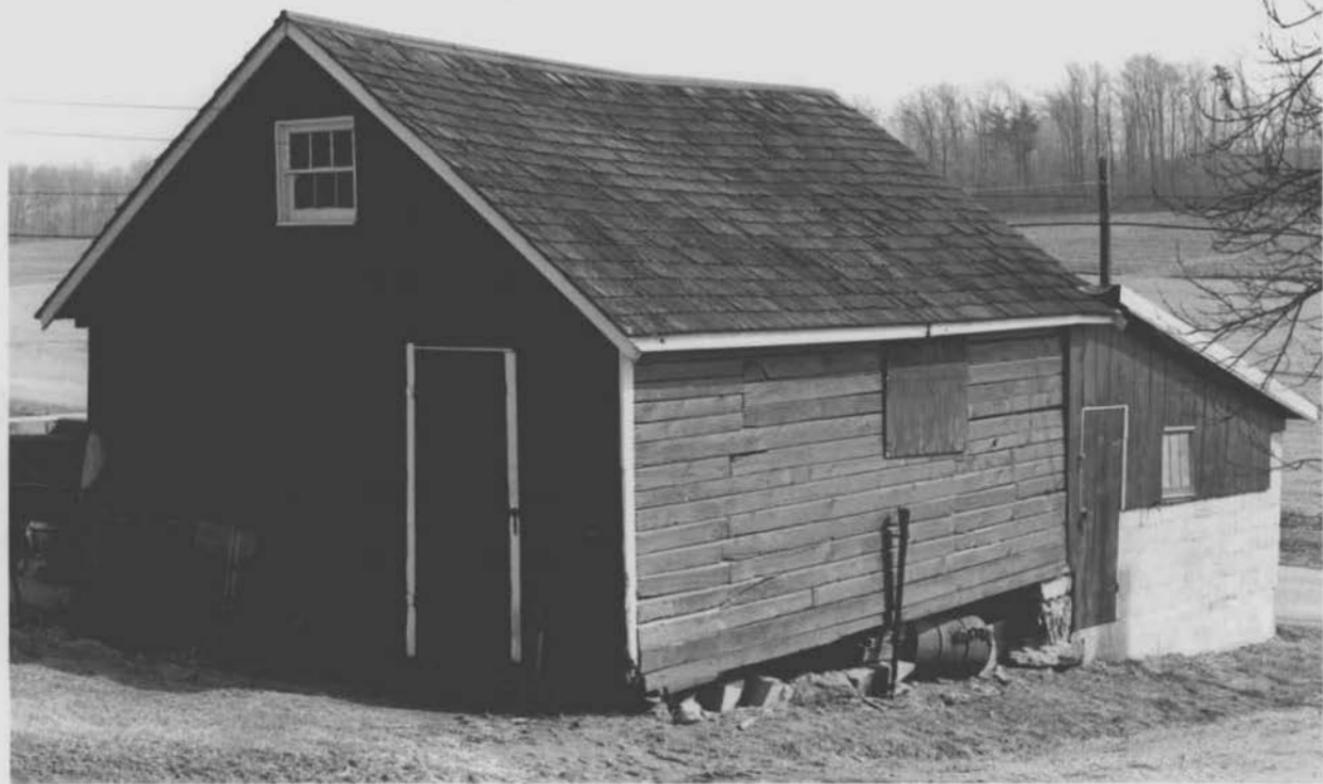
13/13

Corn crib - NW: sweeters.

There is a corn crib just south of the barn, set on stone piers, and with a gable roof with wood shingles. The crib is positioned on the southwest side and is covered with horizontal wood slats. The remainder of the structure is covered in vertical board and batten. The northwest end has a vertical board door to the south and a 3/3 sash centered in the gable end.
