CARR-1307

Joseph Price Farm
3931 York Road One
Millers (vicinity)

Maryland Historical Trust State Historic Sites Inventory Form

MARYLAND INVENTORY OF
HISTORIC PROPERTIES

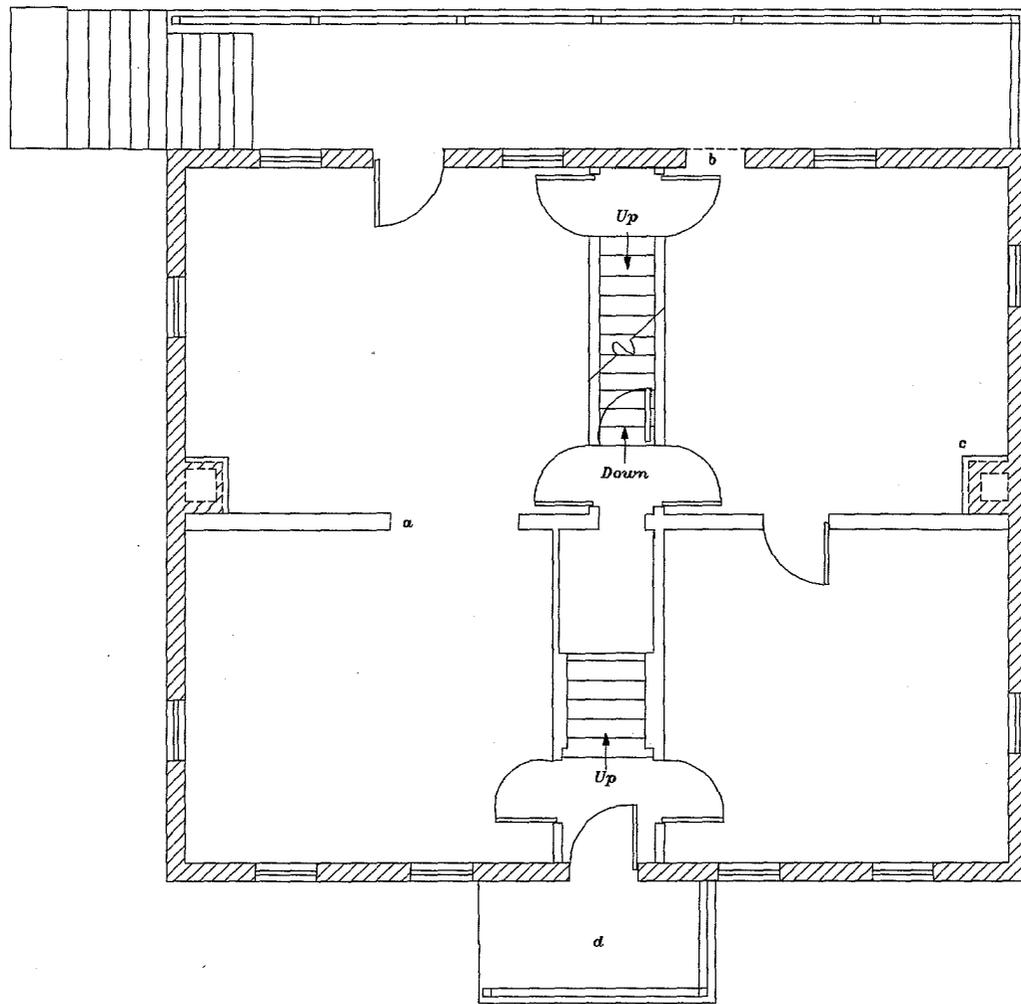
CARR 1307	Joseph Price Farm-House	First Floor Plan	March 1992

- a. Opening widened at unknown date
- b. Doorway closed off on exterior
- c. Existing condition - brick flue studded out and sheet-rocked
- d. Flagstone

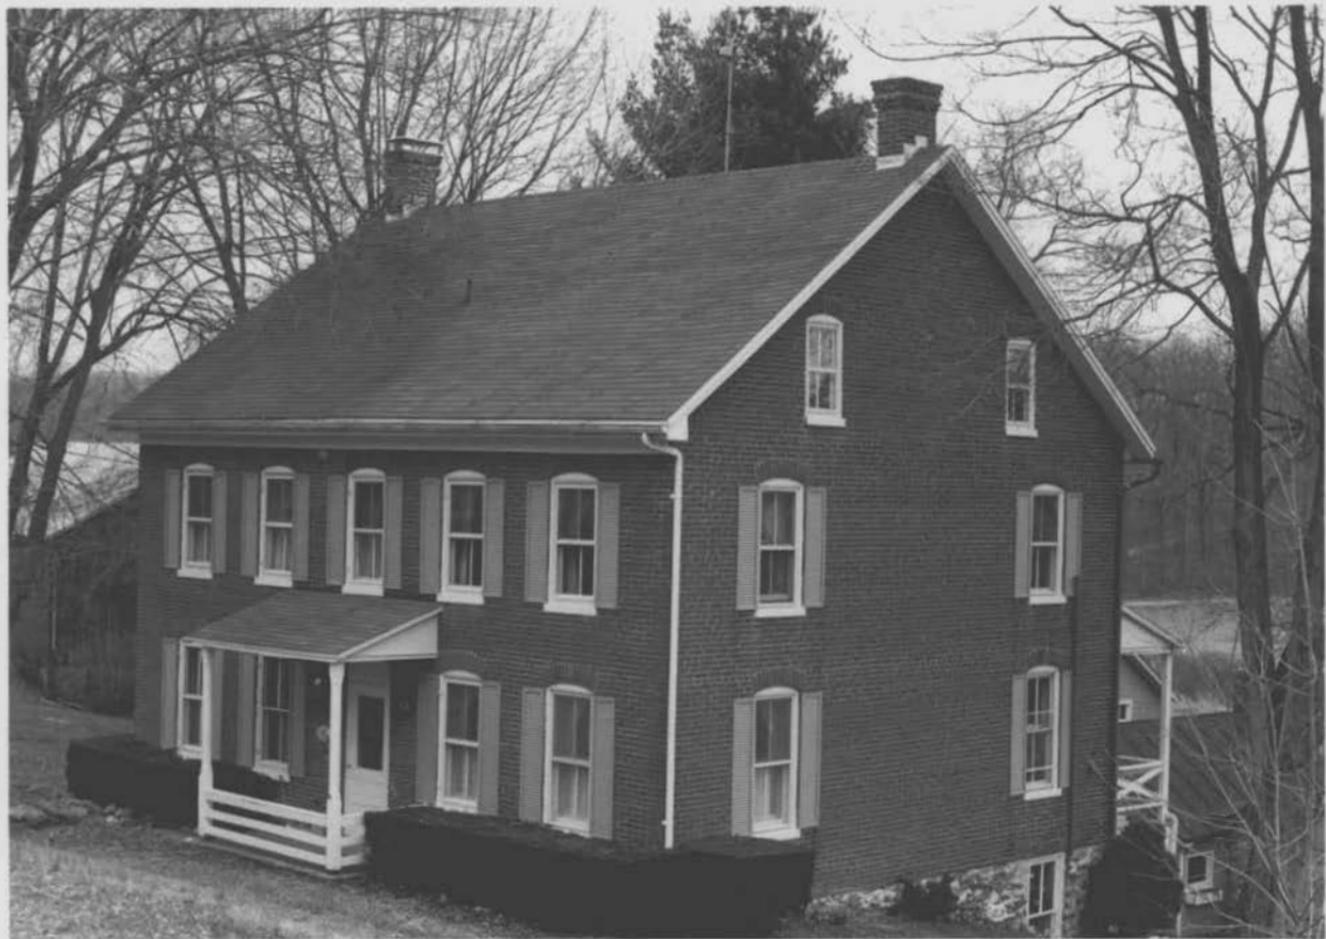
1/9

House - north + west elevs

The brick house is a two-story, five-bay structure with a center entrance on the north elevation which faces the road. It is built of 6-1 common bond brick on a rubble stone foundation and has segmentally-arched windows with 2/2 double hung sash in ogee-molded frames. The windows have wood sills and fixed aluminum blinds, but the cast iron hinges for the original blinds still survive. The front door is four-panel wood, with jigsawn scrolls under the top two panels. There is a one-story, one-bay shed roof porch over the entrance, supported by two chamfered corner posts. The horizontal board rails are a replacement. The original balustrades were across both ends and the western part of the front. The original configuration appears to have had a flat top rail, wide bottom rail, and vertical, square balusters. The gable roof has asphalt shingles and a boxed cornice with fascia board underneath. There are internal brick chimneys on both ends.

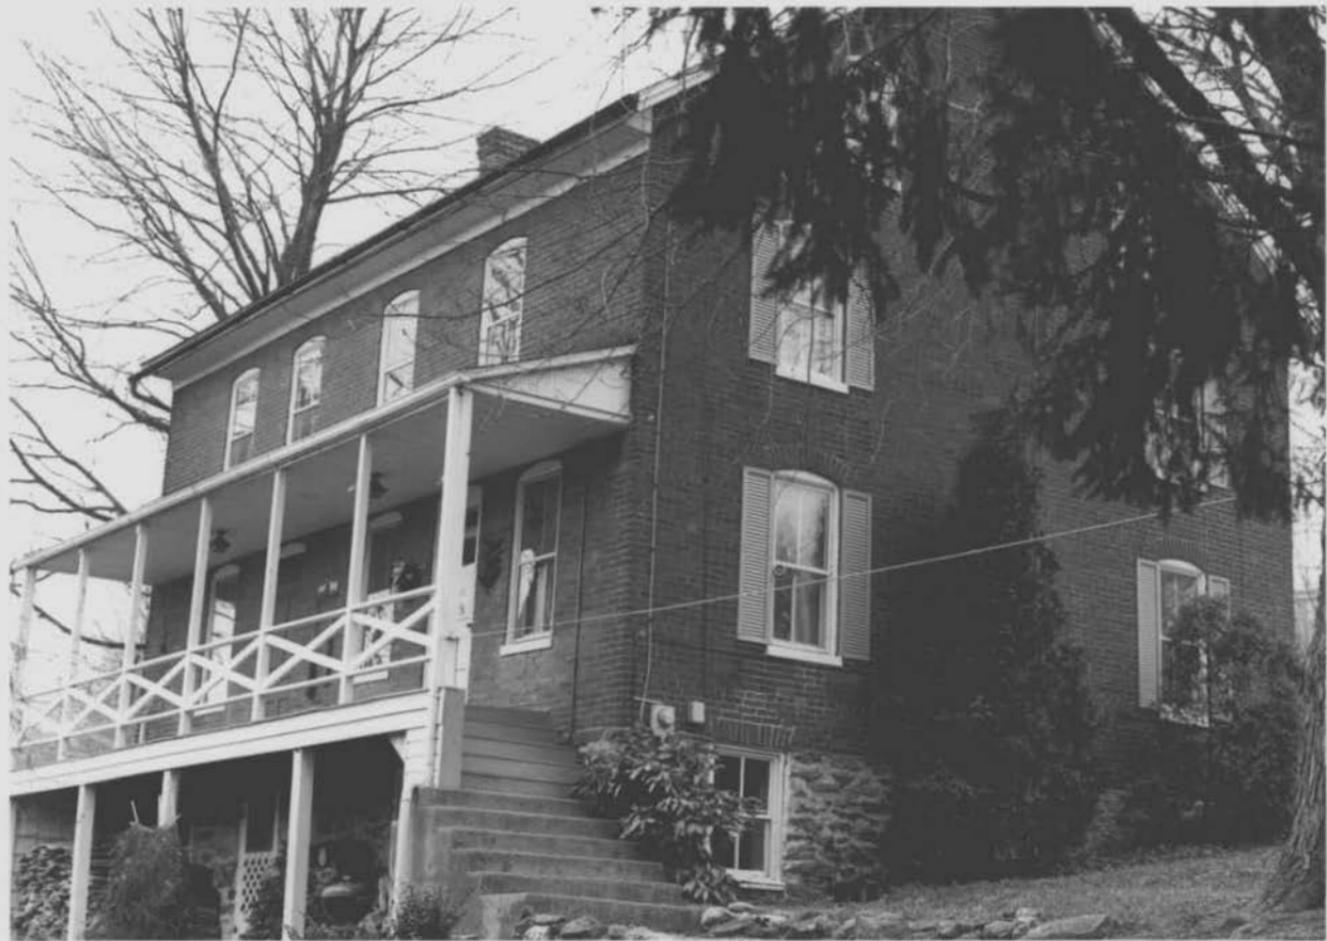
2/9

Neg. Loc.: Maryland Historical Trust
House - South: east elevs.

elevation foundation exposed. The south elevation of the cellar is four bays, with a 2/2 sash, vertical, beaded-edge-and-center, tongue-and-groove board door, another 2/2 sash and matching board door. The first story is five bays, with alternating 2/2 windows and five panel wood doors with single light transoms above. The second-story is four bays. All windows are segmentally-arched 2/2 sash with wood lintels. There is a one-story raised porch on the first story, set on five posts at cellar level. The porch has new posts and cross buck railing, and a shed roof with asbestos shingle siding. The cornice on the rear of the house matches the north elevation. The house is laid out as a double pile with a central entrance and a central boxed stairway. There is also a rear central boxed staircase that runs from back to front. Both stairs end at a central landing on the second floor. The door and window moldings have a broken field and a beaded interior edge. The joists and rafters are sawn, and the latter are mitered at the ridge, with wind braces of small sections set in rabbets in the rafters.

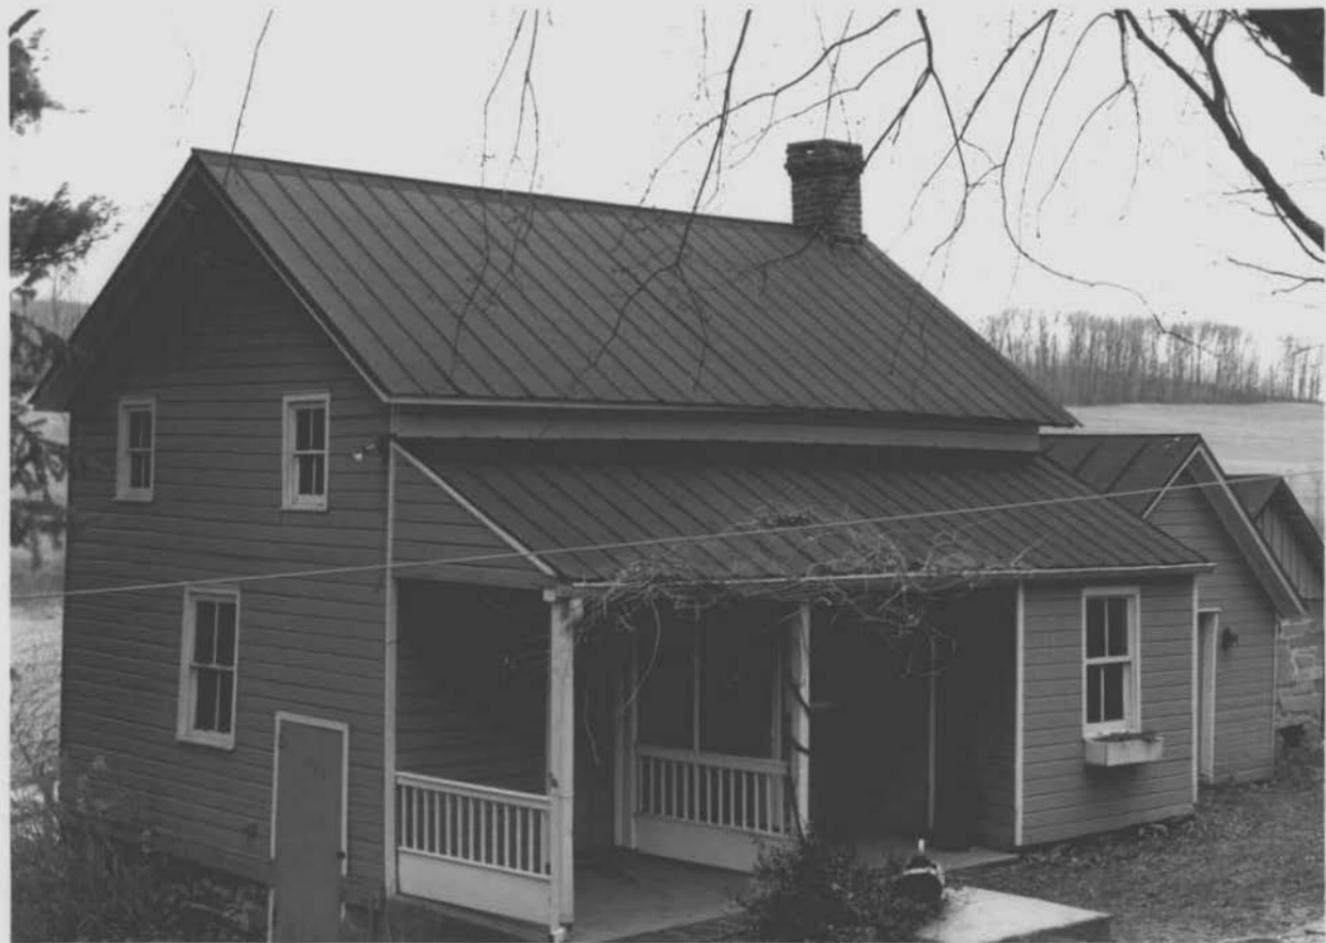
3/9

Neg. #00. Maryland Historical Trust
Summer kitchen - east & north elevs.

The summer kitchen is a two-story nailed frame building with German siding, corner boards, and a rubble stone foundation. It has a reduced second story under the standing-seam metal, gable roof. There is an internal brick chimney on the west end. The north elevation is three bays with a shed roof porch across the whole front. The east bay, between two chamfered porch posts, has a vertical beaded-edge board door that heads to concrete steps down into the spring house. The center bay has a tongue-and-grooved beaded-edge vertical board door into the summer kitchen and horizontal 2/2 sash with new architrave trim. The third bay of the porch is enclosed with German siding with a 2/2 sash on the north elevation and a tongue-and-grooved beaded-edge vertical board door on the east elevation. The interior of this room has floor to ceiling wood wainscot and a door into the summer kitchen.

The east elevation has two small 2/2 double-hung sash in the second story and one large 2/2 sash centered in the first story. On the north end is a tongue-and-grooved, beaded-edge-and-center vertical board door set below floor level. This leads into the spring house, which has a concrete trough at ground level and no framing at the first floor level. There is a porch balustrade, consisting of vertical square balusters between a top hand rail and lower horizontal board rail, that spans the space between the north wall and both posts. The south elevation was originally three bays. The west and center bays have reduced openings with 2/2 horizontal sash and new architrave trim, and the east bay has been boarded. The west elevation abuts a laundry building or rendering house, and has two small 2/2 double-hung sash in the second story. The one-bay wide springhouse is separated from the one-room summer kitchen by a wall. The kitchen has a winder stair on the southeast that projects into the springhouse. The fireplace is on the west wall.

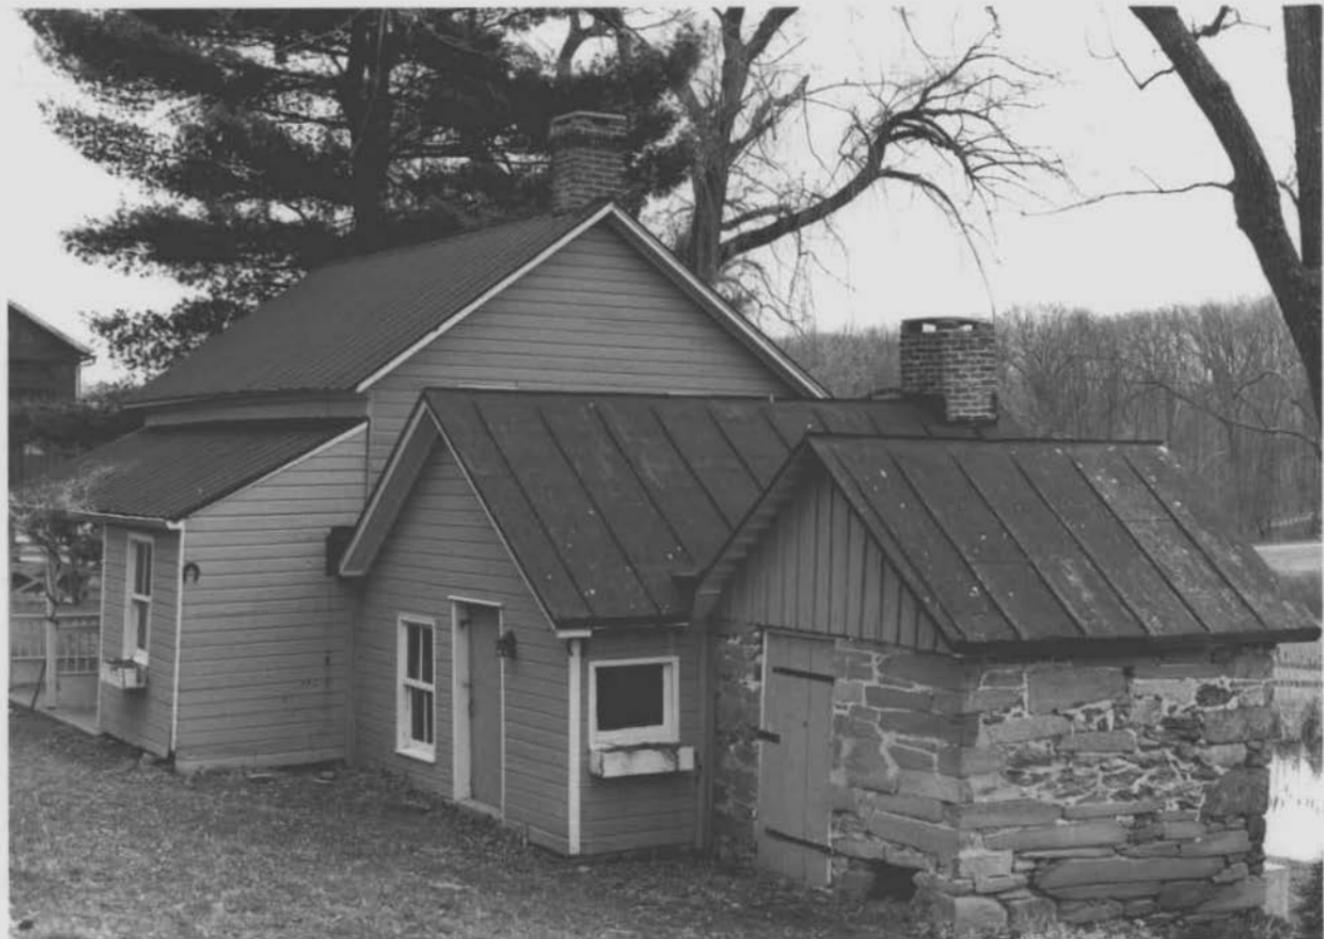
1/9

Summer kitchen, laundry, and smokehouse -

N. & W. elevs.

The laundry building is a one-story frame structure on a stone foundation with standing seam gable roof and German siding. It abuts the summer kitchen on the east and the smokehouse on the west, and was built after both. The gabled north elevation has a 2/2 sash to the east and a vertical board door to the west. The south elevation has an internal, exposed stone and brick fireplace in the center, flanked by a single light window on each side. There is a brick chimney above the ridge. The siding is recent board-and-batten, reportedly copying the earlier siding here. The center of the west elevation wall abuts the smokehouse, but to the north is a single-light window and south of the smokehouse is a tongue-and-groove, bead-edge vertical board door.

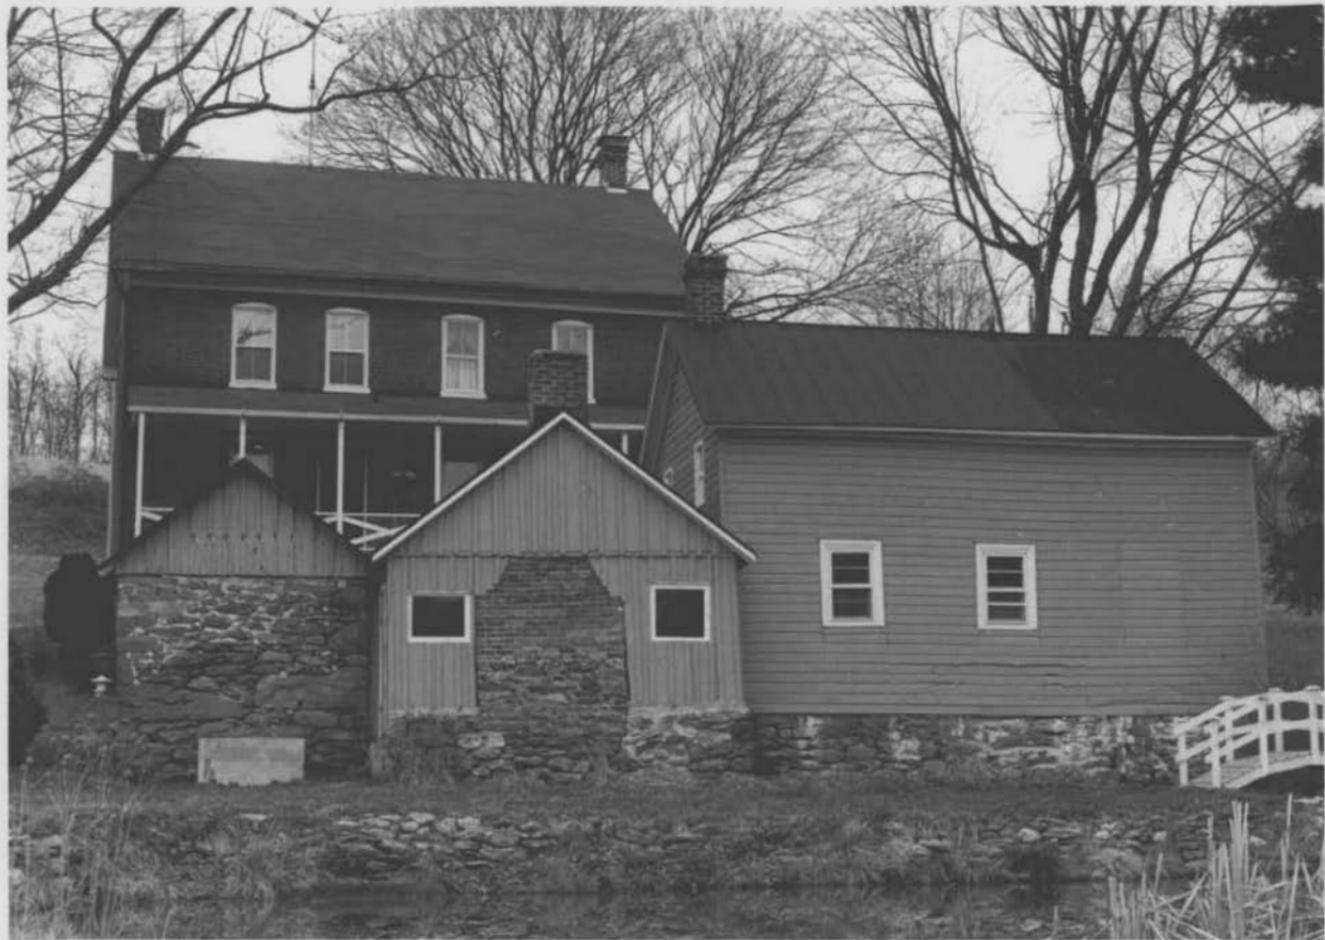
5/9

Smokehouse, Laundry & Summer Kitchen - South
eaves

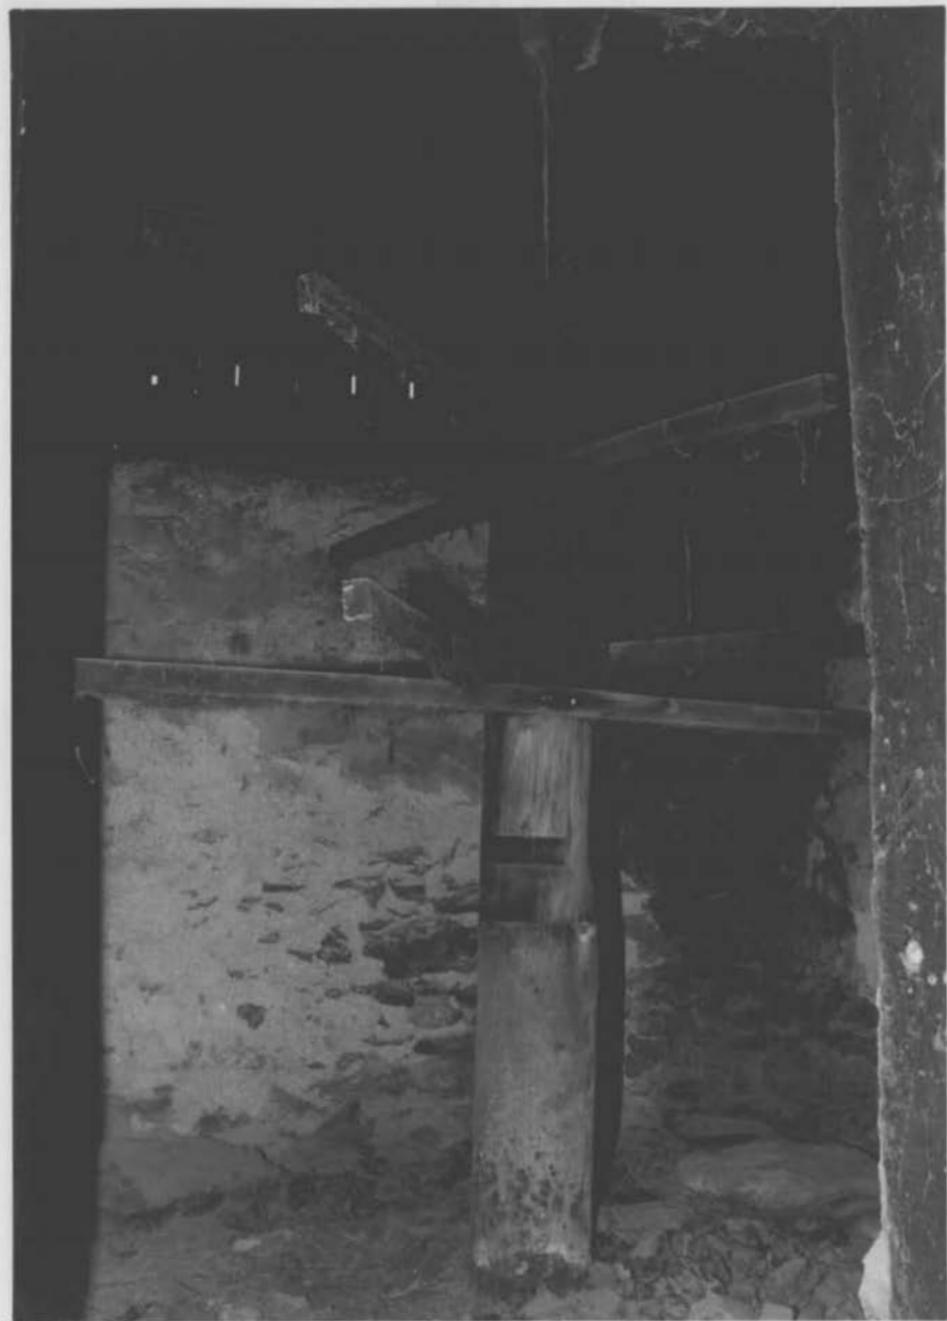
6/9

Smokehouse - interior

The smokehouse is built primarily of uncoursed fieldstone with finely sawn faces. There is some rubble work on the west elevation and quite a bit on the south. The north elevation has an off-centered tongue-and-groove vertical board door on strap hinges with a fire pit opening to the west, at ground level. The gable end has board-and-batten siding and the gable roof has standing seam metal. The interior walls are plastered and the tree survives, but the fire box is now gone.

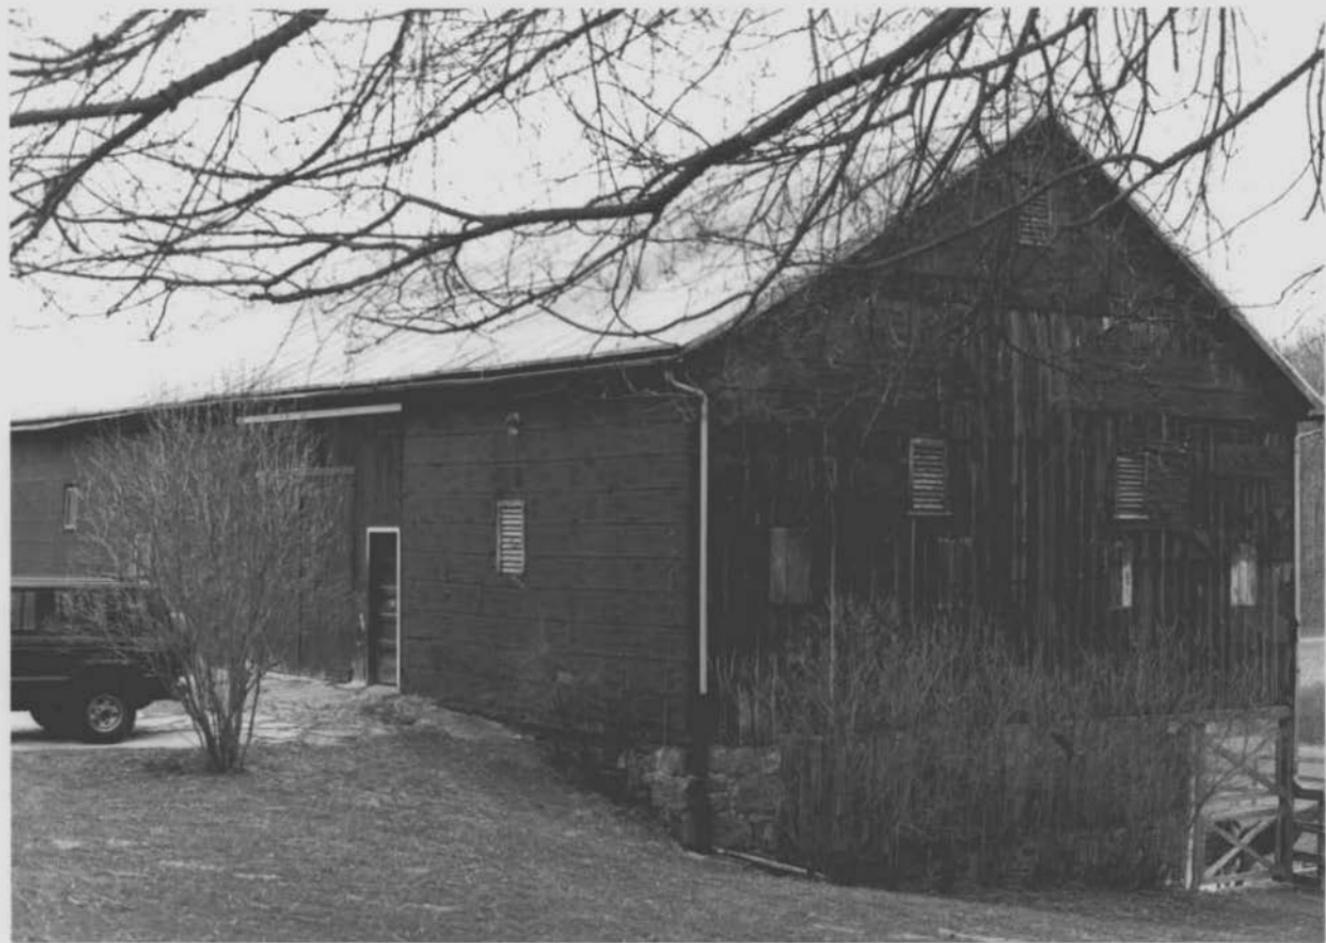
7/9

Barn - north west elev.

The frame bank barn has a rubble fieldstone foundation with quoins and vertical board siding covered in part with brick-pattern asphalt shingle siding. The ramp side is on the north and has a central pair of vertical board doors on strap hinges that are now fixed, and have a smaller pair of double doors on strap hinges set within the large doors. The smaller doors are off center, with a five-panel wood door to the west, also within the larger doors. There are two fixed one-light sash east of the doors and one wood louvered vent west of the doors. There is a standing seam metal gable roof. On the west elevation, the stone foundation is only half the height of the lower story, with wood frame and board siding between the top of the stone foundation and the sill. Above was a row of four vents, now removed and boarded over, with two wood, louvered vents in the row above and one in the gable peak. The east end has one vent in the peak, the two below having been removed, and there were never any below these because this end of the barn contains a wagon shed. The stone foundation here is only one quarter high, with framing above, up to the sill. The foundation wall between the wagon shed and stalls is identical to the west wall arrangement. The wagon shed appears never to have incorporated a corn crib.

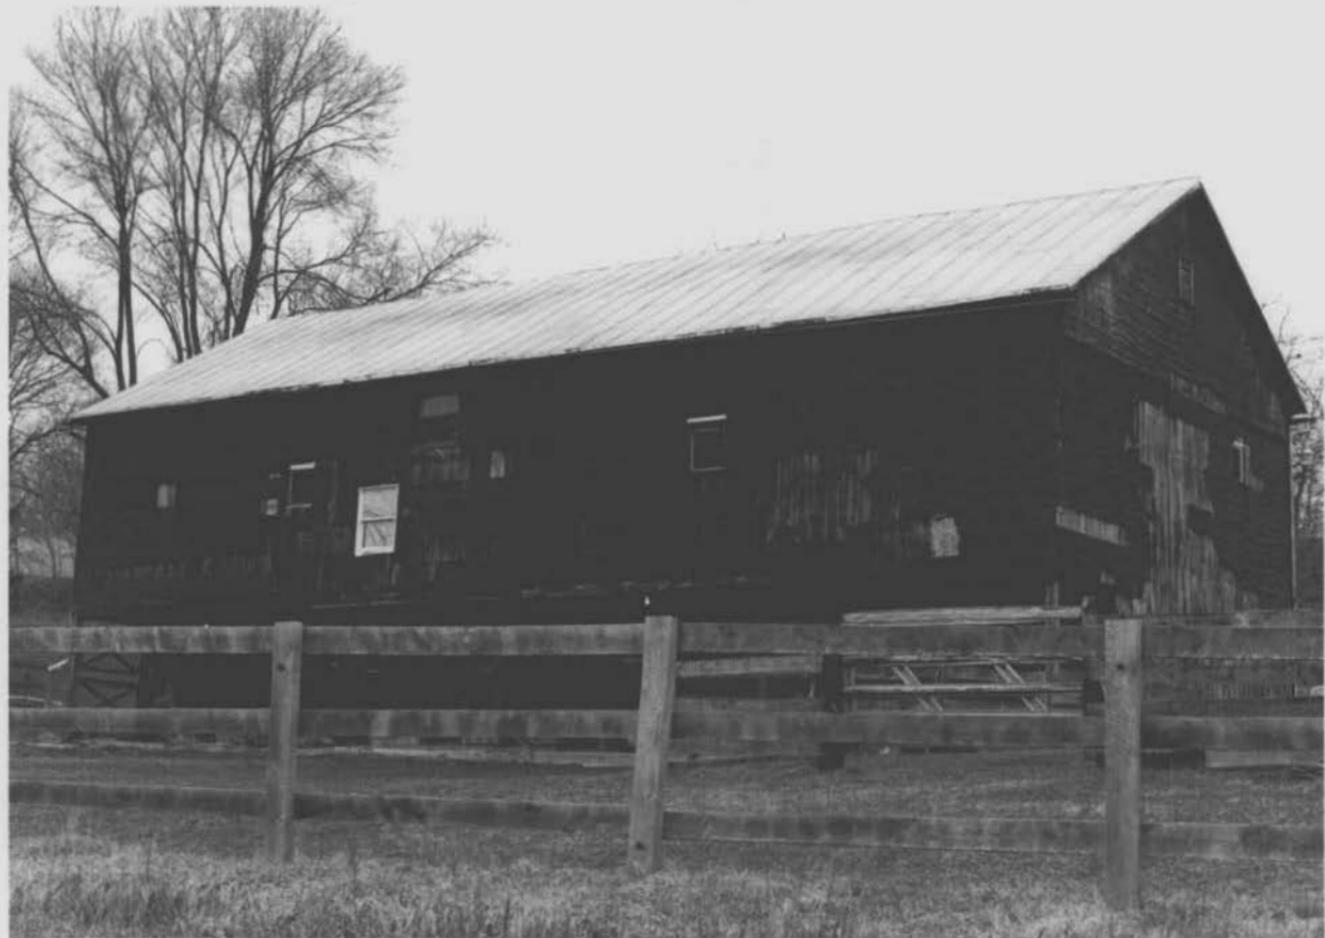
8/9

Burn - south & east elevs.

The south elevation has a low stone foundation wall with horizontal board siding above it, in the lower story. There are five vertical tongue-in-grooved, beaded-edge-and-center board dutch doors on strap hinges, with a large pair of wagon doors of the same siding on the east end. The wagon shed projects into the upper story. This upper-story wall used to have four vents, but they have been removed and two have been boarded. A 1/1 aluminum sash has been added near the center of this wall. There is a butchering hoist under the overshoot. The stalls in the lower story have been altered. The upper story is

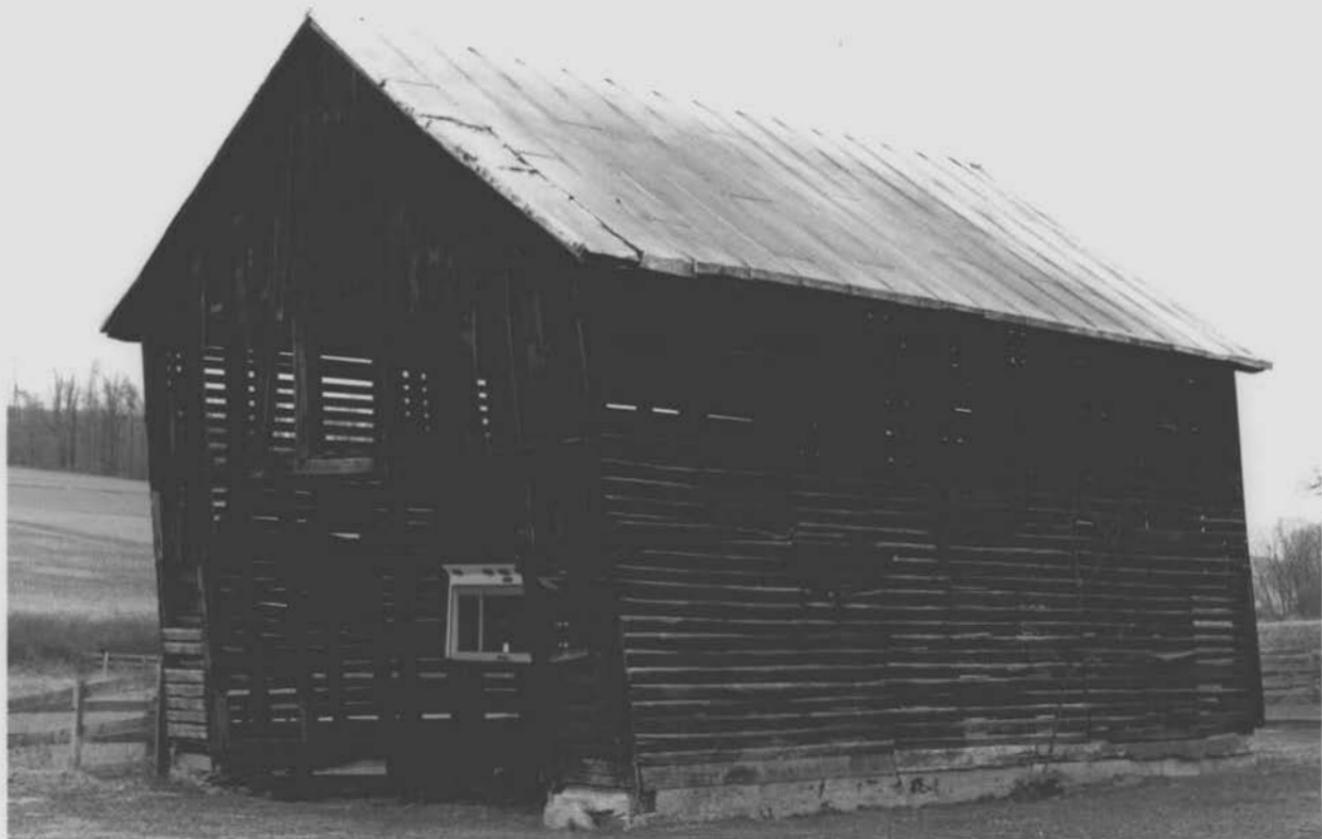
9/9

Corn Crib - east & north elevs.

Southwest of the barn is a wood corn crib with circular seam heavy timber braced frame mortised, tenoned, and pegged together. The rafters are 2x4's mitered at the ridge. The gable roof has standing seam over wood shingles. The northwest and southeast gable ends are open to the central wagonshed below, with vertical board siding with an opening that used to have a door, above. The northeast and southwest sides have corn cribs with horizontal slats inside and on the bottom half outside, with horizontal board siding above. Each crib used to have a door on the northwest end. There is a parged stone foundation wall under the northeast side and stone piers under the southeast.
