CARR-1314

Miller-Warner Farm  
3626 Lineboro Road  
Lineboro (vicinity)

# Maryland Historical Trust State Historic Sites Inventory Form

historic Miller-Warner Farm

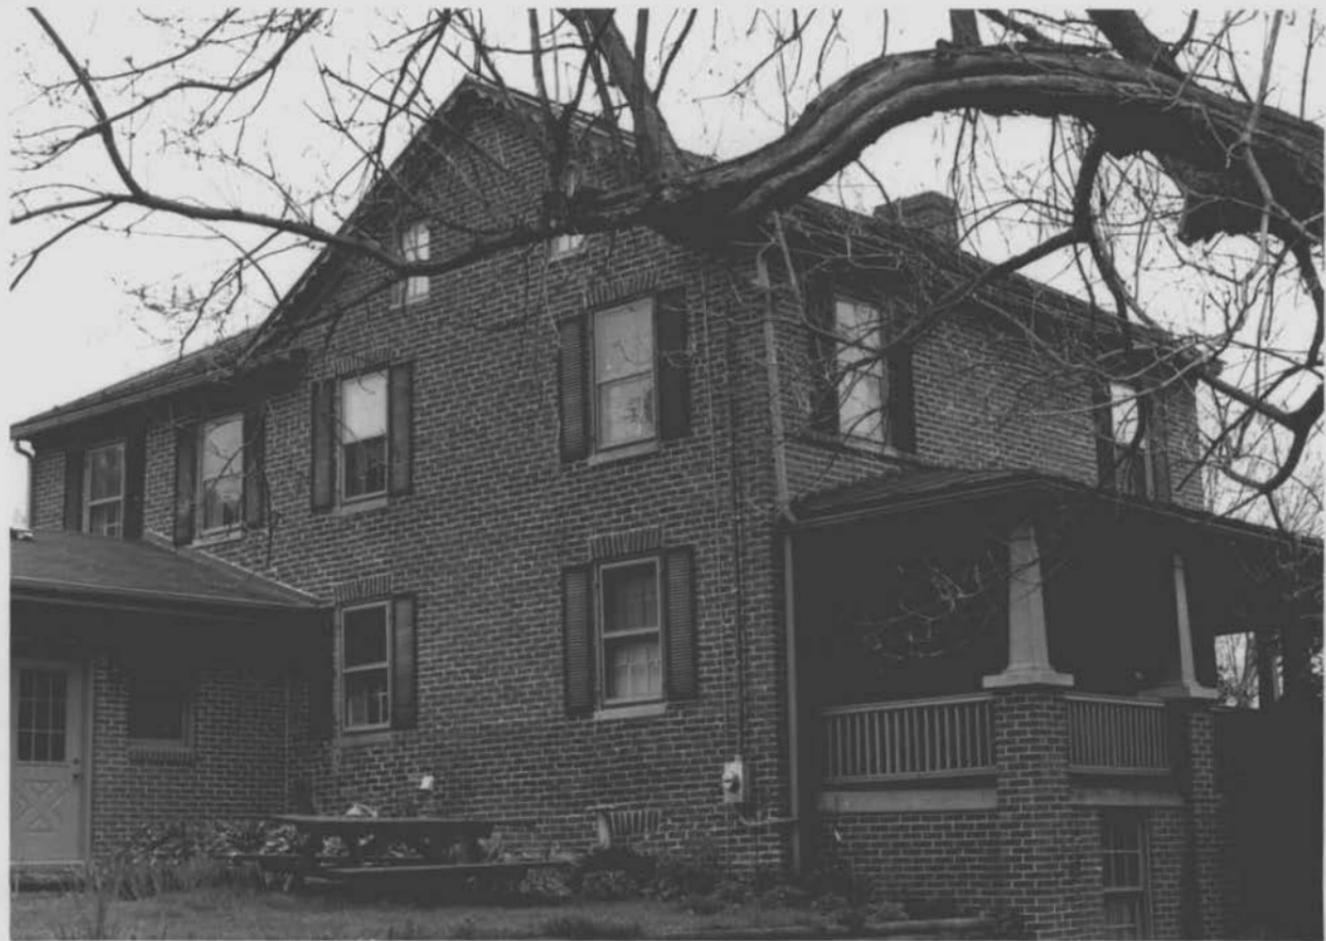
15

House - Southwest to Southeast elevs

The house is a two-story, banked, four-bay by two-bay structure with a two-bay square two-story addition on the northwest. The main block of the house is log encased with all-stretcher bond brick. The addition is built of 6- and 7-1 common bond brick. The house is banked on the northwest with an exposed cellar wall on the southeast (front) facade. The foundation is of rubble stone. It is built on the "Pennsylvania Farmhouse" plan. The windows are 6/6 double-hung sash with wood sills and brick jack arches. They formerly had operating shutters but now have fixed blinds. The first story originally had two center doors, but the south opening has been bricked in. The east opening has a four-light transom and six-panel wood door, with the large panels at the top and bottom and the two square panels set in the middle. The second story has windows only in the two end bays. The gable roof has standing-seam metal, an interior brick chimney on the northeast end, and a boxed cornice with returns. There is a raised, one-story, hipped-roof, wrap-around porch on the southeast and northeast. It has brick piers with concrete caps and battered wood posts. Square-in-plan vertical balusters and brick infill between the piers in the cellar. There are 6/6 sash in each bay of the brick infill, with a door in the east-center bay.

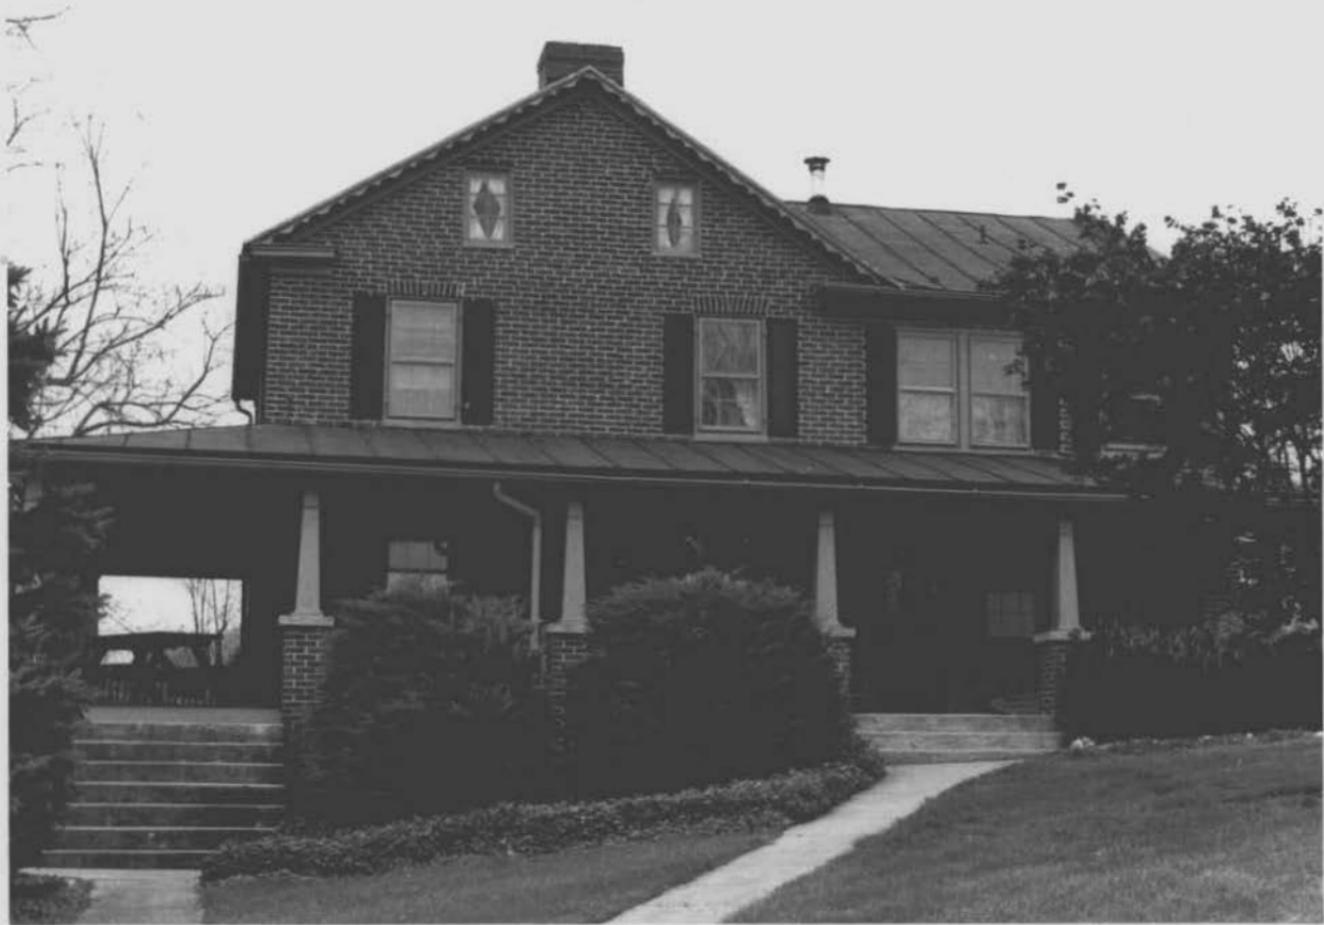
House - northeast corner

The northeast and northwest elevations of the main block each have a pair of six-light sash in the gable end and sawn barge boards with a wave pattern. The northeast elevation of the rear wing has board-and-batten infill in the east bay of the first story and brick in the north bay and the entire second story. The east bay of the first story also has a recent door and a 6/6 sash, while the north bay has a 6/6 sash. In the second story, the east bay has a pair of 1/6 sash and the north bay a single 6/6 sash. The northwest elevation of the addition has two four-light sash in the gable end. The southwest elevation of the wing has a new brick addition at the first story and two 6/6 sash in the second. Some white striping survives on the brick of the wing, but there is no red paint.

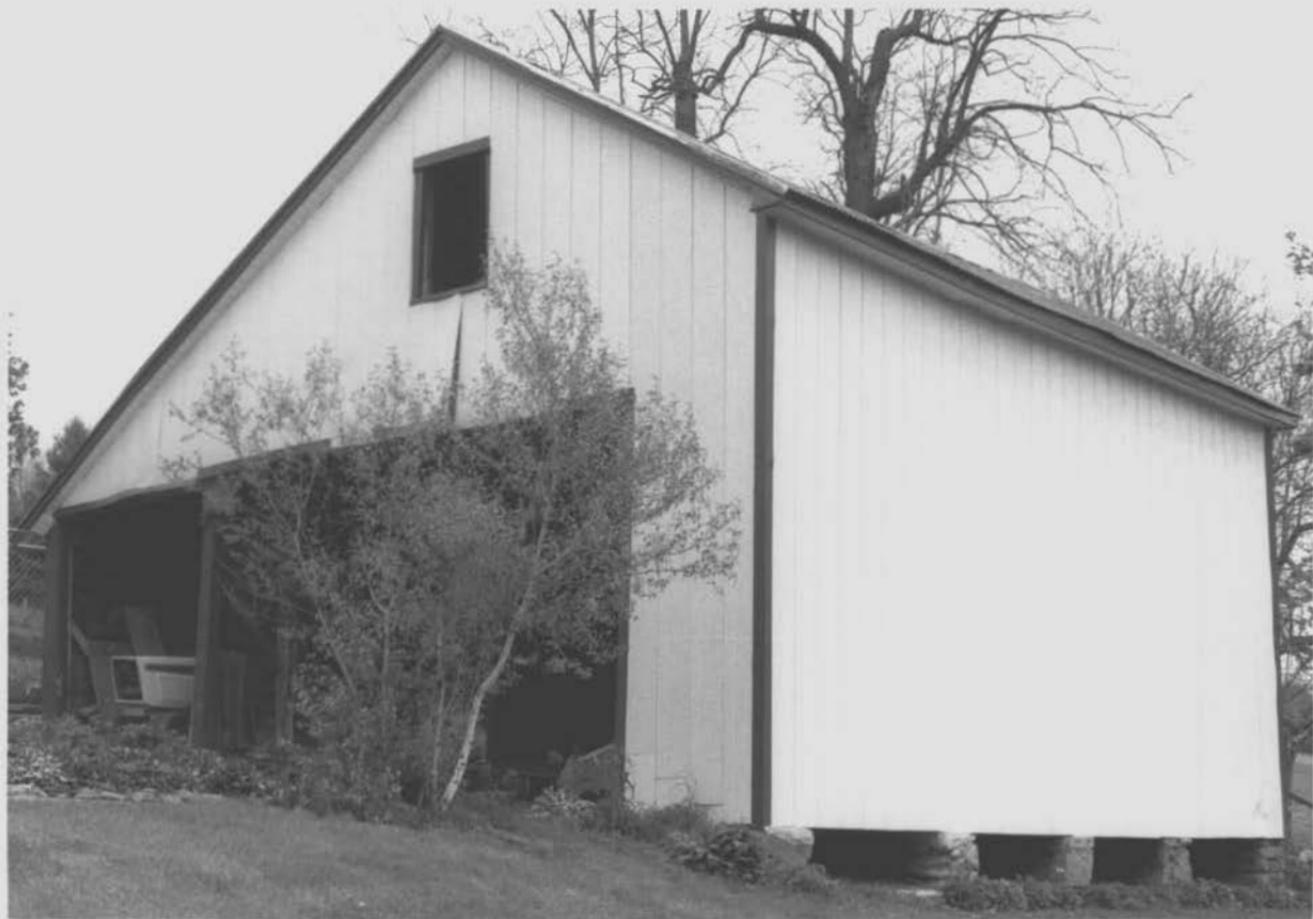
3/5

corn crib - southwest & southeast elevs

North of the house is a hewn frame corn crib/wagon shed that is mortised, tenoned and pegged. The corn crib is on the southeast side and the shed is open on the northeast and southwest ends. It is set on stone piers, has vertical aluminum siding and a gable roof of corrugated metal. The gable end on the southwest has one opening, and that on the northeast has a 6/6 sash. There is a shed addition on the northwest side built of hewn mortised, tenoned, and pegged beams with three-quarter-round log rafters supporting lath. The roof pitch aligns with that of the shed, creating a "saltbox" profile. The northwest elevation of the addition has wide clapboard siding.

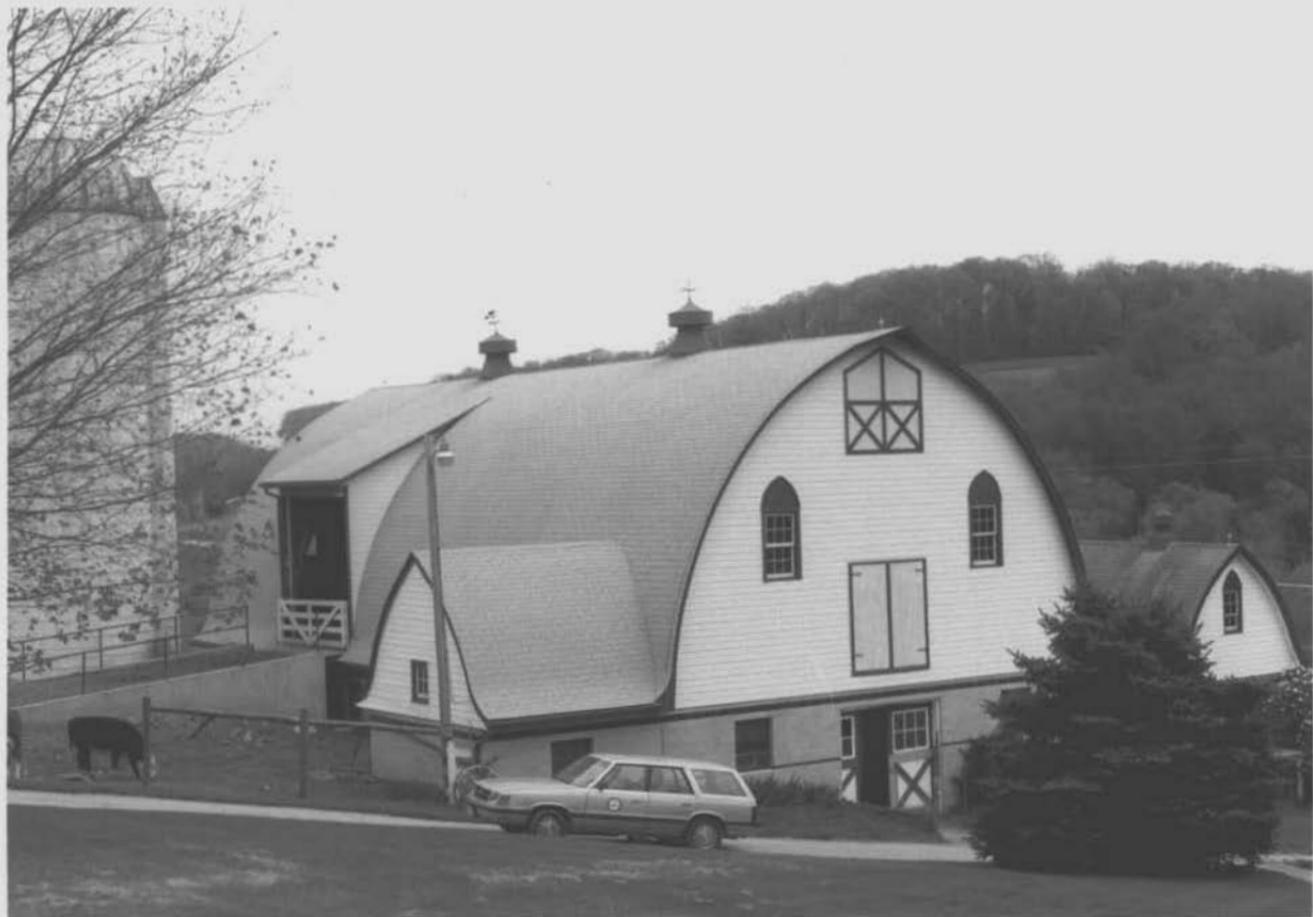
4/5

Barn: Silo - northwest & southwest elevs

The northwest elevation is slightly banked into the hill, with nine nine-light sash on the lower story. There is a new earthen ramp that leads to a new shed-roofed opening in the side of the upper story. North of the barn is a wire-board concrete silo with metal dome roof. Attached to the west side of the northwest elevation is a wing with similar roof profile on the upper story but less than half as high. The lower story is of the same tile. There is a nine-light sash on the southwest elevation of the lower story and a four-light sash in the upper story of the northwest elevation. This wing has an original winder stair in the southeast corner. The original roof also survives. The rafters are made of four boards laminated together and mitered at the ridge. The tongue-and-groove sheathing has a beaded edge. The barn was constructed for a dairy operation and originally had metal stanchions in the lower story, but they have been removed. The southwest end originally had a winch to haul hay up to the second story, according to the owner.

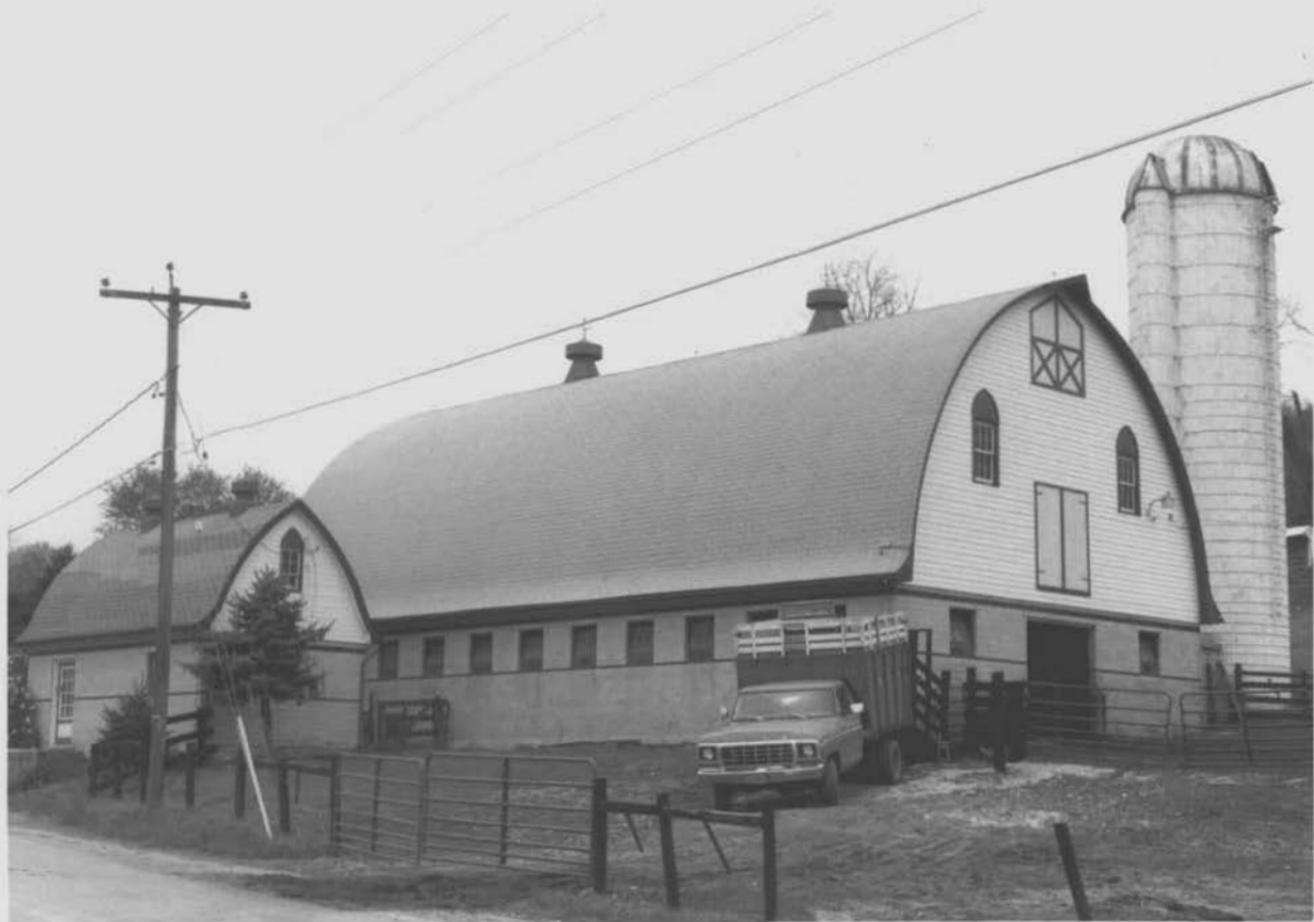
5/5

Creamery, barn: silo - southeast & northeast elevs.

Just southeast of the barn is the creamery. It is built of the same tile, with the same roof profile and with two metal vents on the ridge. The northwest elevation has two doors. That on the north bay has twelve lights over one panel, and the one in the west bay has nine lights over a crossbuck pattern. The northeast and southwest gable ends are identical, with a nine light-metal sash in the lower story and a 4/2 sash, with vinyl siding, in the upper story. The southeast elevation has a twelve-light-and-one-panel door to the south and a nine-light sash to the east. The interior is divided into two rooms by a northwest to southeast wall and used to have a cream separator and a refrigerator for milk, according to the owner.
