CARR-1323

John Kesselring Farm
3650 Senft Road

c.1835

Maryland Historical Trust State Historic Sites Inventory Form

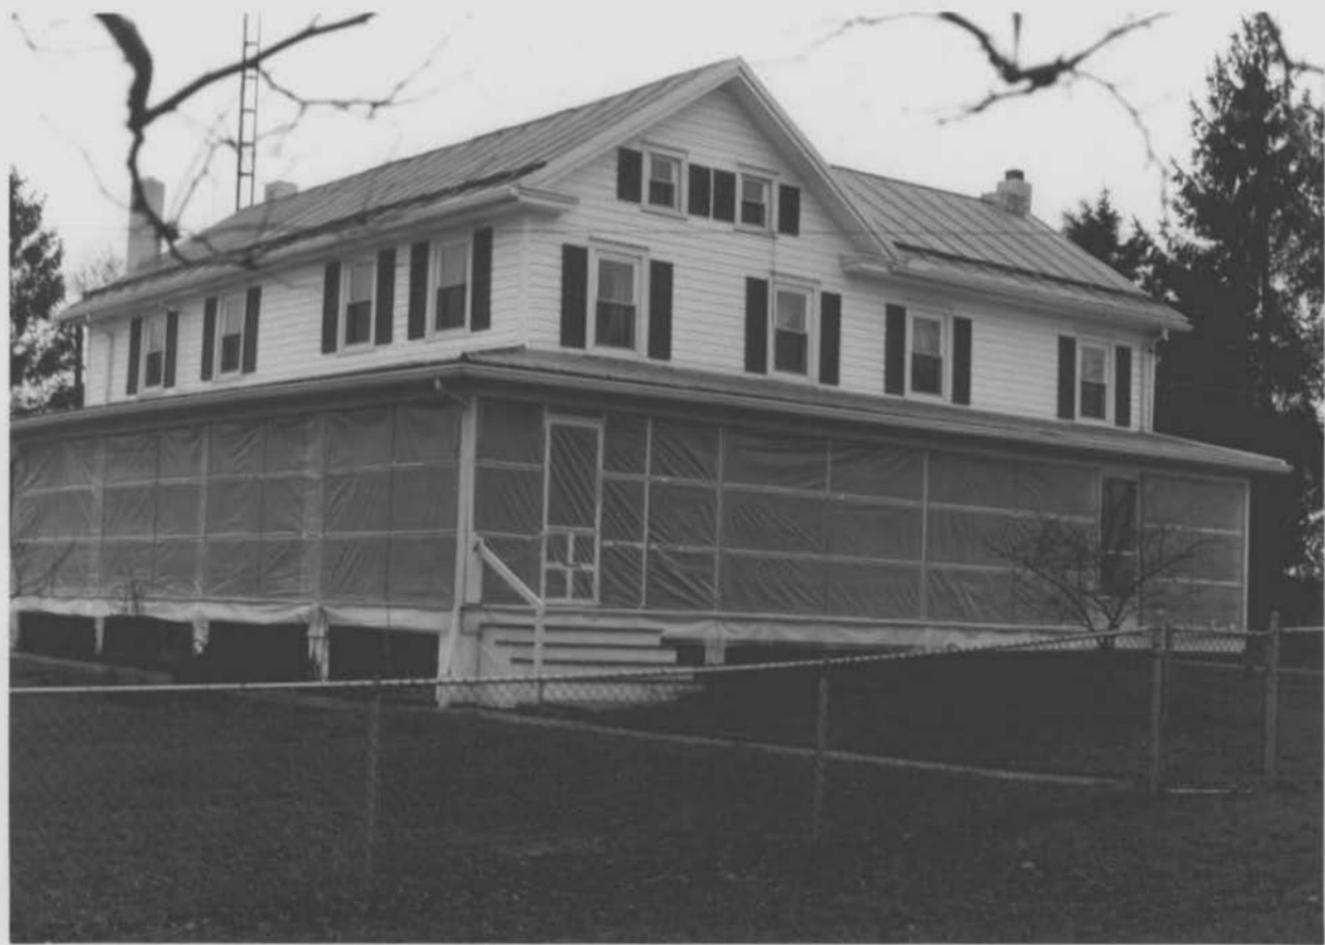
1/3

The house is a two-story, four-bay by two-bay structure with a two-bay by three-bay ell on the west, and is covered in vinyl siding over the earlier German siding. The foundation is of rubble stone. It has a gable roof with standing seam metal covering, and box cornice with returns. The east elevation has two center doors on the first story, with a 1/1 sash in the north and south bays, and four 1/1 sash on the second story. The south central door has one light above two panels, and the north central door has one light above a lying panel, with two panels at the bottom. There is a one-story wrap-around porch on the east and north elevations, with turned posts and a standing-seam metal roof. The north elevation has two 1/1 sash on each story of the main block and two small 1/1 sash in the gable end. The wing has a door in the bay that has one light over two panels. There is a 1/1 sash on either side of the door, with two 1/1 sash on the second story. The porch extends the whole depth of the wing. The south elevation has two 1/1 sash in

Neg. loc. - Maryland Historical Trust
house - north - east elevations

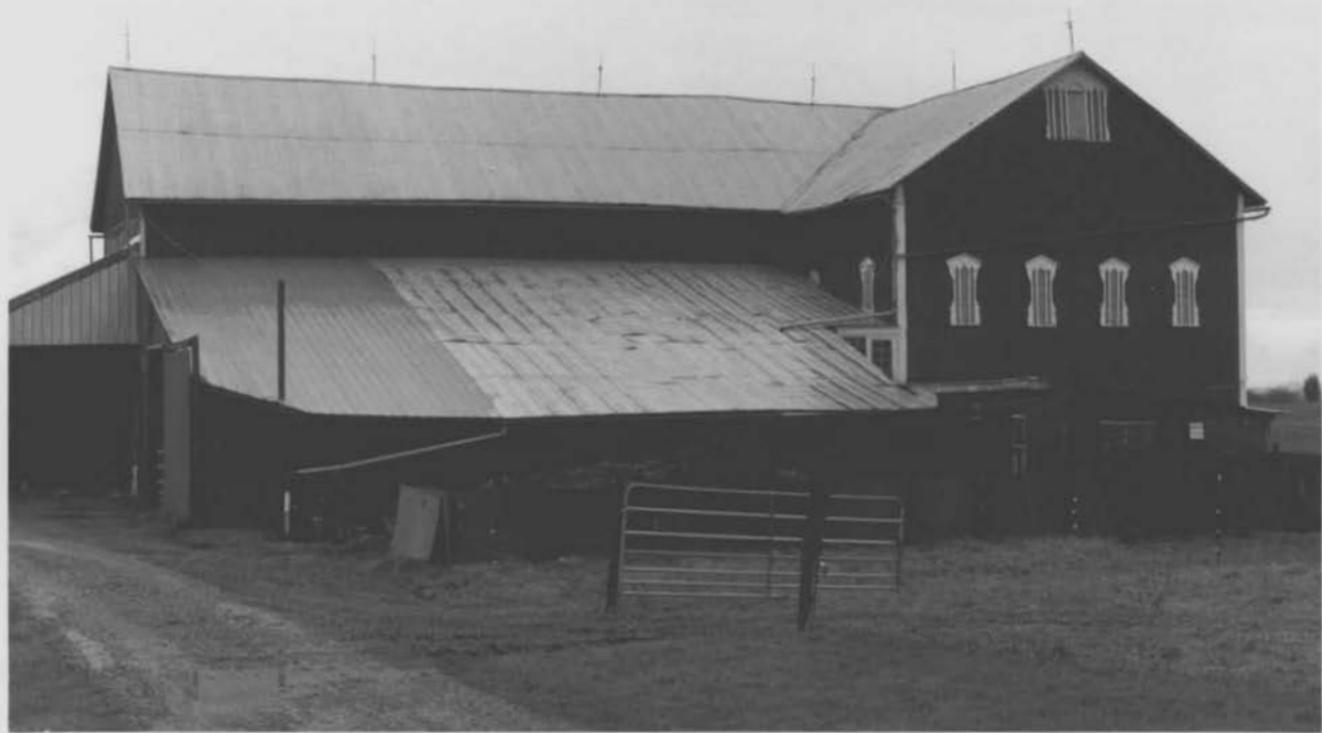
2/3

The barn was built in two stages. The first stage is a forebay, banked barn, that faces east. There is an ell attached to the north half of the east elevation, and this portion reportedly came from another barn that was taken down and moved here. The upper story of the west elevation has two pair of wagon doors, on rollers, in the center. North of these are four wood louvered vents with pedimented tops, and south of these are two like vents, but with a four-light sash in the bottom of each. There is one 6/6 sash on each side of the center ramp in the lower story. The barn has a gable roof covered with corrugated metal and five lightning rods along the north-south gable. It has a rubble stone foundation. The siding throughout is of vertical boards. The south elevation has a tripartite vent in the gable end and the remains of a shed-roofed wagon shed attached below. The east upper story of the elevation of the original section has, from south to north, three pedimented vents, a pair of doors above a second pair, all on strap hinges, another like vent, and two pairs of matching doors. The south elevation of the wing has two pedimented vents, the one to the west having a four-light sash in the bottom. These two elevations are virtually hidden from view behind a much later shed-roofed addition in the crook of the ell. The frame wall of the lower story has horizontal board siding with a beaded edge on top and bottom. From south to north there is a vertical board door on rollers, two 4/4 sash, a tongue-and-groove, vertical board dutch door, another 4/4 sash, another like dutch door, a large opening, a 4/4 sash, a like dutch door, and the remainder of the wall is open, as it is connected with the east wing. The east elevation of the wing has vertical board siding on the lower story, four pedimented vents above, and a tripartite vent in the gable end. The north elevation was not accessible.

barn - east elevation

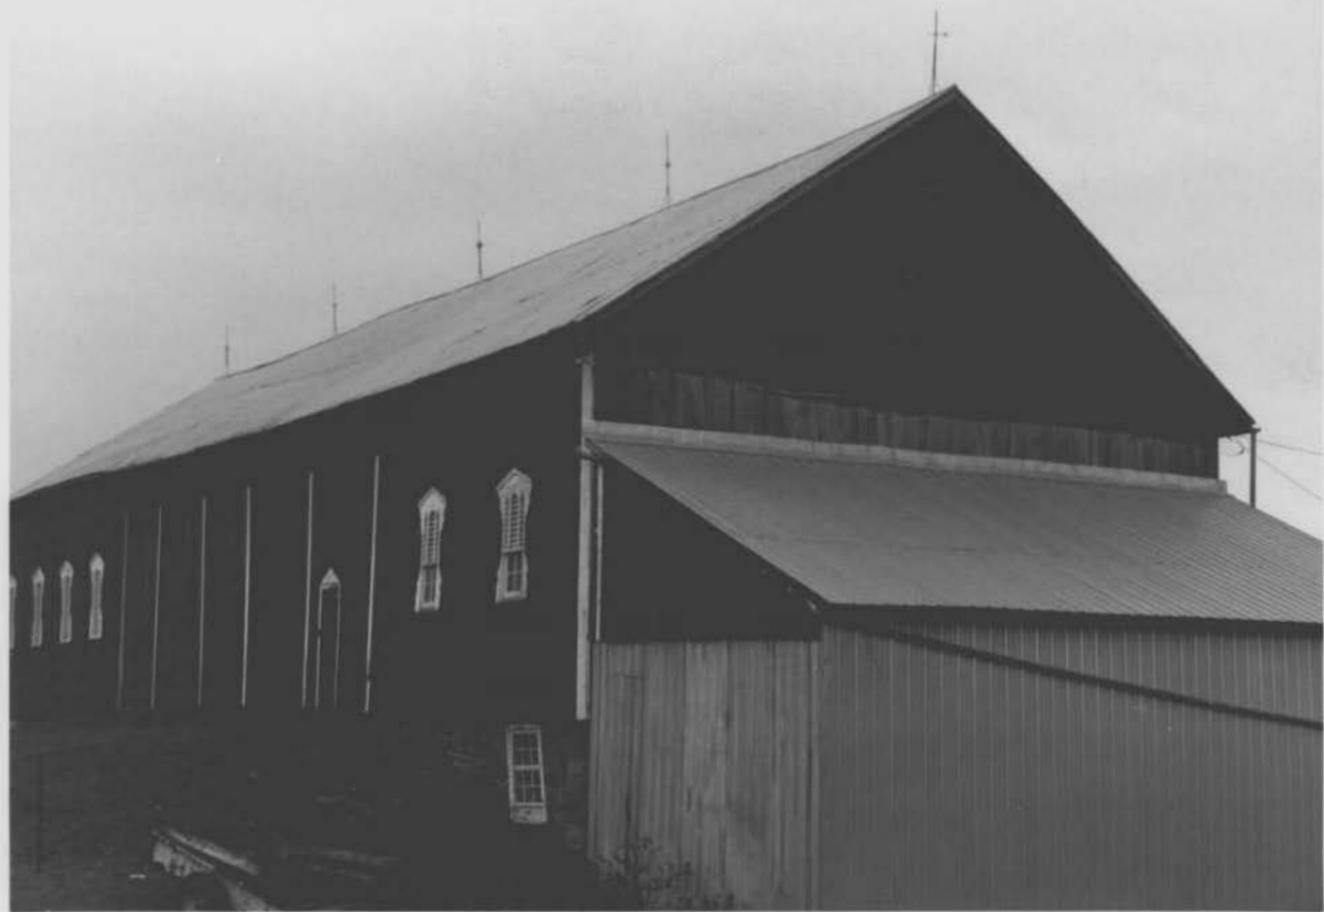
3/3

Neg. Loc.: Maryland Historical Trust
barn - west : South elevations
