CARR-1329

Kanaan Sprinkle Farm  
1801 Ridge Road (Rte. 27)

# Maryland Historical Trust State Historic Sites Inventory Form

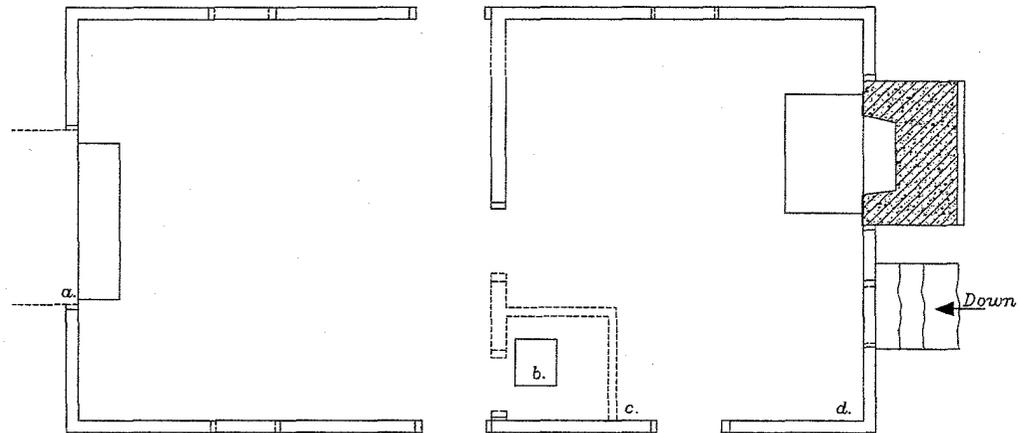
CARR 1329	Kanaan Sprinkle Farm	First Floor Plan	April 1993		
	1801 Ridge Road		Kenneth M. Short

- a. Chimney now demolished - footing not located*
- b. Access hatch to cellar*
- c. Probable second location of stairs*
- d. Probable first location of stairs*

*First floor plan of log structure - plaster, lath, trim, and siding removed. Missing elements dotted in as indicated by structural analysis*

The first story was originally two rooms divided by a log wall placed east of center, and was later altered to have a central enclosed stairway. The center wall also has stone chinking in mortar. Originally, there was a short door in the center of the wall and a tall door at the south end. The center door was later closed off and a door added at the north end. The east room has an ashlar stone fireplace with a semi-circular stone arch. There is dressed stone above the arch, and a wood nailer above it, suggesting that originally there was a high mantle shelf with a frieze below, and exposed stone that was white-washed below it. This fireplace was bricked in and plastered over later. There were once stairs in the southeast corner of the east room, and the southwest corner of this room. There is a hatch in the southwest corner of the room that is about 21½ by 23 inches, and is an access to the cellar. It appears original and probably had steep stairs down to the east. This room formerly had a chair rail, but it is gone. The baseboards here and throughout the house have a beaded top edge, and the floors are random width and appear to be pit sawn. There are traces of red paint on the log walls around the original openings, suggesting that the trim was painted, or at least primed, before the split lath, which was nailed vertically to the logs with cut nails, was applied and plastered. The same surround seems to have been used throughout the house. It has a broken field with a beaded interior edge, and an ogee moulding applied to the exterior edge. Traces of red paint in the southwest corner of the east room suggest that the stairway was boxed in here, or that there was a closet here, originally. Many of the windows in the house appear to have been enlarged. The original doors seem to have all been of beaded-edge vertical boards. They are painted with a red iron oxide first coat, then medium grey, black, and white.

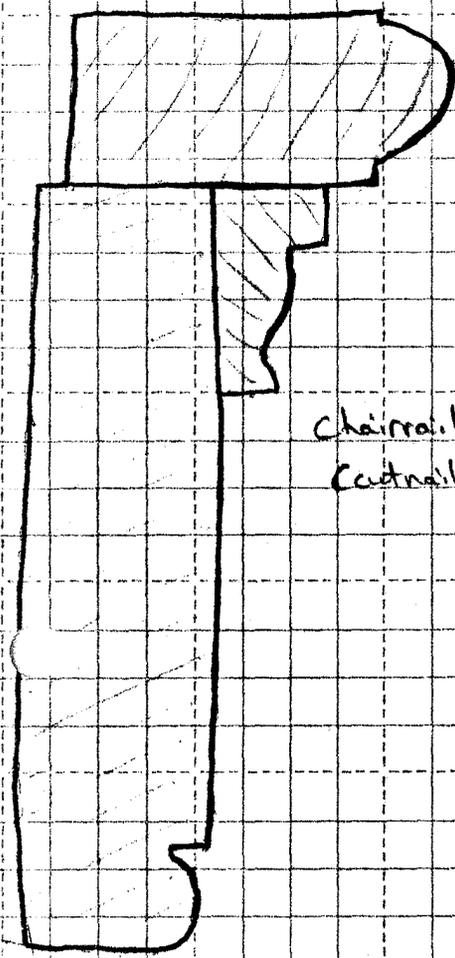
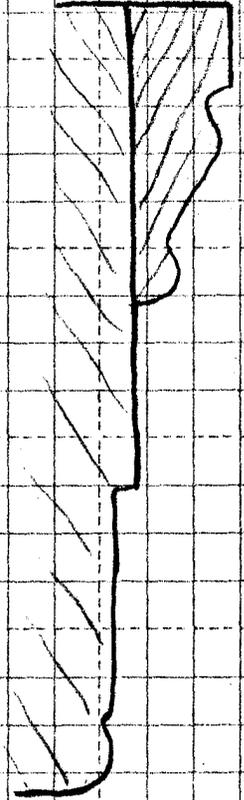
Ridge Rd  
Moulding Profiles

Chairrail  
(actuals used)

Window  
Surround

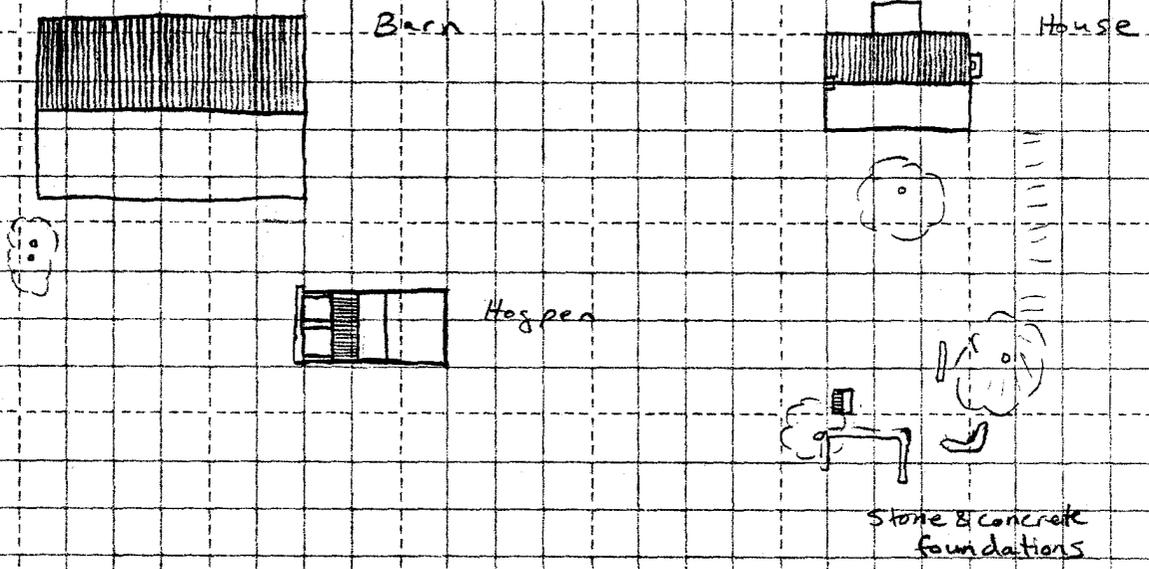
Ridge Rd  
Site Plan

Recent buildings omitted  
for clarity

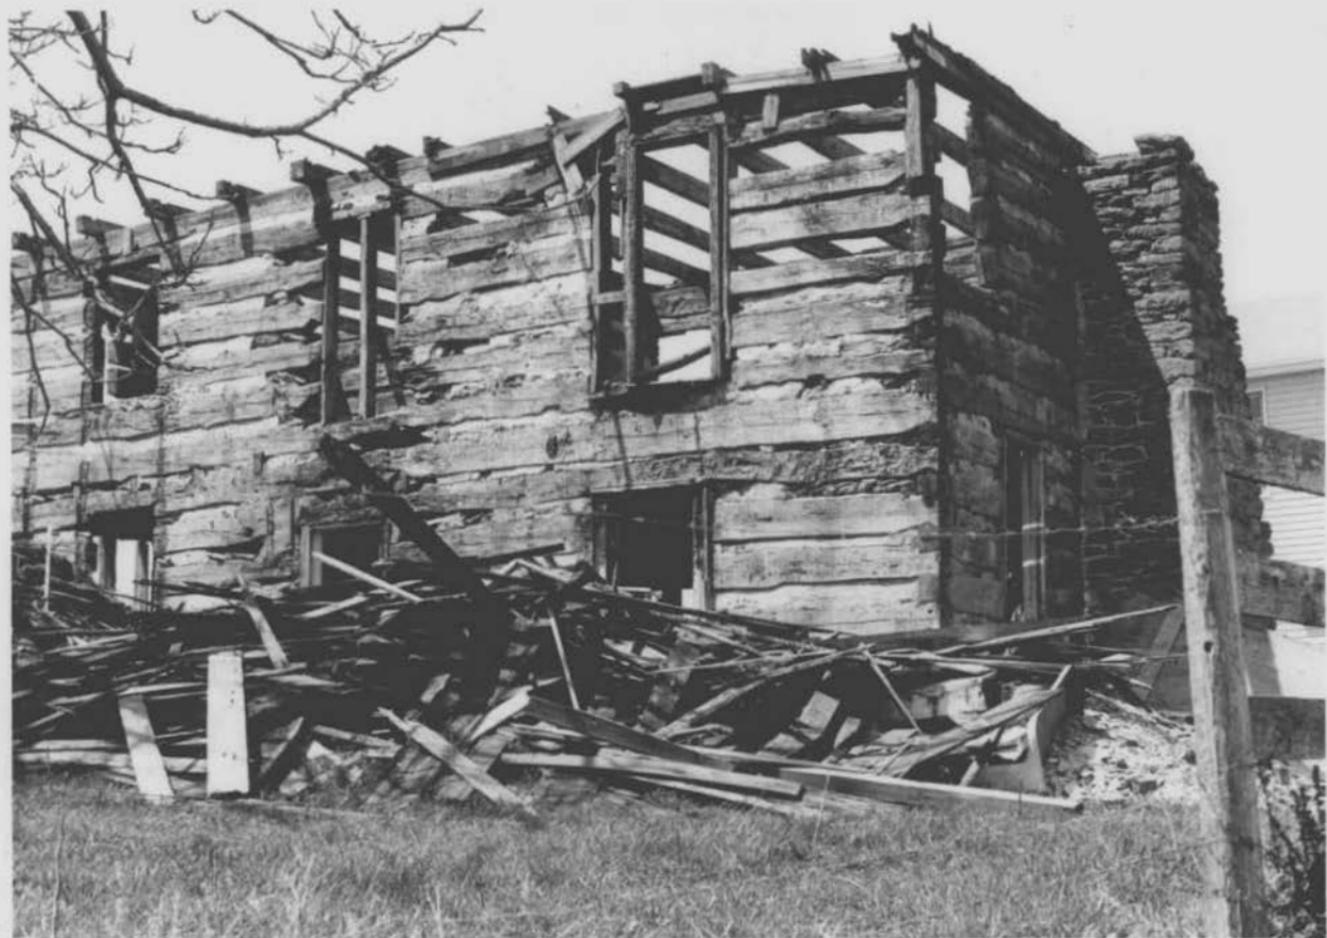
49

Neg. Loc.: Maryland Historical Trust  
South and east elevations

The house is a two-story, three-bay by two-bay structure of V-notched log with a gable roof that has standing-seam metal and a ridge running east-west. The foundation is rubble stone. The logs are hewn on both sides, and have diagonally-laid stone chinking

The east elevation has a cellar entrance that now has a wood hurricane door in the south bay. There are several concrete steps, with several stone steps and stone cheek walls below the concrete. The door is of vertical boards, hung on interior strap hinges, and has a wood box lock. The first story south bay has a 4/4 sash, and the second story south bay has a window opening with the sash missing. The north bay has an exterior fireplace and chimney of partly dressed fieldstone, with brick above the second story. The west elevation has a 6/2 sash to the north and a 2/2 to the south on the first story. The second story has a 2/2 to the north and a 6/6 to the south. The gable end has two single-light sash and an interior brick chimney centered on the ridge. There was originally a large exterior fireplace and chimney centered on this elevation.

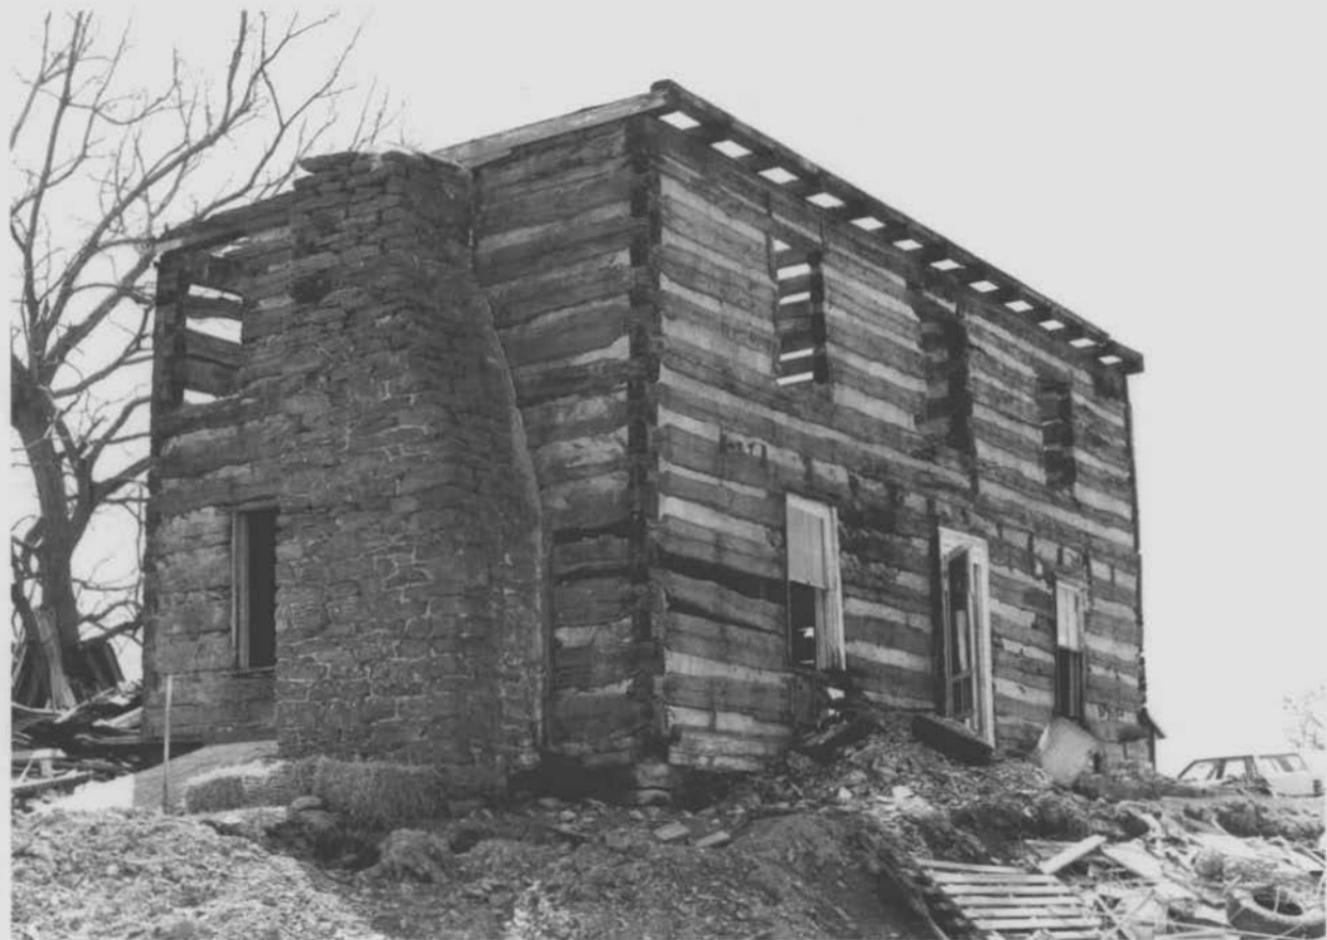
24

Neg. Loc.: Maryland Historical Trust  
east and north elevations

The north elevation has a beaded-edge vertical board door in the center bay, with a 2/2 sash to the east and a 2/1 sash to the west. The second story has a 2/? sash to the east, ?? in the center, and 2/? in the west bay. There is a one-story, one-bay porch in the center bay. It has a concrete foundation, three brick piers, supporting boxed wood posts, and a hip roof with corrugated metal. There is a wood box cornice on the north and south elevations, with tapered rake boards at either end.

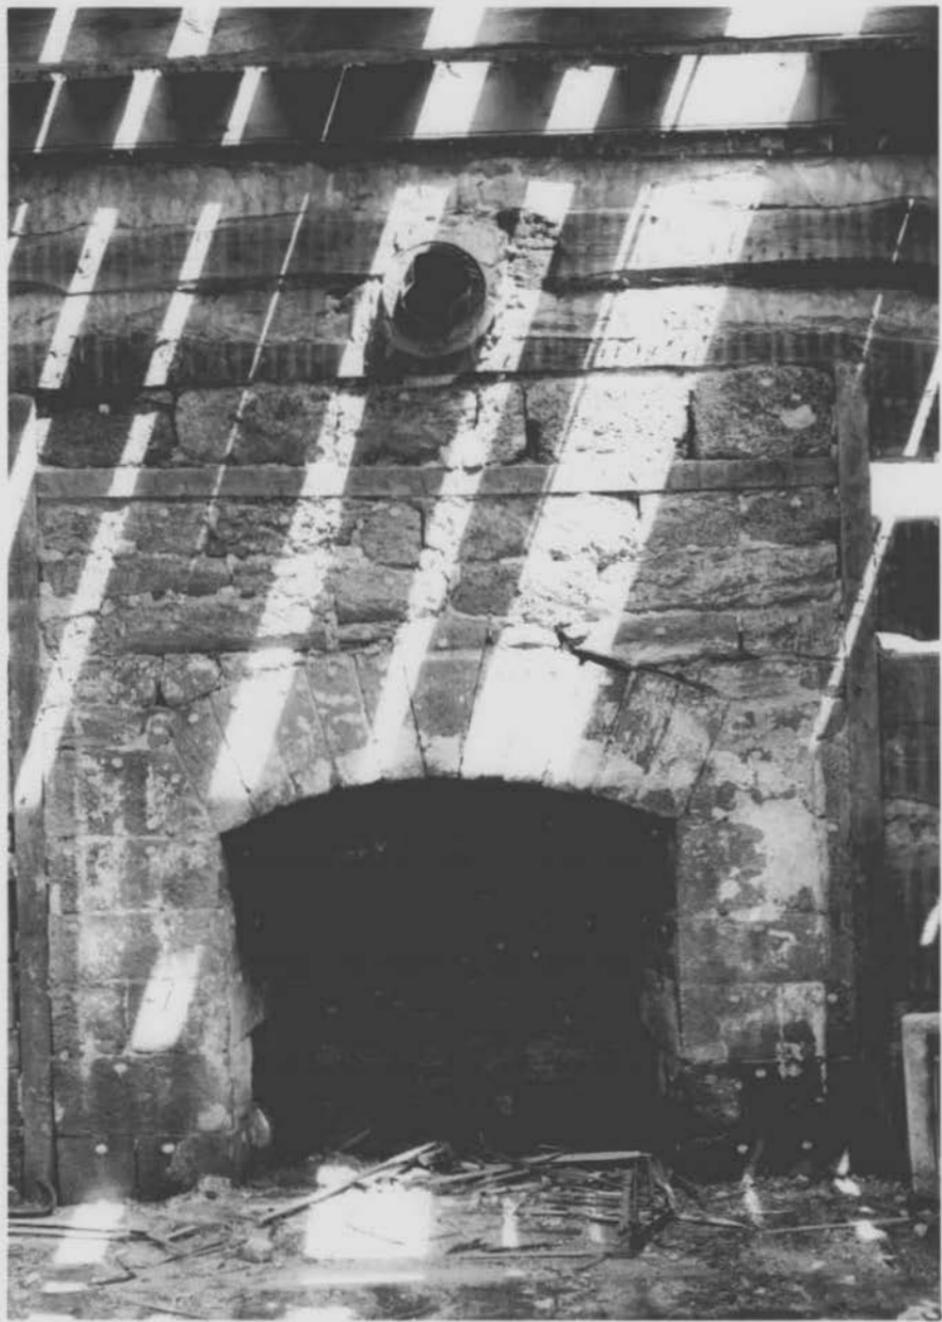
3/7

Neg. loc.: Maryland Historical Trust  
interior-east fireplace

In 1885 an improvement worth \$200 was made to the farm. This was possibly the wing added to the house. The wing was removed some years ago. The house was being dismantled during recordation, but the barn survives. The stone work on the surviving fireplace and chimney of the house is especially well done, and unusual for Carroll County.

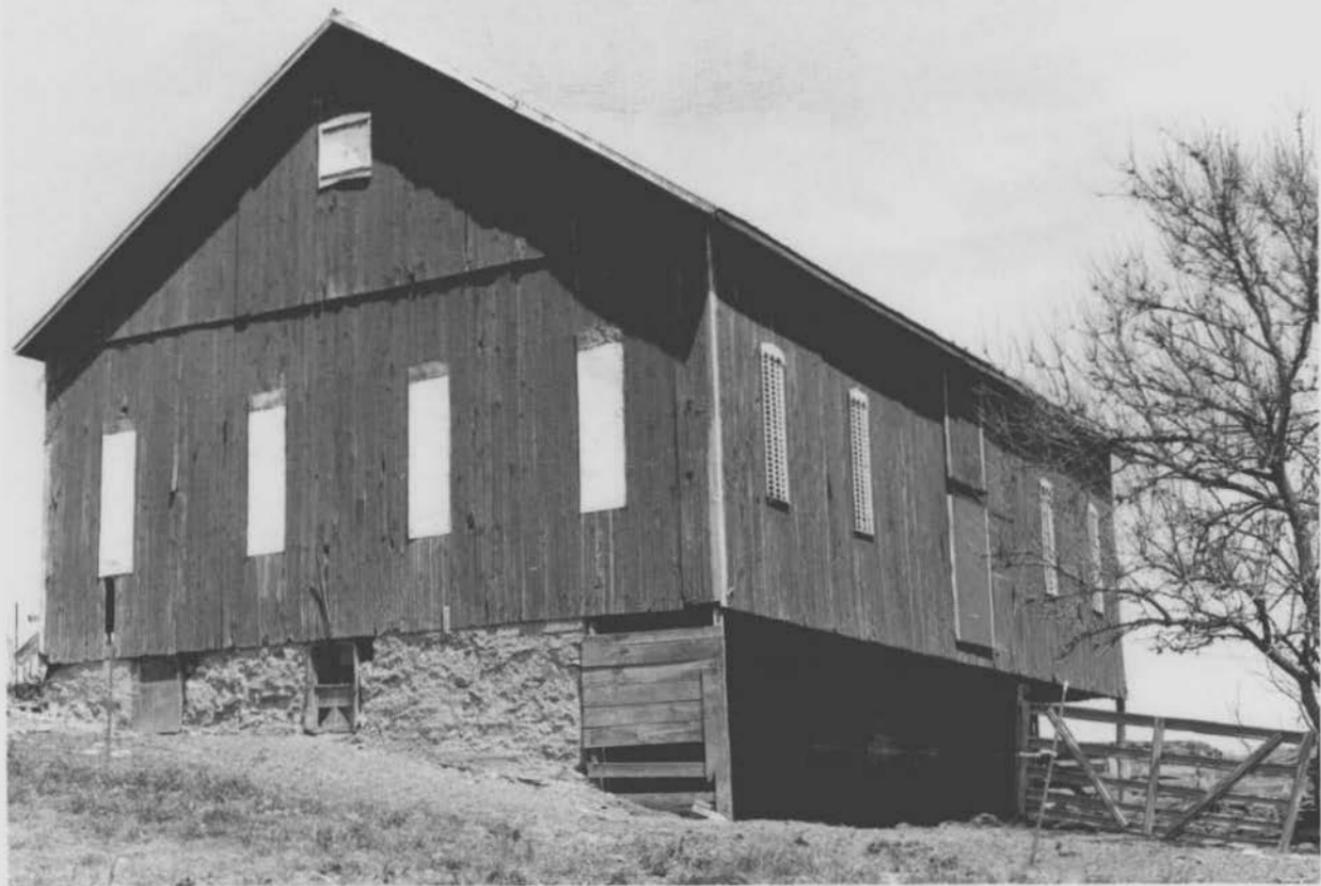
4/4

Barn-northeast; Southeast elevations

Southwest of the house is a bank barn that is four bays by five bays, and faces southeast. The lower story is predominantly small and medium stones in mortar. The southeast elevation is frame, with horizontal beaded-edge-and-center board siding. The upper story has vertical beaded-edge-and-center board siding and the gable roof has inverted-V-seam metal. The lower story of the southeast elevation has, from south to east, a dutch door on strap hinges, a six-light sash above a boarded-up opening, two dutch doors on strap hinges, a boarded-up opening, another dutch door on strap hinges, a ladder to the forebay fastened to the wall, a six-light sash over an empty opening, and a dutch door on strap hinges. There is a post under each corner of the forebay. The upper story has two tripartite wood louvered vents on each end, and in the center a short door on rollers above a tall door on rollers. The southwest elevation has a  $6/7$  in the south bay and a  $6/4$  in the west bay of the lower story. The upper story has four boarded-up vents, and a small boarded vent in the gable end. The northeast elevation has two  $6/6$  sash, and a door on strap hinges to the east, in the lower story. The door was probably
