CARR-1331

Daniel Englar Farm  
1291 McKinstry Mill Road

c.1800-1825

# Maryland Historical Trust State Historic Sites Inventory Form

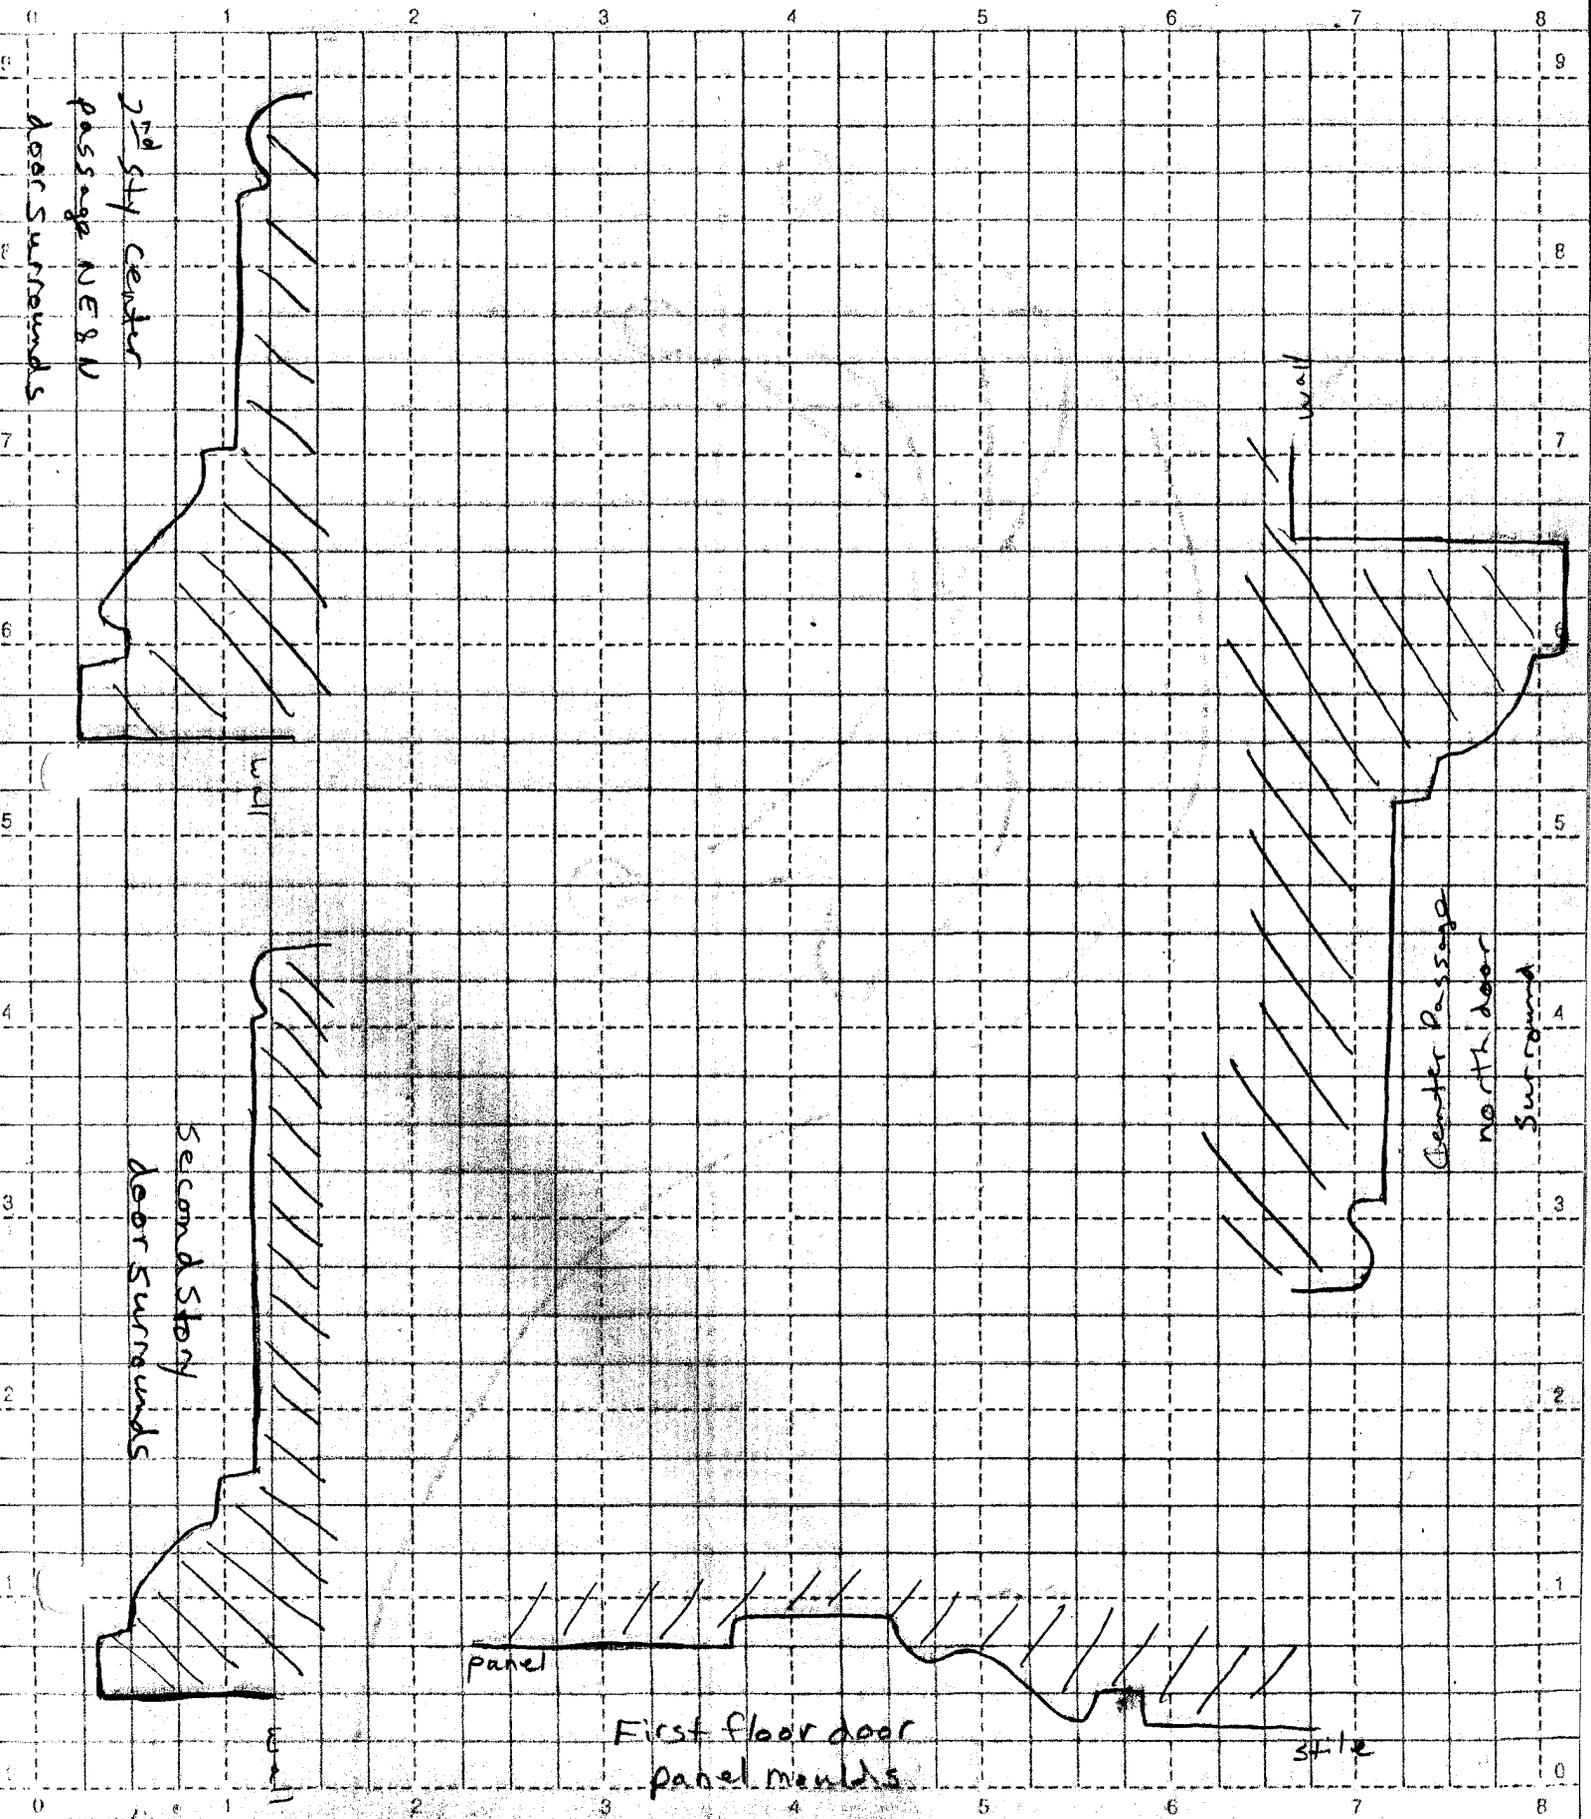
1291 McKinstry Mill Rd  
Moulding profiles

2nd STY center passage NE & N door surrounds

Second story door surrounds

First floor door panel moulds

Center Passage North door Surround

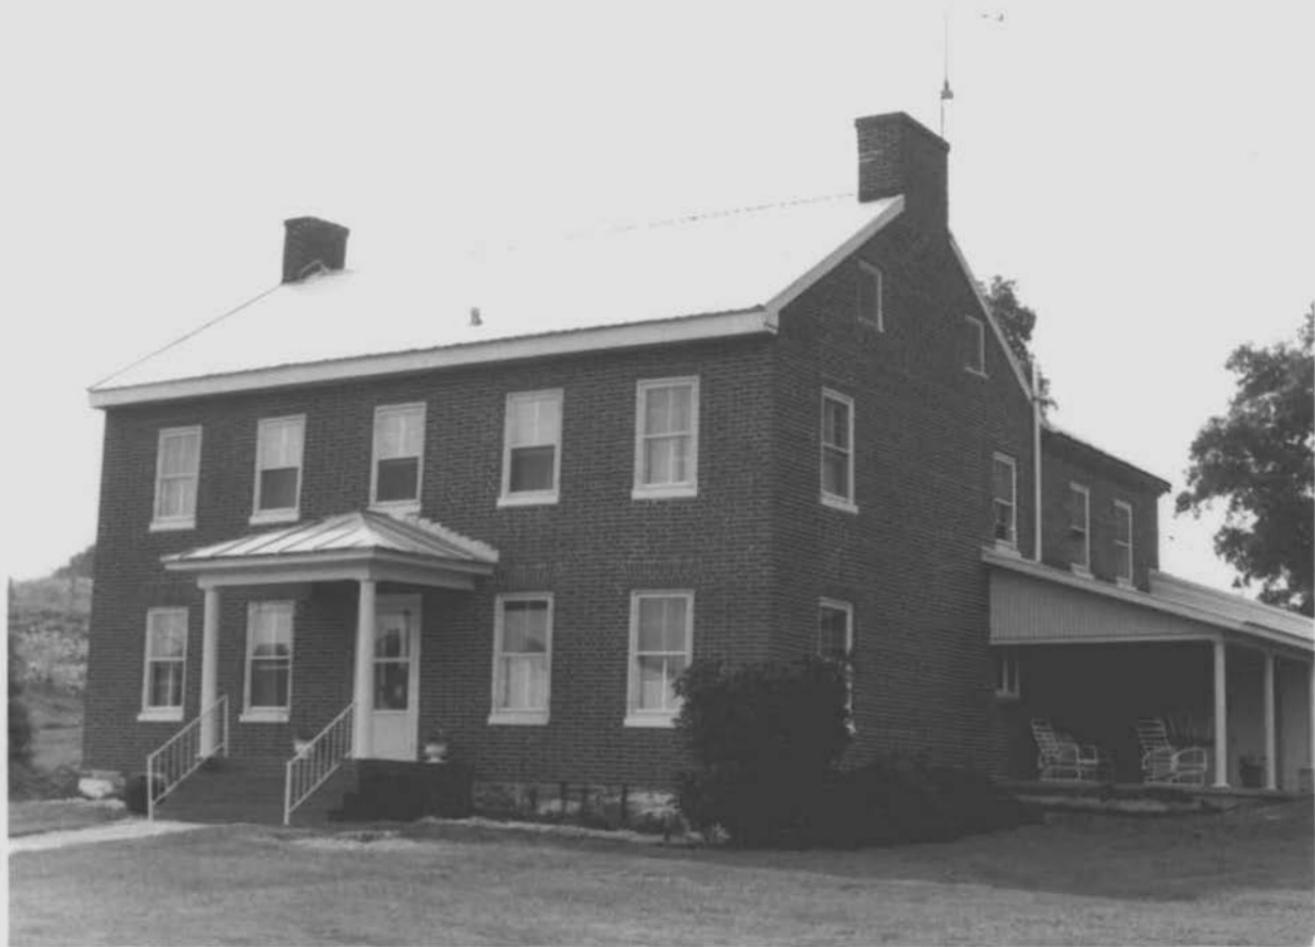
119

house - south & east elevations

foundation and a gable roof with inverted-V-seam metal. The ridge on the main block runs east-west, while the ell ridge runs north-south. The south elevation of the main block has Flemish bond brick. There is a central entrance with a six-panel door and a one-light transom. The panels are flat and sunk, with an astragal on the outer edge of the panel mould and an ogee inside it. The top two panels have been removed and glazed. The two center panels are small and square. The remaining bays of both stories have 4/4 double-hung sash with a very wide vertical muntin. The windows have bullnose frames, painted stone sills, splayed brick jack arches, and formerly had exterior blinds. There is a one-bay, one-story porch with a new brick base and new columns. The hip roof has standing-seam metal. The porch has a full entablature. At the top of the frieze is a recessed ogee bed mould. The cornice projects out some distance, and has an ogee at the top. The cornice of the house is covered by new aluminum soffit. There is an interior brick chimney on each end. There is a brick jack arch between the west and west-center bays of the foundation, but the opening has been infilled with stone.

The first story of the east elevation has the typical 4/4 sash (found on the front) in the south bay, but the north bay opening has been reduced and contains a new sash. The second story south bay has the typical 4/4 sash, but the jack arch is not splayed. The north bay has a matching 4/4, but no jack arch. There are two windows in the gable end, with louvered vents placed over them. The west elevation has a four-light sash in the cellar, to the north, and hurricane doors over an original opening (for which no door survives) to the south. The first story north bay has a new sash, and the opening has been raised. The south bay has the typical 4/4 with the stone sill. The second story also has this arrangement, but the jack arches are straight. The attic has louvers over both windows. The bullnose frames survive, as do small wood sills. These openings have no jack arches. Both the east and west elevations have 5-1 common bond brick.

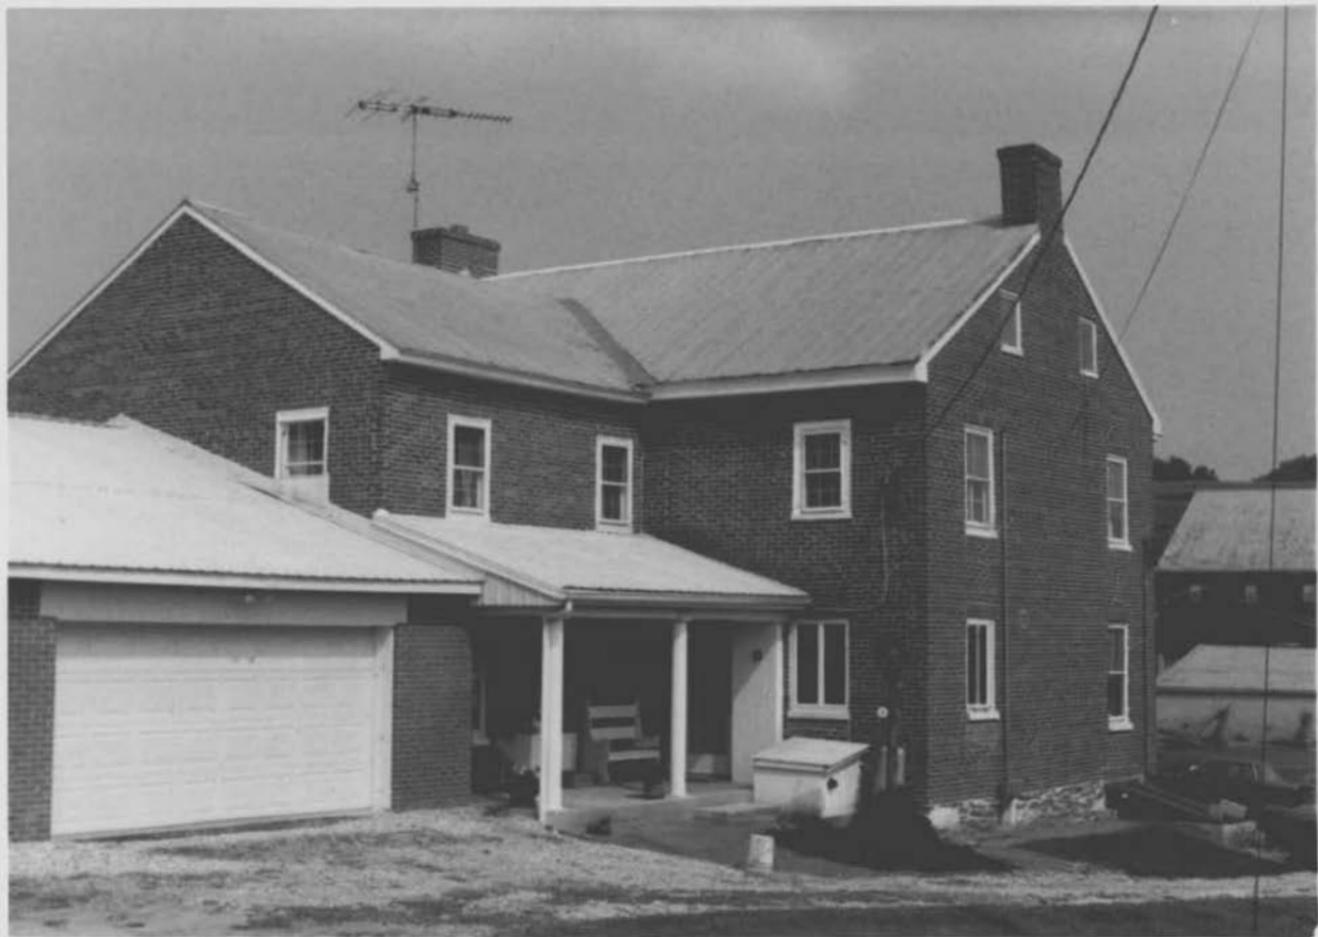
2/1

house-north: west elevations

The north elevation of the house has the attached ell covering the three bays to the east. To the west on the first story is a four-panel door in a lowered opening in the west-central bay, with a new window in a raised opening to the west. The second story has a 6/6 sash in the west bay and a bricked-in window opening in the west-central bay. This elevation also has 5-1 common bond brick.

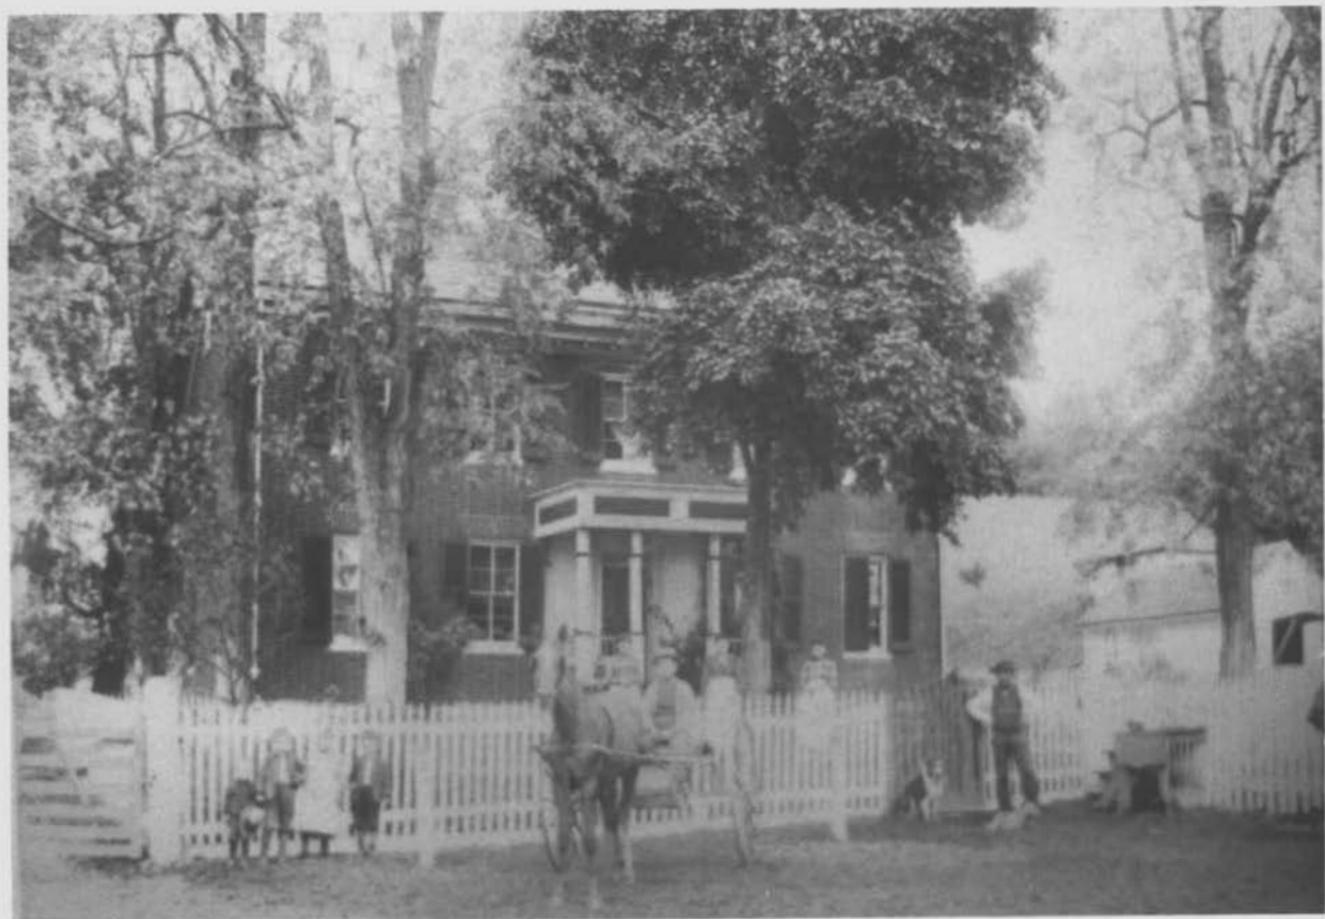
3/9

Neg. Loc.: Maryland Historical Trust  
historic photo c.1890<sup>s</sup>(?)

A photograph of the house, reportedly from the 1890's, shows the front yard enclosed by a picket fence and studded with large old trees. There was a gate in the center of the fence and a set of wood stairs for mounting carriages such as the one shown in the picture. The original (or earlier) porch was a one-bay structure with four posts and a flat roof with a panelled fascia. The two panels on the front and single panel on each side were painted a dark color, like the blinds. The wall of the house under the porch was painted a light color, like the posts, balusters, and window sash. The cornice of the house appears to be wood dentils with wide interdentils. Southeast of the house was a one-story, gable-roofed wood building. The ground cellar can be seen above and beyond it.

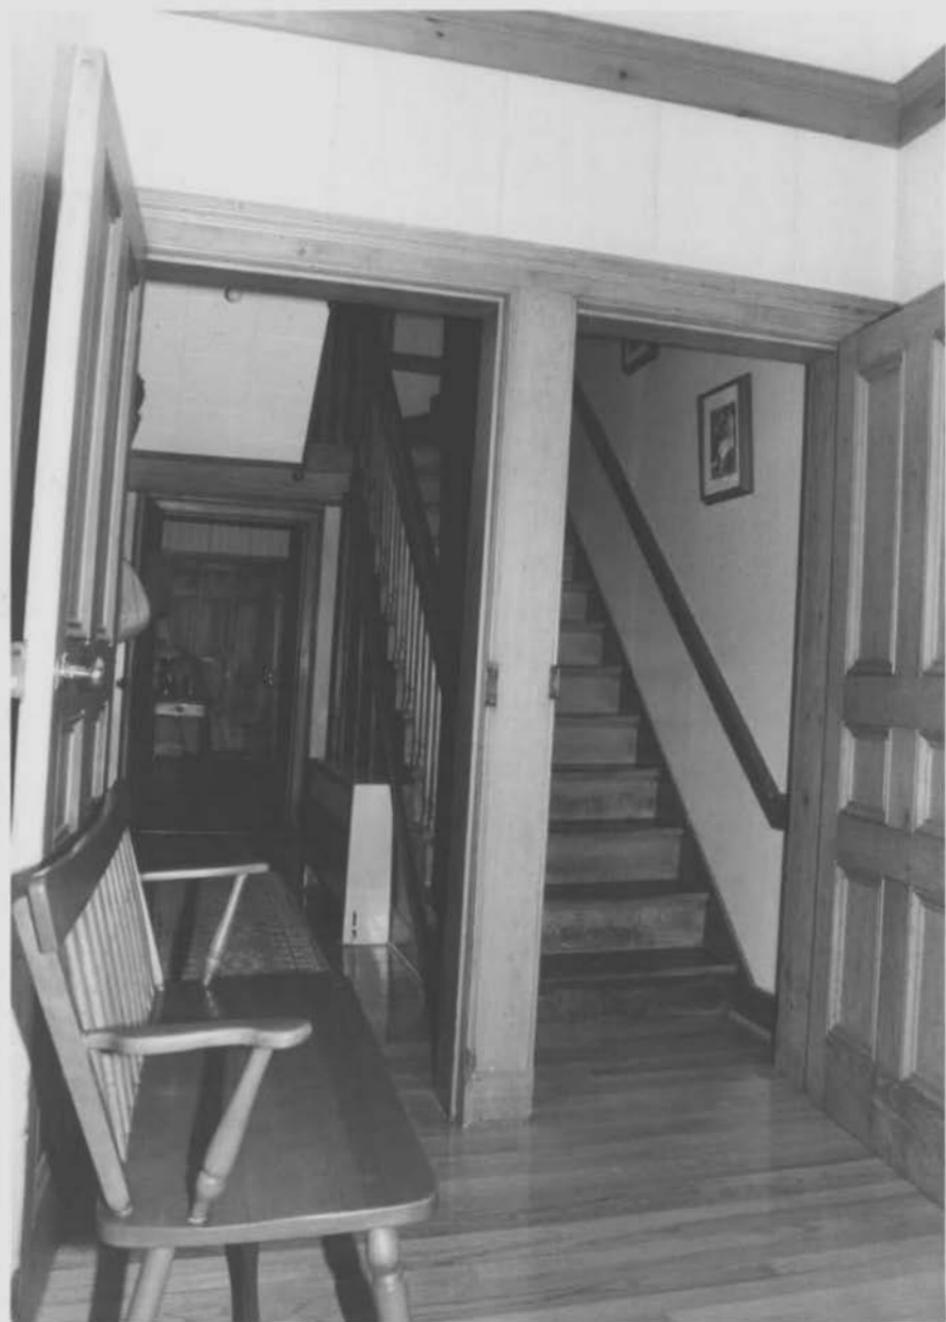
Starhall (- view) north

The first floor of the house is a center passage, double pile plan with an ell addition on the rear. The center passage has a straight run of stairs on the east wall up to a landing at the north end. The stairs have an open stringer with sawn brackets. The edge of the stairs are moulded, with a cavetto and bead underneath the edge. There is a plain turned newel post with one annulet near the top. The balusters are the same, but are thinner in profile, and the hand rail is moulded. Below the stringer are five flat, sunk panels in pegged mortise-and-tenon frames, with ovolo panel moulds. The paint has been stripped from these panels. There is a pencilled line on the field of each panel, about one inch from the margin on all four sides, and the corners have concave pencil lines apparently done with a compass. There is a surround for all five panels, with an ovolo on the outer edge and a cavetto on the inside.

About two feet south of the stairs are two doors, separated by a center post, that divide the passage east-west into a northern section with the stairs and a smaller southern entrance way. These doors have six panels, with the square panels in the center. The panels are sunk, and have ogee panel moulds. The reverse of the panels are flat, but also have ogee panel moulds. The door surrounds on the south side have a beaded interior edge and an ogee near the outer edge. The surrounds on the north side have a beaded interior edge and an ovolo on the outer edge. The doors are stripped of paint, but have no pencilled lines on the panels. They are hung on cast iron butt hinges stamped with "N. Eng. Butt Co." and "wire joints". Each door has a cast iron box lock with a brass knob. Unless otherwise noted, all of the first story doors are identical to these. The north (rear) door opens onto the ell. It has six raised panels, with the small panels at the top, and quarter-round panel moulds. Each panel is marked with two concentric squares with concave corners. The door is hung on cast iron butt hinges marked "Thos Clark" and "Patent". The door has been moved from elsewhere and re-hung here; the hinges were originally on the opposite side, with the knob on the side that is now hinged. Also, a strip of wood has been added to the side of the door to widen it.

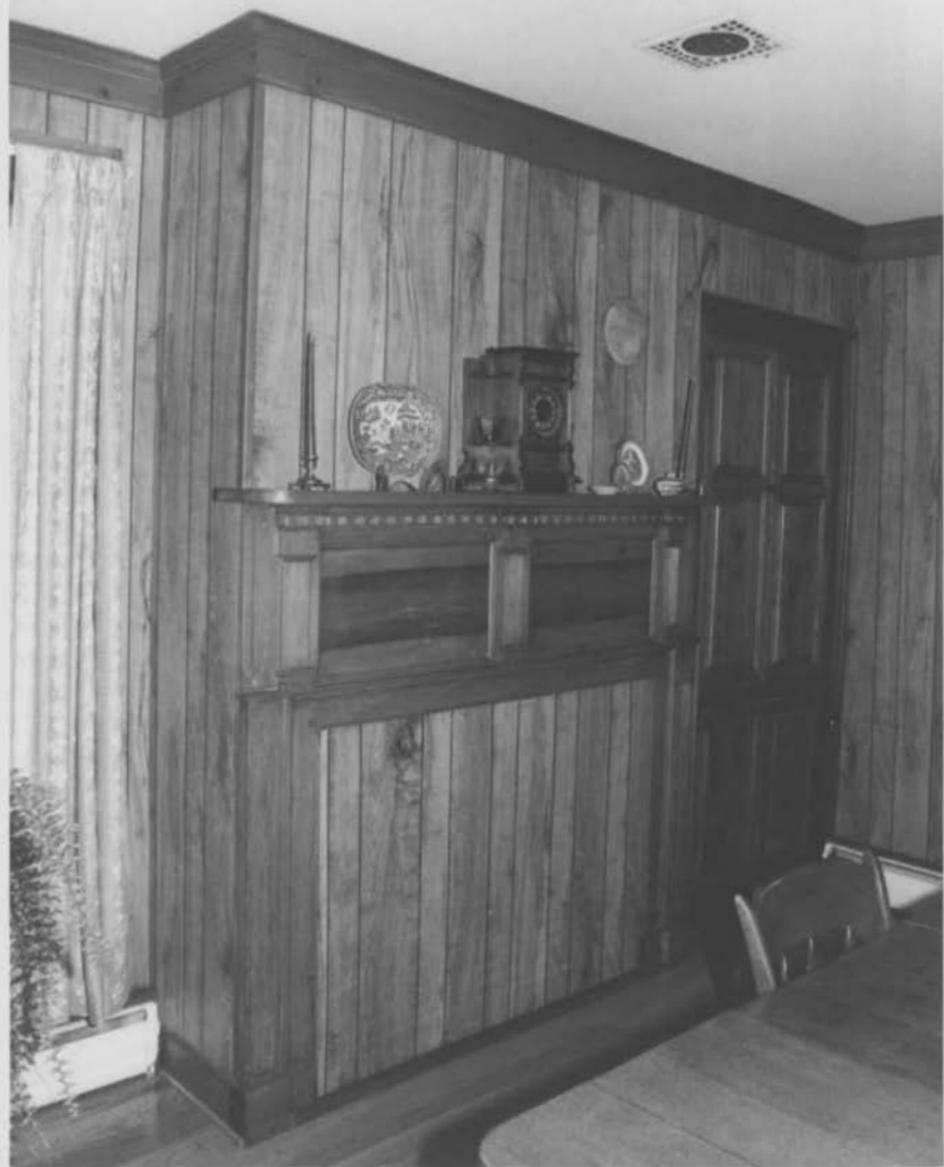
5/9

1st story - southwest room, fireplace

The southwest room has a wide fireplace set north of center on the west wall. The mantel has a beaded interior edge around the opening, and fluted pilaster strips. Above the opening are two flat panels, with an ovolo moulding above them. The frieze has fluted pilaster strips on each end and in the center. Above the frieze is a band of gouge work with alternating x's and pairs of vertical lines. There is a plain wood mantel shelf with a cavetto bed mould. North of the fireplace is a cupboard with two one-panel doors at the bottom and two two-panel doors above. The panels are raised, with ovolo panel moulds cut on the edge of the rails, not applied to them. The cupboard has a surround with an ovolo on the outer edge, a cavetto inside of that, and a bead on the inner edge. All of the woodwork in this room has been stripped of paint.

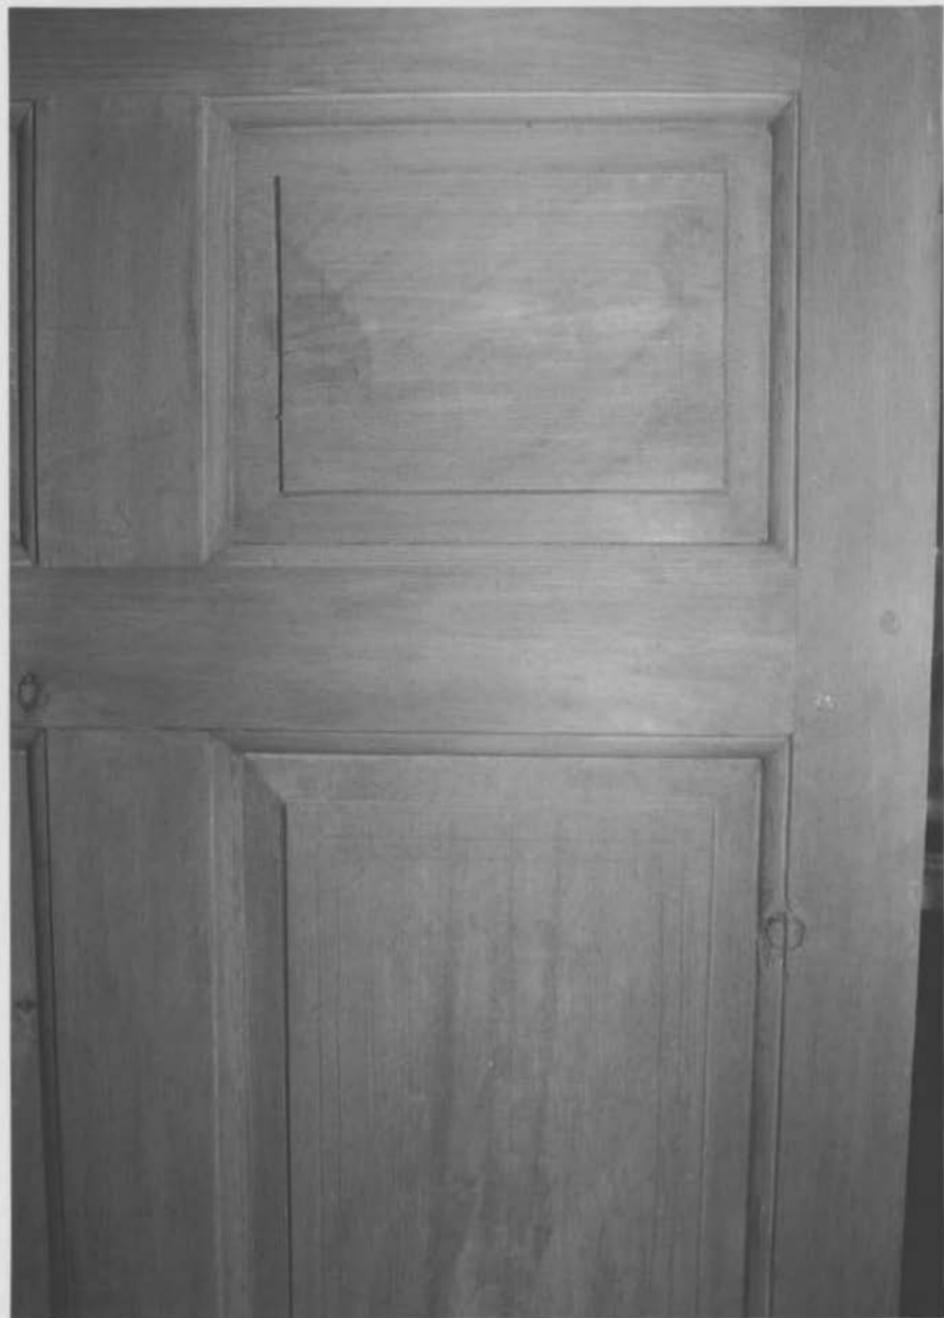
4/9

2nd story - northeast room, north door  
panel detail

From the stair landing at the north end there are four steps on the south up to the center passage, and four steps on the east up to the northeast chamber. The door to this chamber has six sunk panels, with no moulds, and the top two panels are square. The door surround has a beaded interior edge and a Greek-profile ogee on the outer edge. The door is hung on cast iron butt hinges stamped with "Baldwin" and "patent". This chamber has a door on the north wall, to the west, that leads to the ell. This door has six raised panels with ovolo panel moulds. It has been stripped of paint, and the obverse of the panels retain slightly incised lines on the field that form a square with concave corners. The center panels have similar markings on the field. The outer square has rounded corners, and the inner square has concave corners, with the ends extended to touch the outer square. The fields

of the bottom panels have two concentric squares, both with concave corners. The reverse of each panel is flat, and is marked with a plain square. This door is hung on cast iron butt hinges that are marked "patent" only. This door surround also has a beaded interior edge and an ovolo on the outer edge. The east bay of the north wall has a closet, set into the wall, that appears to be original, though they may be made from reused materials. The two closet doors each have two raised panels with quarter-round panel moulds. The top panels are marked with three sides of a square (the top side of the square is missing and the sides of the square run off the top of the field.) The bottom panels have three sides of a square with concave corners at the top. The bottom of the square, and its corners, are missing. The surround has a beaded interior edge with an ovolo on the outer edge. The closet doors are hung on unmarked cast iron butt hinges. There is a door centered on the south wall of this room. It has six raised panels with quarter-round panel moulds. It too has been stripped, and the obverse of each fielded panel has two concentric squares with concave corners marked on it. The reverse of each panel is flat, with a square marked on it. It is hung on unmarked cast iron butt hinges. The surround matches that on the north wall. The northeast room has a random-width pine floor that runs east-west. There is a chimney on the east wall that formerly had a mantel shelf, according to the owners. The window surrounds are narrow and have an ogee moulding.

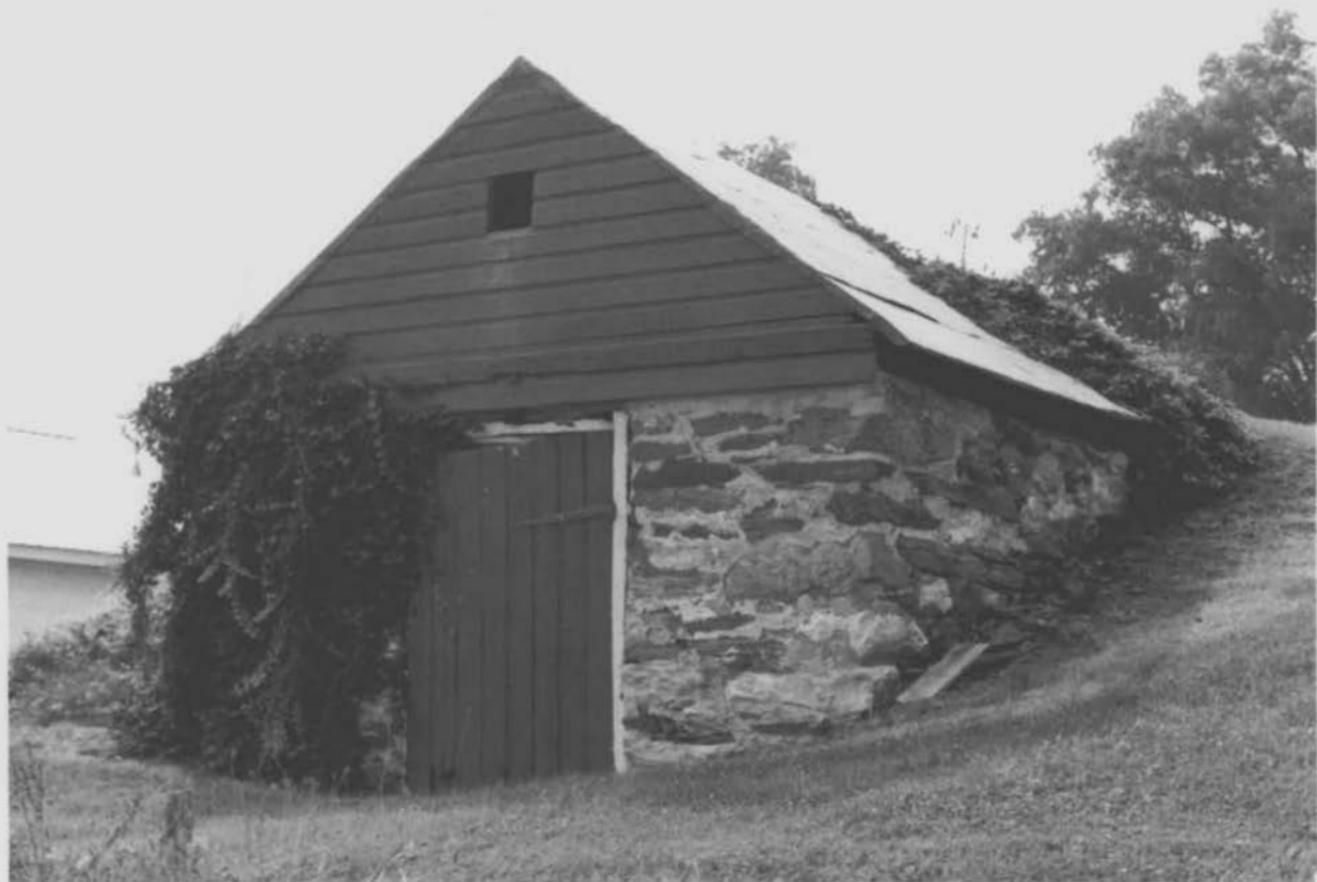
7/9

ground cellar - south & east elevations

About twenty-five feet east of the house is a ground cellar of rubble fieldstone set into a south-facing slope. The south elevation has a tongue-and-

groove vertical board door on strap hinges, and German siding in the gable end. The front section of the cellar is not underground, but has a gable roof with a north-south ridge and flat-seam metal. The interior was not accessible but appears to have a front room, with a four-light-over-two-panel door on the north wall that leads to the cellar proper, under the hill.

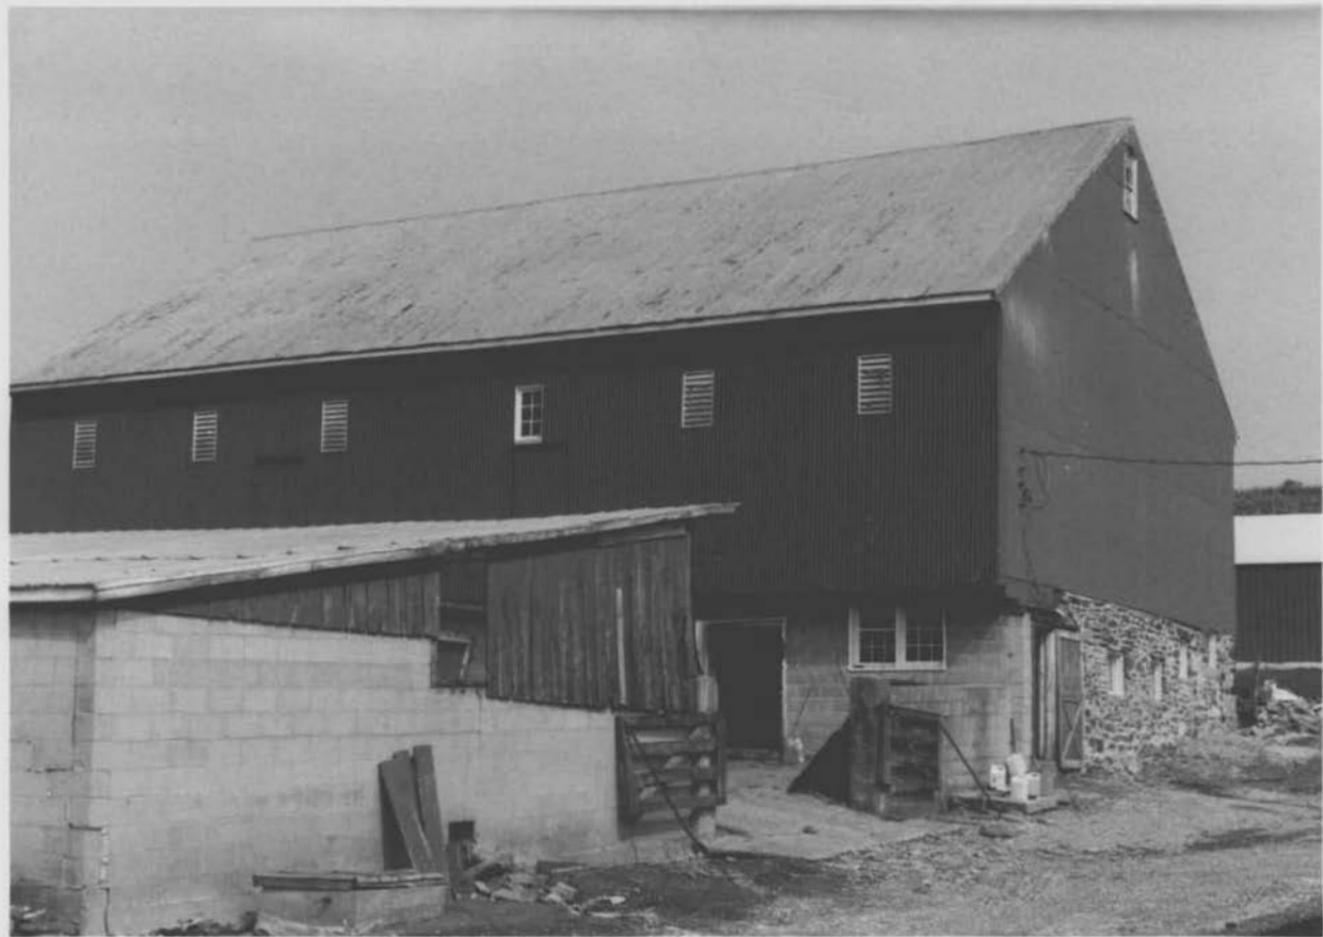
8/9

barn-north: west elevations

South of the house, beyond the old roadbed and the stream, is the bank barn. It has been altered. It is banked into the hill on the south, with the forebay on the north. The upper story is covered with metal siding. The gable roof is covered with corrugated metal and has an east-west ridge. The lower story of the north elevation has a new CMU wall under the middle of the forebay. The upper story has two doors. Above the level of the doors are two wood-louver vents to the east of the east door, one just west of that door, and two to the west of the west door. Above the west door is a six light sash. The west elevation lower story openings have been altered. The upper story has one 6/6 in the gable end. The south elevation has a wood vent, with louvers that are diamond in section, in the west bay of the lower story. The upper story has two pair of wagon doors on rollers, with two vents both to the east and west. There is a CMU silo attached to the east bay. The east elevation has also been altered on the foundation, and a CMU shed has been added as well. The upper story has a metal louvered vent in the gable end.

The original forebay wall on the lower story still survives in part. It is frame and had horizontal sheathing. The stall arrangement has been altered and the east end of the barn has been converted to a dairy operation with metal stanchions. There are two hewn summer beams, with wood posts for support. The joists are hewn on the top and bottom in the barn, but are hewn on all four sides under the forebay. The upper story has two wagon floors in the center with a hay mow on each end and granaries in the southeast and southwest corners. The framework is mill-sawn and mortised-and-tenoned and pegged. The bents have five major posts, and the roof truss is a purlin-post system. The rafters appear to be sawn. They are pegged at the ridge, but the type of joint is not distinguishable. The rafters support wood lath and wood shingles.

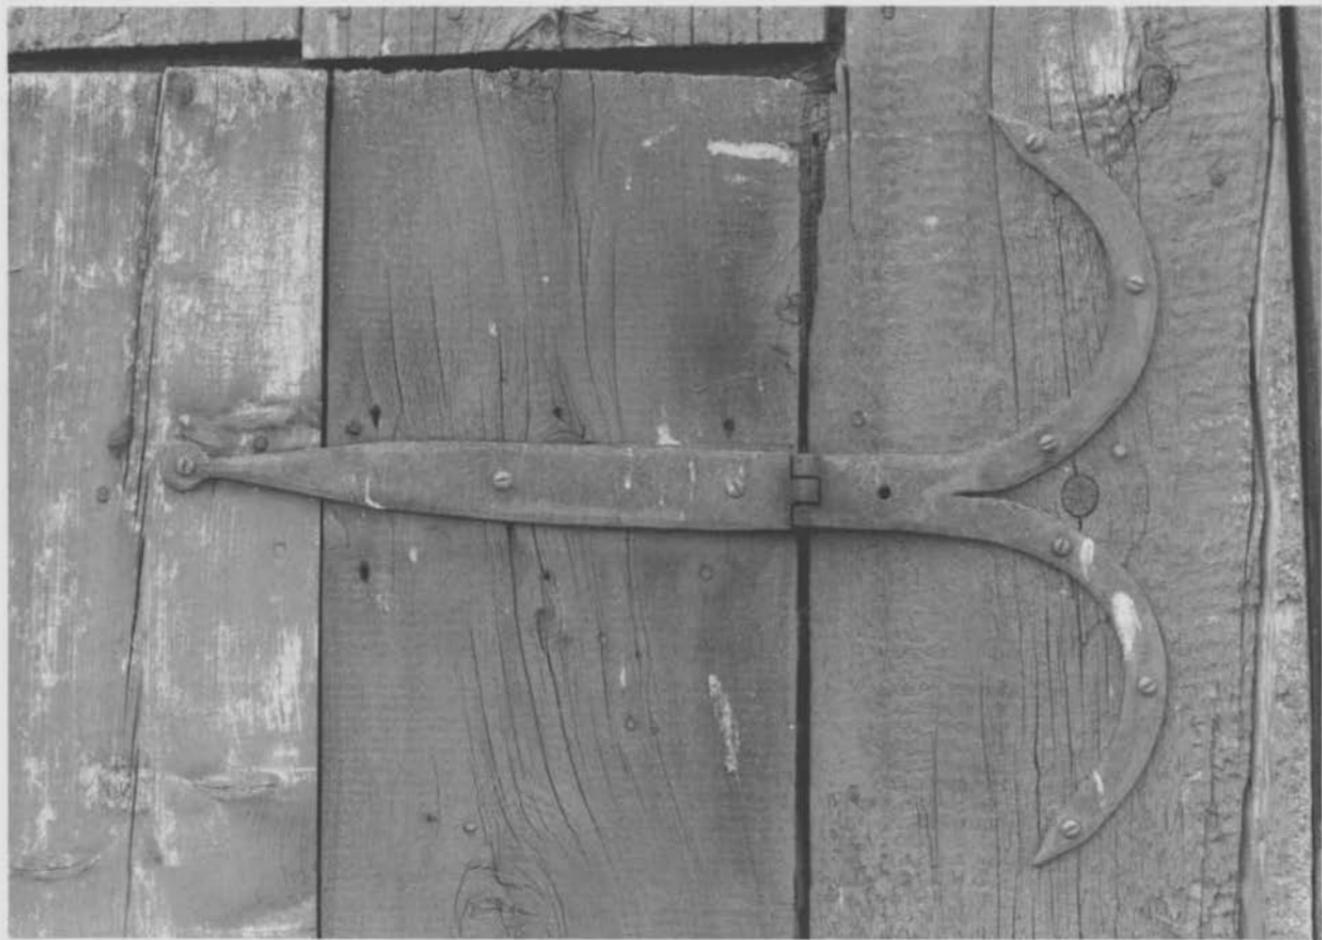
9/9

Neg. loc.: Maryland Historical Trust  
wagon shed - hinge on corn crib door

Northwest of the barn is a wagon shed with corn cribs on both sides. It has a gable roof of corrugated metal with a north-south ridge. The west elevation has a shed-roof addition. The south elevation is missing the door on strap hinges that was on the west bay crib, but the east bay crib has decorative strap hinges that are probably cut and not hammered, because they are extremely regular. The end of the hinge connected to the frame has two semicircular arcs coming off of the top and bottom at the hinge joint. The center of the shed has no wagon doors, and no evidence that there ever were any. The east elevation has German siding spaced

with gaps between each board. The north elevation has vertical-board siding and center wagon doors on strap hinges. The shed is set on concrete piers, and is built with a part-hewn and part circular-sawn heavy-timber braced frame with pegged mortise-and-tenon joints. The sawn rafters are mitered and nailed at the ridge, and support lath.
