Addendum to Maryland Historical Trust Maryland Inventory of Historic Properties Form

Inventory No. CARR-1332

Name of Property: Daniel Engel Farm

Location: New Windsor, Carroll County, Maryland

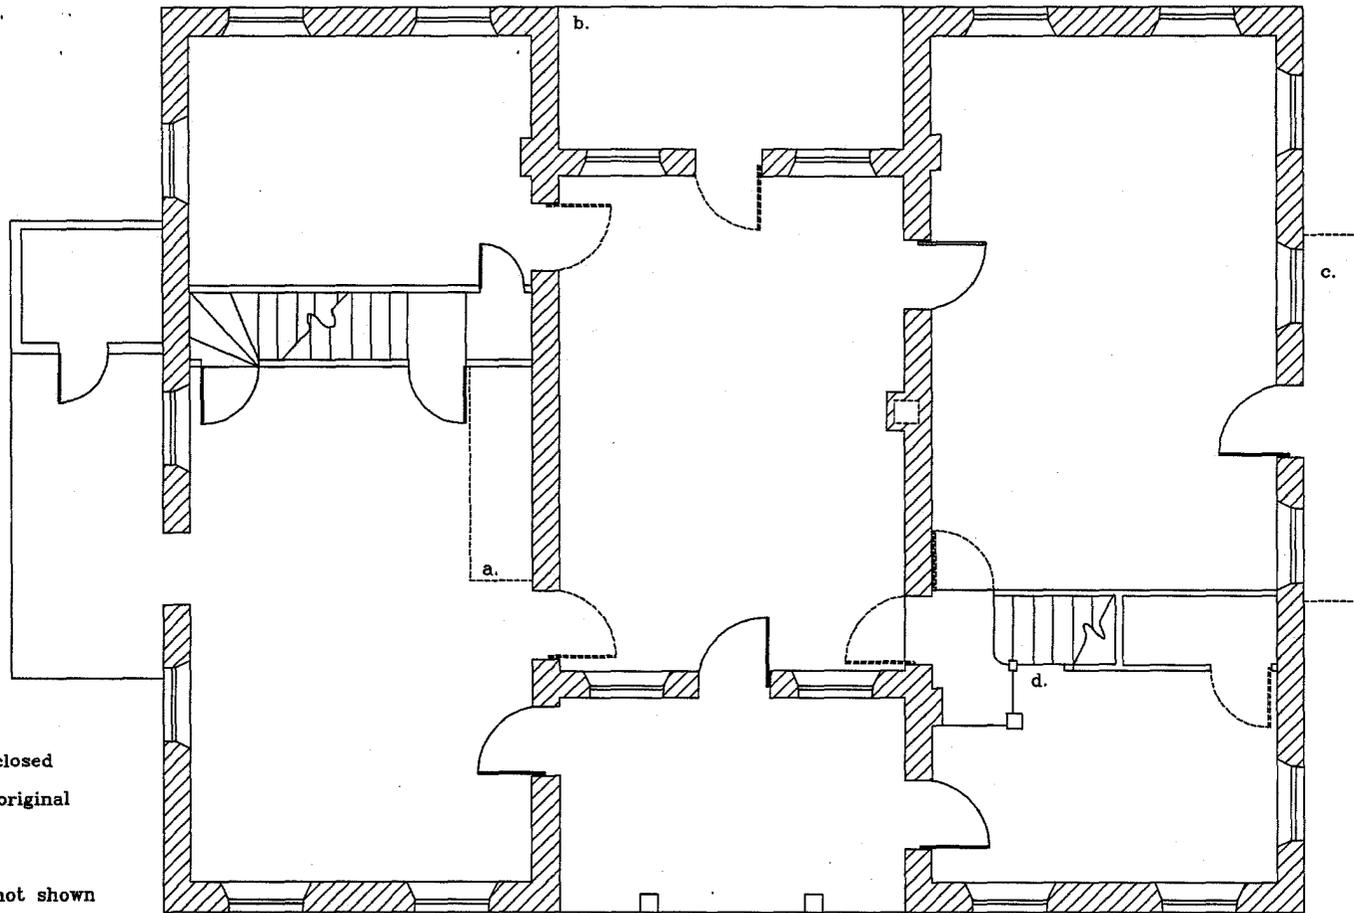
CARR 1332	Daniel Engel Farm	First Floor Plan	October 1993

- a. Chimney flue now enclosed
- b. Porch now enclosed, original posts missing
- c. Porch now missing
- d. Later wall and door not shown

The first story has a single large room in the center, a large room in the northwest and southeast, a small room in the northeast and southwest, and a staircase dividing the large and small room in both the north section and south section. The window and door surrounds throughout the house have a broken field, with the inner half of the field splayed. The window jambs are also splayed and under the sill is a moulding with a broken field and a bead at the bottom. The northwest room is four bays wide by two deep. It has a new, narrow oak floor. The baseboards have an ogee on top, with a Greek torus below it. There is an enclosed, straight run of stairs on the east with a raised landing of very narrow strip flooring. The northeast room is one bay wide by two deep, and the landing extends into this room. There is a square, panelled oak newel post with six turned balusters and a moulded handrail. A short section of the west wall, at the bottom of the stairs, was originally open, and probably had balusters, but has since been closed off. The baseboards in this room are plain.

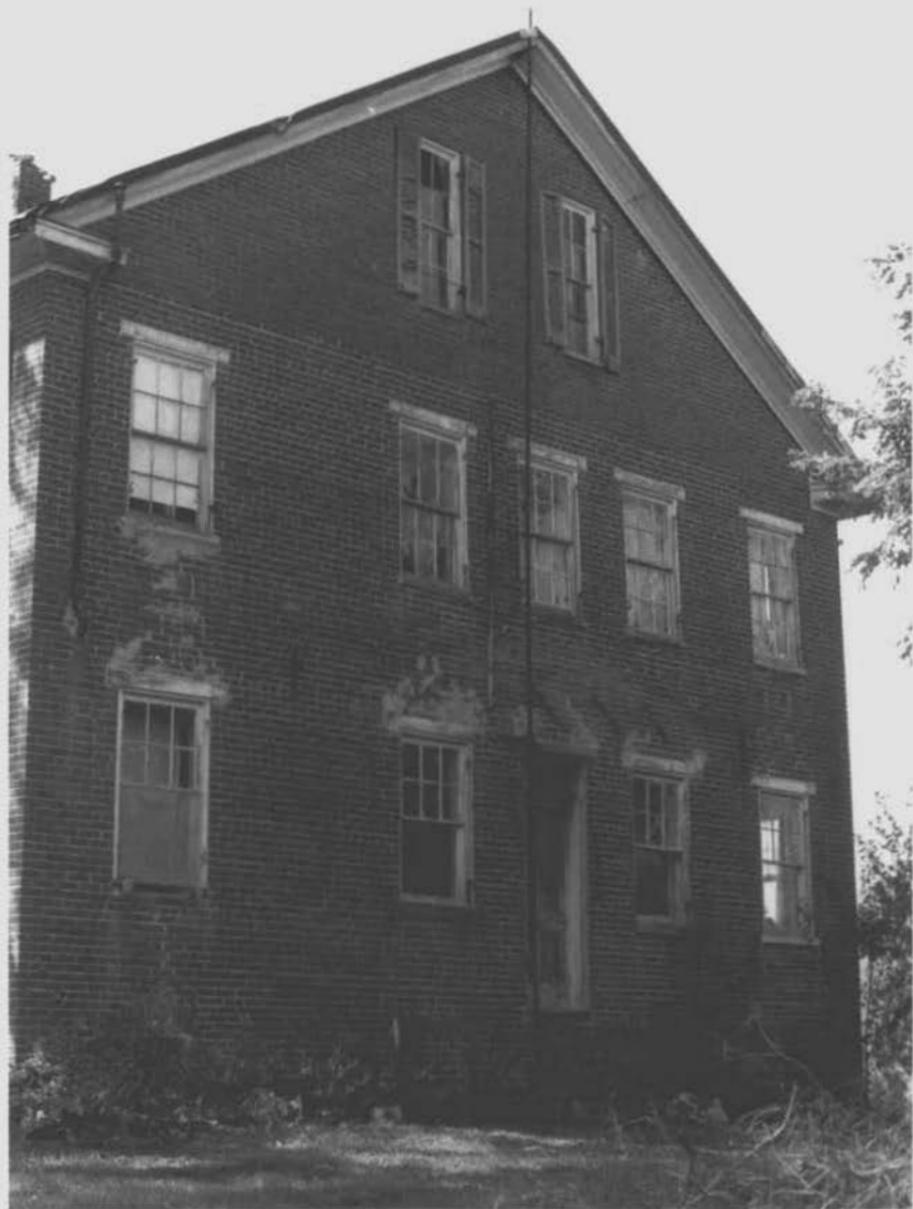
1/5

Neg. Loc.: Maryland Historical Trust
house - north elevation

are built of 3-1, 4-1, and 5-1 common bond brick. There is a gable roof with a north-south ridge, standing-seam metal, and a box cornice with returns. The north elevation was originally the primary facade. The foundation has a four-light sash in a flat mitered frame, with a splayed brick jack arch, in the east bay. The east-center and west center bays have bricked in openings, and the west bay a boarded-up opening, all the same size as the east bay. The first story has a center entrance with a four-panel door that has sunk panels with no panel moulds. The door has a bullnose frame, slate sill, four-light transom, and wood lintel with bullseye corner blocks. The four flanking bays each have a 6/1 sash with wood sills, bullnose frames, wood lintels with bullseye corner blocks, and hinges for blinds. There is a ghost of a pedimented portico that covered the center three bays of the first story, and the west brick cheek wall survives. The second story has five 6/6 sash with the same details as on the first-story. The three center bays are spaced closely together, with a larger gap between them and the west bay, and an even larger gap between them and the east bay. There is a brick gable end on this elevation built of 5-1 common bond. Both the brick and mortar in the gable are different from that in the walls below. The gable has two 4/4 sash in bullnose frames with wood sills, straight brick jack arches, and blinds.

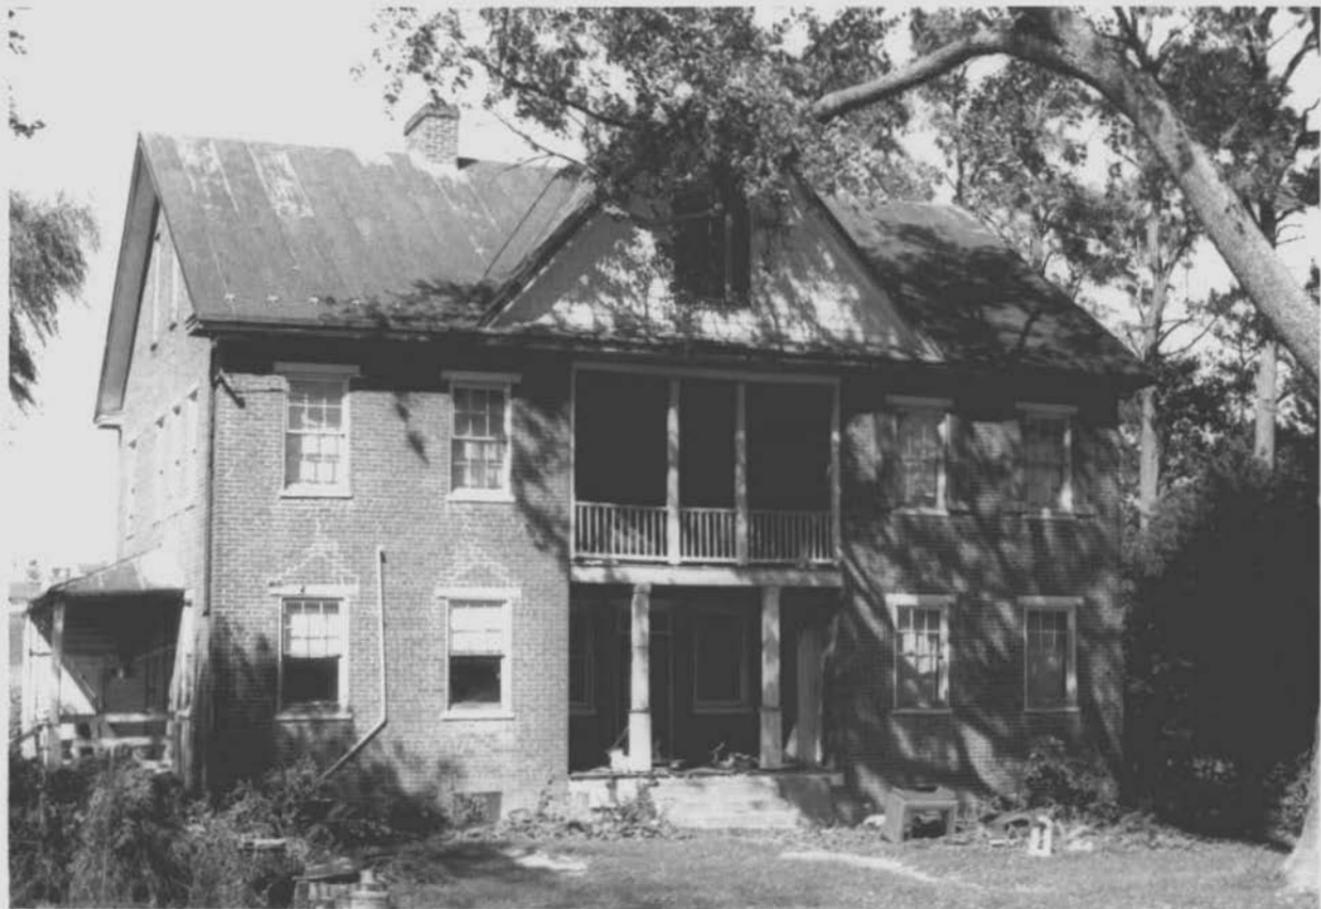
2/5

Neg. Loc.: Maryland Historical Trust
house - east elevation

The east elevation is seven bays, with the center three bays recessed and filled with a two-story porch under the roof of the house. The foundation is in one plane, and has a four-light sash in the south bay, a boarded-up opening in the south-south-central and south-central bays, concrete steps in the center bay, and boarded-up openings in the three bays to the north. The south bay details match those found on the north elevation foundation. The first story has 6/1 sash on the north and south two bays. The recessed center three bays have a center entrance with a four-panel door and four-light transom that are identical to the north elevation door. The door is flanked by a 6/6 sash on each side. The north elevation of the recess has a four-panel door and four-light transom near the west corner, and the south elevation of the recess has the same arrangement, set east of center. These doors and windows match those on the north elevation. There are two square boxed columns that support the porch above. The second story has a 6/1 in the south two bays and a 6/6 with blinds in the north two bays. The center three recessed bays are identical to the first story, but there are no openings on the north and south elevations of the recess. The second-story porch has two chamfered columns set close together, with a chamfered half-column on each end. The balusters are square in plan, set between narrow rails on top and bottom. There is a gabled wall dormer over the center three bays that has wood shingles with clipped corners and one 4/4 sash with blinds.

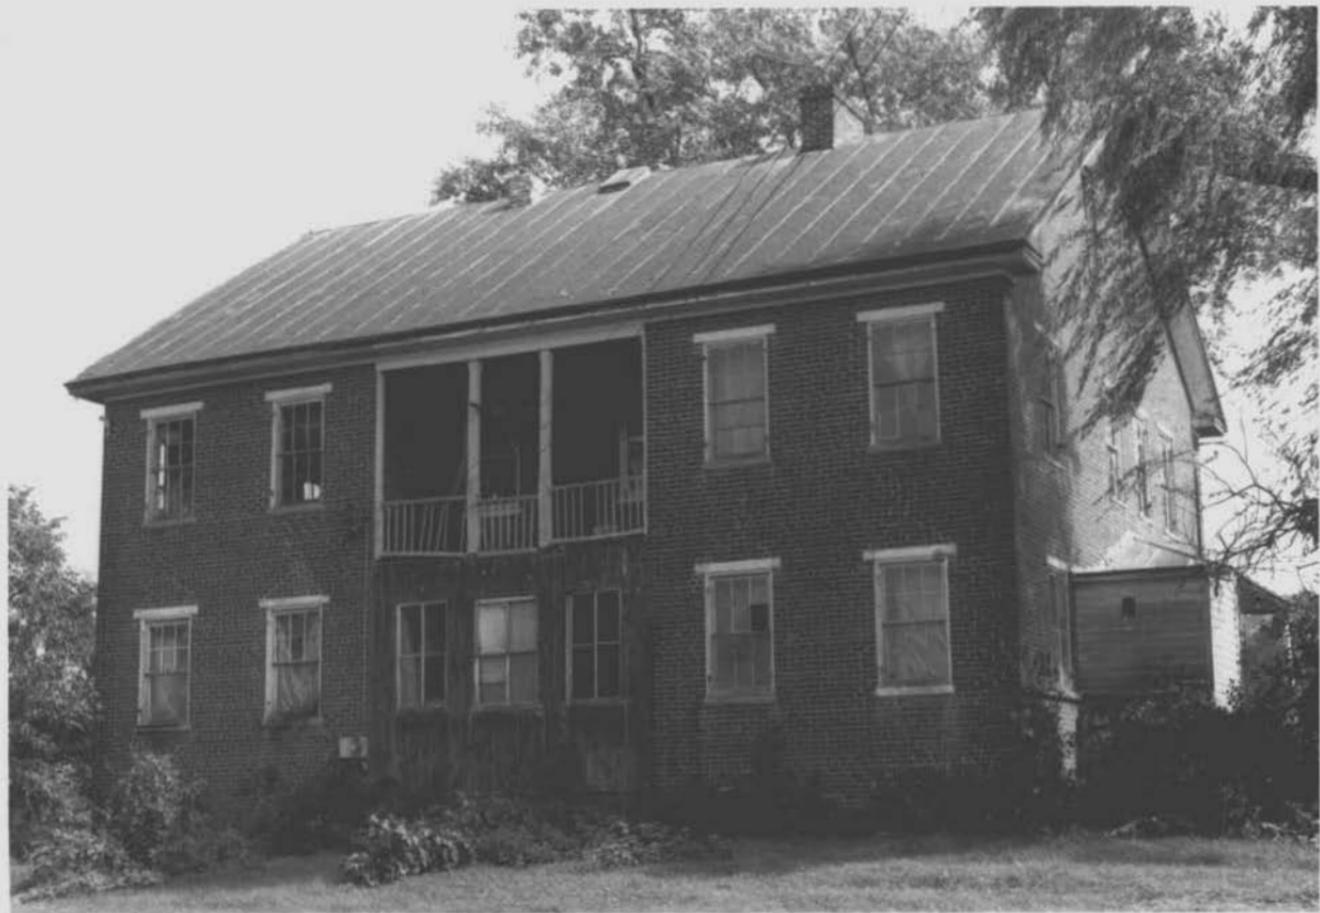
3/5

Neg. loc.: Maryland Historical Trust
house-west elevation

The west elevation is also seven bays, with the center three recessed and now enclosed on the first story. The foundation wall is in one plane, and has, from north to south, three four-light sash, nothing, and three four-light sash. The first story has a 6/1 sash in the two north bays and a 6/6 sash in the two south bays. The porch is enclosed with three large four-light sash and beaded-edge-and-center vertical boards. The originally recessed wall has a center doorway with a four-light transom and a stone sill, and a 6/6 on each side. The door is missing. The brick is painted red and striped in white. The second story has two 6/6 sash on each end, and the same arrangement in the center three bays as is found on the east elevation. The porch details are identical to the second story east porch, too. There are two interior brick chimneys, one each over the north and south walls of the recess, and they are centered on the ridge.

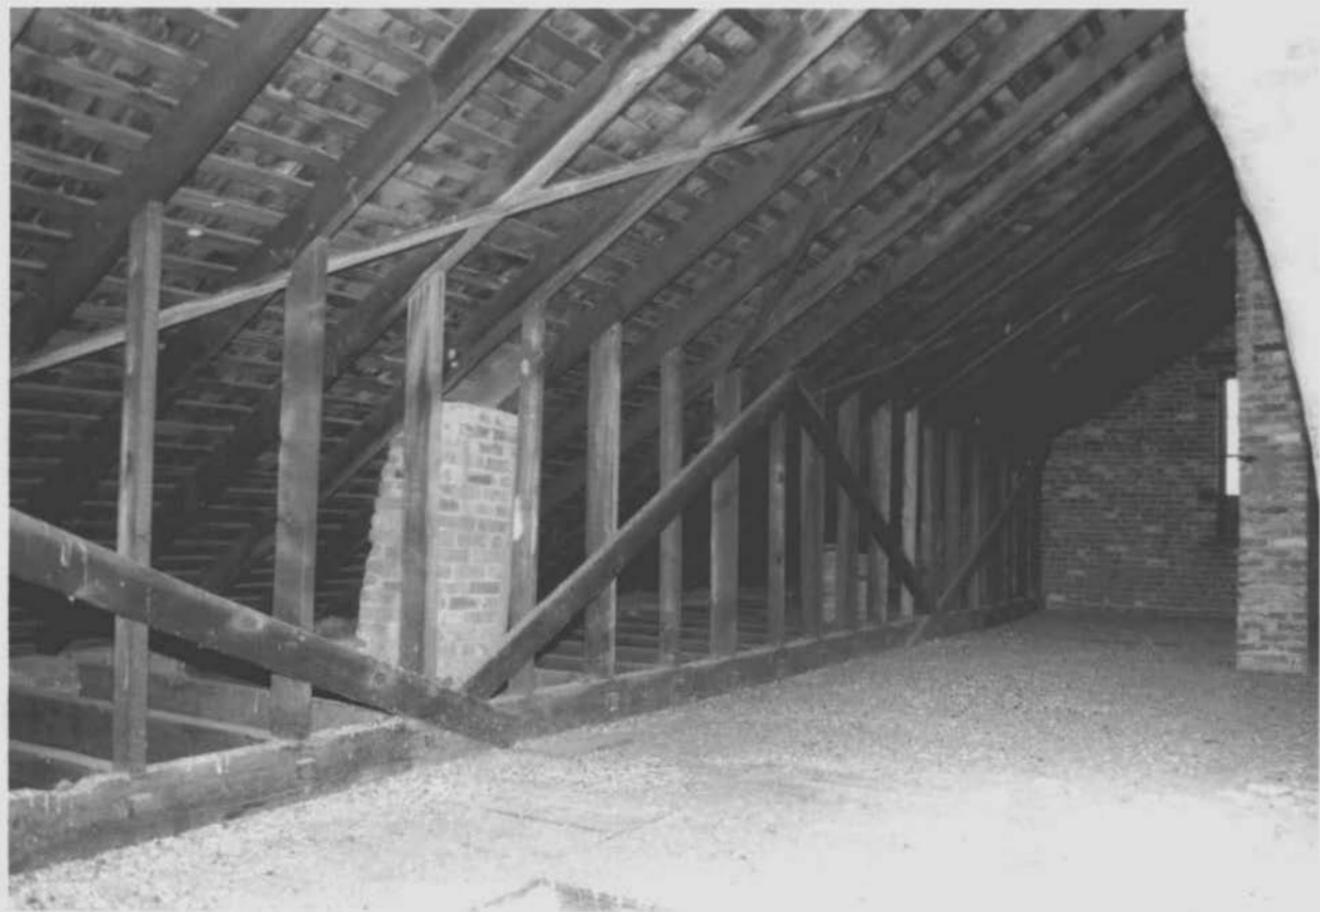
4/5

Neg. Loc.: Maryland Historical Trust
house-attic framing

The attic joists are 1½ by 8 inches, run north-south, and rest on top of the two interior brick walls. The roof structure is a later addition, and has a unique truss for support. The rafters are 2 x 6, spaced 23½ inches on center, and are circular sawn. They are mitered in the peak, although the gabled wall dormer has a ridge beam. The rafters support lath and wood shingles. Each rafter has a vertical post underneath of it, placed about one-third of the distance from the outer wall to the ridge. There are diagonal braces nailed across these posts. The posts rest on a horizontal beam running north-south that rests on top of the floor and in pockets in the gable end walls. This beam is mortised, and there are short beams that are 3 x 8, spaced 24½ inches on center, that are tenoned into them. These beams pass over the east or west walls and support a plate on their outer end. The rafters are notched over this plate. The top of the brick wall is three wythes thick and has been rebuilt. The entire truss is made of circular sawn lumber. The gable ends have hewn lintels over the windows, with a mill-sawn, reused beam set up against the lintel at one end and resting on the floor at the other, acting as a wind brace. There were originally five chimneys that passed through the roof. They all survive in the attic, but only the two center ones exit through the roof now. There are three chimneys located along the north interior wall, and two on the south interior wall, one to the west and one in the center.

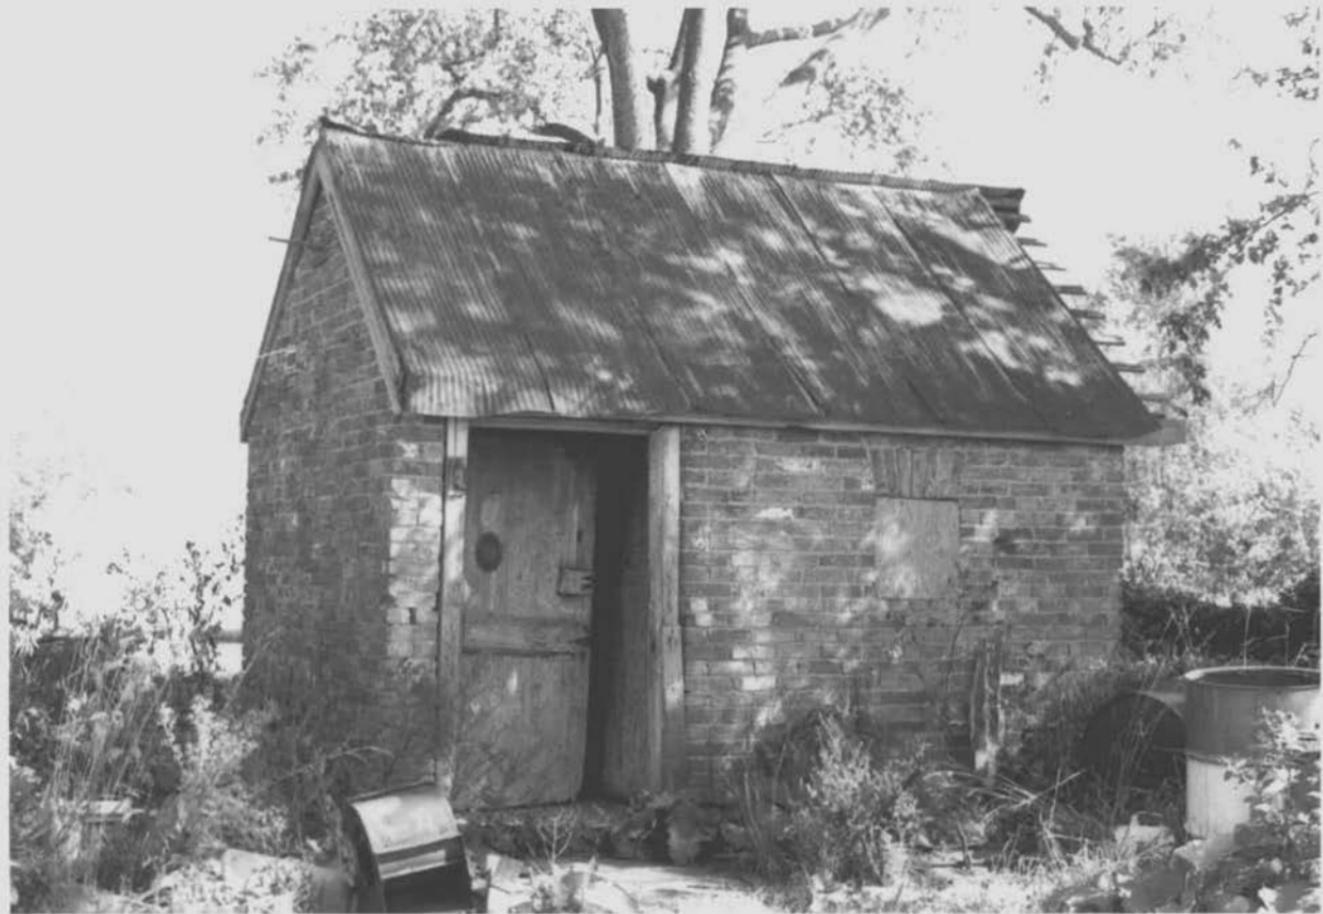
5/5

Neg. Loc.: Maryland Historical Trust
Springhouse - South elevation

About fifteen feet southeast of the house is a springhouse of 6-1 common bond brick, with a gable roof of corrugated metal and an east-west ridge. The north elevation has a small, boarded-up opening in the center that has a splayed brick jack arch. The west gable end is brick, while the east gable end has German siding and overhangs about 8 inches. The south elevation is two bays, with a two panel door in the west bay

that has sunk flat panels made of beaded-edge vertical boards. The door frame has a large bead on the inner edge and is mortised-and-tenoned and pegged on the interior. The door has interior strap hinges and a wood boxlock on the exterior. The internal mechanism of the lock is metal. The east bay has a boarded-up opening with a splayed brick jack arch. The interior has a concrete floor, parged walls, and a tongue-and-groove board ceiling. There is a concrete trough on the east wall. The ceiling follows the outline of the rafters and, presumably, a tie beam.
