"The Beautiful Farm"
Taneytown (vicinity)

c. 1812

**Maryland Historical Trust
State Historic Sites Inventory Form**

Survey No. CARR-1381

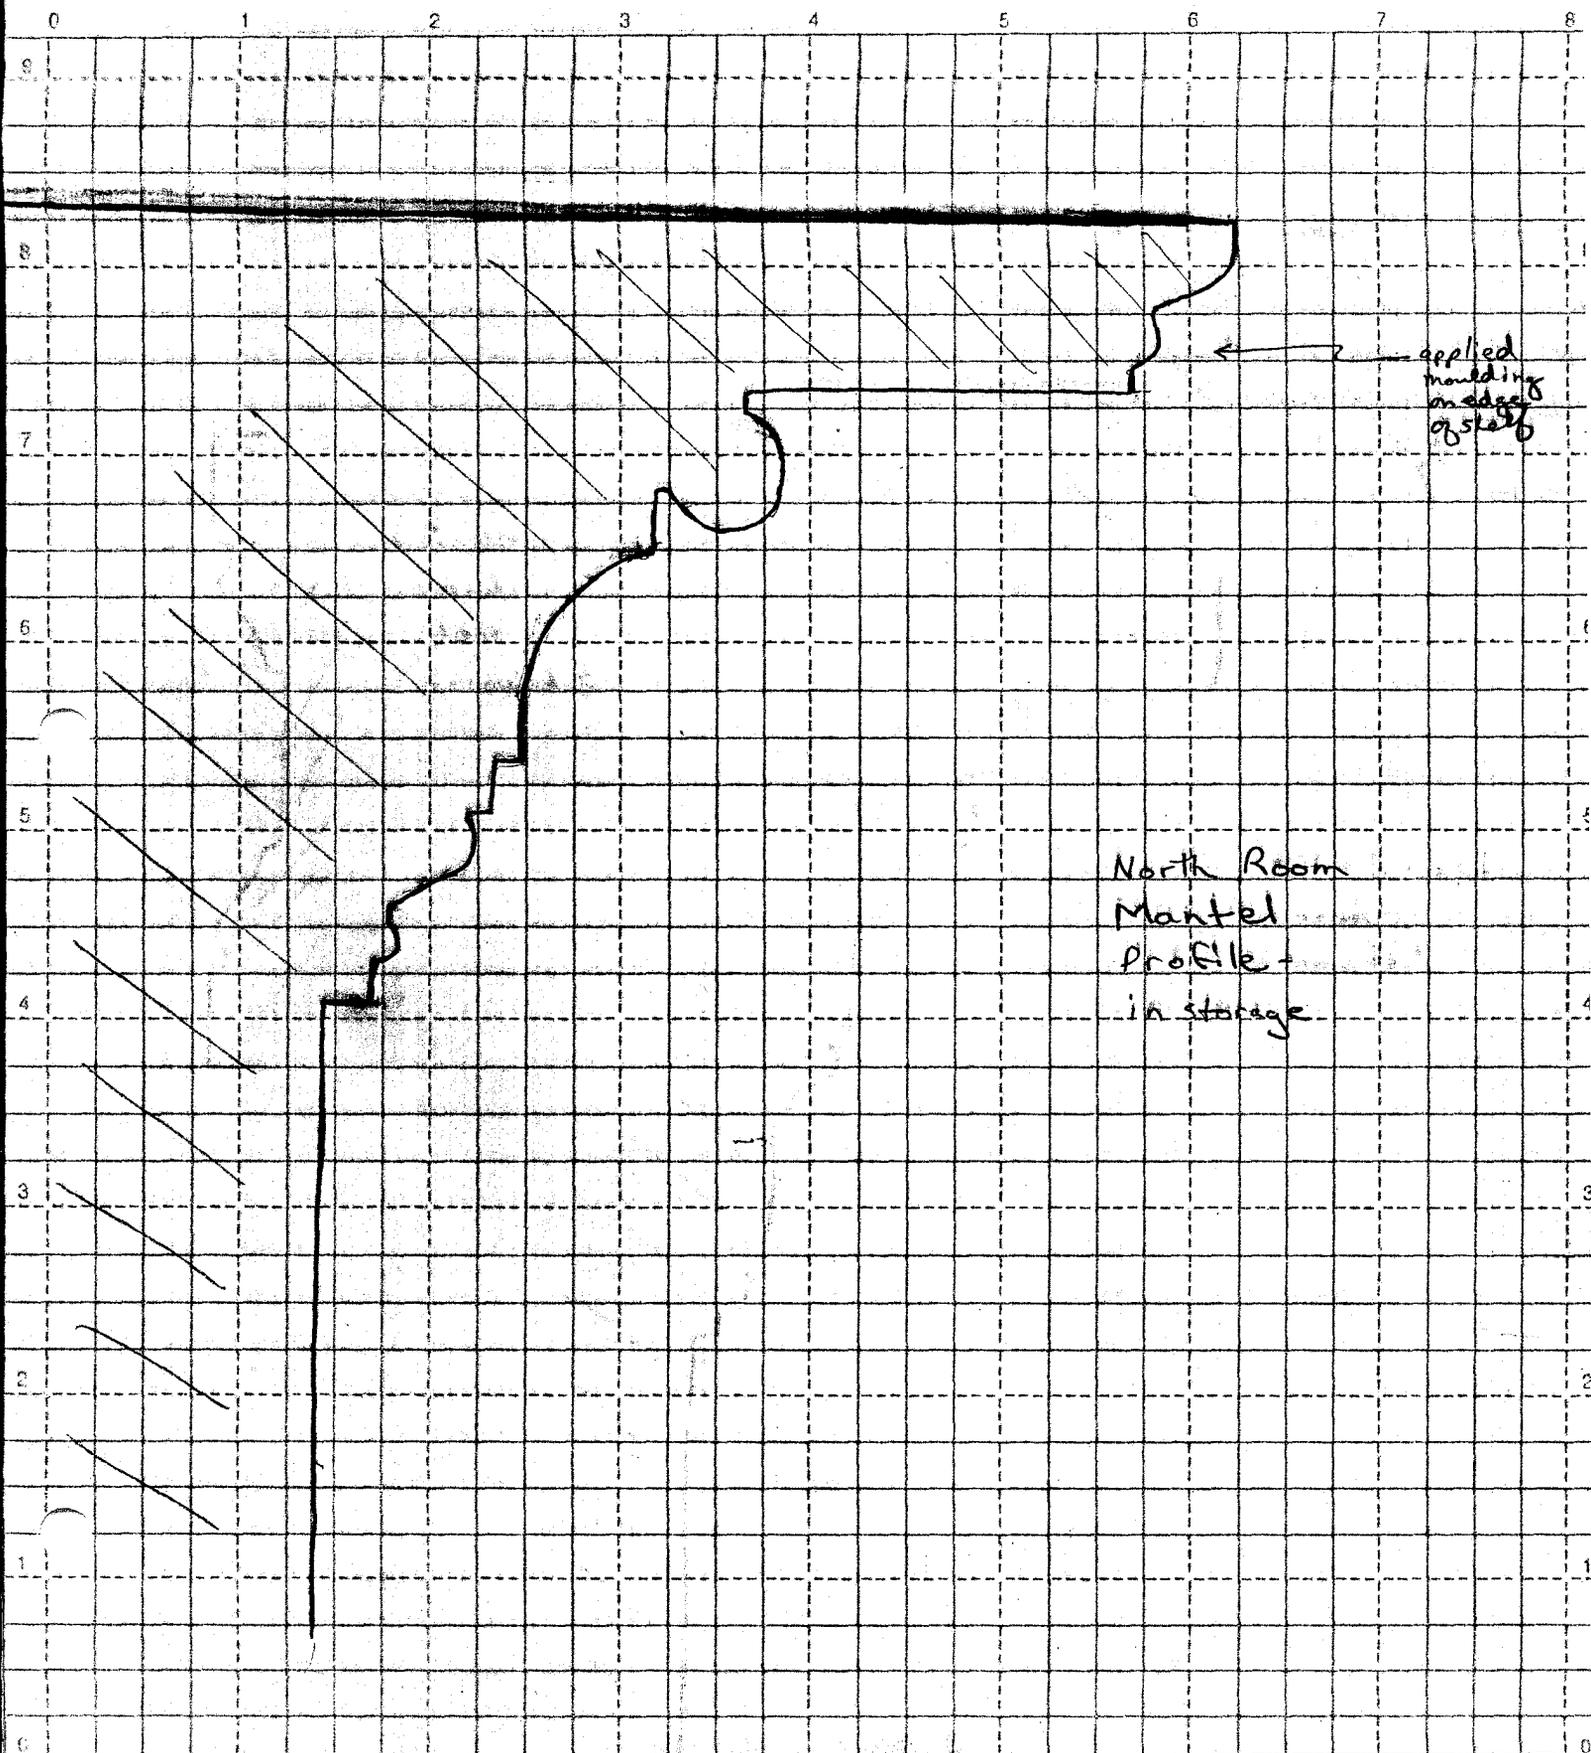
Moulding Profiles

← applied moulding on edge of steps

North Room
Mantel
Profile -
in storage

The open stringer stairs have simple sawn brackets in an ogee profile, and turned balusters and newel. The hand rail is relatively flat, with two astragals on each side. There is an applied board, with a beaded bottom edge, under the hand rail along the tops of the balusters. The wall under the stairs has beaded-edge, wide vertical boards, as does the stair to the cellar, which is set at an angle. It has a cast-iron box lock marked "J & N" and a porcelain knob. There are replacement butt hinges. The vertical boards are nailed with wrought nails and the risers and treads have wire nails, with some cut nails stuck into them. The stringer has a bead on the bottom edge, with a narrow board underneath of it that has an ovolo on the bottom edge. The baseboard along the stairs has an ovolo on the top edge. Inside the stairs to the cellar, on a board above the door, are roughly-cut markings "IX IIII". The southwest doorway has a new frame and a Queen Anne door. There is an exposed sawn joist under the landing, and the flooring above it is also exposed.

the property. It has a beaded interior edge surround with engaged half columns and a plain frieze. The bed mould has a pronounced bead under the mantel shelf, with a cavetto below that, then an ovolo, and an astragal at the bottom. The mantel shelf has a moulding applied to the edge, and was fastened with cut nails. There is a small room off the southwest wall of the west room, to the west, with another small room to the southeast of this one. The latter room has a door on the southeast with two lights over two panels, and plain surrounds with butted corners and beaded interior edges on the verticals only. The door has a cast-iron box lock marked with what appears to be "RE C°, USA" in a diamond, and with a porcelain knob.

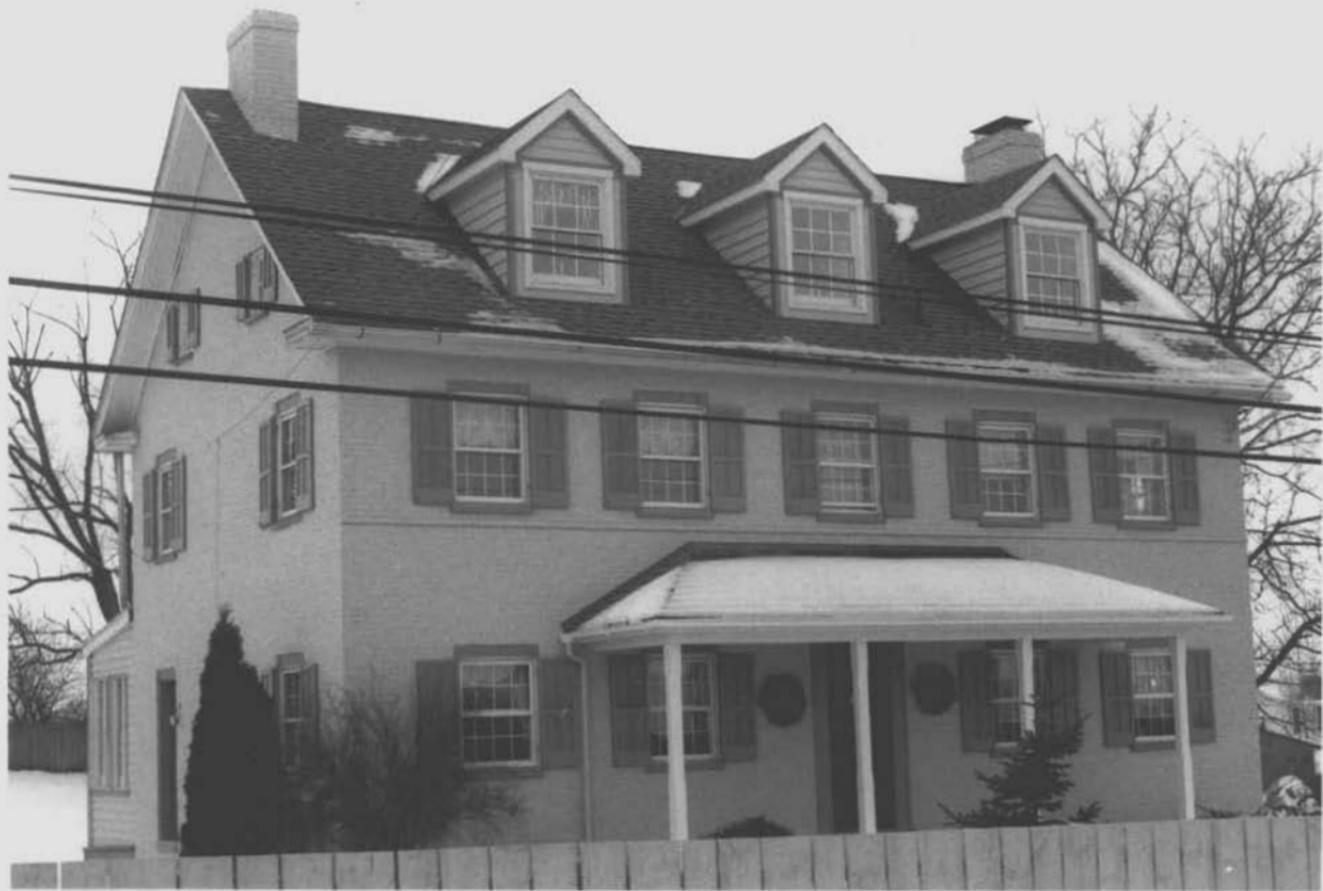
1/2

SE & NE elevations

The southeast elevation has 4-1 common bond. The south bay of the foundation has a pegged mortise-and-tenon window frame with a concrete sill. The former sash was set at the outer edge of the frame and hung on cast-iron butt hinges. Now there is a

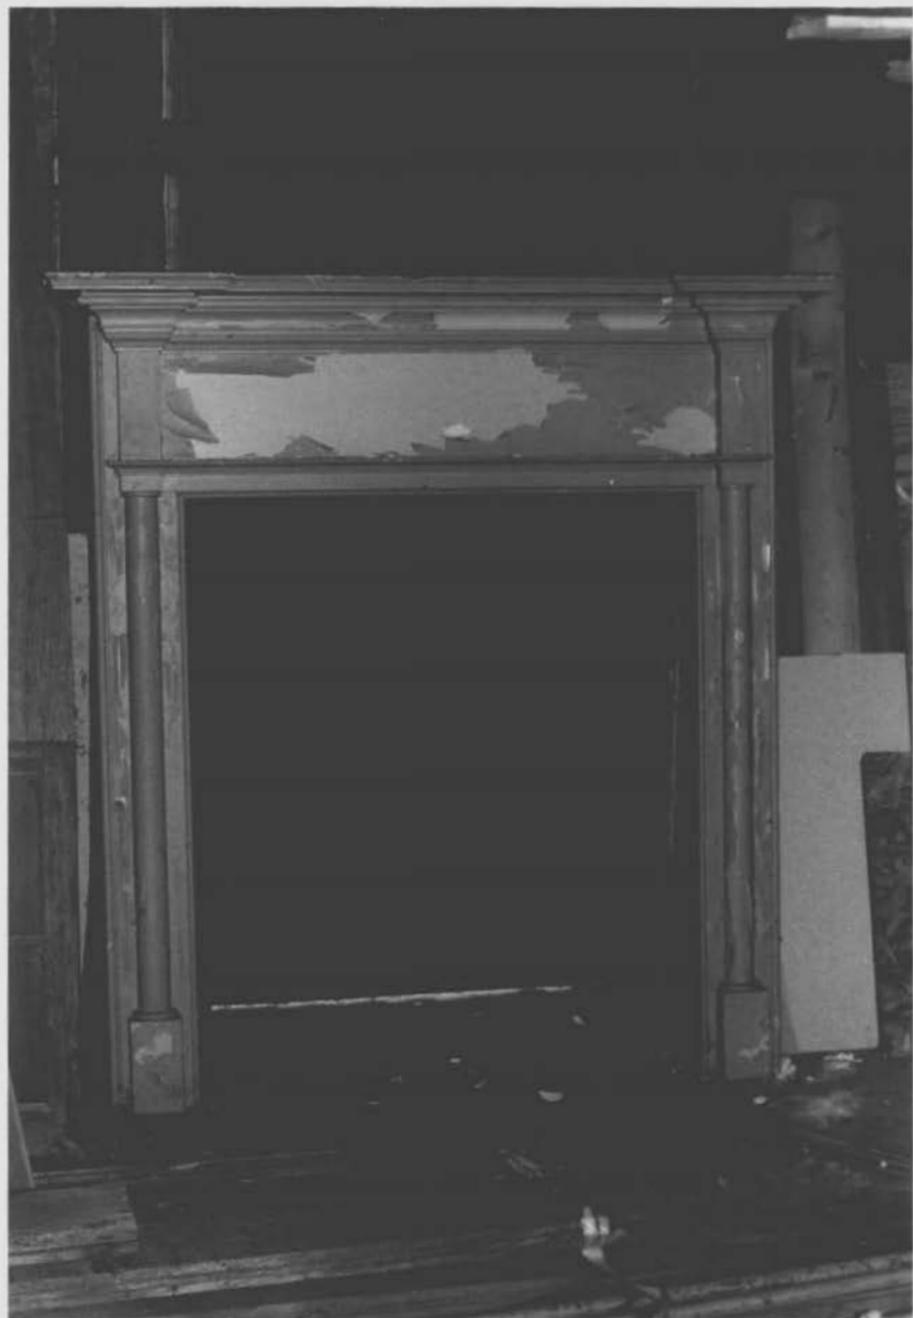
2/2

Neg. Loc.: Maryland Historical Trust
mantel removed from north room

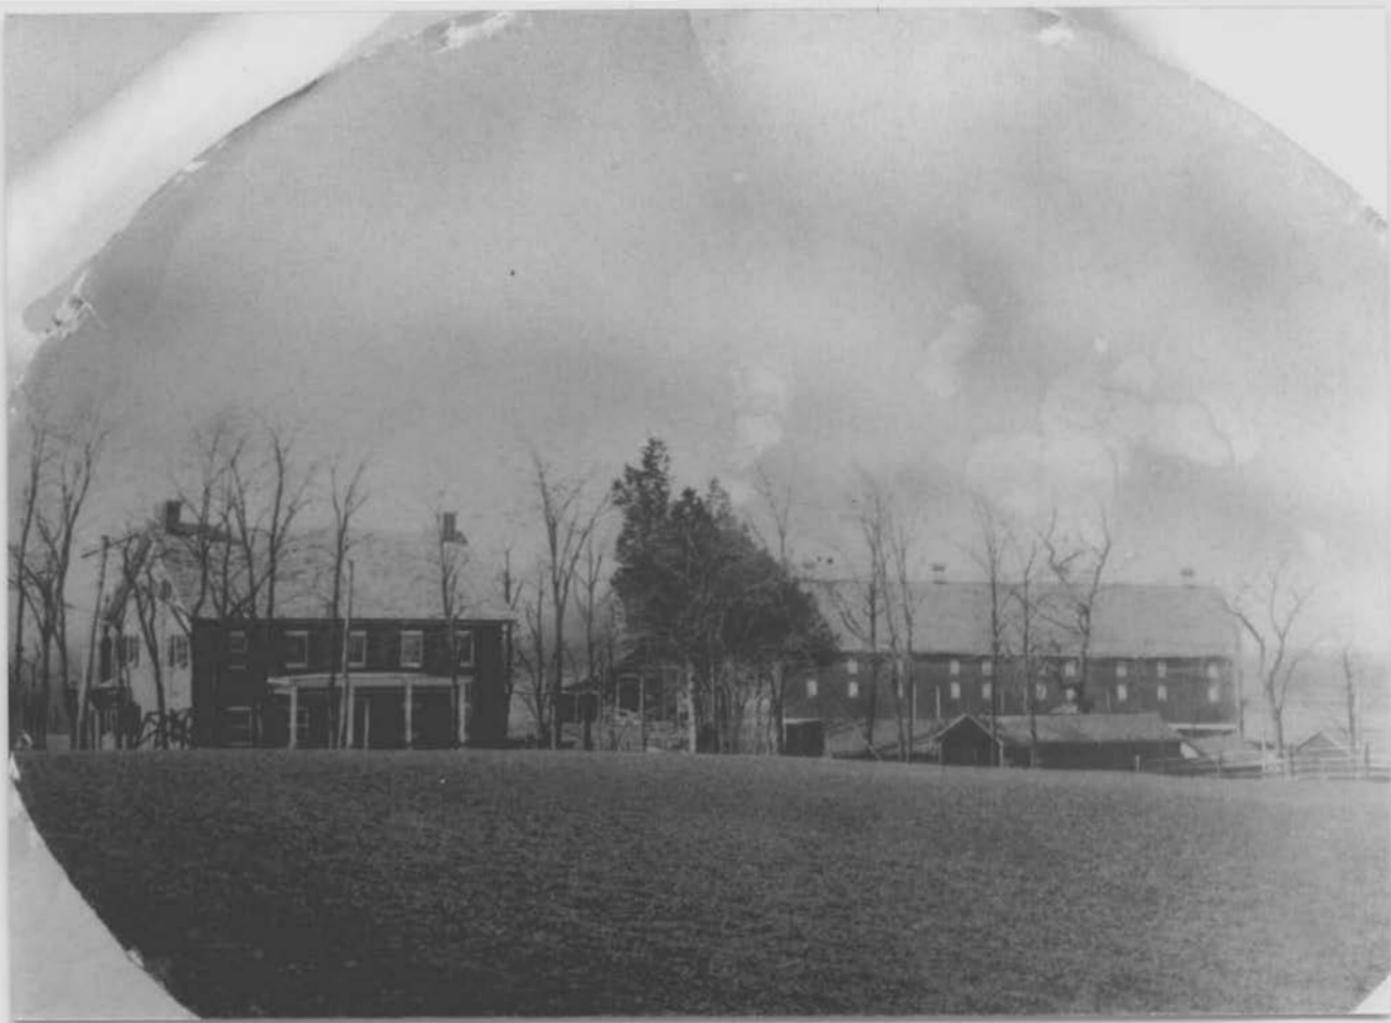
Historic photo c. 1900-10
