CARR-1382

Wadlow Store & Dwelling
Freedom

State Historic Sites Inventory Form

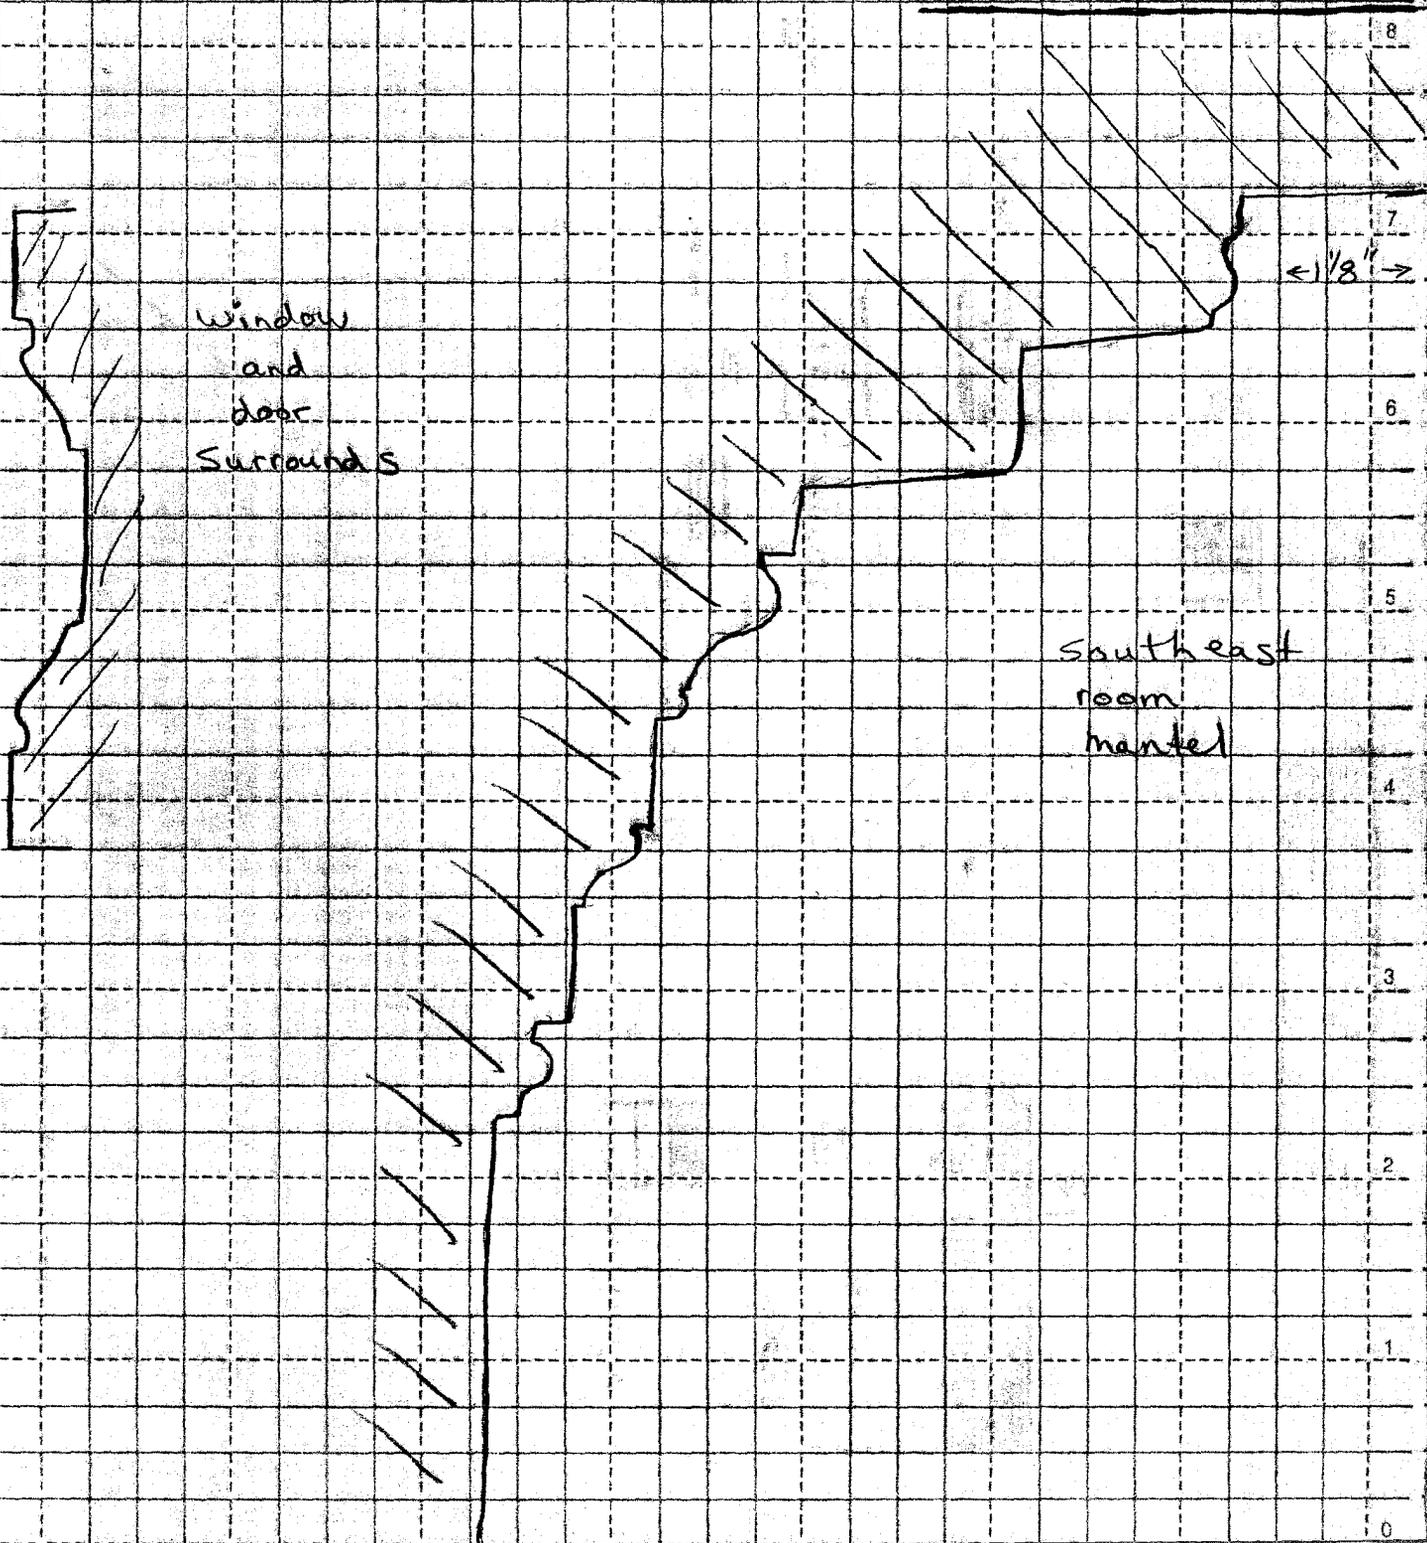
707 Old Liberty Rd.
Moulding Profiles

Window
and
door
surrounds

southeast
room
mantel

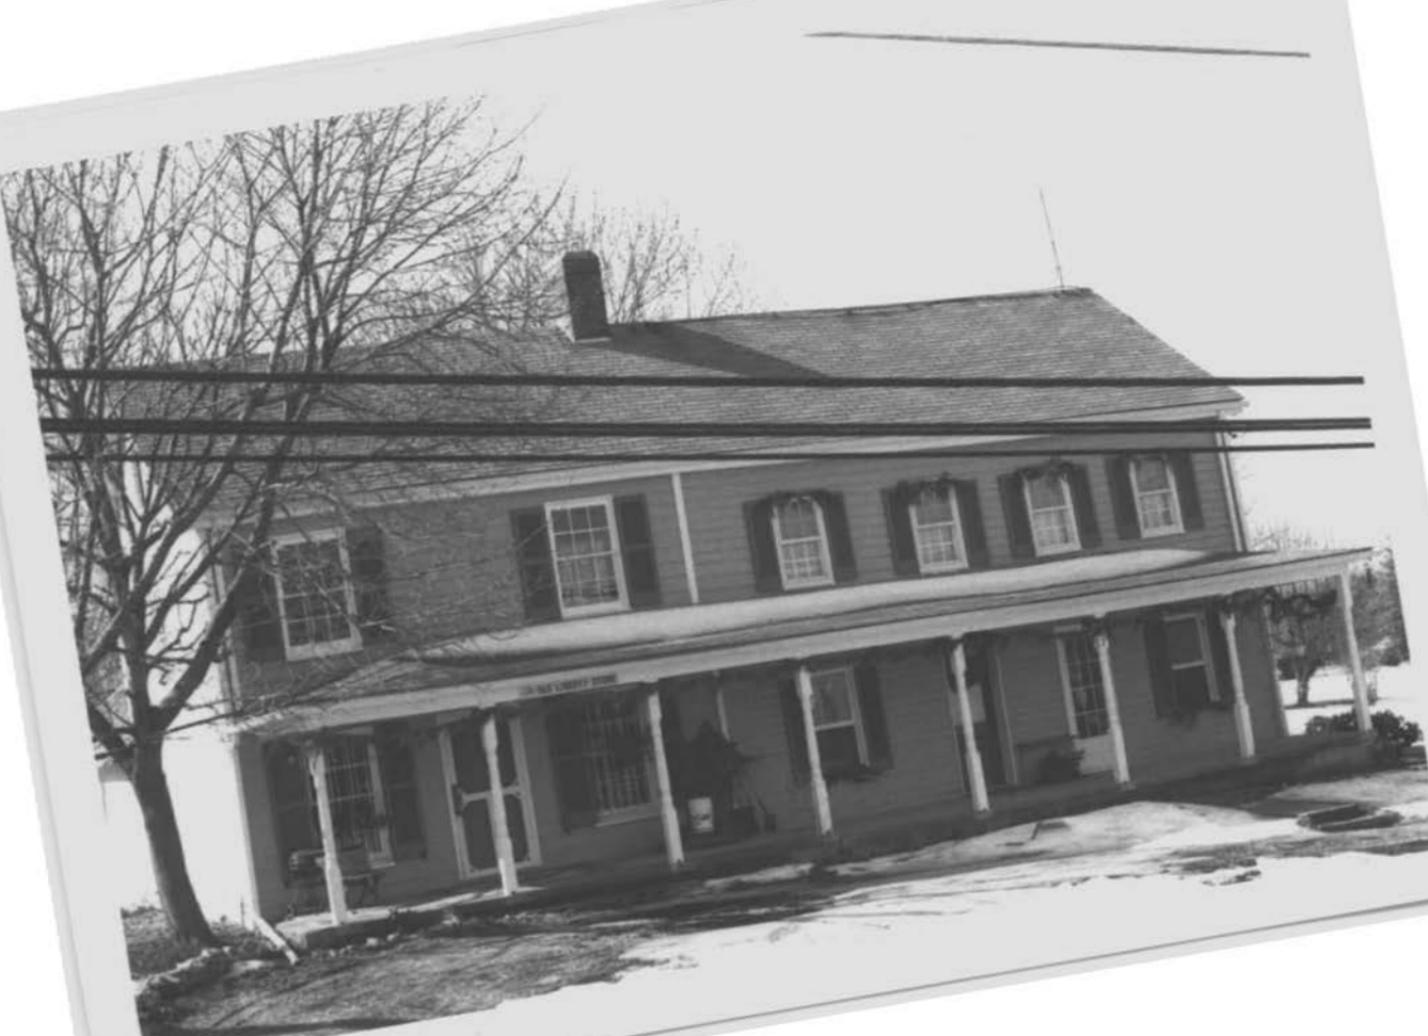
1/2

northeast elevation

The house is a two-story, four-bay by two-bay, Pennsylvania Farmhouse plan log structure with a rubble stone foundation and a gable roof with asphalt shingles and a northwest-southeast ridge. There is an interior brick chimney on the southeast end. The northeast elevation has German siding on the first story and clapboard on the second. Asbestos shingles were recently removed to reveal these materials, and the shingles remain on all the other elevations. The first story has, in each bay, a 1/1 sash in a narrow, broken-field frame that has a bevelled interior field. There is a wood sill and blinds. Those to the east are marked "V" and to the north "III". The shutter holdfasts have a cast-iron shell pattern. The east-center bay has a door with one light over one panel, and the same frame as the windows. This frame is found in the north-center bay, but the door has been replaced by later infill. The second story has four 6/6 sash with

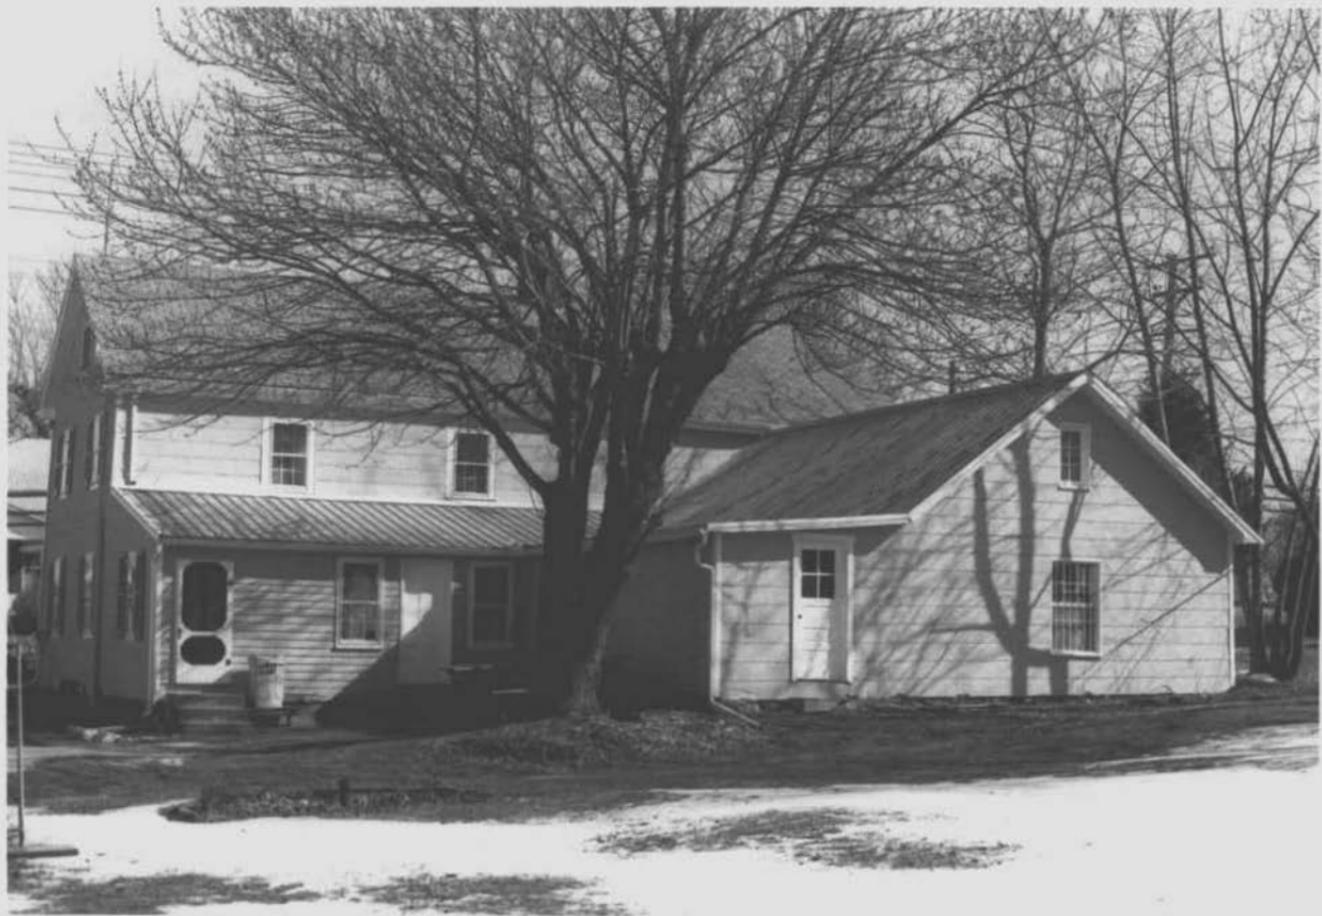
2/2

Neg Loc.: Maryland Historical Trust
northwest & southwest elevations

The northwest elevation has a large, later opening in the foundation that has two six-light sash. The first story has two 1/1 sash in frames like those on the northeast, and wood sills. The blinds are marked "VI" and "VIII". The second story is identical to the first, but the markings on the blinds are not visible. The gable end has the same window frames, but the blinds are closed. The southwest elevation has an enclosed one-story porch with a shed-roof that has inverted-V-seam metal. It has a concrete foundation and German siding. There are four bays, with from west to south, a four-light over two-panel door in the same frame as on the northeast; a 6/6 sash with wood sill and beaded-interior-edge frame; a four-panel door with flat, sunk panels, quirked ogee panel moulds, and a beaded-interior-edge frame; and a 6/6 sash identical to the other on this porch. The second story of the house has two 6/6 sash in wide frames that are possibly mortised and tenoned. The outer edge of the frame has an applied moulding that matches the frames on the northeast elevation.

The southwest elevation of the store is one bay. On the first story is a centered 6/6 sash with wood sill, beaded-interior-edge frame, and bars. The gable end has a six-
