CARR-1385

John W. Few Farm
Clearview Road

Maryland Historical Trust State Historic Sites Inventory Form

historic John W. Few Farm

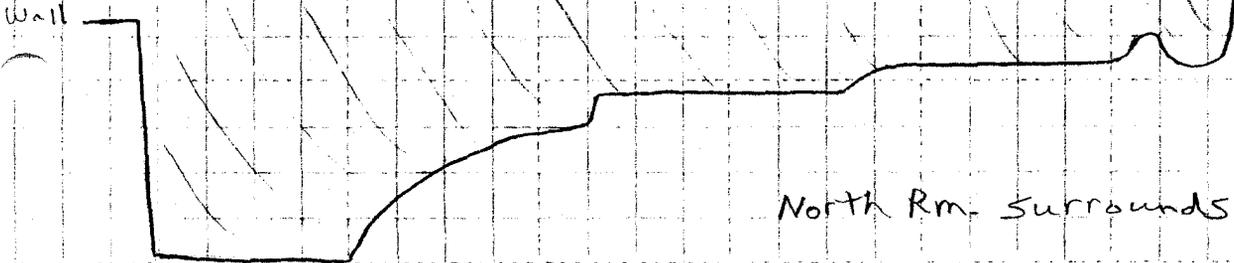
1525 Clearview Rd
Moulding Profile

North Rm. Surrounds.

The north room door has four panels with sunk fields and small ogee moulds. The edges of the fields also have ogee mouldings run on them. The cast-iron decorative butt hinges and box lock have no markings. The surrounds have a broken field with a beaded-interior edge and a cavetto on the outer edge. The oak flooring is $2\frac{1}{4}$ inches wide and runs northwest-southeast.

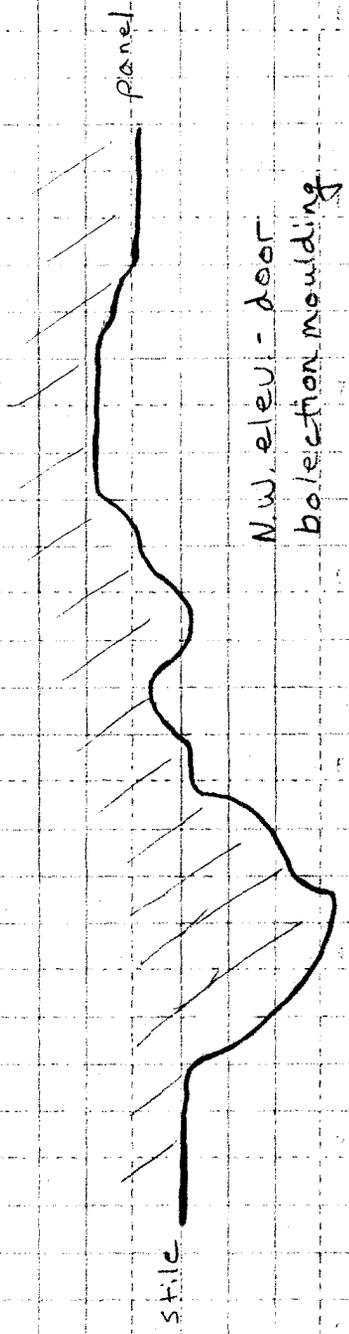
N.W. elev. - door
bolection moulding

and a new two-light sash in the west bay. The first story has a center entrance with a four-panel door that has sunk, fielded panels with wide bolection mouldings. The top two panels have semi-circular arched tops. There is a one-light transom and a plain surround with a cornice with a cavetto. On each side is a 4/4 sash with the same surround and cornice as on the door. The vertical muntins are wider than the horizontal ones. The windows have blinds. There is a centered, one-story, one-bay porch with a concrete block foundation and a gable roof of standing-seam metal with a northwest-southeast ridge. The porch has four square posts with caps that have a cavetto moulding. The vertical balusters are rectangular in plan. The second story has three 4/4 sash identical to the first story. There is a wood box cornice with returns. The soffit appears to be covered with German siding. There is an interior brick chimney on the southwest and a new, exterior brick chimney on the northeast.

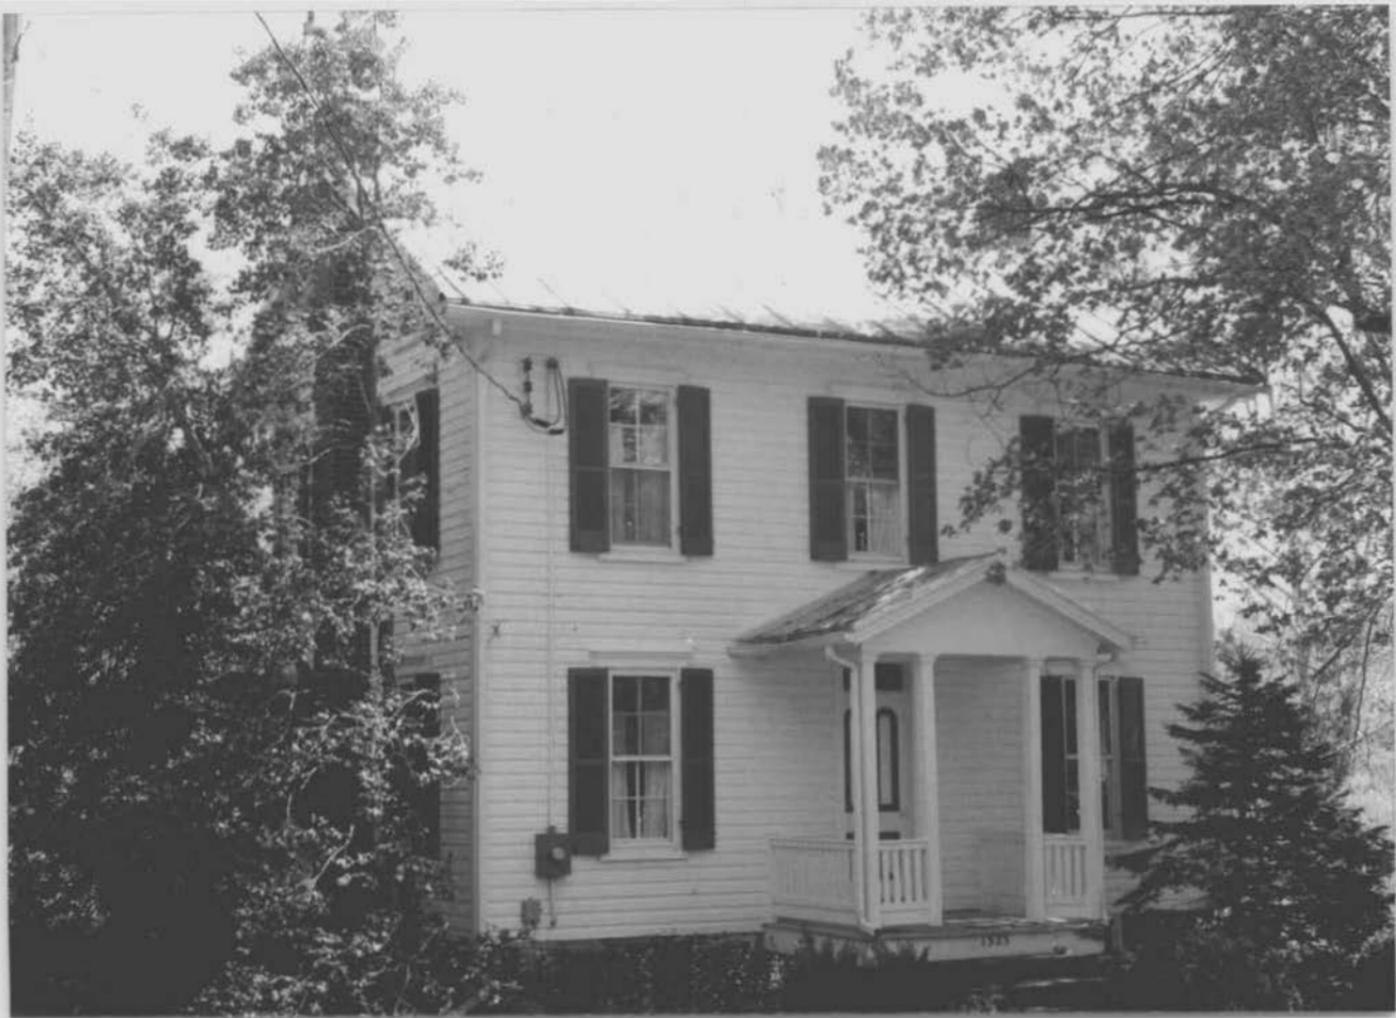
4

house - northeast & northwest elevations

The house faces northwest toward the road and is banked on the northeast. It is a three-bay by two-bay, two-story structure with a rubble stone foundation, German siding with corner boards, and a gable roof with standing-seam metal and a northeast-southwest ridge. The northwest elevation has a boarded-up opening in the north bay

The northeast elevation has two 4/4 sash on both the first and second stories that match those on the northwest. The gable end has two four-light sash with the same surrounds. On the southeast elevation there is a later one-story addition. The second story of the original house has three typical 4/4 sash, and the same cornice with returns. The southwest elevation has a new door in an old mitered frame, with a beaded-interior edge, in the west bay of the foundation. The first and second stories each have two 4/4 sash, and the gable end has two four-light sash like those on the northeast.

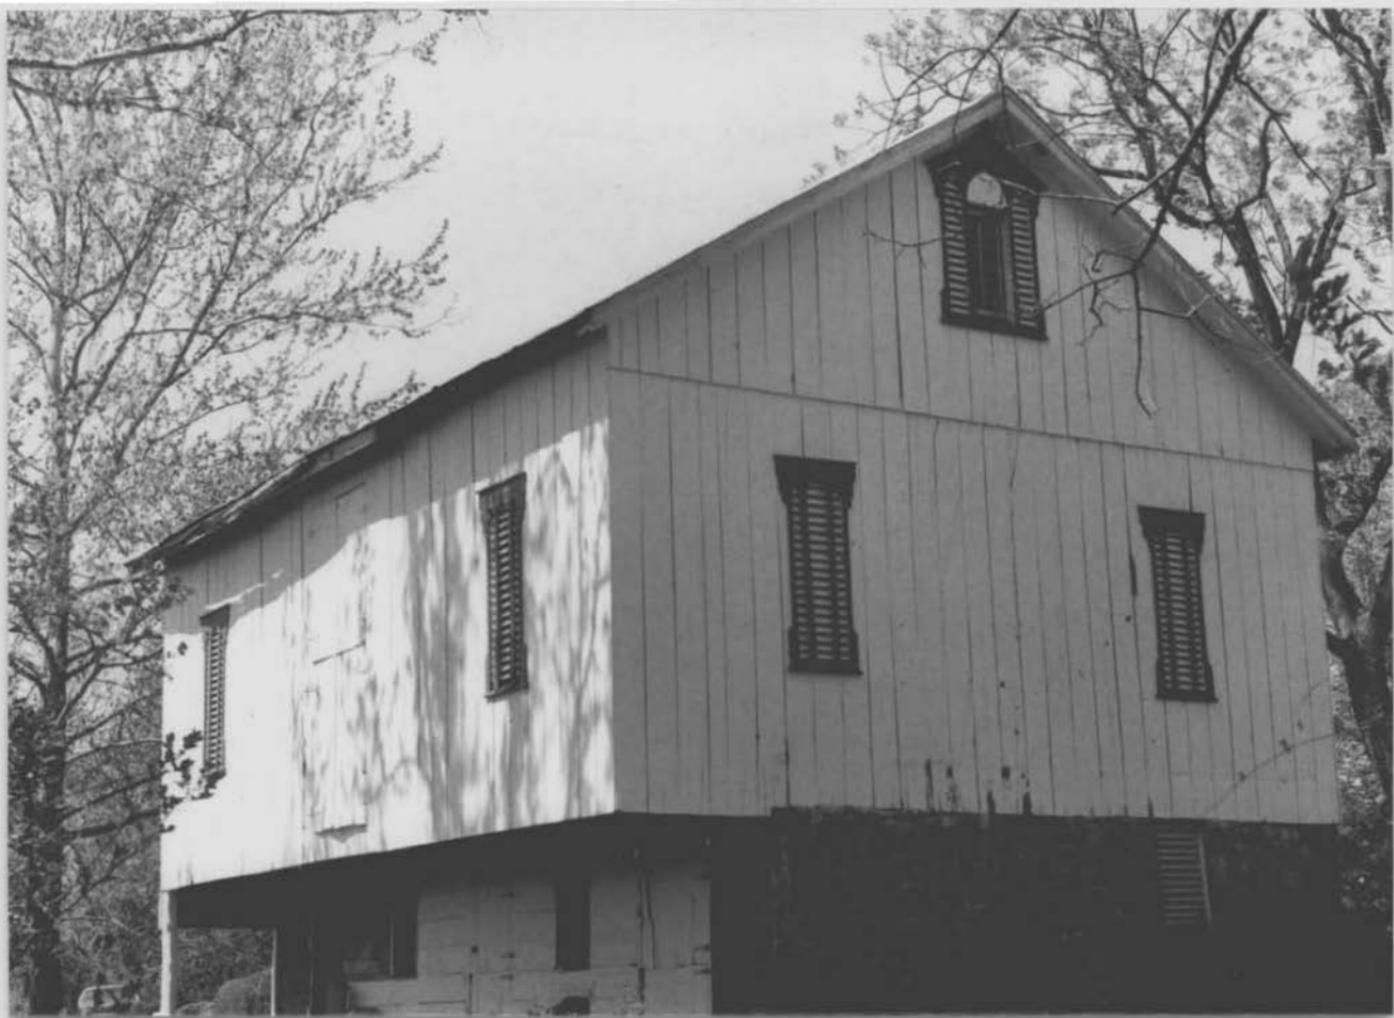
7/4

barn - south & east elevations

About 100 feet south of the house is a frame bank barn with a forebay facing southwest. The lower story is rubble stone on three sides, with horizontal board siding on the southwest. There is a very low stone wall below the siding and wood sill on the southwest. The upper story has vertical-board siding. There is corrugated metal on the gable roof, which has a southeast-northwest ridge. The southwest elevation, lower story, has vertical-board dutch doors on strap hinges with a vent above three horizontal slats. There are three doors, and between each pair is a vent with diamond-in-section wood louvers. The upper story has center double doors over double doors. These are flanked by one tripartite wood louvered vent on each side.

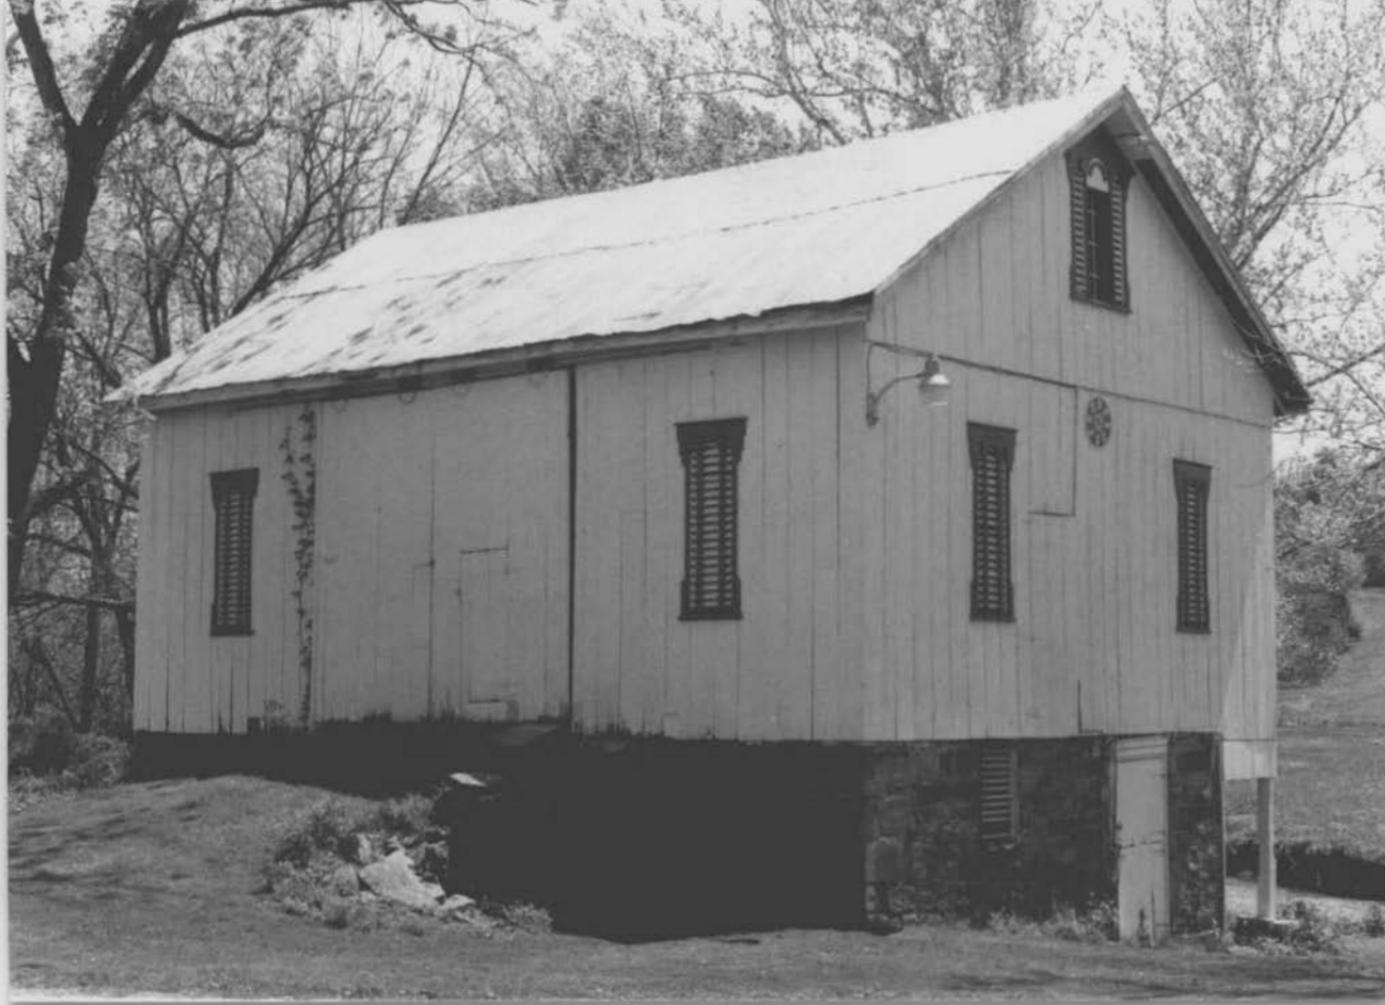
3/4

barn - north & west elevations

The northwest elevation has a diamond-section vent in the north bay of the lower story and a typical dutch door in the west bay. This door has carved on it "C. W. 1917; CARRO; C. W. 191[1?]." The upper story has two tripartite vents. In the gable peak is a narrow window opening with a later sash behind it, and one vent on each side. It has a pedimented surround. The northeast elevation has a ramp that has been built up, with stone cheek walls. The barn rests on only slightly sloping ground. There are no openings in the lower story. The upper story has center double wagon doors on rollers, with one tripartite vent on each side. The southeast elevation has a diamond-section vent in the east bay of the lower story. The upper story has two tripartite vents. The peak has the same detail as on the west, but appears to have an original six-light sash.

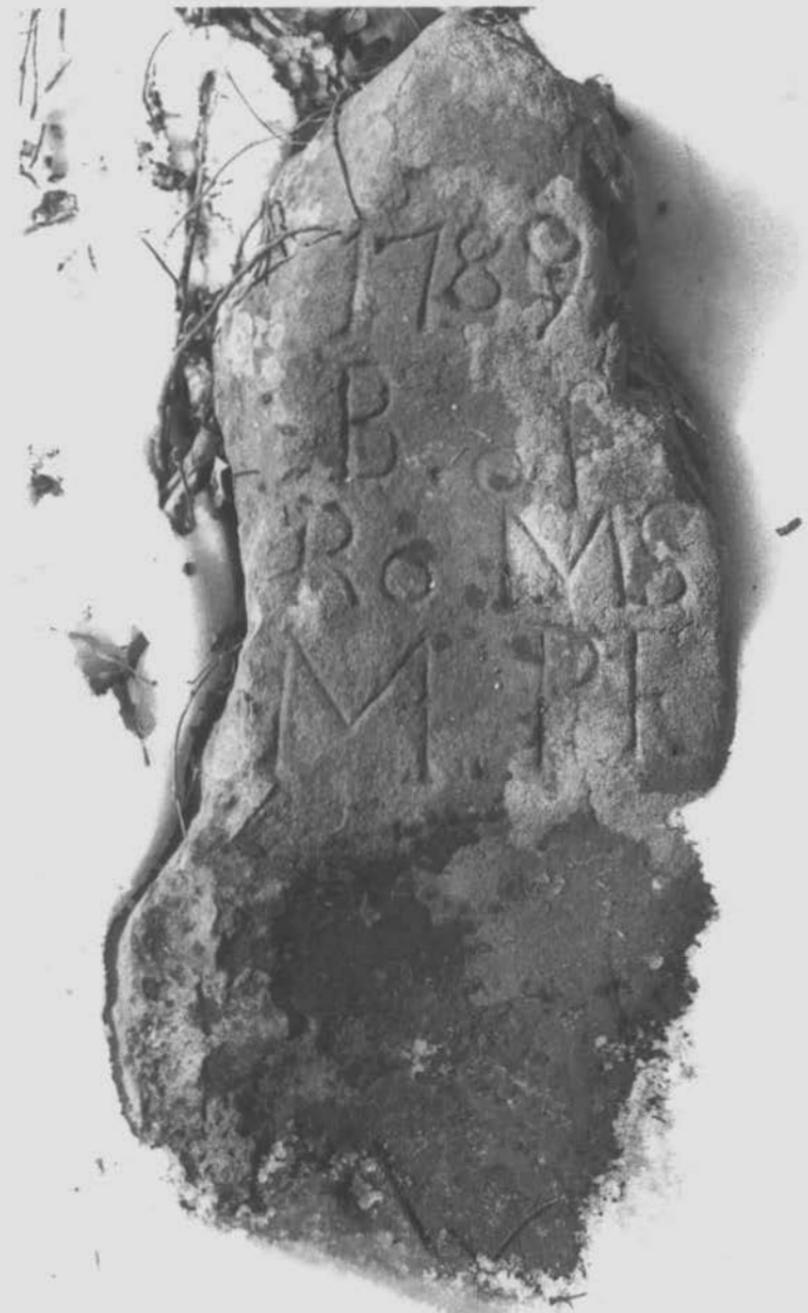
4/4

1789 Boundary Stone

The beginning boundary stone of "Resurvey on Meadow and Something is about 1000 feet north of the house, on the northwest side of Clearview Road. It is set close to the road, just north of the S-curve, and is currently laying on its back. It appears to be granite, with irregular edges, but is roughly pointed at the top. It is about 4 feet long by

10 inches wide. The top one foot, seven inches is deeper than the bottom, and is carved with:

1789
B. of
Ro MS
M. PF.
