CARR-1395

George Washington Devilbiss Farm  
New Windsor (vicinity)

# Maryland Historical Trust State Historic Sites Inventory Form

Survey No. CARR-1395

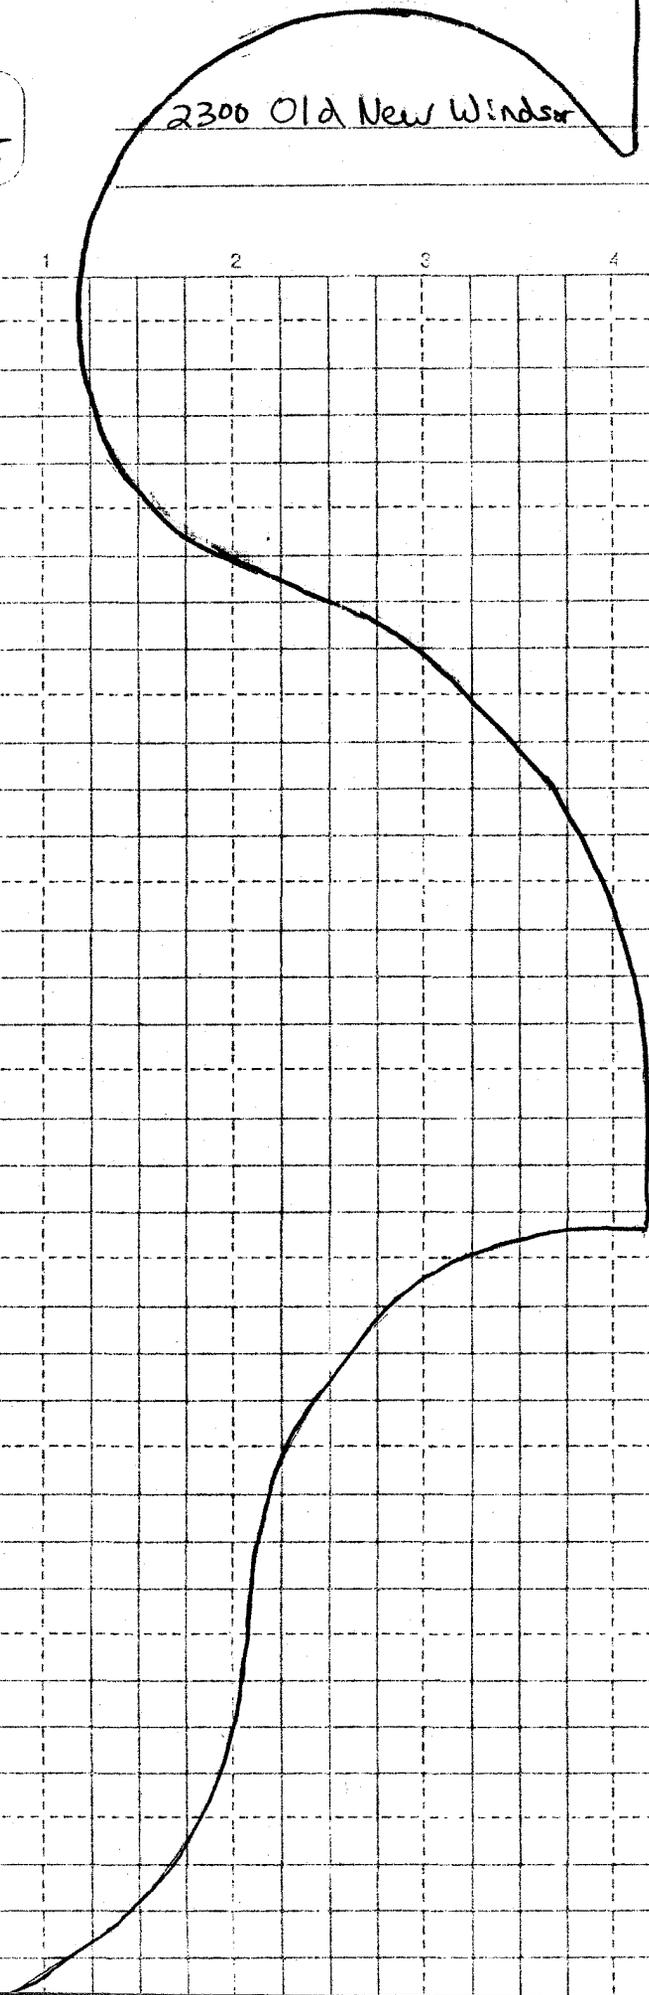
2/5

The east ell room has a mantle shelf hung on the north wall, set on two sawn brackets. There is a set of enclosed winder stairs between the east and west rooms of the ell, with two steps below the door in the east room. The west room reportedly had the same arrangement but has now been remodeled for a kitchen and the stairs have been closed off. The west room has a brick chimney centered on the west wall and a pantry off to the south.

First Story  
East Etl Room  
Mantel Bracket

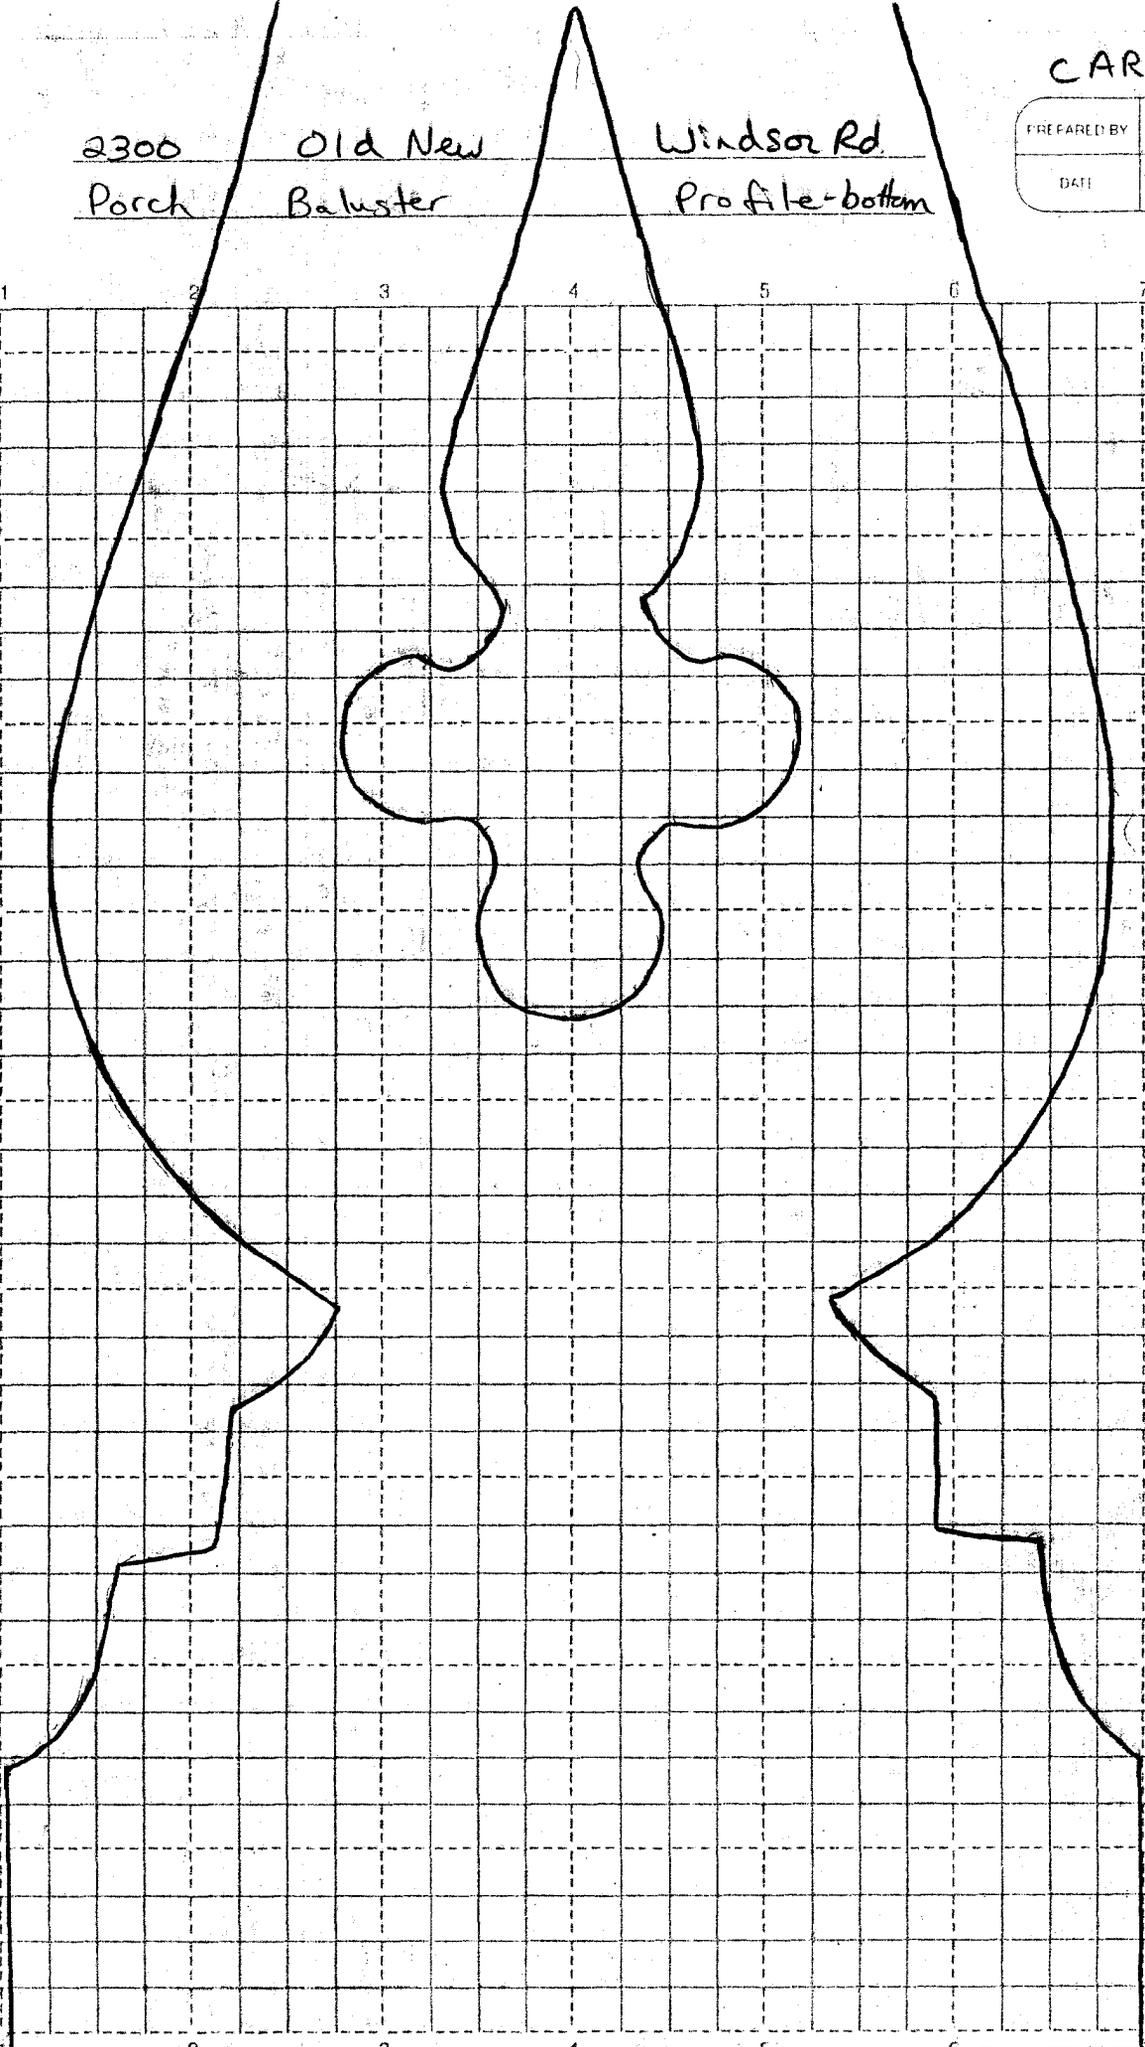
DATE  
5/5

bay. The north bay has a three-light sash with a wood sill and a beaded interior-edge frame. There is a one-story, three-bay porch set on three brick walls that run east to west. The porch has four square columns set on plinths, with a quirked ogee at the top of each column. The railing is jigsawn, having two-dimensional cushion balusters with pendant drops between them. The porch has a half-hip roof with standing seam metal. The soffit of the porch has three panels with bolection mouldings. The first story has a center entrance with one light over two lying panels. There are dentils under the light and an ogee cornice above it. There is also a one-light transom. On either side are two 2/2 sash in beaded interior edge frames with blinds. The bottom half of the blinds are adjustable. The second story has five identical 2/2 sash. The central wall dormer is gabled and has an oculus with a square center light. The house has a wood boxed cornice with returns.

2300  
Porch

Old New  
Baluster

Windsor Rd.  
Profile-bottom

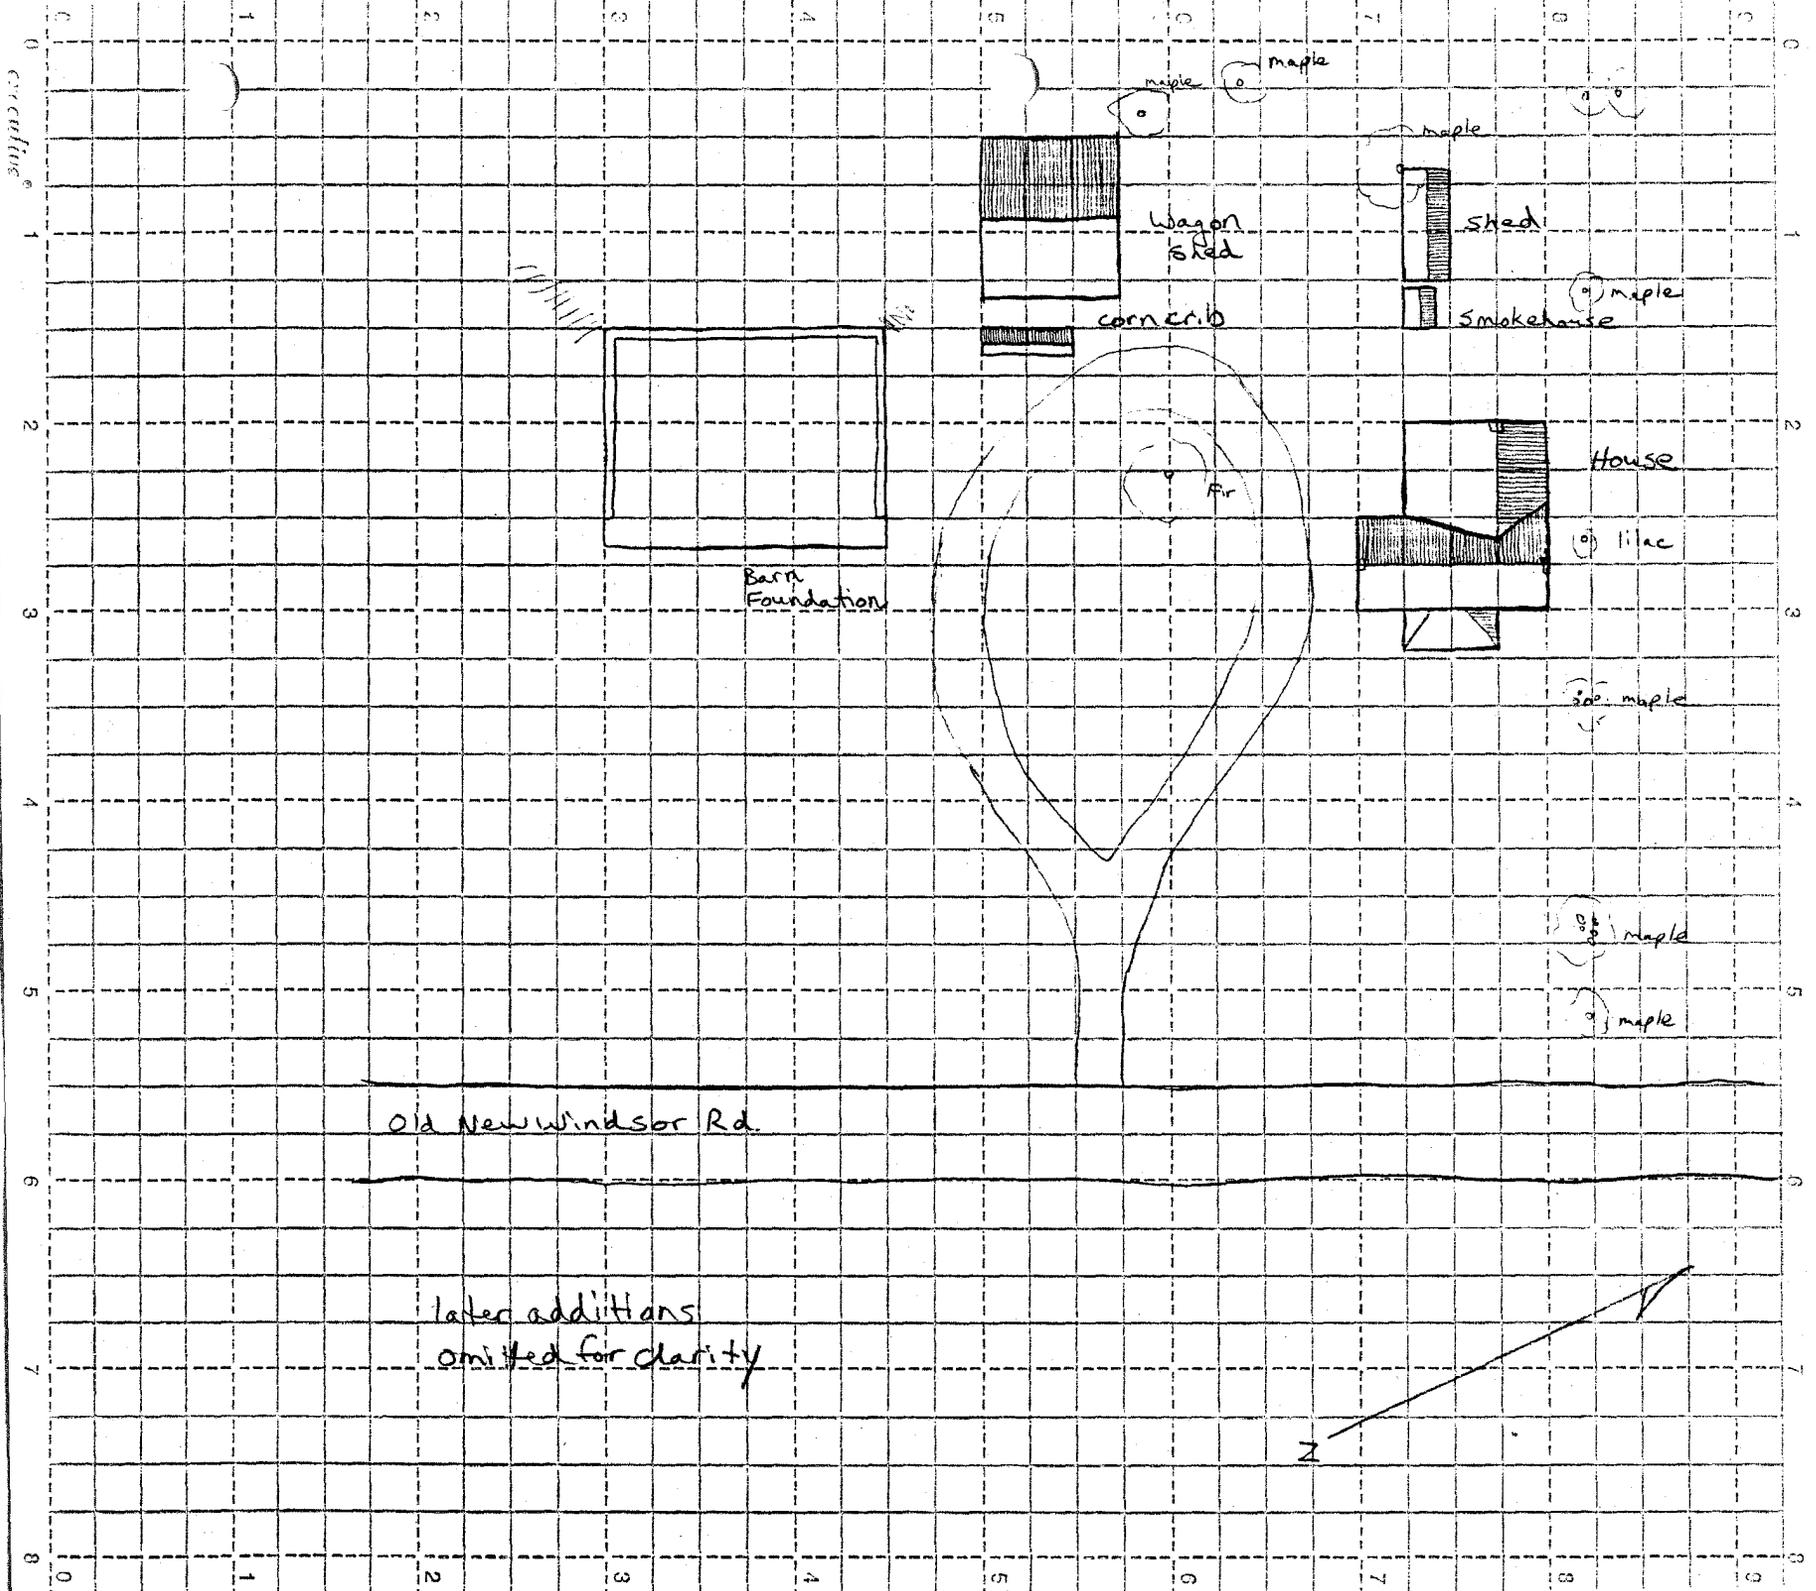
Site Plan

The George Washington Devilbiss Farm is located at 2300 Old New Windsor Road, on the west side of the road, approximately 2½ miles southwest of New Windsor in western Carroll County, Maryland. It is located a few hundred yards from the Frederick County border along Sam's Creek. The site slopes down gently to the east. The complex consists of a frame farmhouse, a smoke house, a wagon shed, a shed, a corn crib, and the foundation of a bank barn.

There is a smoke house about 20 feet west of the house. It has German siding with

About two feet west of the smoke house is a shed with a rubble stone foundation and vertical-board siding. The gable roof has corrugated metal and an east-west ridge. There is a beaded-edge-and-center vertical-board door on the south elevation, to the west, and a nine-light sash to the east. The interior of the shed is not accessible. There is an addition on the west elevation that has beaded-edge-and-center vertical-board siding and a door of matching material on the south elevation. This addition was originally used as a chicken house. The west and north elevations of this addition have German siding. The north roof has standing seam metal. There are no openings on the north side of the shed or the addition. There was formerly a privy on the west side of the addition, but it was recently demolished.

About 80 feet southwest of the house is a wagon shed that has vertical-board siding and a gable roof with inverted-V-seam metal and a north-south ridge. The north elevation has center double wagon doors on strap hinges with a pair of doors on strap hinges to each side. These doors are original, with hewn corner posts. The entire structure is built of hewn posts and sills with circular-sawn braces and circular-sawn horizontal members of smaller dimension. The center section of the wagon shed has rafters that are approximately 2 x 4 and are mitered at the ridge. They were charred when the bank barn burned. The frame has mortised-and-tenoned-and-pegged joints. There was originally a crib on both the east and west sides of the wagon shed. The shed has a rubble stone foundation. The south elevation was identical to the north but most of the doors are now missing. Only the west pair of doors survives.

The corn crib is about 10 feet east of the wagon shed. It has vertical slats on the east and west and a vertical-board door on strap hinges on the south elevation. The gable roof has a north-south ridge. This is a long, narrow, free-standing building. The north elevation has vertical-board siding. The corn crib has a mill-sawn, mortised and tenoned and pegged frame. The rafters are of sawn scantling and are mitered at the ridge.

About 30 feet south of the corn crib is a barn foundation of rubble stone with a cistern on the north side that originally collected water from the roof through gutters. The barn had a silo on the west with a chute that connected it. The barn was banked on the west. There is no surviving fore-bay wall for the lower story. The south elevation had two windows, although the north elevation was altered for a dairy operation.

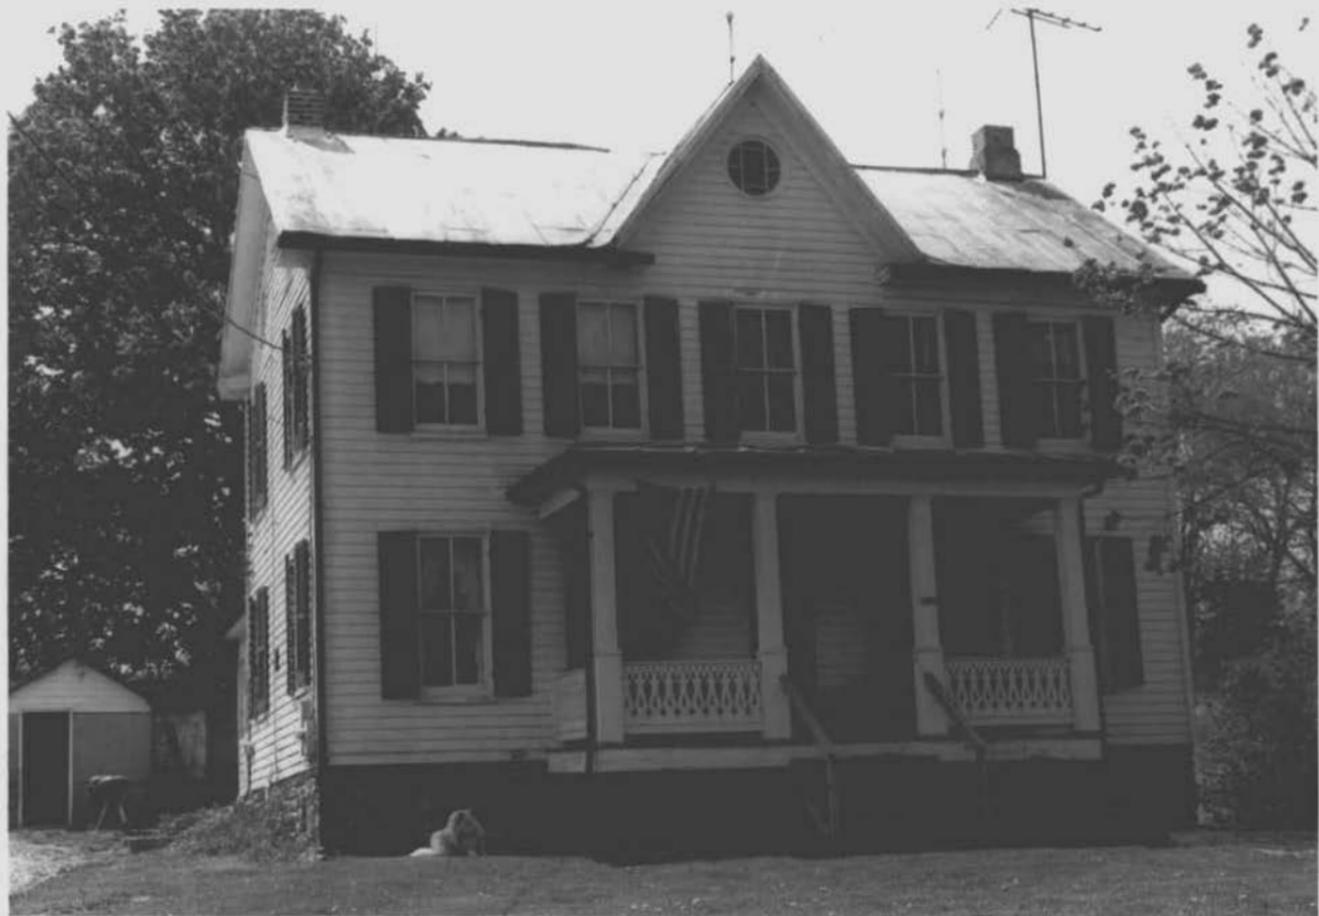
1/4

The house is a 2½-story, five bay by two bay central gable "I" house with a rubble stone foundation of Sam's Creek metabasalt. The house has German siding with corner boards and a gabled roof with a north-south ridge and standing seam metal. There is an interior brick chimney centered on each gable end. The house faces east toward Old New Windsor Road. The foundation of the east elevation has a boarded-up opening in the south

house - east elevation

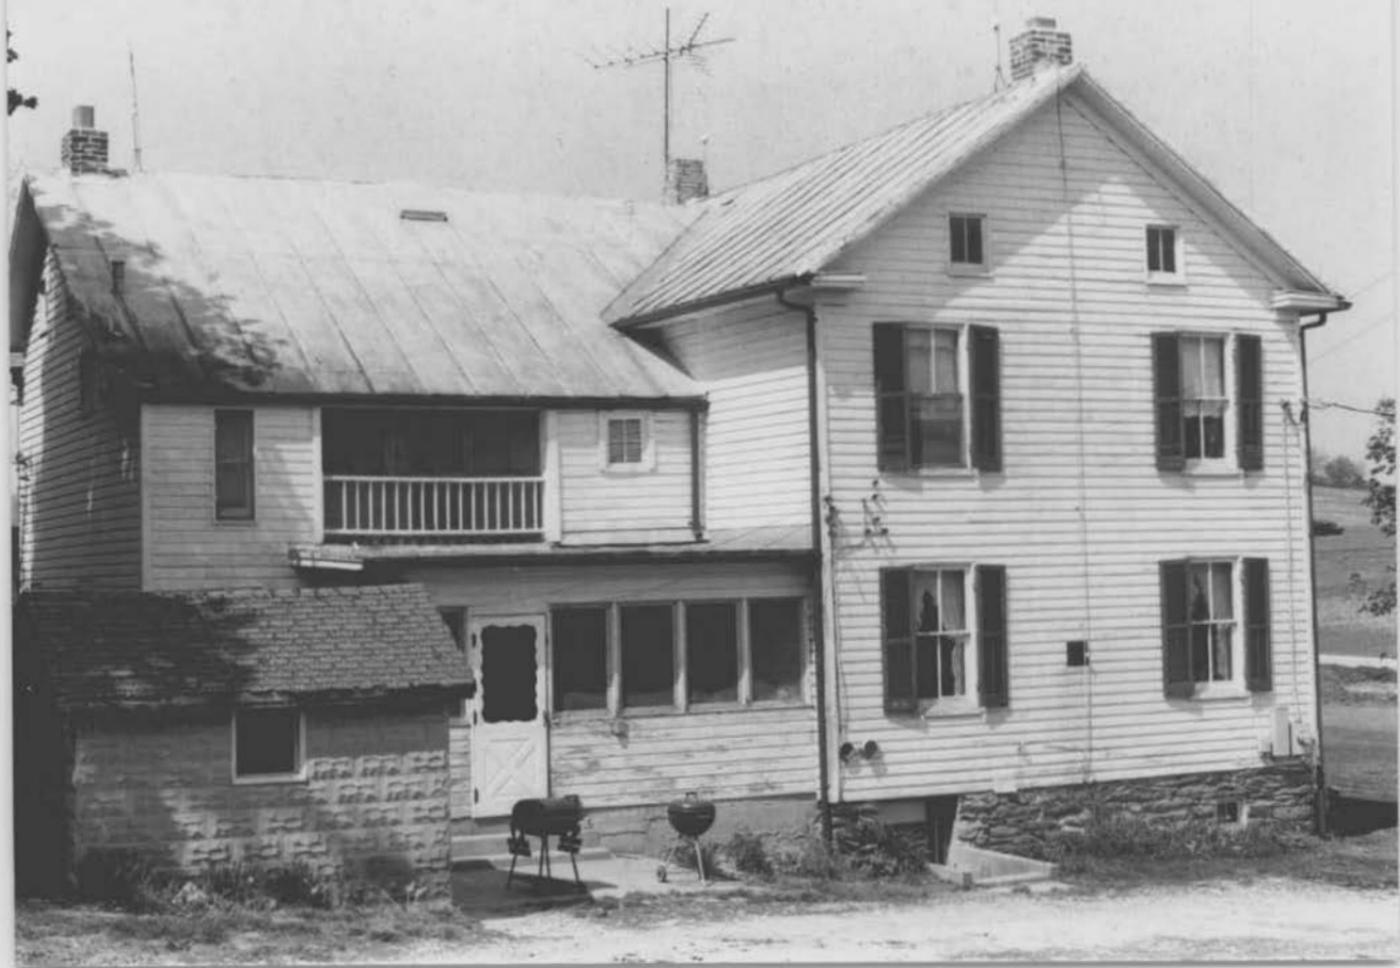
2/4

The west elevation of the ell on the first story originally had two windows. They have recently been infilled and there is a pair of one-light casement windows in the south bay. The second story has a 1/1 double hung sash in the south bay. The gable end has two two-light sash. The ell has an identical cornice with returns matching that on the main block. The ell roof has a salt-box profile which slopes lower to the south. The south elevation of the ell has a projecting bay to the west. The first story of this bay had a window that has now been infilled with a one-light casement. The second story has a tall two-light sash. There is a porch between the west bay and the main block of the house. It has now been infilled on the first story, but the original first story wall has a new door to the west and a 2/2 sash to the east. The second story has rectangular-in-plan vertical balusters and a 2/2 sash to the west, a door in the center, and later infill to the east with a four-light casement.

The west elevation of the main block, on the first story, has a four-panel door with semi-circular arched top panels and bolection mouldings. The south elevation of the house in the foundation has a door to the west with two lying lights above three lying panels. There is a two-light sash to the east. The first and second stories have two 2/2 sash and the gable

Neg. Loc.: Maryland Historical Trust  
house - west and south elevations

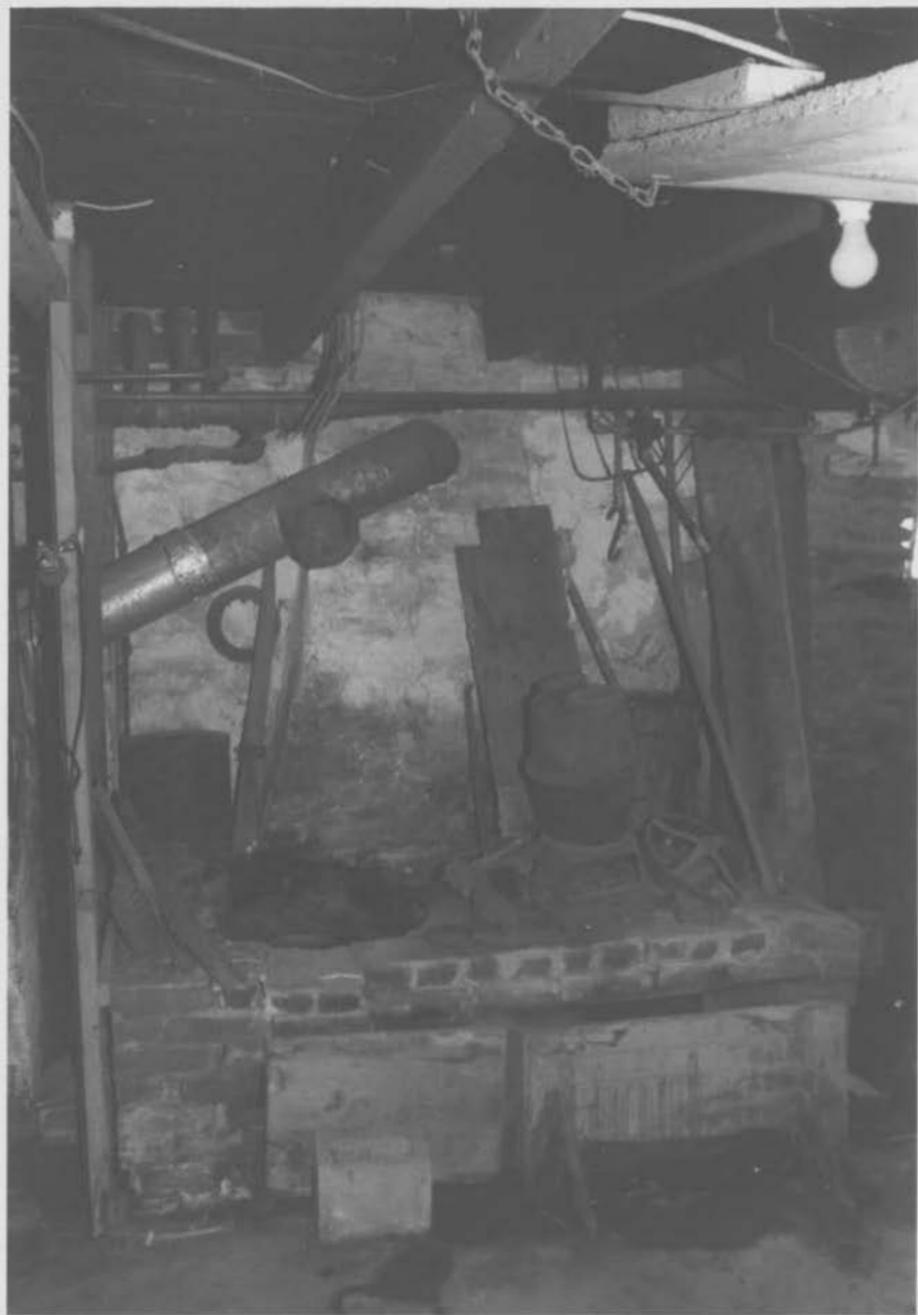
$\frac{3}{4}$

The cellar has two summer beams that run east-west. They are circular-sawn and are 8 inches wide by 10 inches deep. Each summer has one post underneath of it. The summers are set close together and support the studs for walls above. The joists are 2¾ by 7¾ inches and are spaced 21 to 26¼ inches on centers. They are circular-sawn and run north-south. They rest right on the wall and lap each other over top of the summer beams. There is a parged brick cistern in the southeast corner of the cellar that originally collected rain water and there is a cooler next to it. The foundation has plastered walls. There is a stone chimney buttress on the south wall. The flooring has a chimney header placed between two joists and the other joists are tenoned into this header. On the opposite, or chimney buttress, side of the header is a nailer that supports boards underneath the hearth. The north wall of the cellar has a brick hearth with two round holes, one of which still has an iron kettle set into it. There are two openings on the front of this brick hearth in which to build a fire underneath of the kettles. Off the back of the hearth is a brick chimney. This structure is 5 feet 10½ inches long by 3 feet, 6½ inches deep, and 1 foot 9½ inches high. The openings are 2 feet in diameter. This was apparently used for laundering and for butchering. The ell also has a cellar underneath of it. The joists run north-south and are identical to those in the main block. They have cross bracing. There was originally a partition between the main block and the ell. The north summer beam ends at the beginning of the ell and used to have a post underneath of it to support the north end of the summer. There is brick nogging in the walls that is laid in mortar. According to the owner, it is only placed in the first story of the house.

house - cellar hearth

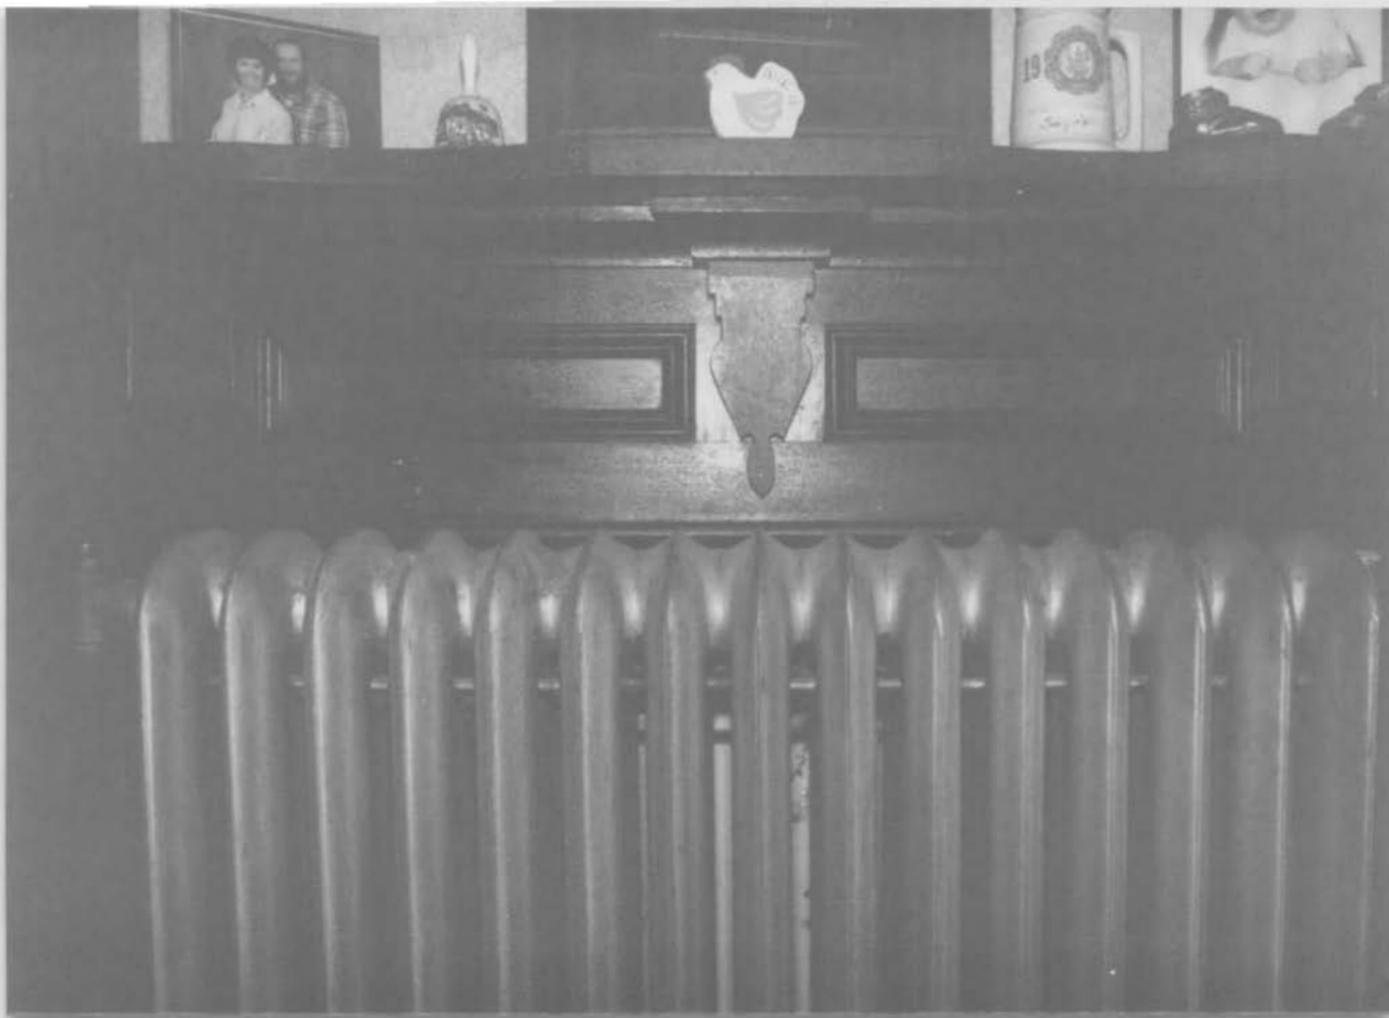
7/4

The north room has a mantle piece centered on the north wall, with a radiator placed in front of it. There was never a fireplace here. The mantel is wood with plain pilasters that are grained to imitate oak. There are two panels in the frieze that have sunk, flat fields with ogee panel moulds. The fields are grained like birds-eye maple. The mantle has a cavetto bed mould with a drop pendant in the center that has birds-eye maple graining. There is a block on each end that also has birds-eye maple graining. The rest of the mantle is grained to imitate walnut.

Neg. loc.: Maryland Historical Trust  
north room mantle
