CARR-1400

3280 Sam's Creek Road
New Windsor (vicinity)

Maryland Historical Trust State Historic Sites Inventory Form

historic Stem-Nusbaum House

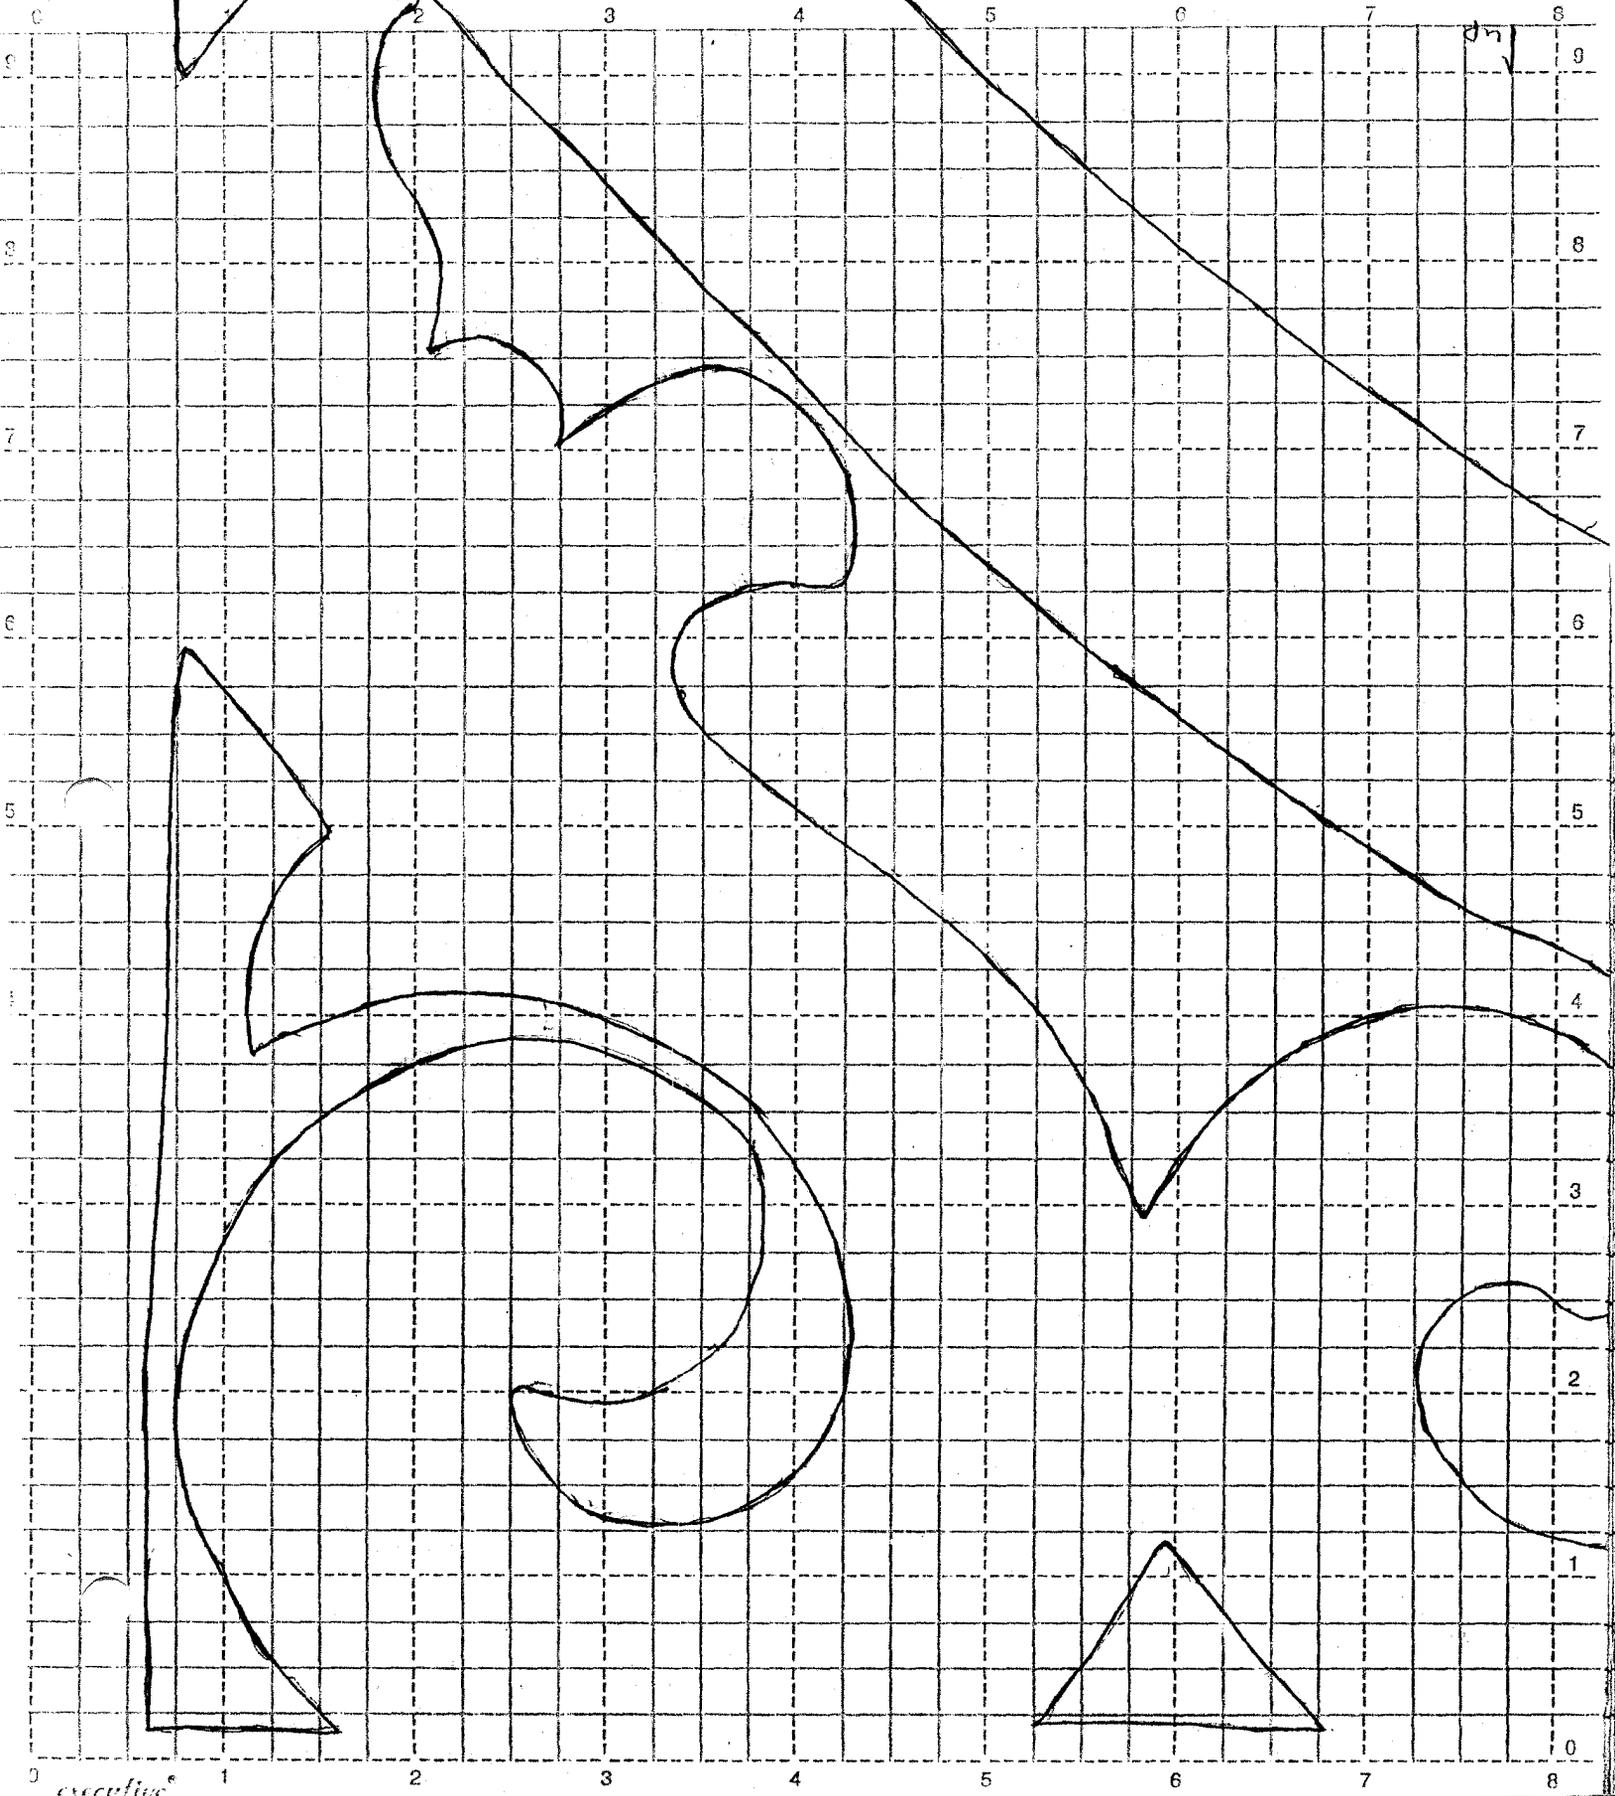
Porch Bracket

one-story, three-bay shed roof porch with a corrugated metal roof on the first story. It is set on brick piers that are painted red and striped. Much of this finish survives. There are brick end walls on either end of the porch. The porch has four square posts set on piers. The posts are chamfered, with an applied ogee moulding near the top, and have jigsawn brackets set above this ogee. In the middle of each pair of posts is a pendant drop. There are no railings, nor any evidence that there ever were railings on the porch. The second story has three 1/1 sash identical to the first story. There is a dentil cornice. The dentils are unusually long. There is a central gabled wall dormer with an oculus and a dentil raking cornice. On each gable end, centered on the ridge, is an interior brick chimney, and there are lightning rods along the ridge.

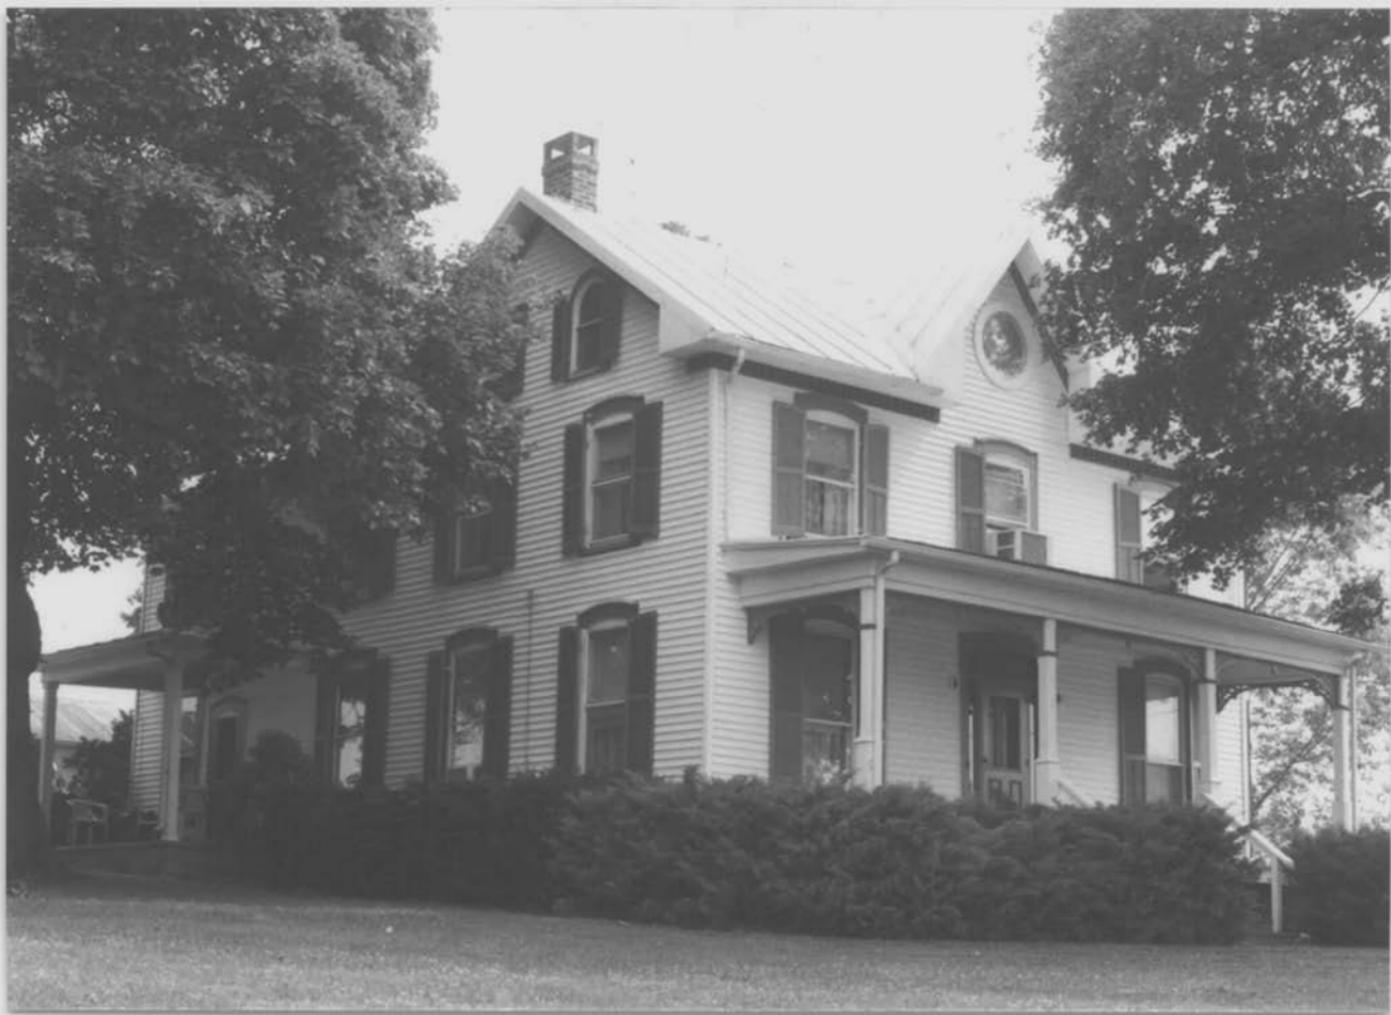
Stem Nusbawm House
3280 Sam's Creek Rd.
Carroll County, Maryland

On the south elevation the first story has a center entrance. The door has two lights over two panels with bolection mouldings. There are sidelights with one light over one panel. The sidelights have frosted glass in an intricate floral pattern. Each panel has the same bolection mouldings as the door. The segmentally-arched transom has one light. The architraves on the sides have a beaded interior edge while the top architrave has a piece of cornice trim that is an ogee with a kick. This entrance is flanked by an original or early 1/1 sash on each side. They have the same segmentally-arched architrave as the doorway and also have a wood sill and exterior blinds, the bottom half of which are adjustable. There is a

The west elevation of the main block has two two-light sash with beaded interior edge frames and brick jack arches in the foundation. The first story has two typical 1/1 sash as does the second story. The gable end matches that on the east.

Neg. Loc.: Maryland Historical Trust
west & south elevations

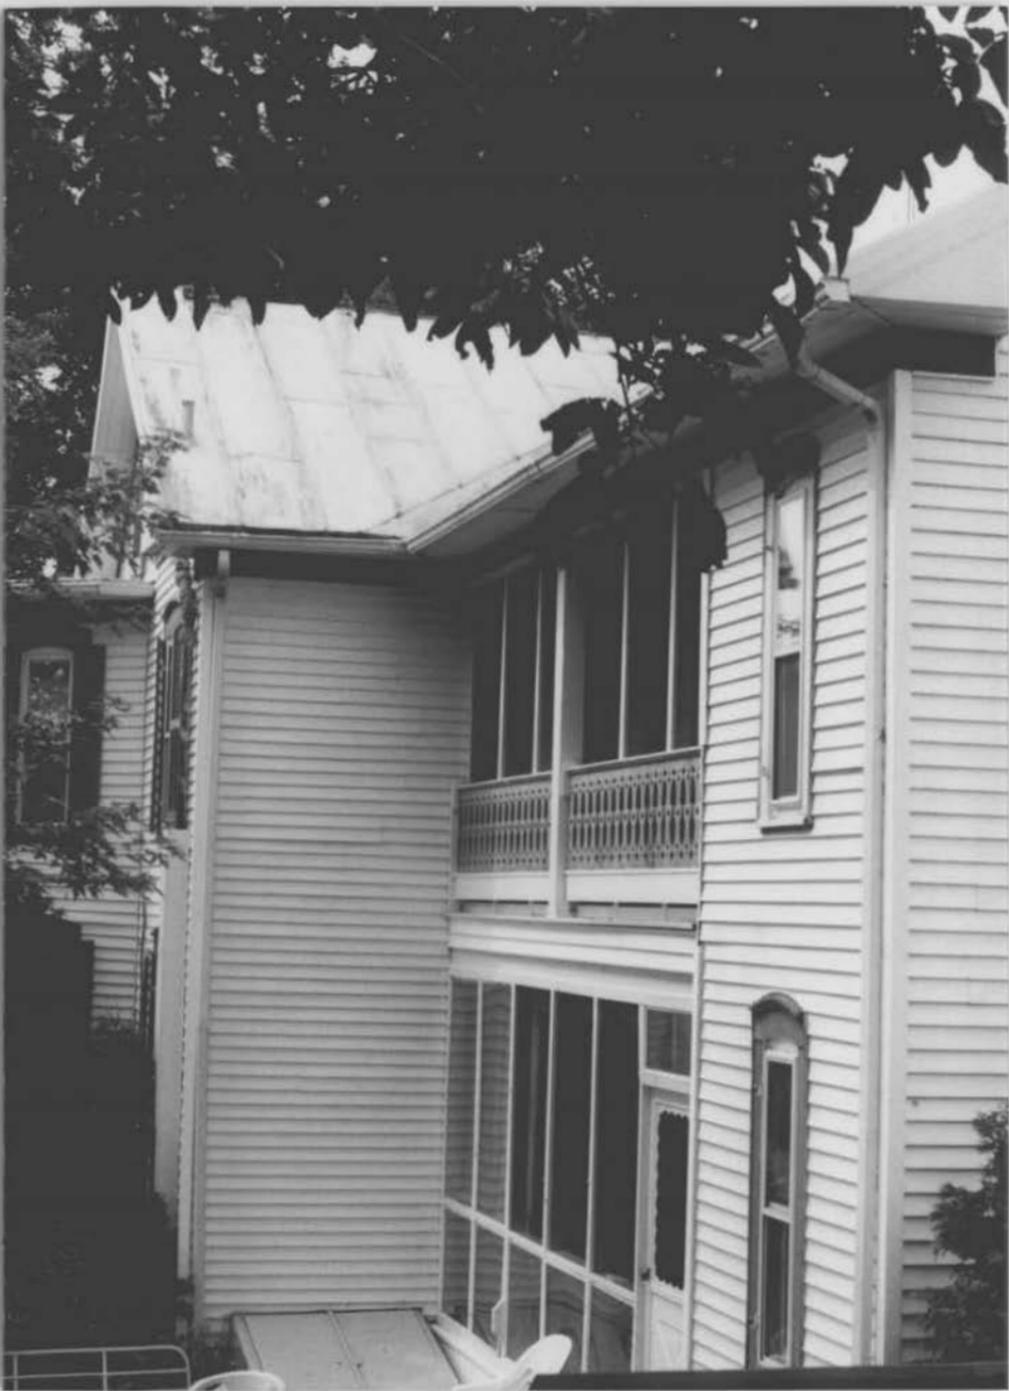
Stem-Nusbaum House
3280 Sam's Creek Road
Carroll County, Maryland

The east elevation has a projecting three-sided bay in the south bay. This has a brick foundation that is painted and striped. Each of the three sides of the bay has a typical 1/1 sash with blinds on both the first and second stories. The bay has a dentil cornice. The roof is not visible. The north bay on both the first and second stories has one typical 1/1 sash. The gable end on the east elevation has two semi-circular 1/1 sash with blinds, the bottom half of which are adjustable. They also have a wood sill and a plain architrave. There is a dentil cornice in the raking eave. The north elevation of the main block has no openings. It, too, has a dentil cornice.

The east elevation of the ell is recessed from the plane of the east elevation of the main block. The southern three bays of the ell are recessed even further to create a two-story porch set under the gable roof of the ell. On the first story, from south to north, is a boarded-up door in a flat opening with a cornice that has an ogee and kick. Then is a 2/2 sash with the same details found on the south elevation windows, and a four-light over two-panel door in a flat opening with a typical ogee cornice. The north bay has a typical but narrow 1/1 sash that originally had one blind. The second story has no opening in the south bay. The south-center bay has a 2/2 sash like that found on the first story. Just south of the north-center bay is a flat-arched door with typical ogee trim. The north bay has a 1/1 sash like that found on the first story in this bay. There are no original details surviving on the first story of the porch. The second story has one center post that is square, and has jigsawn balusters.

Neg. Loc.: Maryland Historical Trust
east elevation - fr. north

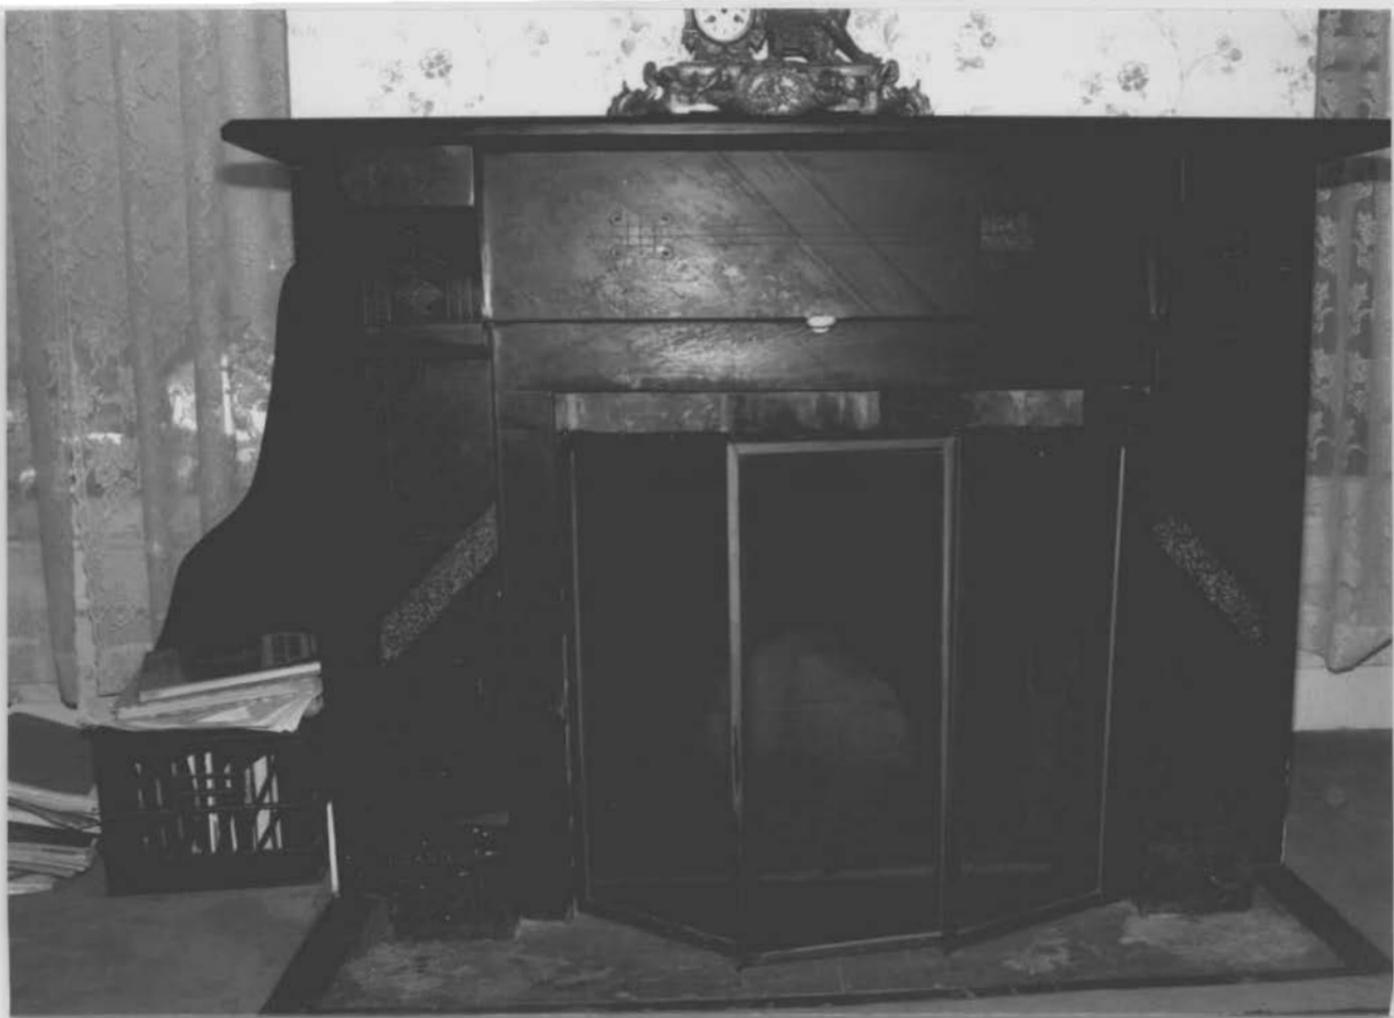
SW room mantle

The southwest room has, centered on the west wall, a fireplace with a rebuilt brick fire box. There is a marbled slate mantel that has pilaster strips with incised lines for decoration. The strips are painted to imitate red marble with a diagonal stripe across the center that has black bands on each outer edge and a speckled black and white center band. The brackets above the pilasters are also red, with incised diamonds that are speckled black and white and are flanked by black triangles. The frieze is also red and has a center stripe

like the pilasters. To each side of this stripe are incised squares with the speckled pattern within them. The hearth is also slate. The baseboards are plain and the door and window architraves match the passage and not the wide opening to the center room. The latter must, therefore, be a later alteration.
