CARR-1406

753 Old New Windsor Pike
Westminster (vicinity)

Maryland Historical Trust State Historic Sites Inventory Form

historic Carroll Nursery

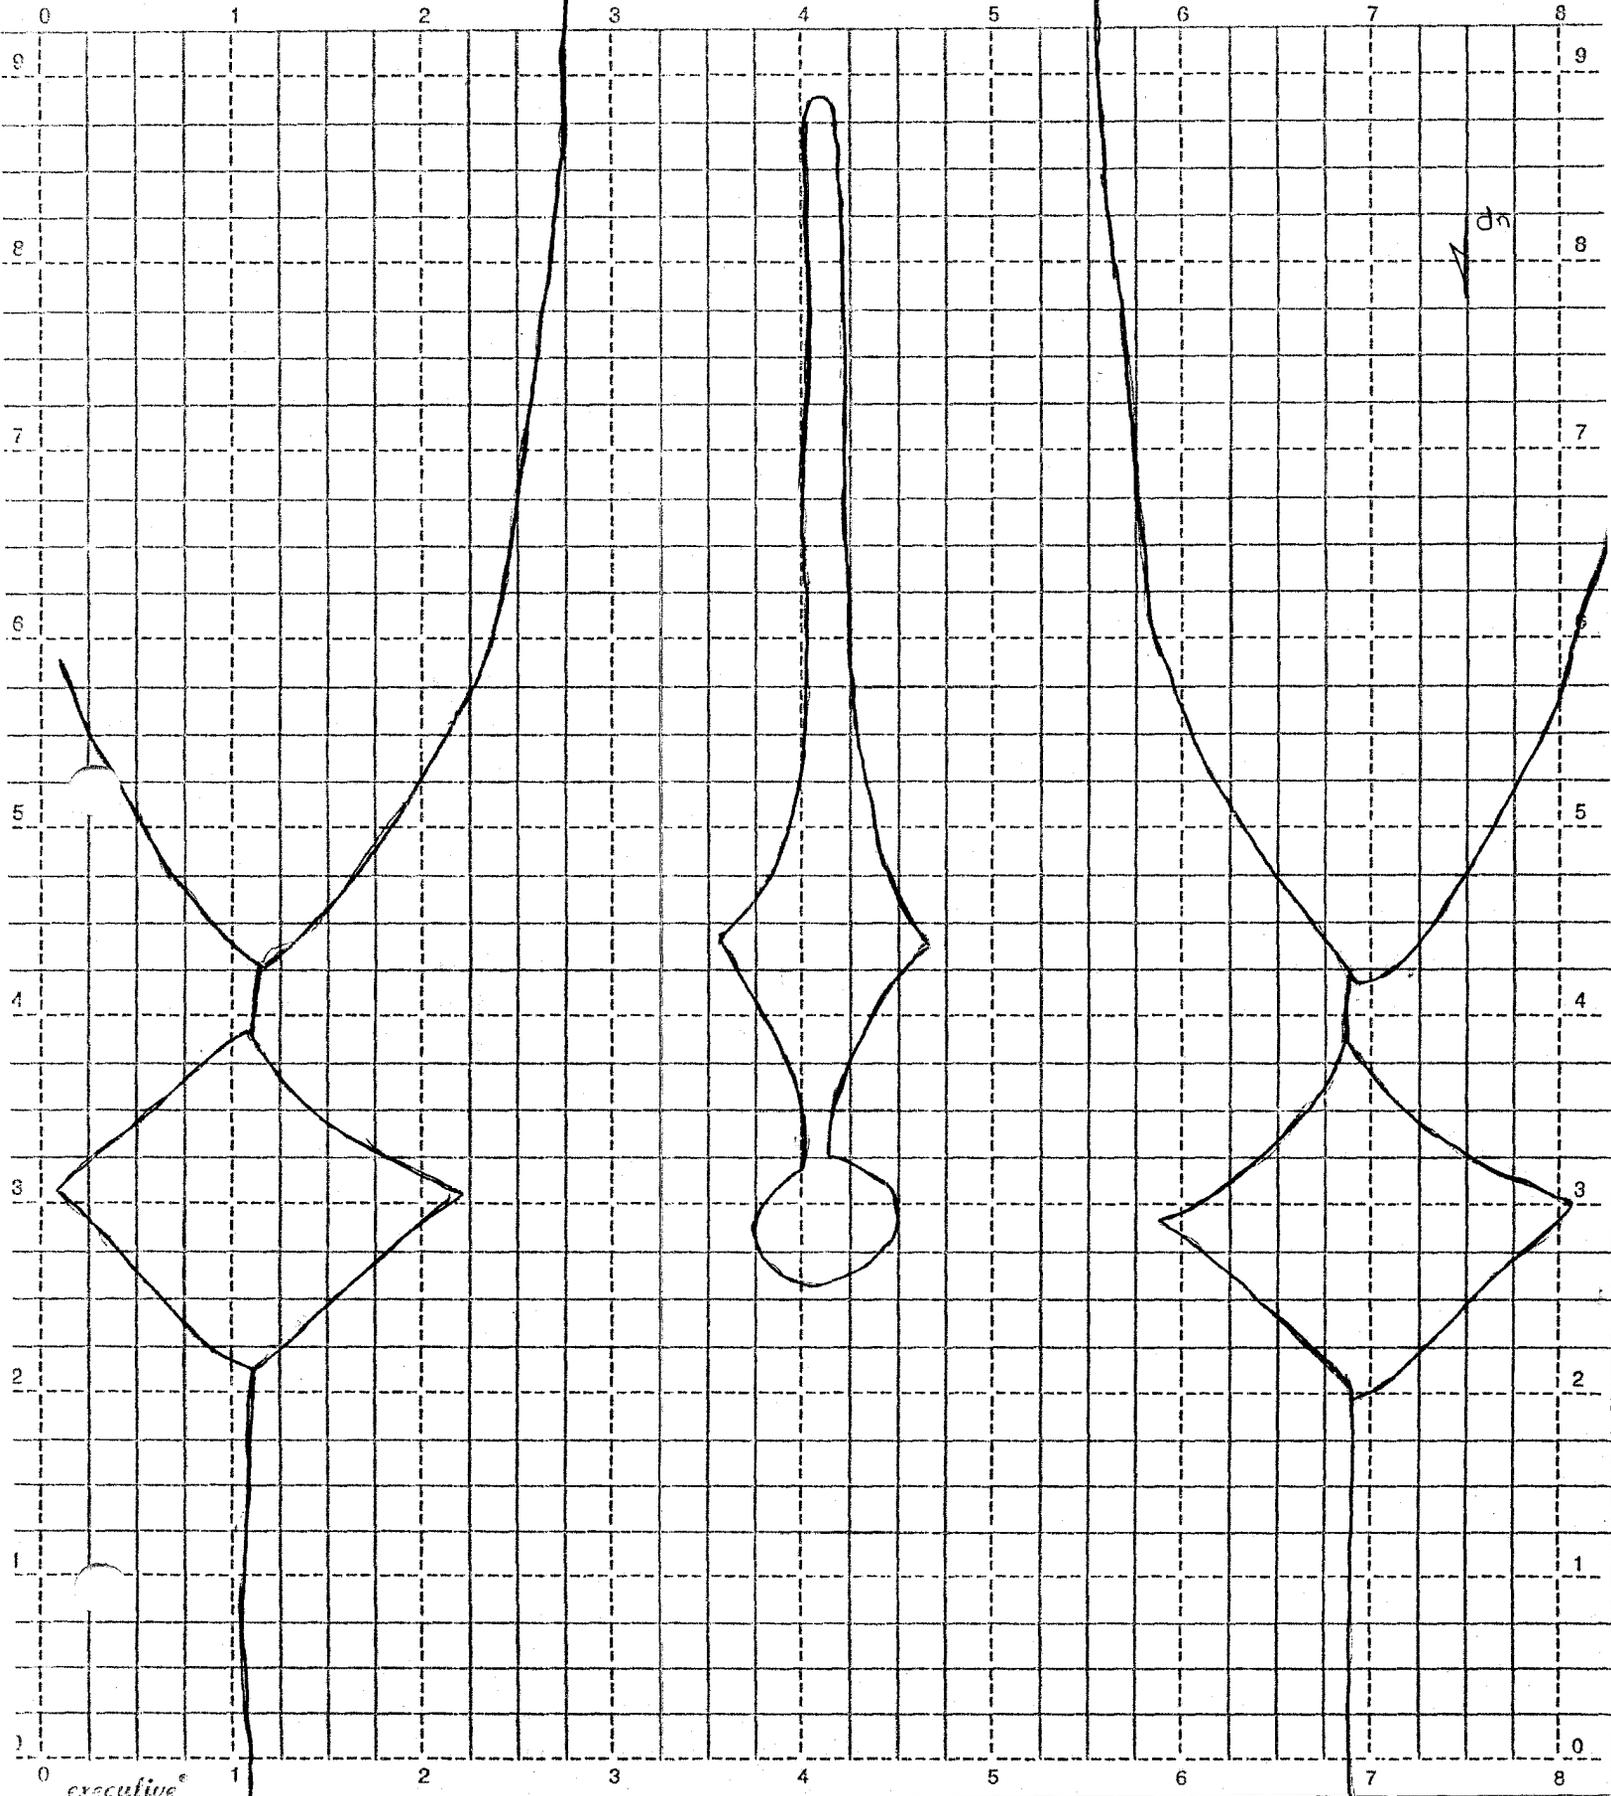
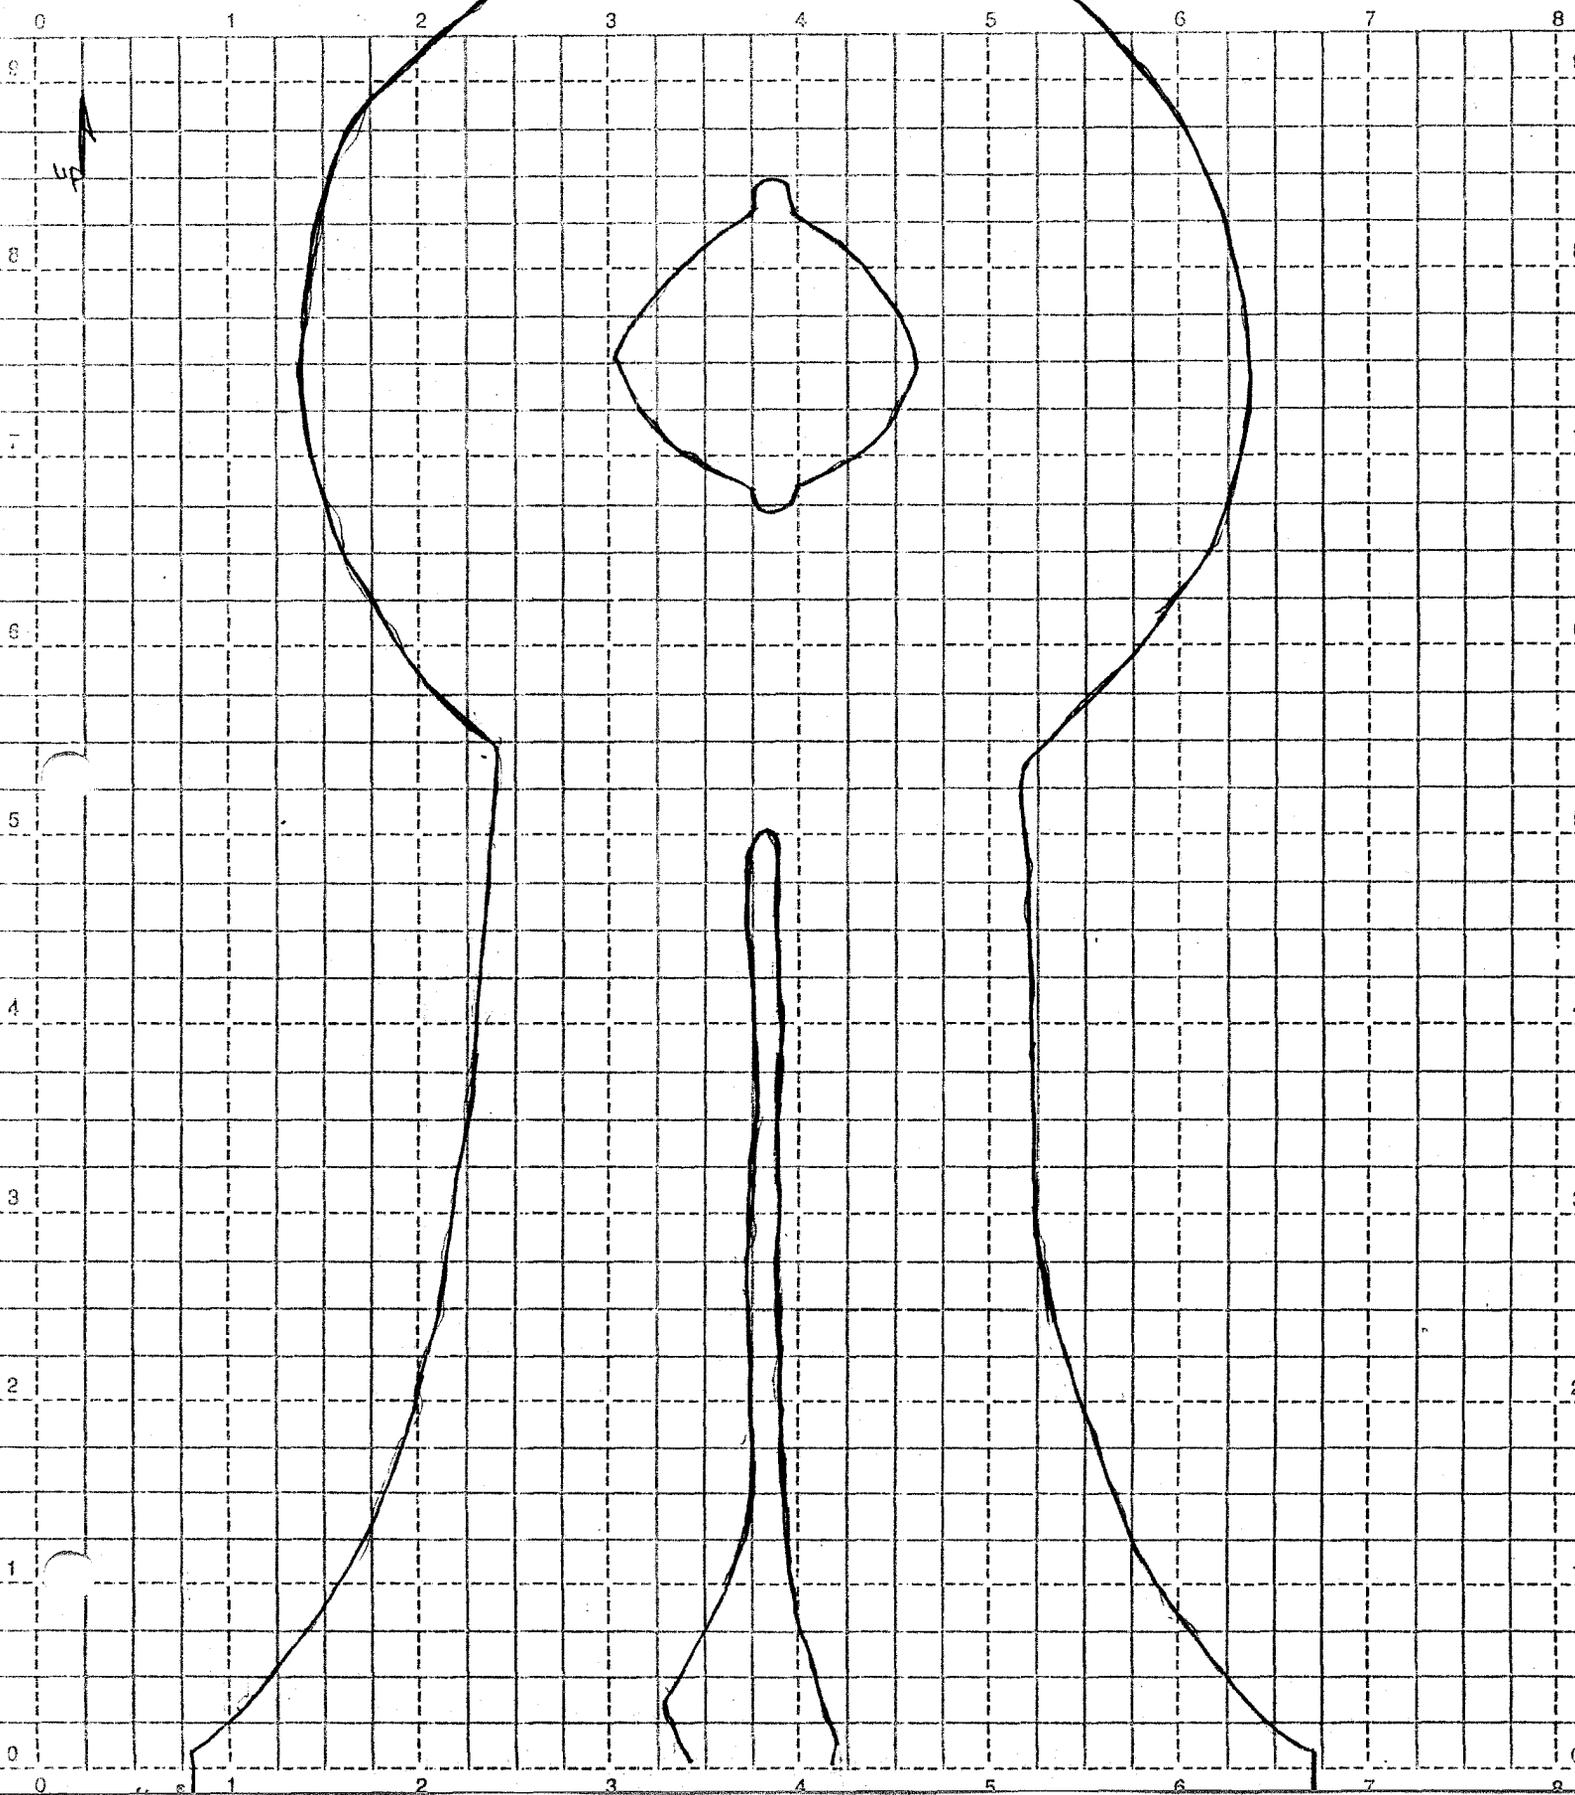
753 Old New Windsor Pike
Porch Baluster

On the northwest elevation, the first story has a 2/2 sash in a beaded interior-edge frame in the north bay. The north-center bay has an identical 2/2 sash. The west-center bay has a door with one light over two lying panels over two panels in a beaded-interior-edge frame. The panels have sunk fields and quirked ogee panel moulds. The west bay has an identical 2/2 sash. The second story has three 2/2 sash that are shorter than those on the first story. There is a wood box cornice with returns and a central gable wall dormer with a 1/1 sash that has a plain surround. There are wood shingles next to the sash that have clipped corners. Above the window are diamond-pattern wood shingles. There is an interior brick chimney on each end of the house. The first story has a one-story, four-bay porch that extends on each end just beyond the outer edge of the end bay windows. The porch has brick piers on each end and one in the center. It also has four square wood posts with caps that have a Greek ovolo at the top and an ogee-and-kick below. There is a jig-sawn railing.

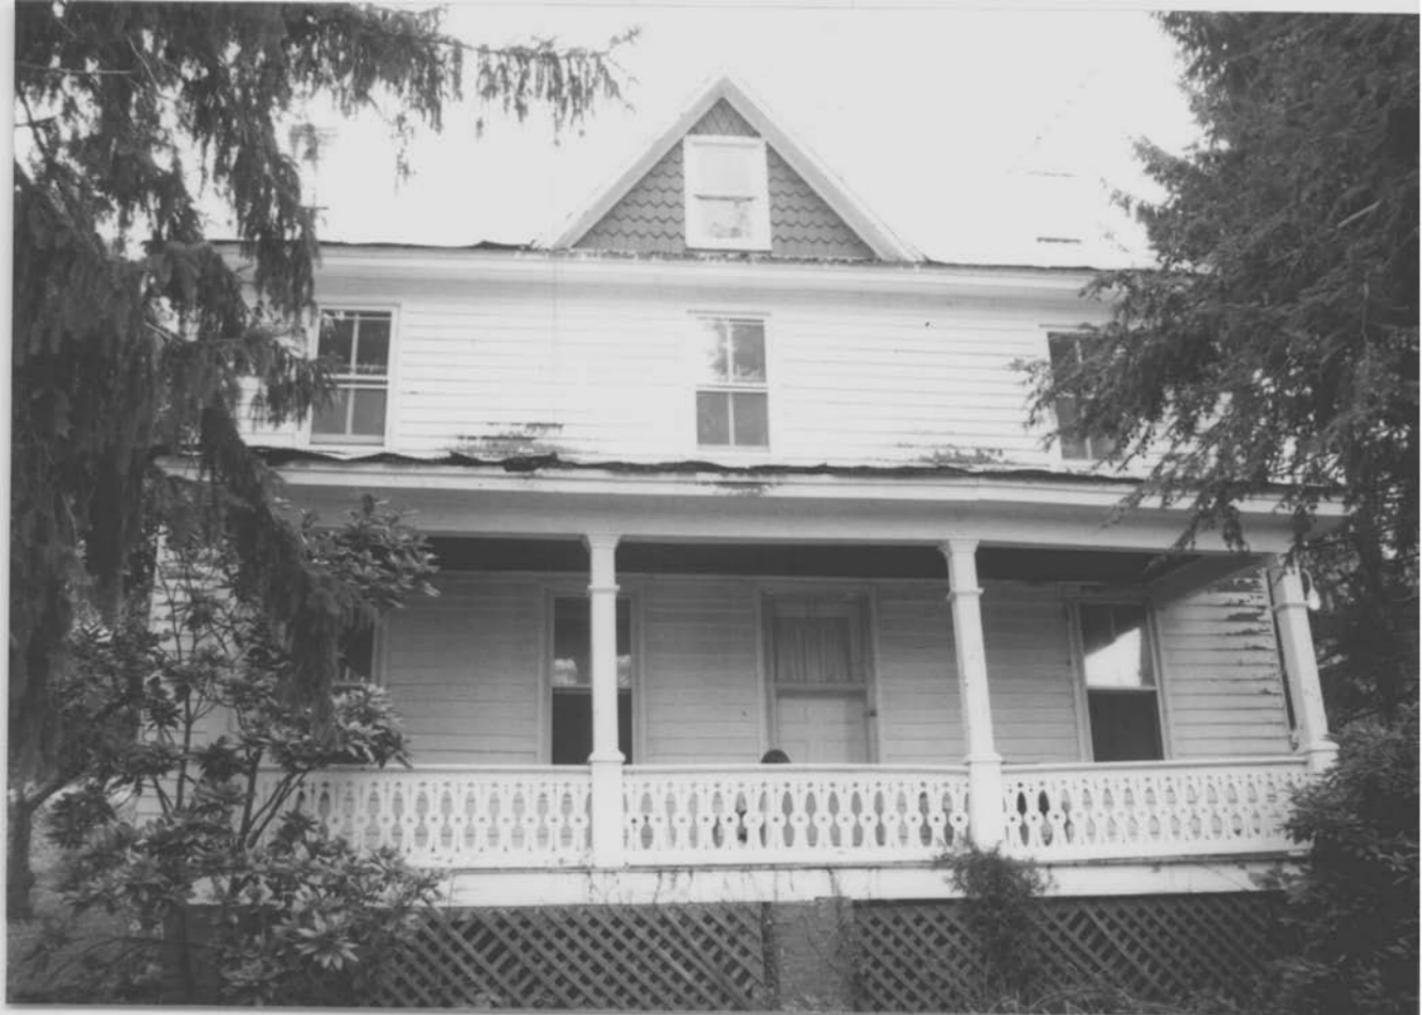
northwest elevation

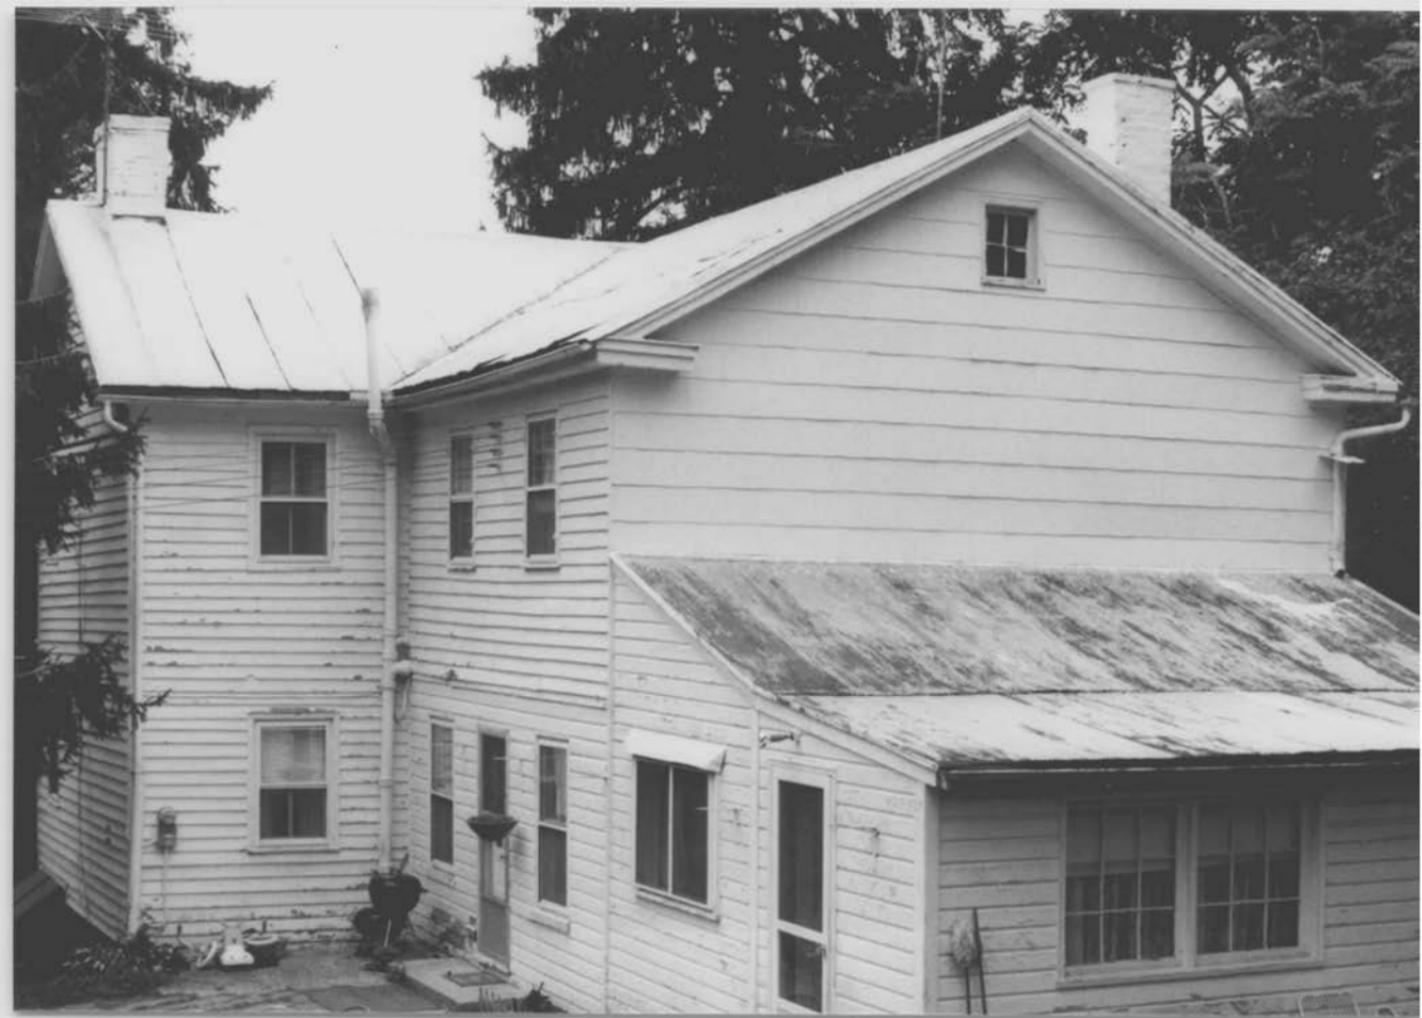
Neg. Loc.: Maryland Historical Trust
Southwest and Southeast elevations

The southwest elevation foundation has a hurricane door in the west bay and a boarded-up opening in the south bay. The first story has a 2/2 sash in the west bay. The second story is identical. The gable end has two four-light casement windows. The southeast elevation has a 2/2 sash in the south bay of the first and second stories. There is an ell attached to the east bay.

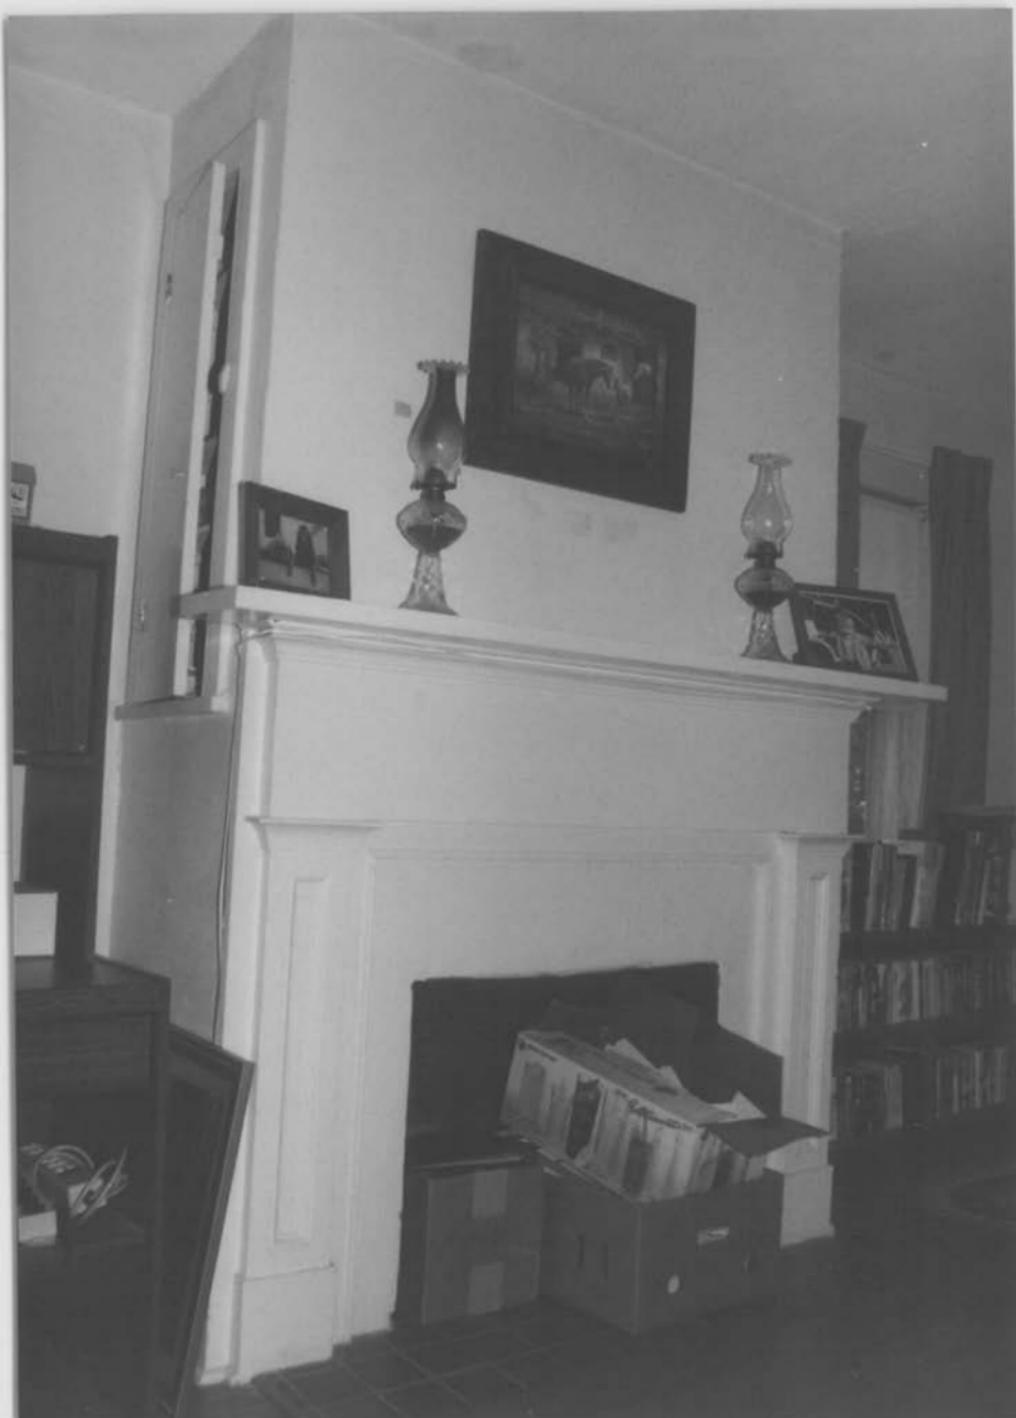
Southwest room mantle

The southwest room has 2¼-inch oak flooring that runs northwest to southeast. It has the same architraves as in the passage. The baseboard has a broken field with a bead on the top edge. There is a fireplace centered on the southwest wall. The wood mantel has a double bead on the interior and has pilasters with sunk, flat panels and quirked Greek ogee panel moulds. The pilaster capitals have a cavetto. The frieze is plain. The bed mould has a Greek ovolo just below the mantle shelf with a cavetto below it and a fillet at the bottom. The fireplace has splayed jambs that are plastered and has a plastered surround. The southeast side of the fireplace has a cupboard with a board door that has battens let into the boards on the reverse side. The door is hung on cast iron butt hinges marked "BALDWIN" and "PATENT". The cupboard has a beaded-interior-edge surround that is mitered at the corners.
