CARR-1456
Miller Family Farm
Millers (vicinity)

Maryland Historical Trust State Historic Sites Inventory Form

historic Miller Family Farm

street & number 4219 Millers Station Road _____ not for publication

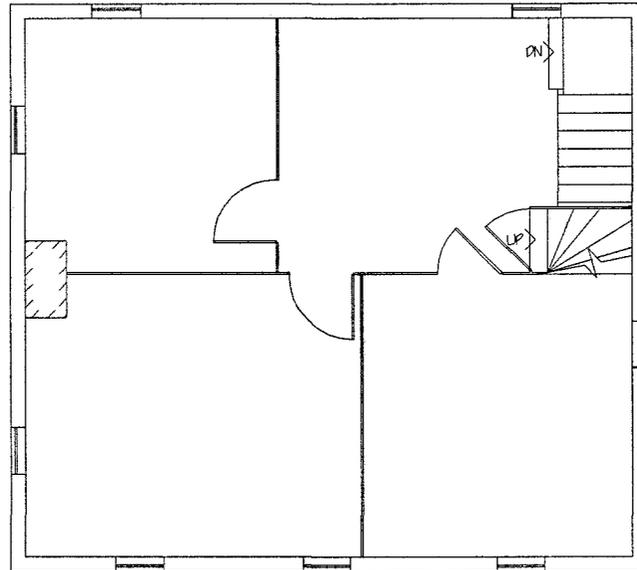
CARR- 1456	MILLER FAMILY FARM	MEASURED BY KEN SHORT AND MATT HANKINS	SECOND FLOOR PLAN

The second story of the original southwest section of the log house has a virtually pristine original configuration. The stairway has a landing on the northwest, then turns to the southwest with two steps up to a large room or stair hall. Off of this stair hall are three other rooms in the east, south, and west corners. This stair hall has a beaded-interior-edge architrave with a typical backband for this house. There is an enclosed winder stair in the east corner of the stair hall that leads to the attic. The winder stair starts in the middle of the building and turns to the southeast, which is an unusual placement. The door to the enclosed stair is on the southwest side of the enclosure. The interior walls of the chambers are tongue-and-grooved, beaded-edge vertical boards. There are six-panel doors, some with Norfolk latches. The door to the south chamber opens out, while the other two doors open in. Because of this, the doors that open in have the typical architrave for the second story, while the door that opens out does not. That architrave can be found on the room-side of the doorway. All three of the chambers have typical second-story architrave around the windows. The wall between the south and east chambers is also of beaded-edge vertical boards.

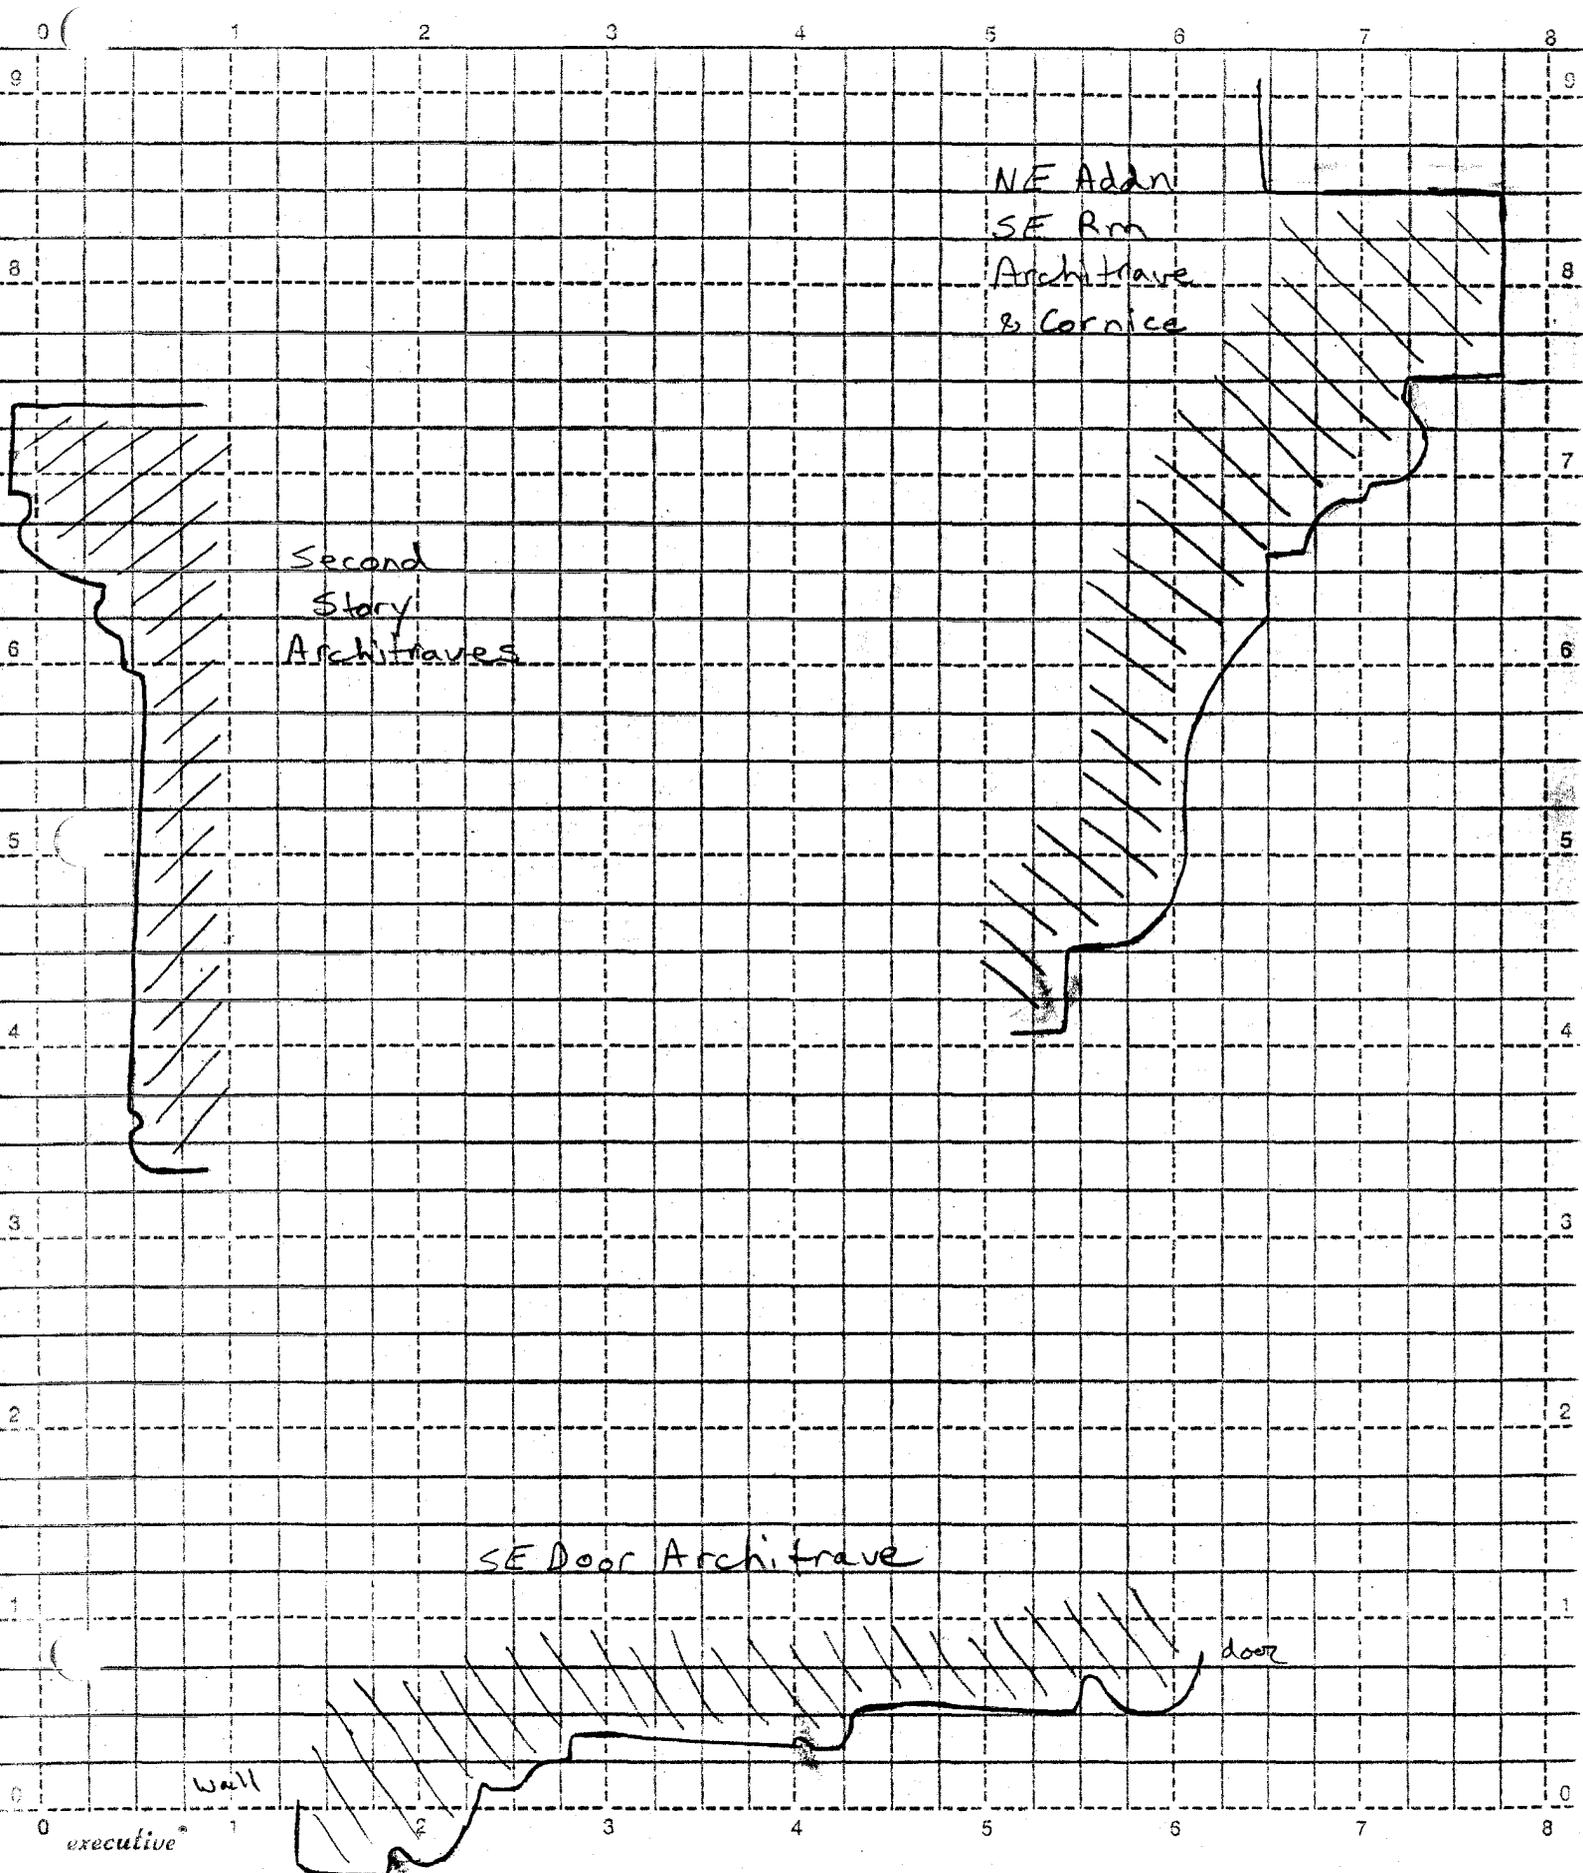
4219 Millers Station Rd
Moulding Profiles

The first story now has a center-passage, double-pile plan. The front door in the passage is hung on three large cast iron butt hinges marked "WARRANTED" and fastened with blunt tip screws. The architrave here has a broken field with a bead at the break, a bead at the inner edge, and a quirked steep ogee-and-bead backband. There is a straight run of stairs along the northeast wall. The balusters are gone, but the stair has a turned newel and a ¾-round handrail. The stairs have been partially rebuilt and are wire nailed. There is a vertical-board wall under the stairs. The door to the cellar was originally on the southwest wall of the stairs, but this area has been infilled and the door moved to the northwest side of the stairs. Most of the passage has recent infill. There is a wide opening on the southwest wall to the south room.

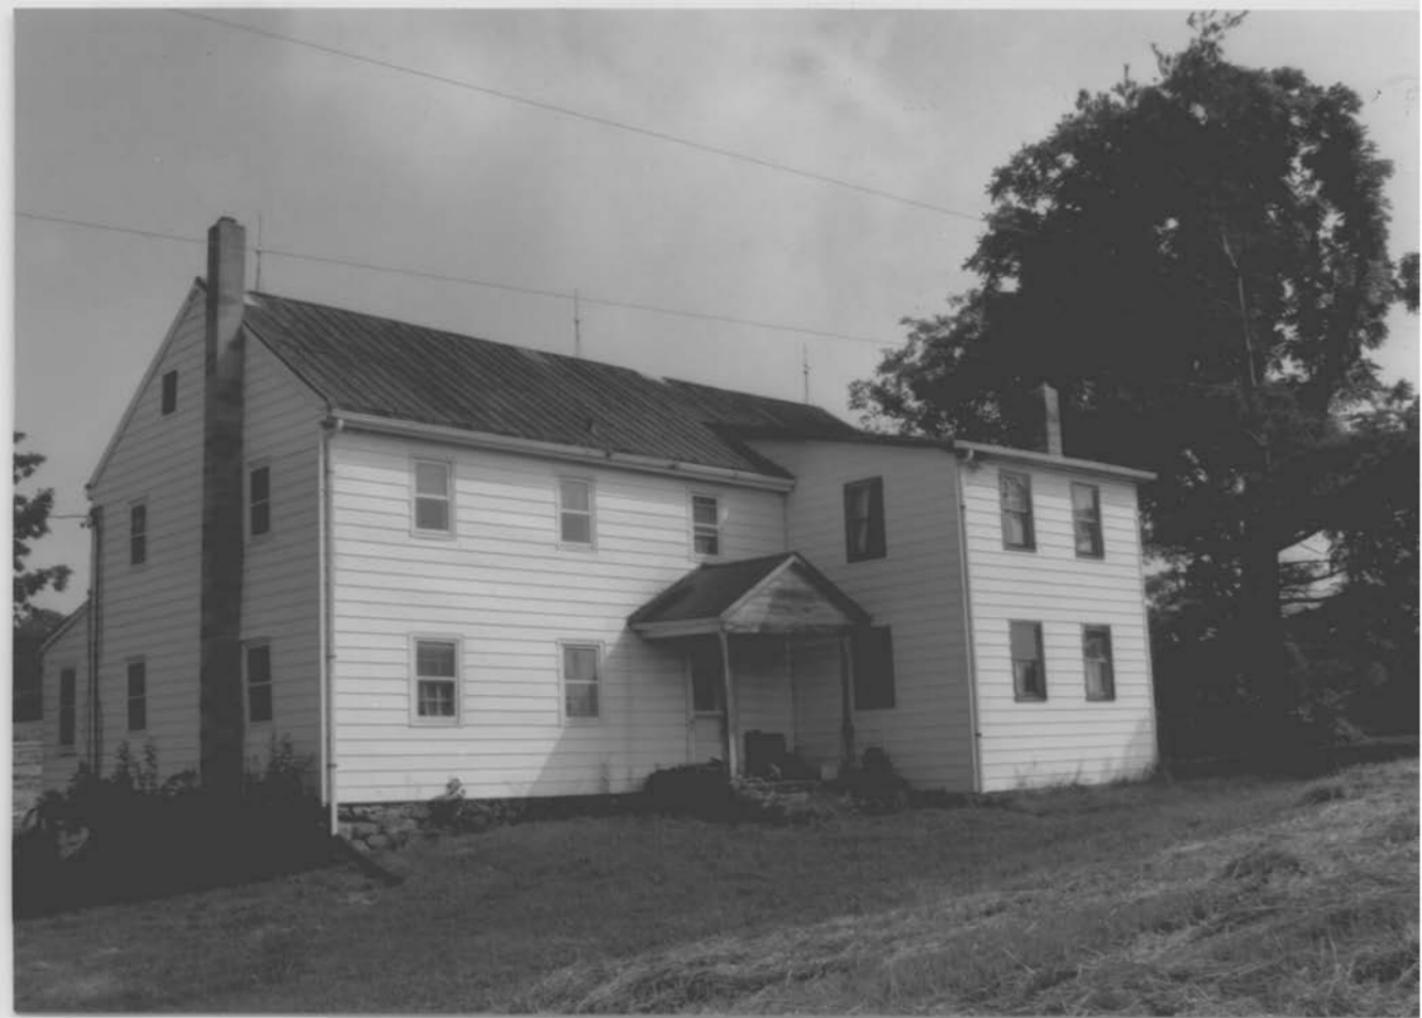
$\frac{1}{5}$

On the southeast elevation, the first story has two 6/6 sash to the south and an altered

door in the center bay. This was originally a six-panel door, but now has a nine-light sash above two panels. There is a three-light transom. The doorway has a one-story, one-bay porch with a gable roof of asphalt shingles and a northwest-to-southeast ridge. It has chamfered posts, and most of the trim is wire nailed. The second story of this section has three 6/6 sash. There is a box cornice and a standing-seam metal roof on this side. The southeast addition has two 1/1 sash on the southeast elevation. It has a shed roof that slopes to the southeast. The southeast addition was added about 1970. The house is banked on the northeast, with the foundation partially exposed on the southwest. On the southwest elevation the first and second stories have two 6/6 sash. On the northwest elevation, the first story has an enclosed porch. The stone in the foundation differs on the three west bays from that in the two north bays. At the north corner, there is German siding under the aluminum siding. The enclosed porch has an asphalt-shingle shed roof. The second story has, from north to west, no opening, a 6/6 sash, a break in the aluminum siding where the walls are offset several inches, a 6/6 sash, no opening, and a 6/6 sash. On the northeast elevation, the first addition has two 6/6 sash on the first and second stories.

SW $\frac{1}{4}$: SE elevs.

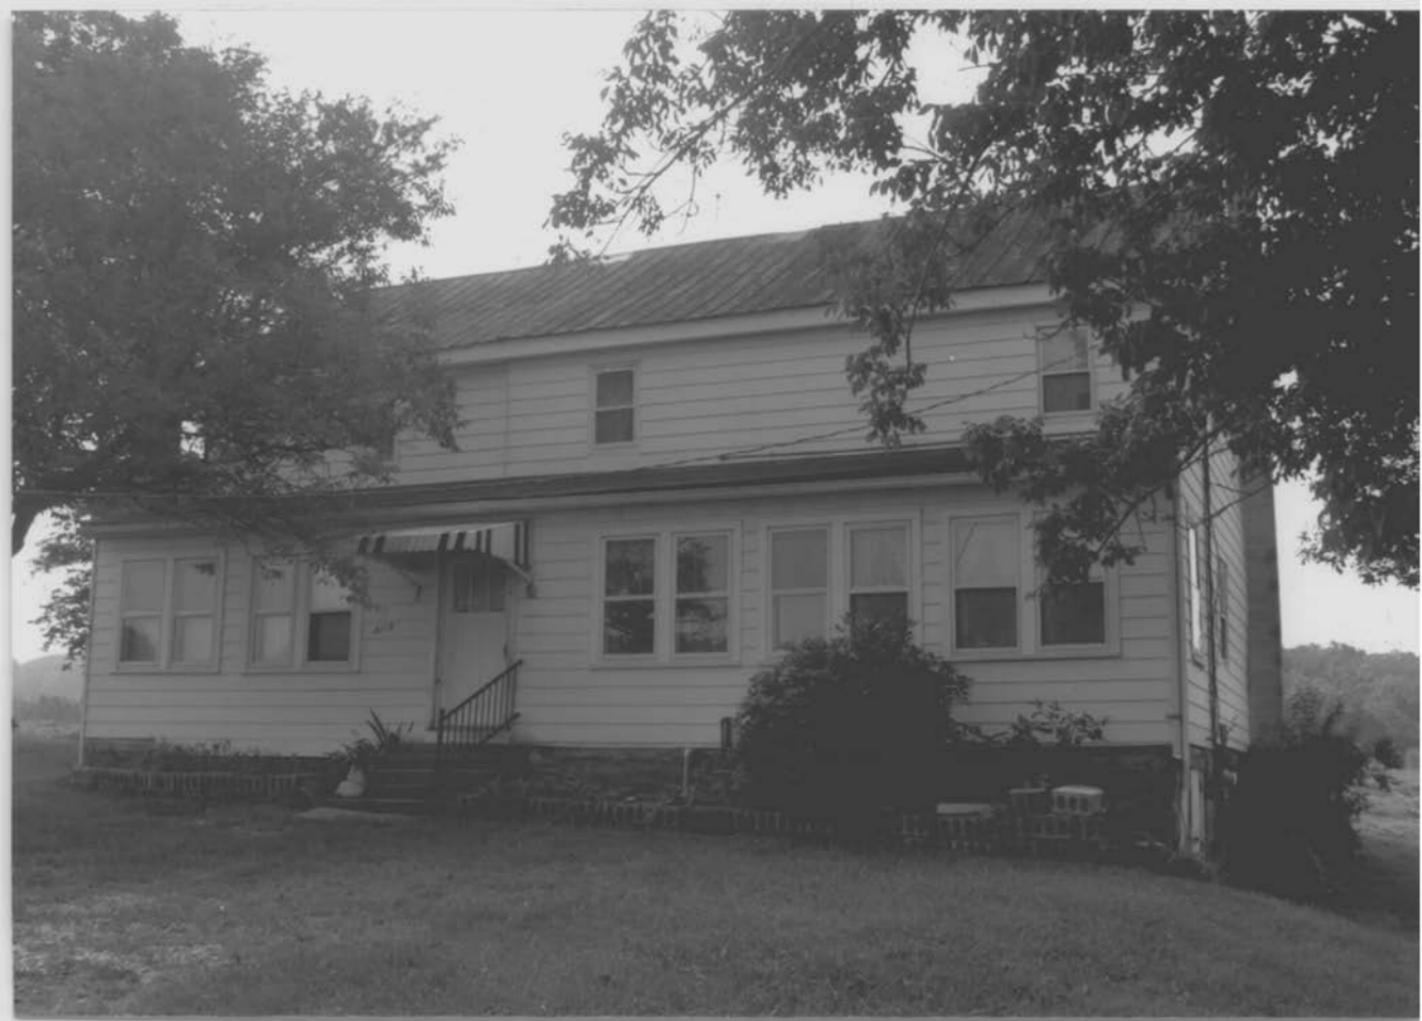
2/5

NW elev.

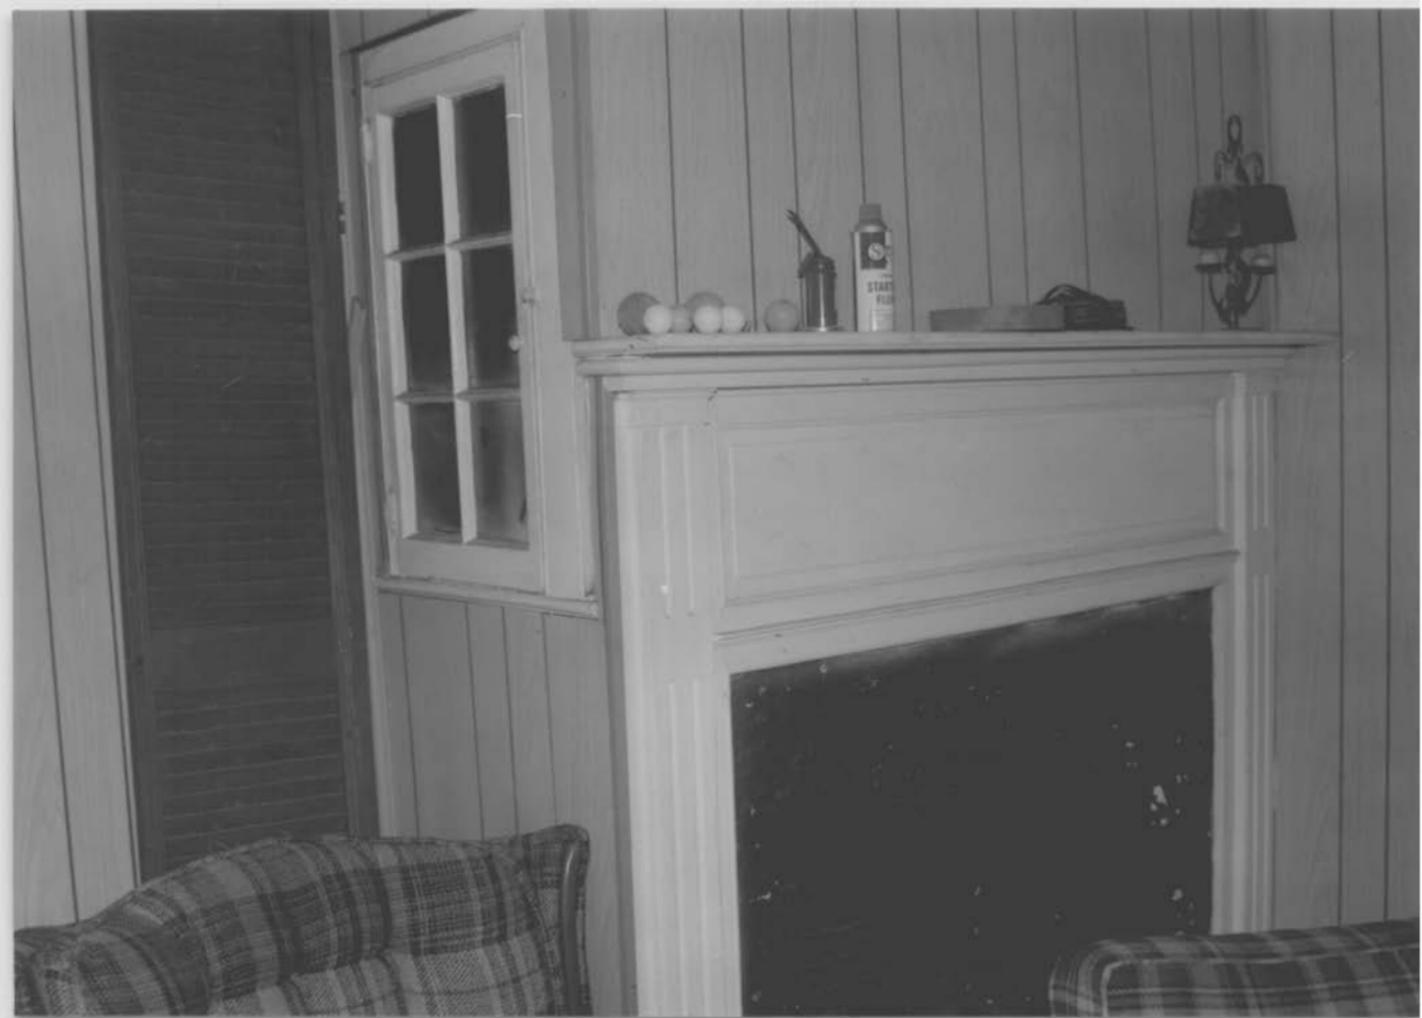
3/5

The south room has a fireplace on the southwest wall that has splayed, plastered

jamb. The wood mantel has pilasters with three fillets and there is a paneled frieze. On the southeast side of the fireplace is a cupboard with a six-light door. The south room has the same architrave as the front door. The northwest room also has this architrave. The northwest wall has been completely removed, opening this room to the enclosed porch.

South room mantel : cupboard

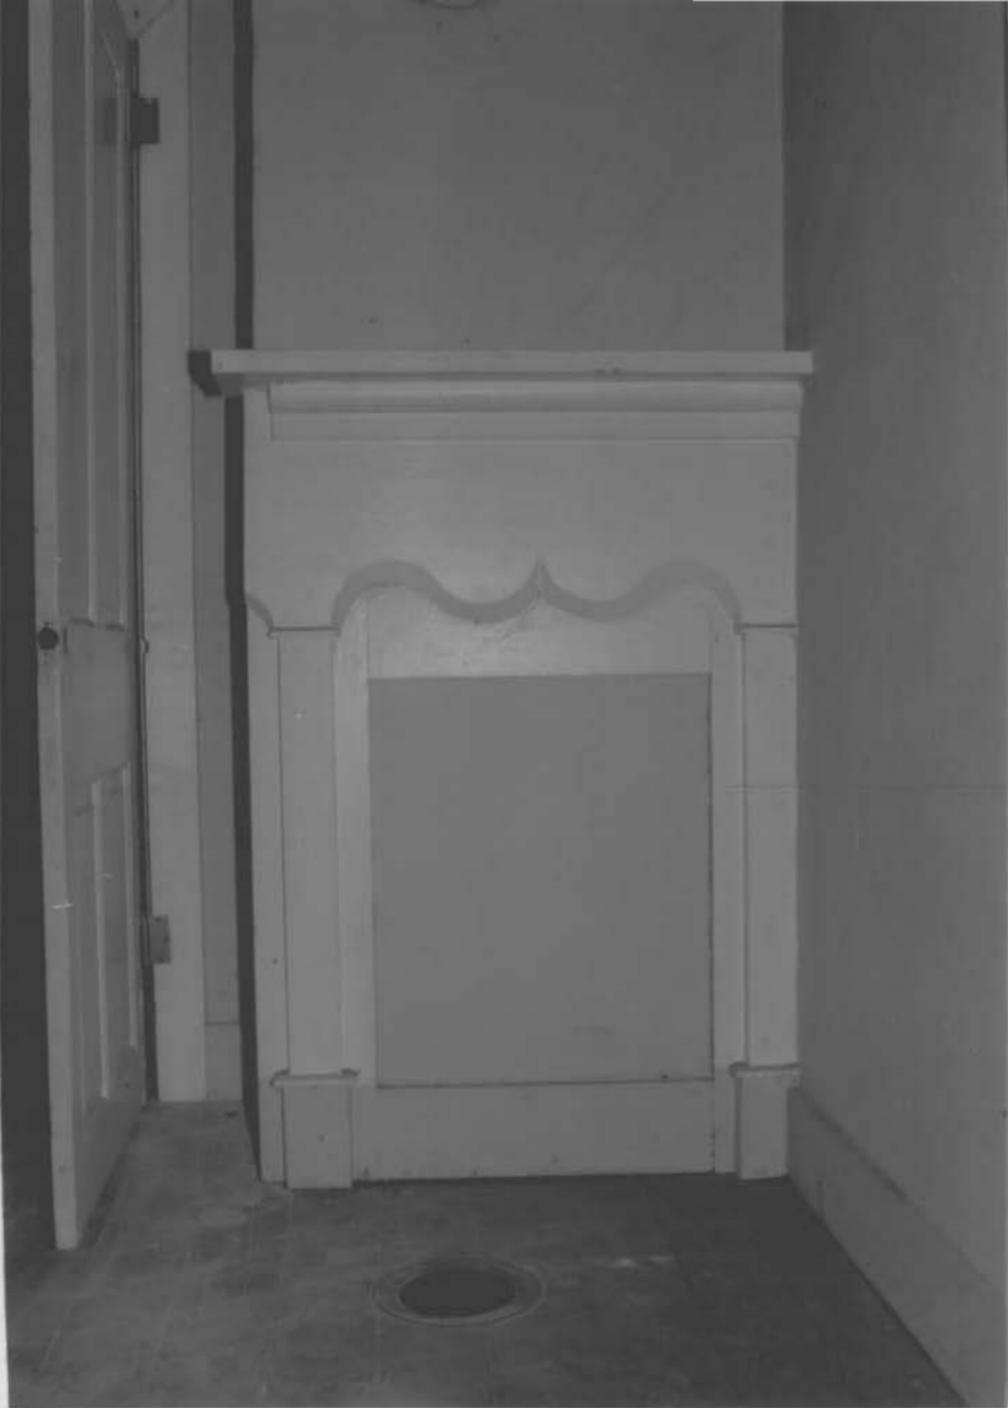
5/5

Neg. Loc.: Maryland Historical Trust
NE addition - SE chamber mantel
