CARR-1492

William and Mary Woods Farm
Uniontown (vicinity)

State Historic Sites Inventory Form

332 Clear Ridge Rd
Moulding Profiles

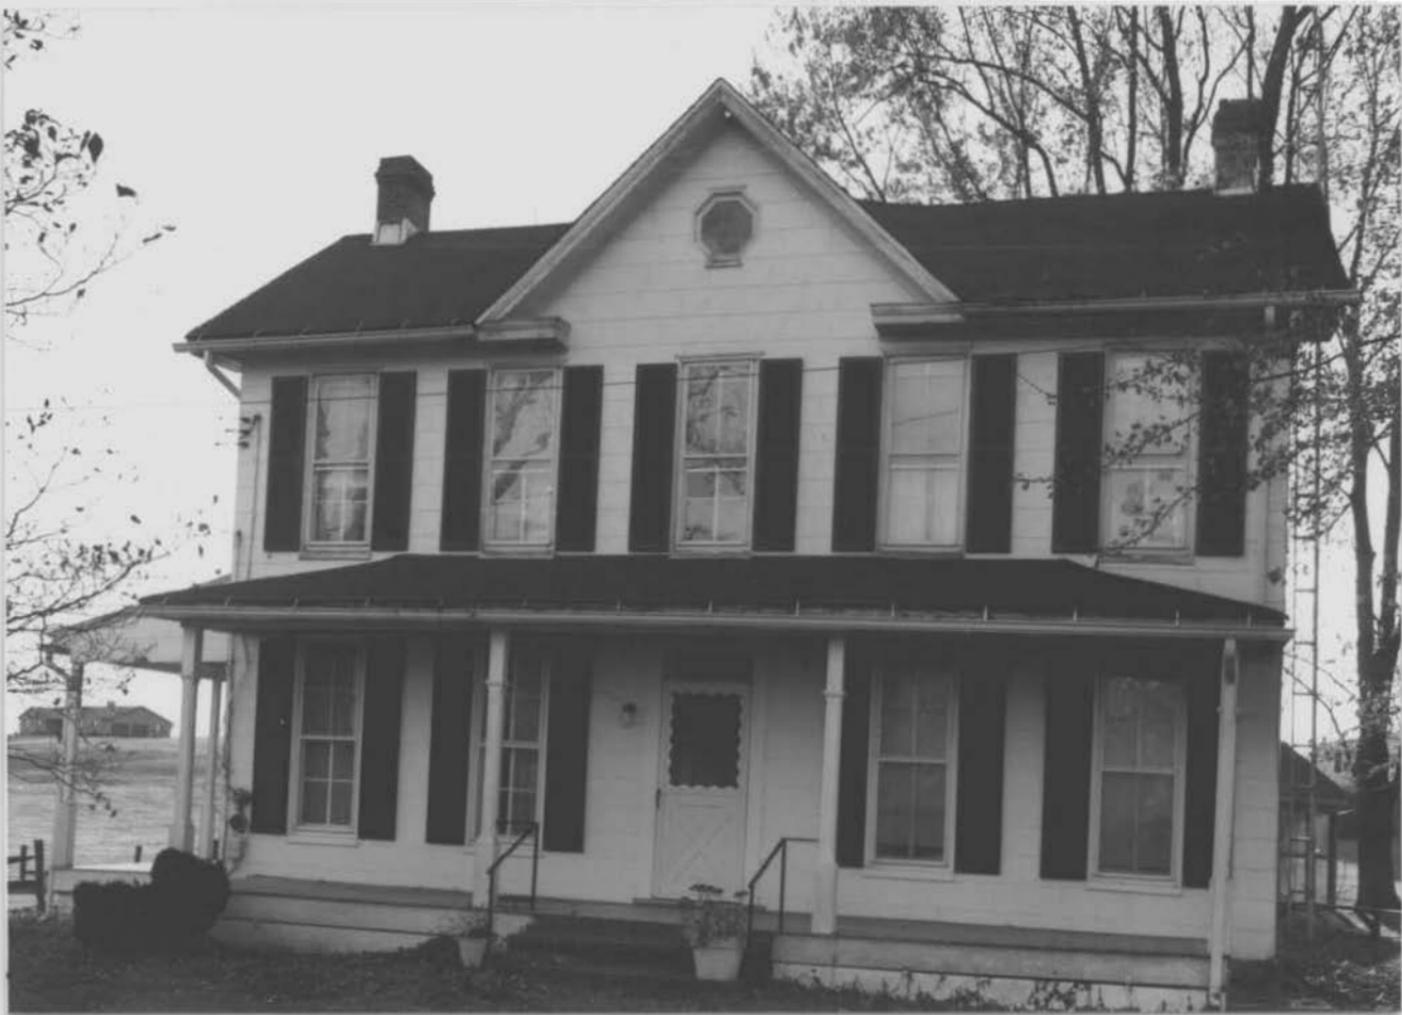
Neg. Loc.: Maryland Historical Trust
east elev.

On the east elevation, the first story has a center entrance with a double door. Each door has one oval light above one bolection-moulded panel. The transom has one oval light, as well. There are two 4/4 sash on either side. The house has a one-story, five-bay porch, with four chamfered posts and a half-hip roof with asphalt shingles. The porch apparently had jigsawn brackets at one time. The second story has five typical 4/4 sash. There is a wood box cornice with paneled soffit and returns. There is also a central gabled wall dormer with an octagonal oculus.

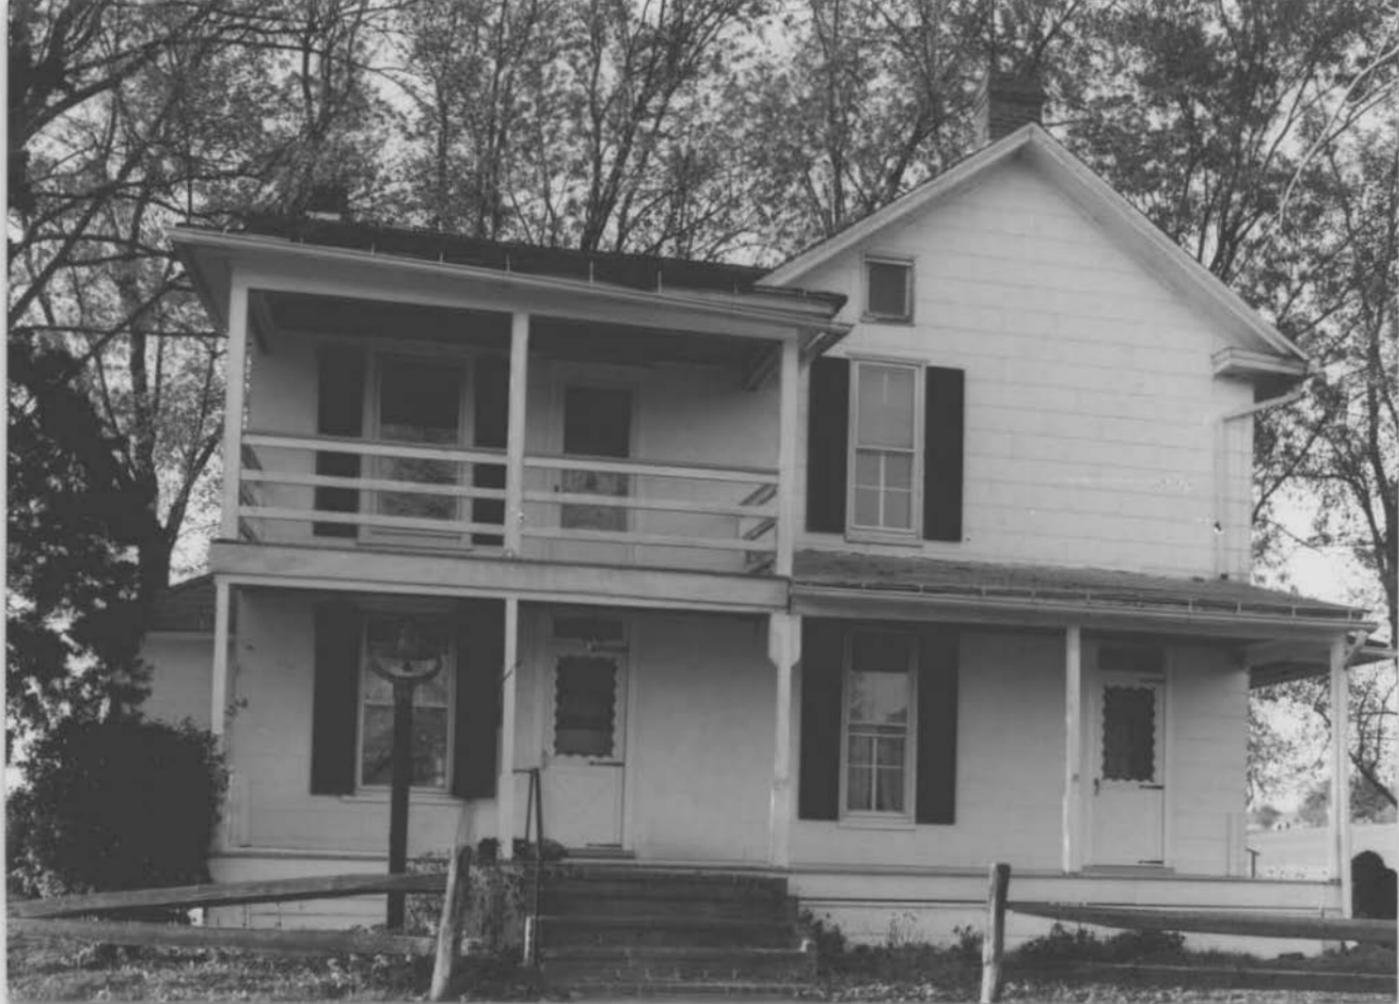
2/7

S. elev.

The south elevation of the addition has two bays. The first story has a 6/1 sash and a door with three lying lights over two lying panels. There is a one-light transom. The second story has a 1/1 sash and a door like that on the first story. The addition has a two-story porch with square posts and horizontal rails. It has a flat roof. The main block has a typical 4/4 sash and a door identical to the addition. There is a two-bay, one-story porch on the south elevation of the main block built at a different time than the porch on the addition. The second story has a 4/4 sash and no opening to the east. The gable end has a jalousie window in an original opening in the east-center bay.

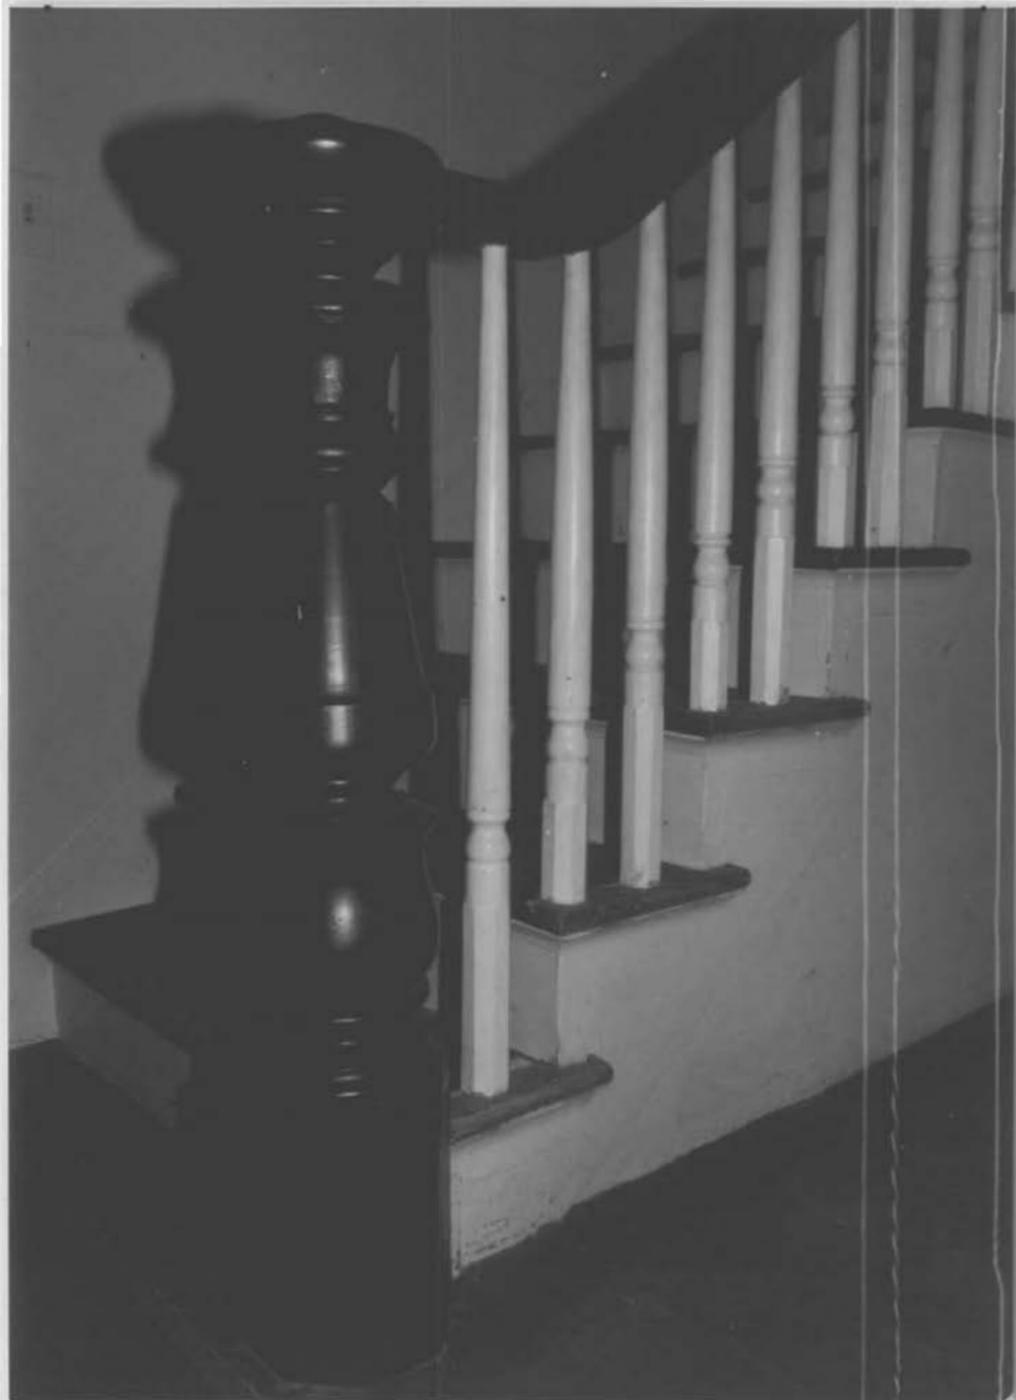
3/7

Neg. loc.: Maryland Historical Trust
newel & balusters - 1st story

The first story has a center-passage, single-pile plan with two rooms in the ell. The center passage has an open stringer dog leg stair on the south wall with a landing at the west end. It has a turned walnut newel post, tapered turned balusters, and a walnut handrail. The stairs are natural wood in the center and are grained on either side. Originally, the passage was open beneath the stairway, but it has been enclosed now with old doors reused from elsewhere. There are four-panel doors with crossetted architraves. Above them are oval one-light transoms that pivot in the center. There is a cast plaster medallion.

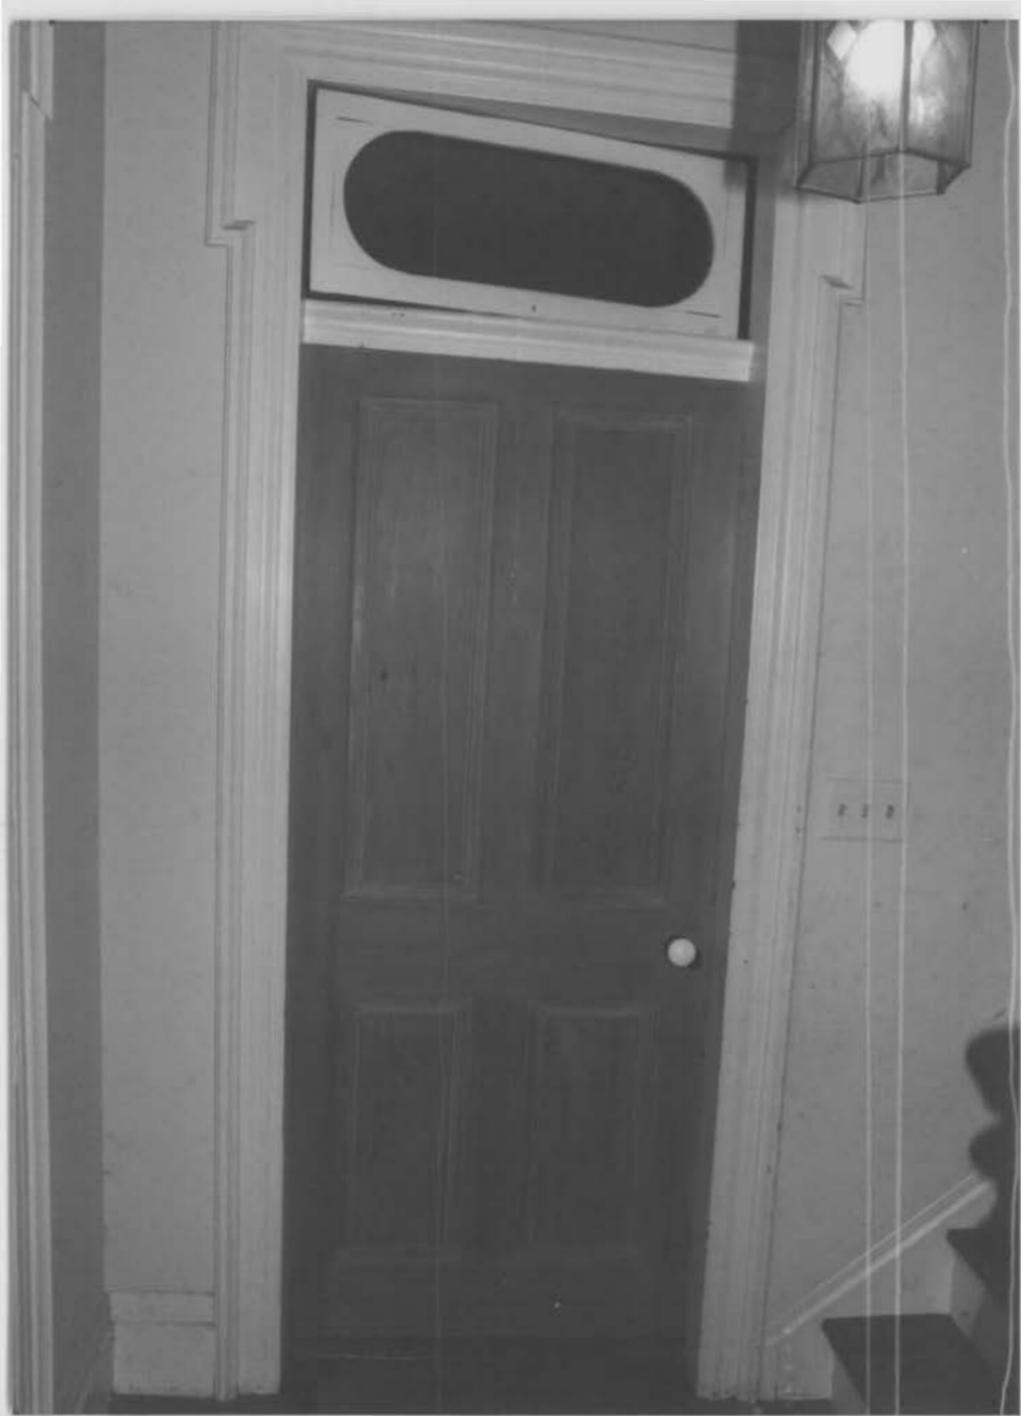
doorway to south room

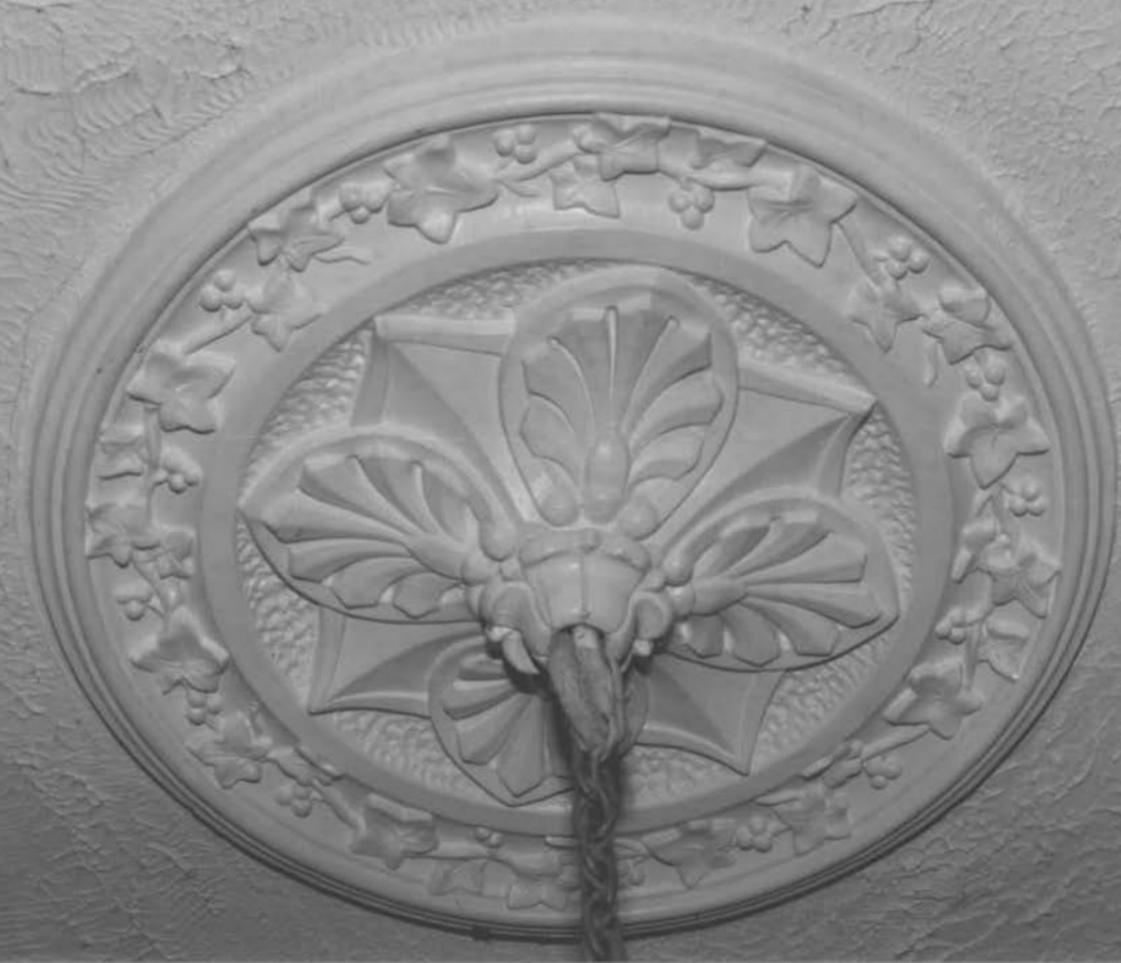
5/7

Neg. Loc.: Maryland Historical Trust
ceiling medallion - 1st story passage

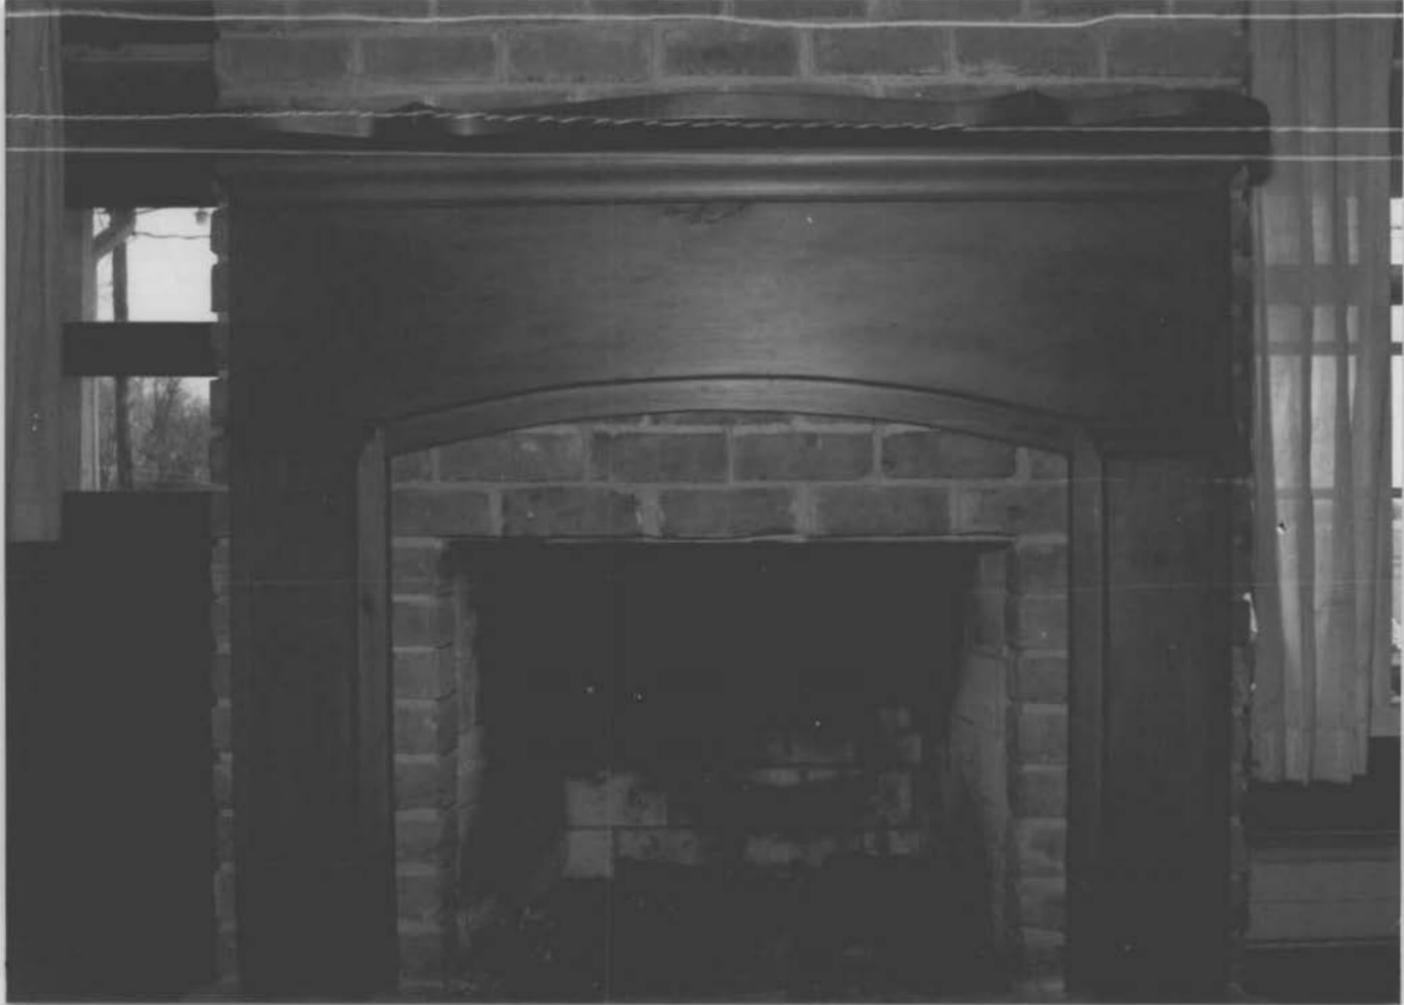
6/7

Neg. loc.: Maryland Historical Trust
mantel - South room

The southeast room has a fireplace on the south wall that has been completely rebuilt. The wood mantel appears to have been reused. It has pilasters, a segmentally-arched frieze, and a decoratively-cut shelf. There is a cupboard on the west side of the fireplace set above the height of the mantel shelf. It has a one-panel door. There are panels below the windows.

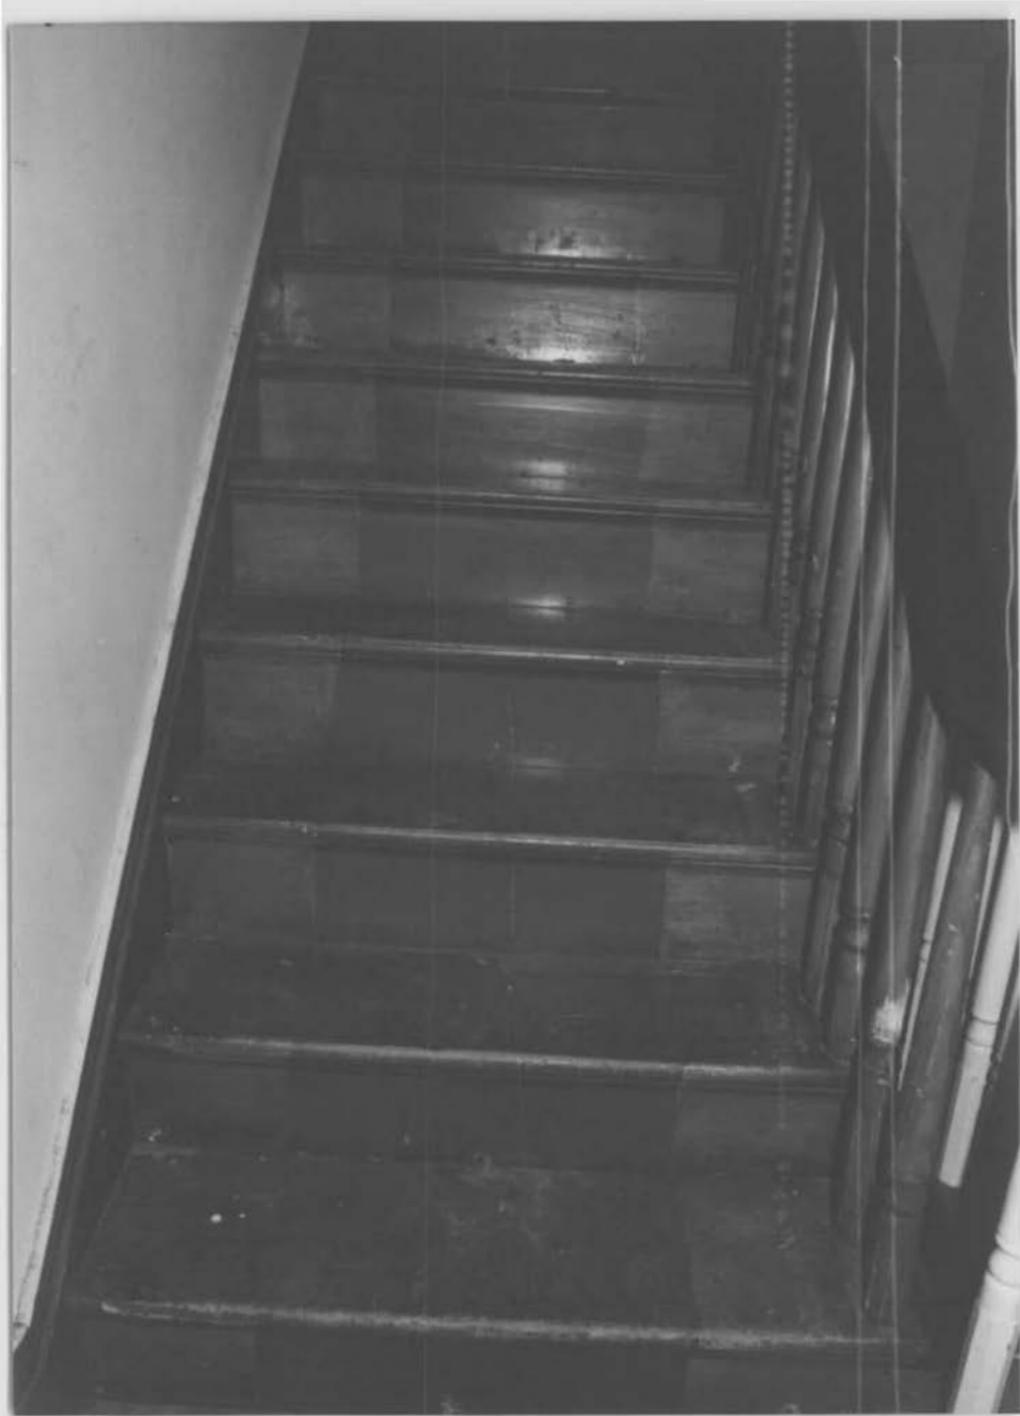
7/7

Neg. Loc.: Maryland Historical Trust
attic stairs

The top of the attic stairs are now enclosed, but were not originally. The rafters are mill sawn and are tapered. They are mitered at the ridge with no ridge board, and have a miter cut at the foot that rests on top of a thin board false plate. The rafters are reused from another building. The main block of the house is built of a heavy-timber, mortised-and-tenoned-and-pegged frame. The posts and plate seem to be 6 inches square. One of the stair girts is 5½ inches square, and is mill sawn. The bottom of the joists are notched slightly to lap ovetop of the plate.
