CARR-1552

148 Pipe Creek Rd., Uniontown Vicinity

Maryland Historical Trust
State Historic Sites Inventory Form

historic Joseph & Esther Englar Farm

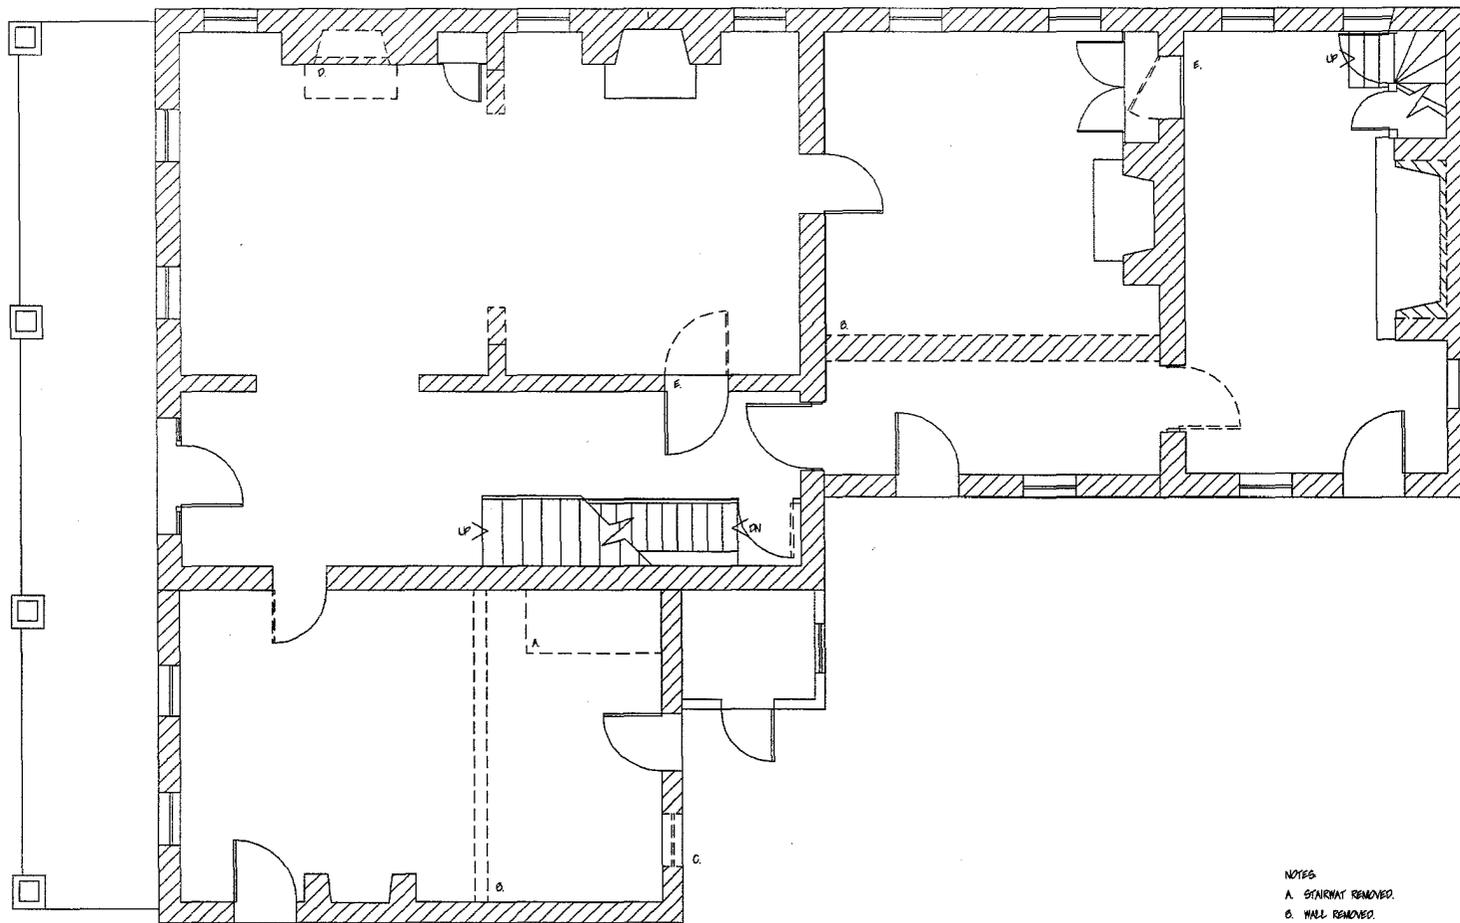
CARR-
1552

- NOTES
- A. STAIRWAY REMOVED.
 - B. WALL REMOVED.
 - C. WINDOW CLOSED OFF.
 - D. FIREPLACE CLOSED OFF.
 - E. DOORWAY CLOSED OFF.

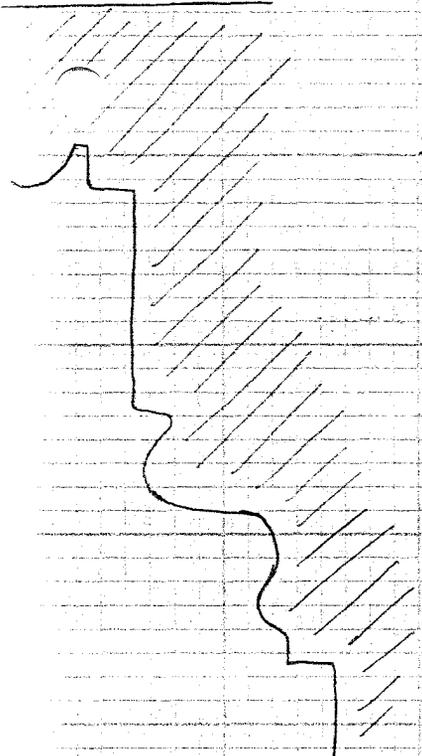
S.W. Room
under sill
trim

The southwest room architrave has a broken field with a beaded interior edge, and this trim appears to be a later replacement. There is new chair rail that replaces original chair rail. There is a fireplace on the west elevation that is now closed off. To the north of the fireplace is a built-in closet with architrave that matches that in the passage. The door has three panels. There is a large opening on the north elevation, and the architrave is the same as that found on the windows. The soffit board of this opening is in three pieces, two of them small ones, and it appears that this opening was originally wide and was widened even further at the same time that the window trim was updated, although it is possible that the opening has been altered more than one time. The opening is arched in the top corners.

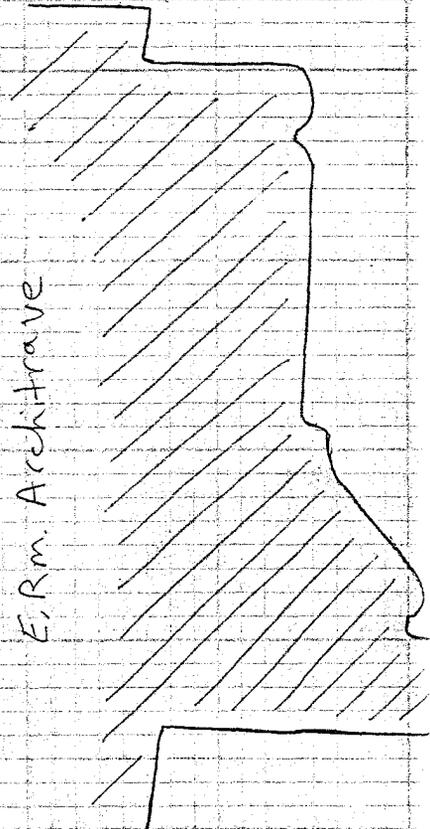
E. Rm. Architrave

The east room architrave has a quirked Greek ogee back band and a beaded interior edge. This room has been converted to a modern kitchen with linoleum on the floor and a dropped ceiling. Both the east and north doors have the same architrave, but the east door itself is a later replacement. The north door was originally six panels. The room appears to have been divided originally into two rooms, based on a portion of the surviving partition wall on the east. There is a fireplace on the east elevation, set south of center. It has slightly splayed brick jambs and a wood mantle with octagonal columns. There is a one panel frieze that has quirked steep Greek ovolo panel moulds. In the northwest corner the plaster wall has the ghost of a winder stair that formerly stood here.

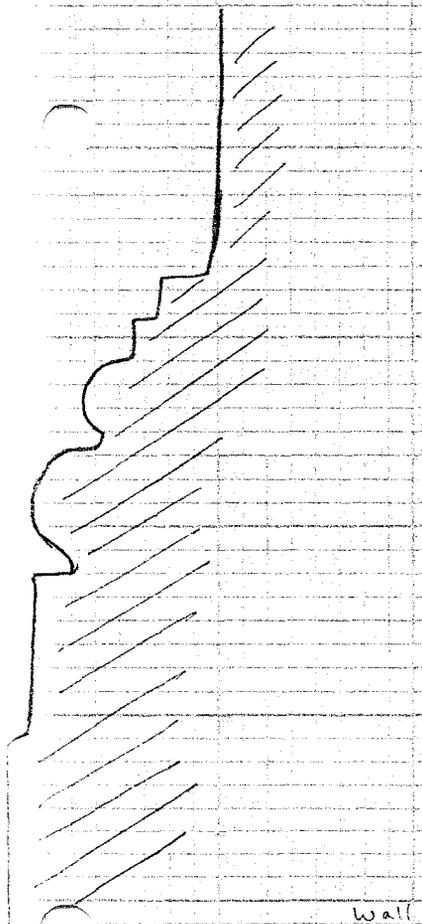
Passage Architrave

Passage
Baseboard

The first story has a center-passage plan with two rooms on the west and one room on the east, and a two-room ell on the north. The center passage has random width flooring running north-south. South of the stairway it has a grained, combed finish, while north of the stairs there is a later finish covering the graining. The ceiling has riven lath. The doorway to the east room has a transom above. The east door architrave has a quirked Greek ogee-and-bead backband and

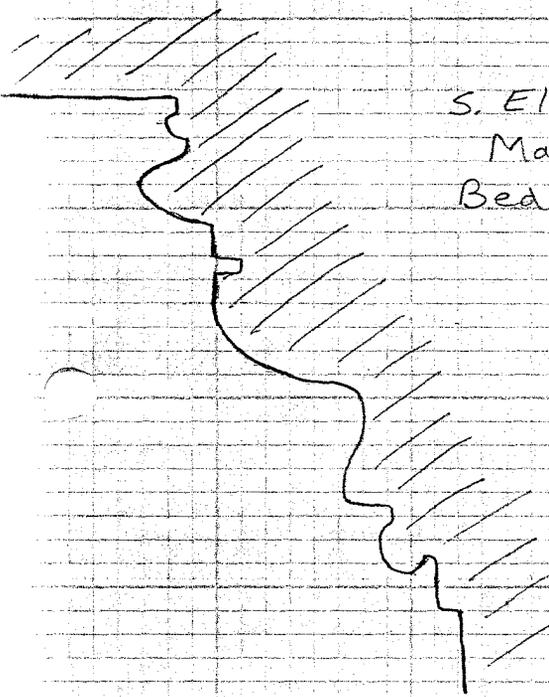
S. Ell Rm
Mantel
Bed Mould

The south ell room has a fireplace centered on the north wall. It has a wood mantle with a plain surround and a back band on the inner side, not the outer side. The back band has a quirked ogee and bevel. The frieze has one panel and the edge of the mantle shelf is moulded. The fire box has splayed plastered jambs and surround. To the west of the fireplace is a built-in closet with two two-panel doors at the top and two smaller two-panel doors below. They are hung on two cast iron butt hinges marked "N. ENG. BUTT. CO." The closet architrave has a quirked ogee and bevel back band. The closet was added later, as there is a doorway behind it from this room to the north ell room. This doorway has architrave with a beaded interior edge, but the back band has been removed. The door has six panels and originally opened into this room, but it

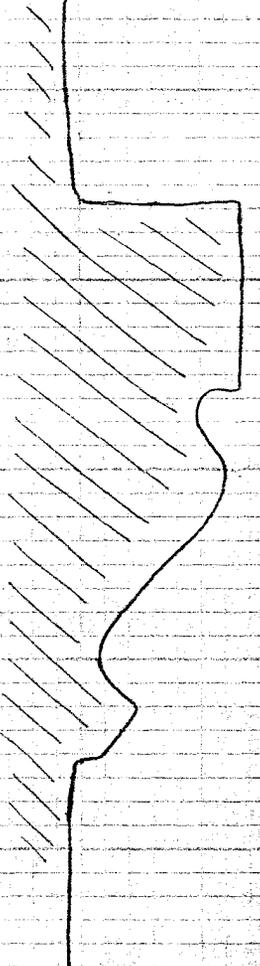
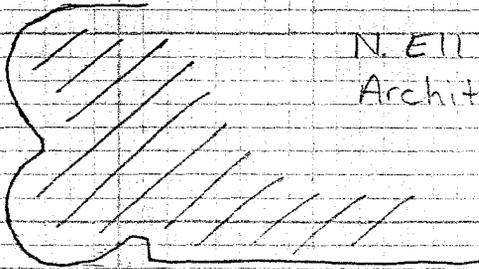
N. Ell Rm
Architrave

The north ell room has 2-inch wide flooring that runs east-west. There is a large cooking fireplace on the north elevation. It has splayed brick jambs that have been added to the sides. The wood mantle shelf is gone. The crane is gone, but the stone and the iron ring to hold it are still in place. West of the fireplace is an enclosed winder stair with three steps below a six-panel door. It has a wrought Suffolk latch with lima bean cusps and is hung on cast iron butt hinges. There is a closet under the stairs with a beaded-edge vertical board door and cast iron butt hinges. All of these hinges are heavily painted. The windows of this room have a double bead on the edge of the frame, except for the north window which has plain trim. The door on the east elevation, to the exterior, has beaded-edge vertical boards on its exterior face. The door is now glazed in the center, and the architrave has a beaded interior edge. The door to the south ell room also has a double bead on the edge of the frame. The window in the south bay of the west elevation is new and has new plain trim. This window replaces a door from an earlier period.

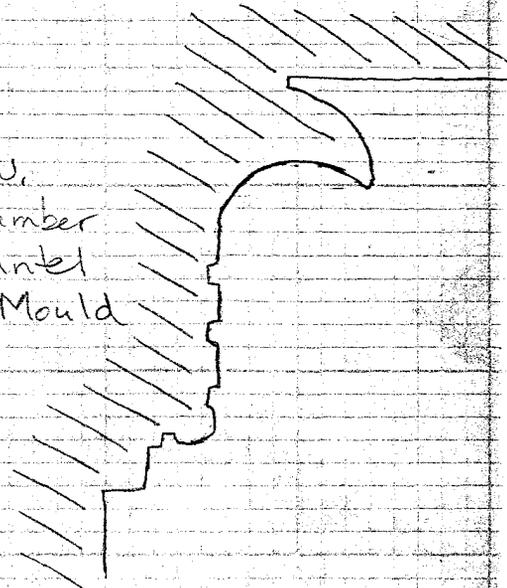
S. W.
Chamber
Mantel
Bed Mould

The southwest chamber has a door like that of the south chamber and the architrave is the same as that in the second story passage. The door has a later cast iron rim lock marked "D.M. & C^o. NEW HAVEN". There is a fireplace centered on the west wall that has brick splayed jambs and a brick hearth. The surround is plastered. There is a wood mantel with paneled pilaster strips and a paneled frieze. The bed mould has a beak moulding and the edge of the mantel shelf is moulded. To the north of the fireplace is a closet with a three-panel door and a typical architrave. There is peg rail on the three sides of the closet, with a shelf above the peg rail. On the north elevation is a door to the northwest chamber. The southwest chamber has chair rail. The window frames have a quirked ogee and bead applied to the frame and not the full architrave.

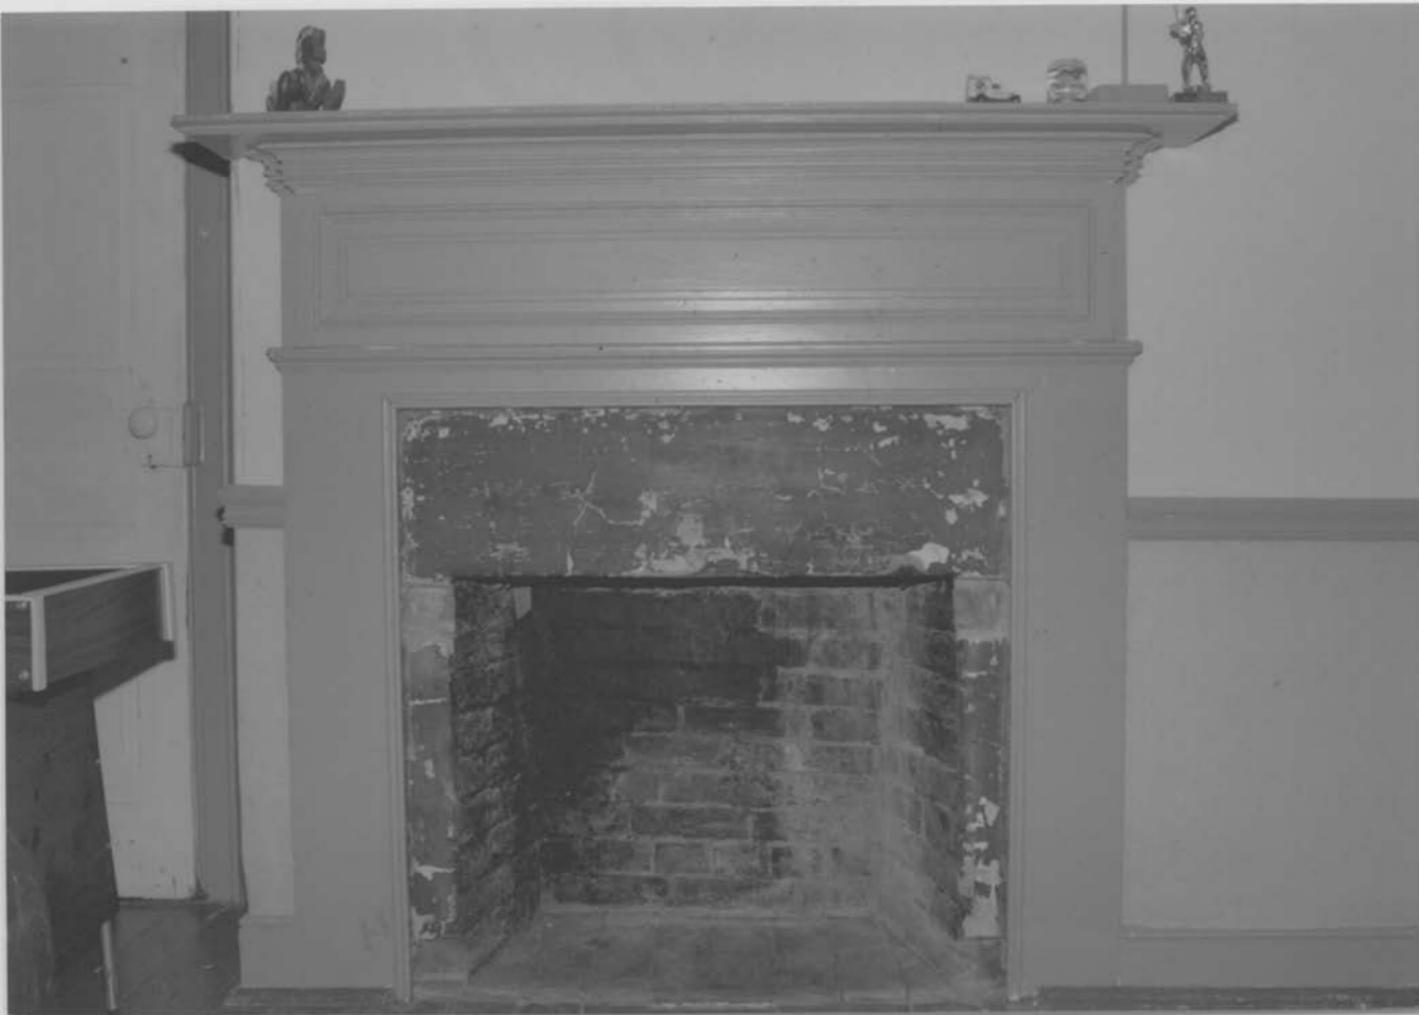
2 OF 17

S. Ell Chamber Mantel

The south ell chamber has been altered, first by enlarging it by removing the east wall and enclosing the eastern porch, and secondly by cutting up the south ell chamber into several rooms. The door from the chamber into a bathroom that has been placed inside this room does not match others in the house and it is not certain where it came from. It is a six-panel door with cast iron butt hinges marked "THO. CLARK" and "PATENT". It has a metal plate rim lock with a brass tab marked "JOHN HARPER MANUFACTURER" and has a brass knob. There is a fireplace on the north wall that has splayed brick jambs, a brick hearth and a plastered surround. It has a wood mantel has a plain architrave, a paneled frieze, and a bed mould with a beak moulding. The mantel shelf is thin and has a groove run along the edge. This shelf seems to be applied to the edge of the thicker mantle shelf. The east elevation is much altered. There is a door here with six panels, but it is not clear where this comes from. The door is now hung upside down, it has a later cast iron rim lock marked "R. & E. CO," and it has cast iron butt hinges with "BALDWIN" and "PATENT". The wall here has been moved west about 15 inches from where the original brick wall was. There is evidence that this chamber had chair rail. The window frames on the west elevation have an ogee and bead applied to the edge, but it is a different profile from that in the chambers of the main block. The later eastern brick wall has two windows. That to the north is original and must have been reused, but the window to the south is later. The south opening

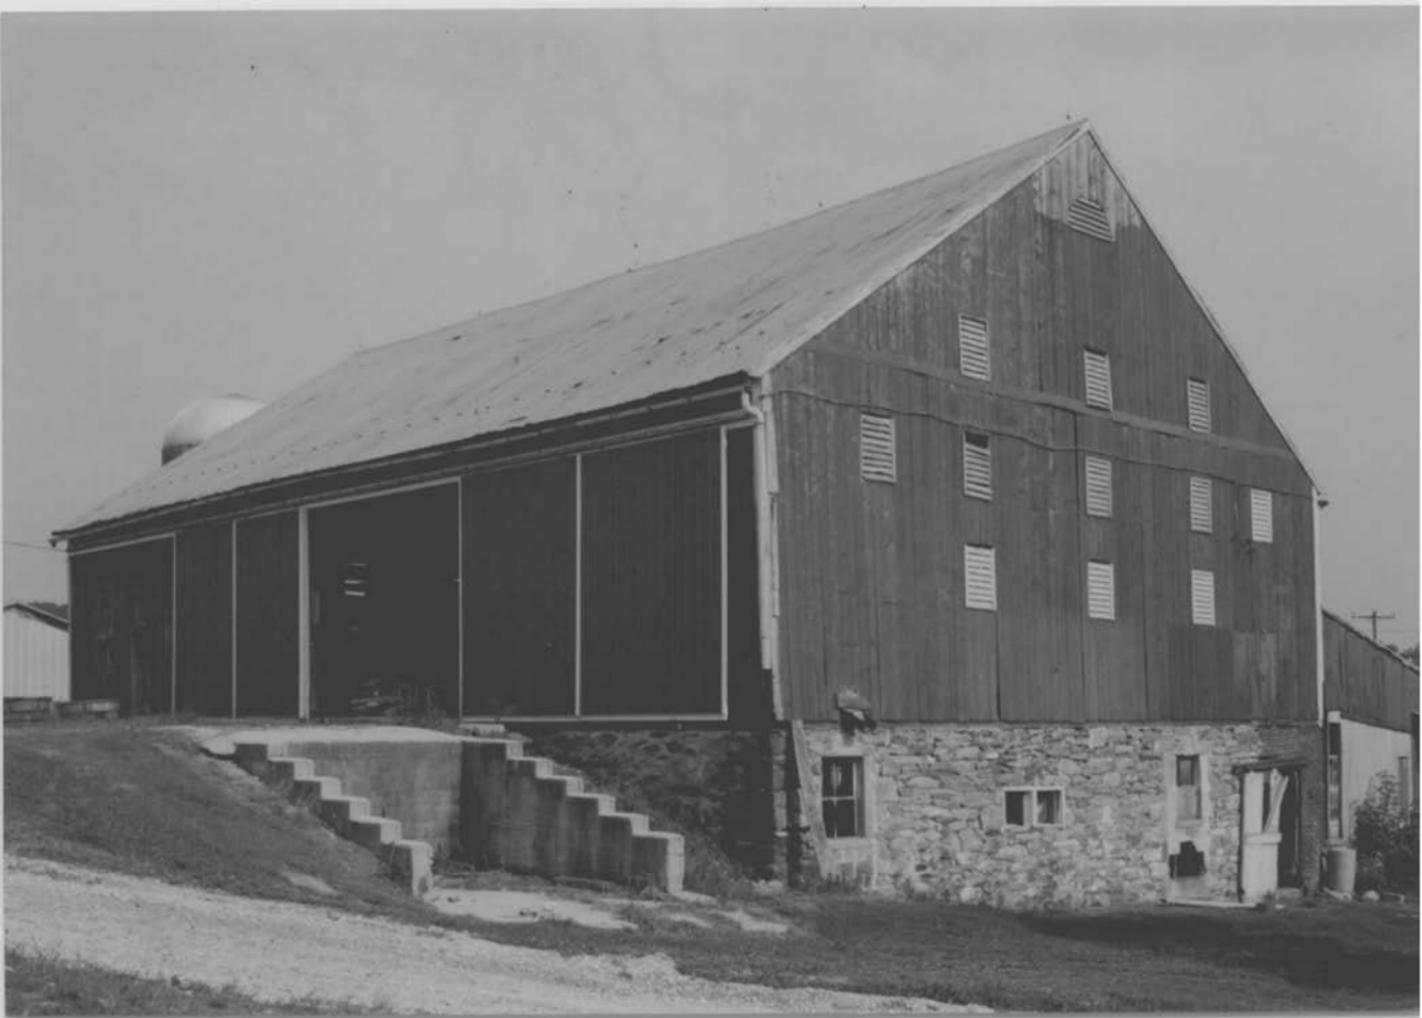
3 OF 17

Barn - N & W Elev

About 120 feet east of the house is a frame bank barn. It is 70 feet 8 inches long by 48 feet 5 inches wide. The barn is banked on the north, with a ramp here to the upper story, and has a south-facing forebay. The lower story is of rubble stone on the north, east, and west elevations. The upper story has random-width, beaded-edge, tongue-and-groove vertical board siding. There is a gable roof with corrugated metal and an east-west ridge, and there are lightning rods along the ridge and snow eagles along the eaves. The north elevation has two pair of wagon doors that are covered now with aluminum panels. There is a one-light sash to the east and a door cut through between the sash and the wagon doors. To the west are two windows. On the west elevation the lower story has, from north to south, a door that has been converted into a window with CMU infill, a wide opening in the center covered with corrugated metal, a door converted to a window (again with CMU infill) and a brick wall with a doorway under the forebay. The door here was hung on rollers. The upper story has three wood louver vents, with five similar vents above it, three vents above that, and a semicircular wood louver vent in the gable end. The south elevation has a shed addition to the west that obscures the upper story openings. The lower story is a frame wall and has, from west to east, a Dutch door on tapered strap hinges with rounded ends, a vent that has now been cut out, a Dutch door, and then several altered openings where there may have been a vent and a door.. The eastern half of the lower story has had the whole wall cut out and moved beneath the projecting forebay. This new wall is constructed of CMUs and steel sash and was likely done when the eastern half of the lower story was converted to a milking parlor. The east elevation has a stone wing attached to the lower story, set to the south. This wing projects to the east and has been extended further to the east with an enlargement of

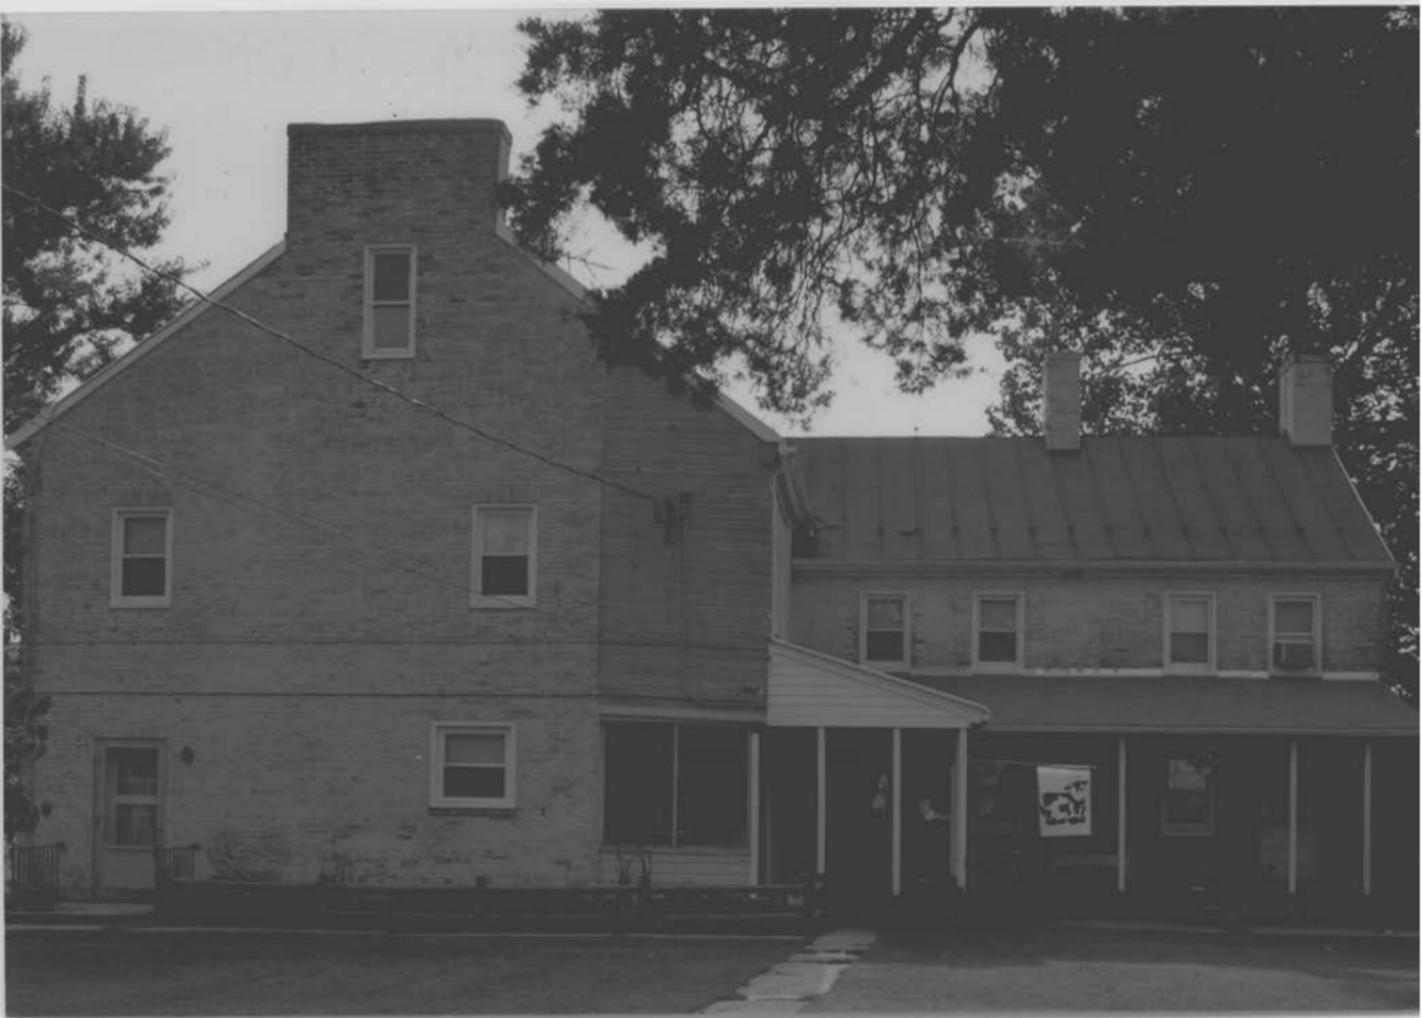
4 OF 17

East Elevation

The east elevation of the ell is four bays and is set back from the original east wall of the main block about five feet. It is currently all in one plane and is all of five-to-one common bond brick, but there is a clear break between the two northern bays and the two southern bays and the header courses do not line up. Thus, it would appear that the two southern bays were originally a two story porch that were enclosed with a brick wall at a later date. On the first story, from south to north, there is a door with one light over two panels, a new one-over-one sash, a new one-over-one sash, and a six-panel door with the two center panels converted to a single light. This door has a stone sill and the opening has been widened. The second story has four new one-over-one sash, and the cornice is identical to that on the west elevation. There is a new one-story ell porch on both the east and north elevations.

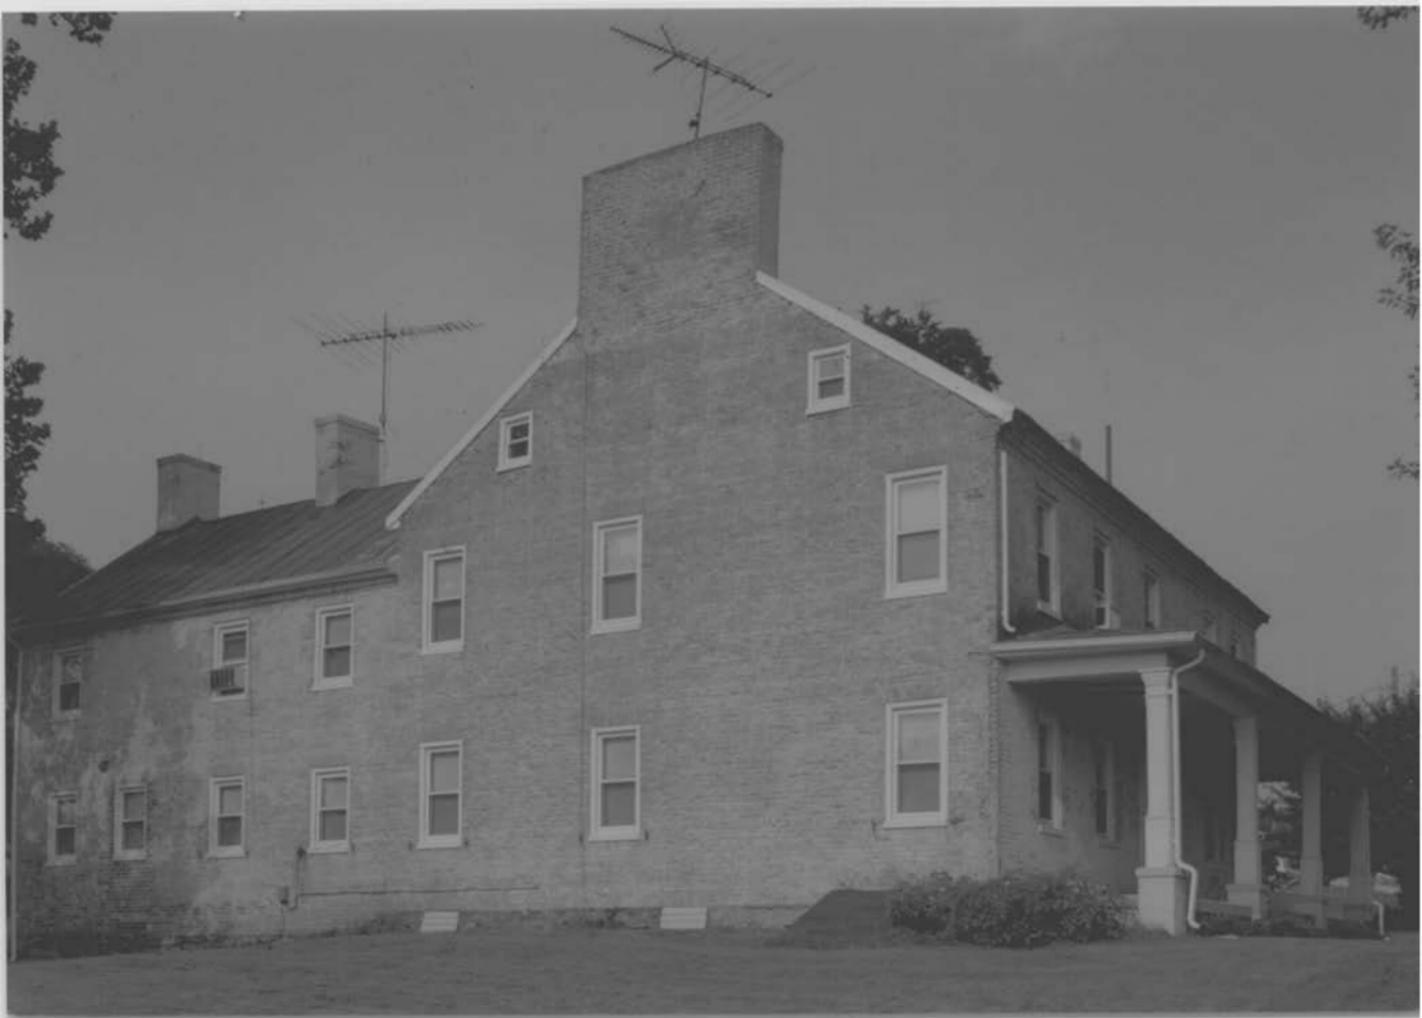
19 OF 17

West Elevation

The west elevation is seven bays, all in the same plane and all built at the same time. Four bays are in the ell and three in the main block. This elevation has five to one common bond brick on a rubble stone foundation. The first story has seven new one over one sash. The north-north-center bay has new brick beneath the window opening, indicating that this was once a door. The second story openings are the same as the first, except that there is no opening in the north-north-center bay. The window openings in the main block are set higher on the wall than those in the ell and are taller openings. The gable end has two new one-over-one sash. The ell cornice has at least two courses of corbeled brick. There are interior brick chimneys on the north gable end of the ell and in the center of the ell and there are lightning rods along the ridge. The north elevation is five-to-one common bond brick, and here can be found evidence of penciling beneath the later paint. The first story has a new window opening in the east bay, the second story has a bricked-up door opening in the west bay, and the gable end has two new one-over-one sash.

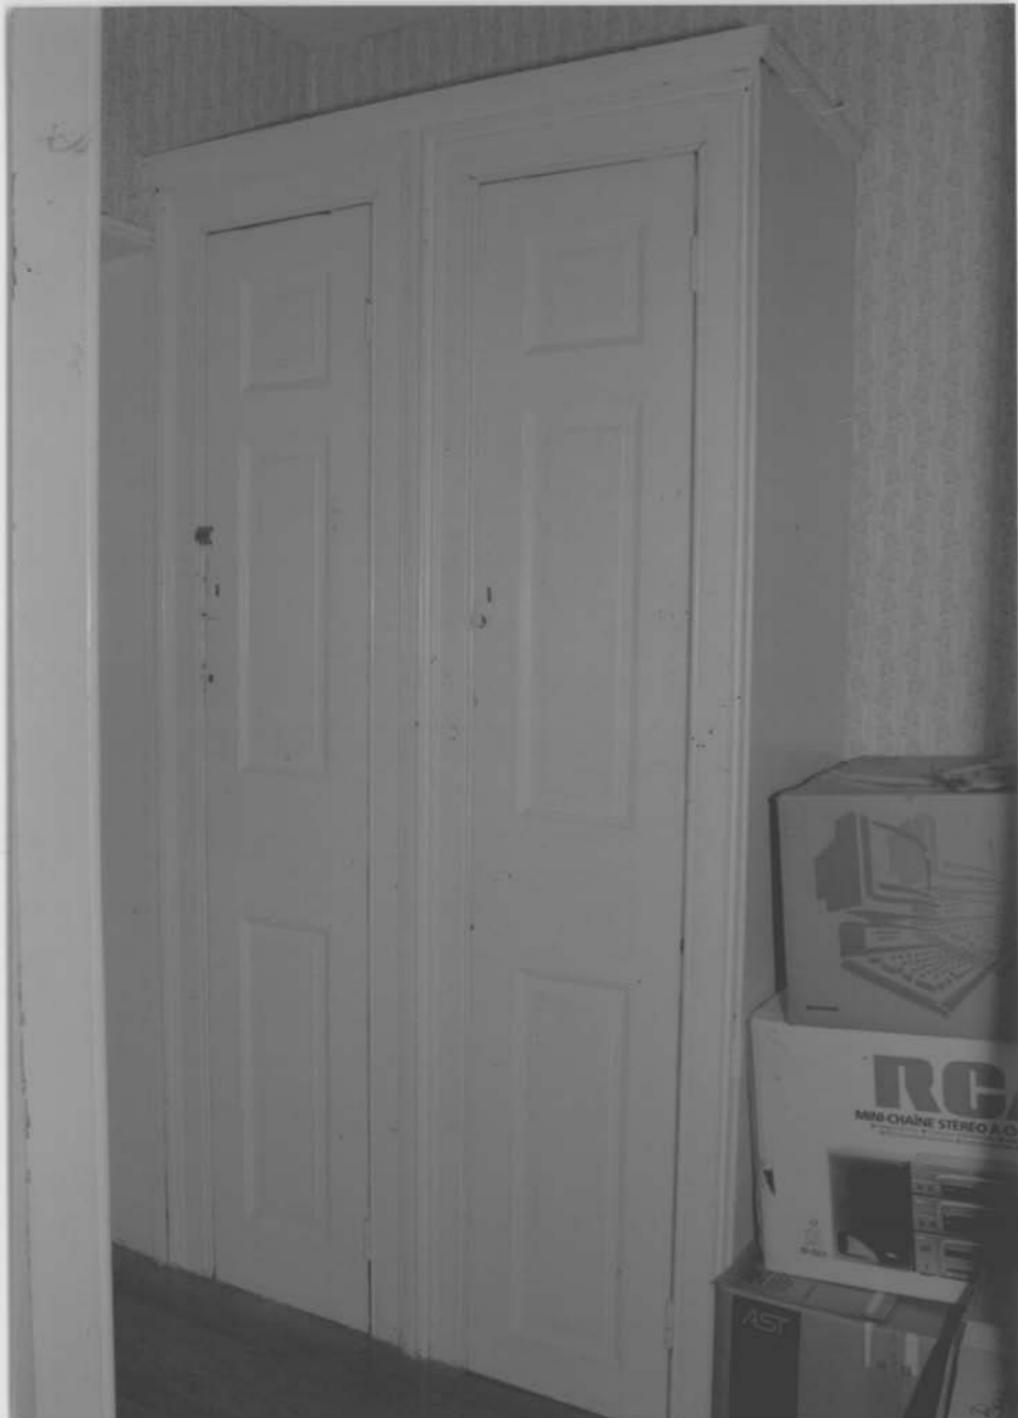
10 OF 17

Neg Loc: Maryland Historical Trust
E11 Passage Closet

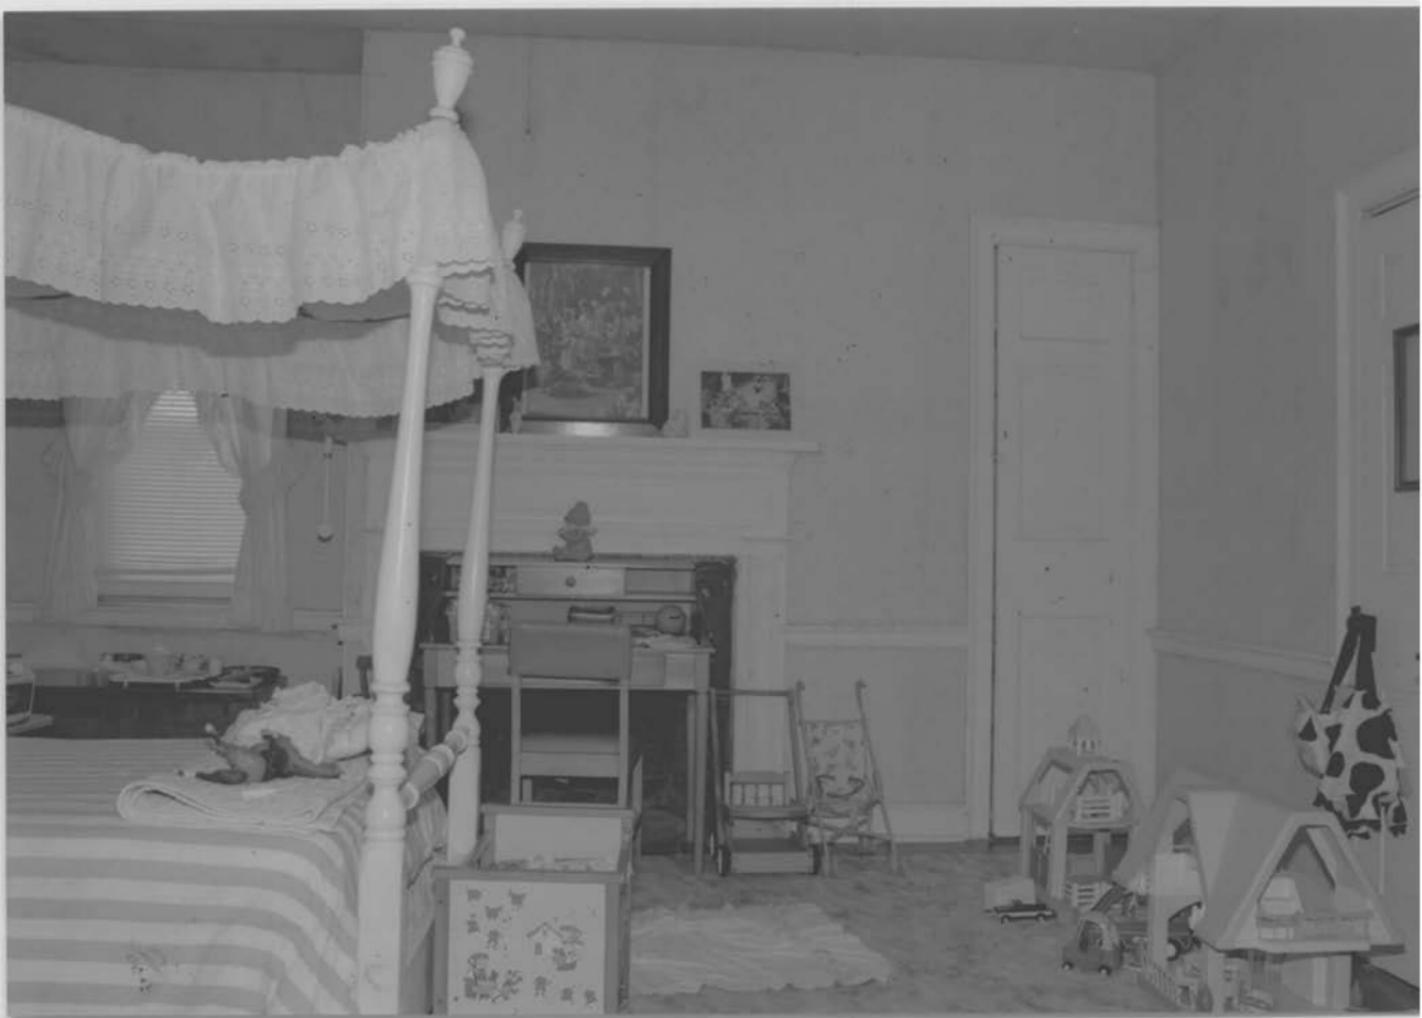
11 OF 17

3. W. Chamber - V. W. West
-2862

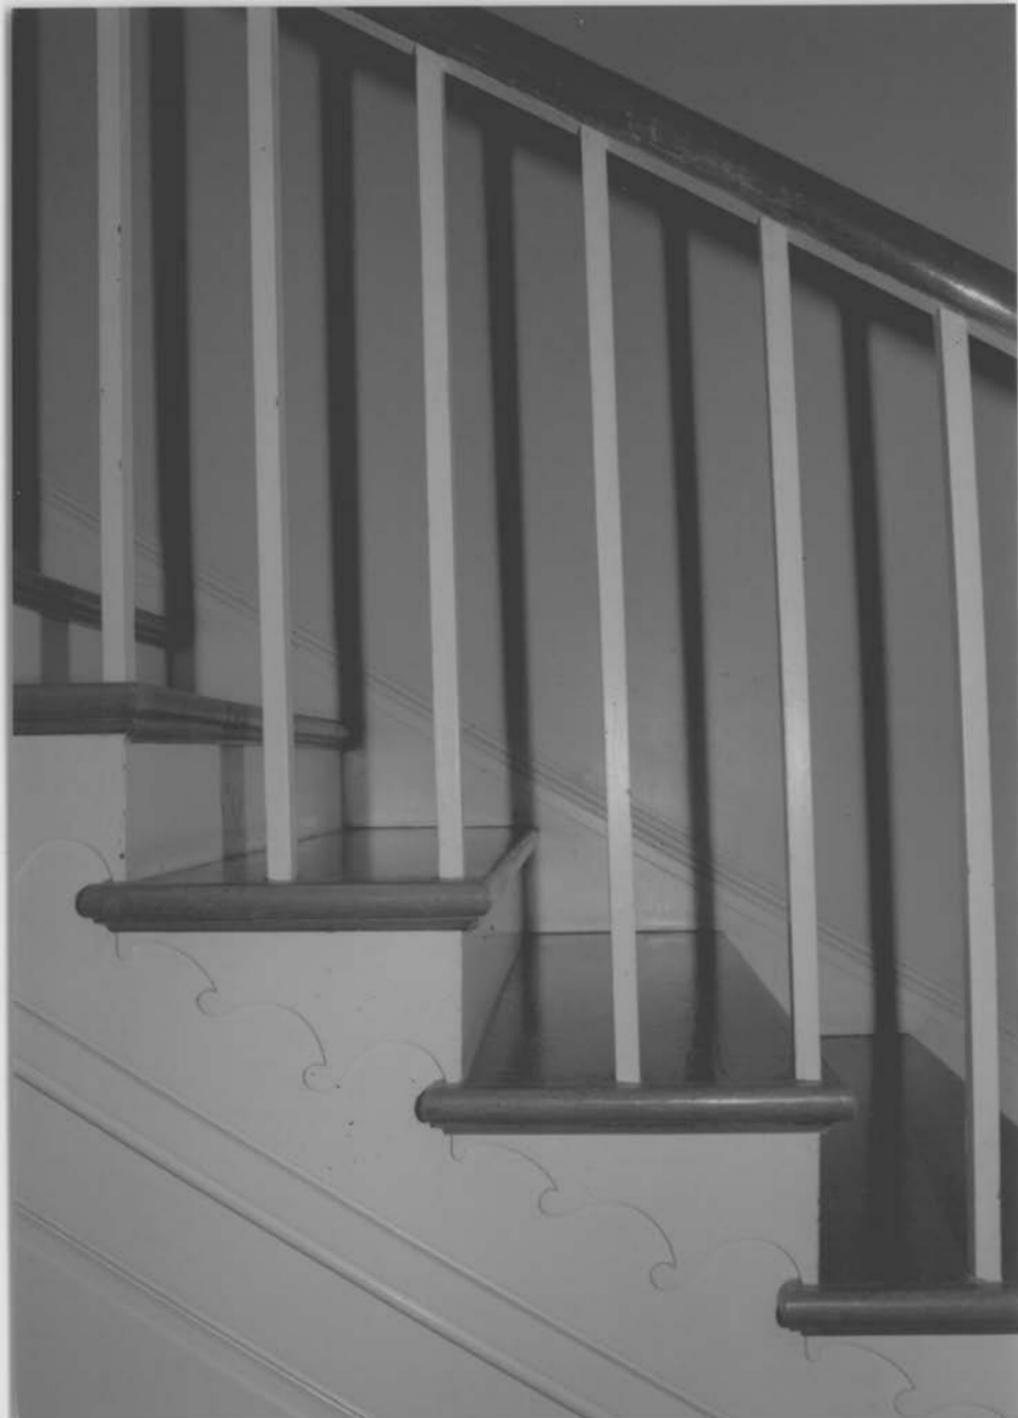
13 OF 17

Slide brackets

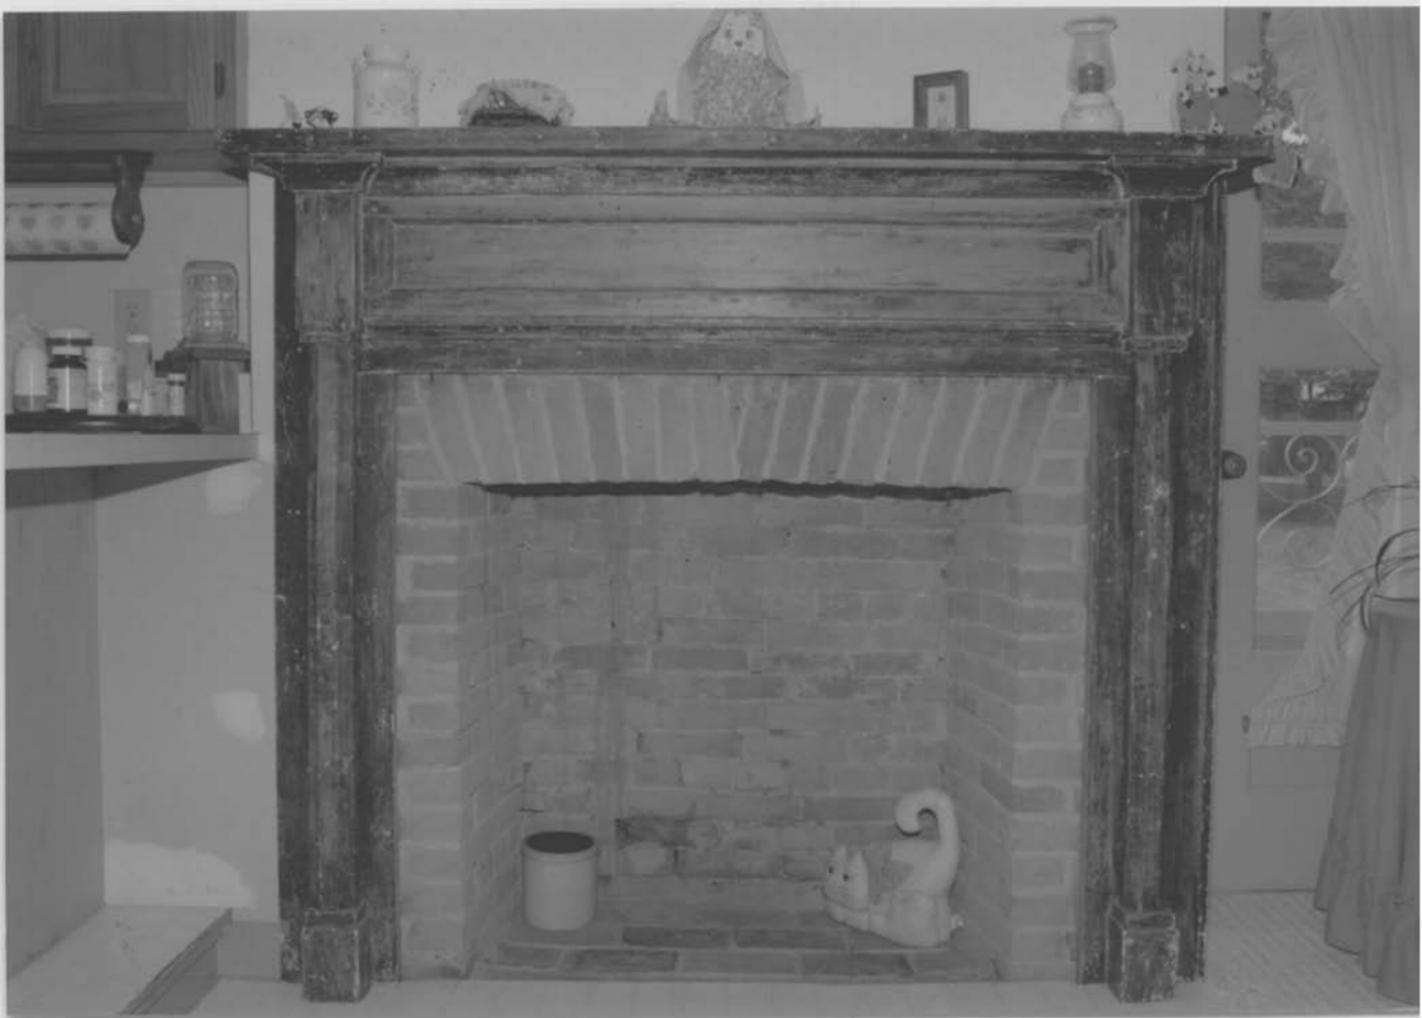
15 OF 17

E. R. M. Marble

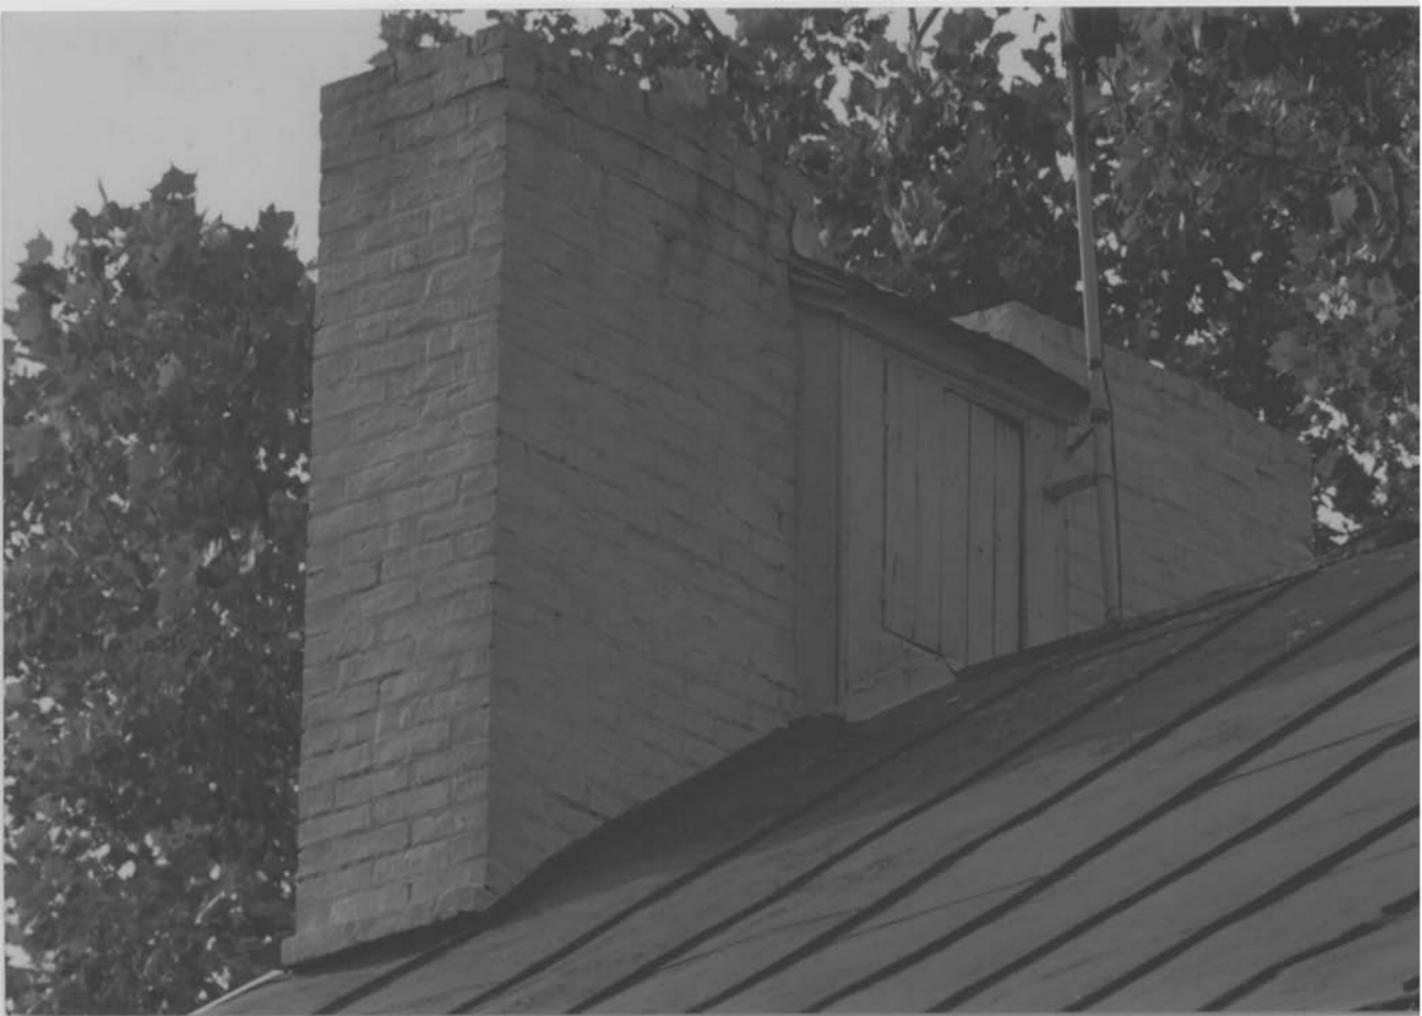
16 OF 17

Neg Loc: Maryland Historical Trust
W. Chimney Detail S&E Elevs

The house is a two-story, five bay by two bay brick structure with a gable roof of standing seam metal with an east-west ridge and with a four-bay by one-bay brick ell on the north or rear elevation that has a standing seam metal gable roof with a north-south ridge. The house was built in two stages. The three western bays of the main block and the ell were built in 1817 and the two eastern bays of the main block were added circa 1844. There were additional alterations as well. The south elevation has Flemish bond on both the original section and the later two-bay addition. There is a center entrance with a four-panel door that has bolection-moulded panels. On either side of the door are side lights with two lights above a bolection-moulded panel. There is a transom with three oval lights. Each jamb and the soffit have panels, and there are paneled pilasters flanking the doorway with a plain frieze and large ogee cornice. The stone sill is in two pieces, suggesting that the original doorway had no side lights. There are two new one-over-one sash on either side of the doorway. The second story has five new one-over-one sash. The window openings have splayed brick jack arches. The brick is painted yellow and appears to be painted red beneath the yellow. The cornice has four courses of corbeled brick. There is a one story five bay porch with a new concrete deck and a half hip roof of standing seam metal. The porch has a stone foundation with several courses of brick on top and brick piers supporting four large square columns that are chamfered. An historic photo shows an earlier version of the porch in which there are eight square columns, consisting of four pairs of two. There is an interior brick chimney on the east gable end and paired interior brick chimneys on the west gable end. The latter have a wood box set between them that has a vertical board door on the east. The roof ridge has lightning rods.
