MD 482 over east Branch

MARYLAND INVENTORY OF HISTORIC BRIDGES  
HISTORIC BRIDGE INVENTORY  
MARYLAND STATE HIGHWAY ADMINISTRATION/  
MARYLAND HISTORICAL TRUST

MHT No. CARR-1559

SHA Bridge No. 6036 Bridge name MD 482 over East Branch

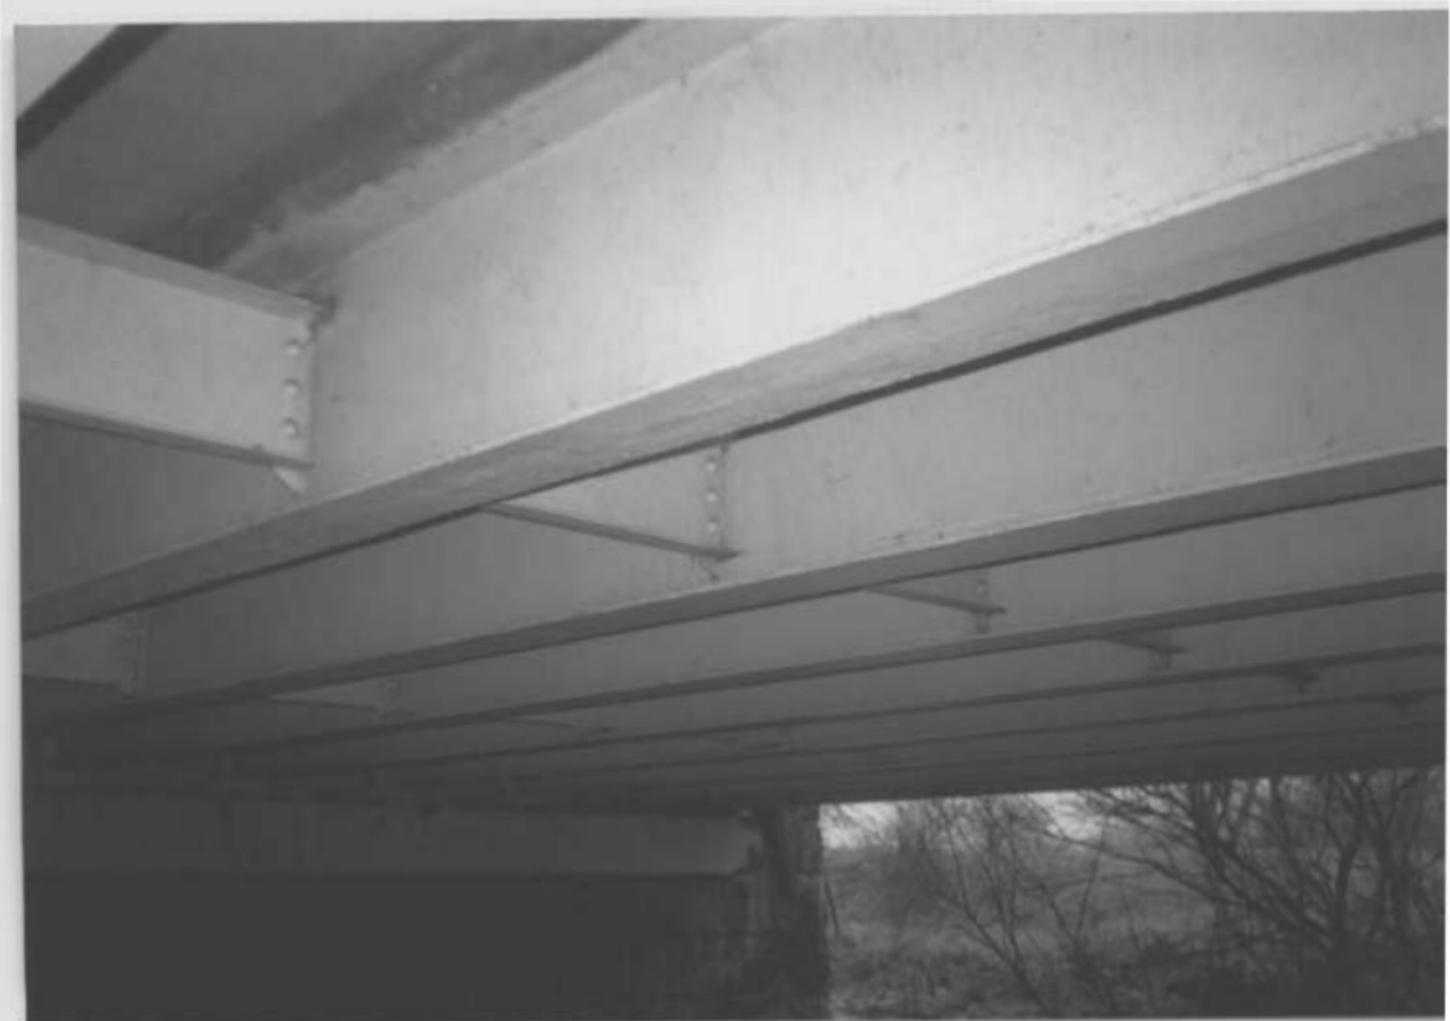
1. CARR-1559
2. MD 482 over EAST Branch  
(6036)
3. Carroll
4. Eric Griffiths
5. 3-97
6. MD SHPO
7. detail of Girders under  
Bridge
8. 10+6

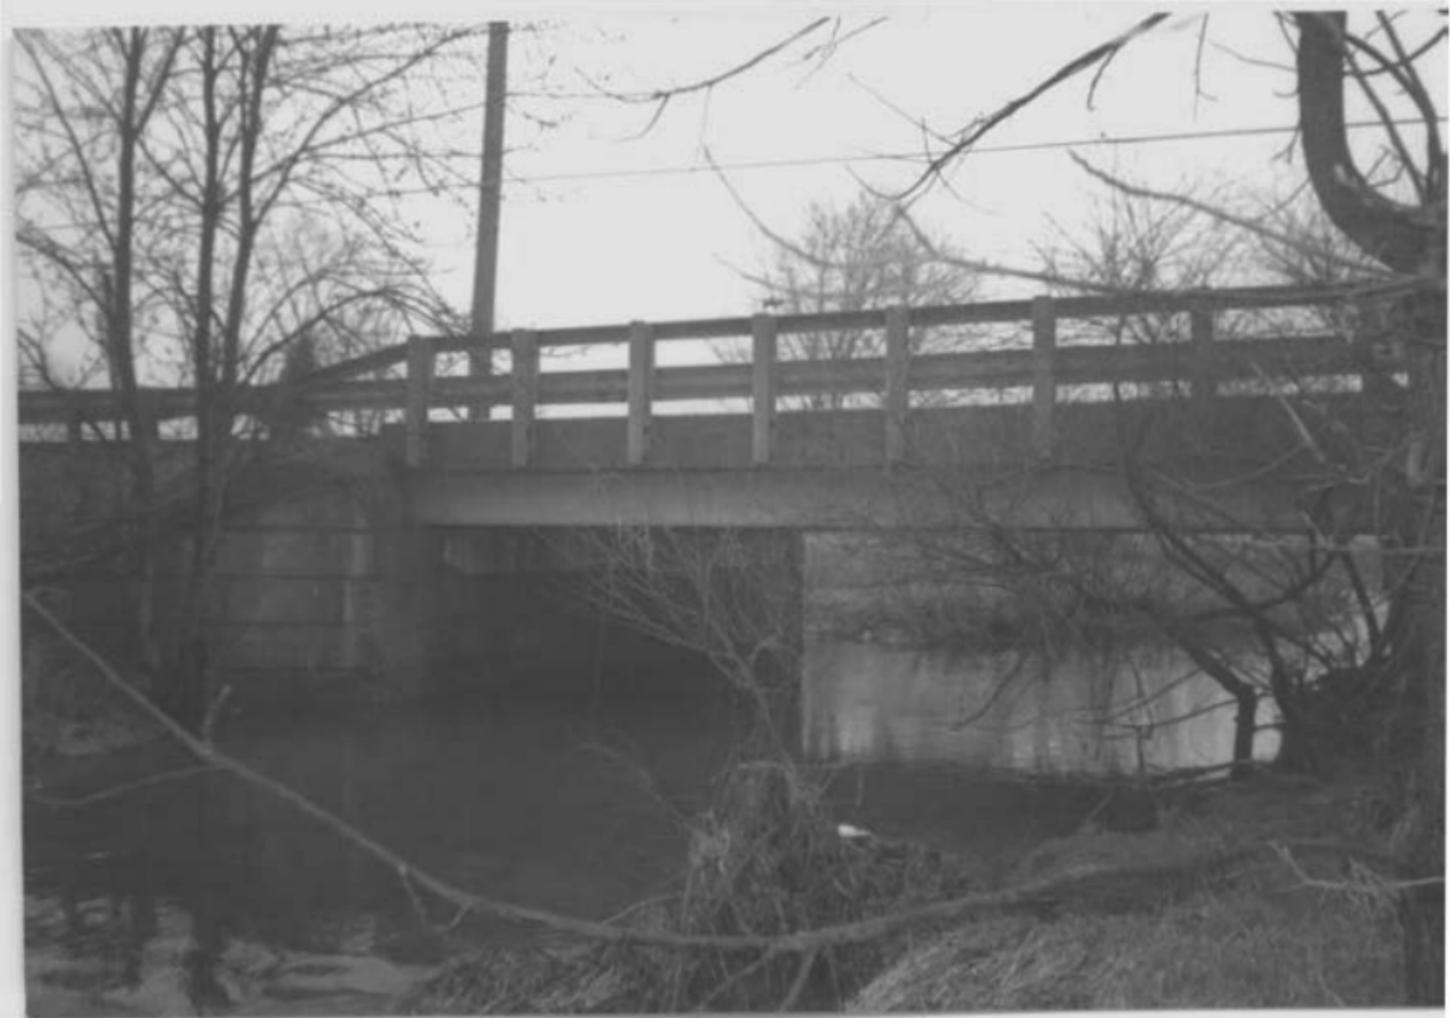
7. South Elevation of Bridge

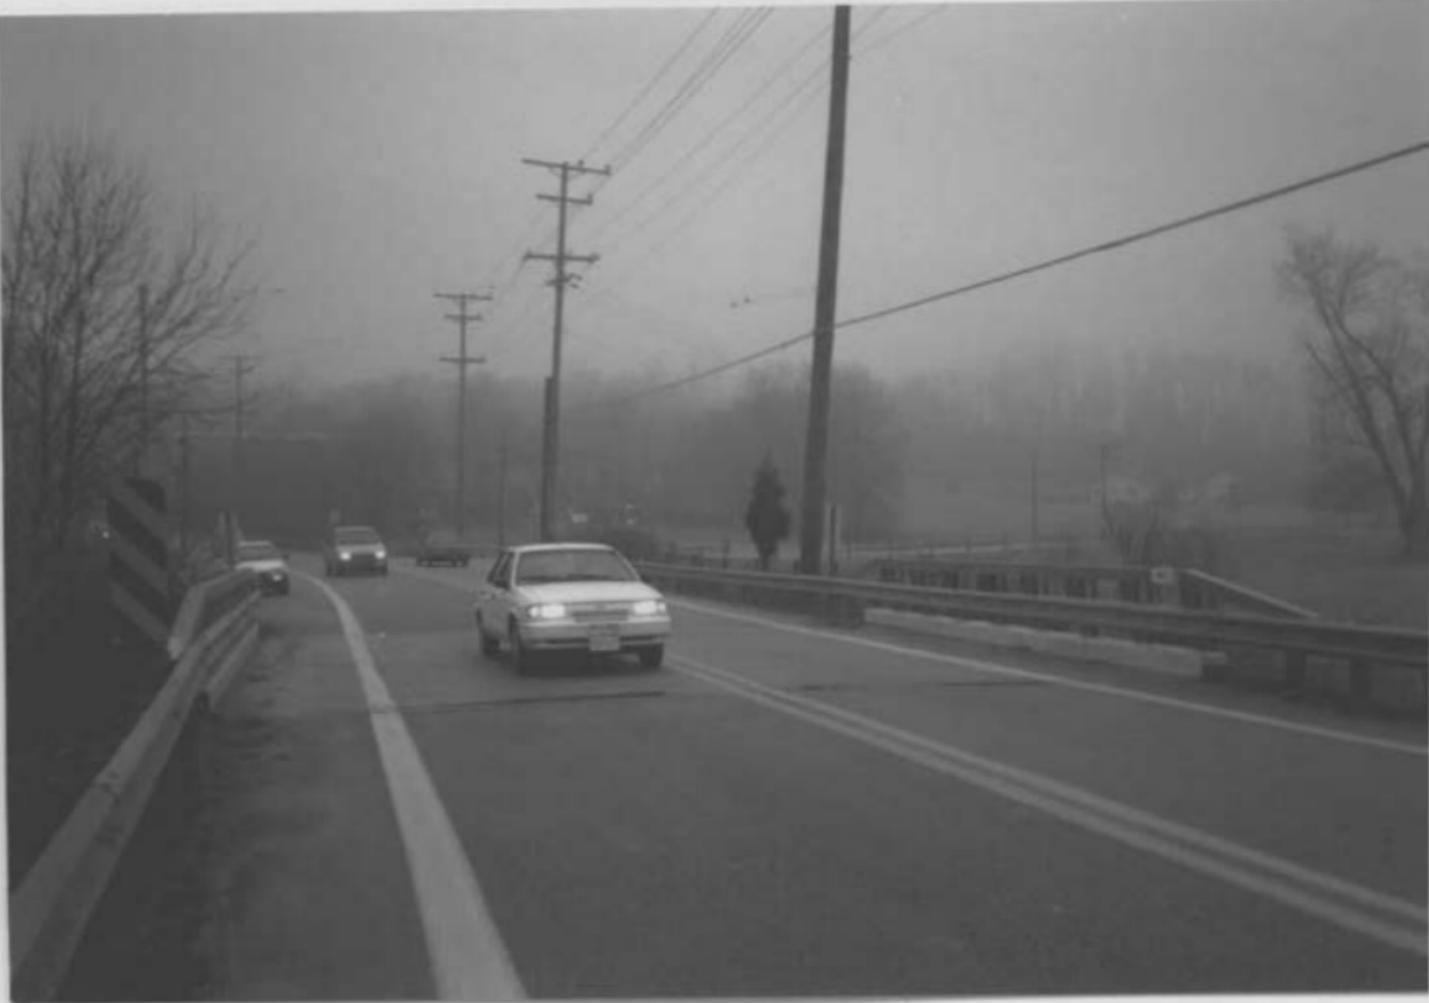
1. CARR-1559
2. MD 482 over EAST Branch  
(6036)
3. Carroll
4. Eric Griffiths
5. 3-97
6. MD SH90
7. West Approach
8. 30+ 4

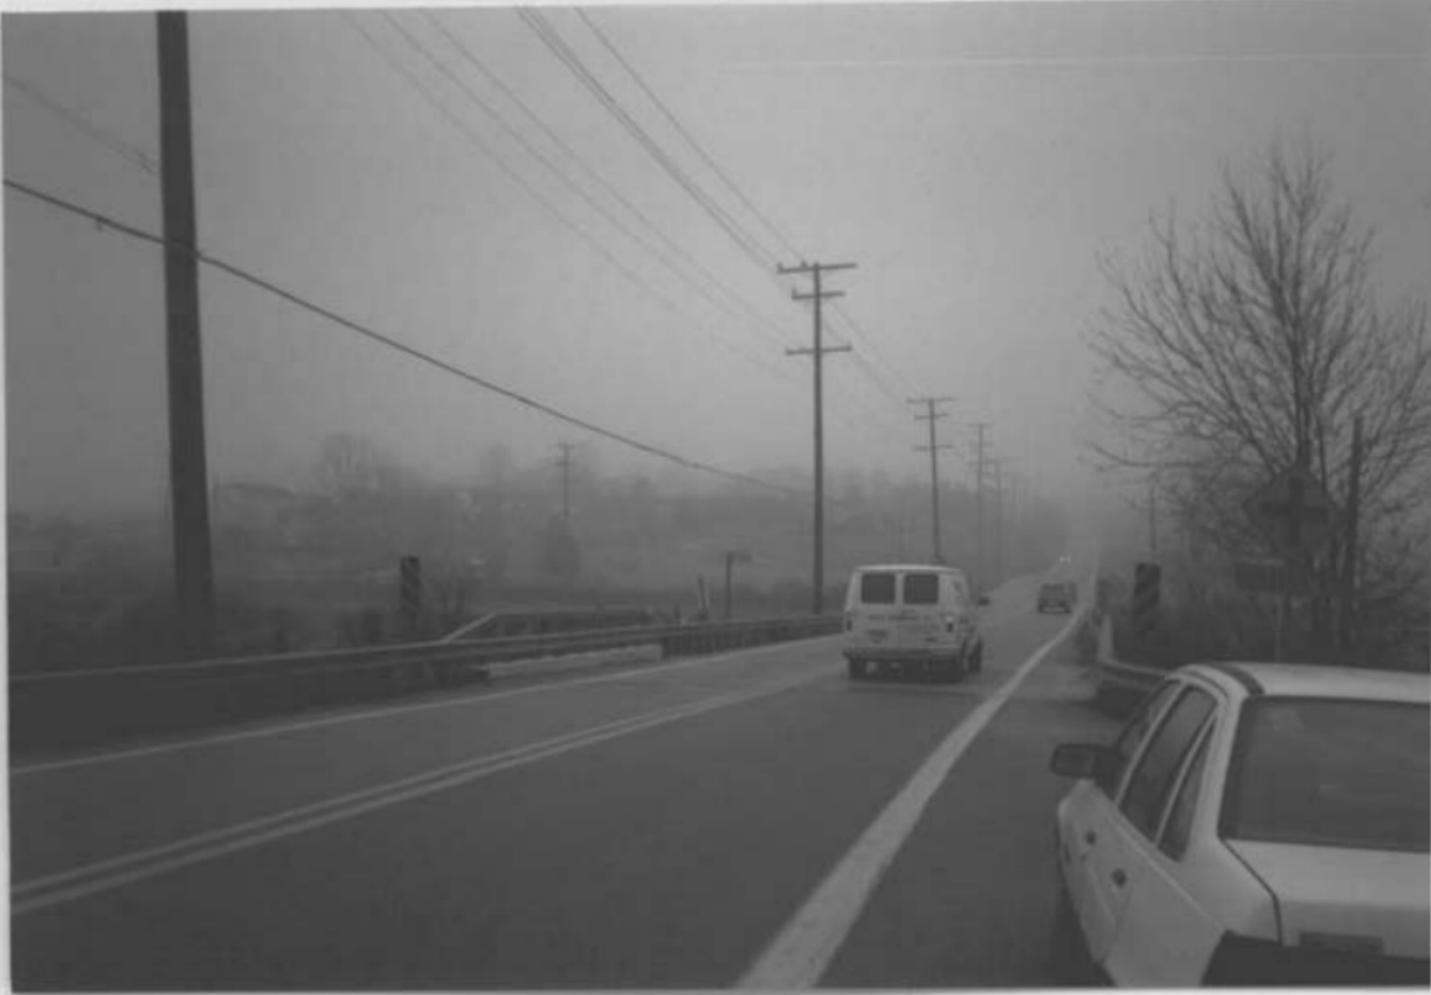
1. CARR-1559
2. MD 482 over EAST Branch  
(6036)
3. Carroll
4. Eric Griffiths
5. 3-97
6. MD SHPD
7. EAST Approach
8. 4 of 6

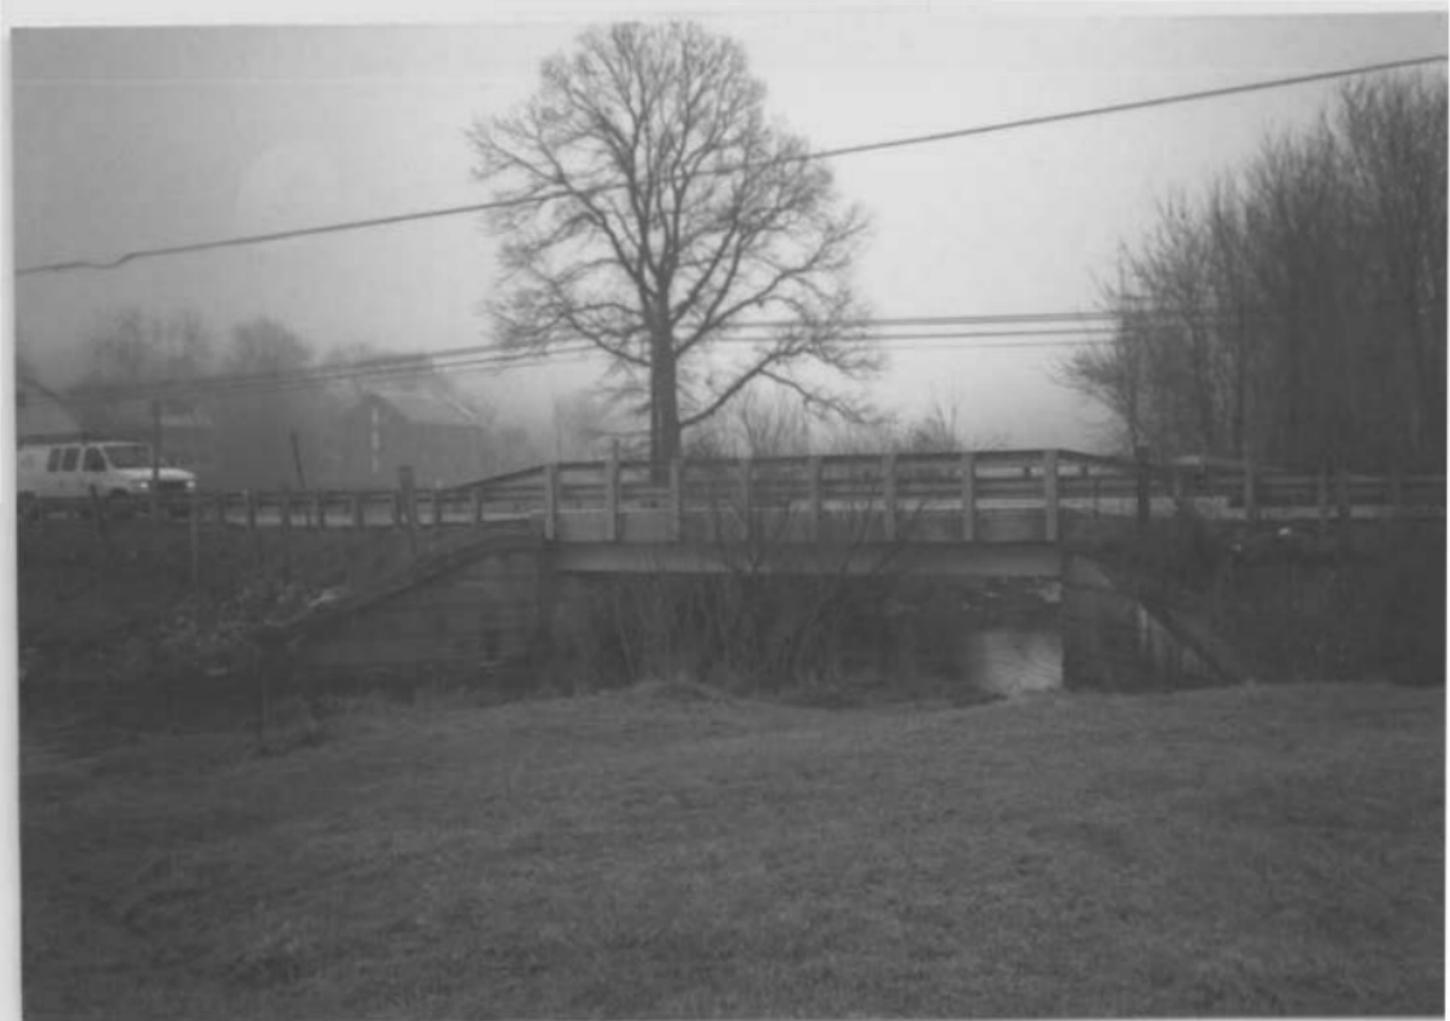
1. CARR-1559
2. MD 482 over East Branch  
(6036)
3. Carroll
4. Eric Griffiths
5. 3-97
6. MD SHPD
7. North Elevation
8. 5 of 6

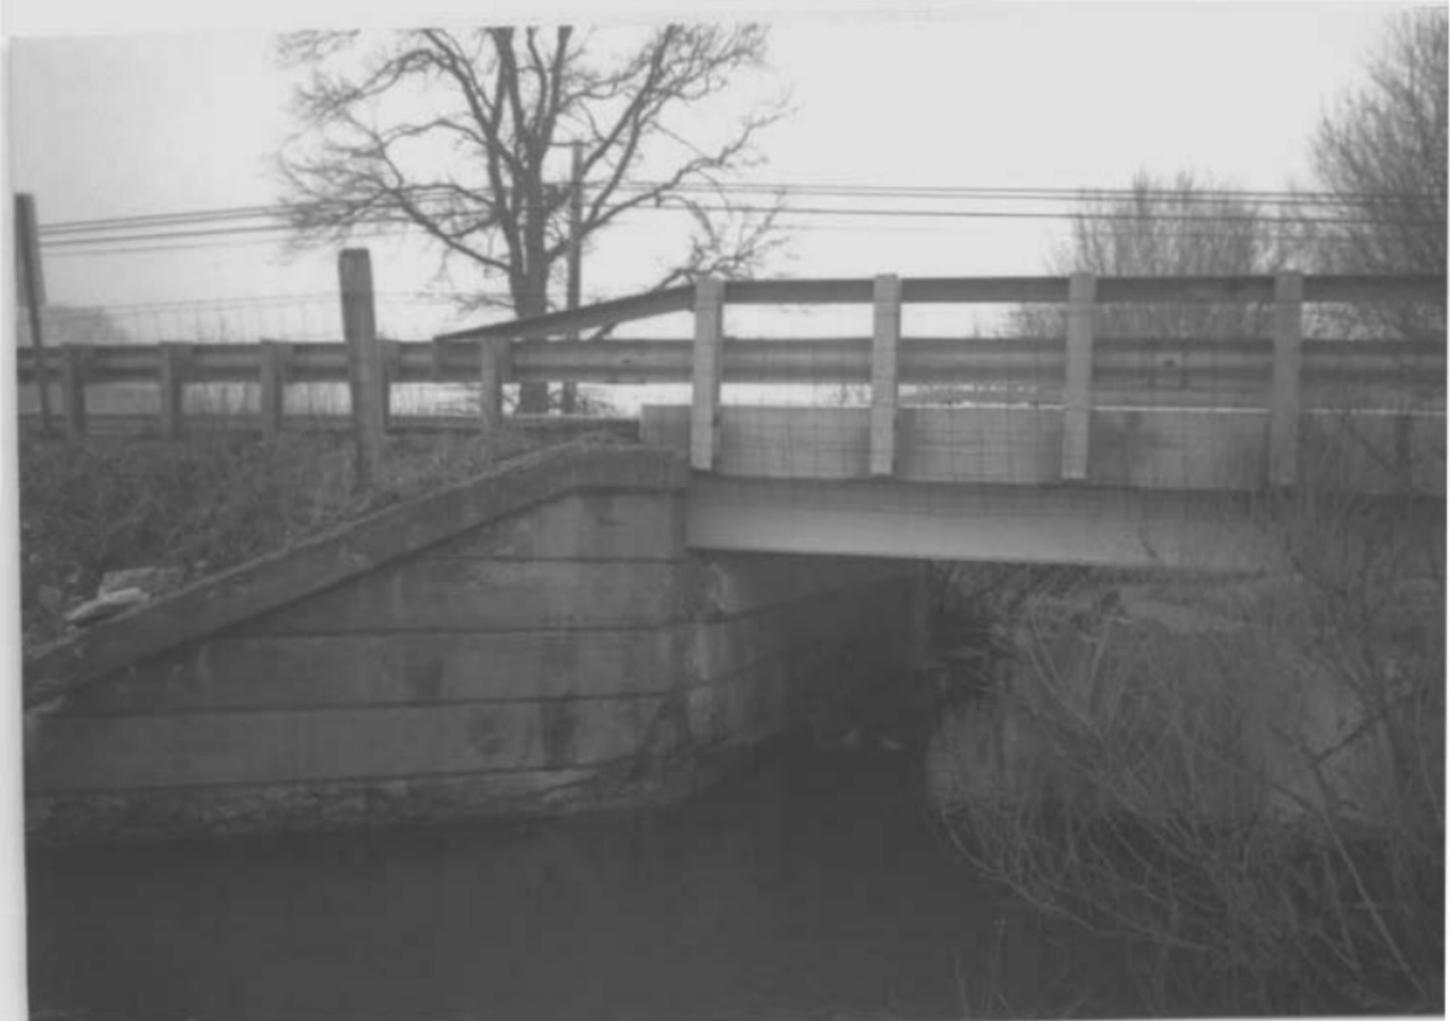
According to the 1995 inspection report, this structure is in fair condition with minor section loss, cracking, spalling, and scour. The girders have minor pitting and section loss in the web areas and bottom flanges. The concrete surface has some light surface erosion. The concrete is in poor condition in the substructure. The abutments have spalling and horizontal cracking. There is heavy spalling at the west abutment and wing wall. There is also scour along the northeast wing wall and the west abutment.

1. CARR -1559
2. MD 482 over East BRANCH  
(6036)
3. Carroll
- 4 Eric Griffiths
5. 3-97
6. MD SHPD
7. Condition of Northeast Wingwall
8. lot 6
