CARR-1585

405 S. Main Street, Mt. Airy

**Maryland Historical Trust
State Historic Sites Inventory Form**

historic Calvary United Methodist Church Parsonage

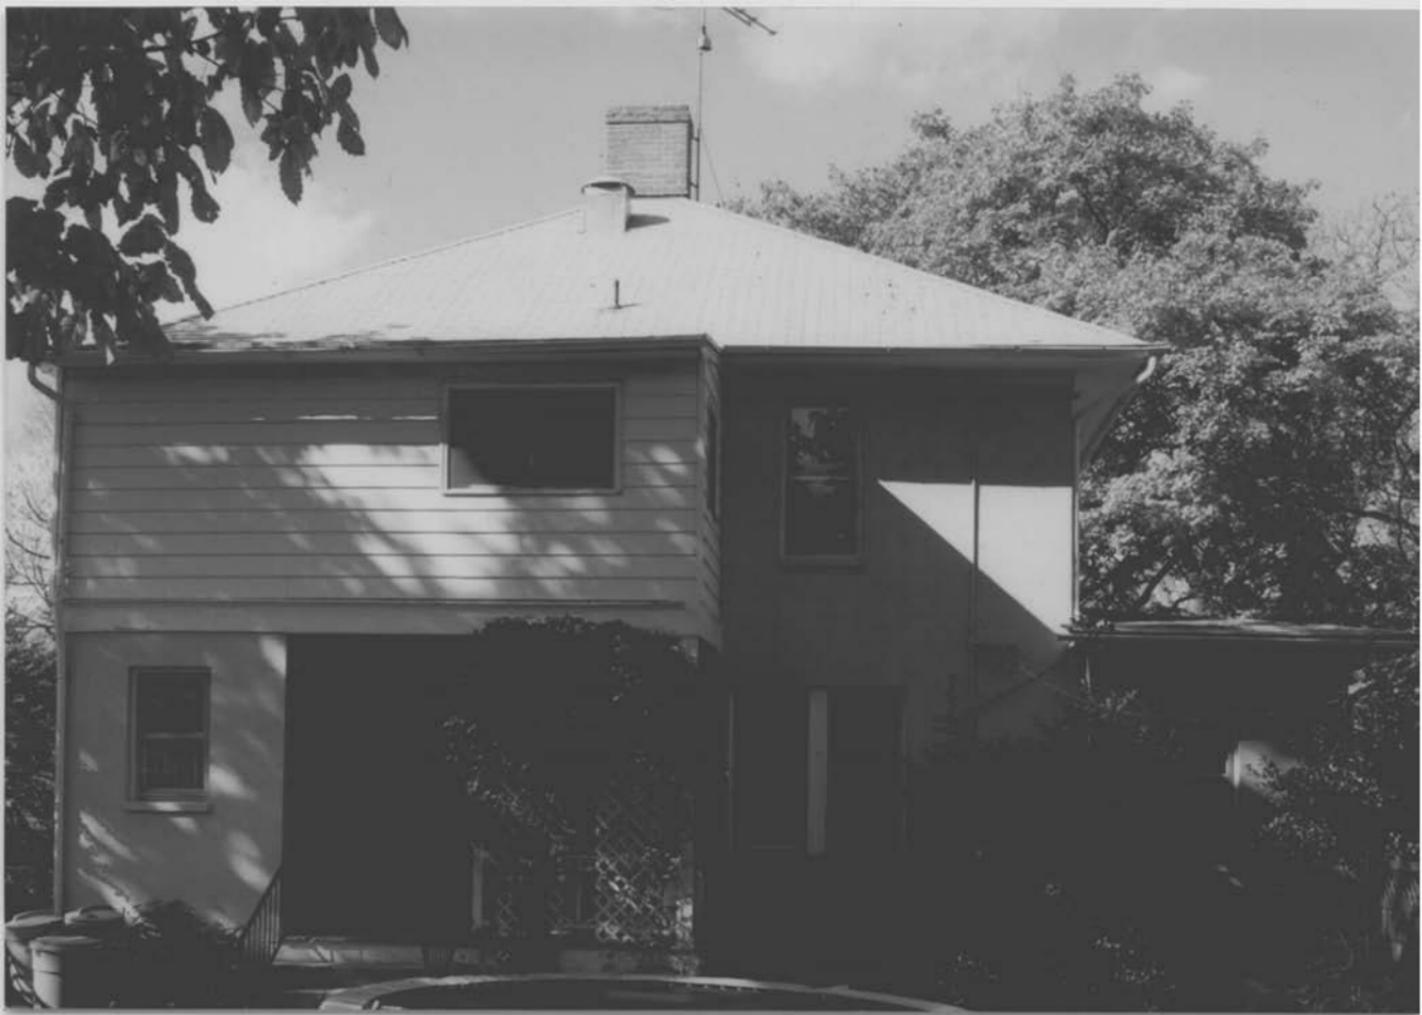
10F5

SE. Elevation

The first story of the southeast elevation has a projecting pantry on the south that has a 1/1 sash set south of the south bay. The south bay has a one light over three light and paneled door. The east bay has paired 1/1 sash. The second story has a porch that is now enclosed with aluminum siding and 2 one light casements. This porch covers the south two-thirds of the house with a turned post under the east corner. The east bay has a 1/1 sash. On the southwest elevation, the first and second stories each have two 1/1 sash. In the center between the first and second stories, there is a 1/1 sash set at the stair landing level.

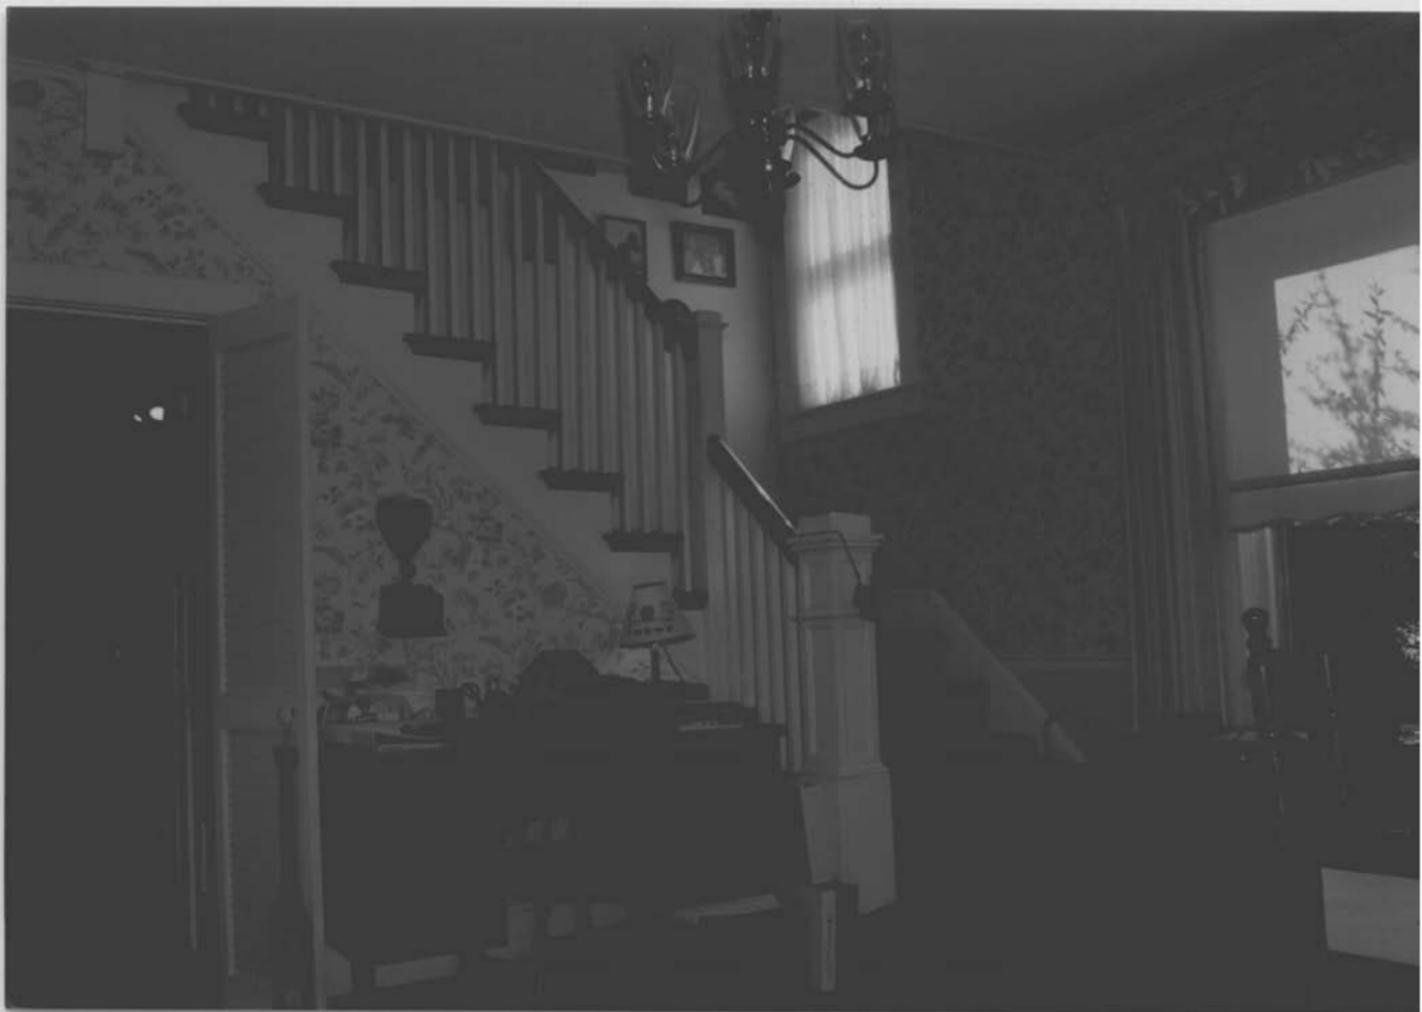
20F5

West Rm - VW South Elevation

The first floor plan is divided into four rooms with a pantry off the southeast end of the house set to the south and an office off of the northeast end of the house set to the east. The first story has oak flooring running northeast to southwest throughout. The west room is an entrance foyer with a two run stair in the south corner. It has a paneled newel post and rectangular in plain balusters and a molded hand rail. The architraves are plain and are rounded off on the corners and are mitered. They were apparently natural varnished pine originally. The northeast elevation has a double wide door opening leading to the north room. The north room has a brick fireplace in the south corner with a wood mantel that has a reeded architrave and a dental cornice. This room has a double wide door opening on the southeast

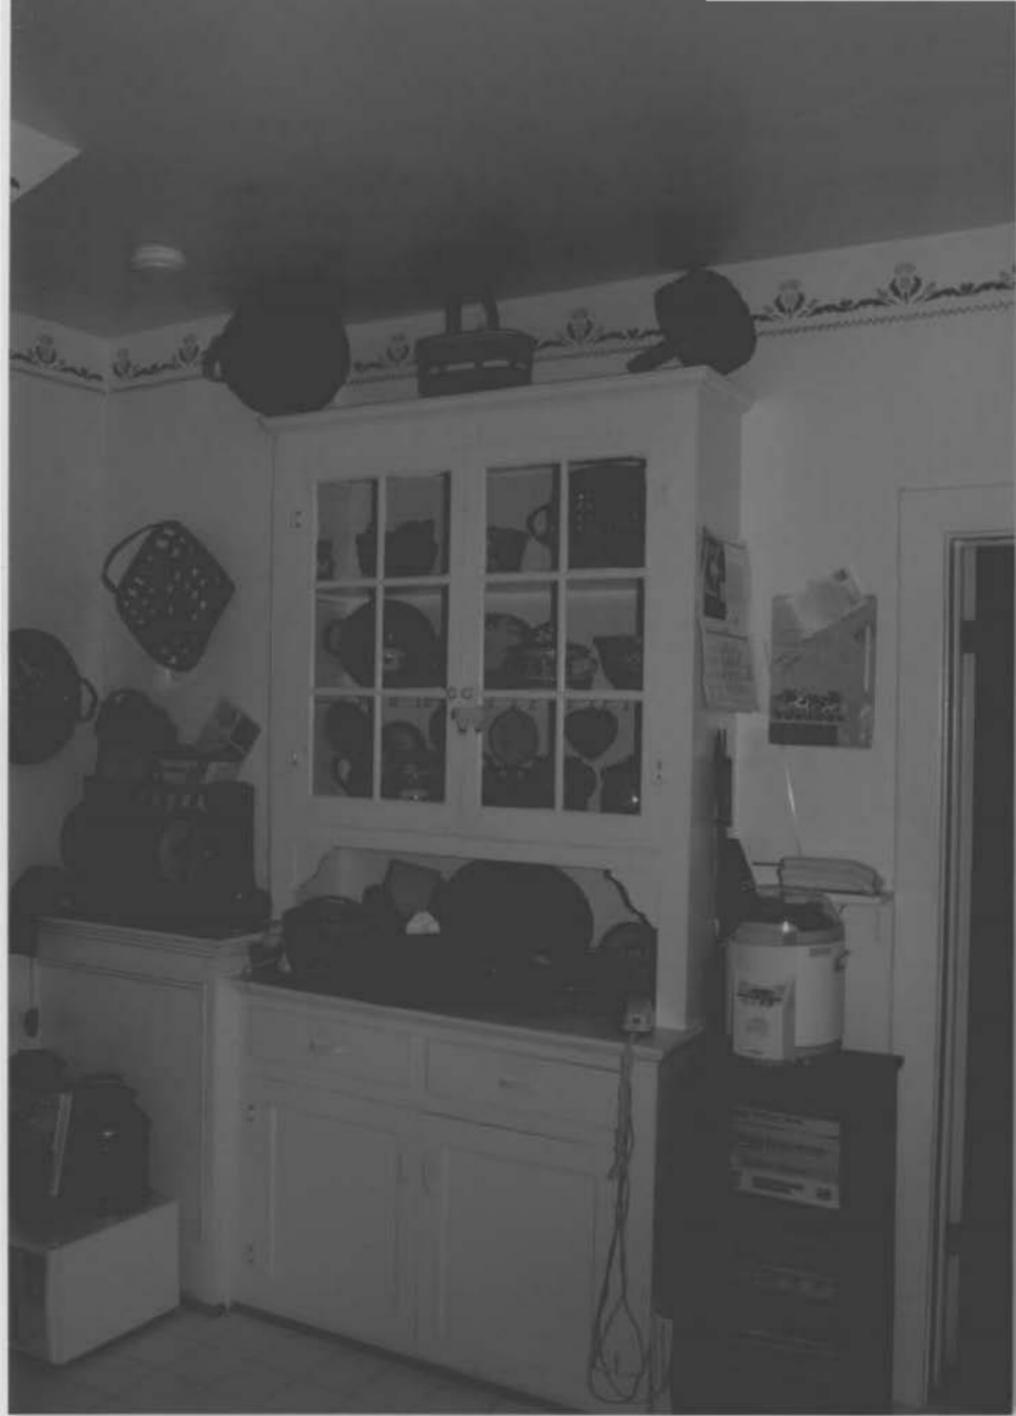
3 OF 5

Neg loc.: Maryland Historical Trust
South Rm - Cupboard

The east room has an exterior side door on the northeast elevation. There is an original built-in corner cupboard in the south corner. It appears this was originally varnished pine and has two glazed doors. There is an ogee cornice molding at the top and there are five shelves inside. The northeast elevation has a door with five lined panels that leads to the northeast room. The northeast room was probably originally an office. It has an original radiator on the northeast elevation. Most of the other rooms in the house have had the radiators replaced with baseboard units. The south room is a modern kitchen and it appears this room always functioned as a kitchen. The northeast elevation has a furnace flue and a built-in wood cupboard to the north of it that has two 6-light doors above a shelf; two drawers below the shelf and two one panel doors at the bottom. There is a five line paneled door to the cellar stairs. On the southeast elevation is a door with one light over three lined panels that leads to the rear porch. To the south of this is a door with five lined panels that leads to the pantry.

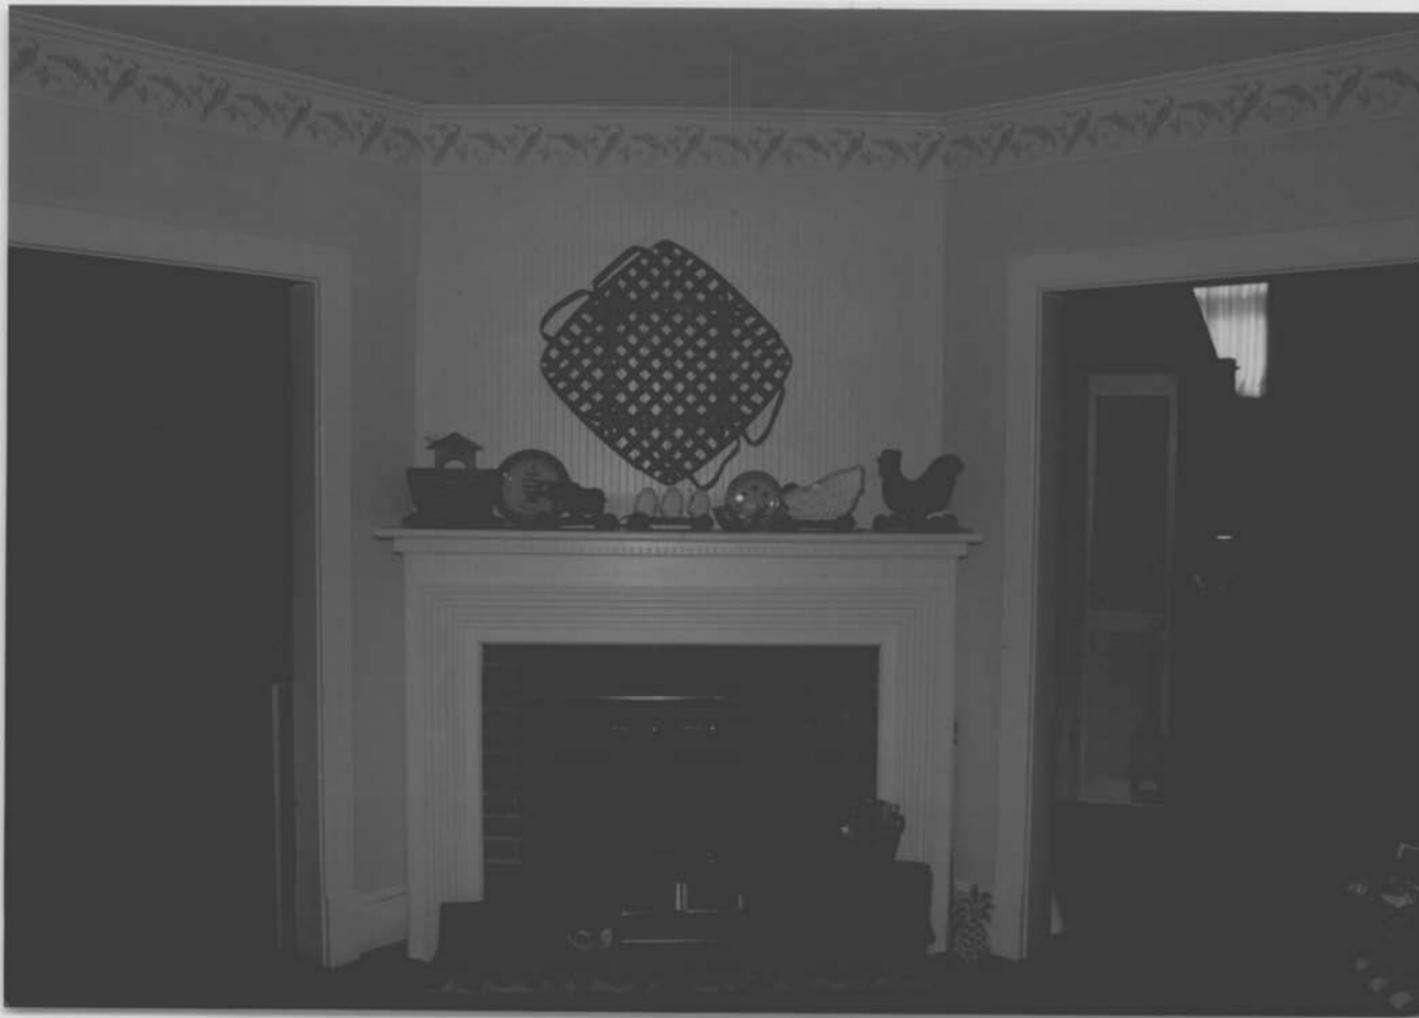
4 of 5

North Rm - VW South Elevation

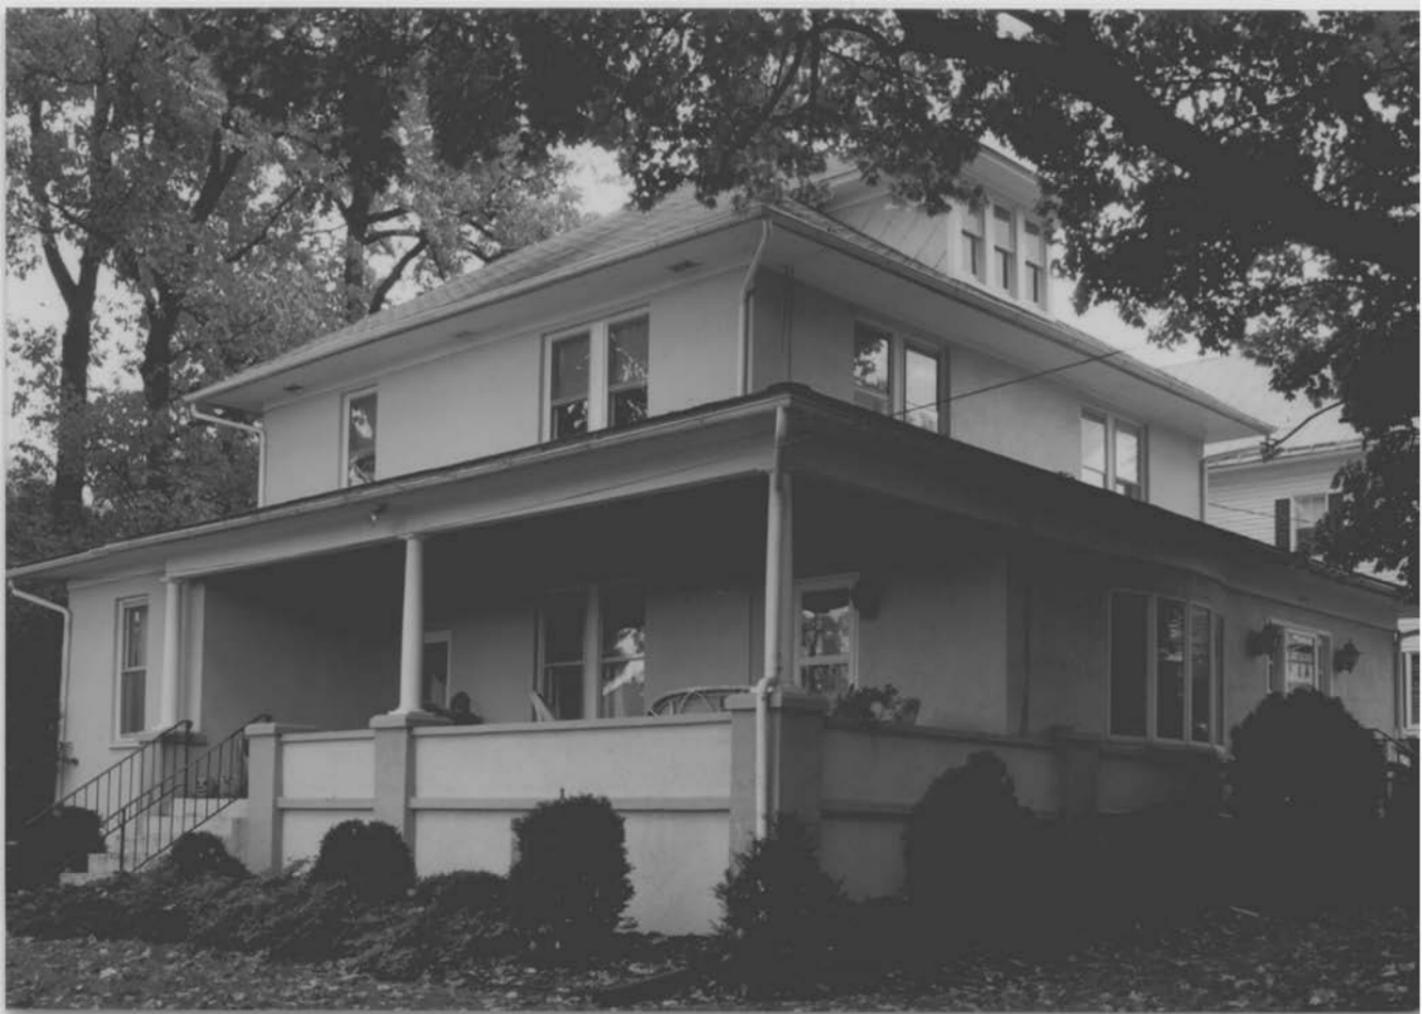
50F5

NE & NW Elevations

On the northwest elevation, the first story has a porch that is enclosed on the northwest with a bay window and a door with side lights. This porch wraps around on the northeast elevation but is not enclosed there. The second story of the northwest has paired 1/1 sash in both bays. The house has a wide over-hanging eave. There is a dormer with three 1/1 sash. The dormer has a hip roof with a widely over-hanging eaves. The sides of the dormers have diamond pattern asphalt shingles. The northeast elevation on the first story has a room at the east end of the porch. This is not a later enclosure of part of the porch but appears to be an original room. The room has a 1/1 sash on the northeast elevation and a wide over-hanging eave. The porch has Tuscan columns set on stuccoed piers with stuccoed balustrade walls between the piers. In the center of the first story is a door with one light over two square panels that have wreaths and swags carved on them and one lined panel at the bottom of the door. Above the two square panels, the rail has carved foliage. The north bay has paired 1/1 sash. The porch is enclosed at the north end with a door that has nine lights over two panels. The second story has a 1/1 sash in the east bay and paired 1/1 sash in the north bay.
