CARR-1587

2224 Bowersox Road, New Windsor

**Maryland Historical Trust  
State Historic Sites Inventory Form**

historic Sallie A. Smith Farm

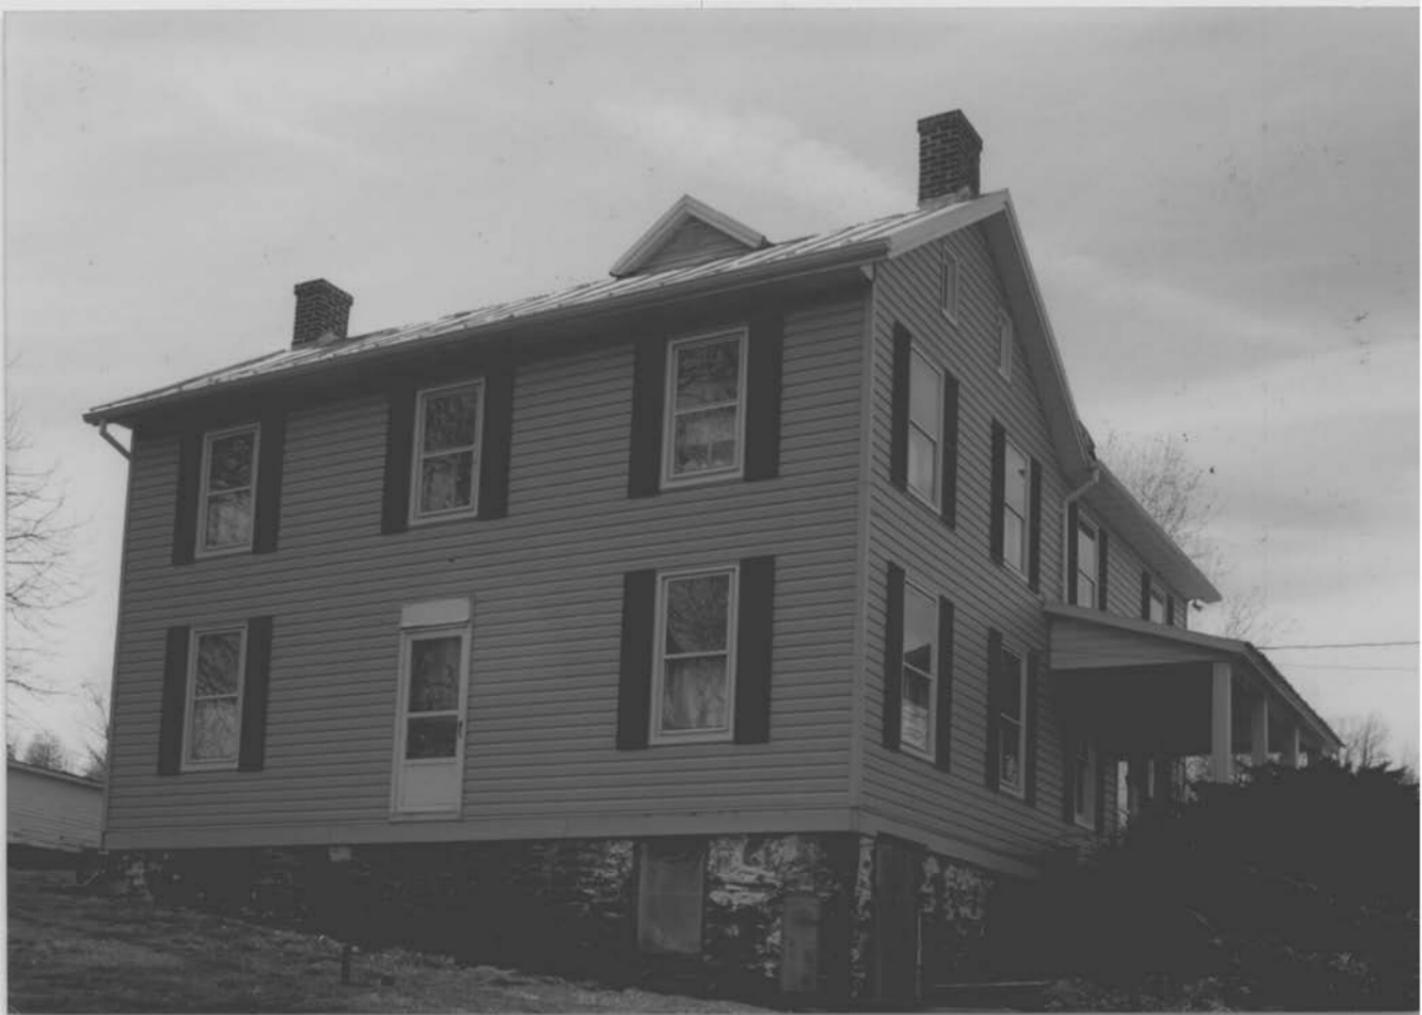
NEG. LOC: MARYLAND HISTORICAL TRUST  
HOUSE - SOUTHEAST & NORTHEAST ELEVATIONS  
1 OF 7

The house is banked into the hill on the northwest and faces southeast. It is a 2 story three bay by two bay frame structure with a 2 story three bay by two bay frame addition on the rear or northwest. The building has a rubble-stone foundation; aluminum siding and a standing seam metal roof with a northeast to southwest ridge. The ell has a northwest to southeast ridge and is set slightly higher than the ridge line of the main block. The southeast elevation has a center entrance with a new doorway. A 1993 photograph of the house shows a front porch that rested on brick piers in this location. It was a one bay one story porch with a hip roof supported by four square posts. There were square balusters above horizontal board rails. The porch has been completely removed. The doorway is flanked by a 1/1 sash on either side, and the second story has three 1/1 sash. These sash are new. There is an interior brick chimney on both the northeast and southwest gable ends. The northeast elevation has a vertical board door in the east bay of the foundation. The first story has two 2/2 sash and the second story also has two 2/2 sash. The gable end has two 1-light sash. The northeast elevation of the wing, which is in the same plane as the gable end of the main block, has a center entrance on the first story with a 1-light transom and a 2/2 sash to each side. There is a shed roof three bay 1 story porch that has standing seam metal, chamfered posts and vertical balusters. The second story has a 2/2 sash in both of the end bays and no opening in the center bay.

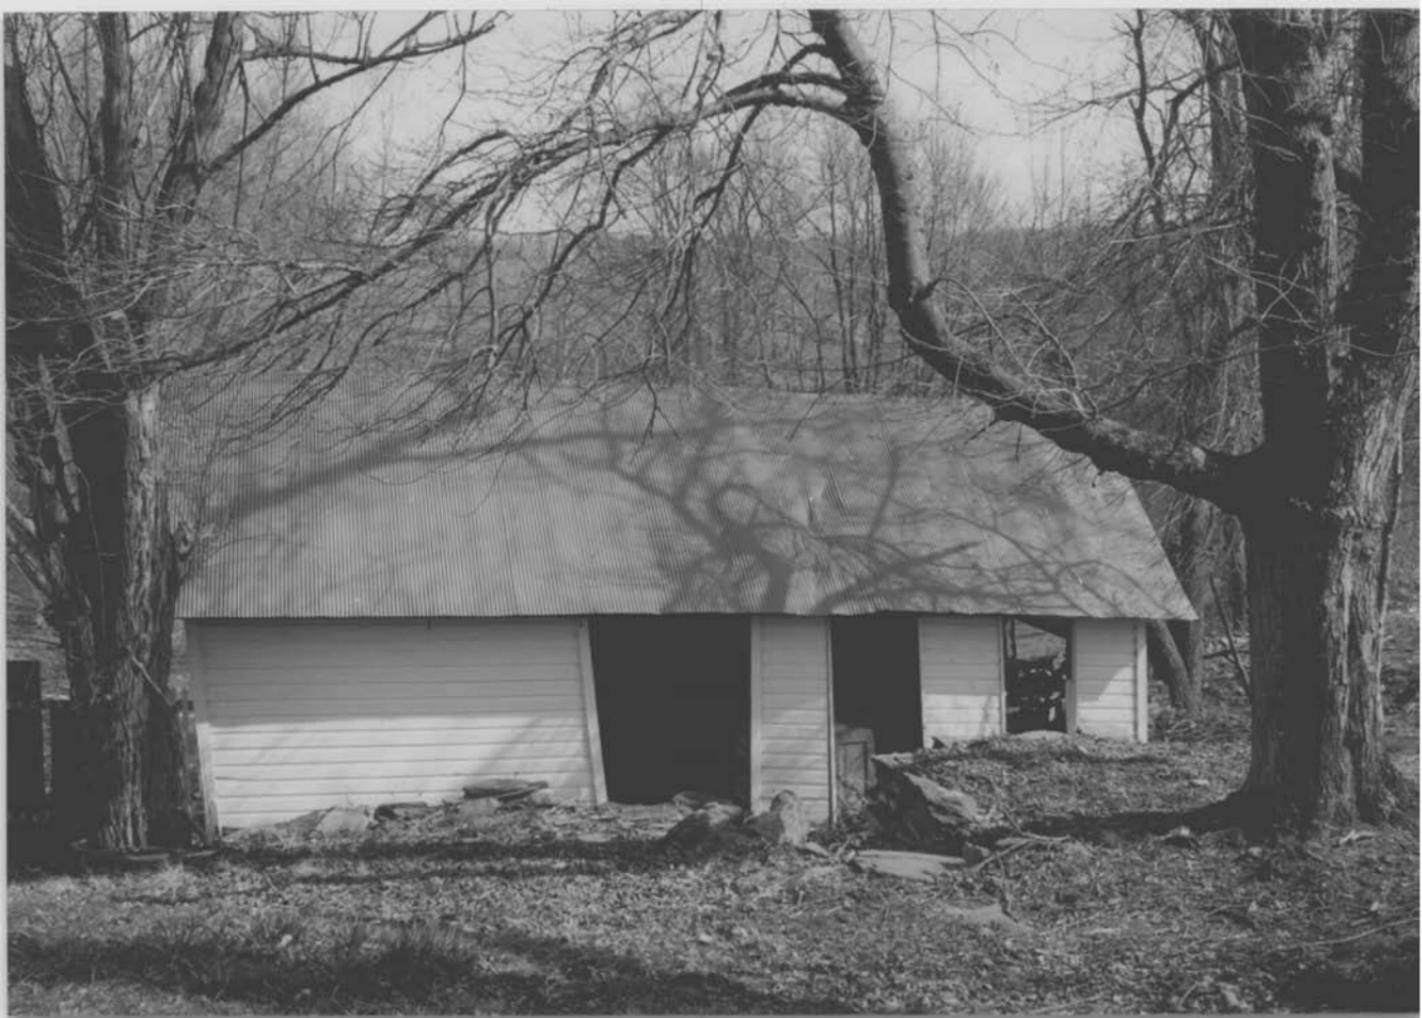
20F7

NEG. LOC: MARYLAND HISTORICAL TRUST  
SPRING HOUSE / SUMMER KITCHEN -  
NORTHWEST ELEVATION

There is a summer kitchen/spring house about 100 feet south of the house. They are two separate structures covered with German siding fastened by wire nails, but they share a common gable roof of corrugated metal with a ridge that runs northeast to southwest. There is an open breezeway or dog trot between the two buildings with openings on the northwest and southeast elevations. The northwest elevation has no openings on the spring house. There is a four panel door with double fields and a window opening to the west of it on the summer kitchen. The northeast elevation has two 1-light casements and a 2/2 double-hung sash in the gable end. The summer kitchen has a rubble-stone foundation and is of two by four construction. It is unfinished on the interior. There is a brick exterior chimney on the southwest end that is collapsed. The spring house has a concrete foundation with circular sawn construction. The roof rafters are also circular sawn and are mitered at the ridge. They are fastened with wire nails. About 4 feet northwest of the building is a rubble-stone wall that parallels it. In the center of this wall lining up with the breezeway is a set of stone stairs.

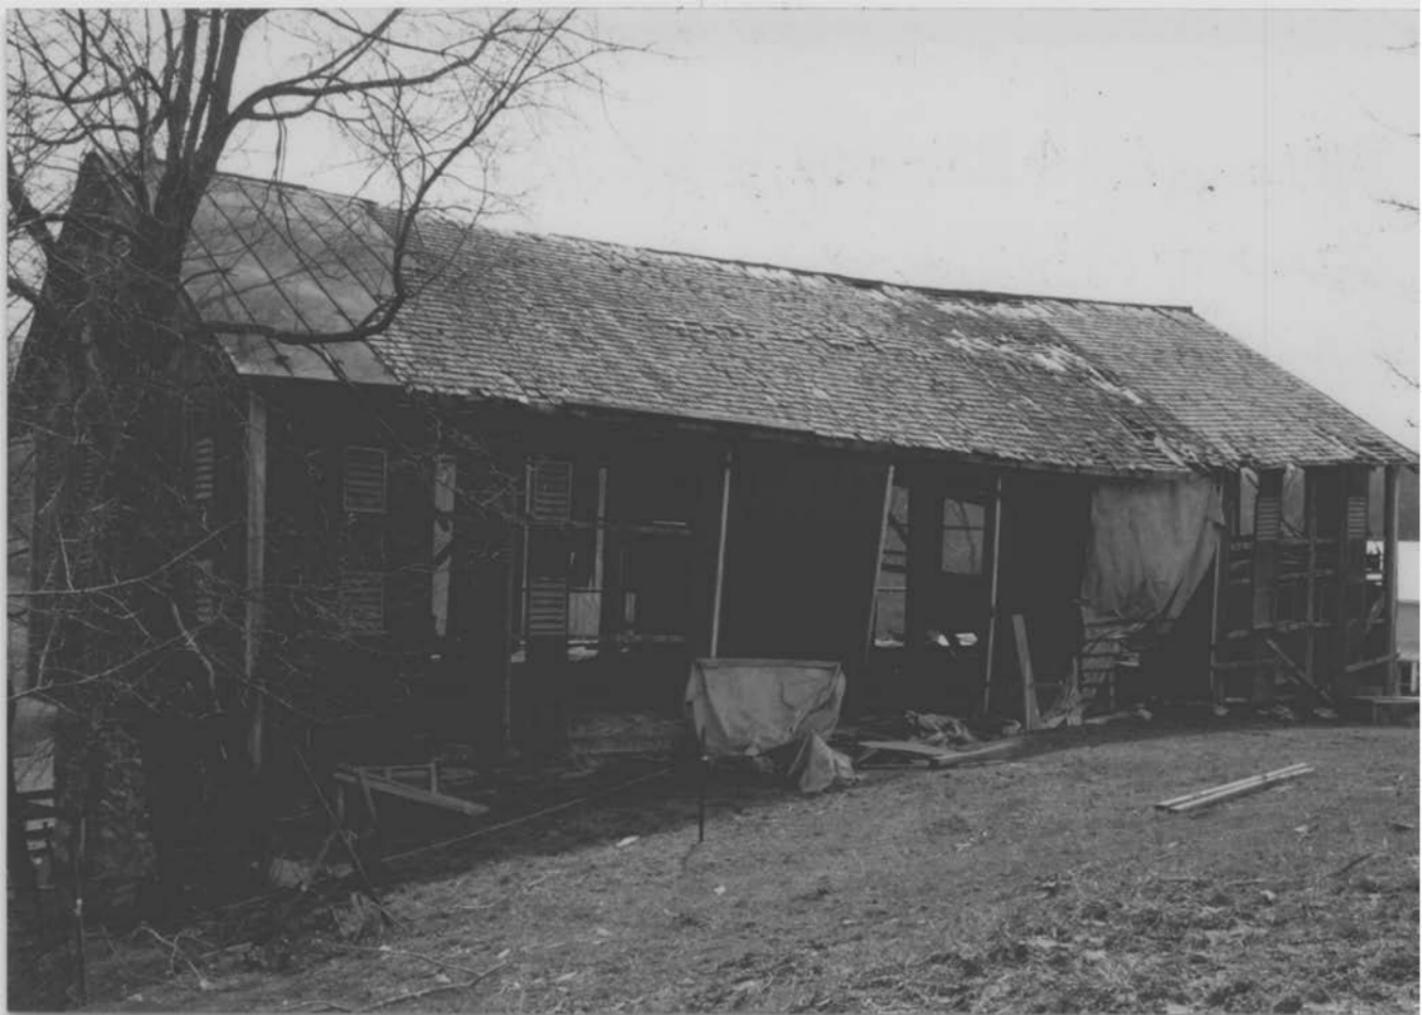
BARN - NORTHEAST & NORTHWEST ELEVATIONS  
4 OF 7

About 125 feet northeast of the house is a frame bank barn with a four bay that faces southeast. It has rubble-stone on the lower story on three elevations with frame on the southeast elevation. The upper story is also of frame. The barn has a gable roof of standing seam metal with a northeast to southwest ridge. On the southeast elevation, the lower story has a horizontal flush board wall. From south to east, this wall has a door opening that had a Dutch door on strap hinges; a vertical board Dutch door on tapered strap hinges with round ends; a boarded-up opening; a door opening that had a single door on strap hinges; a vertical board door on typical strap hinges; a boarded over low opening; a vertical board Dutch door on machine made strap hinges and a door opening that originally had a Dutch door. The upper story is missing most of its vertical board siding. From south to east are two wood louvered vents over two more vents; paired vertical board doors on butterfly hinges over similar doors on tapered strap hinges; two vents over two vents; a single vertical board door on butterfly hinges and two vents over two vents.

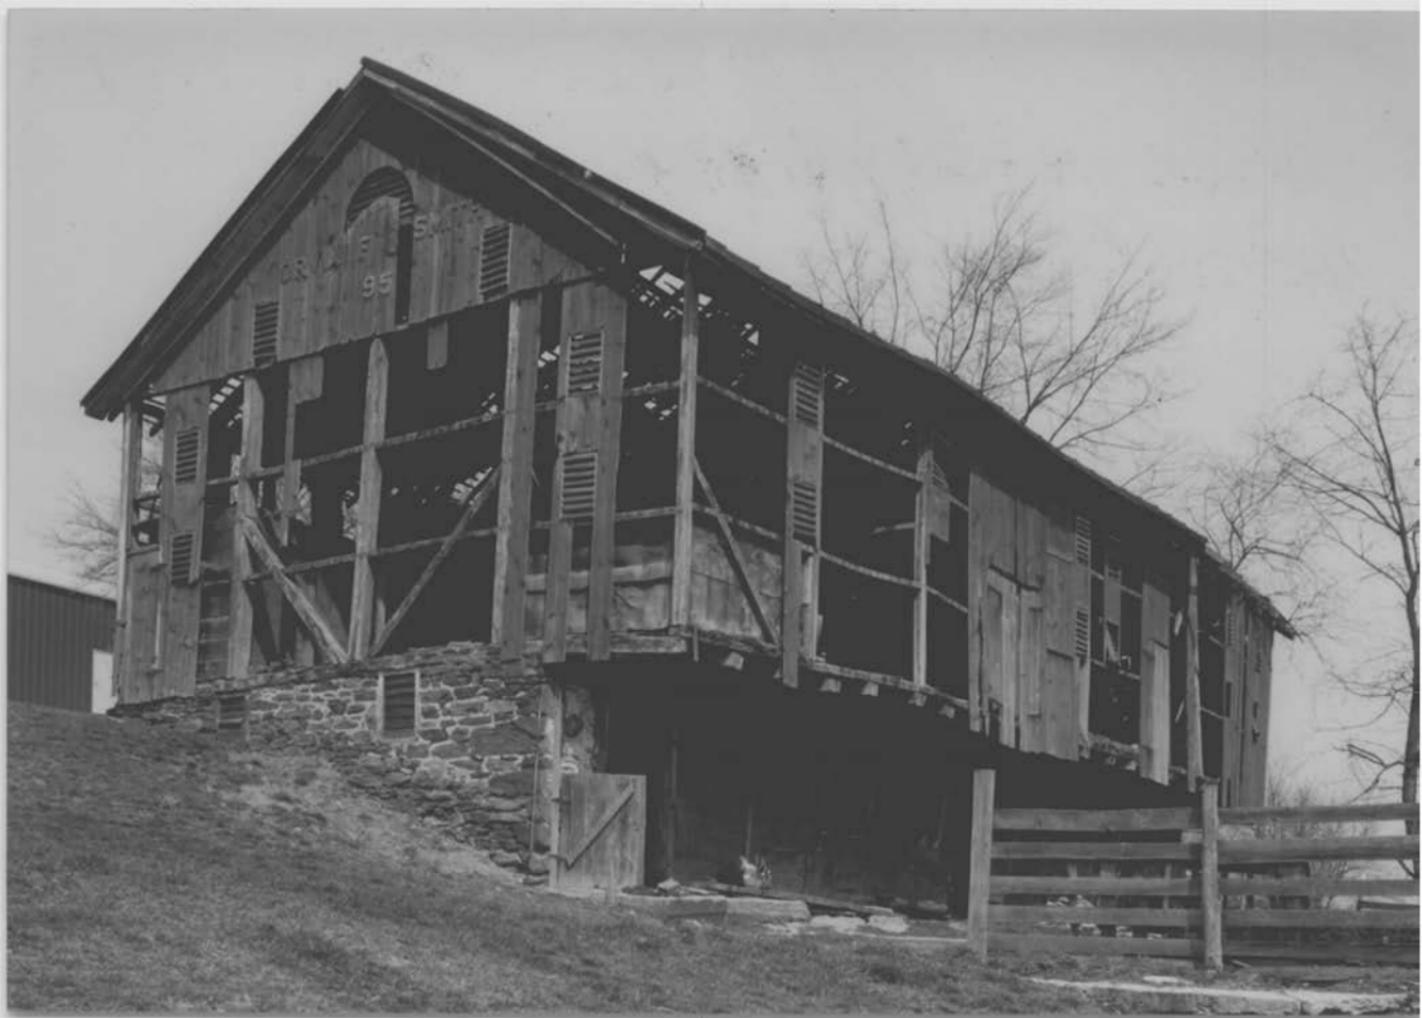
5 OF 7

BARN-SOUTHWEST & SOUTHEAST ELEVATIONS

The southwest elevation on the lower story has two adjustable wood louver vents. The upper story has a grainery door of vertical boards hung on butterfly hinges at the west end corner. Evidence suggests that the upper story had four vents above four vents, but only the two end vents survive. The gable end has a lunette vent with plywood letters below that spell out ORVIL [L] E [R] SMITH [1] 95 [2?]. Below this are two wood vents. On the northwest elevation, the lower story has two adjustable wood louver vents at the north corner. The stone has collapsed at the north corner and along the northwest wall. The upper story has two pair of large wagon doors in the center. These doors have vertical boards and are hung on machine made strap hinges. To the north of these doors are two vents above two vents. The siding here is partially missing and there could have originally been three vents over three vents. To the west of the doors are two vents over two window openings. One of these openings has a single light in an altered 4-light sash. Most of the metal has been removed from the roof on the northwest elevation exposing earlier wood shingles. On the northeast elevation, the lower story has two window openings. The upper story has four vents above four vents. The gable end has a lunette vent and two vents below it.

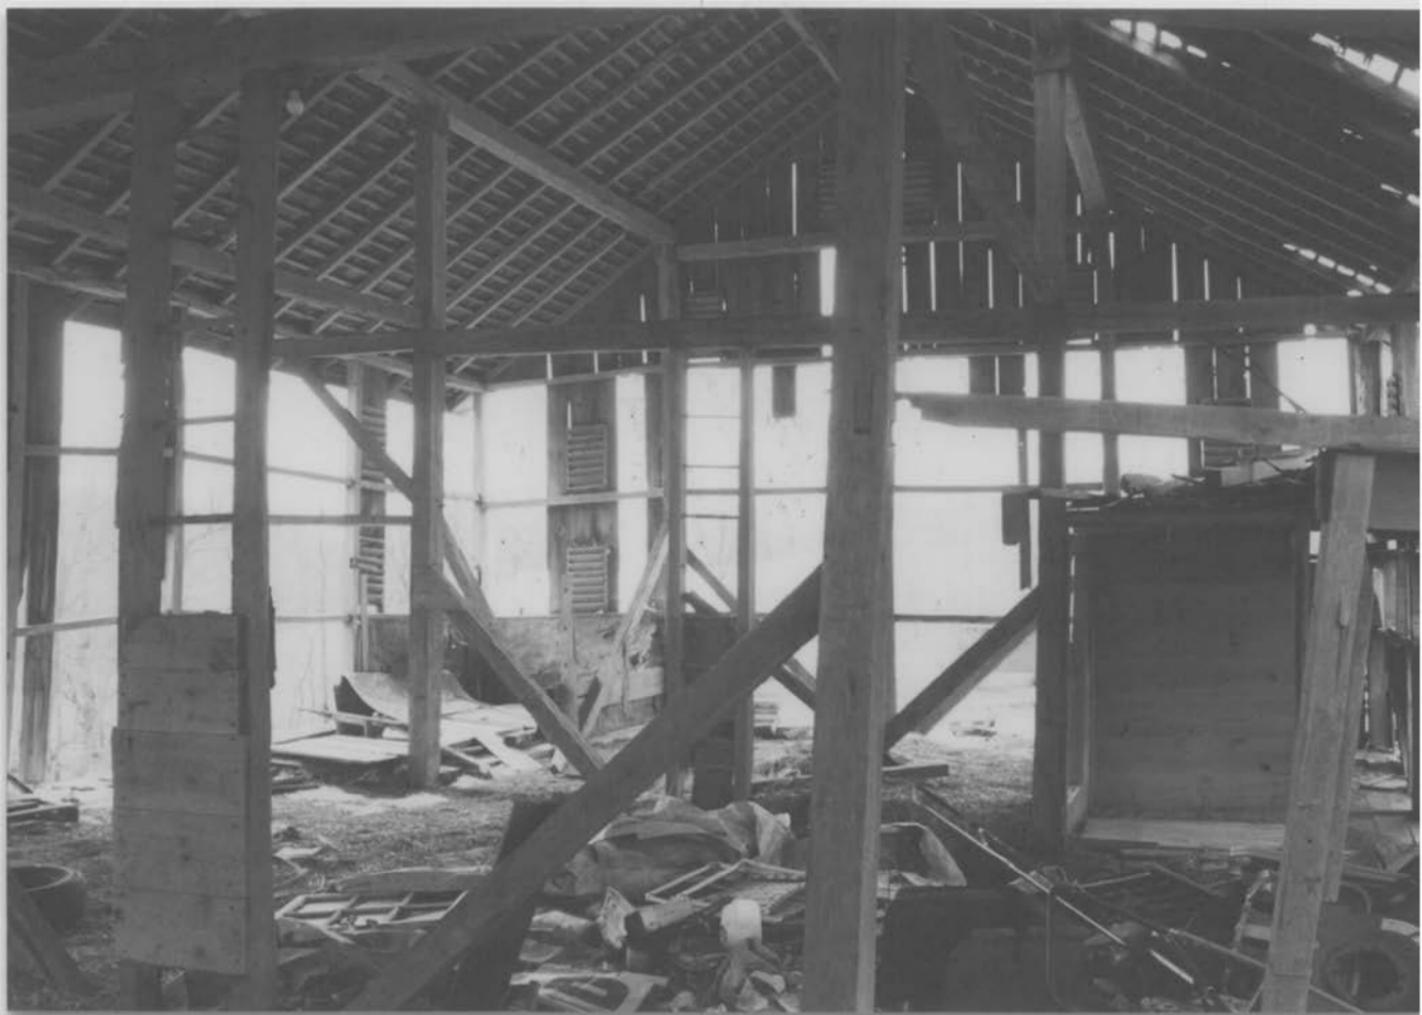
6 OF 7

BARN - UPPER STORY INTERIOR - VW SW

The upper story of the barn is four bays. It has two center threshing floors with a hay mow on each end and a grainery in the west corner. The three bays to the southwest are original and the bay to the northeast was added later. The four original vents have had many members cut out. The posts, braces and girts are all hewn and morticed and tenoned and pegged. The latter posts and four bay framing is all sash sawn. The rafters are sawn and are approximately three by threes that are mitered at the ridge. They support lath and wood shingles. There is a wood hay

track below the ridge. The northeast bay is circular sawn timber that is morticed and tenoned and pegged. The rafters here appear to be the same as though the roof was replaced when the addition was made. There are center posts beneath the purlins in each hay mow and down braces as well. These rest on a sill set on top of the floor. The original section never had these center posts. The wood louver vents are all fastened with wire nails. There are numerous holes in the roof and floor of the barn which is extremely deteriorated and is scheduled to be demolished.

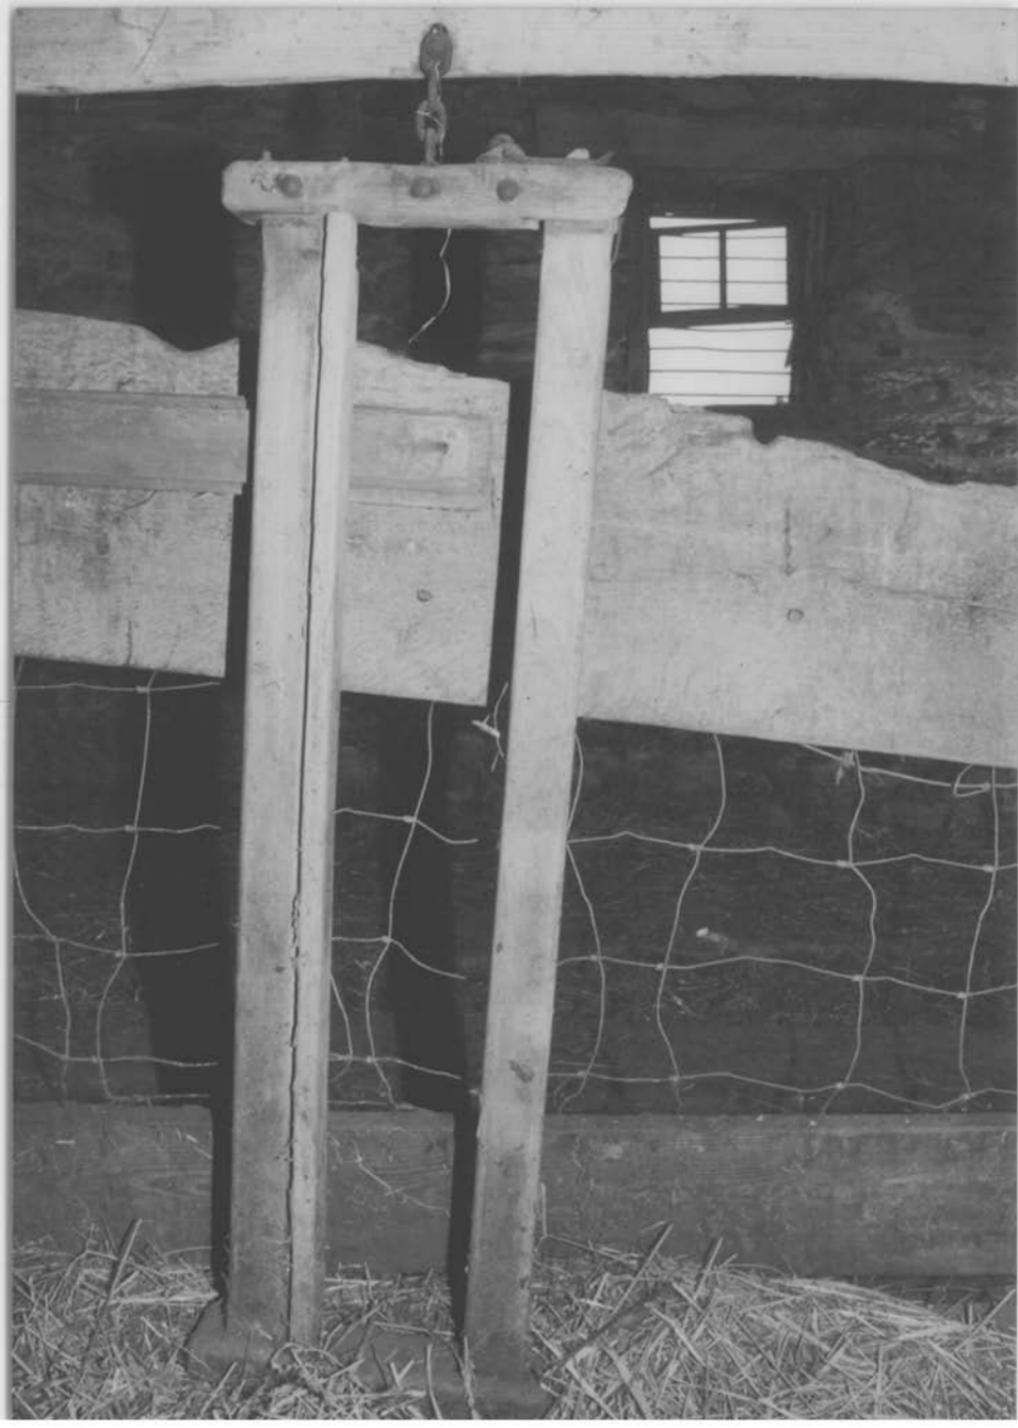
BARN - LOWER STORY WOOD STANCHION  
70F7

The southwest end of the barn has a sash-sawn beam set in the wall that contains wood pegs. In the south corner of the wall is a wood box. The wall was originally parged and some of this survives at the top. In the center of each wood vent is a post that pivots to open the vent. The floor joists are hewn on top and bottom inside the barn and on all four sides beneath the forebay. All but one of these joists run the whole width of the barn. The southeast wall is of hewn frame that is morticed and tenoned and pegged. There is one summer beam that runs northeast to southwest. It has a half lap scarf that is pegged and there is a post tenoned underneath of the summer beam at the scarf joint. The northwest stone wall has partially collapsed and the center posts and four bay wall are leaning to the southeast. The northeast end of the barn has a circular sawn summer beam and the joists are circular sawn on top and bottom. There is a large wood box set in the northeast wall. There is a concrete floor with manure trough on the northeast end and a wood beam that has hanging wood stanchions. There is also a concrete feed trough in this end of the barn.
