Survey No. CARR-1595

historic St. Mark's Evangelical Lutheran Church

street & number 1375 North Main Street  not for publication

name/title	Kenneth M. Short, Historic Planner		
organization	Carroll County Planning & Develop.	date	May 26, 1999
street & number	225 North Center Street	telephone	(410) 386-2145
city or town	Westminster	state	Maryland

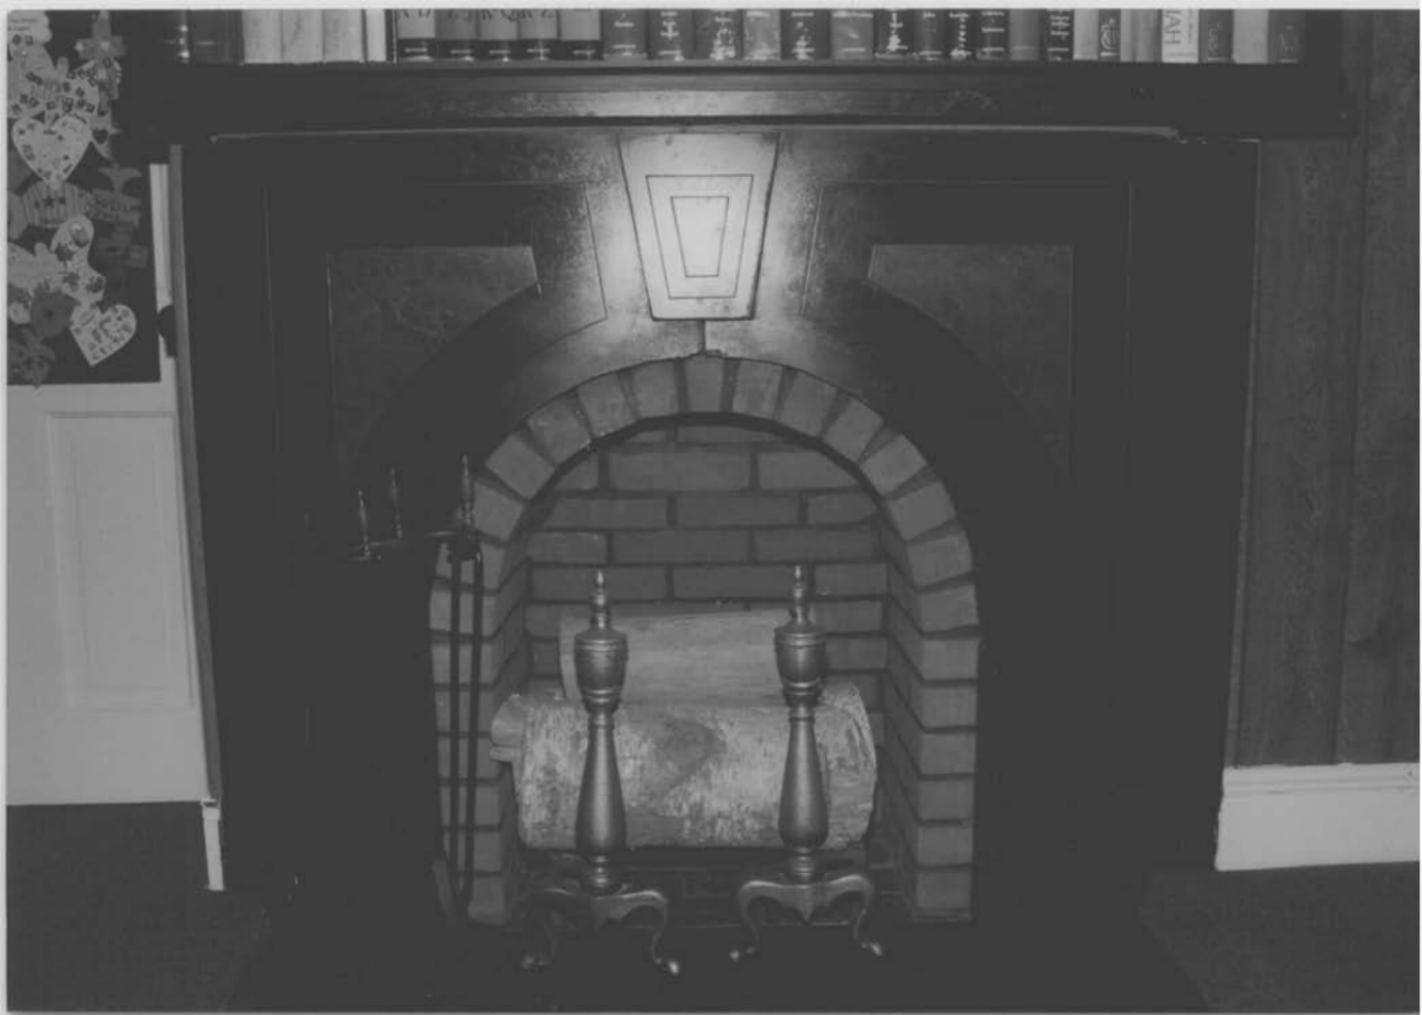
1 OF 5

PARSONAGE - SOUTHEAST ROOM MANTEL

marbleized slate mantel on the north elevation. It has a semicircular arched opening with a simple keystone. These walls are also paneled. The northeast room is a modern kitchen with a powder room off of the northeast of it that was probably originally a pantry. The east elevation also has an exterior door. There is a built-in cupboard on the south wall to the east. A closet under the front stairway is accessed from this room and the stairs to the cellar are here. Moved to elsewhere, there is a cellar underneath the whole house. The joists are sash sawn and are approximately two by eights with bridging fastened with cut nails. Moved to elsewhere, throughout the house are four paneled doors with symmetrical architrave on the doors and windows that is pulvinated in the center and has bulls-eye corner blocks. Moved to elsewhere, above the cellar stair is a stairway to the second story. The second story plan is similar to the first story, but has three rooms across the east half instead of two, and has a cross passage which runs to the south on the west side of enclosed service stairway from the first story. There is a single room in the southwest corner. The attic stairs are enclosed and are set above the service stairway from the first to second stories. The attic has three finished rooms with plaster walls that follow the profile of the rafters and collar beams. Contributing Resources 1.

The house that the church built for a parsonage was a "T" plan structure, also sometimes called a homestead ell or tri-gabled ell, although the north wing of the "T" is shallower than typical, and thus the porch does not wrap around on the north side. This is a national trend in house design and there is nothing traditional about the house. The house has had a few alterations but remains substantially the way it was built, and has a marbleized slate mantel in one of the first story rooms.

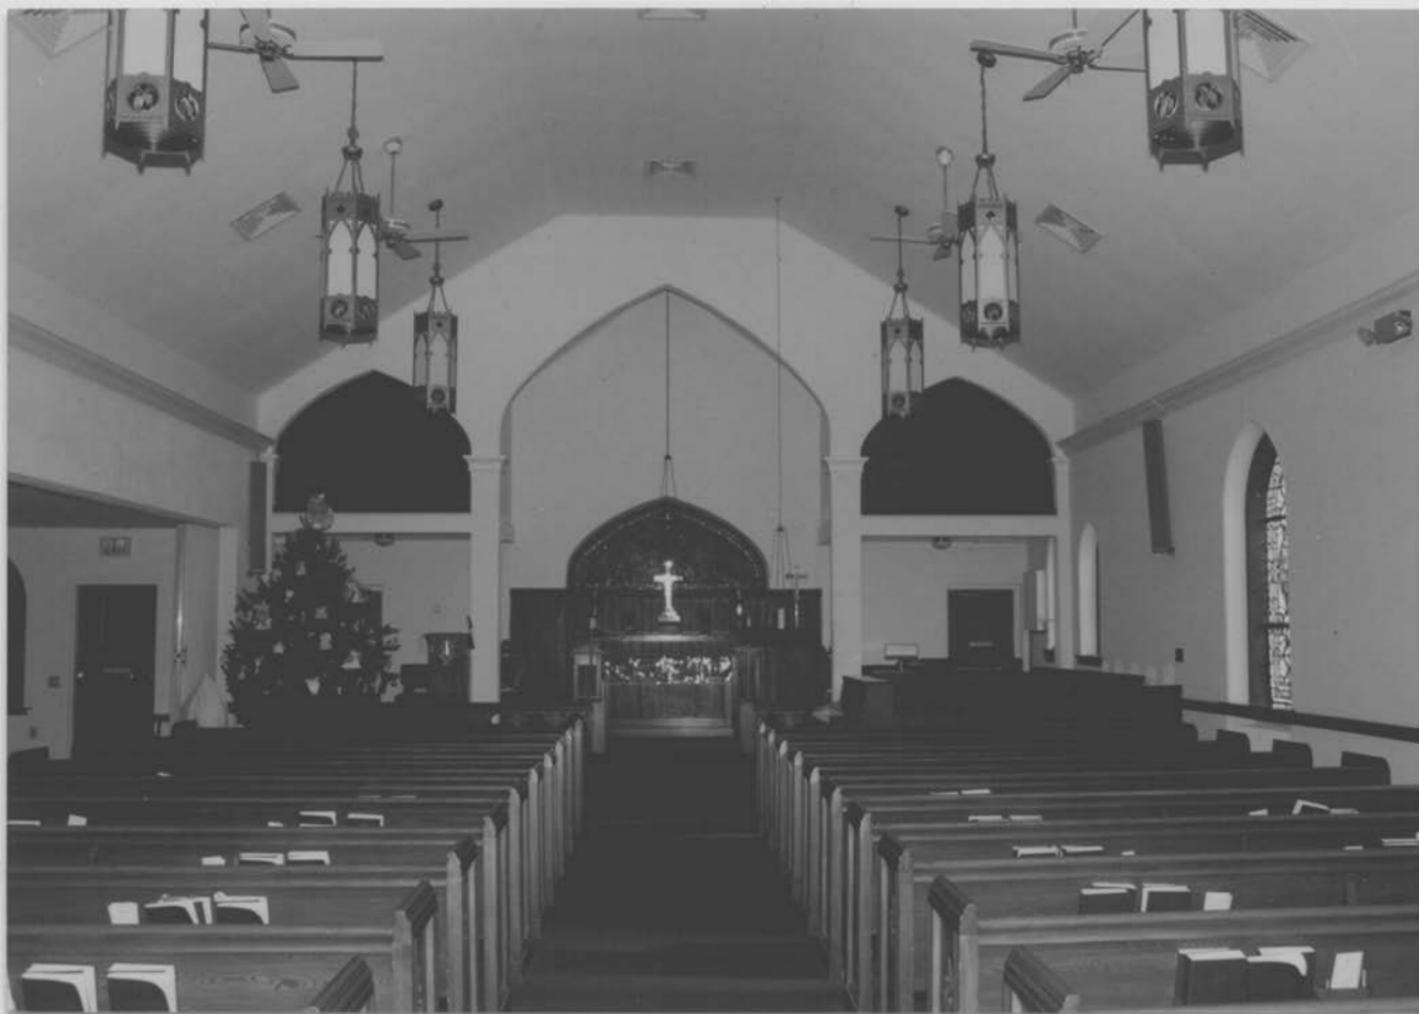
20F5

NEG. LOC: MARYLAND HISTORICAL TRUST  
CHURCH INTERIOR VW EAST

The lower story of the church building has knotty pine paneling and a drop ceiling. The sanctuary north wall has been opened up for expansion. The south wall has an early stained glass. There is a run of plaster cornice on the both the north and south elevations. The wood board ceiling runs east/west following the profile of the rafters and collar beams. The apse has three Tudor arches; the center arch being wider and taller. The arches are supported by two square columns with covetto moldings at the top. The wood pews have square paneled ends with a flower carved in each end.

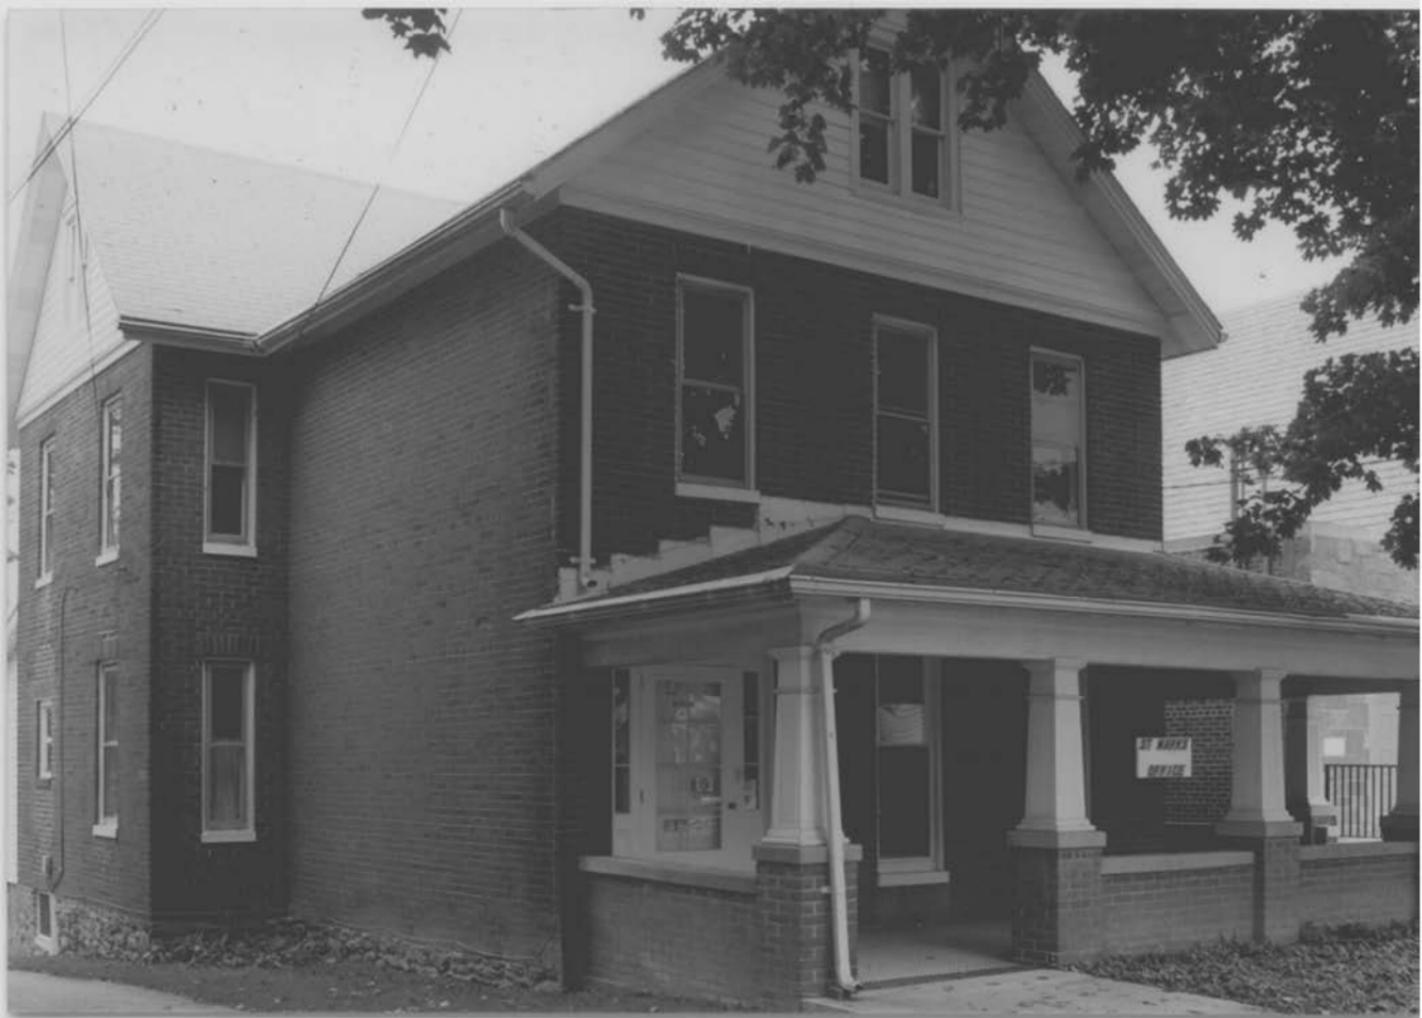
3 OF 5

PARSONAGE - NORTH & WEST ELEVATIONS

The Blank House is located at 1373 Main Street in Hampstead in northeastern Carroll County, Maryland. The house is located on the east side of the road and faces west toward the road. The house is a 2 ½ story three bay by two bay T plan structure with a gable front to the street. It has running bond brick on the west elevation and six to one common bond brick on the remaining elevations. The gable roof has asphalt shingles and an east/west ridge on the western section with a north/south ridge on the eastern or rear T. On the west elevation, the first story has a side passage with a multi-paneled door in the north bay that has side lights of three lights over one panel, and the doorway has a 3-light transom. There are two 1/1 sash to the south. The second story has three 1/1 sash and the gable end has paired 1/1 sash and aluminum siding. There is a 1 story four bay porch that wraps around to the south. It has brick piers and brick walls between the piers. Above the piers are battered fluted square columns that support a hip roof with asphalt shingles.

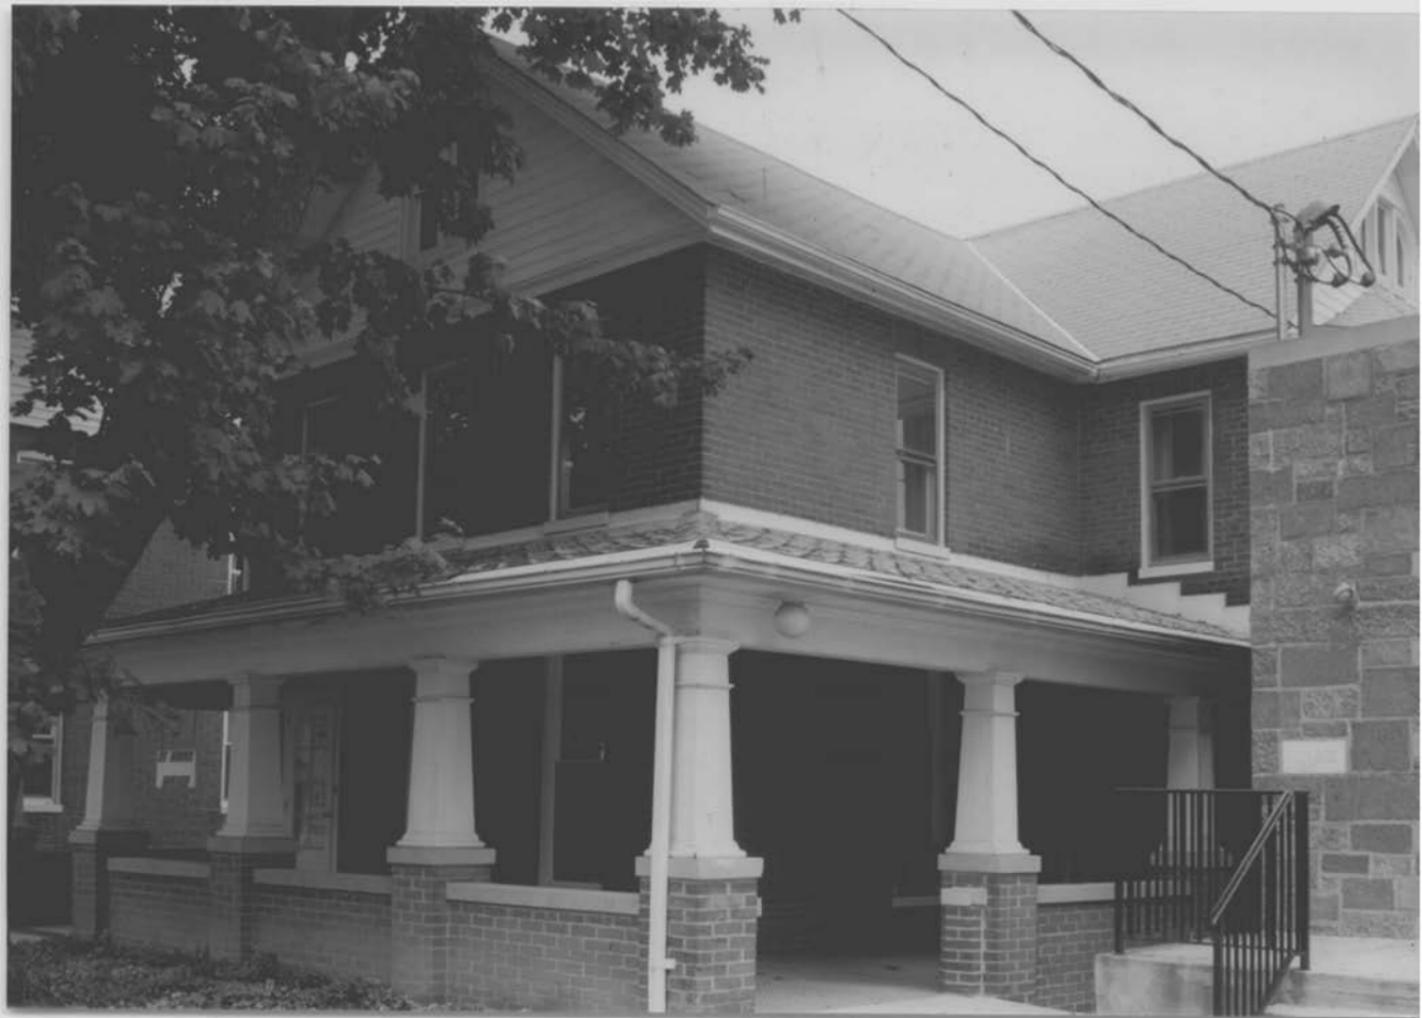
40F5

PARSONAGE - WEST & SOUTH ELEVATIONS

The south elevation has a 1/1 sash in the west bay of the first and second stories. The west elevation of the south T has a glazed multi-paneled door on the first story and a 1/1 sash on the second story. The south elevation of this T in the east bay has a three sided bay window on the first and second stories with a 1/1 sash on each side of the bay window. The gable end has aluminum siding and three 1-light sash. The north and south sash have rounded top corners. On the north elevation, the west bay has no openings. The west elevation of the north T has a 1/1 sash on both the first and second stories. The north elevation of this T; the east bay originally had two 1/1 sash on both the first and second stories, but the first story east window has been reduced and a new sash put in. The gable end has aluminum siding and paired 1/1 sash. The east

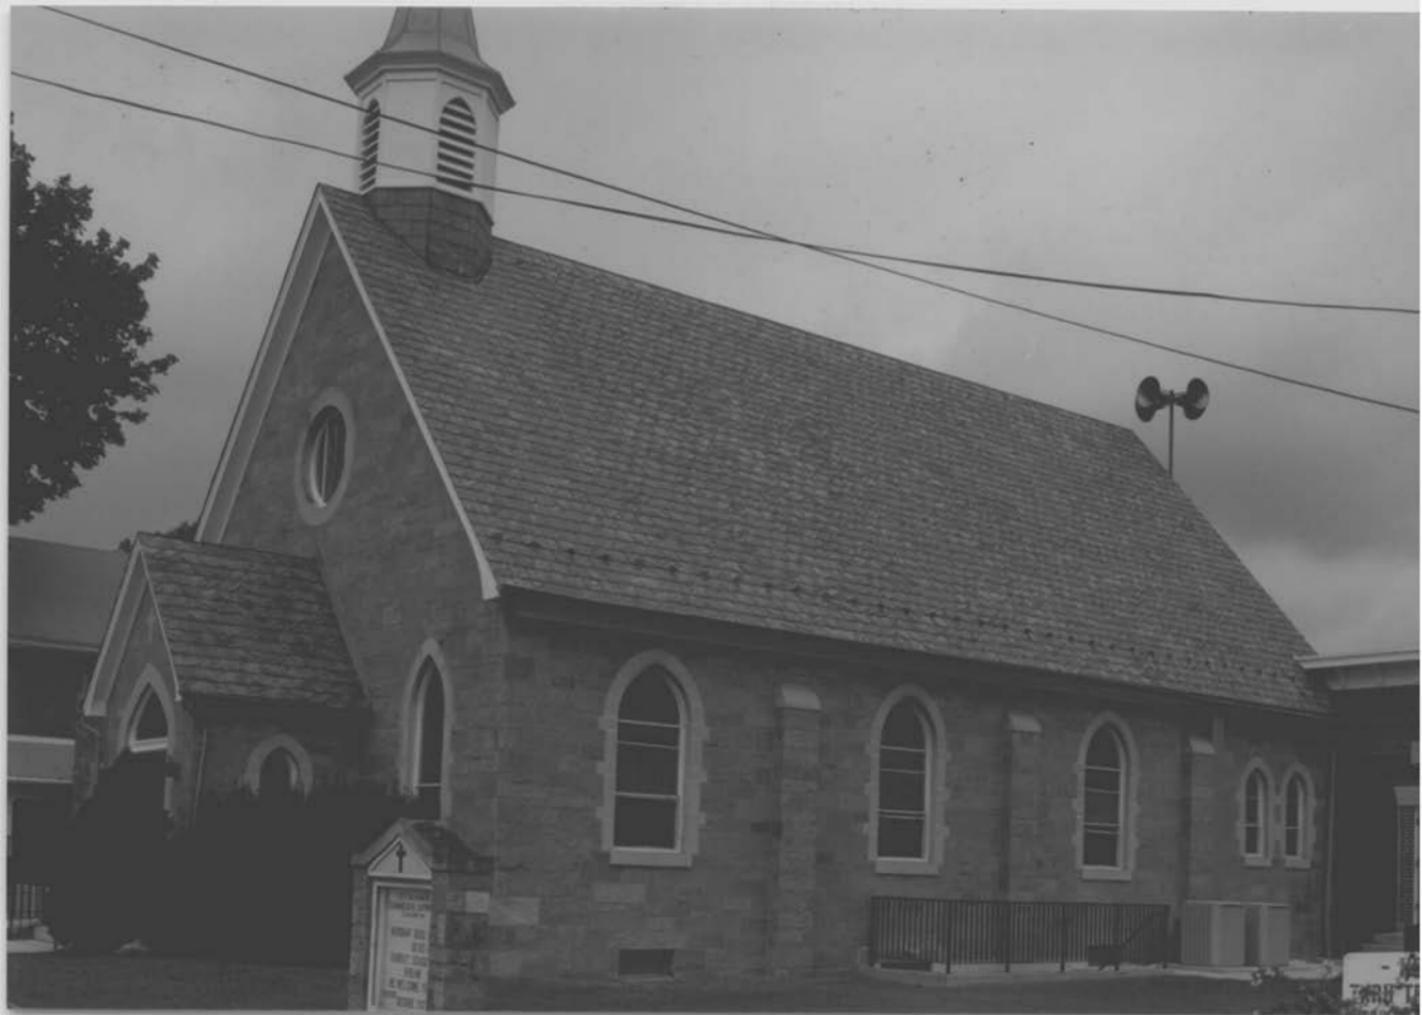
5 OF 5

NEG. LOC: MARYLAND HISTORICAL TRUST  
CHURCH - WEST  $\frac{1}{3}$  SOUTH ELEVATIONS

St. Marks Evangelical Lutheran Church is located on the east side of Main Street in Hampstead in northeastern Carroll County, Maryland and faces west toward the road. It is a 1 story three bay by four bay structure with rock faced ashlar walls and gib surrounds on the windows and doors. It has a gable roof of slate with an east/west ridge. The west elevation has a projecting 1 story one bay center porch that has a gable roof of slate with an east/west ridge. The porch has paired doors with eight panels each and a Tudor arch transom that is now blocked off. The north and south elevations of the porch have stained glass lancet windows. The north and south bays of the west elevation of the church also have stained glass lancet windows, and the gable end has a stained glass rose window. There is a bell tower on the west gable end. It is octagonal and has a copper spire. In the southeast corner are two date stones; one marked "1883" and the other "St. Marks Lutheran Church 1940".

On the south elevation there are three buttresses. The west/west center and east center bays each have a stained glass lancet window. The east bay has paired small stained glass lancet windows. The north elevation has an addition made of the same stone work and dated 1992. There is an addition on the east elevation that projects to the south one bay. This addition is of 7 to 1 common bond brick. The west elevation has a new door in a reduced opening. Above the doorway is a stone marked "St. Marks Sunday School 1938". This addition is four bays deep. The south elevation from west to east has a buttress of 6/6 sash; another buttress two 6/6 sash; another buttress and an exterior brick chimney. There is a bracketed cornice that steps down over the two center buttresses. There are two brick additions to the east of this one of more recent date. The east elevation of the church has a brick gable end with a louver in it. The north elevation of these additions is all of brick and was built in at least three stages.
