CARR-164
GOODWILL
Gamber Vicinity
Private

Circa 1756

INVENTORY FORM FOR STATE HISTORIC SITES SURVEY

"Goodwill"

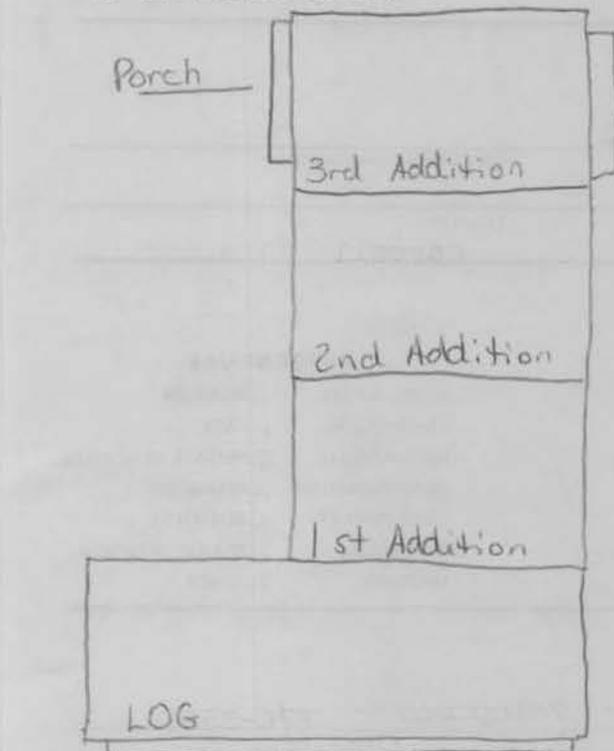
The log L-shaped house has a low foundation of uncoursed stone covered with plaster, white. The earliest wall structure is log. The following three are of wood, though not necessarily log or hewn beams; but of a more modern construction. The three-bay, two-story structure with cellar and attic is entirely covered with white asbestos shingle, and topped with roofs of wood. In fact, the original section is constructed with actual tree branches and notched with wooden pegs. Both gable roofs, save for the asphalt shingle on the front slant of the main block, are covered with tin. The two roofs include one over the back section and one over the original log house. The back section has a hanging cornice, and the main block does not.

Chimneys number two, one interior side end, on the right side of the main block, and three interior chimneys dispersed evenly through the back section, what would have been the back wall of each room before the addition of the next.

There is a recent, left side, one-bay, shed roof porch with cement foundation and platform on the third addition. The second and last is a three-bay front porch with a four-post support. The supports are decoratively turned and have an open, spindle-work brackets at the top of each support. The foundation and decoration work are certainly beyond 1760's, but the actual dates are not known. The front door has a rectangular transom and sidelights. This was added during the nineteenth century.
