**MARYLAND HISTORICAL TRUST
DETERMINATION OF ELIGIBILITY FORM**

Property Name: Jesse Myers Property Inventory Number: CARR-1722
 Address: 1321 Old New Windsor Road City: New Windsor Zip Code: 21776
 County: Carroll USGS Topographic Map: New Windsor
 Owner: Stephen E. and Linda A. Manning Is the property being evaluated a district? yes
 Tax Parcel Number: 0011 Tax Map Number: 50 Tax Account ID Number: 11-000940
 Project: New Windsor Quarry Expansion Agency: _____
 Site visit by MHT Staff: no yes Name: _____ Date: _____
 Is the property located within a historic district? yes no

MARYLAND HISTORICAL TRUST
NR-ELIGIBILITY REVIEW FORM

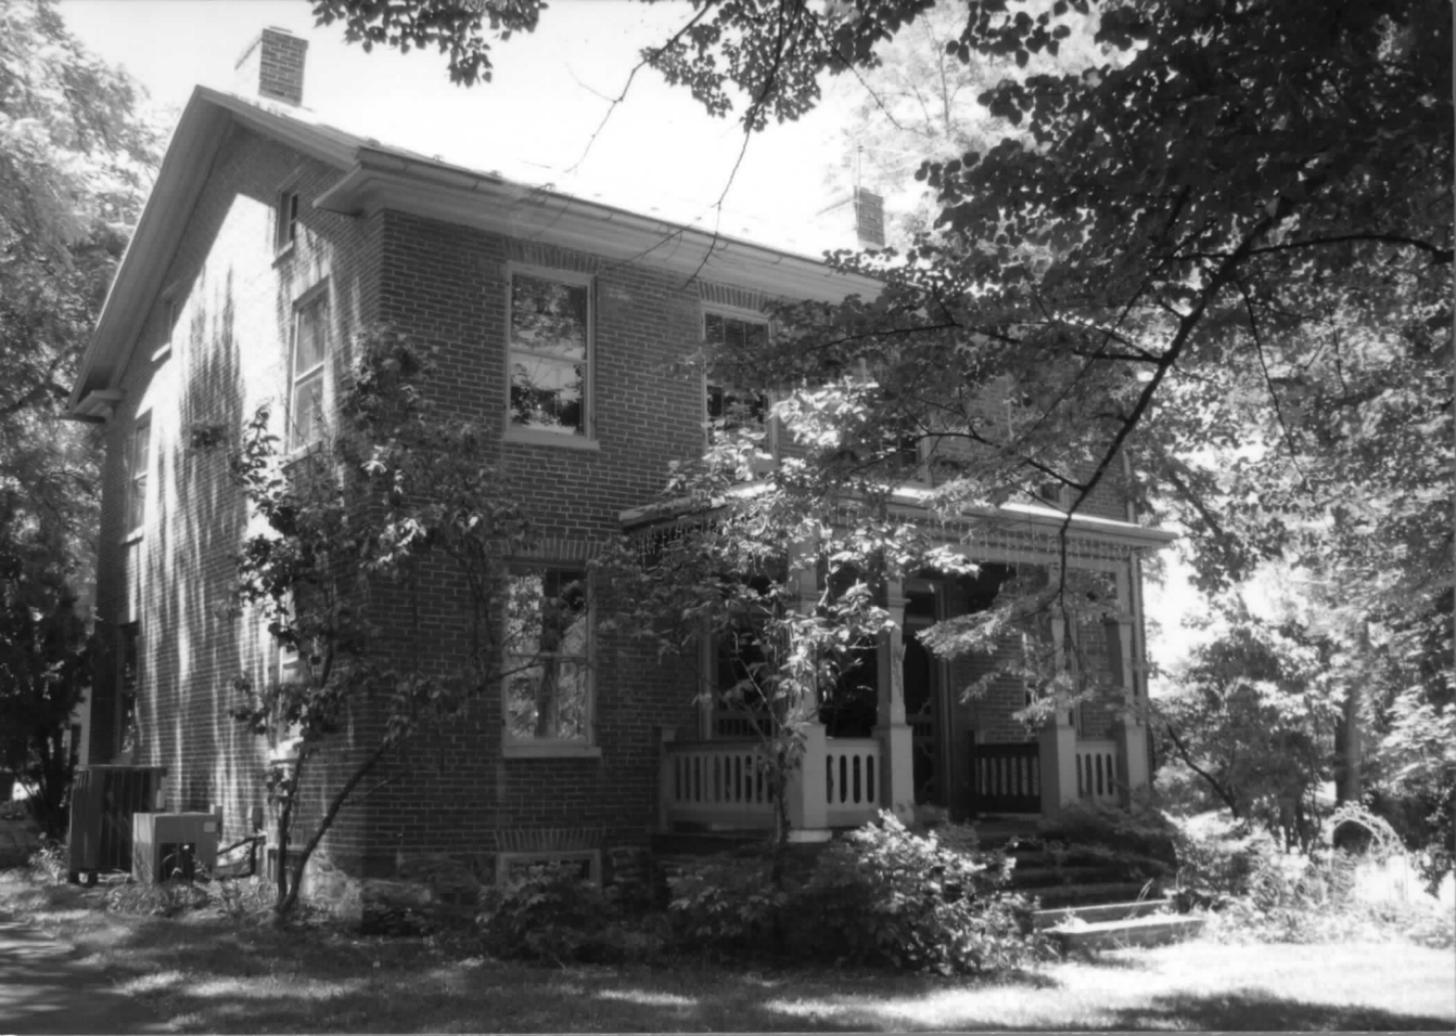
1/15

The front elevation is oriented east facing Old New Windsor Road. The first floor has a window-door-door-window pattern (Photograph 1). The windows are original six-over-six wood windows with wood sills and brick lintels. The doors are original wood and glass panel doors with a single-light transom over each. The doors are covered by decorative wood screen doors. The second floor has four evenly spaced original six-over-six wood windows with wood sills and brick lintels. There is an original one-story, three-bay porch over the front doors. The porch has a hipped roof that is sheathed in standing seam metal. Its roof is supported by four square posts that are chamfered in the center section. Located at the top of the posts are decorative jigsaw brackets. The porch deck is supported by a brick foundation.

View facing northwest, showing the main elevation of the dwelling.

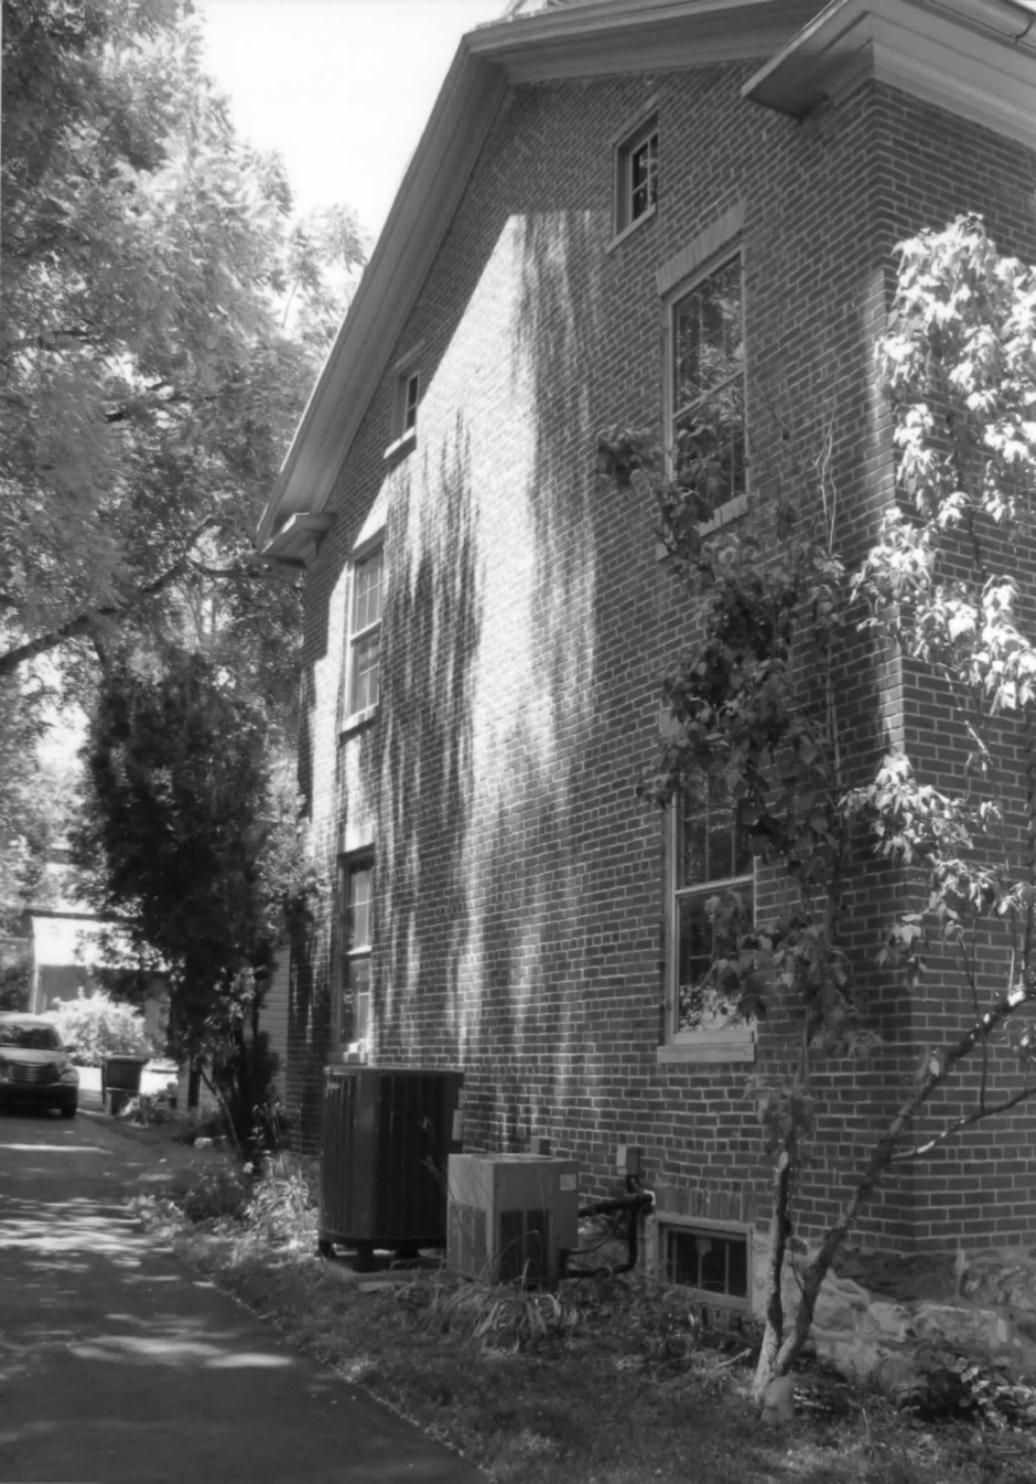
2/15

The south elevation of the dwelling has six windows and is simple in detail (Photograph 2). The first and second floors have two original six-over-six wood windows with wood sills and brick lintels. The third floor has modern four-light wood windows. The majority of the west elevation is obscured by a ca. 1900 addition (Photographs 3 and 4). The only feature that is not blocked by the addition is an original six-over-six wood window on the second floor of the southern end.

View facing northwest, showing the south elevation of the dwelling.

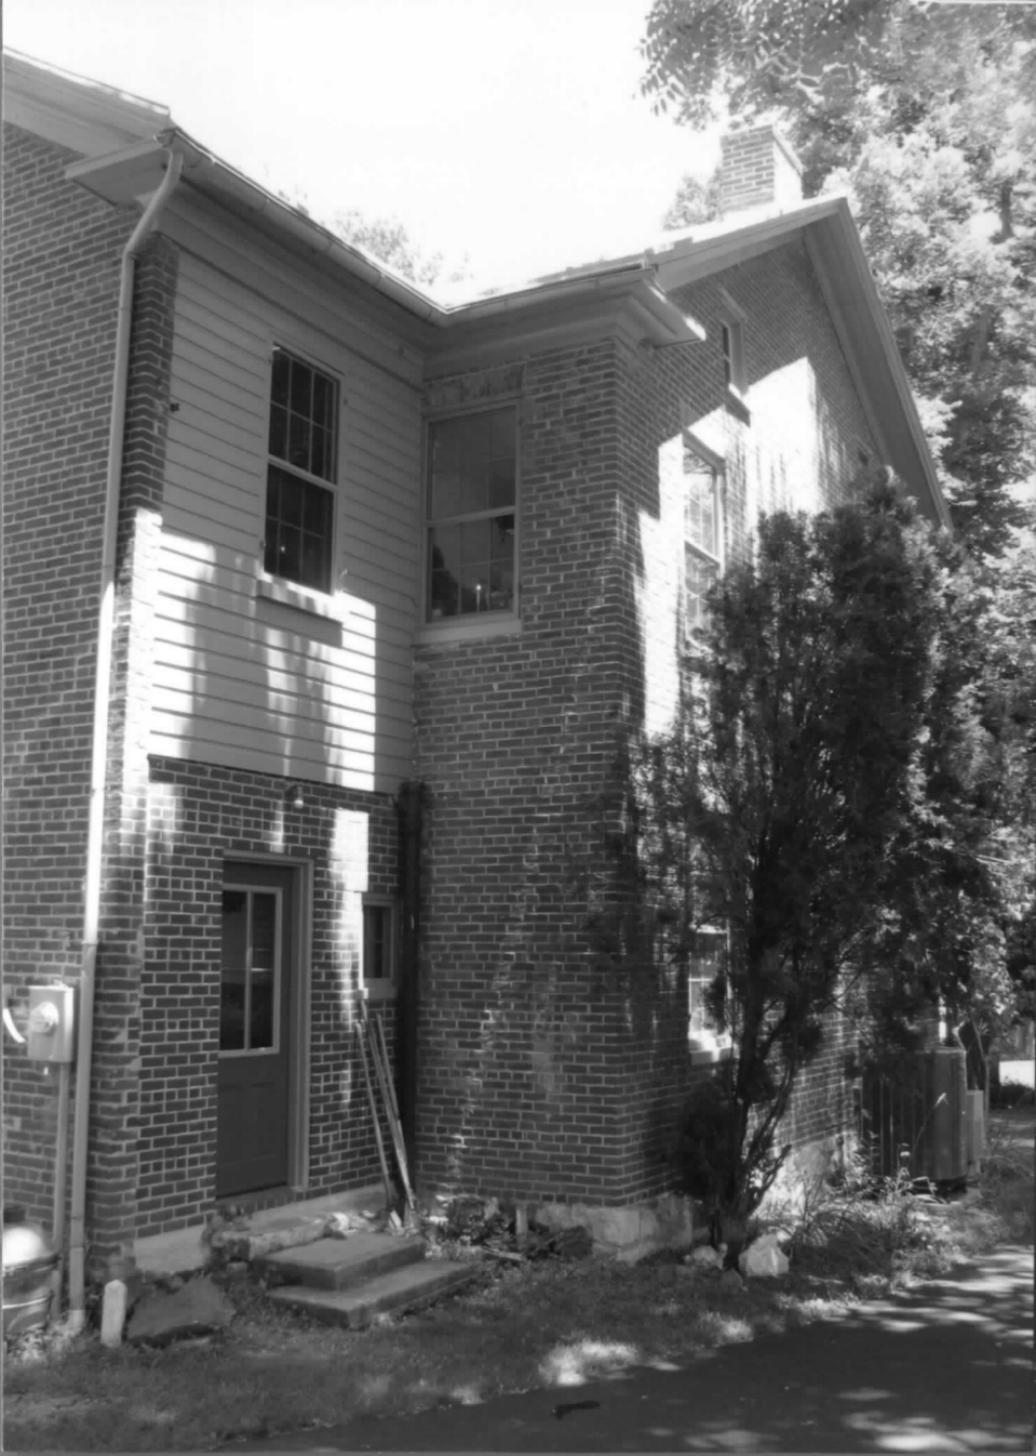
3/15

The ca. 1900 addition is two-and-one-half stories tall. It is constructed of brick with a front gable roof that is sheathed in standing seam metal. The southern elevation of the addition is brick on the first floor and is clad in clapboard siding on the second floor. The first floor has a wood paneled door that has four lights. East of the door is a small original four-light wood window. The second floor has an original six-over-six wood window. The western elevation has an original six-over-six wood window on the first floor and a small modern four-light wood window in the attic. The north side of the addition has an original six-over-six wood window on the second floor. The first floor is obscured by a second addition (Photograph 5). The second addition is one bay wide and one room deep. There is an original six-over-six wood window on the north side of the second addition. Located on the east side of the second addition is an original porch that was enclosed ca. 1990. The enclosed porch has clapboard siding with four modern 12-light windows on the north side. The east side of the enclosed porch has two modern 12-light windows. The enclosed porch is supported by a stone foundation on the western side and a brick column on the eastern side.

View facing northeast, showing the south side of the addition.

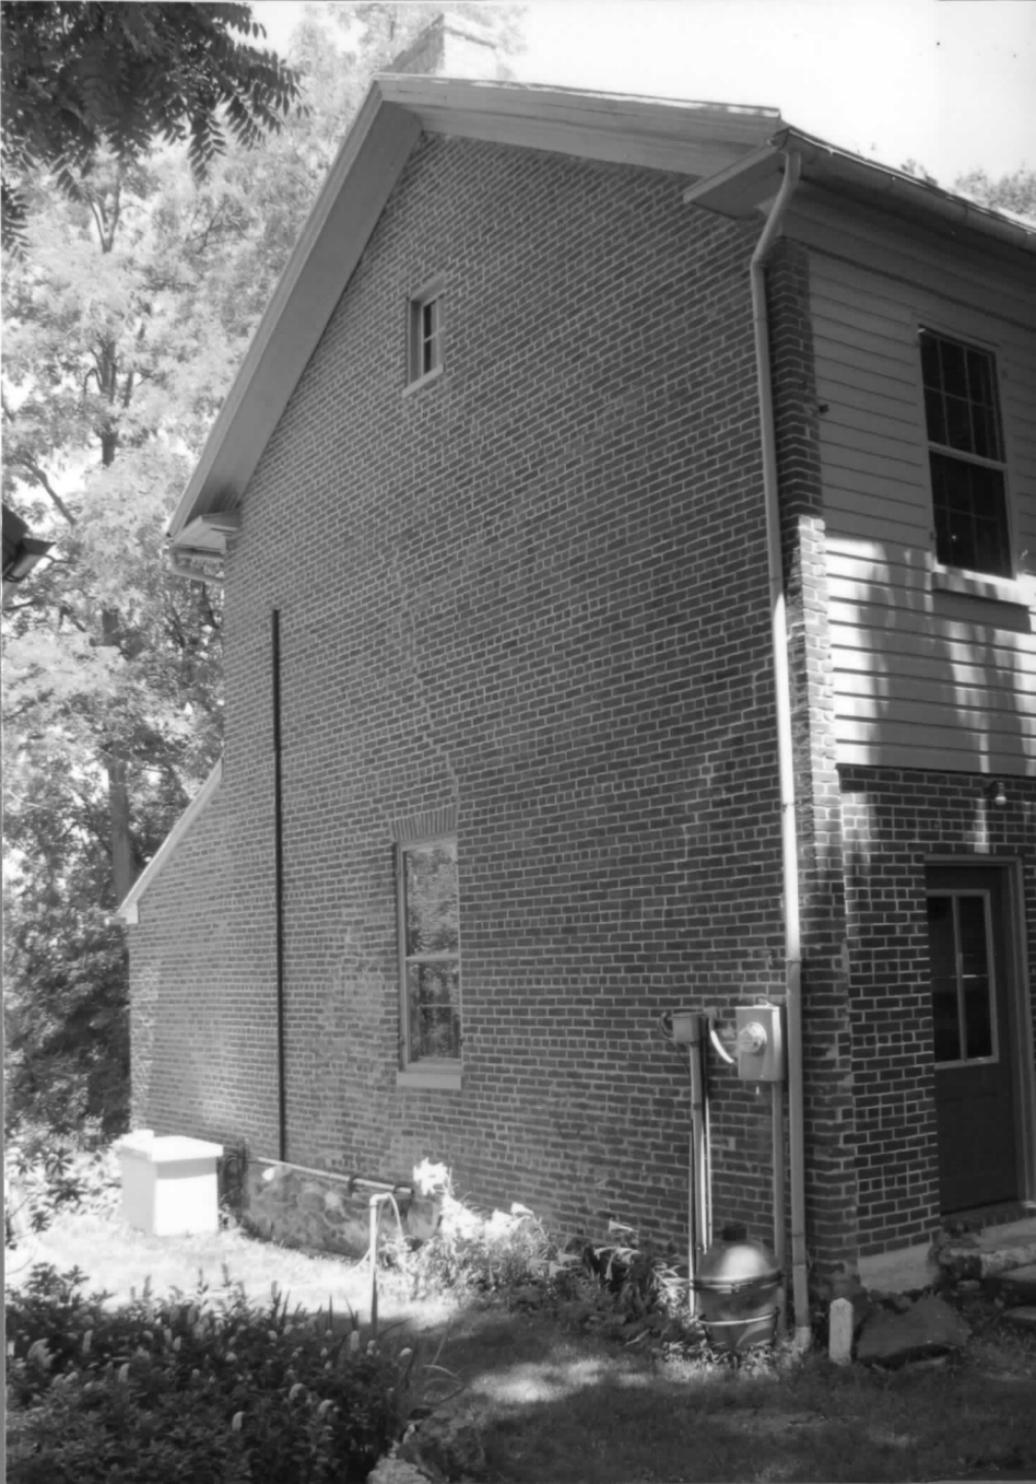
4/15

View facing northeast, showing the west side of the addition.

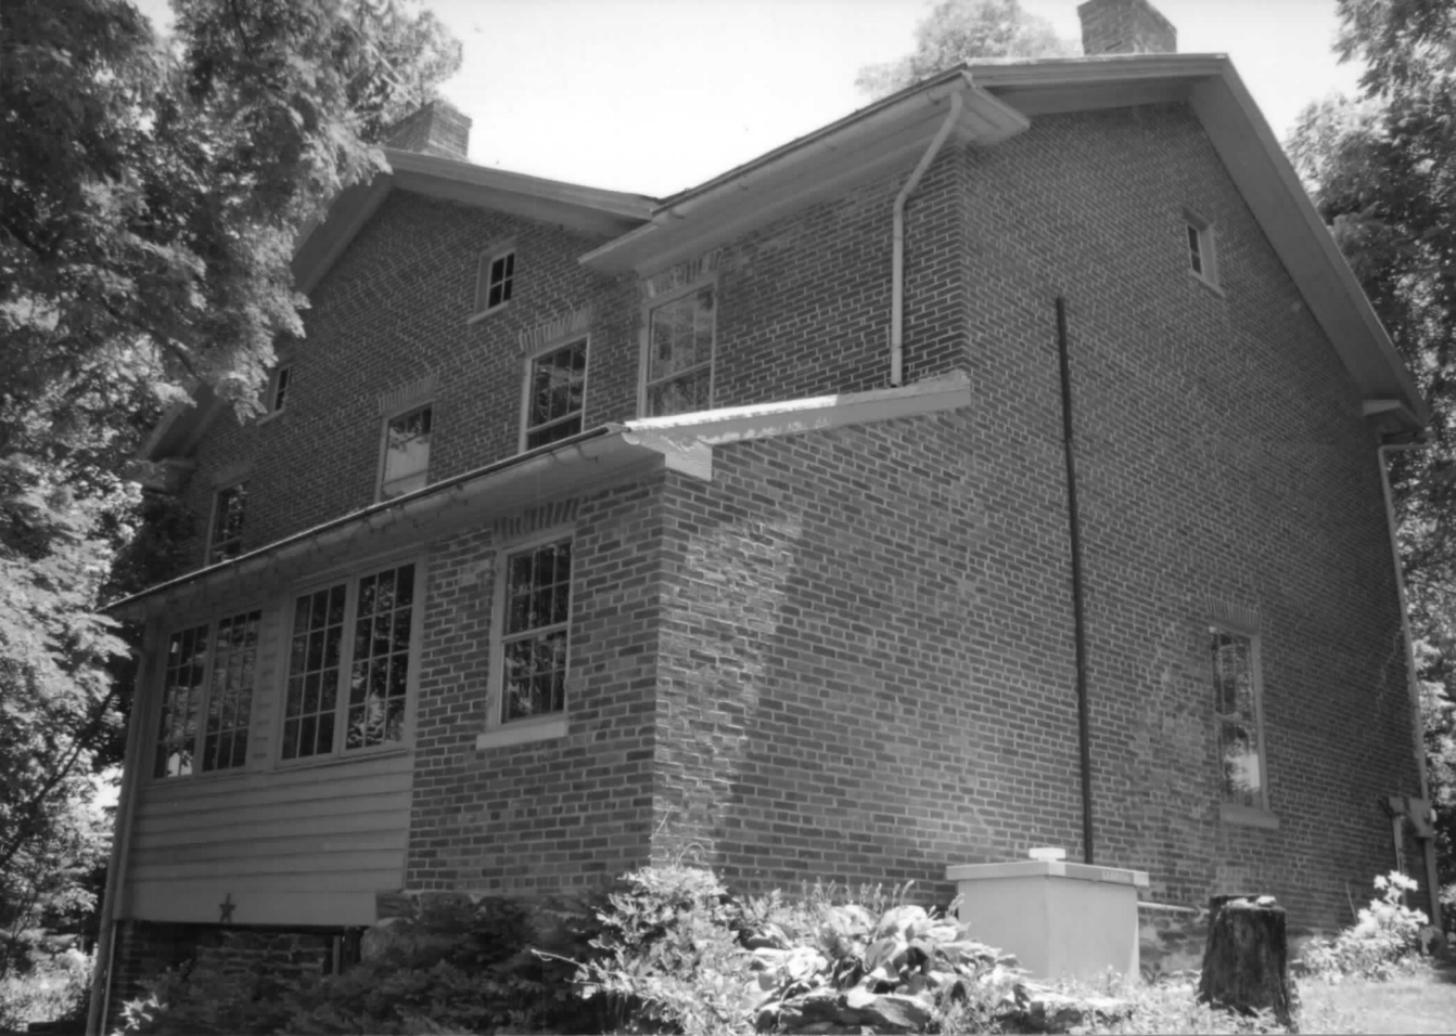
5/15

View facing southeast, showing the second addition and
the enclosed porch.

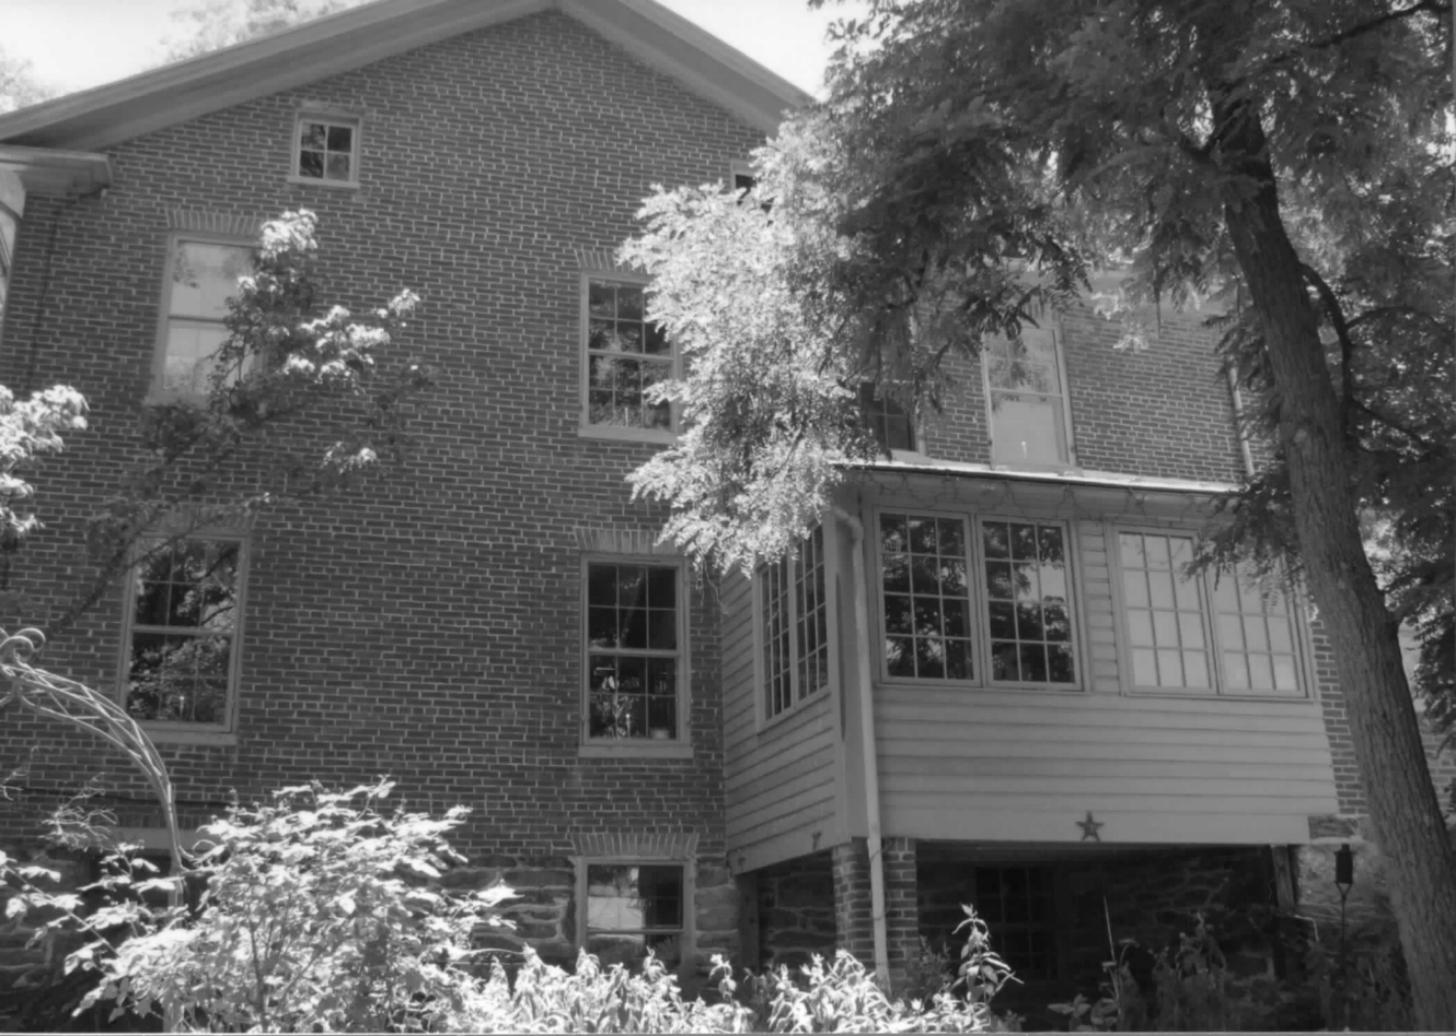
6/15

The northern elevation of the dwelling is partially covered on the first floor by the enclosed porch addition (Photograph 6). The visible section of the first floor has two original six-over-six wood windows. The second floor also has two original six-over-six wood windows. There are two modern four-light wood windows in the attic. The basement level is visible on the north elevation. At the eastern end of the basement level is a modern vertical clapboard door with a six-light window. West of the door is an original six-over-three wood window. Located under the enclosed porch is an original six-over-six wood window.

View facing southwest, showing the north elevation of the dwelling. Note the enclosed porch.

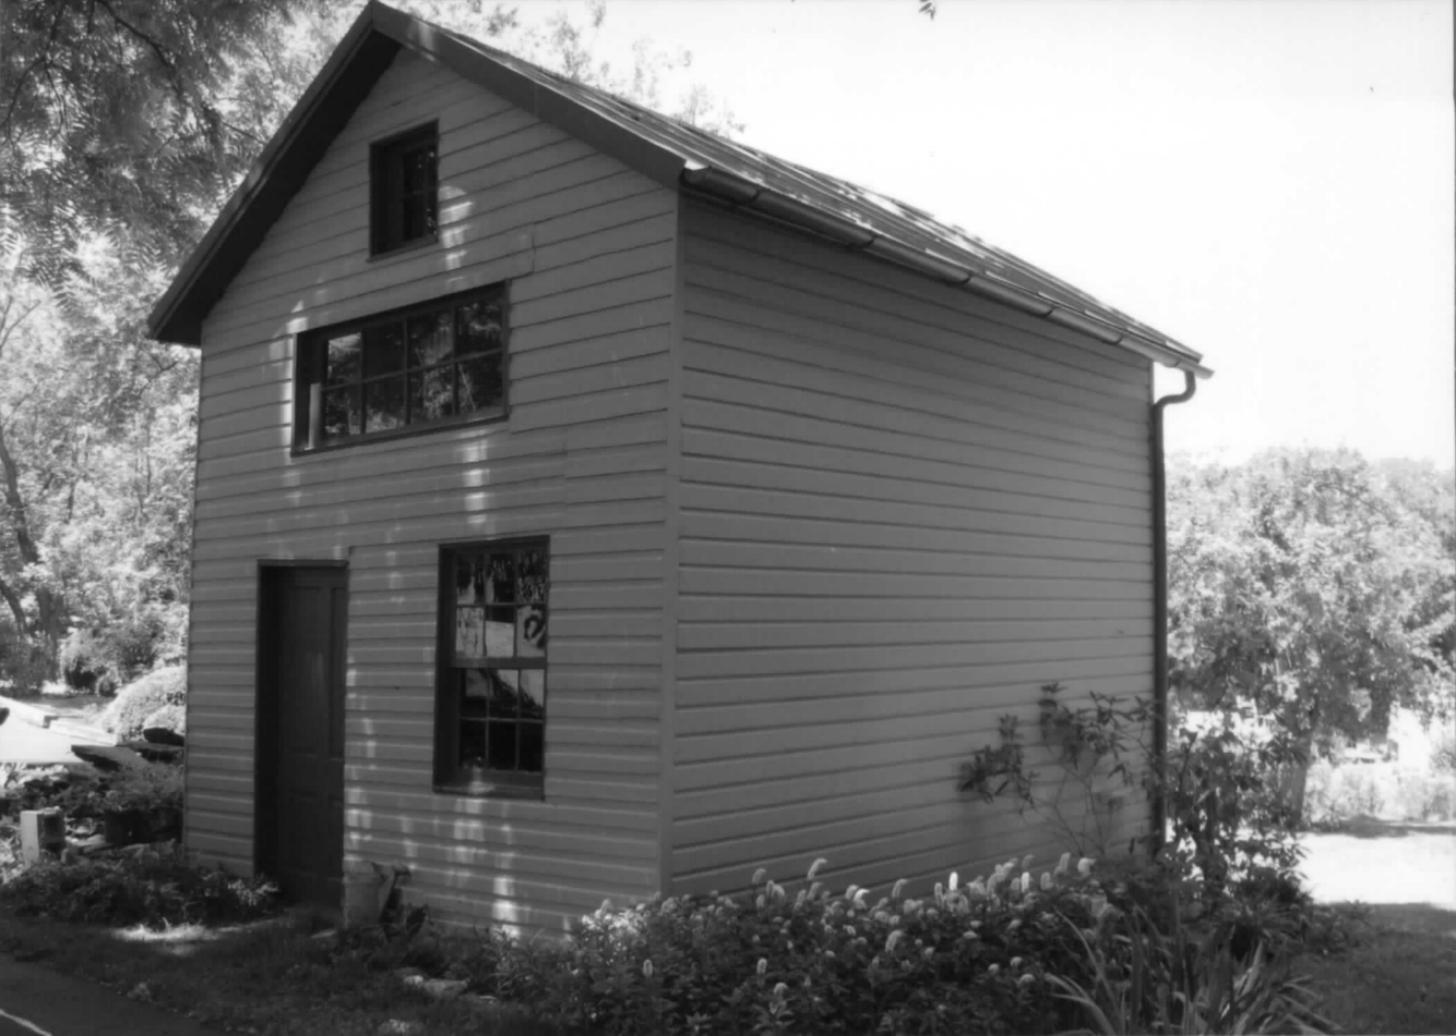
7/15

An outbuilding located west of the dwelling is a ca. 1900 building known by the owner as the "clock shop" (pers. com., Stephen Manning, July 2011). The shop is two stories tall and measures two bays wide and one room deep (Photographs 7 and 8). The shop has a stone foundation and the walls are clad in clapboard siding. It has a gable front roof that is sheathed in standing seam metal. The first floor of the south elevation of the shop has a solid wood panel door and an original six-over-six wood window. The

View facing northwest, showing the south elevation of the clock shop building.

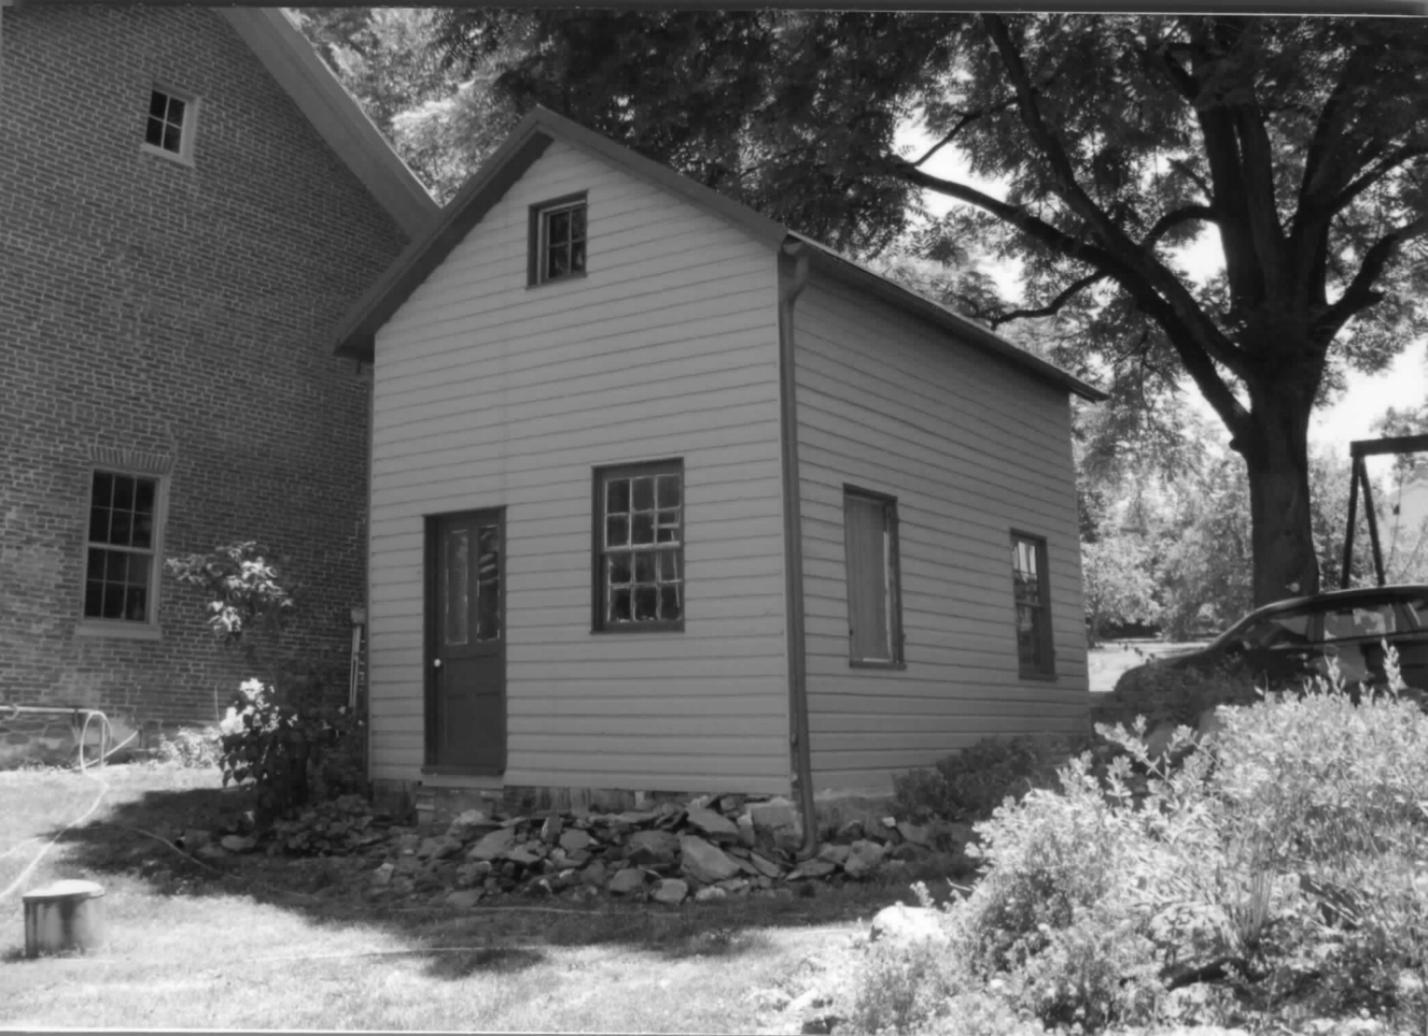
8/15

second floor has an original horizontal wood window that has eight lights. In the gable peak there is an original four-light wood window. The east elevation of the shop does not have any fenestrations. The west elevation of the shop has two original six-over-six wood windows. The north elevation of the shop has a wood and glass panel door and an original six-over-six wood window on the first floor. The second floor has an original four-light wood window in the gable peak.

view facing southeast, showing the rear elevation of the clock shop building.

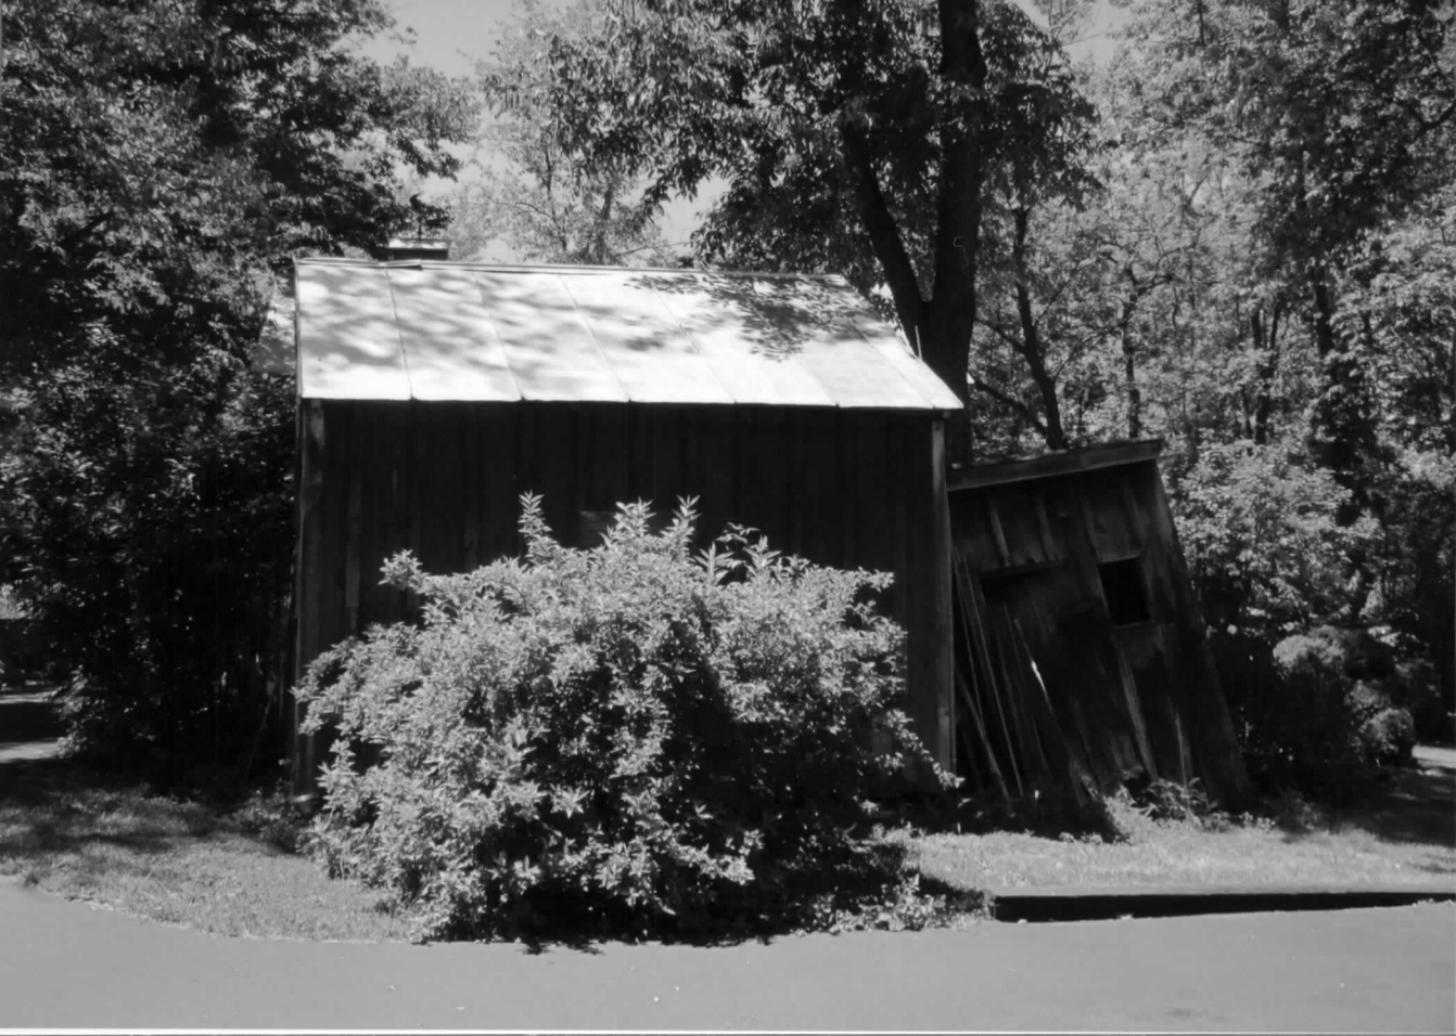
9/15

Located west of the clock shop are a shed and a privy, both constructed ca. 1870 (Photographs 9 and 10). The shed is one story tall and measures one bay wide and one room deep. The walls are clad in board and batten and the gable front roof is sheathed in standing seam metal. The south elevation of the shed has a vertical wood door on the eastern end and a covered up window on the western end. The east elevation has a boarded-up window in the center. The north elevation is obscured by the privy. The west elevation of the shed has a vertical wood door on the southern end. The privy has board and batten walls and a shed roof that is sheathed in standing seam metal. There is a vertical board door and a window without lights on the east side.

View facing northwest, showing the shed and the privy.

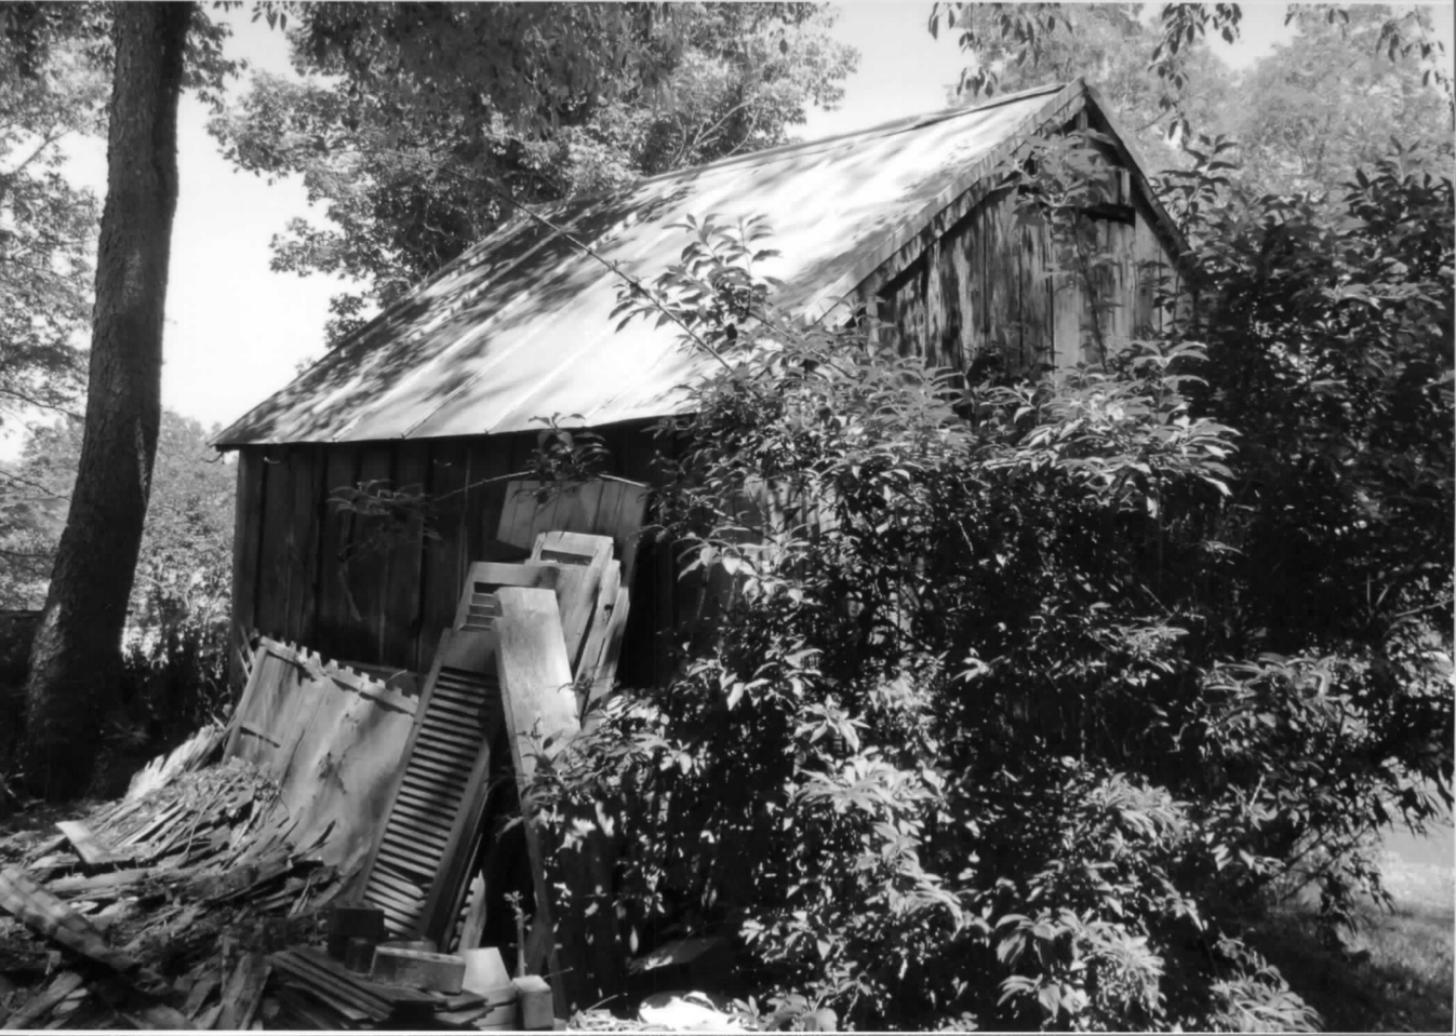
10/15

View facing northeast, showing the southwest corner of the shed.

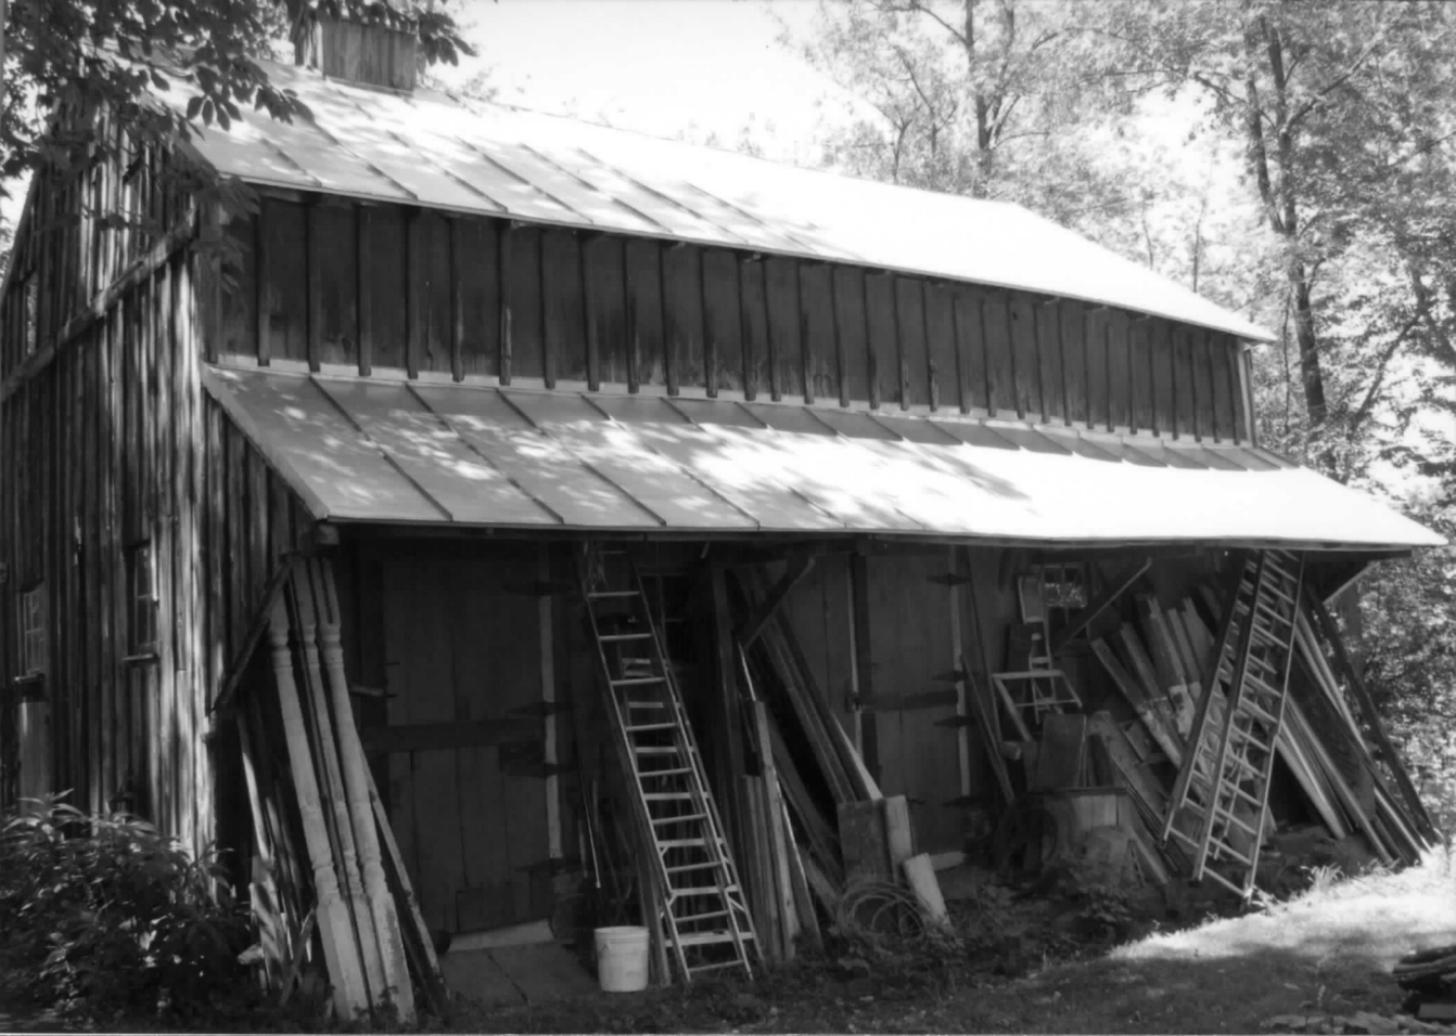
11/15

A barn is located west of the shed and privy. The barn stands two stories tall and four bays wide. It has a stone foundation with walls clad in board and batten, and a front gable roof that is sheathed in standing seam metal. The east elevation of the barn has a pent roof that is supported by four large wood brackets (Photograph 11). Located underneath the pent roof are two vertical board doors and two original four-light windows, which are arranged in a door-window-door-window pattern. The south elevation of the barn has two wood six-light windows on the first floor and two wood four-light windows on the second floor (Photograph 12). The north elevation of the barn has four wood four-light windows, with two on the first floor and two on the second floor (Photograph 13).

View facing northwest, showing the east elevation of the barn.

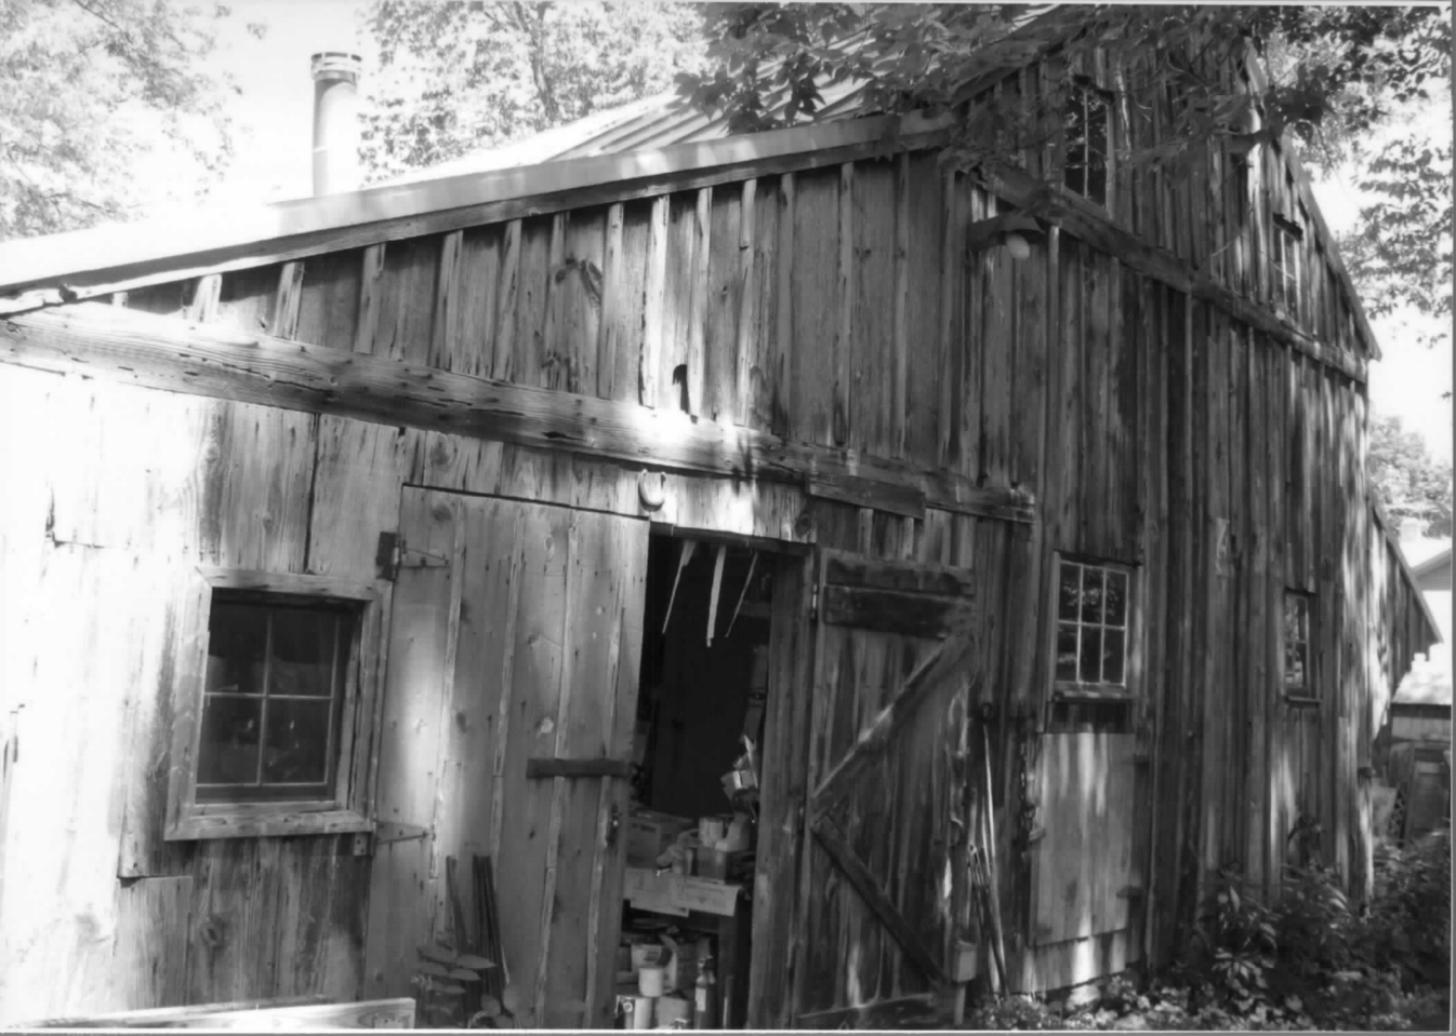
12/15

View facing northeast, showing the south elevation of the barn.

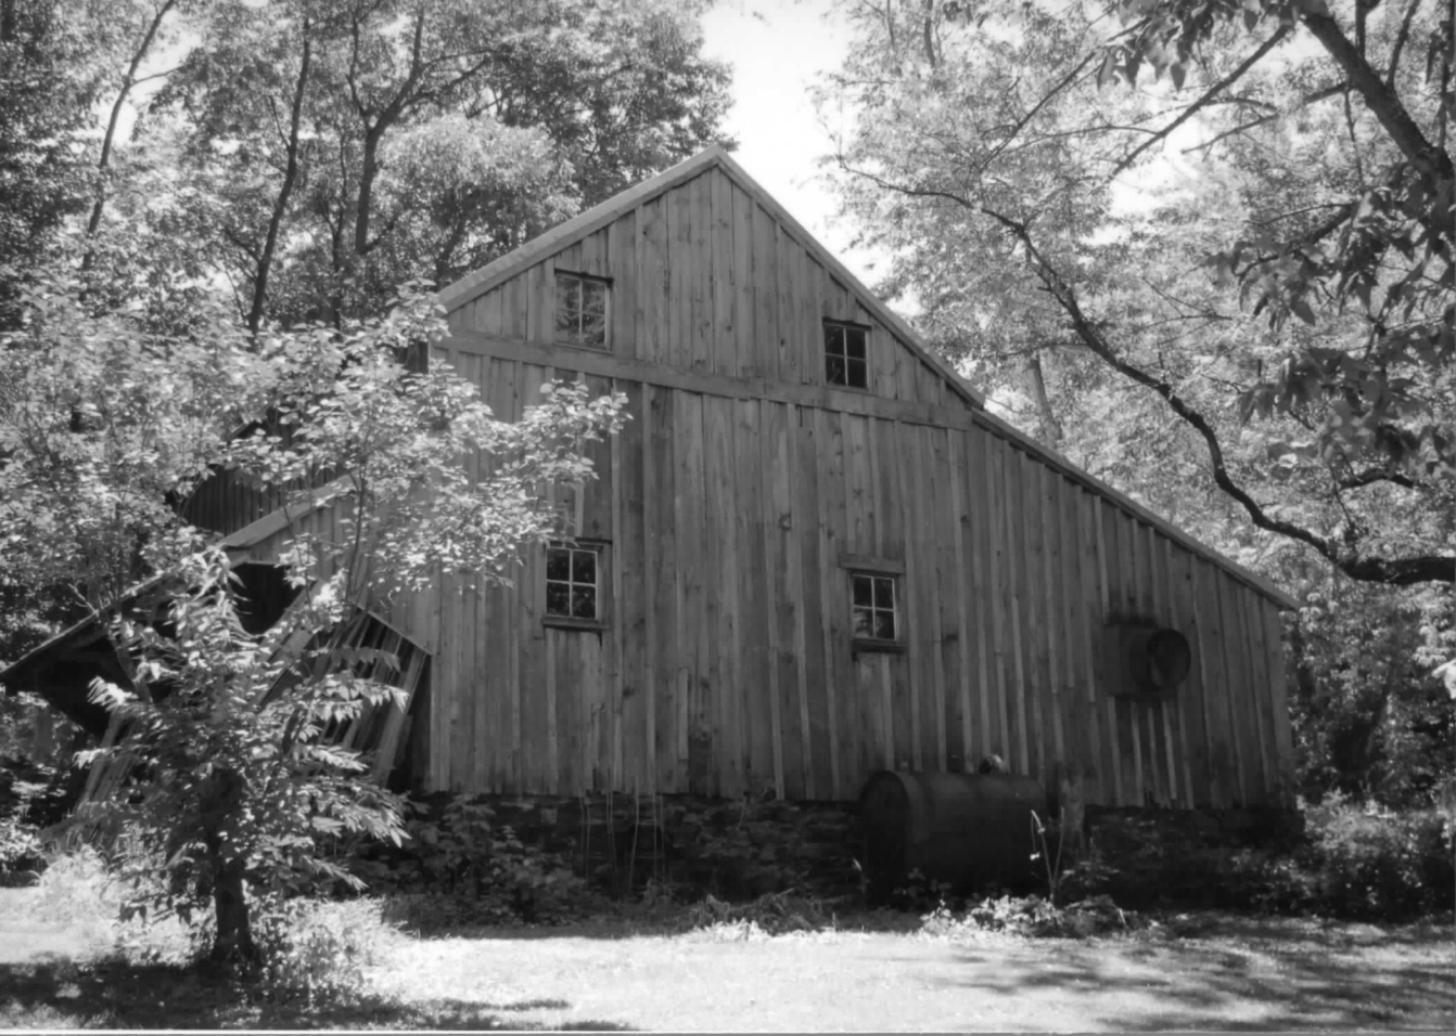
13/15

View facing southwest, showing the north elevation of the barn.
