**MARYLAND HISTORICAL TRUST
DETERMINATION OF ELIGIBILITY FORM**

Property Name: Jesse Myers Property Inventory Number: CARR-1722
 Address: 1321 Old New Windsor Road City: New Windsor Zip Code: 21776
 County: Carroll USGS Topographic Map: New Windsor
 Owner: Stephen E. and Linda A. Manning Is the property being evaluated a district? yes
 Tax Parcel Number: 0011 Tax Map Number: 50 Tax Account ID Number: 11-000940
 Project: New Windsor Quarry Expansion Agency: _____
 Site visit by MHT Staff: no yes Name: _____ Date: _____
 Is the property located within a historic district? yes no

MARYLAND HISTORICAL TRUST
NR-ELIGIBILITY REVIEW FORM

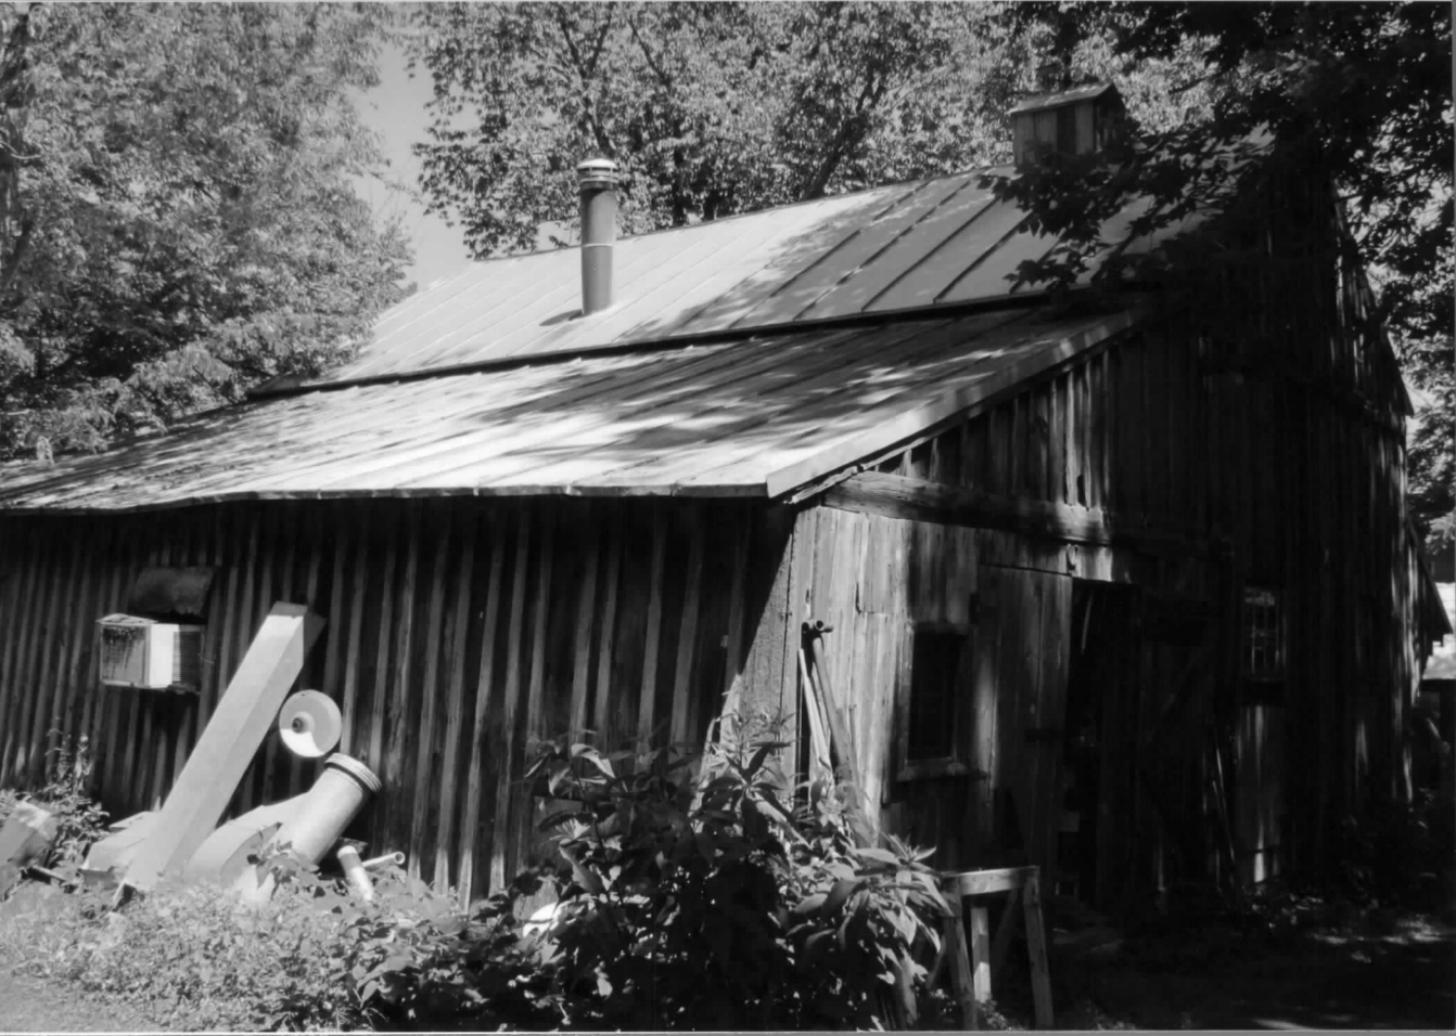
14/15

The west elevation of the barn is obscured with a shed roof addition (Photograph 14). The south elevation of the addition has a pair of vertical wood doors near the main section of the building. There is also a wood four-light window on the west end. The western elevation has two wood windows; one has four lights and the second has a modern air conditioner. The north side of the addition has a metal exhaust fan.

View facing northeast, showing the west elevation of the
barn.

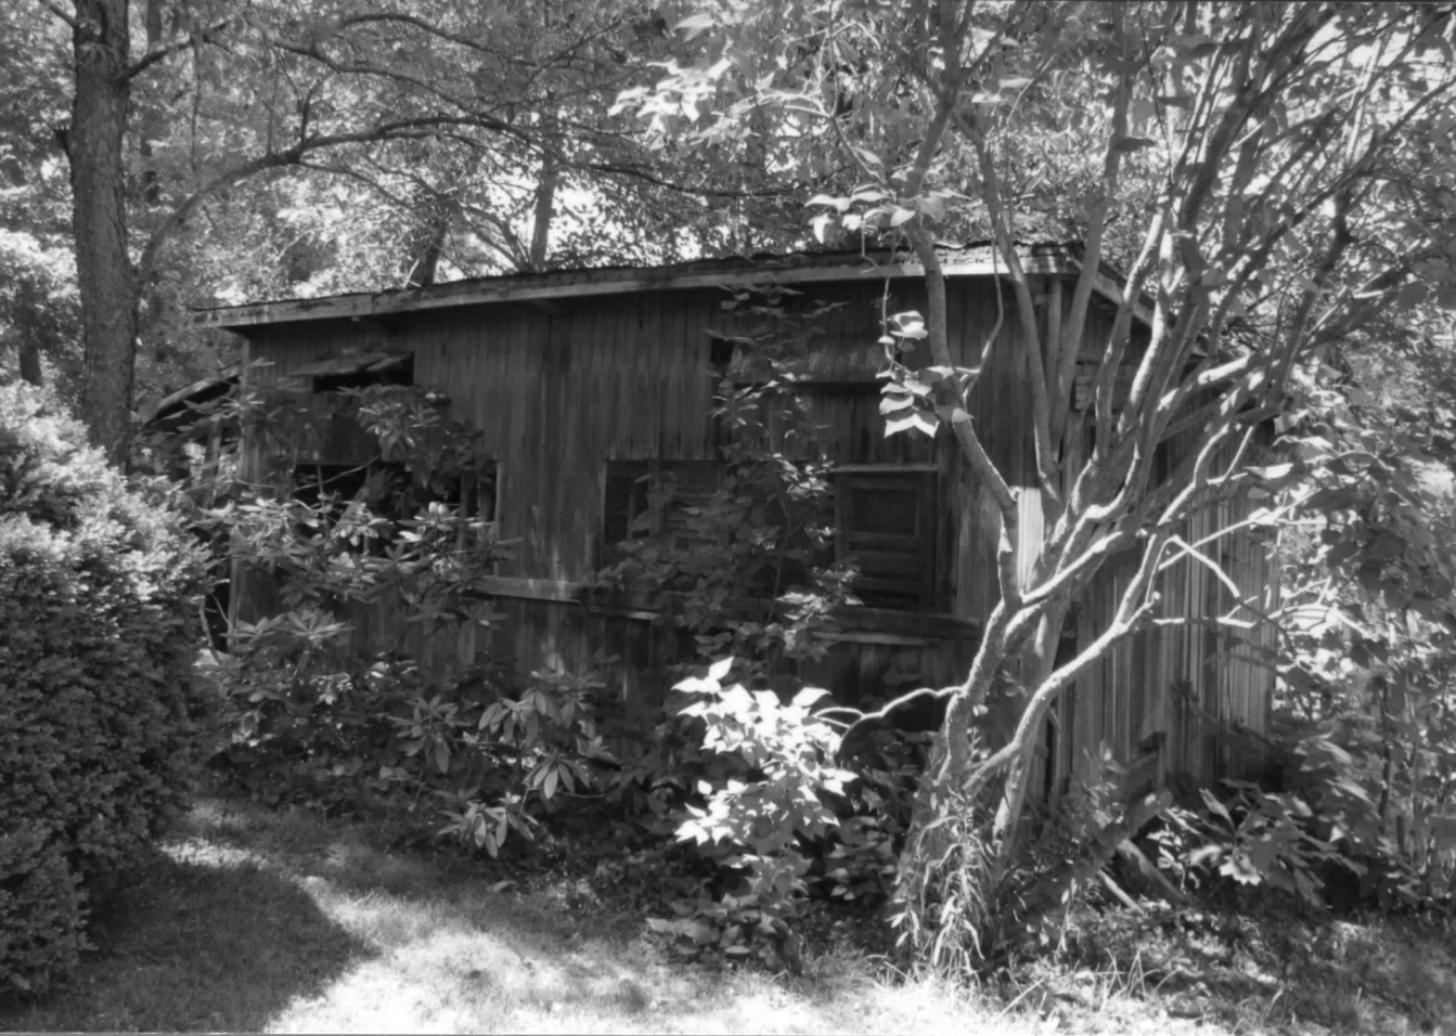
15/15

Northeast of the barn is a ca. 1870 chicken coop (Photograph 15). It is two bays wide and one room deep. The walls are clad in board and batten siding and it has a shed roof that is sheathed in corrugated metal. The south side of the building has two large rectangular windows that are missing their glazing or other covering. Above each window is a small rectangular vent. The west side of the coop has a small tractor shed addition. There are no fenestrations on the north side of the building. The east side of the building has a vertical board door with a wire mesh window.

View facing northwest, showing the chicken coop.

The property retains several of the original outbuildings such as barn, privy, chicken coop and shed. All of the buildings except for the privy and the chicken coop are in good repair. The buildings retain integrity of design, material and workmanship. The dwelling on the property is a vernacular building that retains many original elements such as original wood windows, original front doors and the original front porch. The massing of the dwelling has changed with the ca. 1900 addition; however, it was constructed in a similar style to the dwelling and does not detract from the integrity of feeling and association of the dwelling. All of the windows in the dwelling except those in the attic have been restored instead of replaced by the current owner. The property as a whole is a good example of a late nineteenth-century homestead in New Windsor. The property retains integrity of design by keeping the dwelling original to
