MOUNT LOFTY, DANIEL ROOP HOUSE

# Maryland Historical Trust State Historic Sites Inventory Form

historic  Daniel Roop House

and/or common Mount Lofty

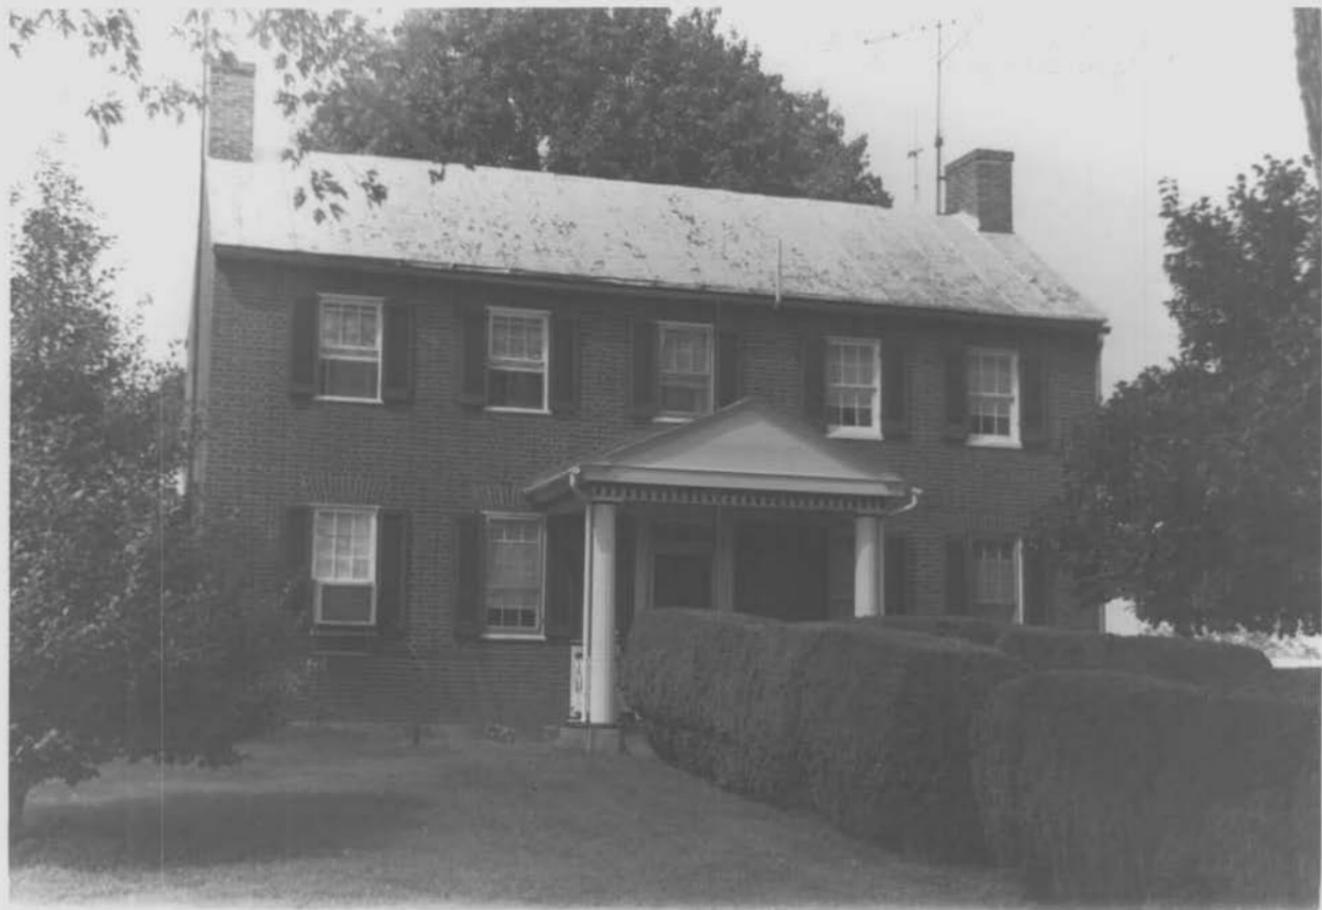
1. CARR-200 Daniel Roop House
2. Carroll County, Maryland
3. Joe Getty
4. July 1985
5. Md. Hist. Trust, Annapolis, Md.
6. south elevation

The house is a two-story, five-bay by two-bay house built in a L-shape. It is constructed of brick and the main facade is laid in Flemish-bond. The main facade has a central entrance with a one-story, one-bay porch. The porch is supported by columns and has a dentil cornice. The first story has nine-over-six pane sash windows and flat-arch brick lintels. There is a molded brick watertable under the first story windows. There is a molded brick cornice under the gable roof. The roof is covered in sheet metal. At both gable ends are interior end brick chimneys with a corbelled caps.

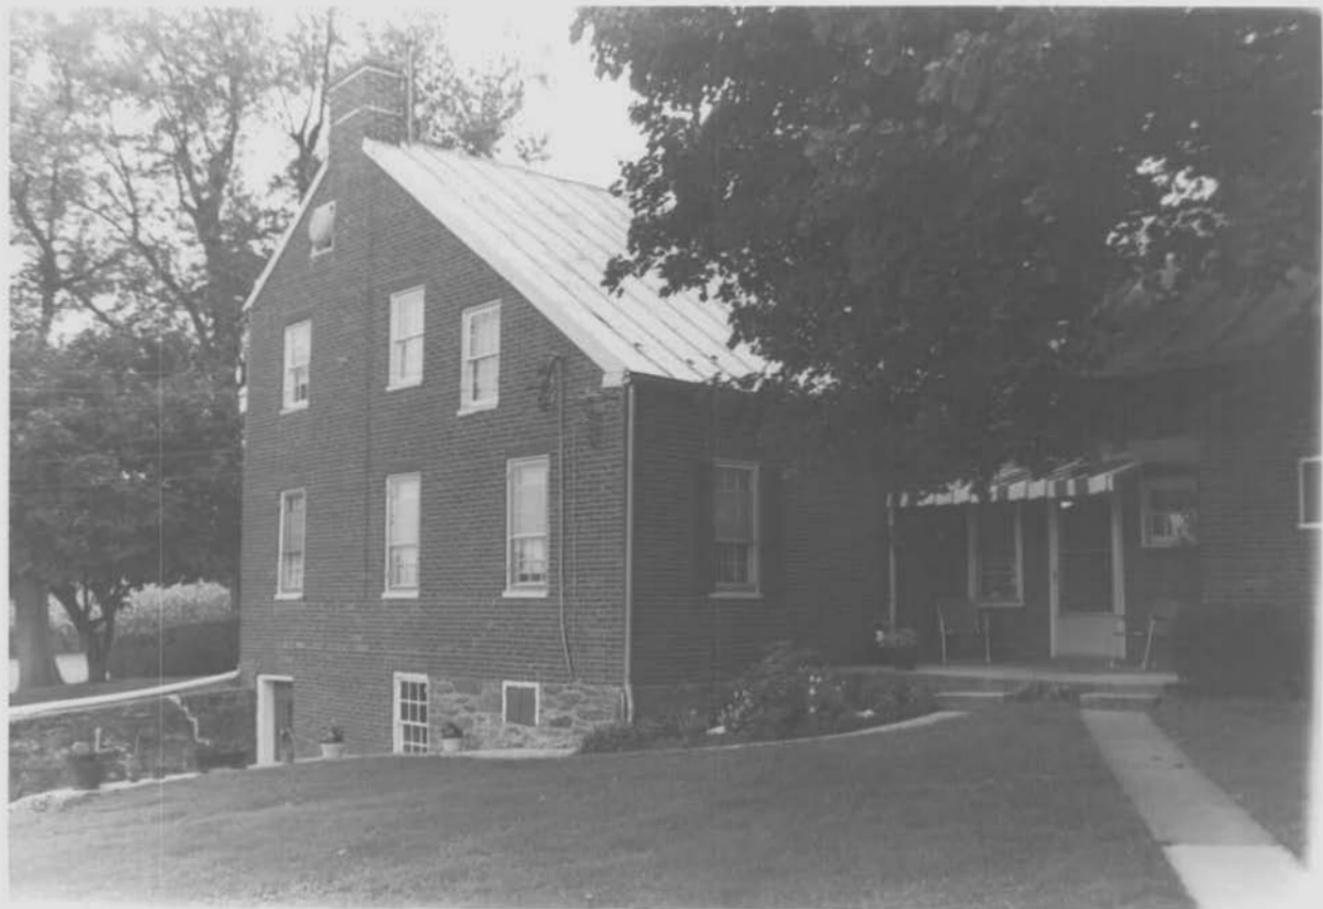
1. CARR-200 Daniel Roop House
2. Carroll County, Maryland
3. Joe Getty
4. July 1985
5. Md. Hist. Trust, Annapolis, Md.
6. east & north elevation

The east gable end has an excavated foundation level with an entrance into the basement. This entrance is protected by a stone retaining wall projectings out from the front of the building. This level of the house is constructed of brick except for a portion of the foundation at the rear which is in stone and has a catslide roof over it. There are three nine-over-six windows on the first story, three six-over-six sash windows on the second story (with the window on the second story under the catslide roof located in an asymmetrical fashion), and a small four-pane window in the garrett.

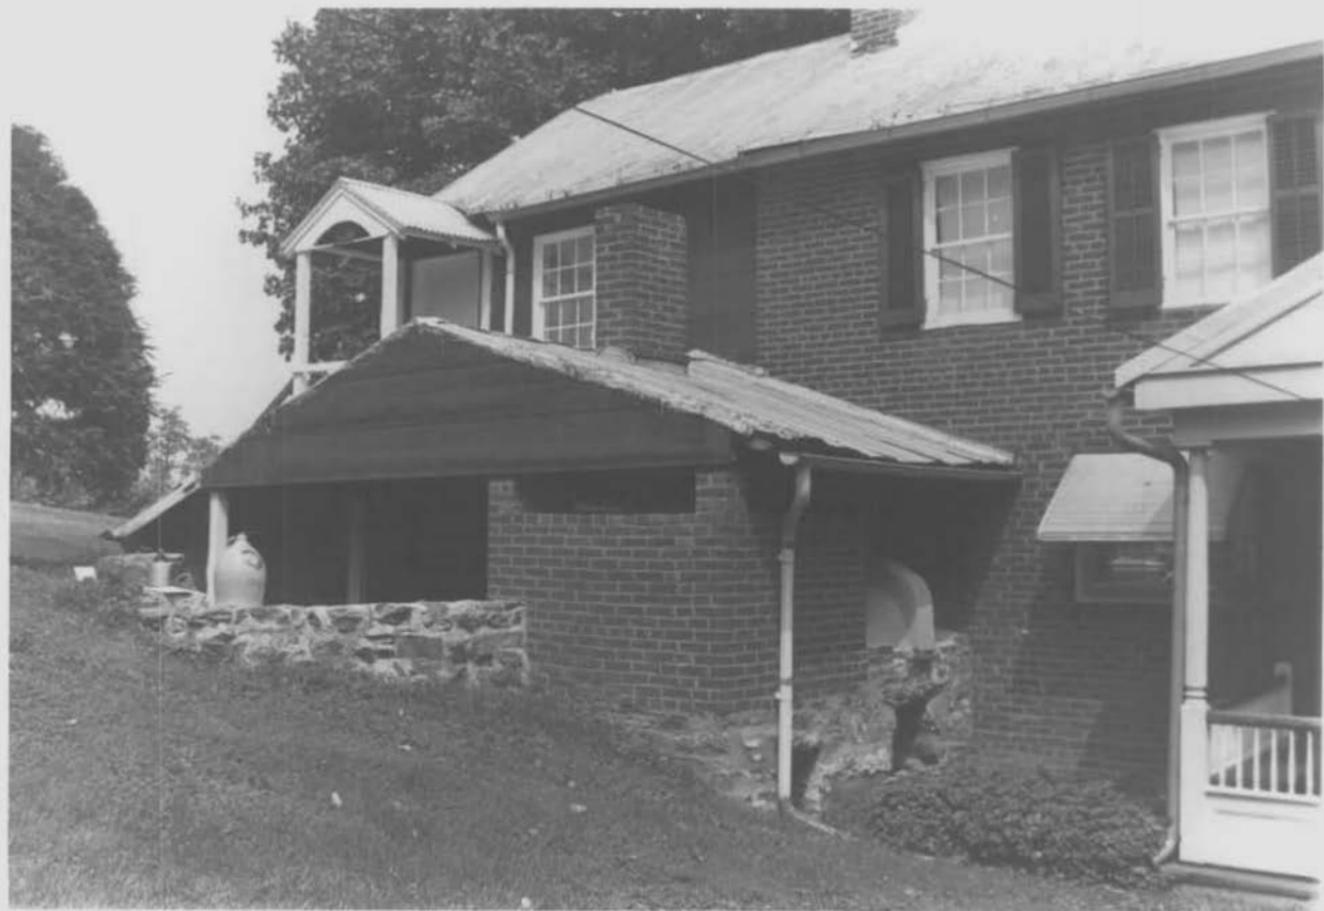
1. CARR-200 Daniel Roop House
2. Carroll County, Maryland
3. Joe Getty
4. July 1985
5. Md. Hist. Trust, Annapolis, Md.
6. west elevation--bake-oven addition

The west gable end of the main block of the house has a modern entrance with a one-story, one-bay gable roof. To the south side of the entrance is a nine-over-six window. The wing projects back on this side and contains a kitchen. The kitchen entrance has a porch that contains a brick oven and drying compartment. The bake oven is enclosed in a gable roof structure on a stone foundation. On the south side of this structure, there is an opening where one can view the rear of the rat-tail style bake oven. Attached to the bake oven is a compartment of drying racks that included two vertical rows of racks with five long wooden drawers in each row. Also on the property is a brick and board and batten smoke house, a chicken house, and a barn.

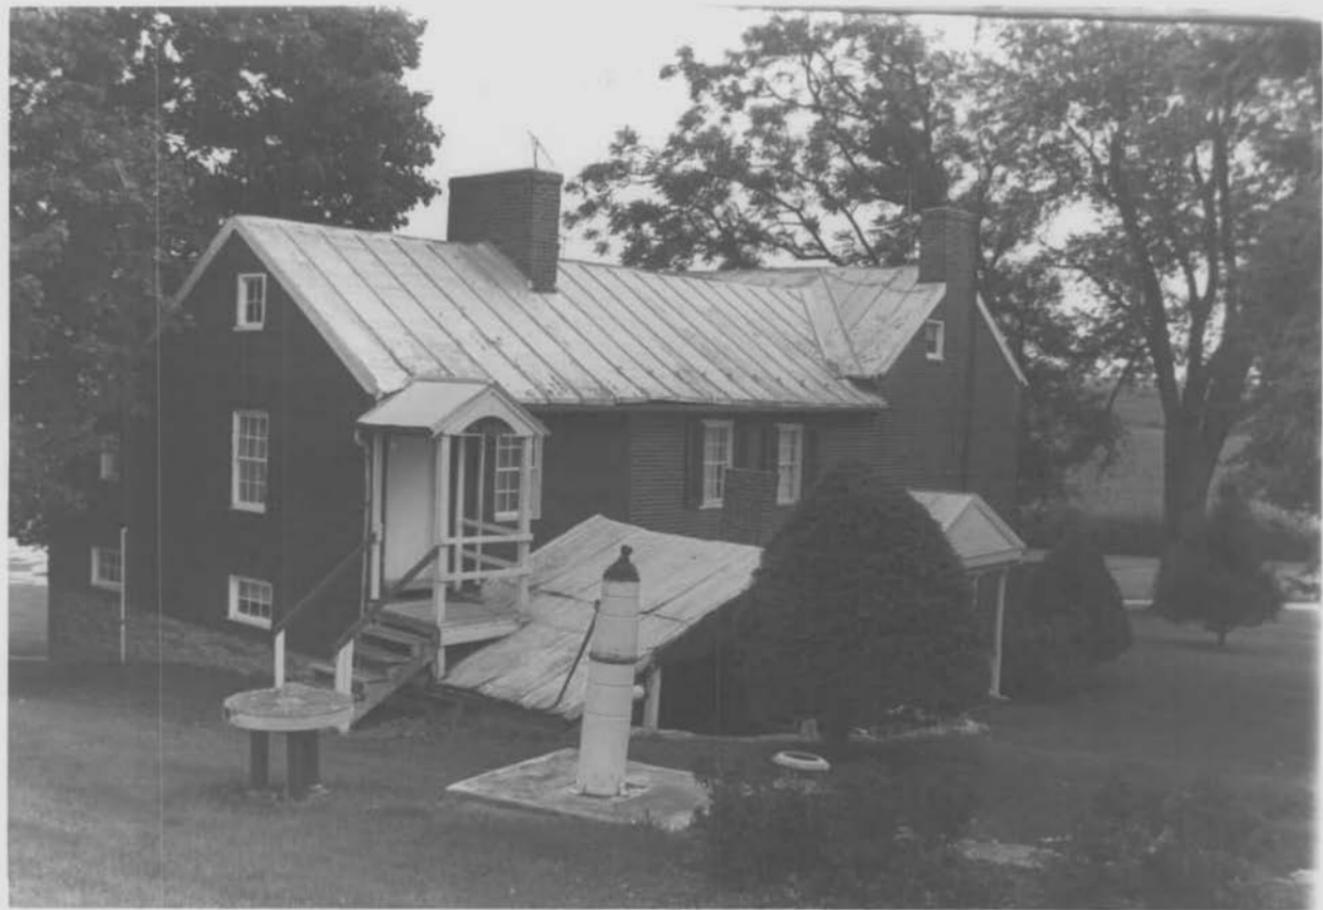
1. CARR-200 Daniel Roop House
2. Carroll County, Maryland
3. Joe Getty
4. July 1985
5. Md. Hist. Trust, Annapolis, Md.
6. north and west elevation

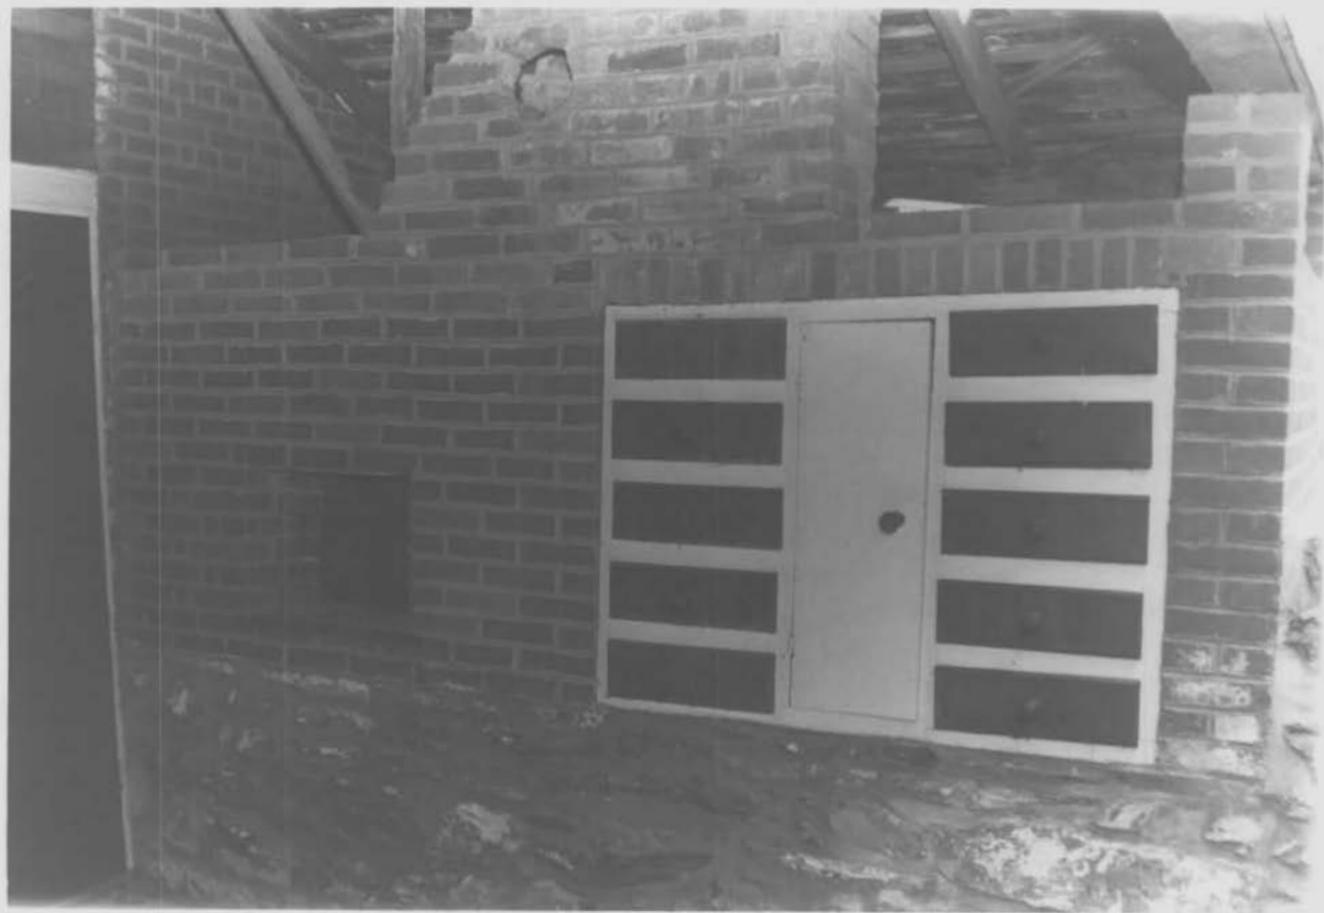
1. CARR-200 Daniel Roop House
2. Carroll County, Maryland
3. Joe Getty
4. July 1985
5. Md. Hist. Trust, Annapolis, Md.
6. bake-oven & dryhouse

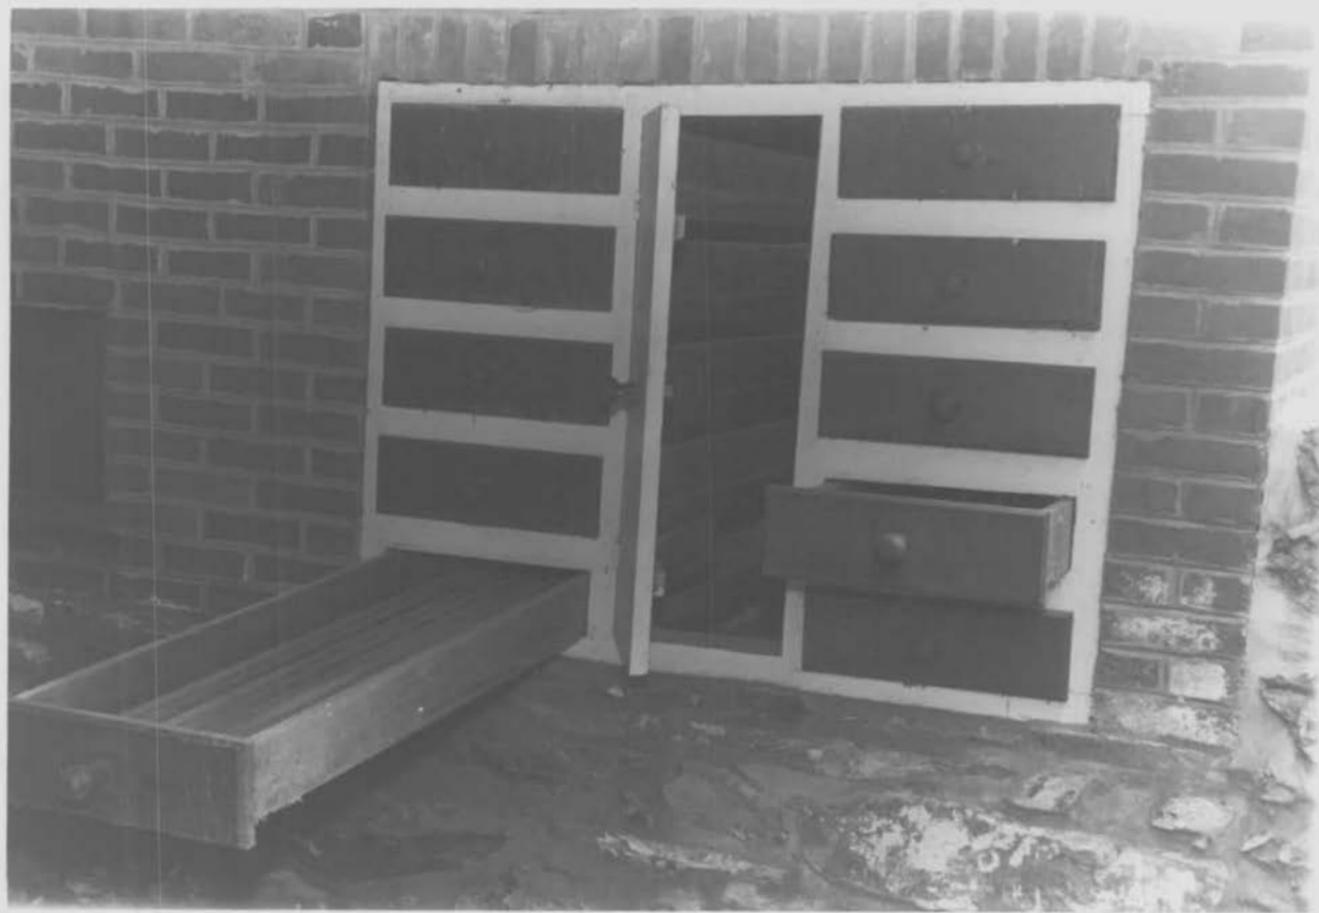
1. CARR-200 Daniel Roop House
2. Carroll County, Maryland
3. Joe Getty
4. July 1985
5. Md. Hist. Trust, Annapolis, Md.
6. drying shelves

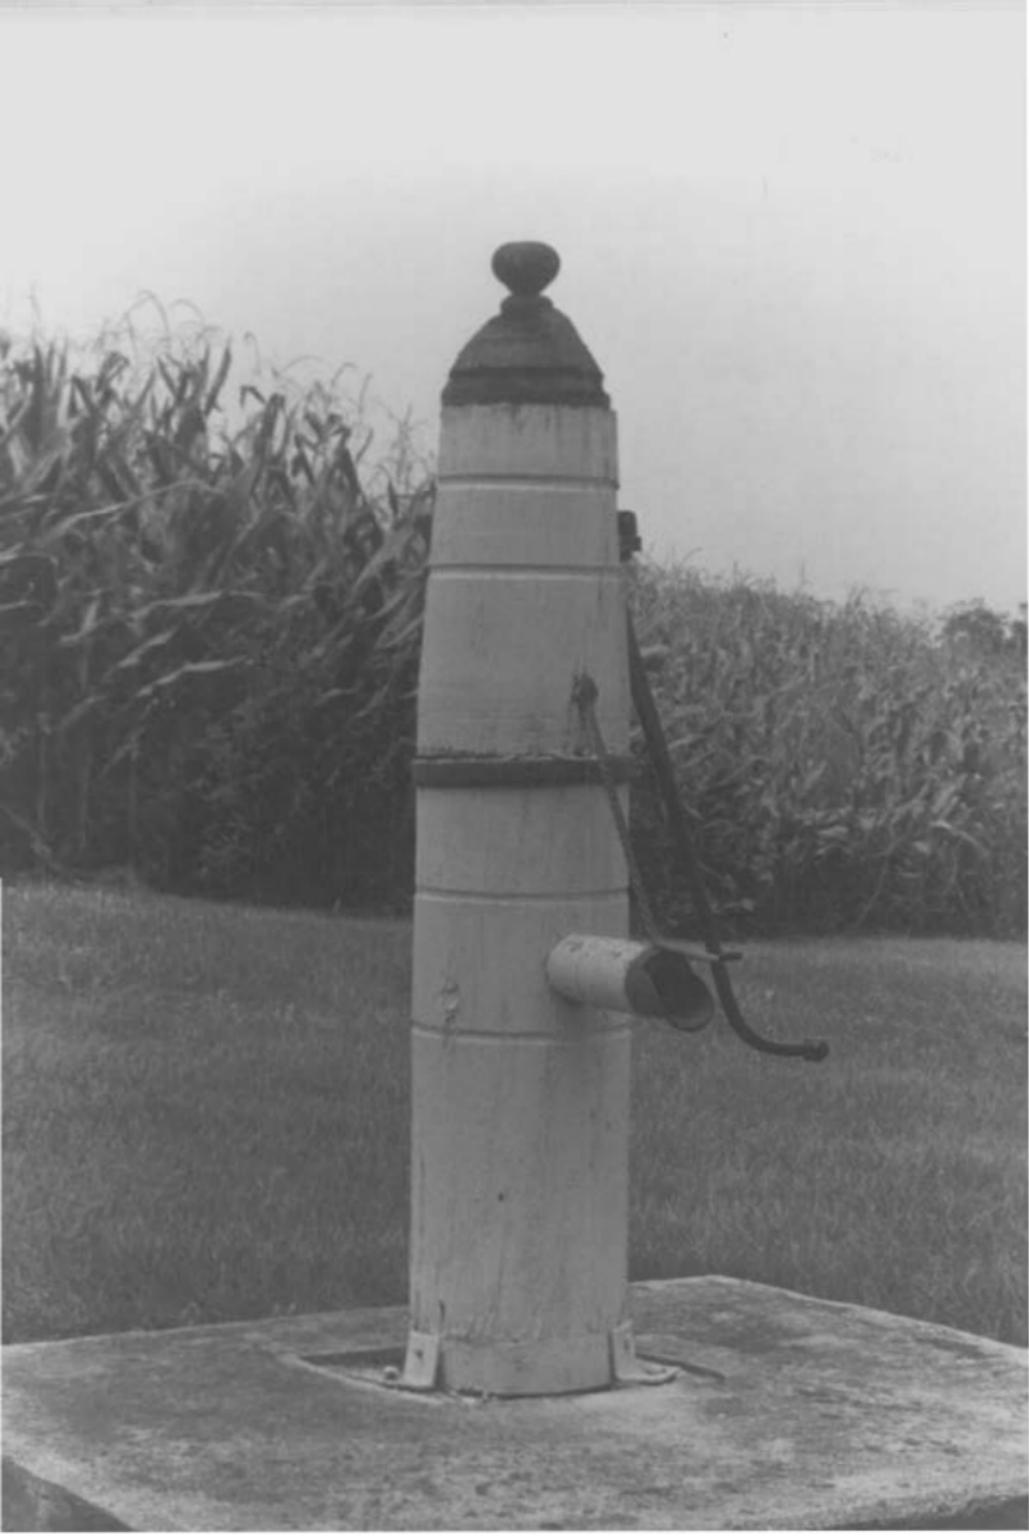
1. CARR-200 Daniel Roop House
2. Carroll County, Maryland
3. Joe Getty
4. July 1985
5. Md. Hist. Trust, Annapolis, Md.
6. cucumber pump

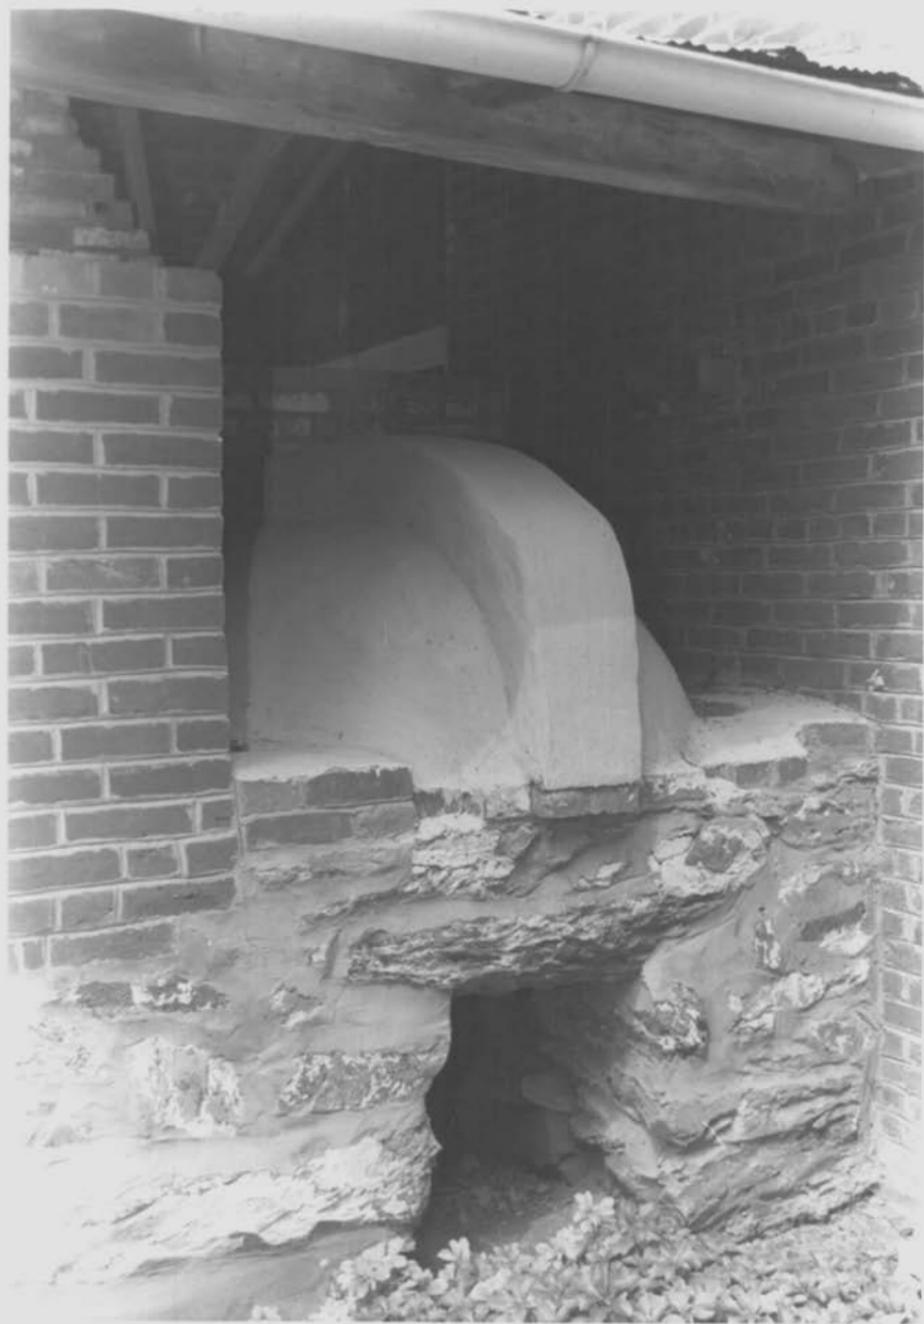
1. CARR-200 Daniel Roop House
2. Carroll County, Maryland
3. Joe Getty
4. July 1985
5. Md. Hist. Trust, Annapolis, Md.
6. rear of bake-oven

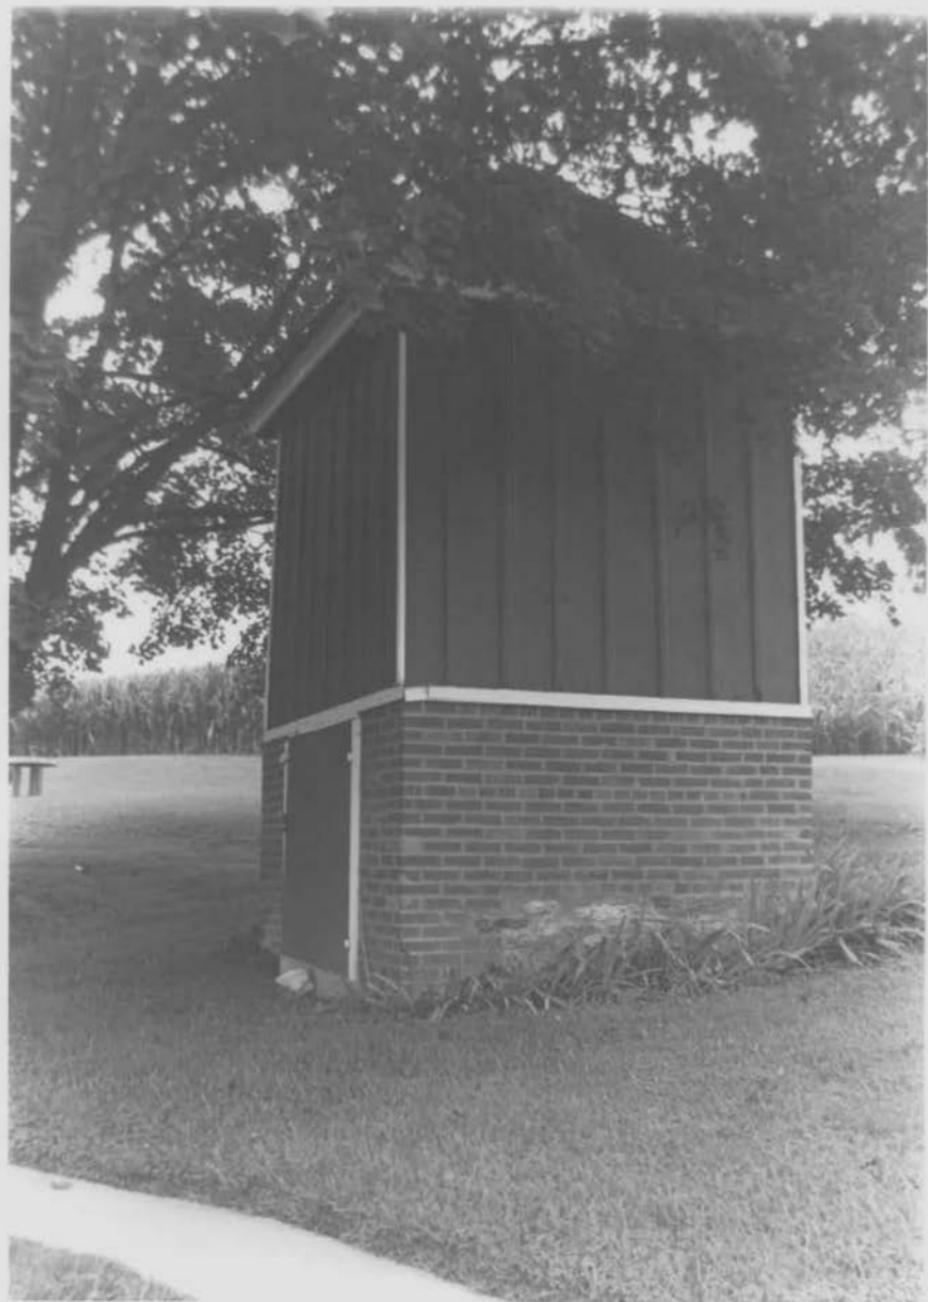
1. CARR-200 Daniel Roop House
2. Carroll County, Maryland
3. Joe Getty
4. July 1985
5. Md. Hist. Trust, Annapolis, Md.
6. smokehouse-s. & e. elev.

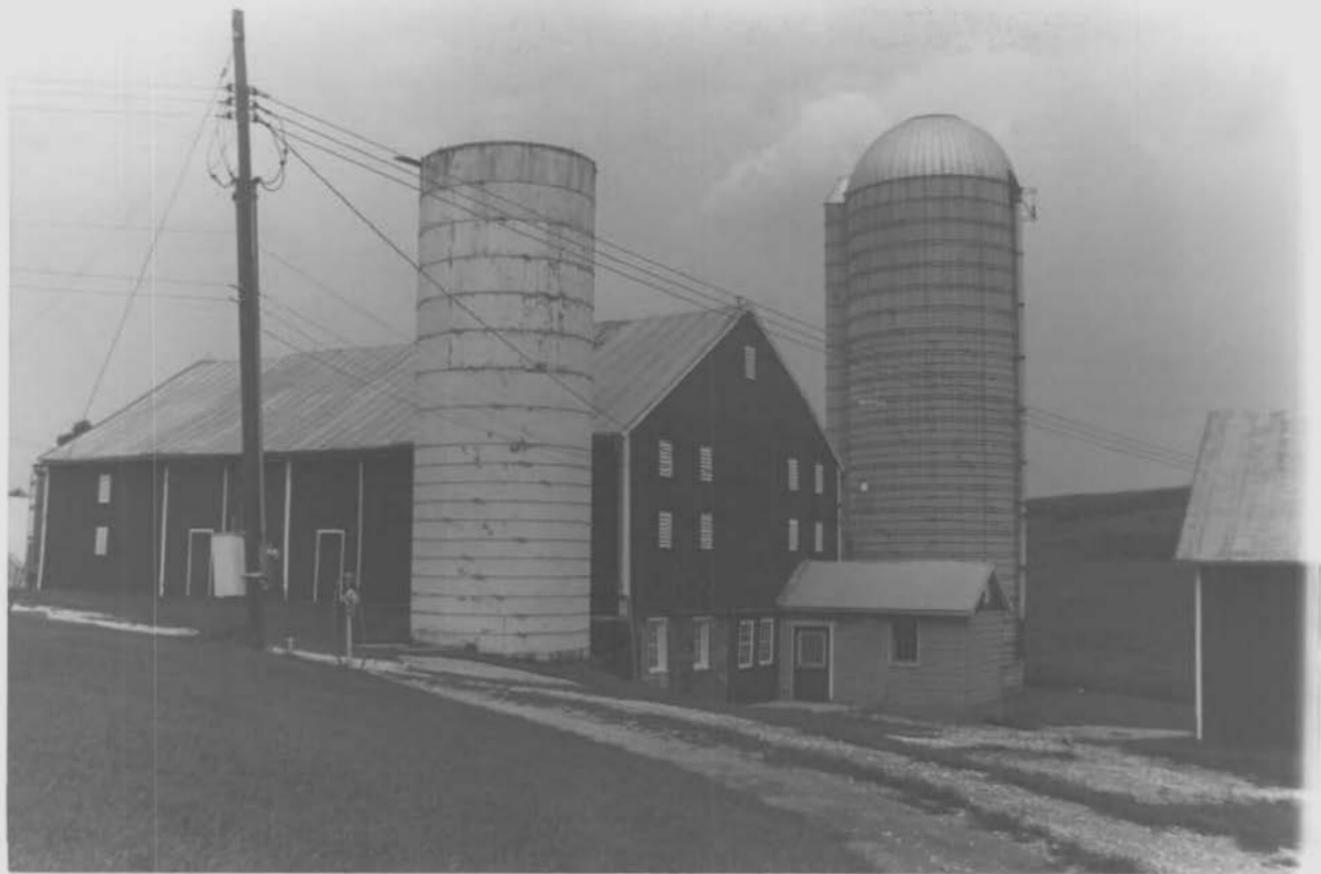
1. CARR-200 Daniel Roop House
2. Carroll County, Maryland
3. Joe Getty
4. July 1985
5. Md. Hist. Trust, Annapolis, Md.
6. barn-s. & w. elev.

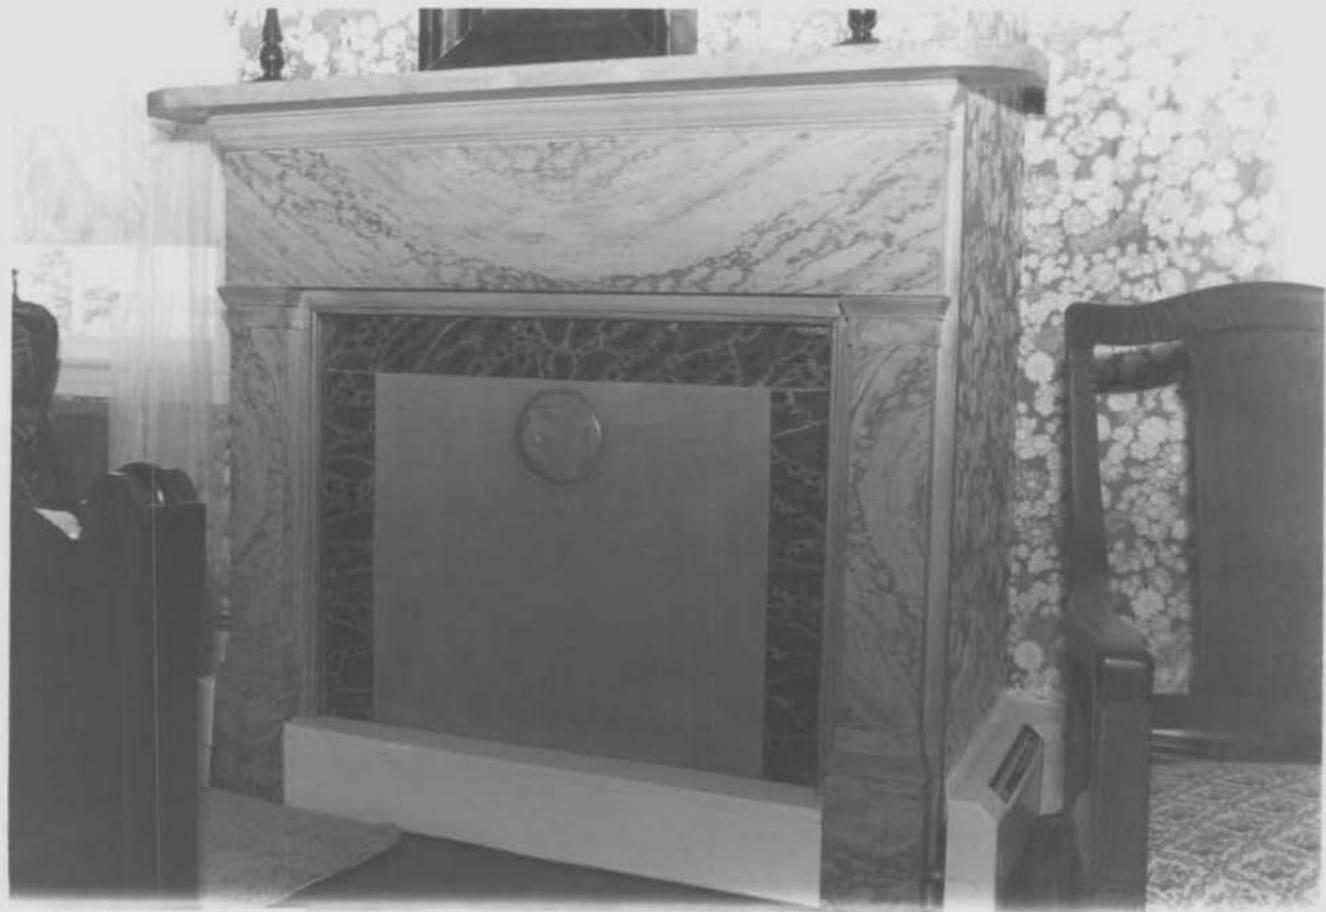
1. CARR-200 Daniel Roop House
2. Carroll County, Maryland
3. Joe Getty
4. July 1985
5. Md. Hist. Trust, Annapolis, Md.
6. 2nd floor-marbelized mantel
