CARR - 24

FARM CONTENT

NATIONAL REGISTER OF HISTORIC PLACES  
INVENTORY - NOMINATION FORM

Farm Content

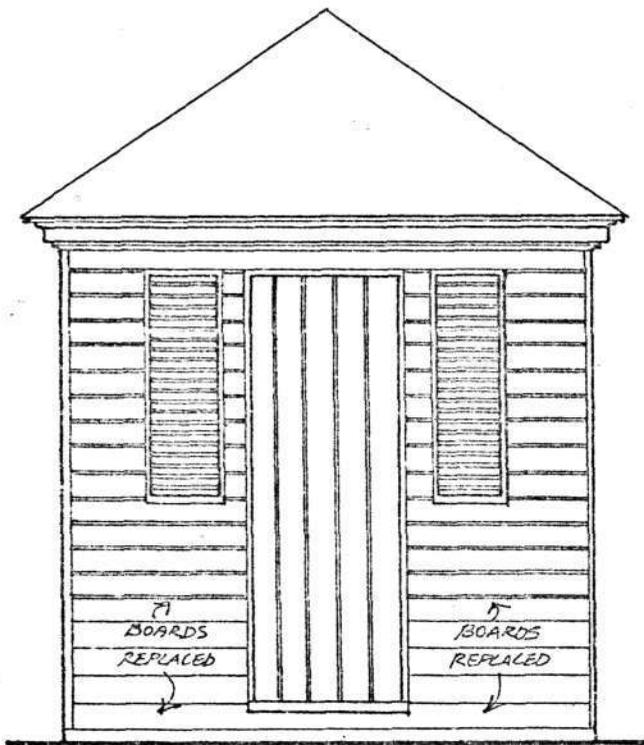
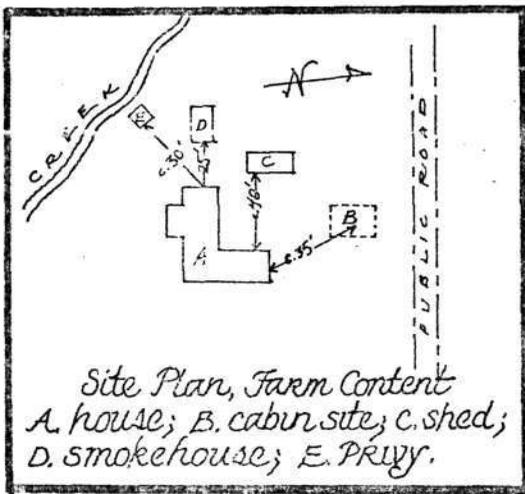
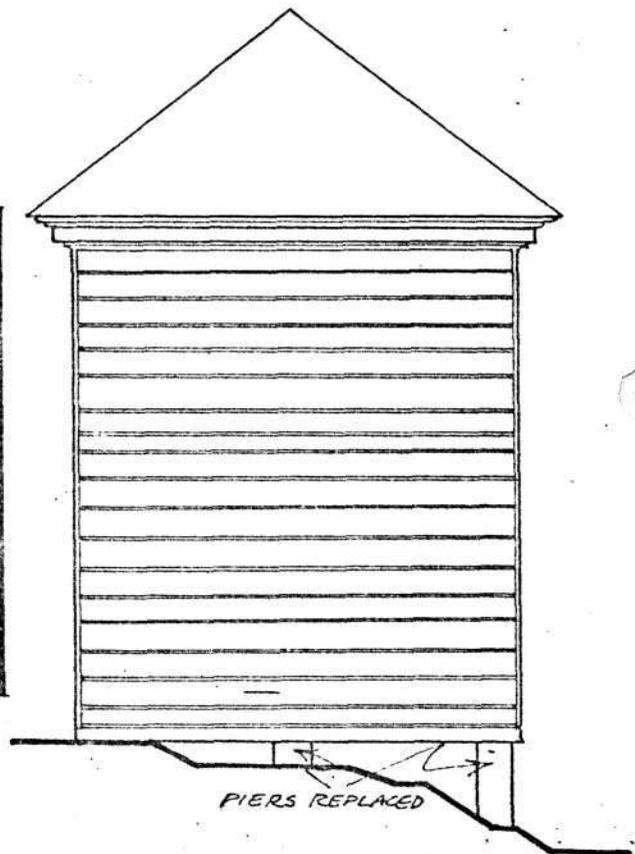
c. 1800 PRIVY-  
 FARM CONTENT  
 CARROLL COUNTY, MD.

Farm Content is an excellent example of rural Federal style architecture in Carroll County. The house is a two-story brick structure with a gable roof. The brick is laid in Flemish bond on three sides of the house. The stepped brick cornice includes one course laid in a sawtooth pattern. On the outside wall of the north chimney is a marble datestone inscribed "DRS 1795." The interior has a central stair hall with a single room off to each side. On the rear of the structure is a two-story ell addition which enclosed an earlier detached kitchen. The interior ornamentation includes molded chairrails and door and window frames, mantels with geometrical patterns, and stairway details. The symmetrical facade arrangement, floor plan, and the ornamental details throughout the house are representative characteristics of the rural Federal style. The property contains a complete set of farm outbuildings and has an unusual privy of an early date. The frame privy has a pyramid roof and was constructed over a stream behind the house.

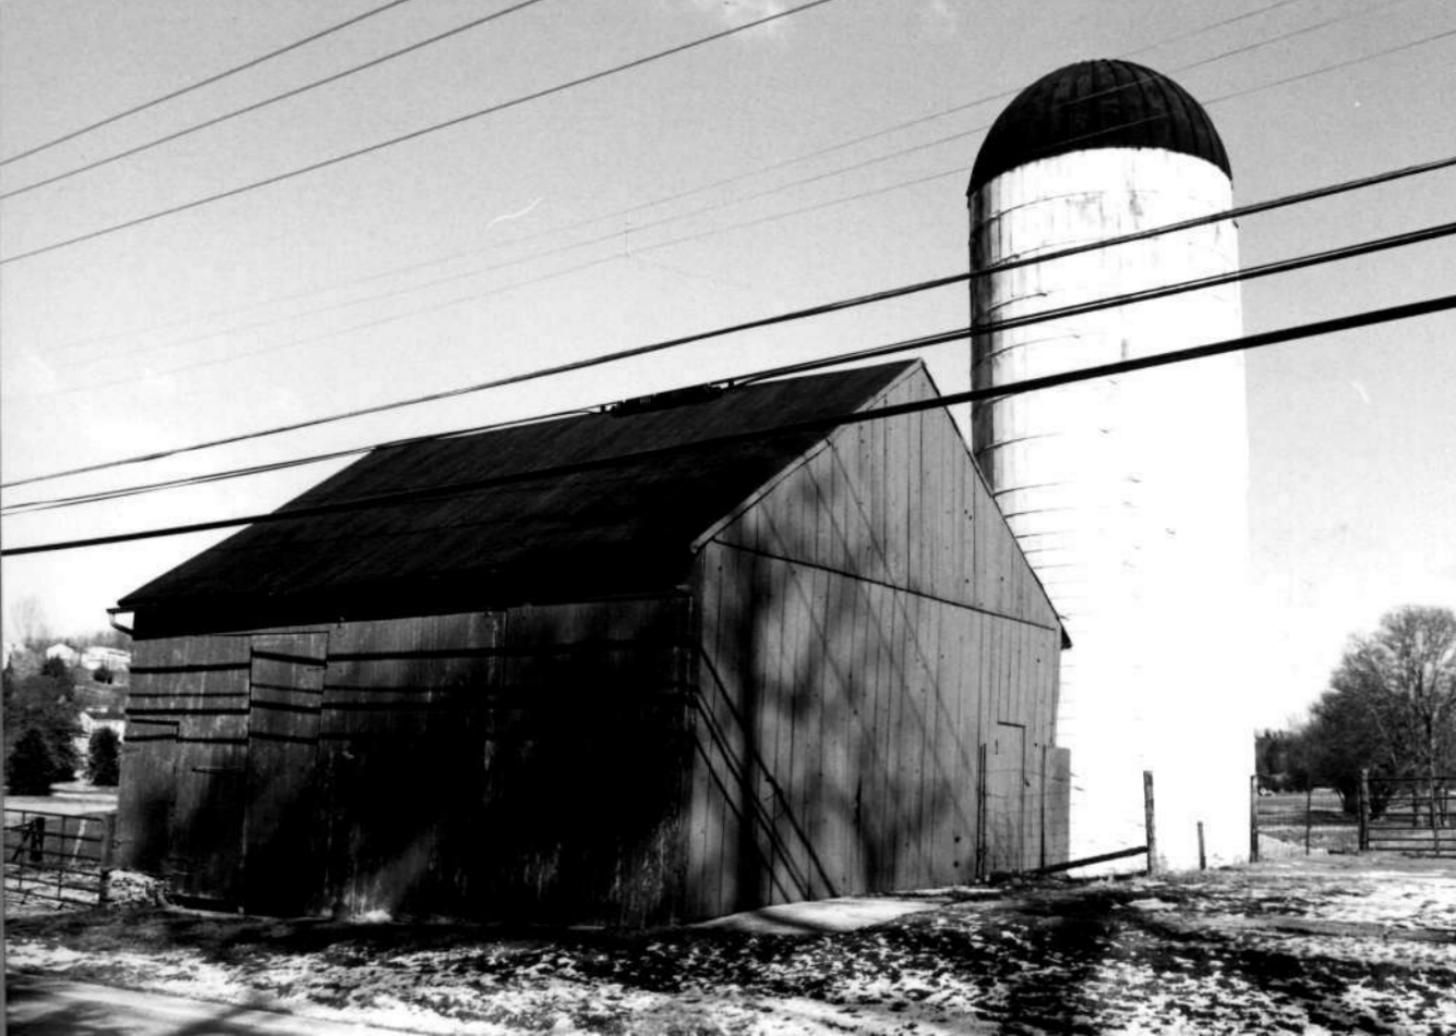
Barrack & silo, SW &  
SE ekus  
10/10

There is a barrack approximately 150 feet north of the house, on the north side of Old New Windsor Road, and it is set about 10 feet off the road. It has vertical-board siding and a gable roof of corrugated metal with a northwest-southeast ridge. According to the owners, it has a date of 1803 somewhere in the building. The southwest elevation has a stone foundation on the west with a vertical-board door above it, two vertical-board wagon doors hung on machine-cut strap hinges, and two vertical beaded-edge-and-center board wagon doors on rollers to the south. The southeast elevation has a vertical-board door set to the east, and a concrete silo at the east corner. The northeast elevation has two pair of vertical-board wagon doors on machine-cut strap hinges. The northwest elevation has no openings. The rafters are exposed, are tapered, and overhang the eaves. The center and end bents are the same, while the other two interior bents are smaller, with fewer timbers. The bents are hewn, heavy timber with bracing. There are three posts in each bent, and two down braces from the girt to the sill. The top girt laps the plates and supports large struts beneath the purlins. The rafters are hewn and some are partly in the round, and they appear to have an open-faced bridle and peg at the ridge. They support lath and wood shingles. The barrack is laid out with two center wagon floors and a hay mow or stable area on the southeast, plus a narrow mow with a raised wood floor on the northwest. This northwest mow has now been closed with circular-sawn, vertical boards fastened with wire nails, with gaps left between the boards.

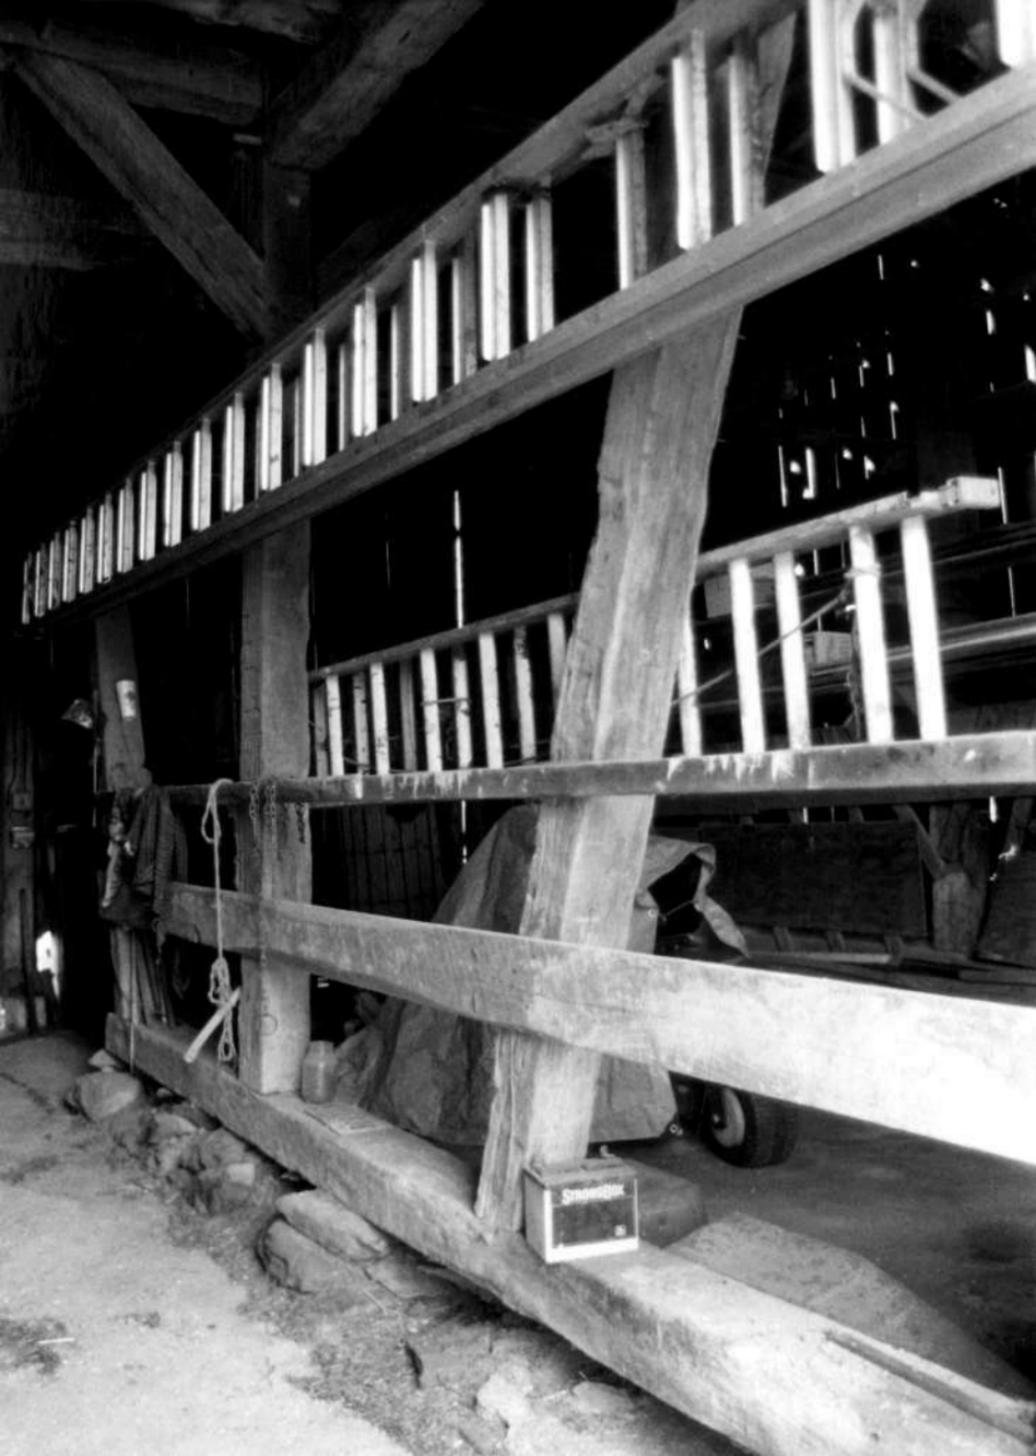
CARR-24  
Farm Content  
Carroll Co. MD  
Merry Stinson 5/03  
MD SHPO  
wagon shed interior  
15/13

Wagon Shed- This timber frame building stands on the opposite site of the Old New Windsor Pike, north of the main farm complex. The 28'x34'5" hewn frame resembles that of a small barn. The wagon shed stands on a stone foundation under a gable roof running east-west. Large barn doors give access to the south side. A batten door opens into the corn crib at the south side's west end. Vertical board siding sheathes the metal-roofed structure. A small silo adjoins the east end of the north side.

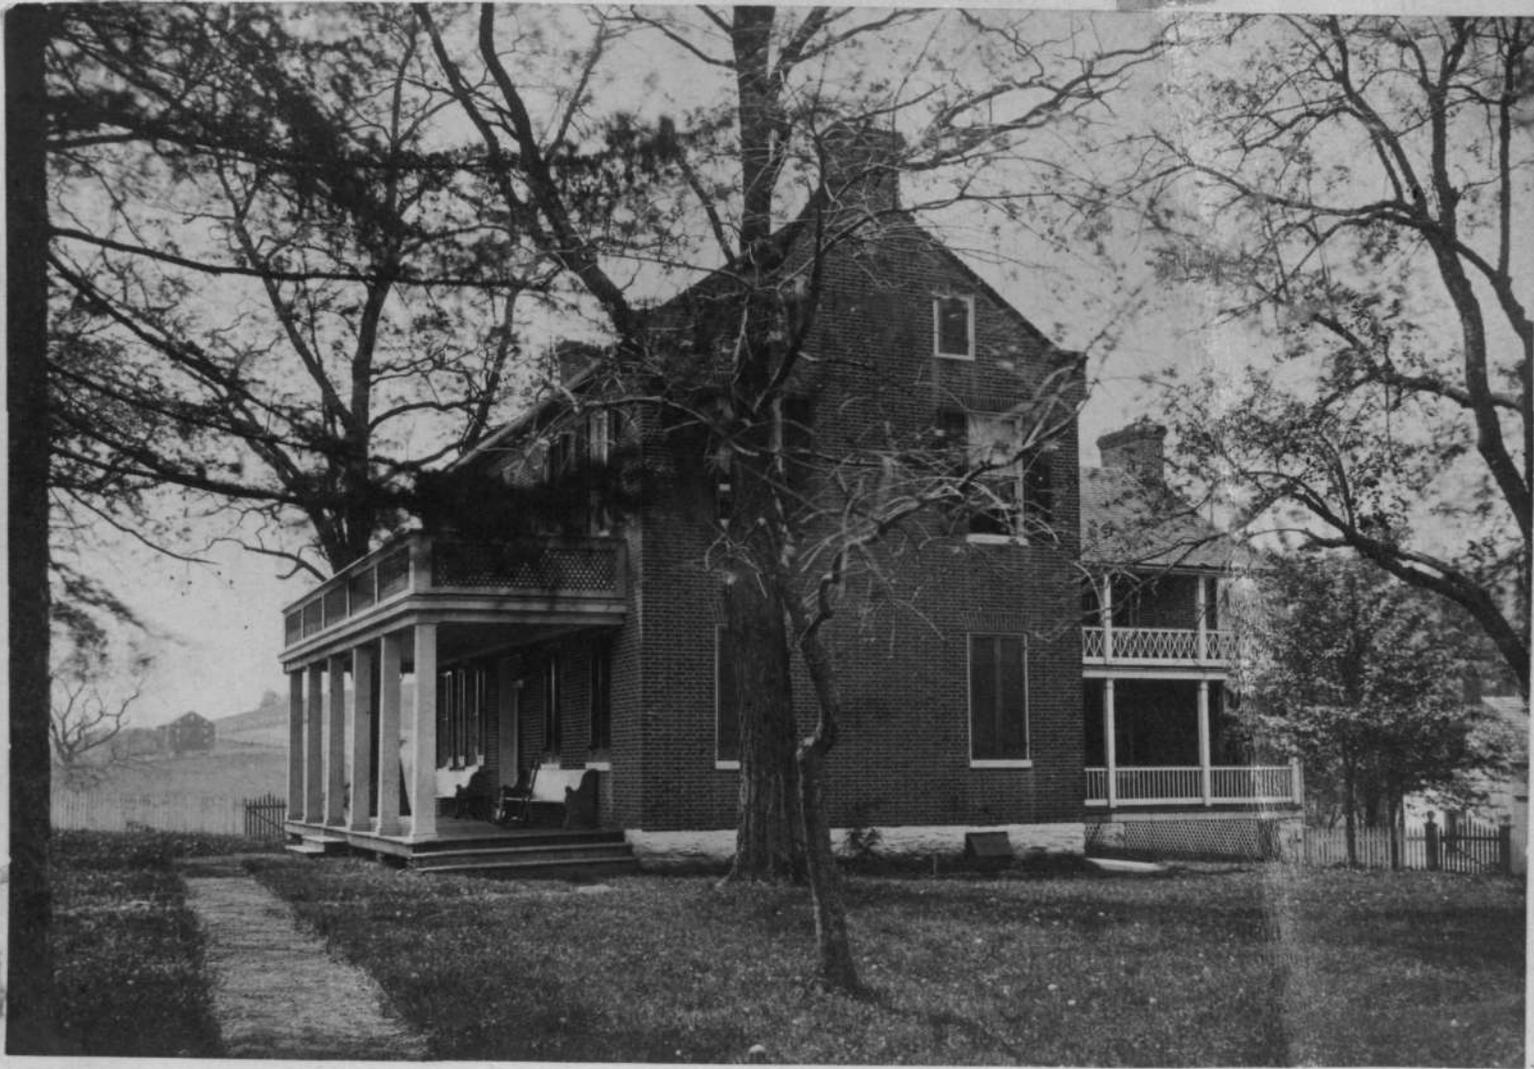
1147. X

- "Farm Content" showing the  
a sectioned plan with the  
a lot of porch. Photo c. 1850

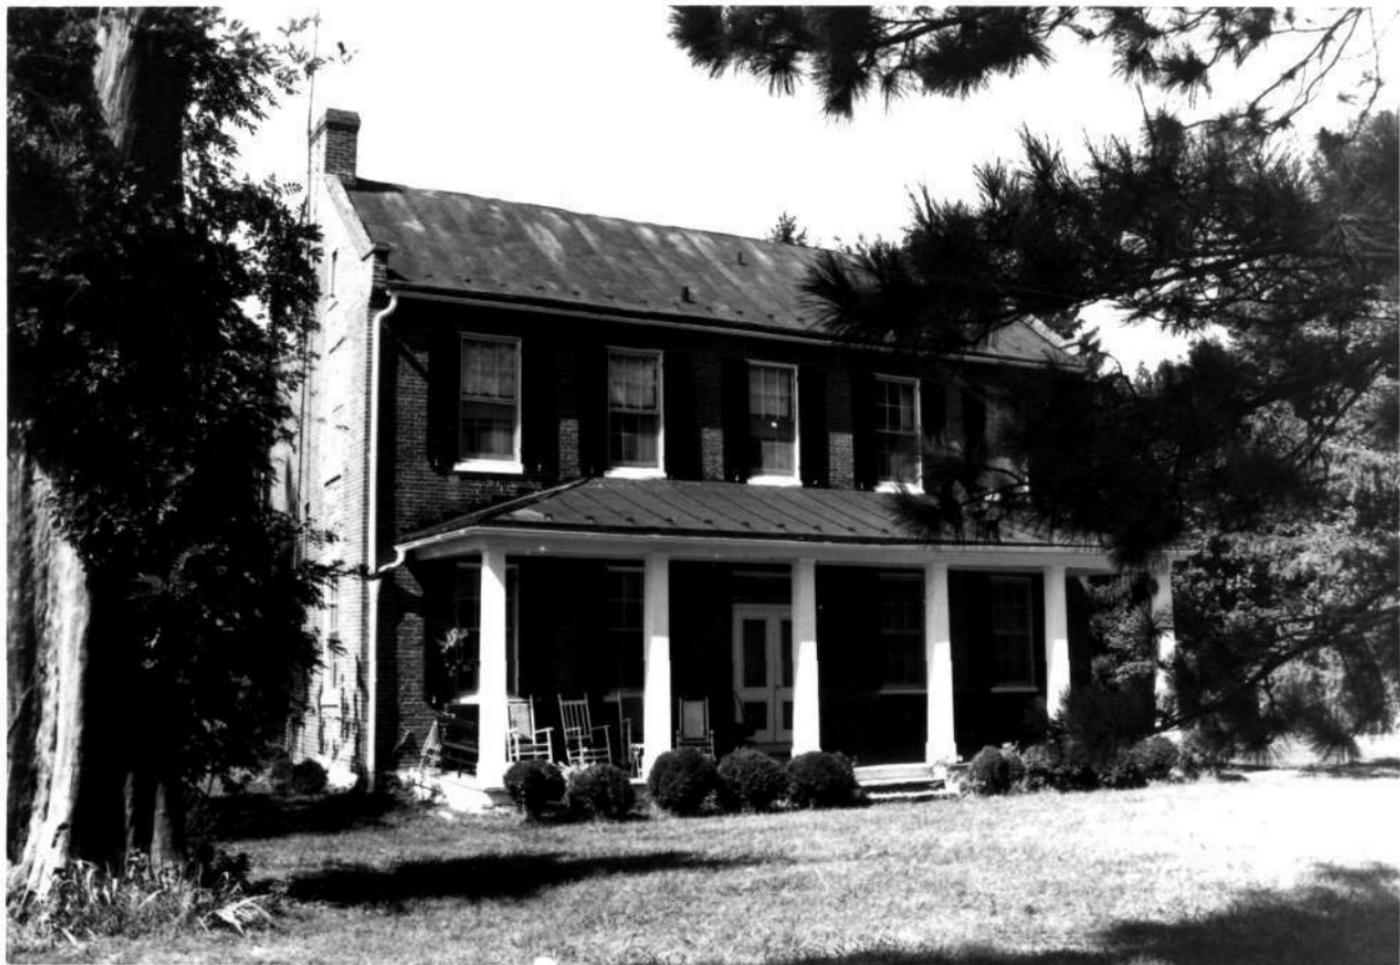
1. CARR-24 FARM CONTENT
2. Carroll County, Maryland
3. Joe Getty
4. August 1983
5. Md. Historical Trust, Annapolis, Md.
6. East elevation (camera facing west)
7. 1/1
