CARR - 406

FRAME HOUSE

Fenby Farm Road
Westminster vicinity

FIELD SHEET--HISTORIC RESOURCES SURVEY

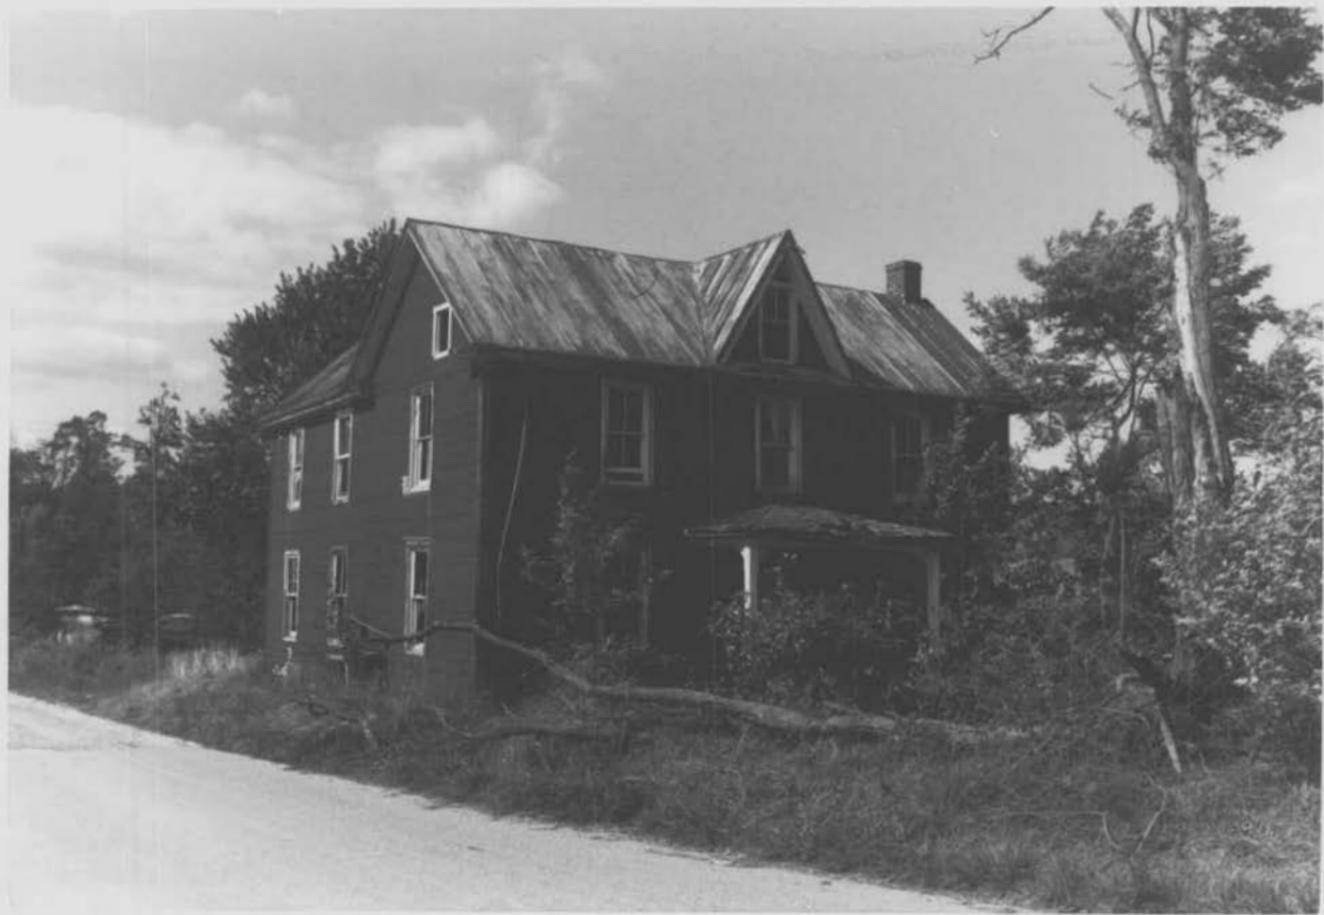
FRAME HOUSE

1. CARR-406
2. Carroll County, Maryland
3. Joe Getty
4. August 1983
5. Md. Historical Trust, Annapolis, Md.
6. South and east elevations (camera facing northwest)
7. 1/1
