HISTORIC AMERICAN BUILDINGS SURVEY
INVENTORY

State Historic Sites Inventory Form

historic Thorndale

CARR-47
Thorndale
3722 Old Taneytown Road

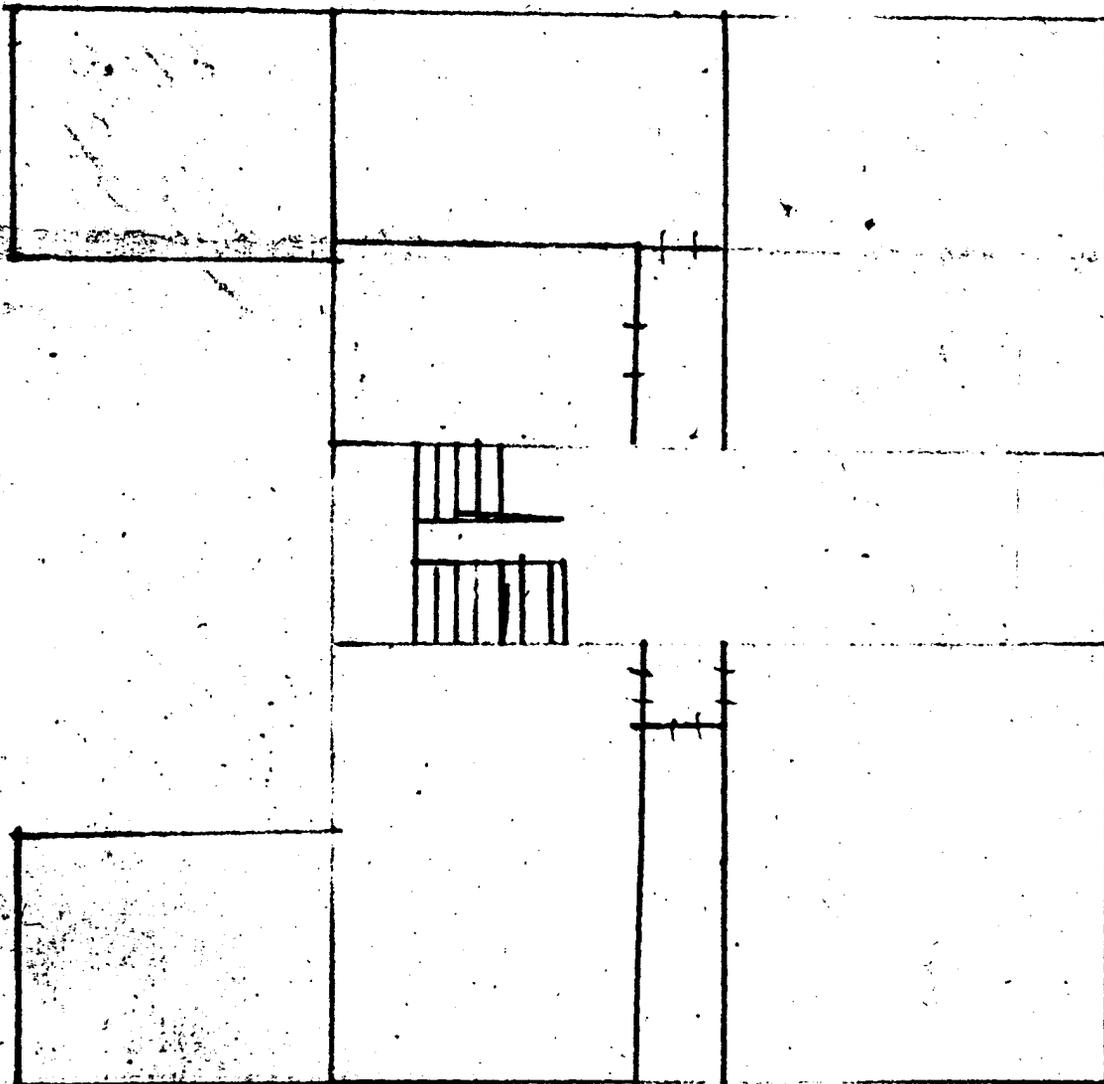
Floor plan in Clotworthy Birnie papers

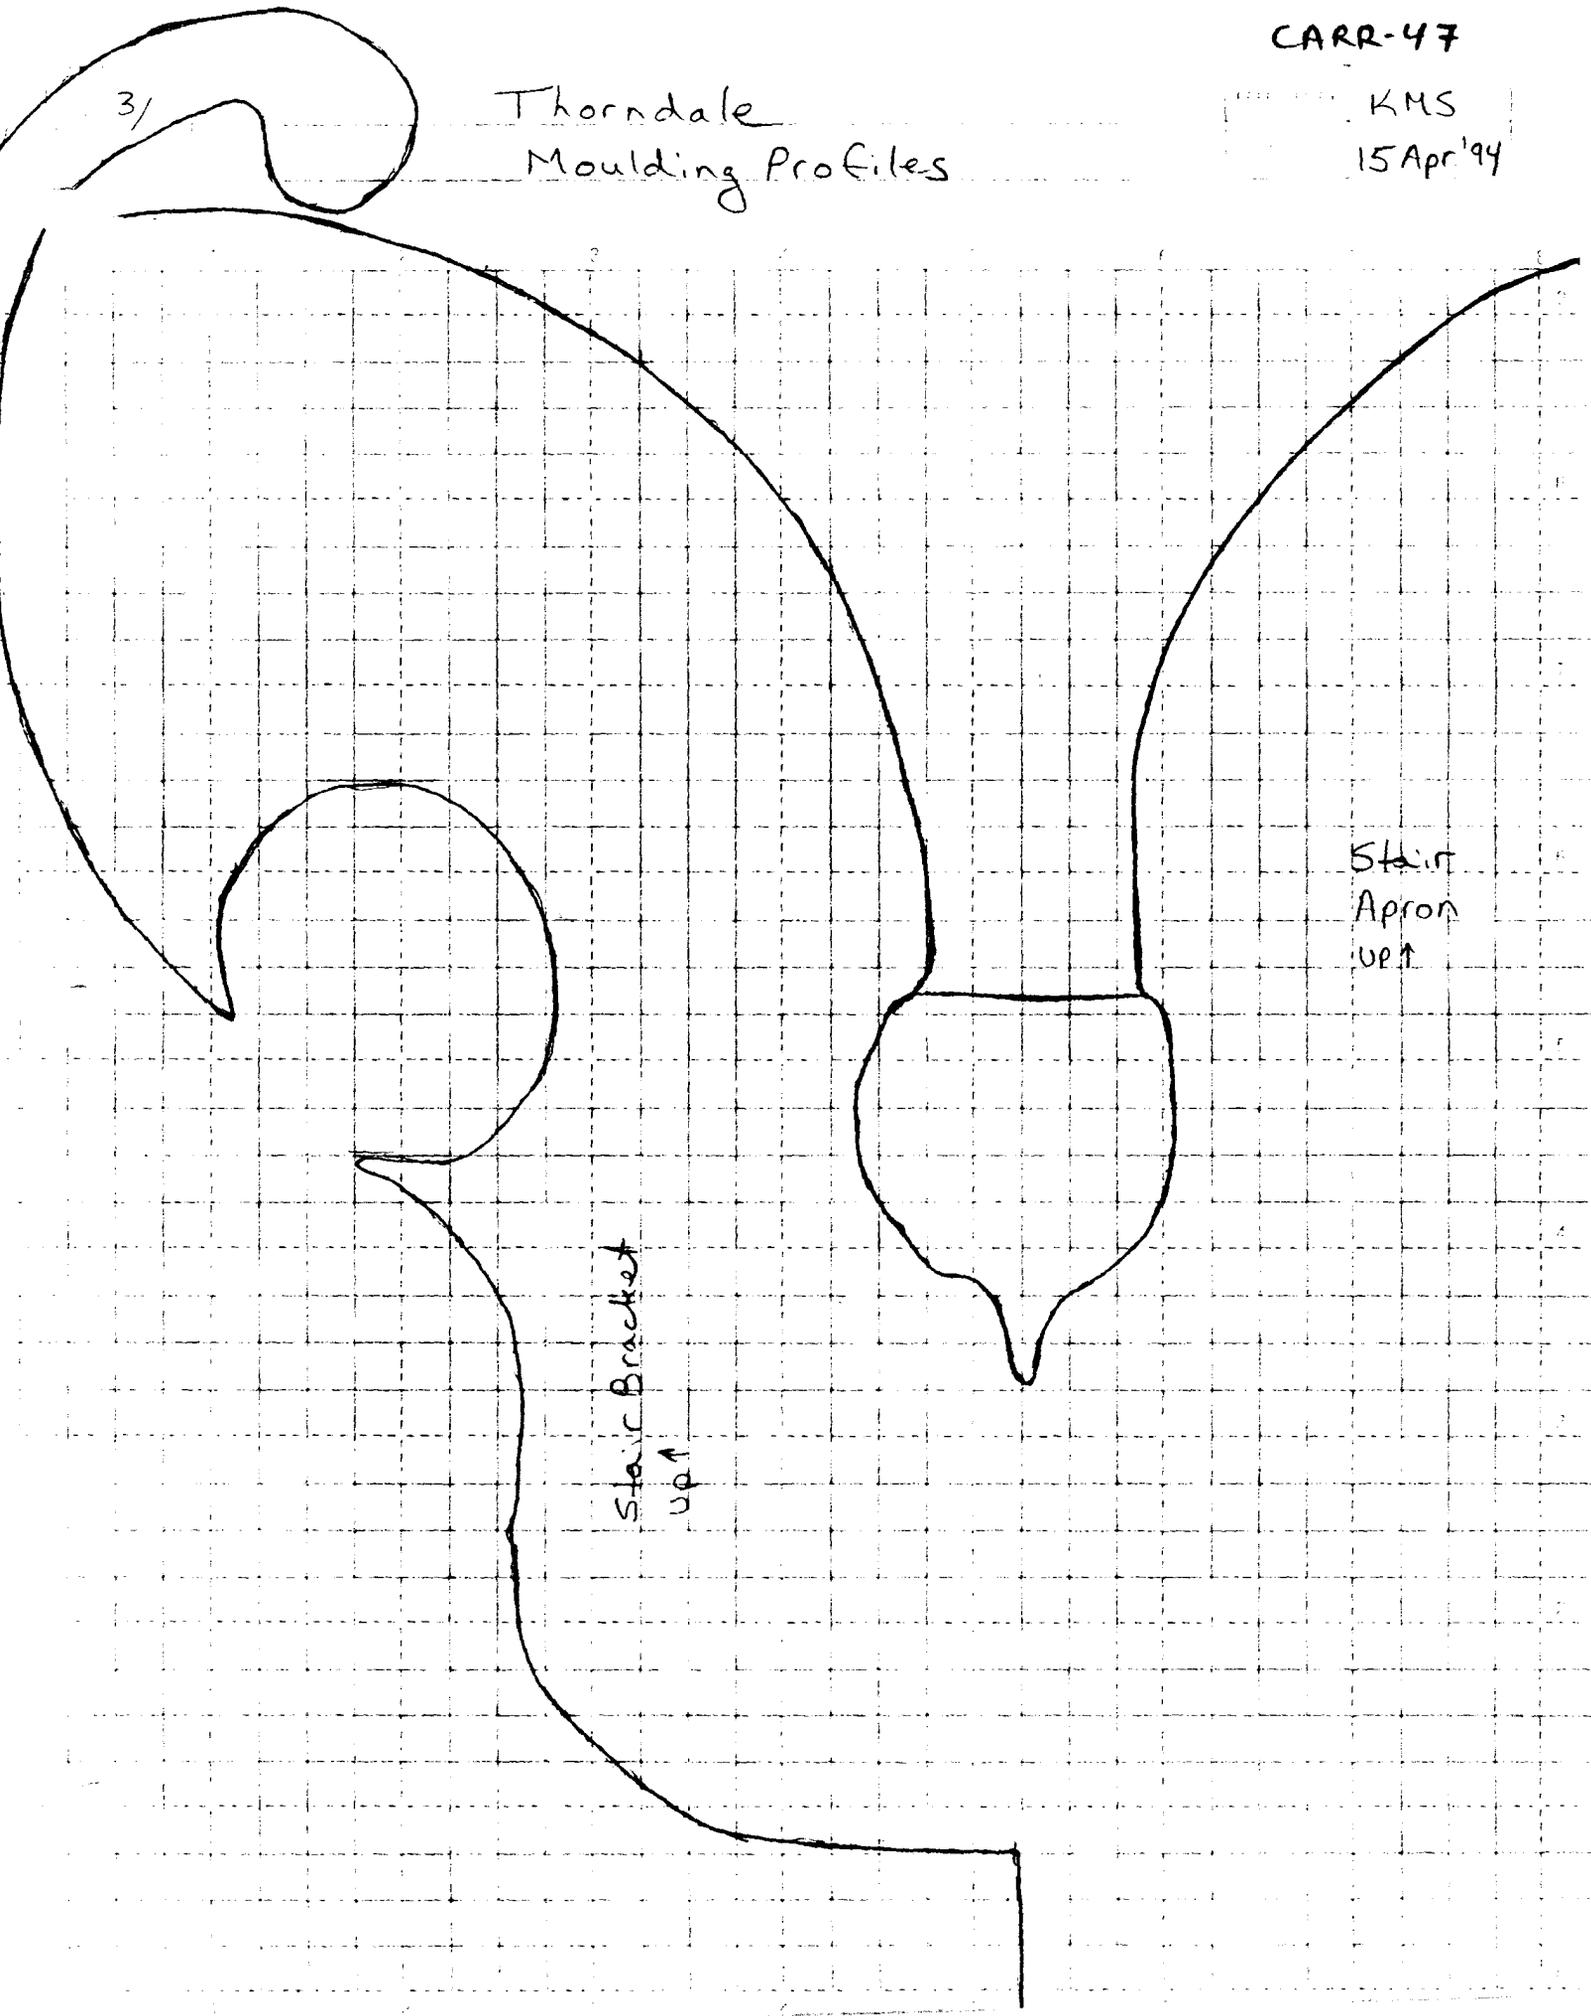
3/

Stair
Apron
up ↑

Stair Bracket
up ↑

northwest. This landing cuts through a boarded-up window. The stair has tapered round banisters and newell and a $\frac{3}{4}$ -round hand rail. There are sawn stair brackets and an apron on the landing that is jigsawed and applied to the frieze and appears to be pendant drops. The bottom edge of the stringer has a bead. There is a peg rail on the northeast wall. There used to be a door on the northeast wall set to the southeast that lead to the north room. At the southeast end of the stair hall is a door that leads to the center passage. This is a typical six-panel door for this house, with a wrought-iron rim lock and a four-light transom. The architrave has a beaded interior edge, a broken field, and a back band with a quirked ovolo with a bead inside it. These architraves are used on the door openings in the center section of the cross passage just northeast of the architrave. This center section has the same cornice as used in the west and south rooms. The northeast wall of this center section of the cross passage is frame and has a typical six-panel door with a cast iron rim lock. The rear side of this door has no panel moulds. The center passage continues to the northeast of this door.

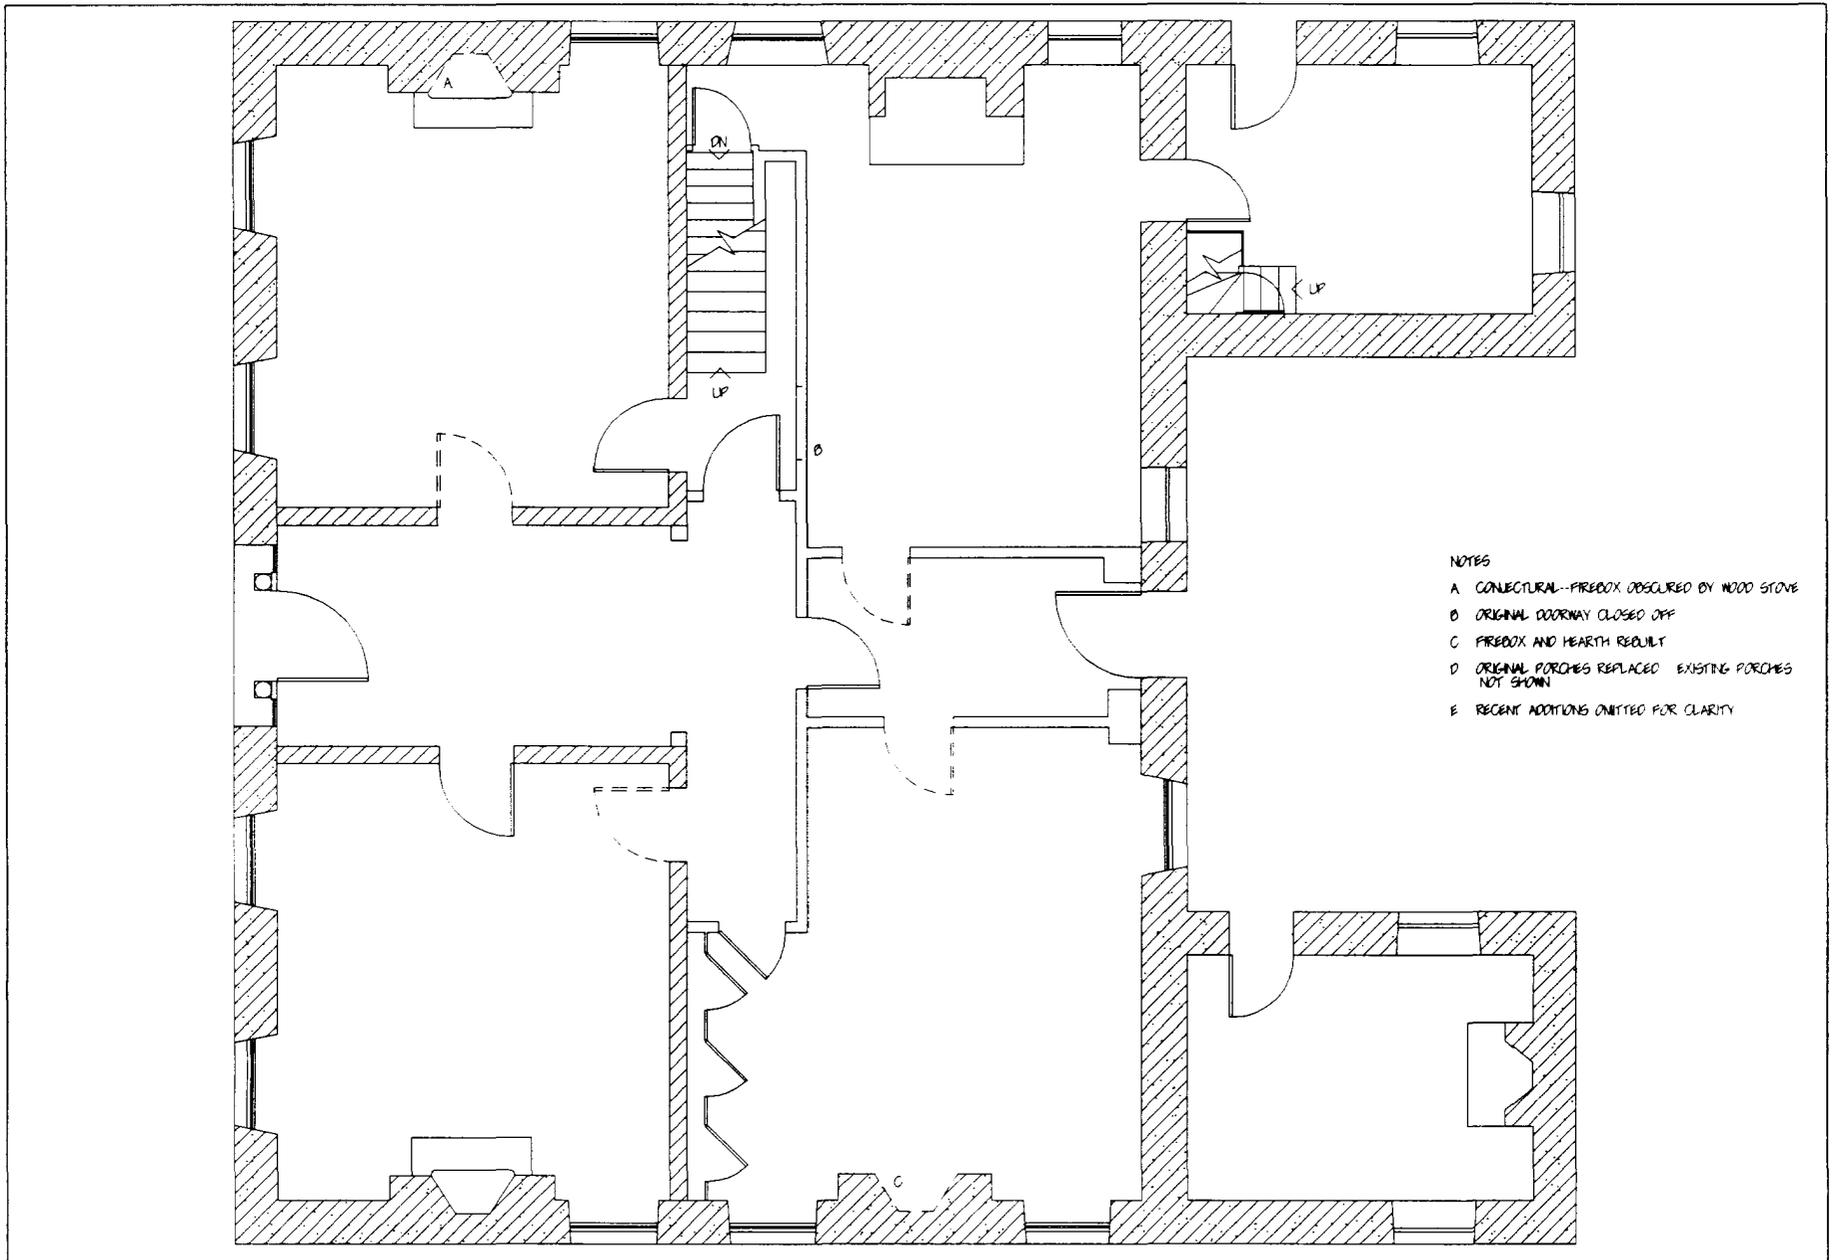
- A CONJECTURAL--FIREBOX OBSCURED BY WOOD STOVE
- B ORIGINAL DOORWAY CLOSED OFF
- C FIREBOX AND HEARTH REBUILT
- D ORIGINAL PORCHES REPLACED EXISTING PORCHES NOT SHOWN
- E RECENT ADDITIONS OMITTED FOR CLARITY

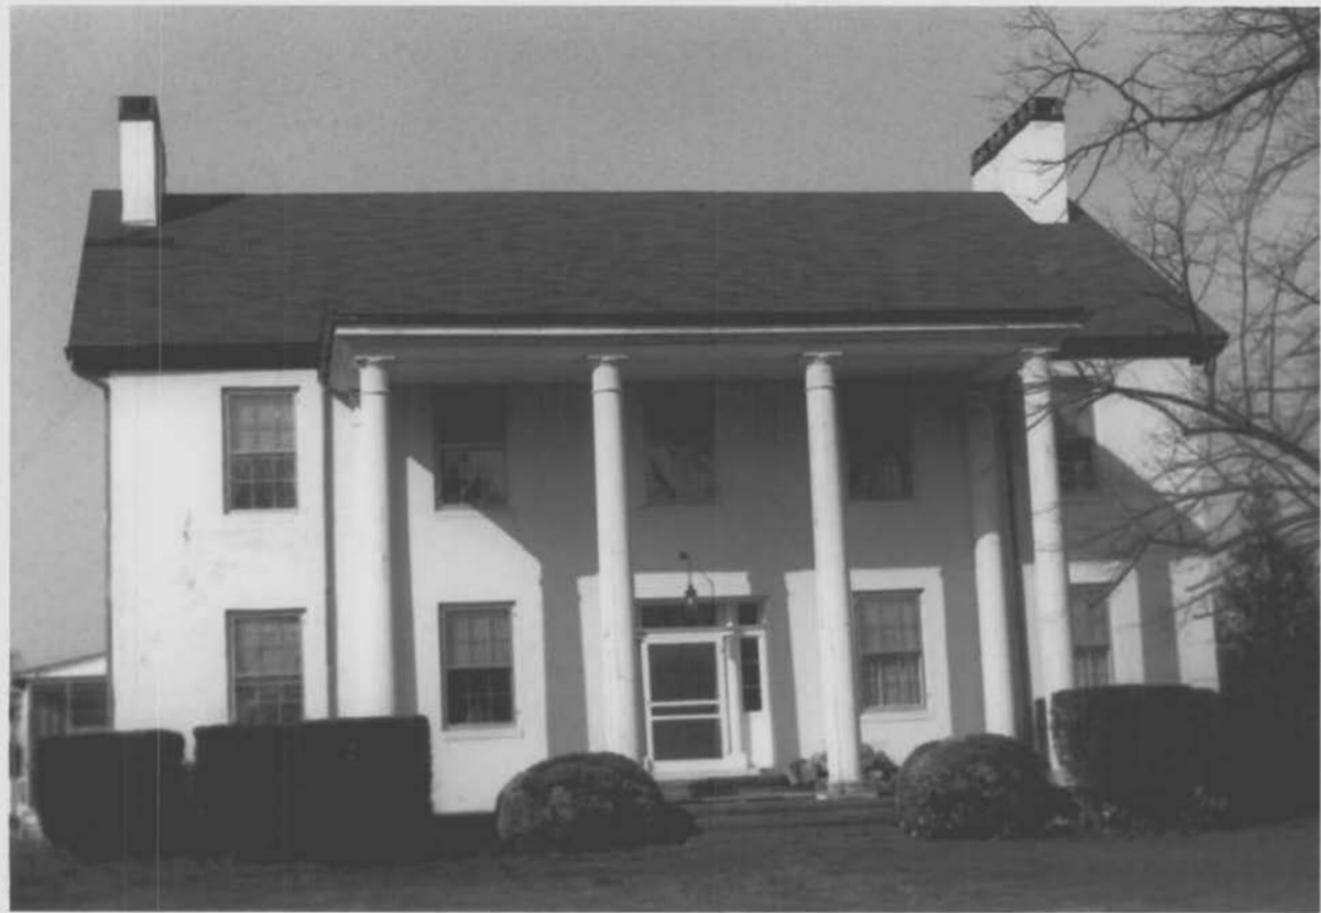
1/11

Neg. Loc.: Maryland Historical Trust
house - SW elevation

The house faces southwest toward the road. It is a two-story, five-bay structure that is "U"-shaped in plan. It is stuccoed and scored to imitate ashlar, and reportedly has rubble field stone walls beneath the stucco. On the southwest elevation the foundation has a 3/3 sash with

horizontal metal bars set in front of it, all in a beaded interior edge frame, in both the west bay and the south bay. The first story has a center entrance with a marble sill and an eight-panel door that has sunk fields. Each field has a raised circle. There are narrow ogee panel moulds on the door and a four-light transom above. The sidelights each have three lights over one panel. The panels are identical to the doors, but have a raised oval rather than a circle on the field. There is a one-light transom above each side light. Between the door and the sidelights are Doric columns, and the headrail moulding acts as an entablature. There are squat columns in the transom set over top of the tall columns. The soffit has three panels and each jamb has two panels which line up with the transom and sidelights. There is a large bead on the edge of the frame. The headrail has a quirked Greek ovolo with a fillet below and a bead on the bottom edge. On either side of the door are two windows with 6/6 sash in a beaded interior edge frame. The sills appear to be stone, but are painted. The windows have shutter hardware. The second story has five identical 6/6 sash. There is a new twentieth-century portico with a herringbone-brick deck and two-story colossal Greek Doric columns of wood. They have a fluted shaft at the top. This portico is three-bays wide. It has a Greek entablature with an ogee below a Greek ovolo in the architrave. The roof of the portico appears to be flat. The house has a gabled roof with asphalt shingles on the southeast and a ridge that runs from northwest to southeast. There is an interior chimney on each end that is parged. These chimneys are very wide. The cornice has three corbelled courses that appear to be brick. There are also returns and overhanging eaves on each end that are of wood and were added later.

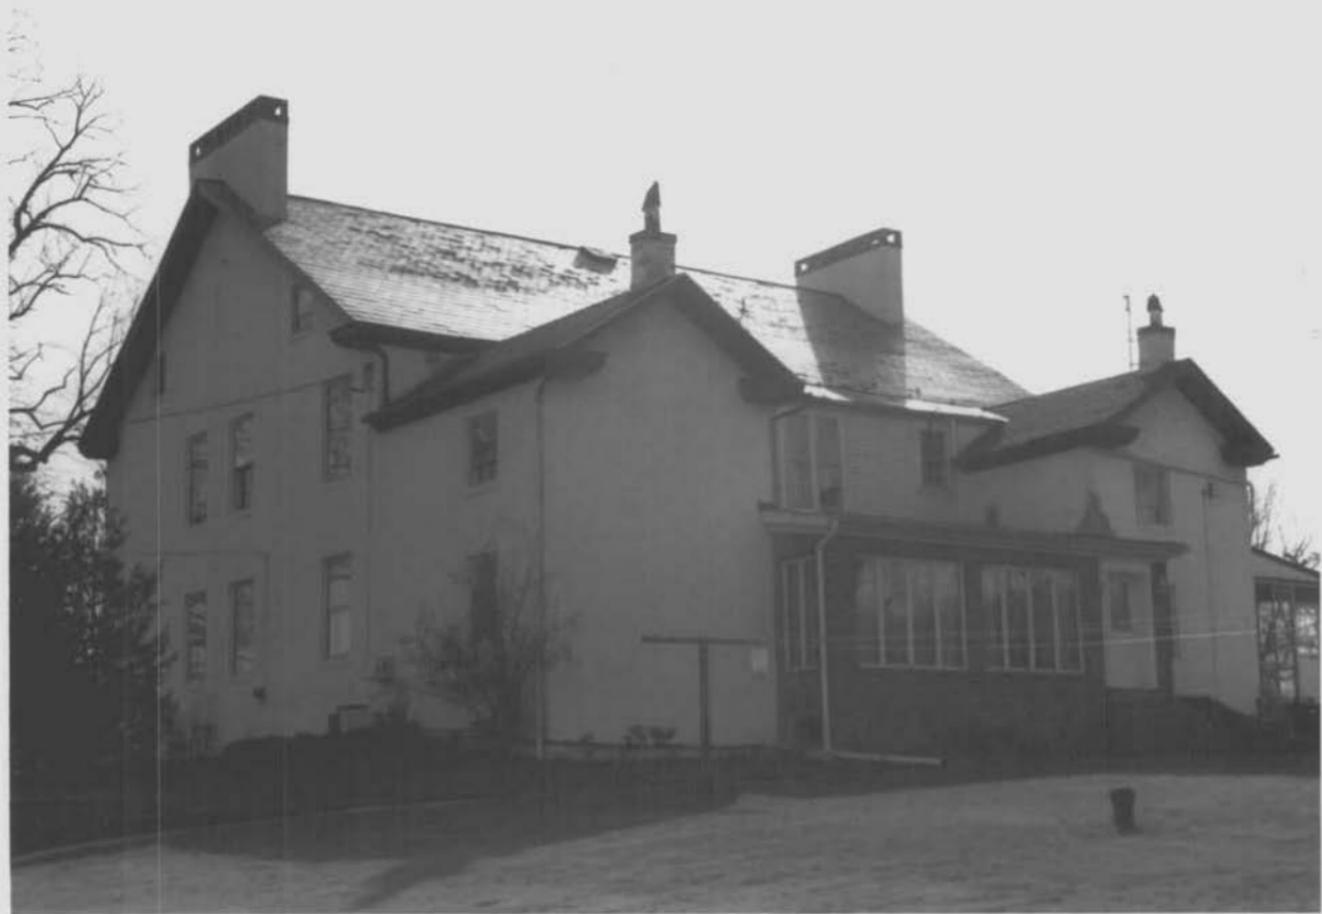
2/11

house. SE & NE elevations

The northeast side of the roof has slate. There is new brick infill between the two wings in the northeast on the first story, with an enclosed porch that has vinyl siding on the second

story. The original northeast wall of the house is four bays, with a 6/6 sash to the east, a door at the end of the center passage, a 6/6 sash to the north of this door, and formerly a door north of that that led into the north room of the main block of the house. This door has now been closed off. The northeast elevation of the north wing is one bay. There are four steps down to beaded-edge vertical board double doors in this foundation. The east door has a four-light sash set into it. On the first story there is a 6/6 sash set east of center. The second story has a 6/3 sash set east of center. The cornice has returns, and there is a parged interior chimney centered on this end on the ridge. The southeast elevation of this north wing has no openings on the first or second stories. The east wing also has a gable roof with asphalt shingles and northeast to southwest running ridge. There is a parged interior chimney on the northeast side, centered on the ridge. The northwest elevation of this wing has a 6/3 sash on the second story. There are no openings on the northeast elevation. The southeast elevation of the wing has no openings in the south bay. The east bay has a 3/3 sash in the foundation, a 6/6 sash in the first story, and a 6/3 sash in the second story. The southeast elevation of the house has the typical 3/3 sash in both the center and east bays of the foundation. The first story has a typical 6/6 sash in the south-center, center and east bays. The second story is identical to the first. The gable end has a 6/3 sash in both the south and the east-center bays.

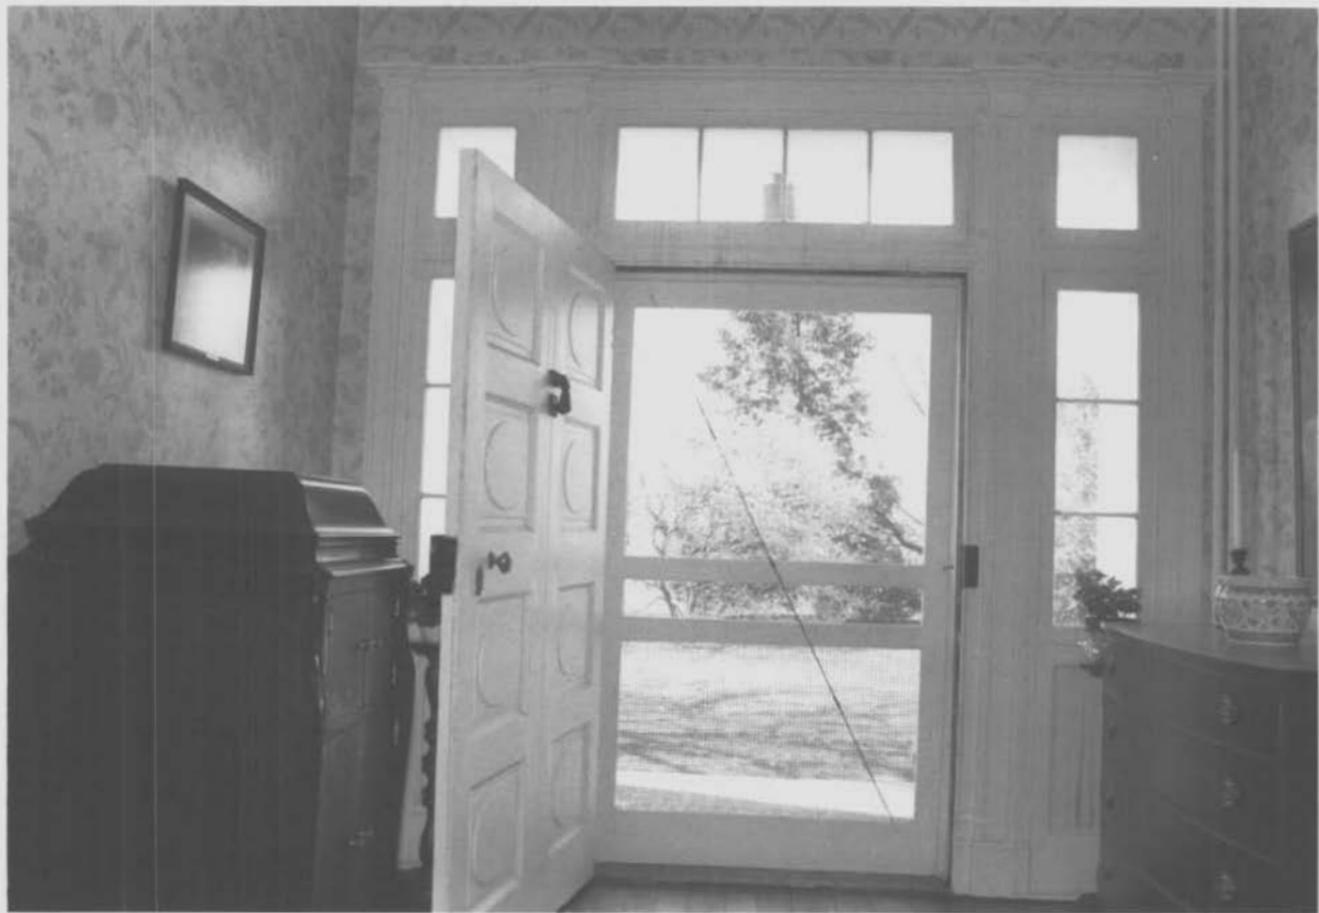
3/11

1st story passage - view SW

The first story has a center passage double-pile plan, with a cross passage that contains the stairs. The architrave along the front door and sidelights has a beaded interior edge, a broken field, and the back band is a projecting pilaster with a sunken center field that has a bead on either side. The panels on the door and under the sidelights have a sunk field and small ogee mould. The door has a large wrought-iron box lock. The random-width pine floor in the passage runs northeast to southwest. The baseboards have a broken field. The architraves on

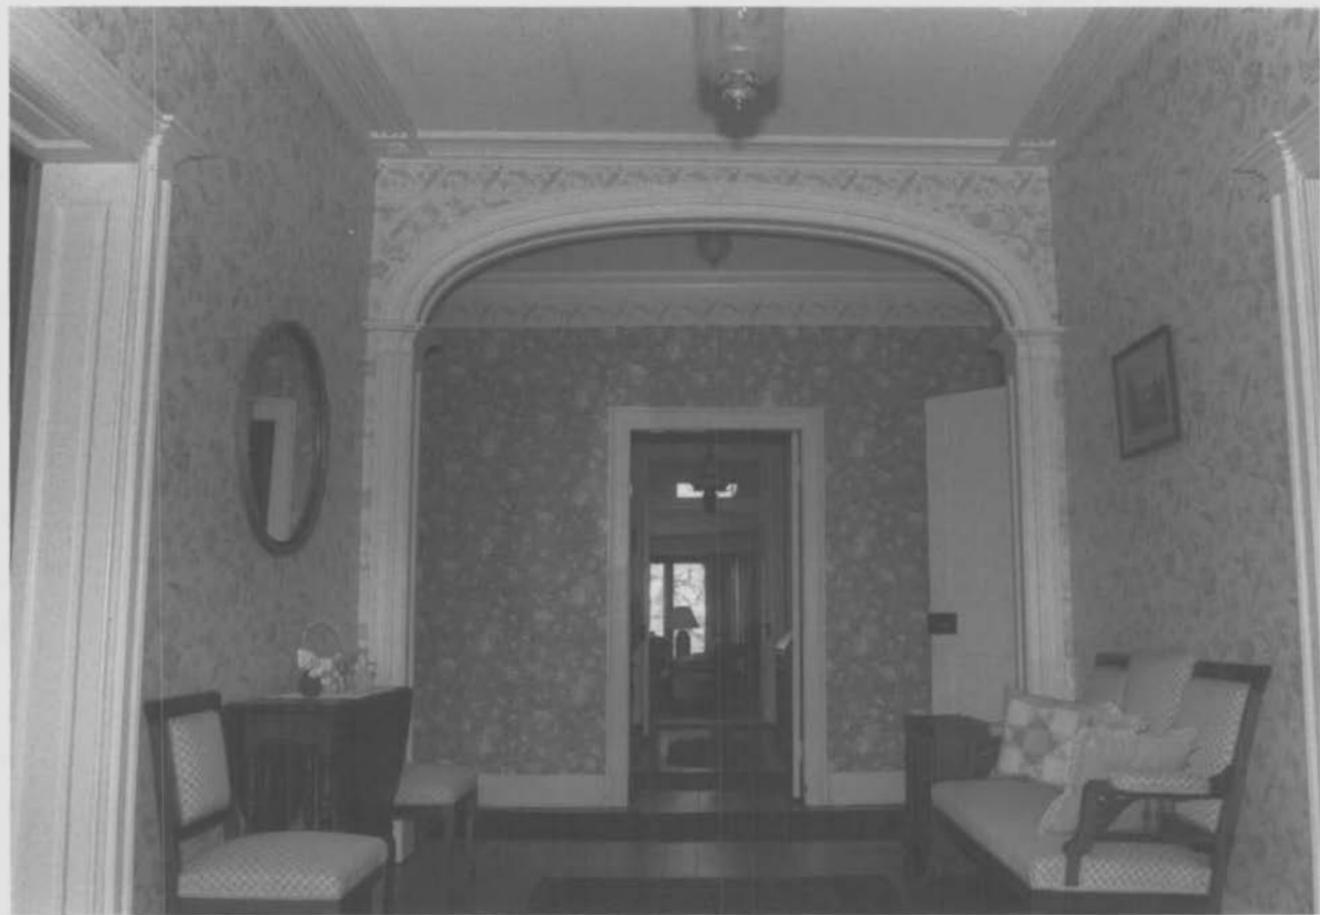
4/11

1st story passage - view NE

the passage doorways match that on the front door, and also have a cornice on top that has a bead at the bottom, two fillets above, and a Greek profile ovolo above that. The doors have a paneled soffit and jambs with a sunk field and a narrow ogee moulding. In the middle of the passage is a semi-circular-arched opening with the same architrave, paneled jambs, and cornice found throughout the passage. The soffit of the arch is also paneled. The arch has a bullseye corner block in the center instead of a keystone. Both sides of this architrave are treated identically. The ceiling of the passage has a moulding around the edge with a bold torus run down the center, flanked on either side by a projecting ovolo moulding. In each corner is a corner block with a patera. The northwest and southeast walls of the passage are masonry. Northeast of the arch is a narrow cross hall. The northwest portion of this cross hall contains the stairway. The southeast end formerly led into the east room. This half of the cross hall has now been closed off and converted to a powder room.

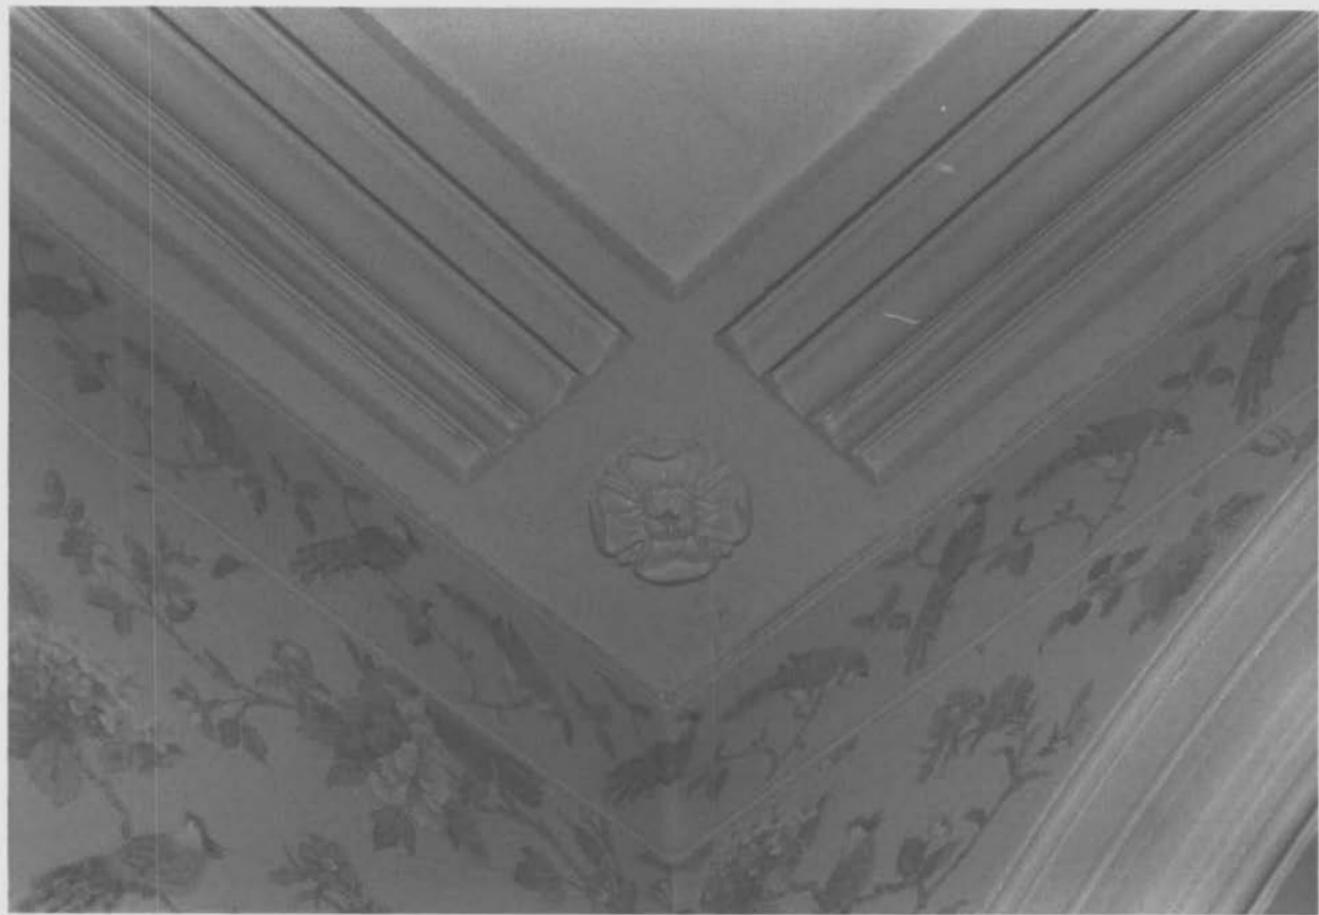
5/11

1st story passage - ceiling detail

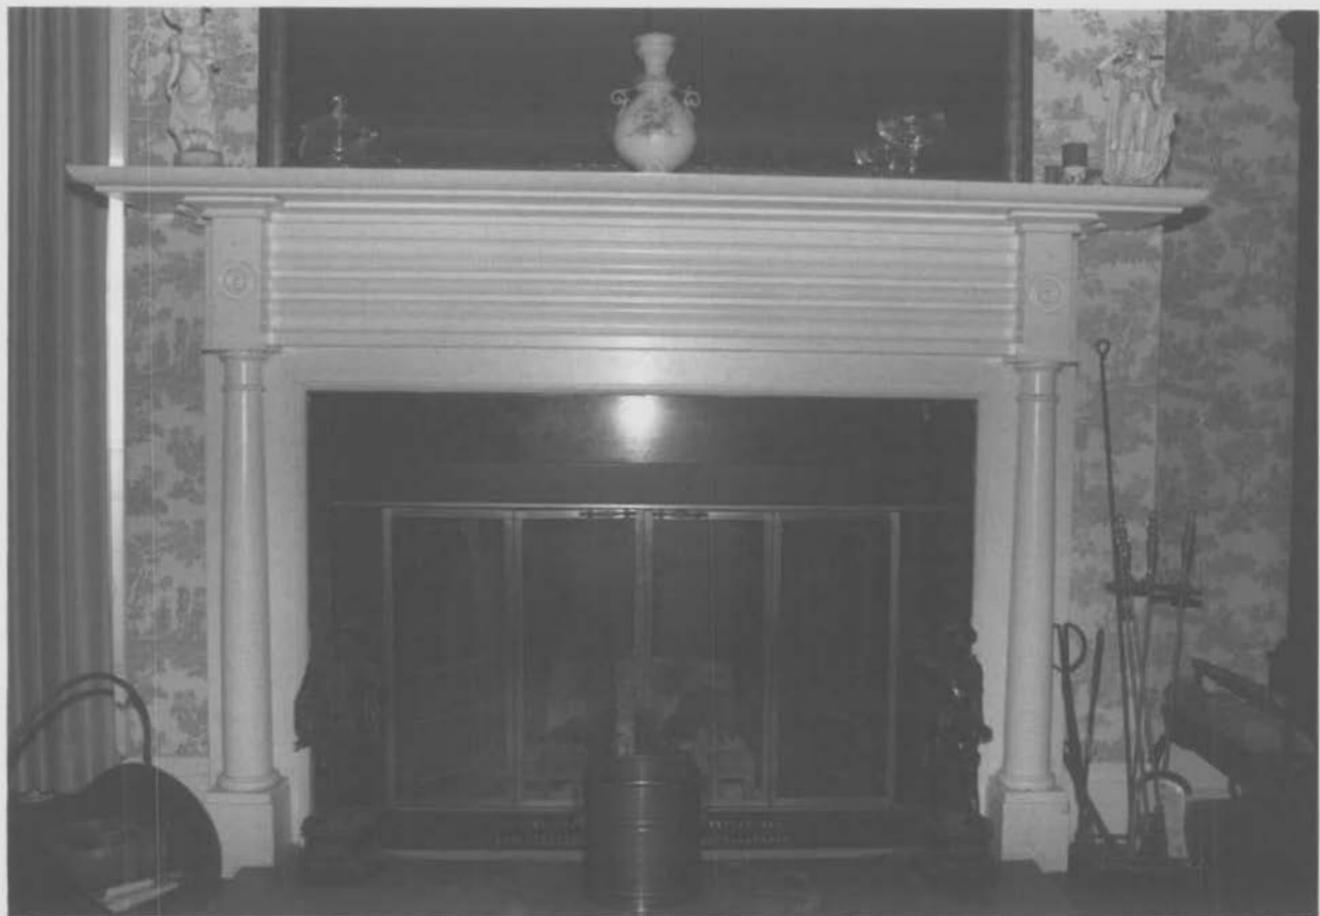
6/11

1st story - south room mantel

The south room also has a masonry wall on the northeast and the door in that wall has now been closed off. It was set to the northwest and led into the cross passage. The windows, door, baseboards, architrave, cornice and mantle in this room are all identical to that in the west room. There is no stove in this room, however. The raised hearth appears to be slate and looks original. The surround is of a black stone that is polished and could be granite. The splayed jambs of the fireplace have a metal lining. The random-width pine floor runs northwest to southeast.

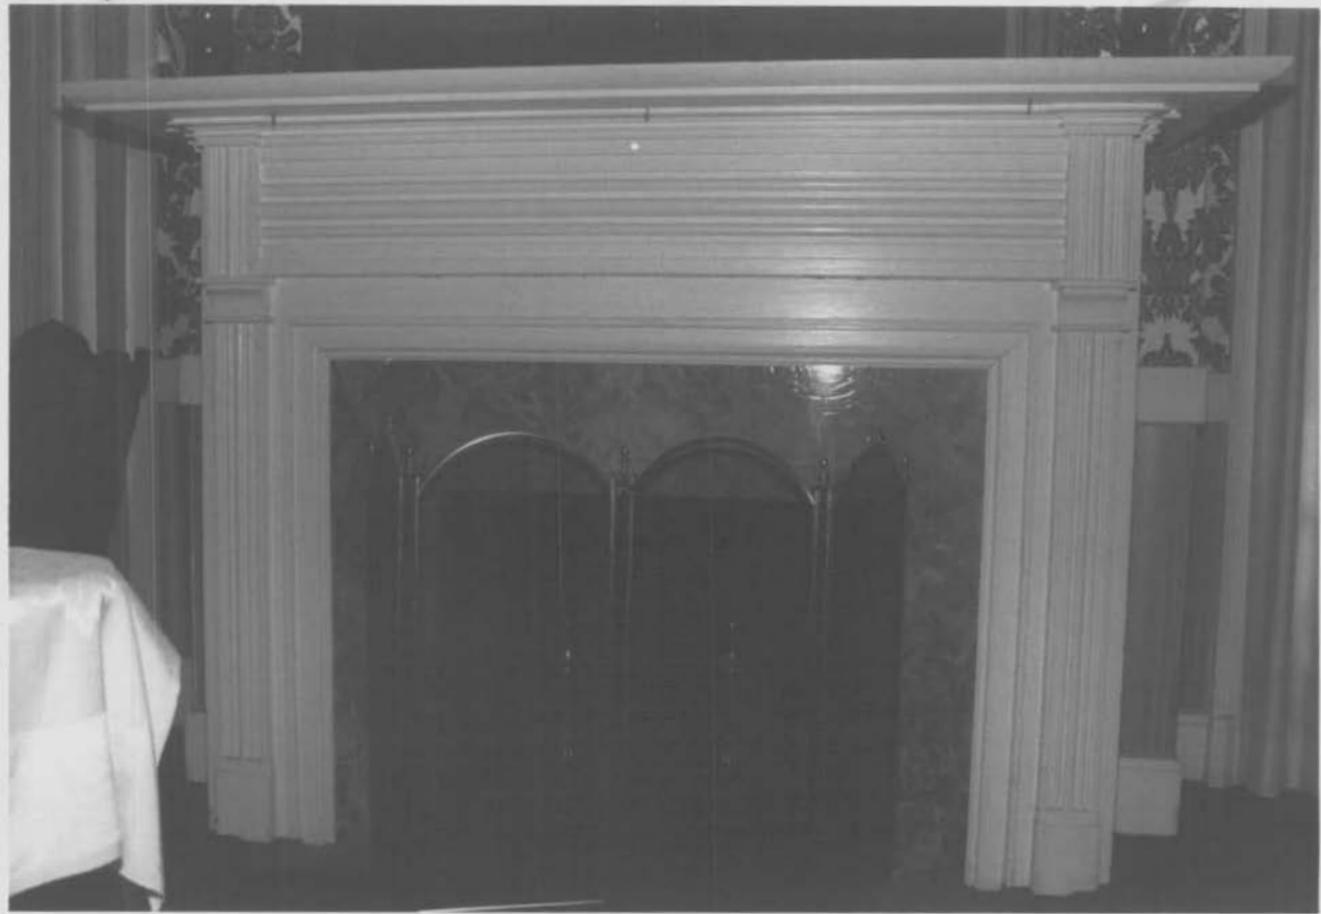
7//

1st story - east room mantel

The east room has a fireplace on the southeast wall. The mantel has pilaster strips on either side, with a large torus in the center flanked by a smaller torus on each side. This same moulding is used on blocks above each pilaster strip. The frieze has an identical profile, but the mouldings are all of a larger scale. The bed mould has a fillet at the top, then a cavetto, another fillet, and a bead at the bottom. The mantle shelf has an ovolo-moulded edge. There is a new hearth, a new surround, and a new firebox. The baseboard and architrave mouldings are identical to the south and west rooms. There is a plain chairrail in this room. The windows are the same as the south and west rooms, but there are no ovals on the panels underneath the windows and the cornice is also identical to those rooms. The north corner of this room is enclosed. Behind the wall is the cross passage. At the southeast end of this enclosure is a typical six-panel door that leads from this room to the cross passage. It has a wrought-iron rim lock. Southeast of this door the southwest wall has a built-in cupboard with three doors that have four lying panels each, one above another. They have sunk fields with ogee panel moulds and are hung on cast iron butt hinges. Above each door is a small one-panel door. On each end, and between each pair of doors are pilaster strips that have a torus in the center flanked on each side by two fillets. Each pilaster strip has a cornice with a Greek profile ovolo and a bead on the bottom of it.

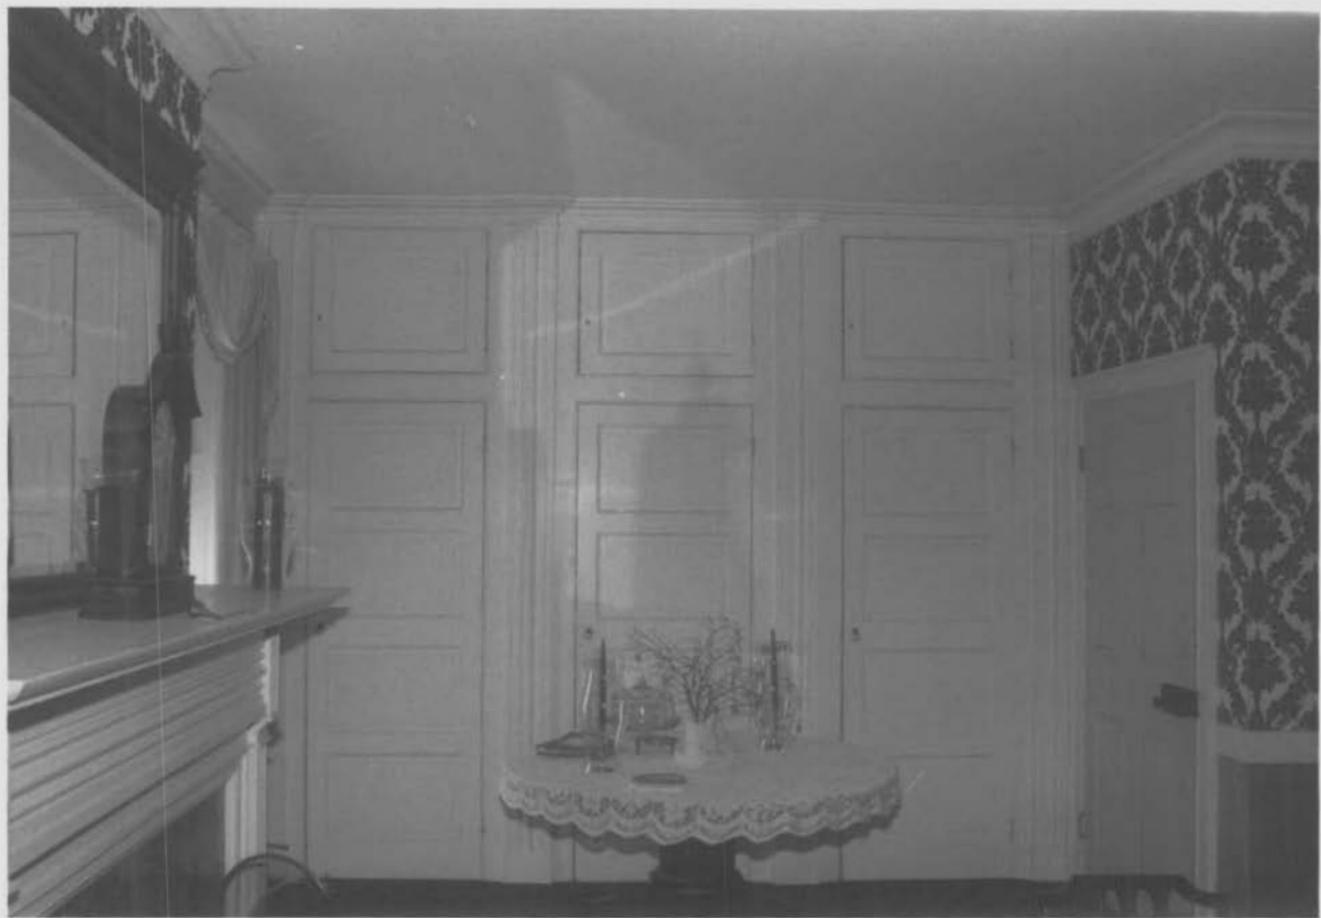
8/11

1st story - east room closet

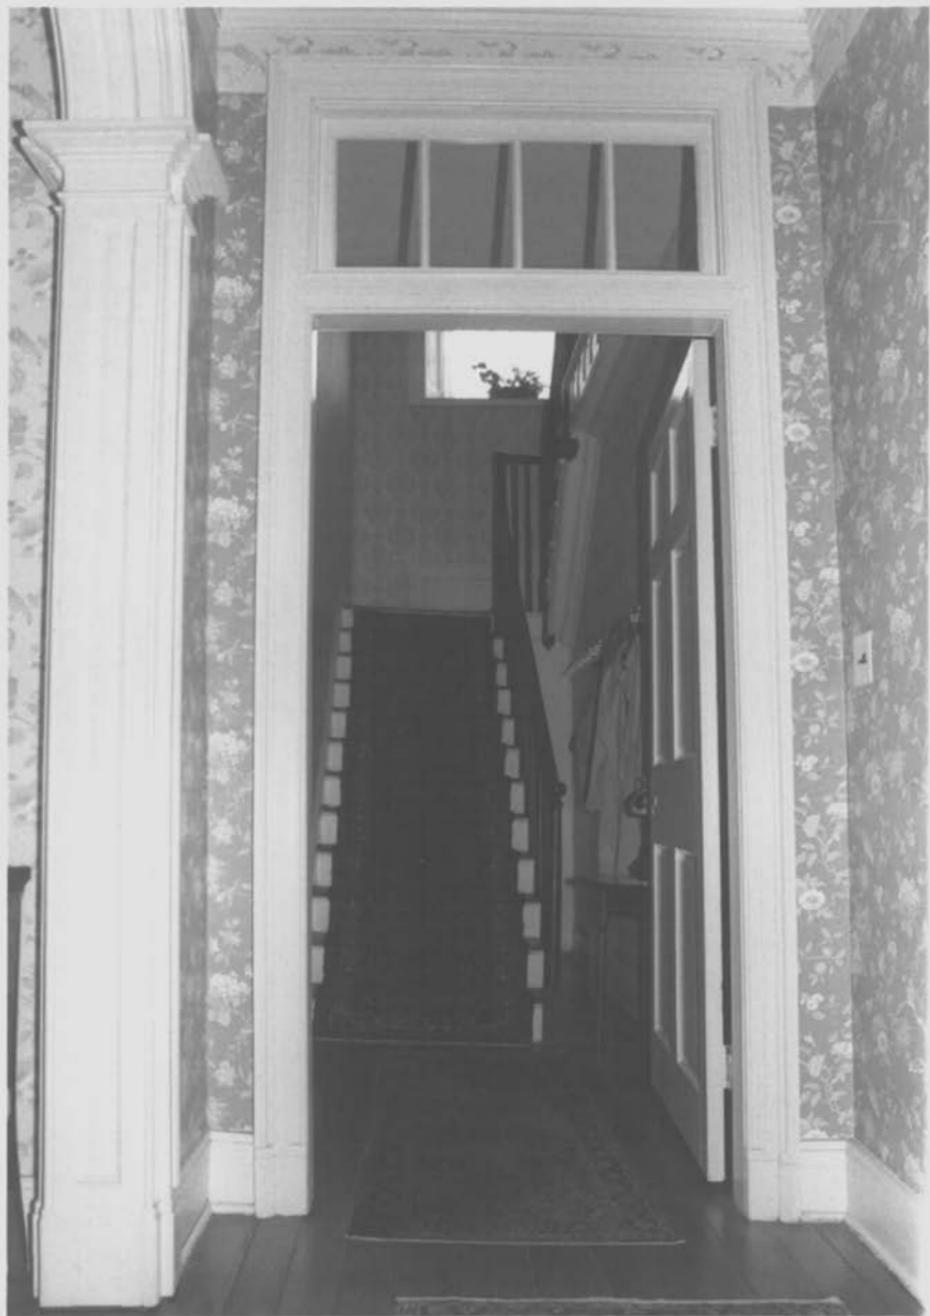
9/11

1st story stair hall

The stairhall has the same floor running northwest to southeast and the same coved cornice. There is an open string dog-leg stair on the southwest wall with a landing at the

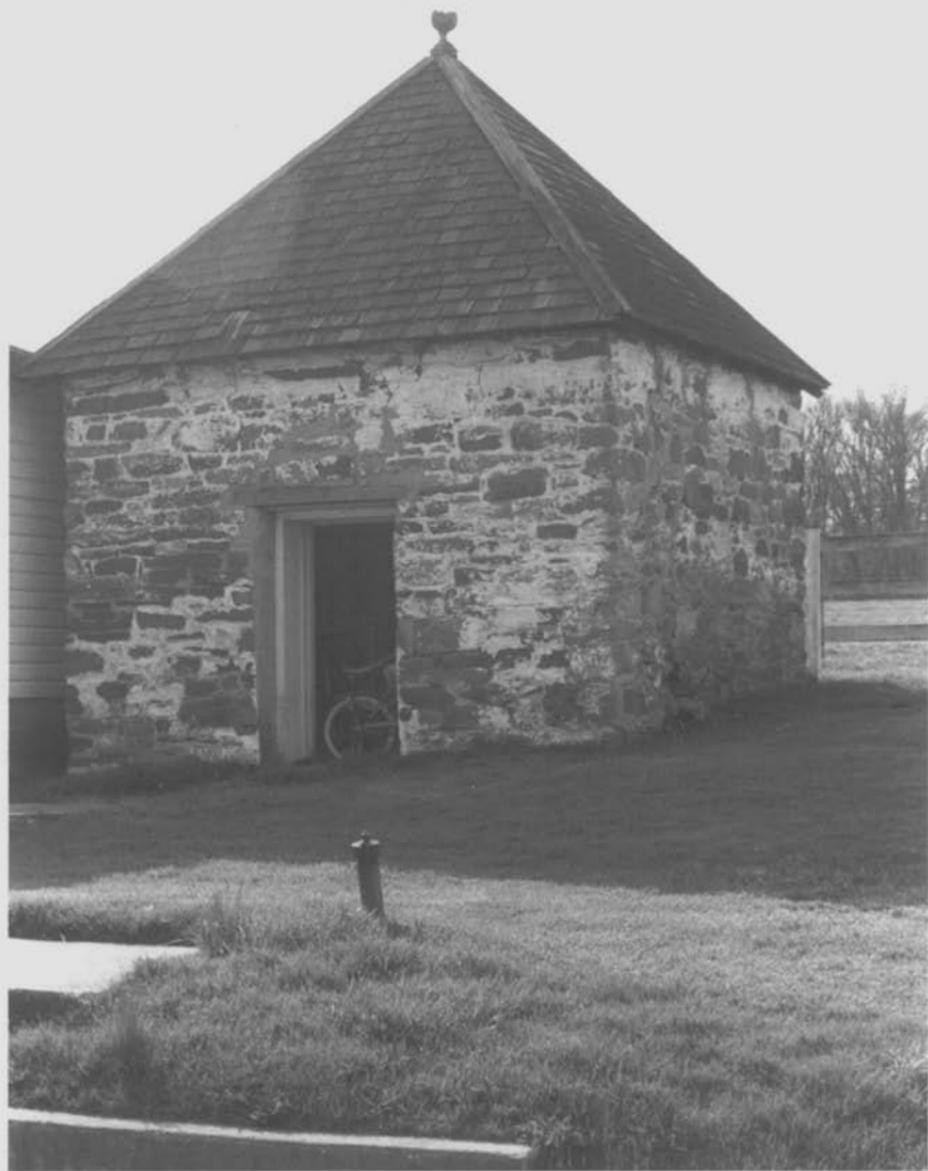
10/11

Smokehouse - SE & NE elevations

About 75 feet north of the house is a smokehouse which is square in plan and is built of rubble fieldstone. It has a hipped roof with wood shingles and boards nailed along the hip ridges. There is a finial at the peak that is very deteriorated, but appears to have been a ball. On the southeast elevation is a doorway with a new wood lintel, frame, and door. The smokehouse has been refinished inside, but was originally plastered. It is now studded out. There is a splayed vent on the northwest elevation. The building has hewn plates and the rafter ends are tapered. The plates are half-lapped at the corner on top of the end girts. The ridge rafters are hewn while the other rafters are sawn. There are beams running from northwest to southeast that are sawn and have metal hooks on which to hang meat.
