CARR-54

Peter Royer House, site

Architectural Survey File

Maryland Historical Trust State Historic Sites Inventory Form

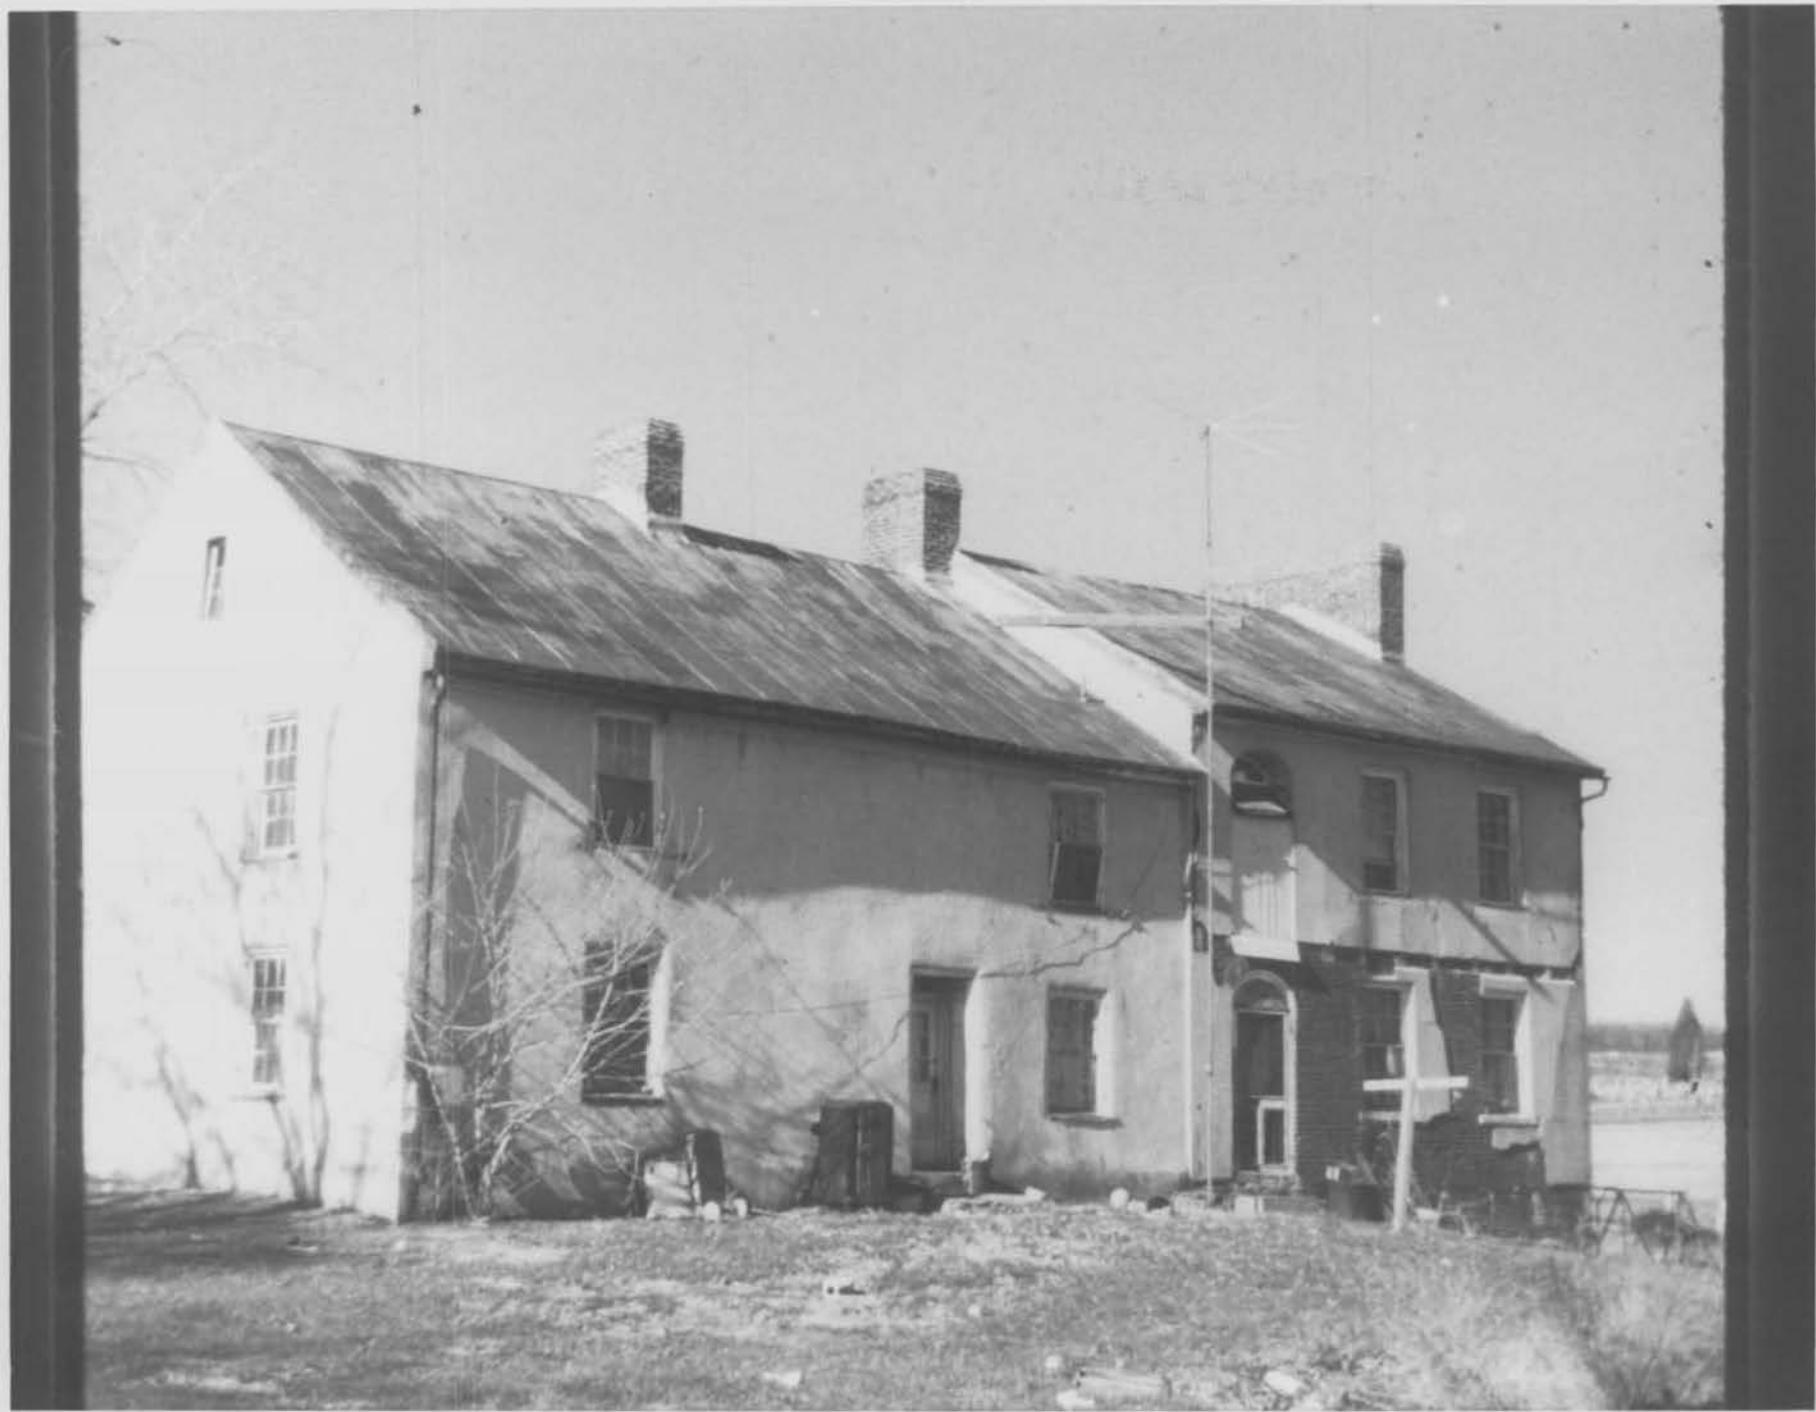
1. CARR-54 PETER ROYER HOUSE
2. Carroll County, Maryland
3. Joe Getty
4. March 1968
5. Getty, York St. Manchester, Md.
6. S & W elev. (camera facing ne)
7. 1/4

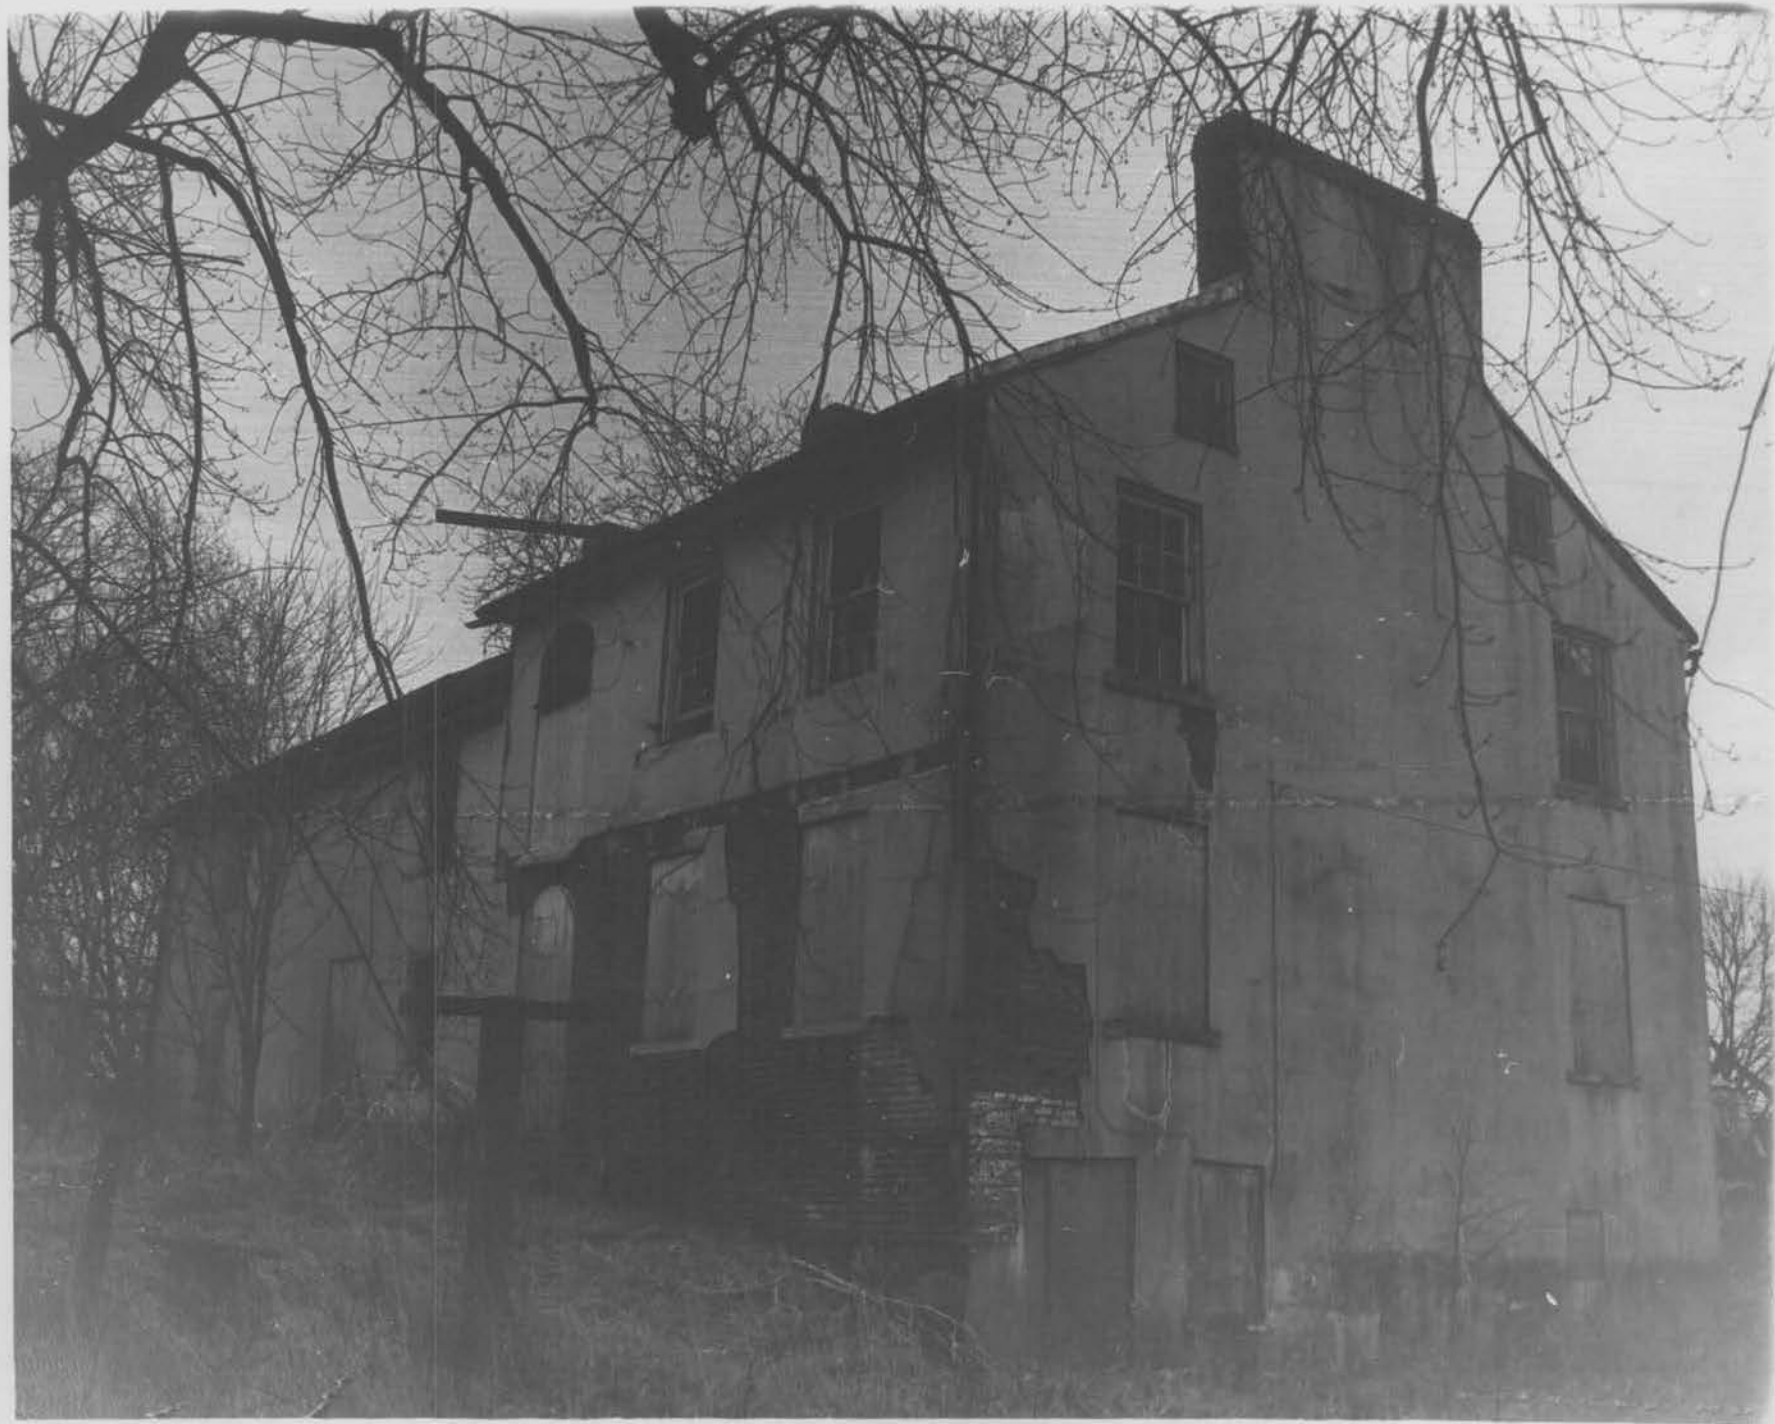
1. CARR-54 PETER ROYER HOUSE
2. Carroll County Maryland
3. Joe Getty
4. April 1977
5. Getty, York St., Manchester, Md.
6. S & E elev. (camera facing nw)
7. 2/4

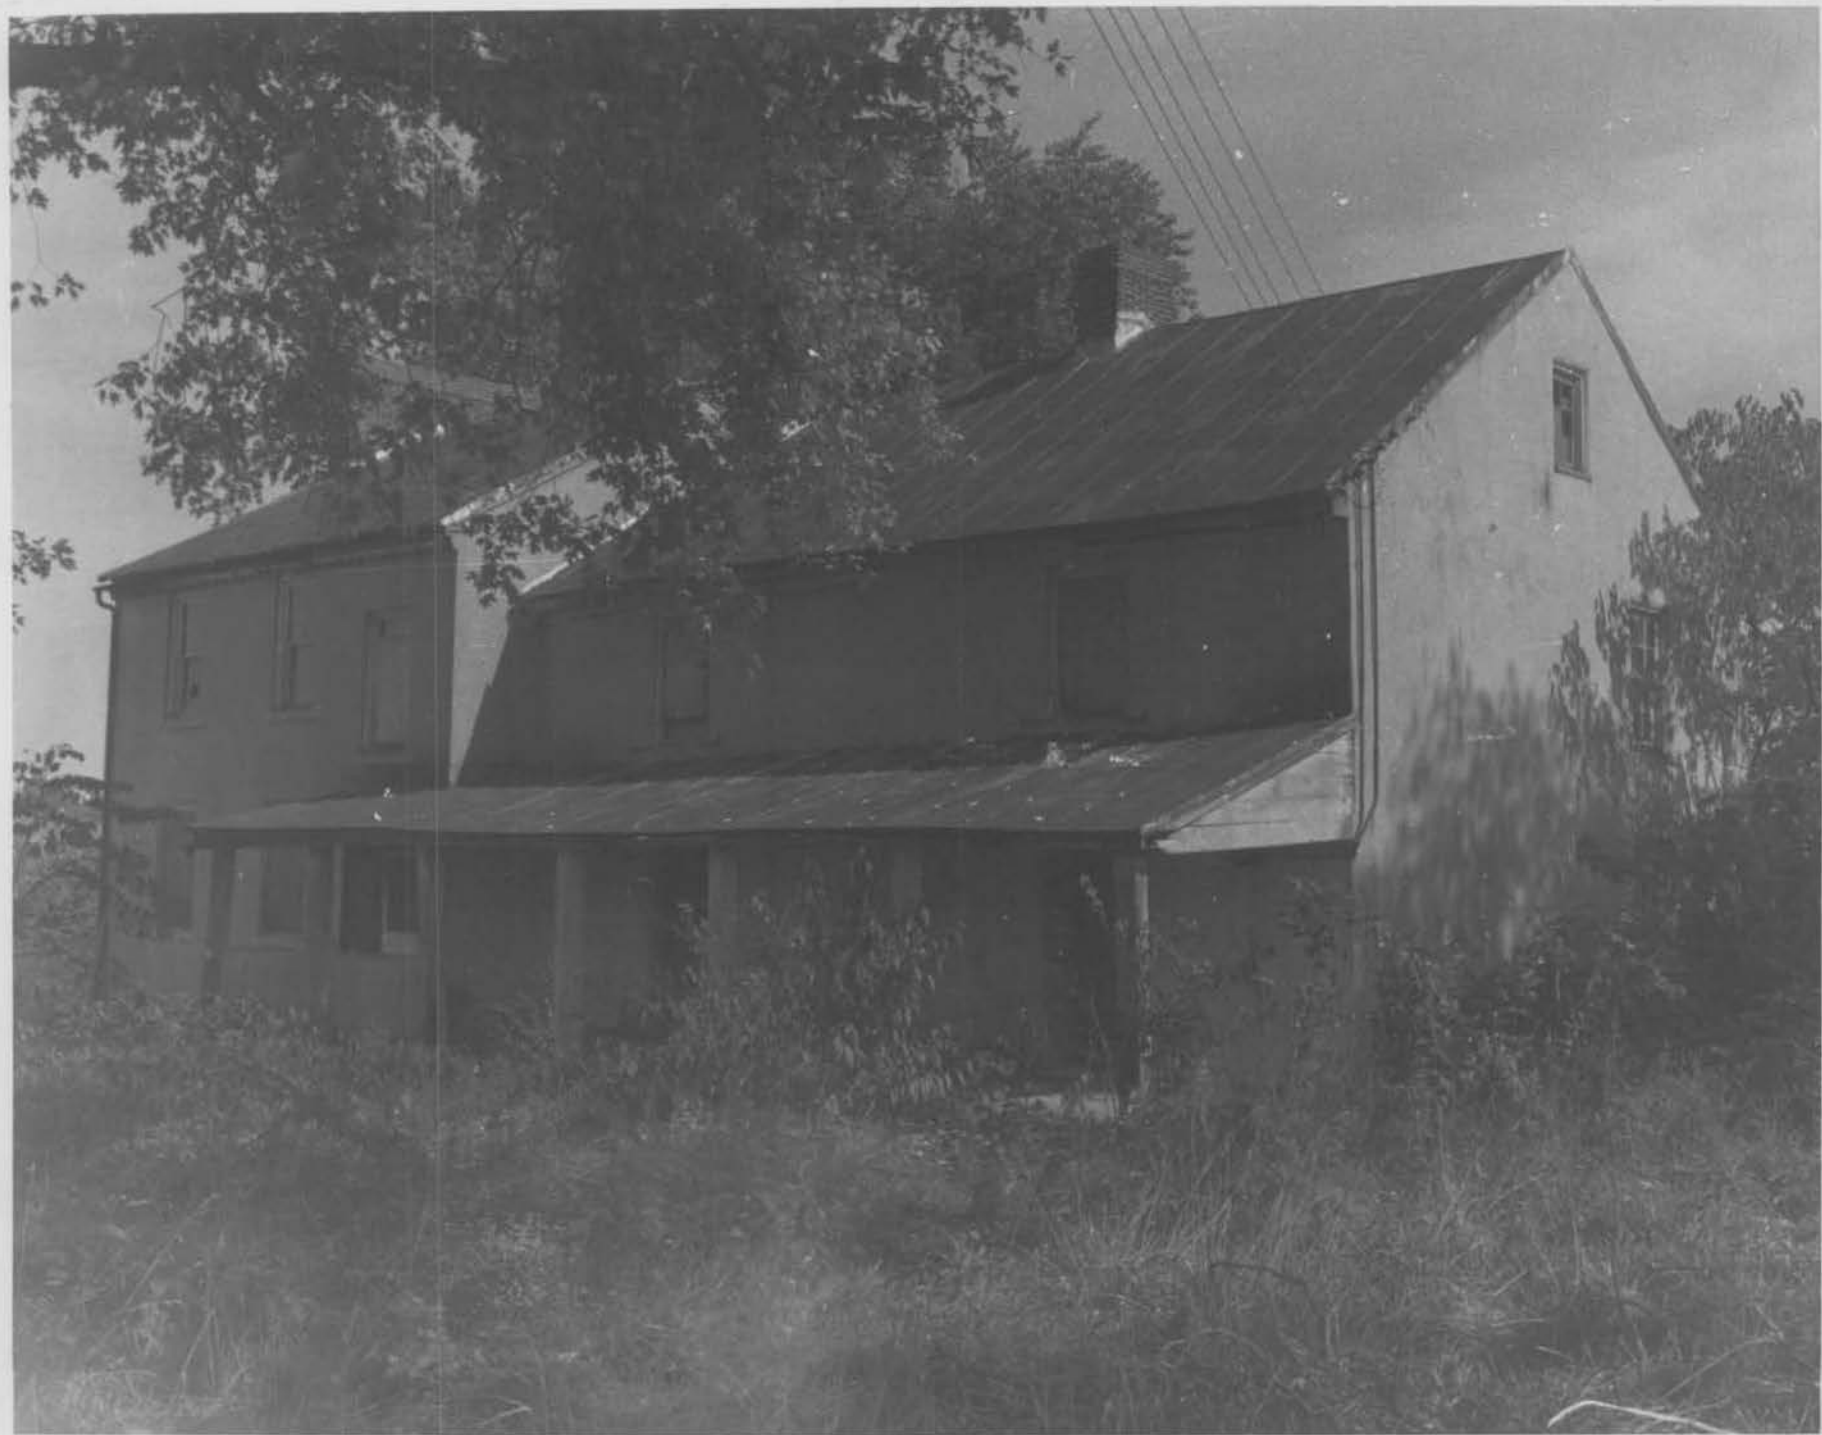
1. CARR-54 PETER ROYER HOUSE
2. Carroll County, Maryland
3. Joe Getty
4. June 1977
5. Getty, York St., Manchester, Md.
6. N. & W. elev. (camera facing se)
7. 4/4

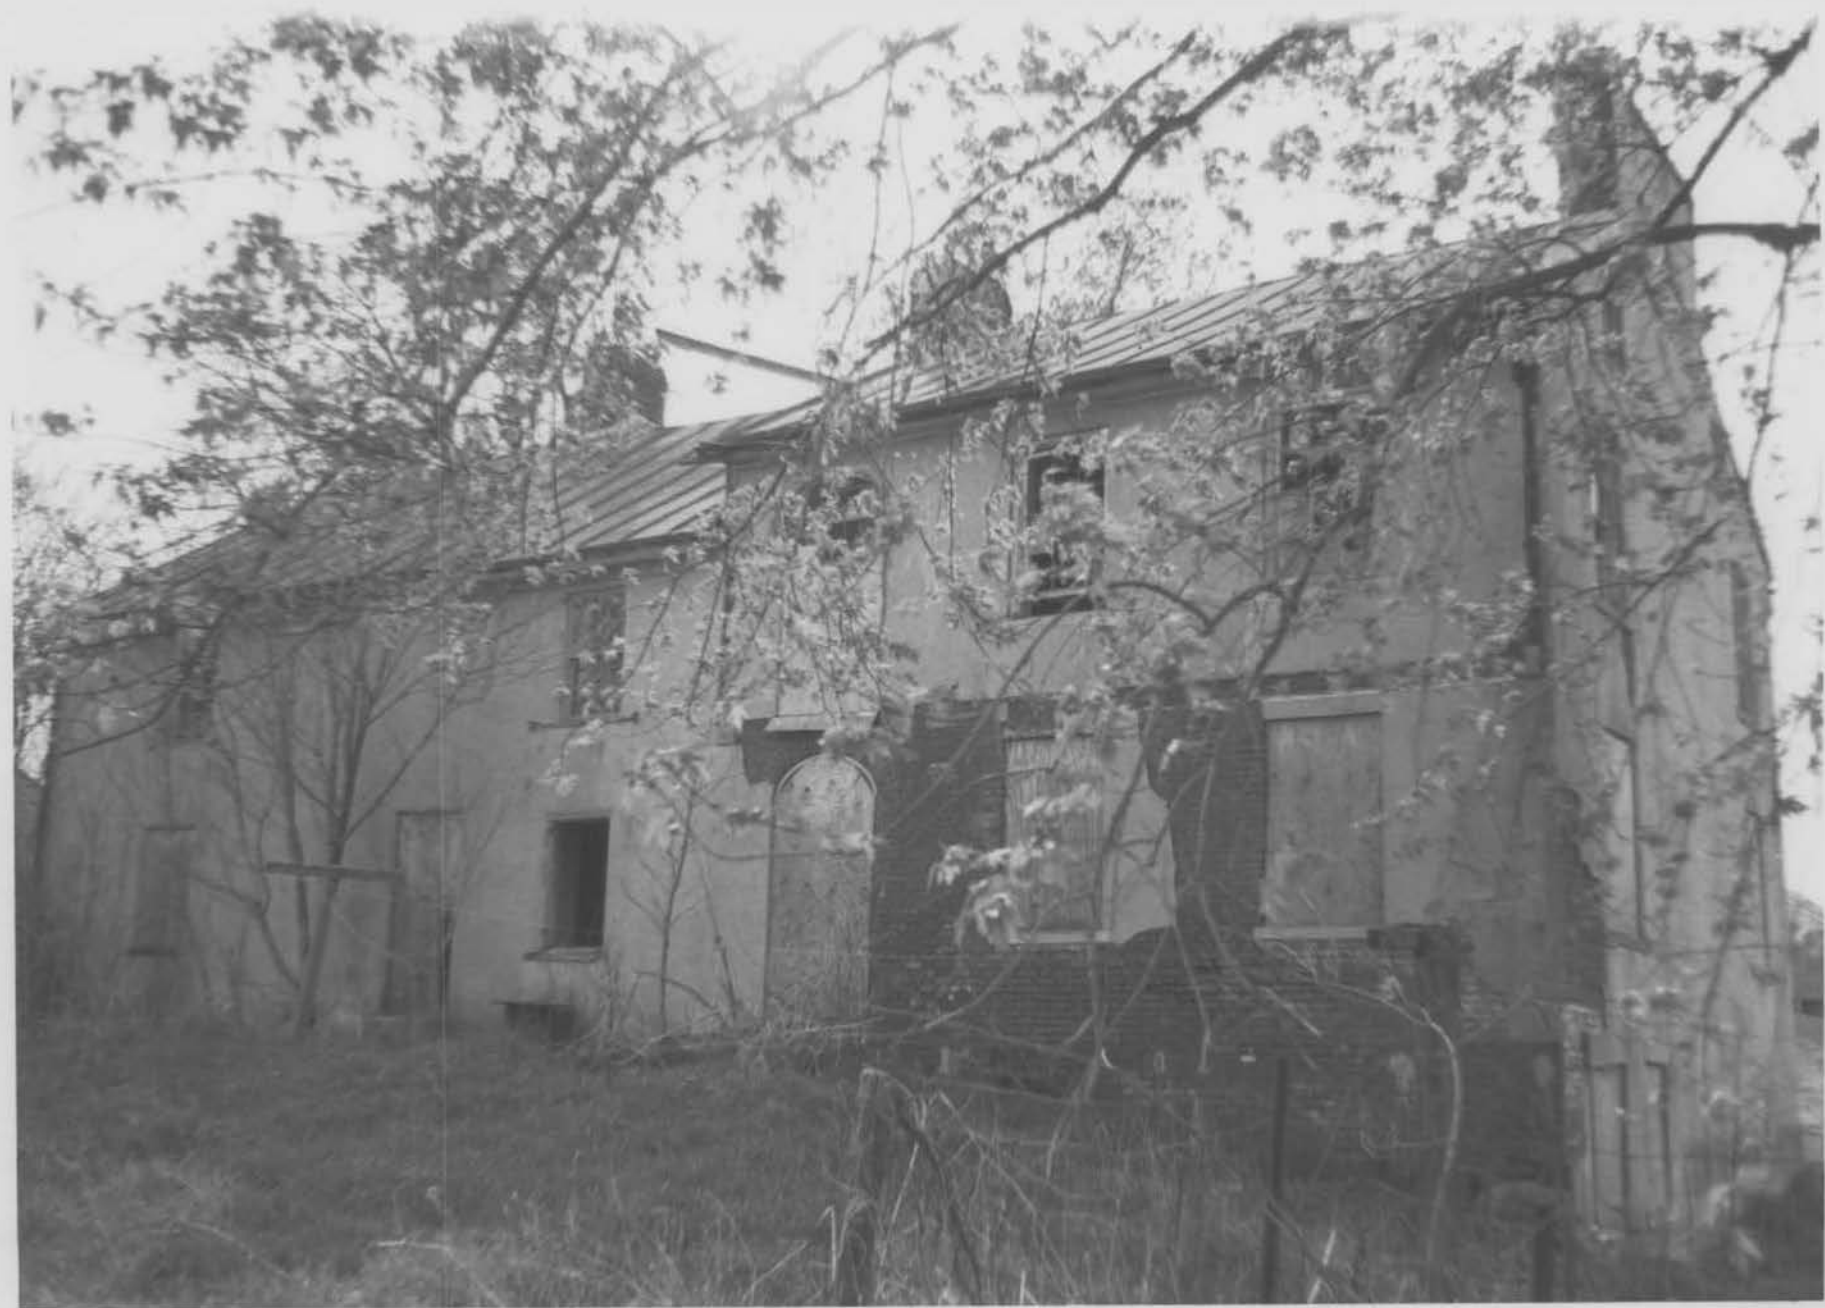
1. CARR-54 PETER ROYER HOUSE
2. Carroll County, Maryland
3. Joe Getty
4. May 1977
5. Getty, York St., Manchester, Md.
6. S. elev. (camera facing n)
7. 3/4
