CARR - 54

PETER ROYER HOMESTEAD

Maryland Historical Trust State Historic Sites Inventory Form

FIELD SHEET--HISTORIC RESOURCES SURVEY

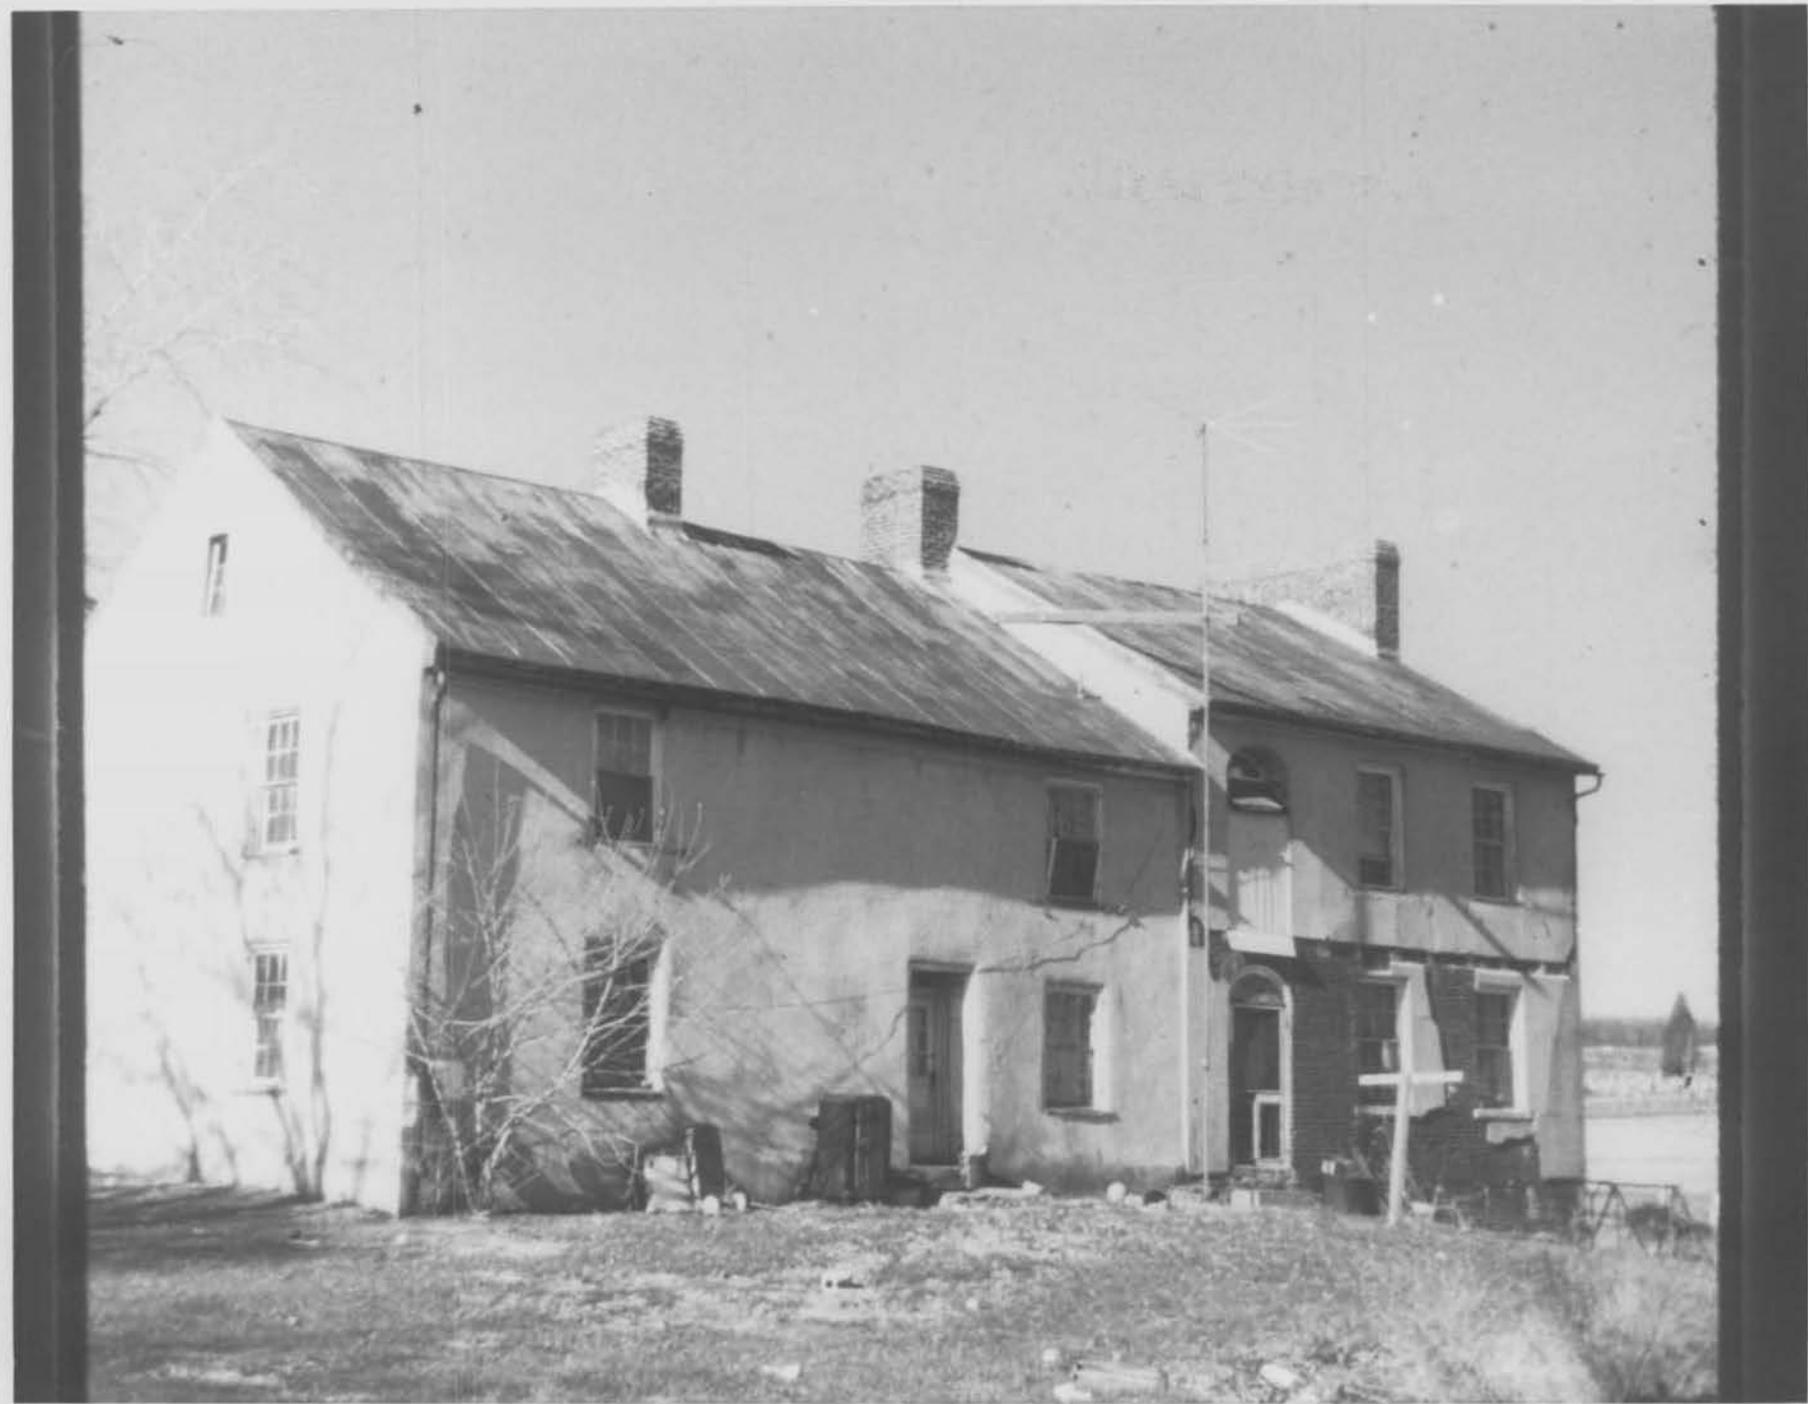
1. CARR-54 PETER ROYER HOUSE
2. Carroll County, Maryland
3. Joe Getty
4. March 1968
5. Getty, York St. Manchester, Md.
6. S & W elev. (camera facing ne)
7. 1/4

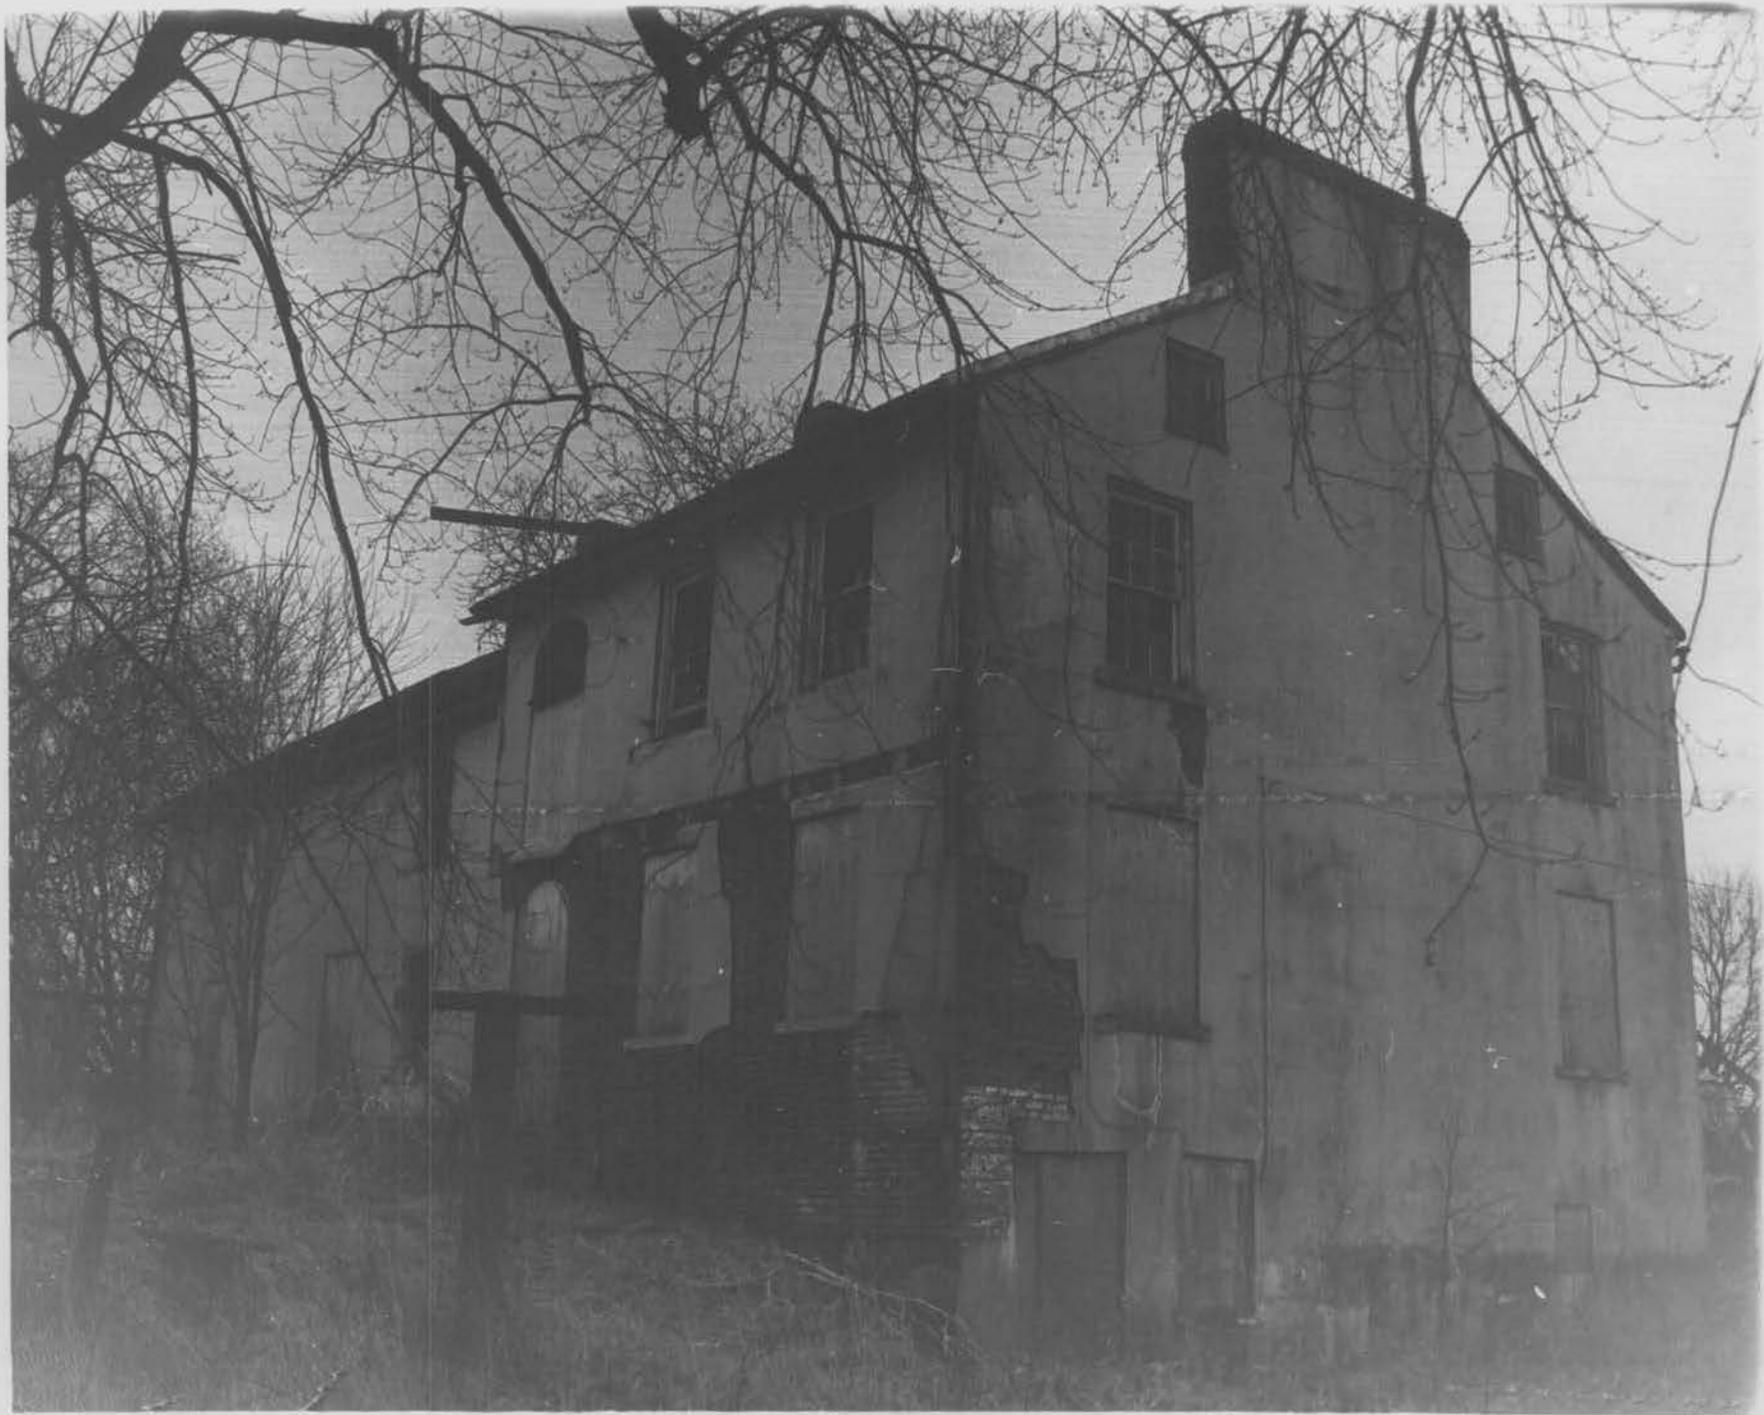
1. CARR-54 PETER ROYER HOUSE
2. Carroll County Maryland
3. Joe Getty
4. April 1977
5. Getty, York St., Manchester, Md.
6. S & E elev. (camera facing nw)
7. 2/4

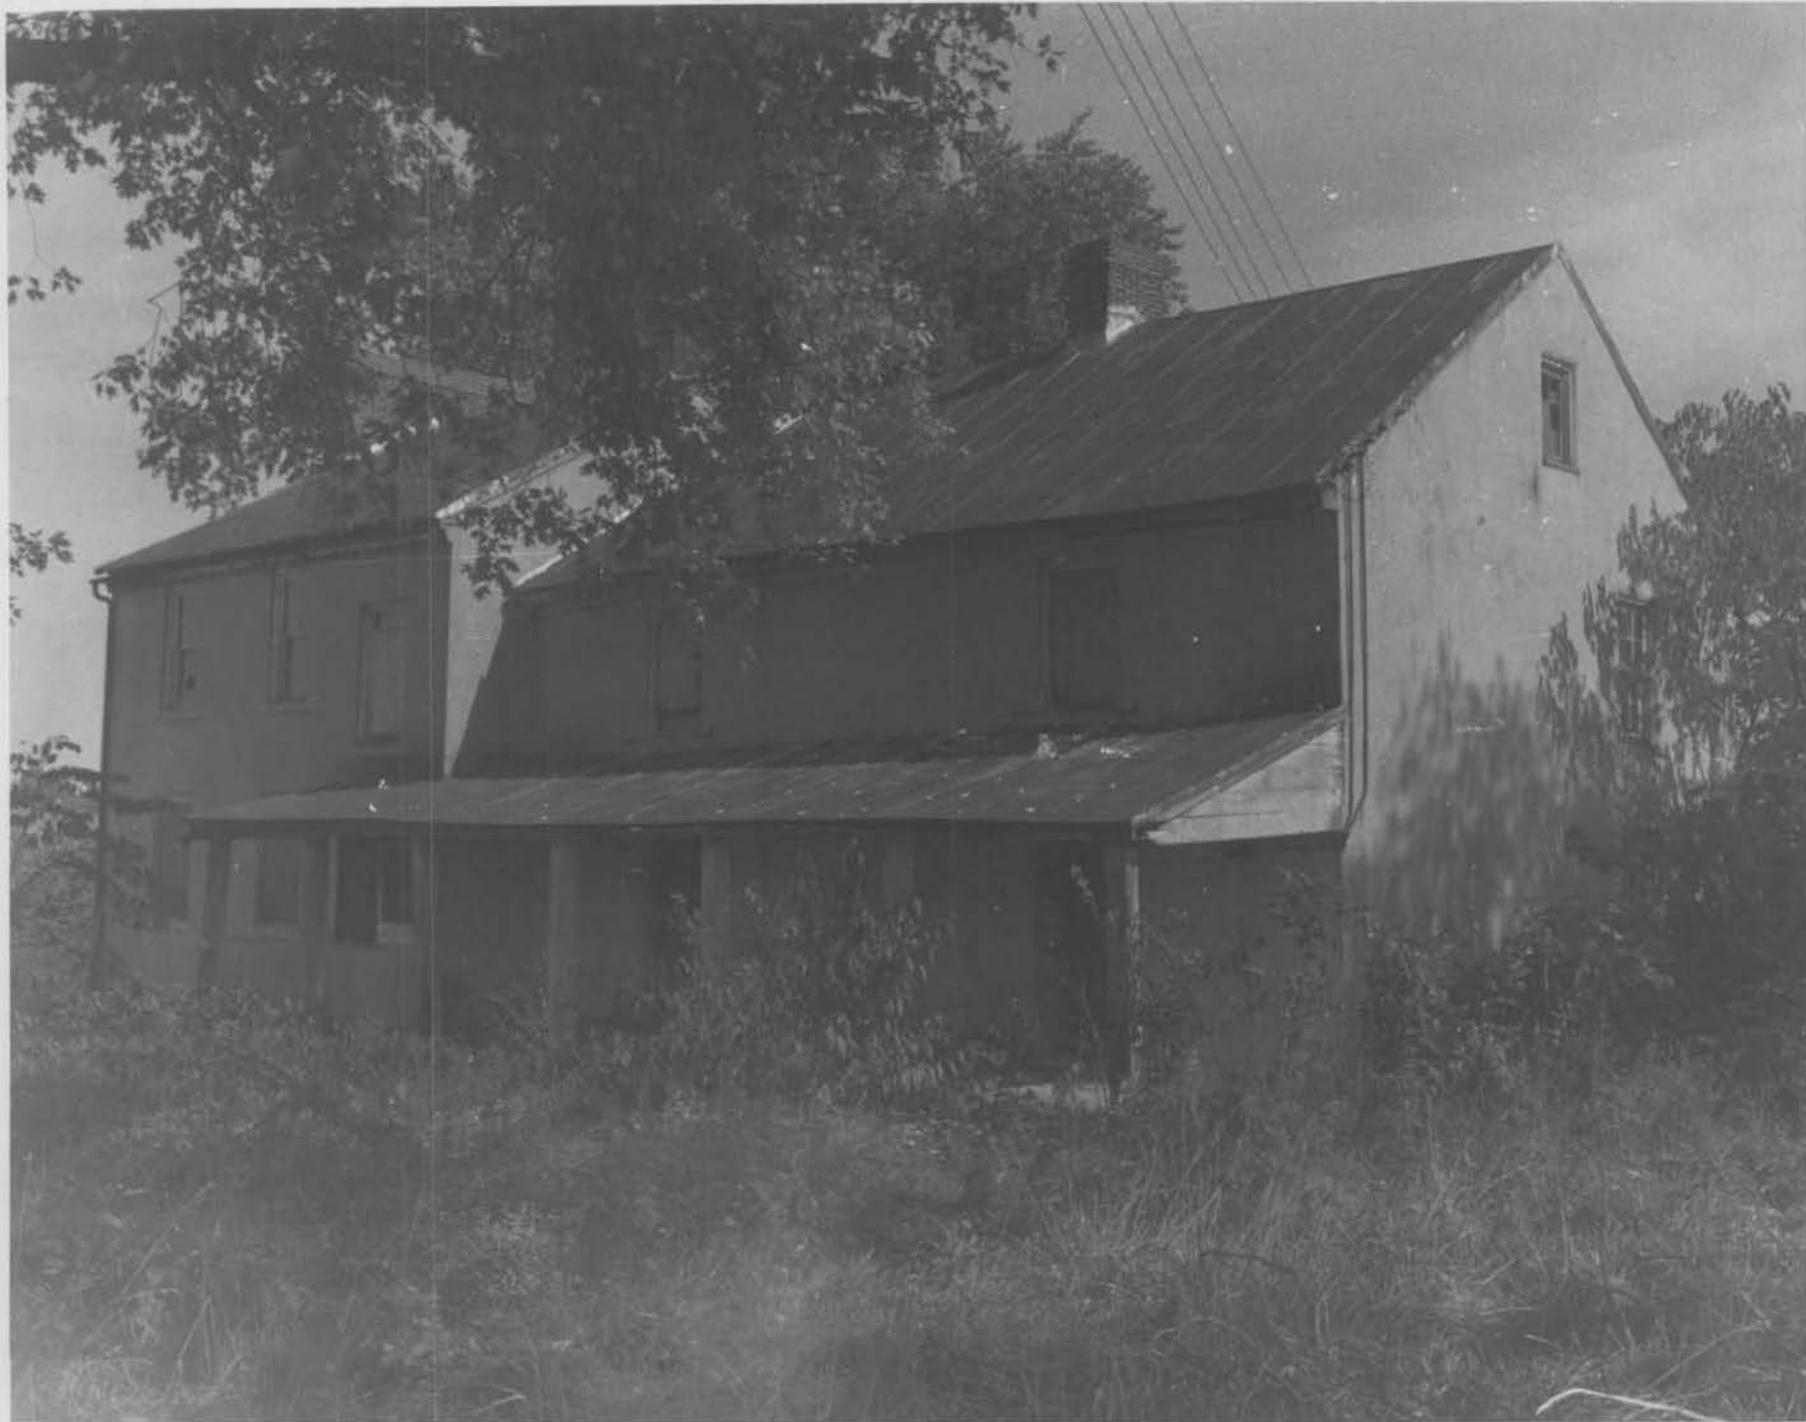
1. CARR-54 PETER ROYER HOUSE
2. Carroll County, Maryland
3. Joe Getty
4. June 1977
5. Getty, York St., Manchester, Md.
6. N. & W. elev. (camera facing se)
7. 4/4

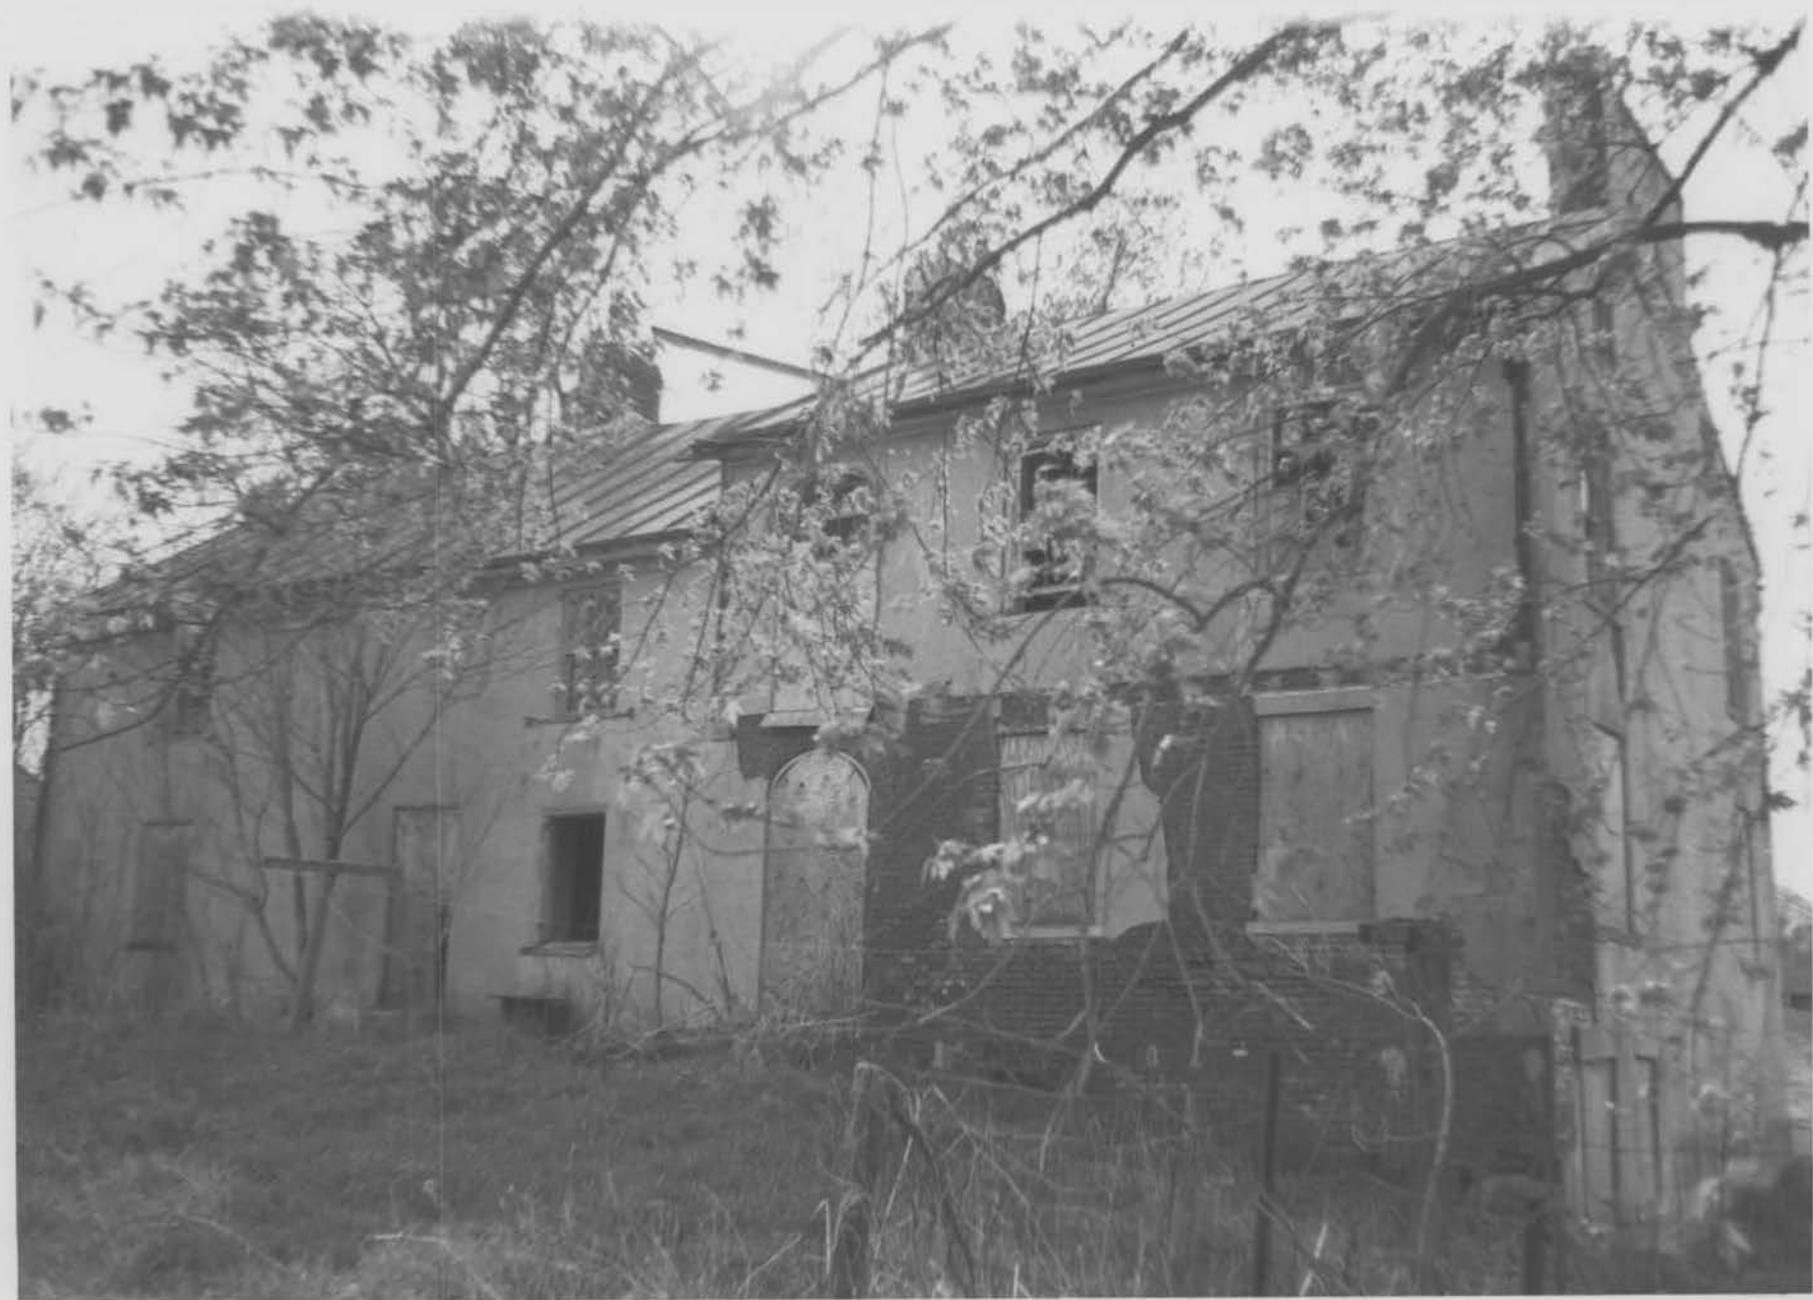
1. CARR-54 PETER ROYER HOUSE
2. Carroll County, Maryland
3. Joe Getty
4. May 1977
5. Getty, York St., Manchester, Md.
6. S. elev. (camera facing n)
7. 3/4
