CARR-549

Ridgeville United Methodist Church  
(Ridgeville M.P. Church, Boulevard Office Center)  
108 East Ridgeville Boulevard (MD 144)  
Mt. Airy  
Private

# Maryland Historical Trust State Historic Sites Inventory Form

historic Ridgeville M. P. Church

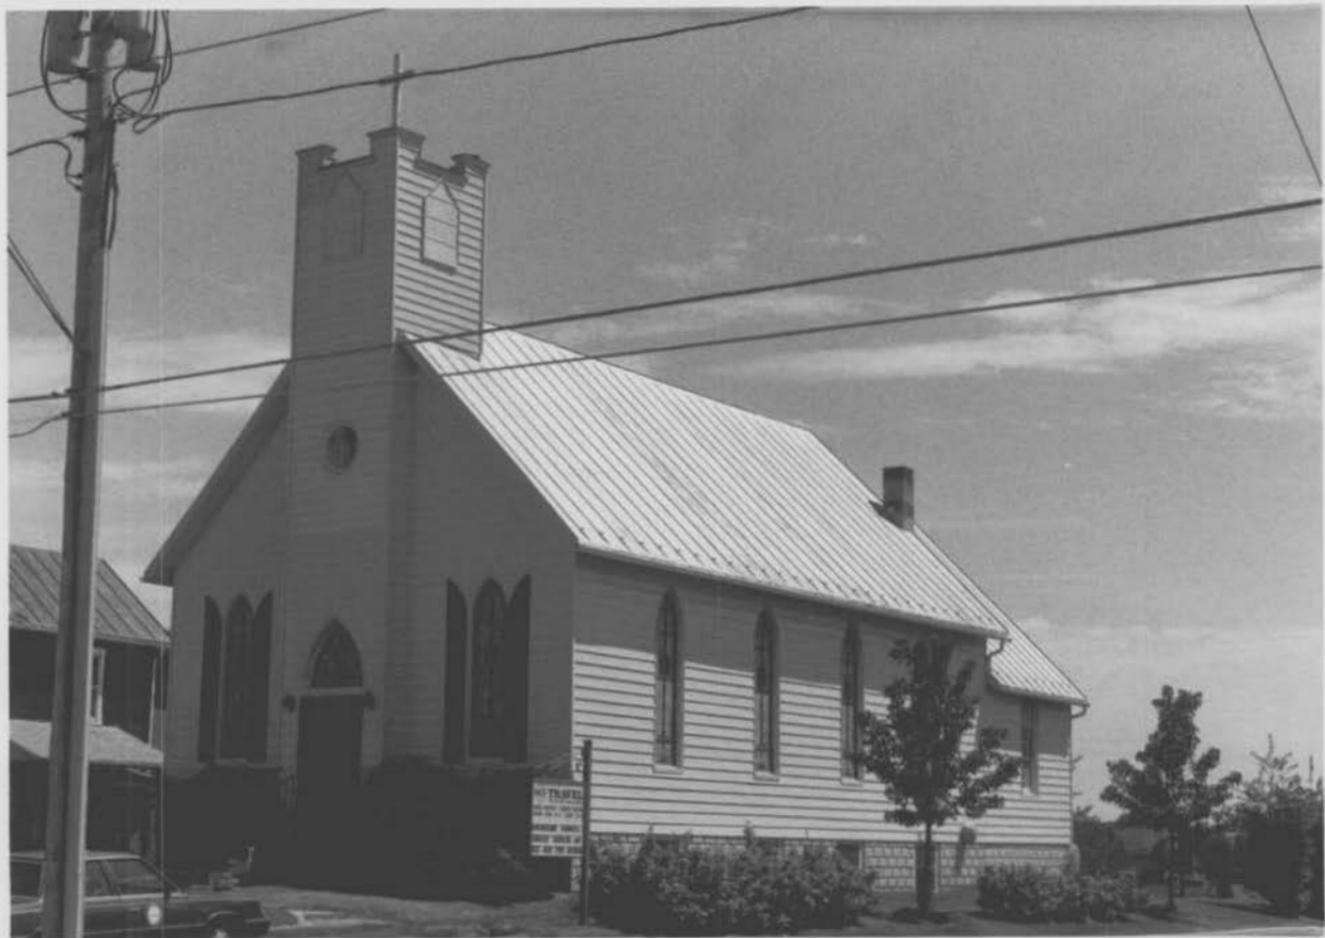
113

north & west elevations

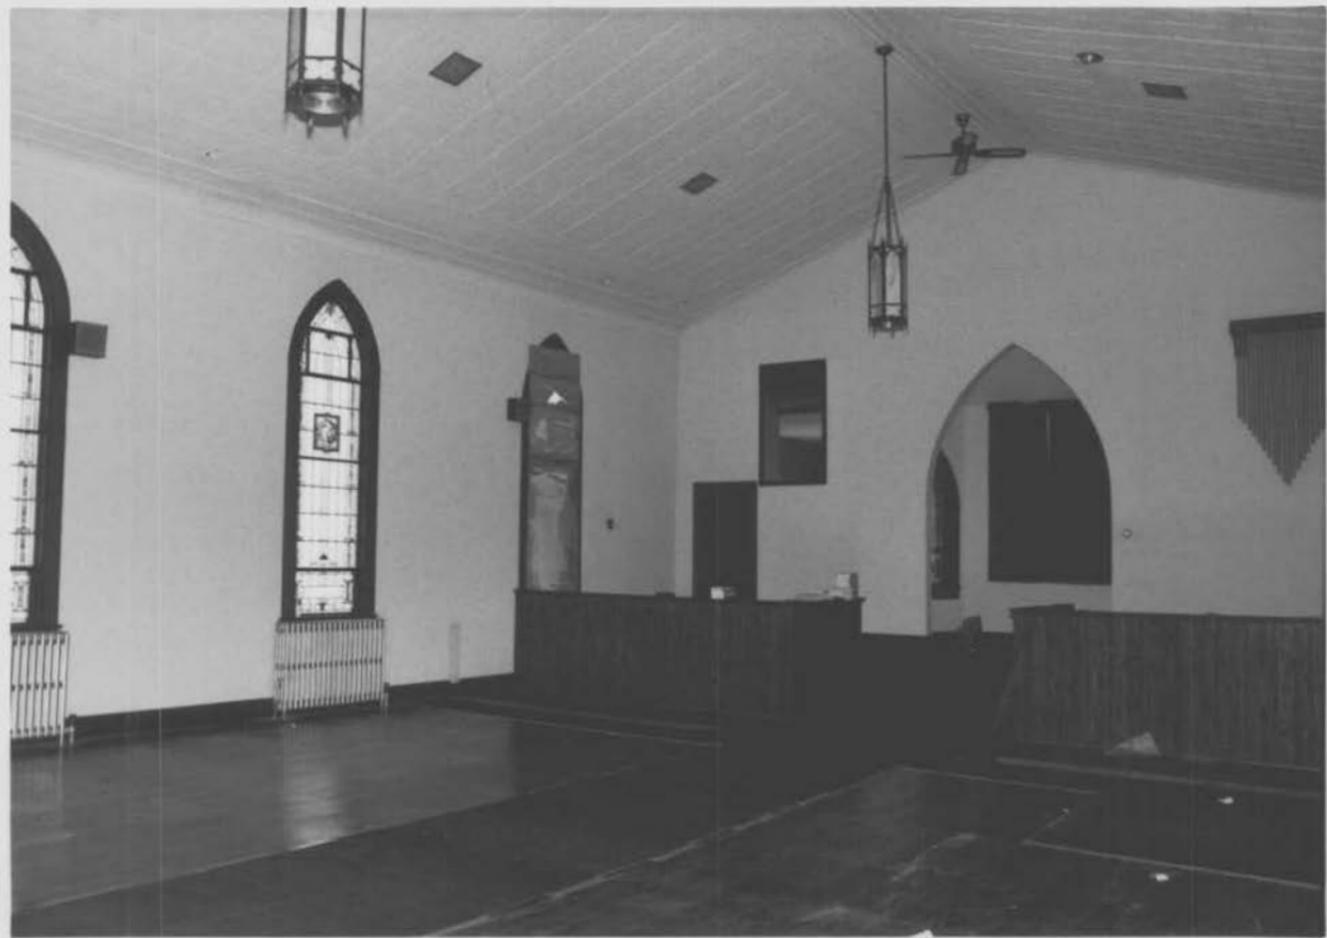
2/3

interior - east & south elevations

There is a raised dais on the south that has been altered, and the chancel furniture has been removed. Apparently there was originally an altar rail straight across this end, between the south and south-central bays, and it had an opening in the center. The south wall has a recessed, three-sided apse with a small stained-glass lancet on the southeast and southwest sides. These windows match the others, except that they have light green margins. There are two new doors on the south wall into the south addition. This section is divided into two rooms, with knotty pine panelling. The social hall below has no exposed details. The church was recently sold and will be converted to commercial space.

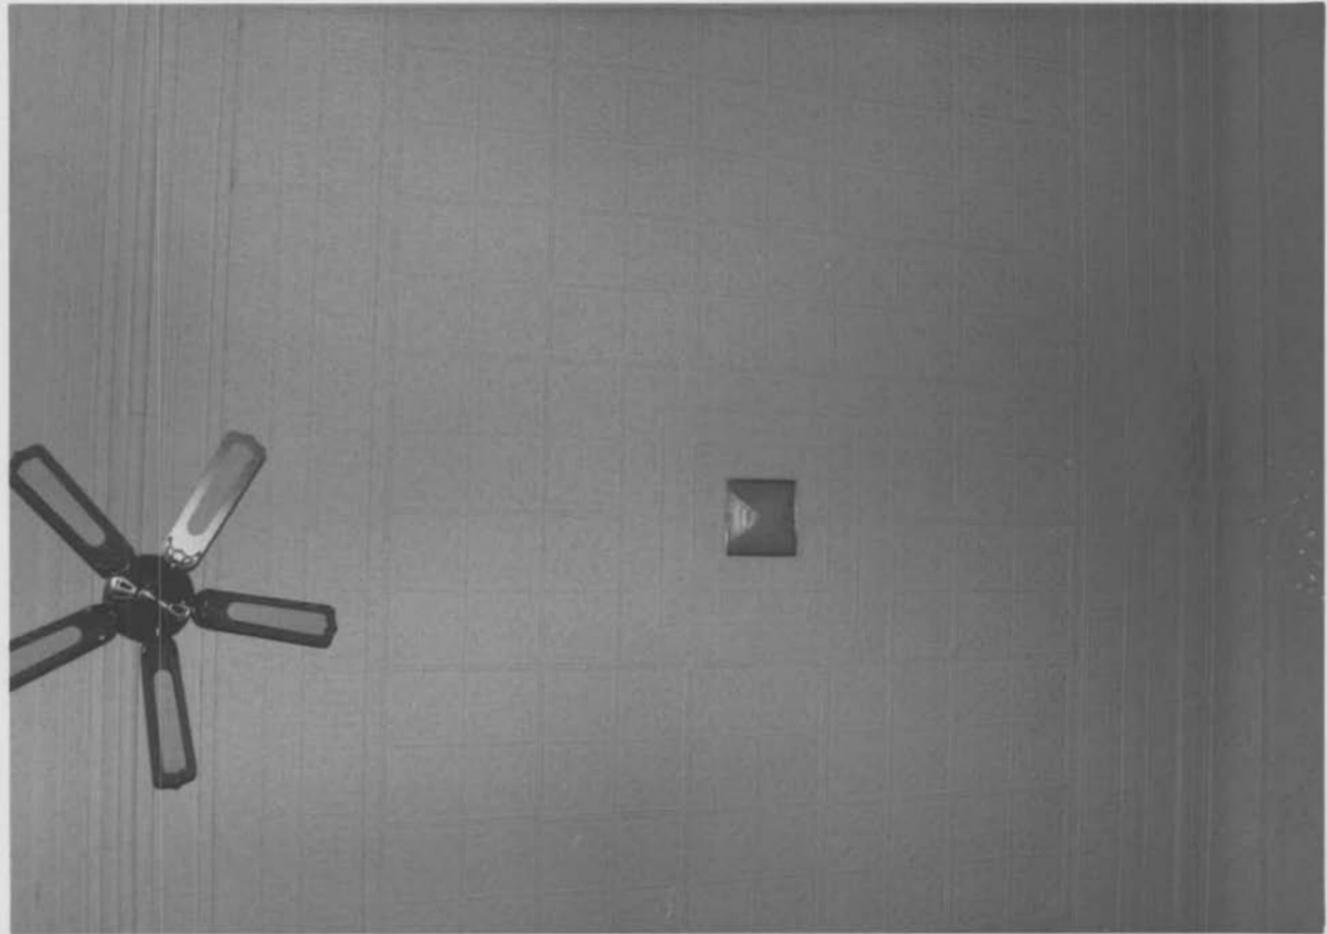
3/3

interior ceiling detail

Inside the bell tower is a vestibule with new six-panel double doors on the west, in an original opening. These lead to stairs down to the cellar. On the east is a single four-panel door into a closet. There is an access hatch in the ceiling of the closet that leads to the bell tower. On the south wall of the closet is a four-panel door into the sanctuary. On the south of the vestibule are new six-panel double doors into the sanctuary. All of the door and window surrounds have two back-to-back shallow ogee mouldings down the center of the field. The sanctuary has three-inch-wide tongue-and-groove pine flooring that runs north-south. The pews have been removed, but there was formerly a center aisle. The baseboard has an ogee moulding on the top and the walls have textured plaster. The gabled ceiling has pressed metal with a cove cornice. Each side of the ceiling has three large, square metal panels that are original. Inside each panel is a square, recessed light. There are two square patches in the cornice, in the center of the east and west walls, that suggest there were once interior chimneys here.
