CARR - 668

ROBERTSON FARM

FIELD SHEET--HISTORIC RESOURCES SURVEY

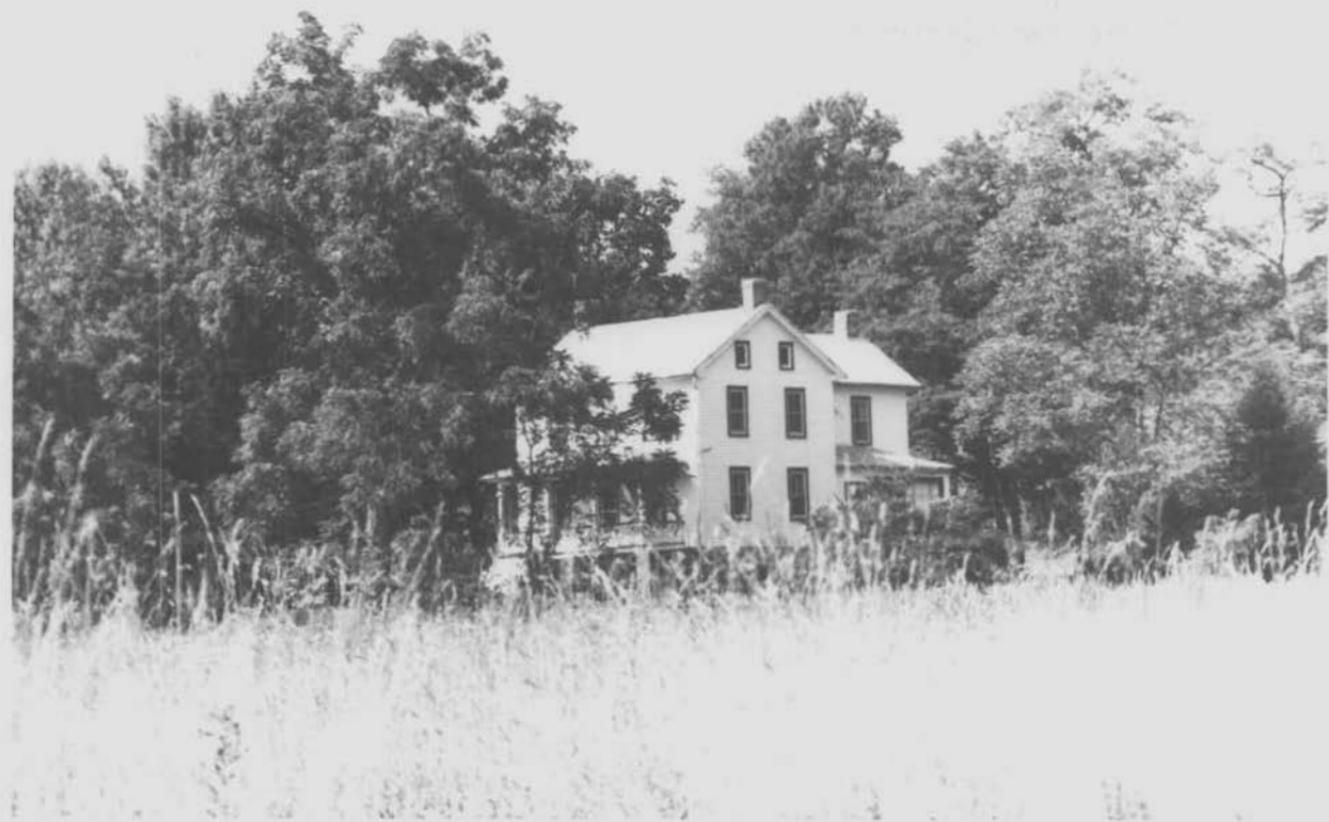
bank house - full basement level on main facade
2 story front porch (basement, 1st story) with stick-style trim
1 story porch on inner side of ell
mid-to-late 19th c. wood trim

1. CARR-668 Robertson Farm
2. Carroll County, Maryland
3. Joe Getty
4. August 1983
5. Md. Historical Trust, Annapolis, Md.
6. North and east elevations; camera facing southwest
7. 1/2

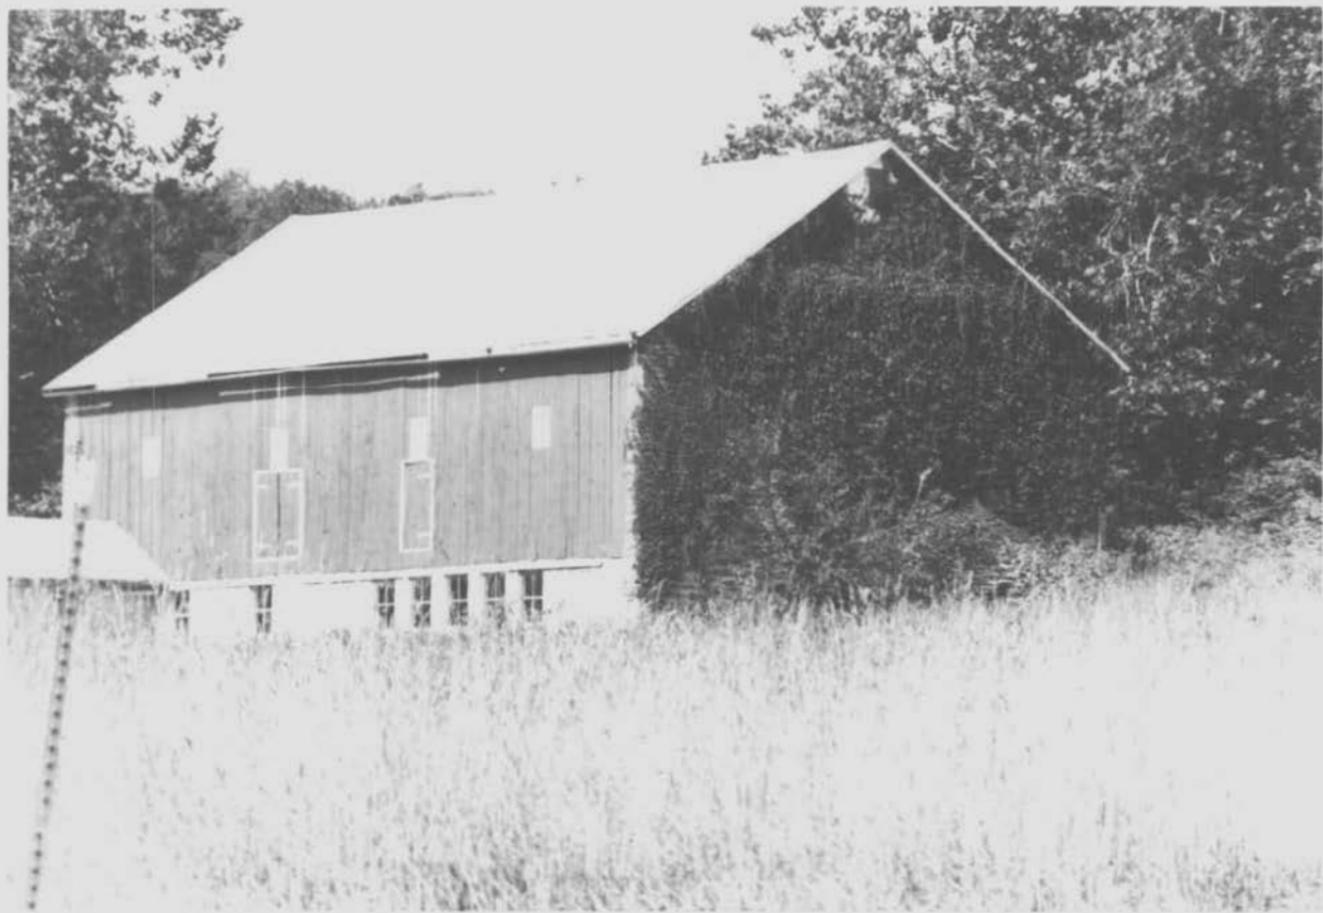
Stone-end bank barn - vertical ventilation slots mid 19th century

1. CARR-668 Robertson Farm
2. Carroll County, Maryland
3. Joe Getty
4. August 1983
5. Md. Historical Trust, Annapolis, Md.
6. Barn - north and east elevations
7. 2/2
