CARR - 684

1050 MEDFORD ROAD

WESTMINSTER PLANNING DISTRICT

FIELD SHEET--HISTORIC RESOURCES SURVEY

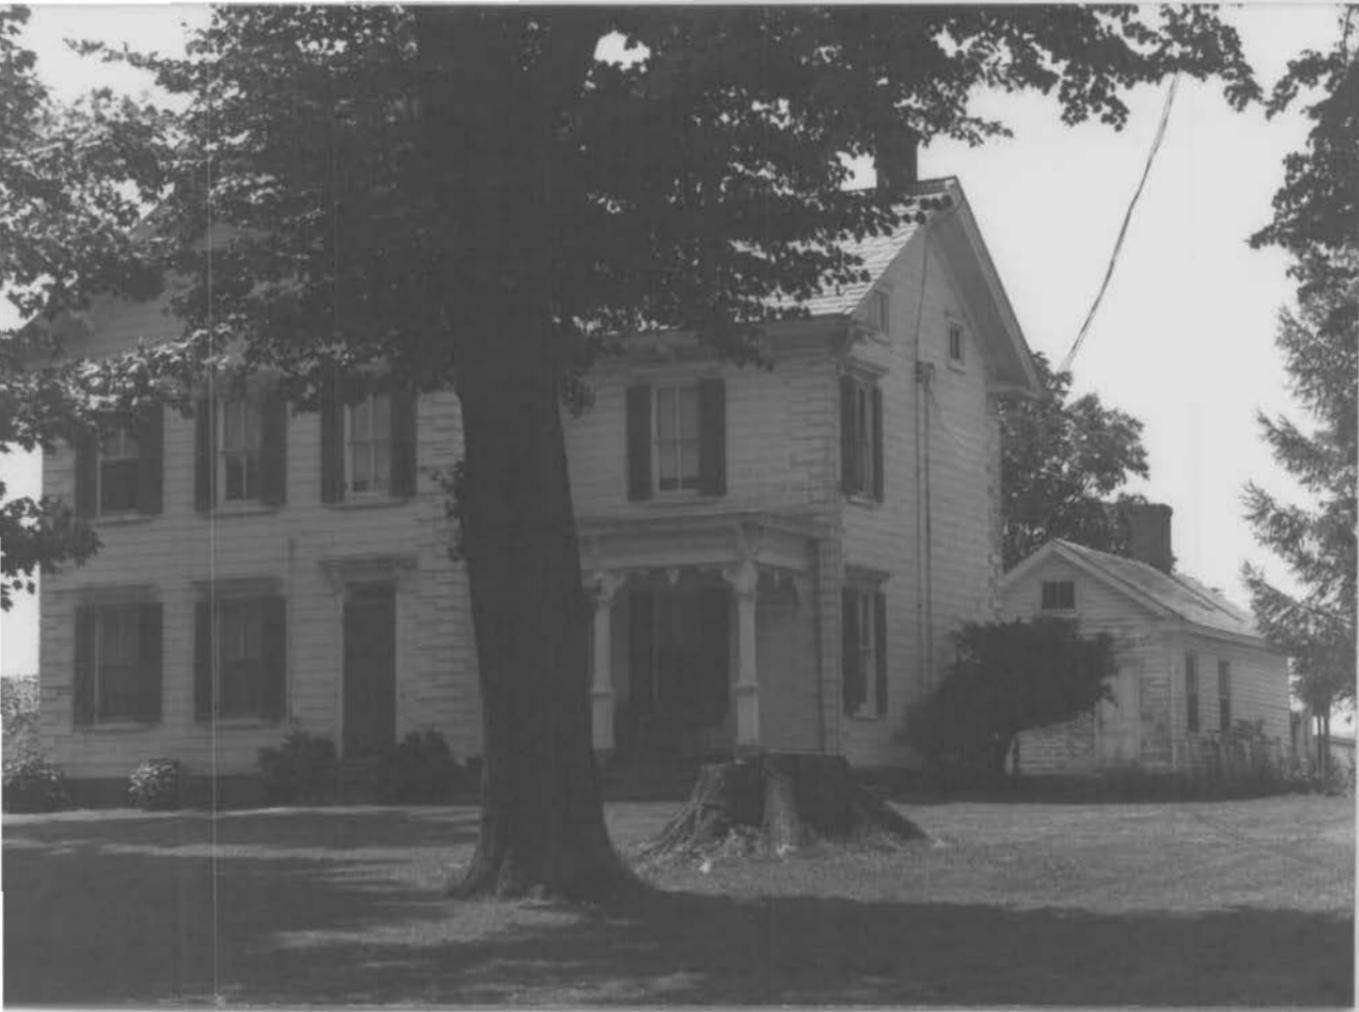
1. CARR-684 1060 MEDFORD ROAD
2. Carroll County, Maryland
3. Joe Getty
4. August 1983
5. Md. Historical Trust, Annapolis, Md.
6. East and north elevations (camera facing southwest)
7. 1/1
