CARR - 736

1206 MARTIN DRIVE

Westminster vicinity

FIELD SHEET--HISTORIC RESOURCES SURVEY

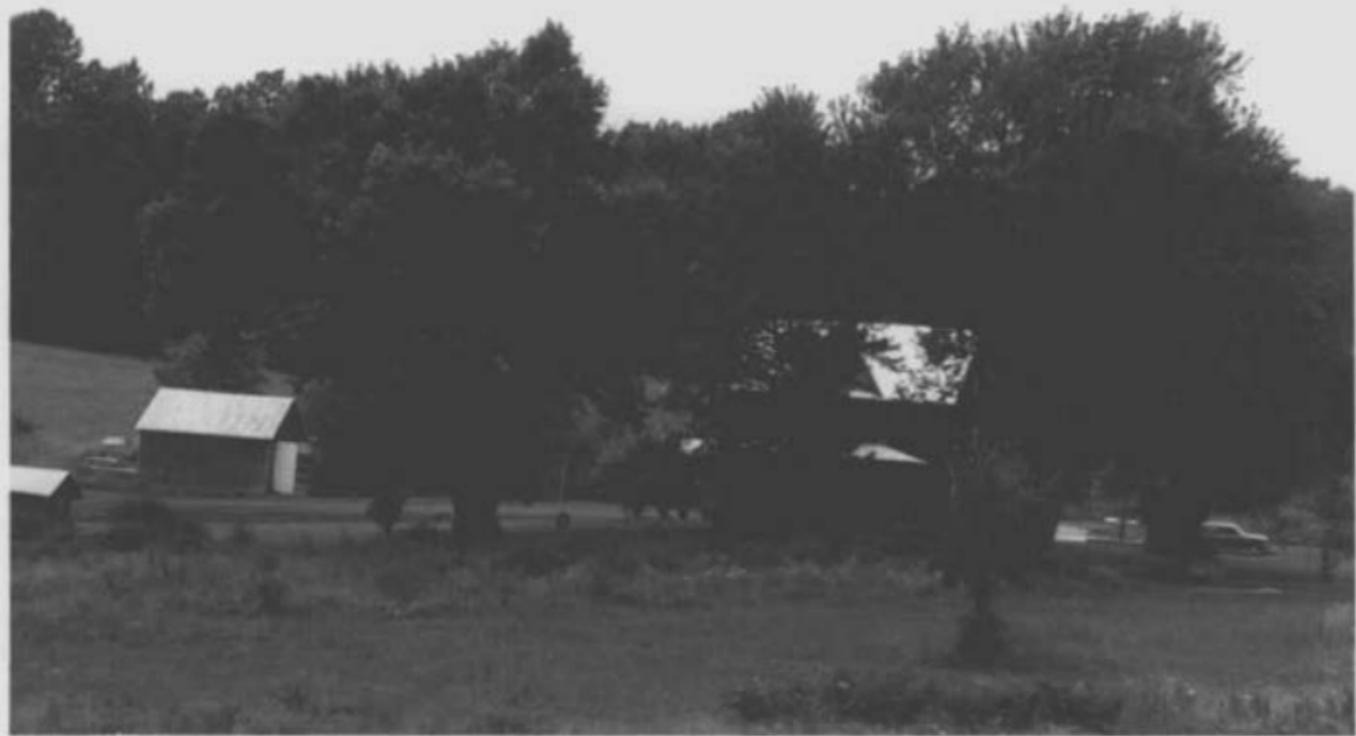
CARR. 736

1. 1206 Martin Drive
2. Carroll Co., Md.
3. J. Getty
4. 8/83
5. Md. Hist. Trust, Annapolis, Md.
6. east elevation
7. 1/1

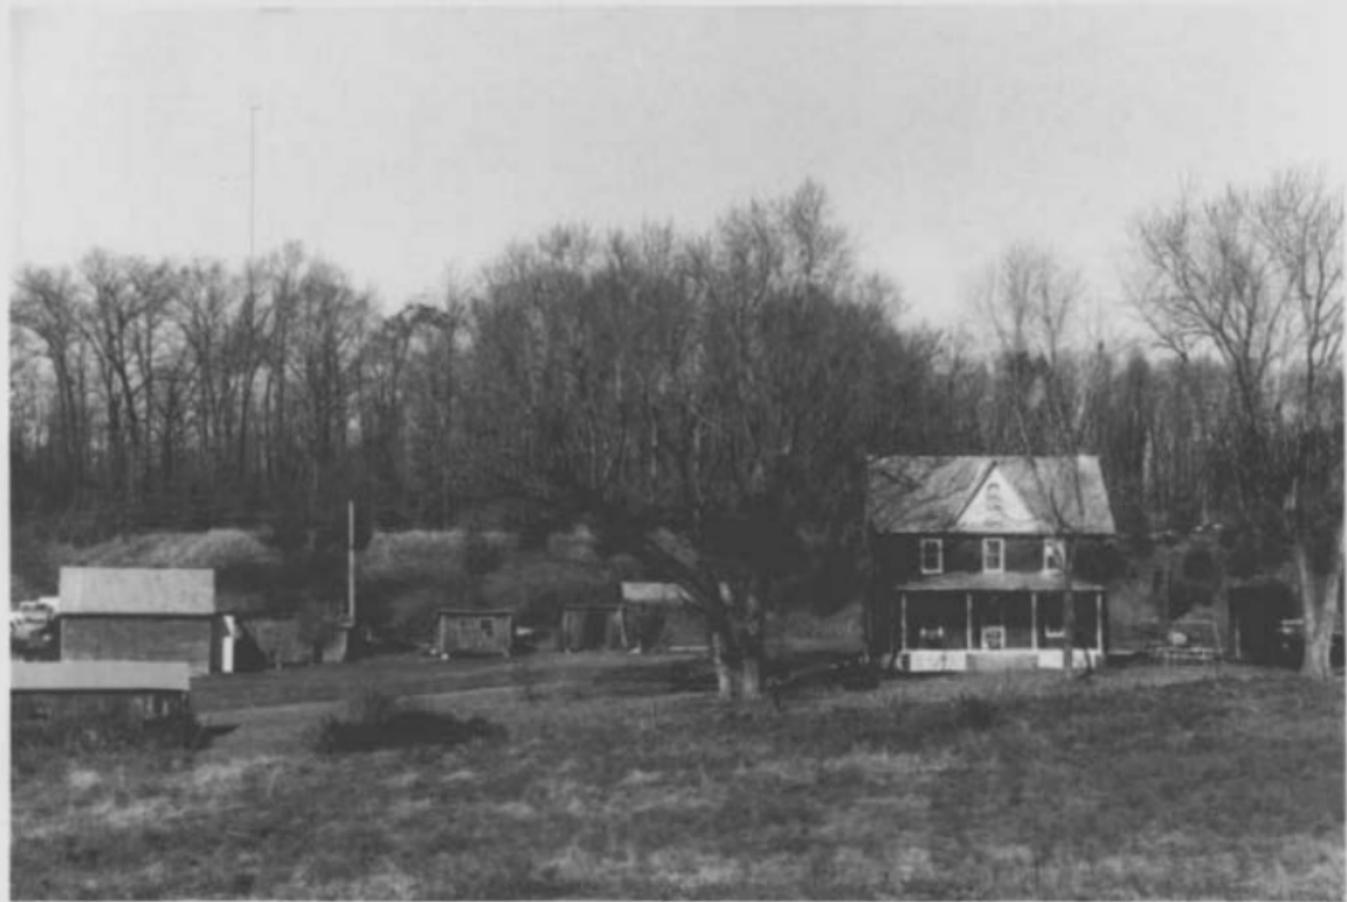
CARR - 736

east facade
