CARR - 782

623 OLD WESTMINSTER PIKE

FIELD SHEET--HISTORIC RESOURCES SURVEY

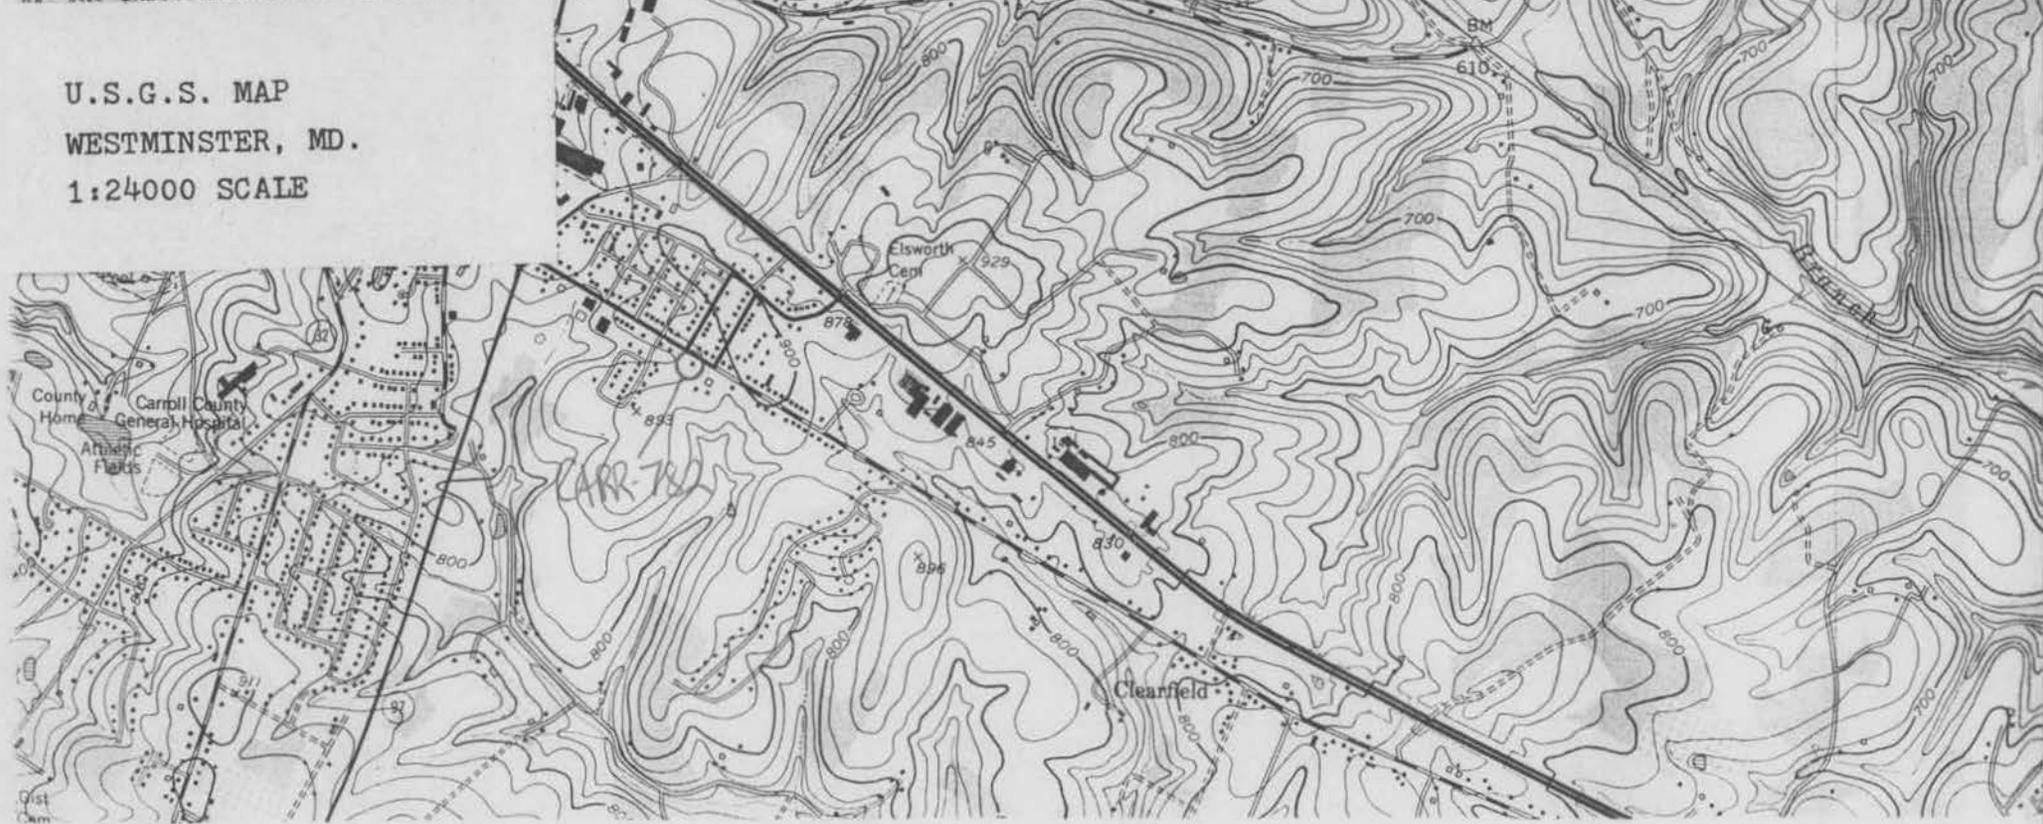
1. CARR-782 623 Old Westminster Pike
2. Carroll County, Maryland
3. Joe Getty
4. August 1983
5. Md. Historical Trust, Annapolis, Md.
6. North elevation; camera facing south
7. 1/1
