CARR-816

Francis L. Shipley Farm  
Old Washington Road

**Maryland Historical Trust  
State Historic Sites Inventory Form**

historic Francis L. Shipley Farm (House)

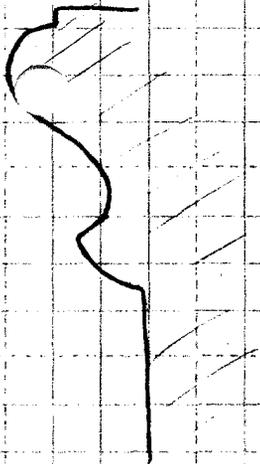
Window and Door  
Cornice

frieze

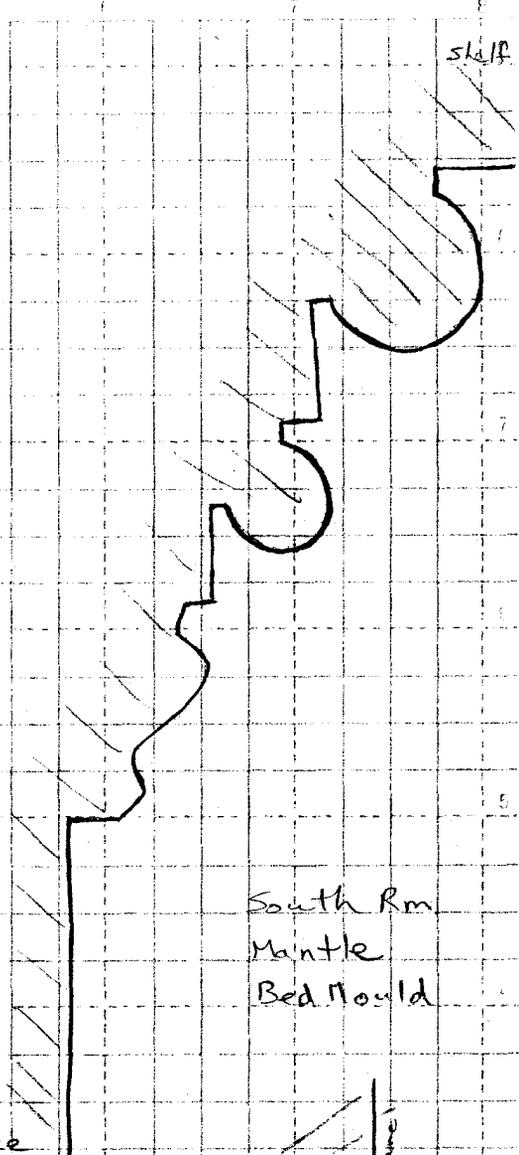
South Rm  
Mantle  
Bed Mould

The northeast room has a fireplace on the north wall, set to the west. It has an identical, but smaller, mantel to that in the south room. The bed mould is also identical, but each moulding is smaller. There are later applied mouldings on the frieze, pilasters, and plinths. The door to the south room has ogee panel moulds on the northeast room side. The northwest room has a fireplace on the north wall, to the east. It is small and has a new firebox. The wood mantel has plain pilasters and frieze, and a simple bed mould with a quirked ogee. The ell has a rebuilt fireplace on the west wall. It originally had a trammel bar, but it has been removed. The simple wood mantel has narrow pilasters, a plain frieze, and a simple, bevelled bed mould. South of the fireplace is a closet with double doors over double doors. Each door has a flat, sunk panel, while the reverse is bevelled. They have pegged mortise-and-tenon joints and cast-iron butt hinges with no markings. North of the fireplace is a beaded-edge vertical-board door and wall that is set diagonally and leads to a closet under the enclosed winder stairs in the northwest corner. This door is hung on cast-iron butt hinges, one of which is marked "N. ENG. BUTT C°." On the south wall is a door to the enclosed portion of the south porch. There are peg rails all around the room; they probably originally had hooks.

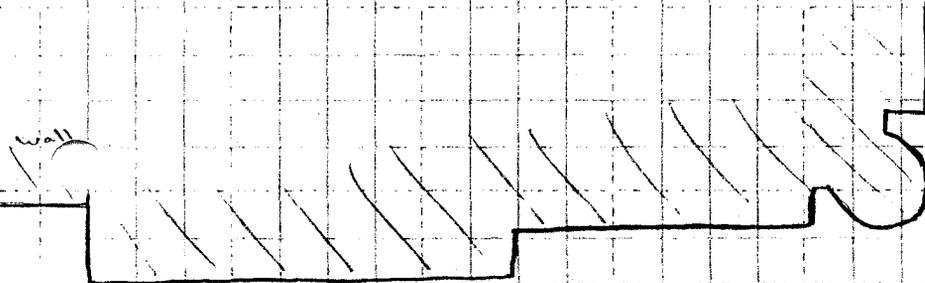
Window and Door Surround

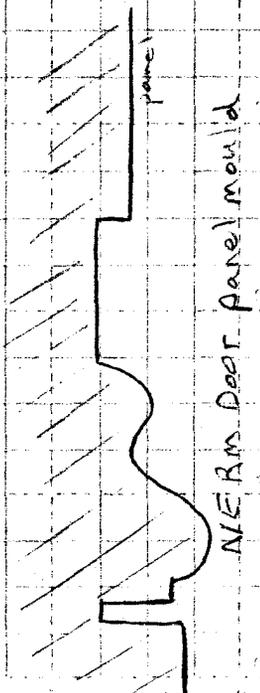
NE Rm Door Panel Mould

sketch

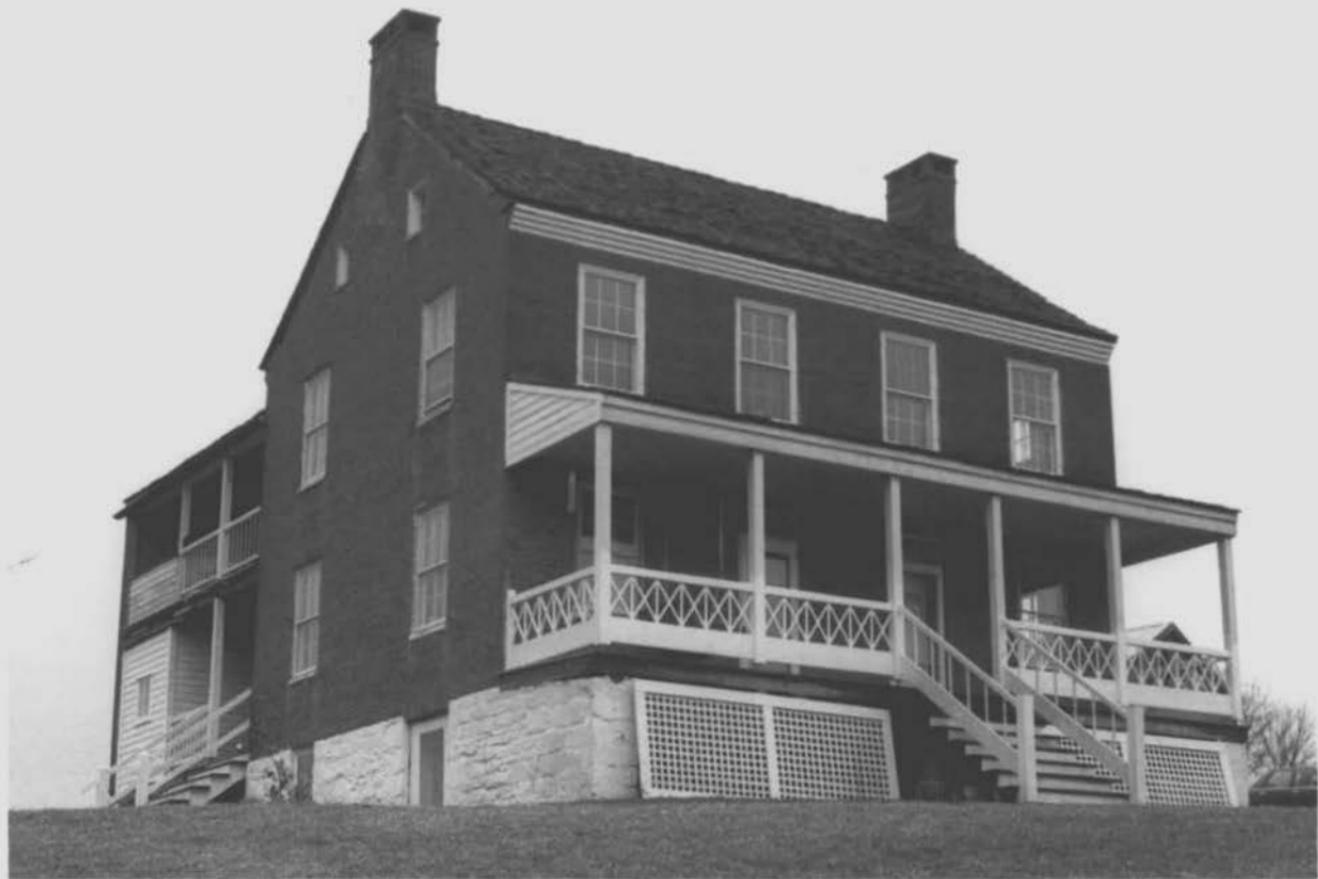
1/3

Neg. Loc.: Maryland Historical Trust  
house - south & east elevations

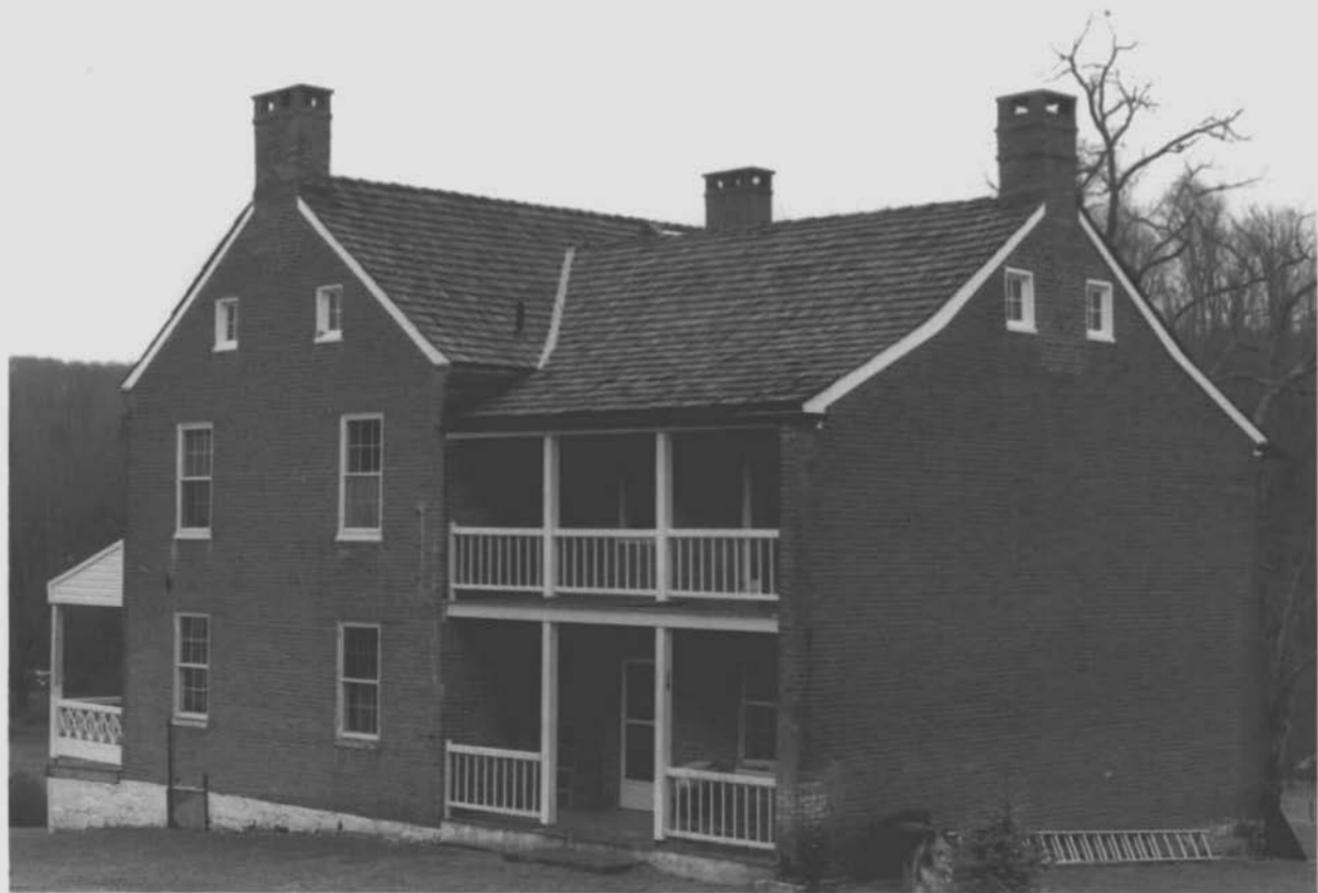
2/3

Neg. Loc.: Maryland Historical Trust  
house - north & west elevations

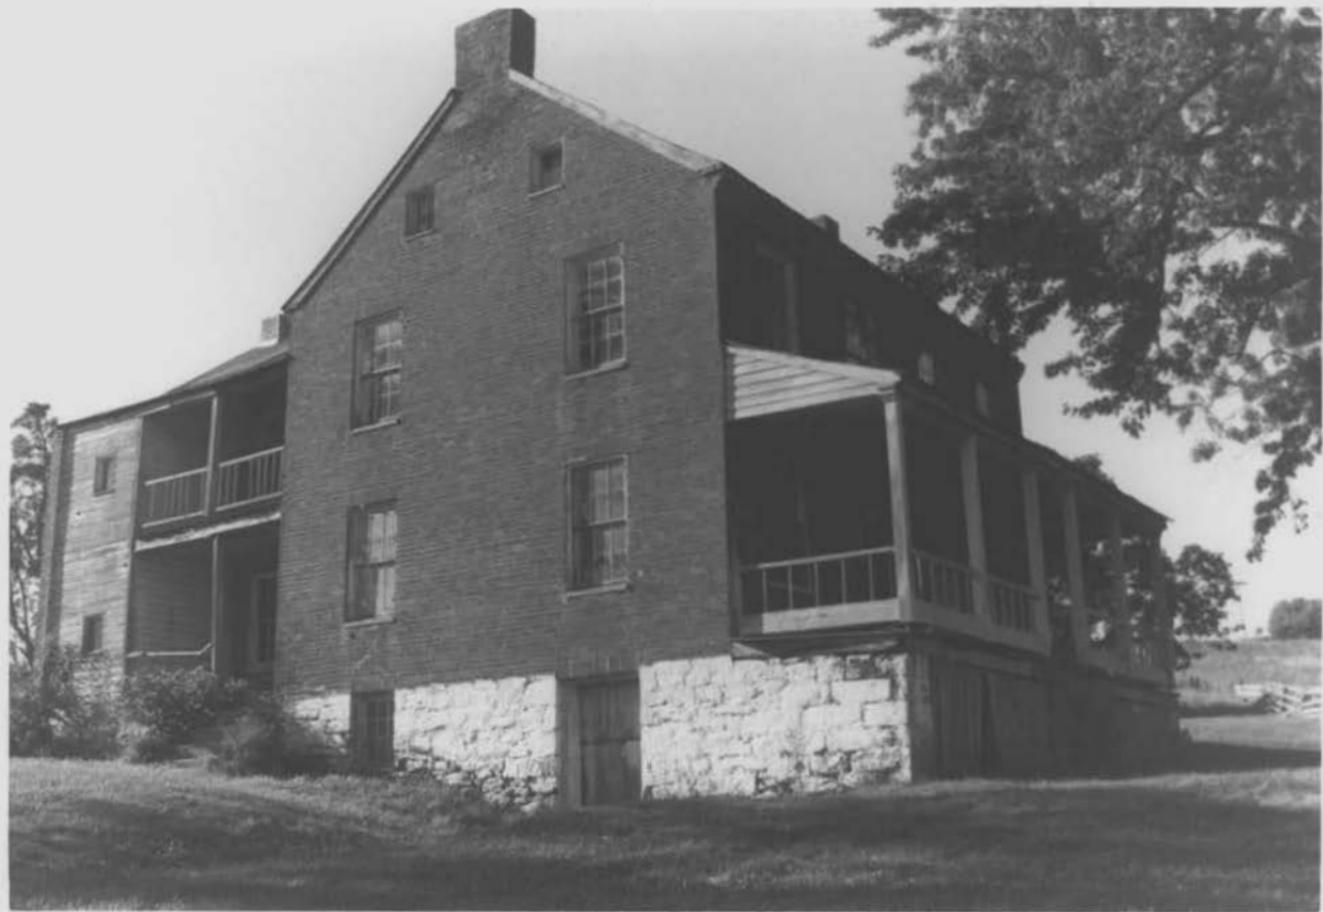
1. CARR-816 Francis L. Shipley House
2. Carroll County, Maryland
3. Joe Getty
4. July 1985
5. Md. Hist. Trust, Annapolis, Md.
6. south and east elevation

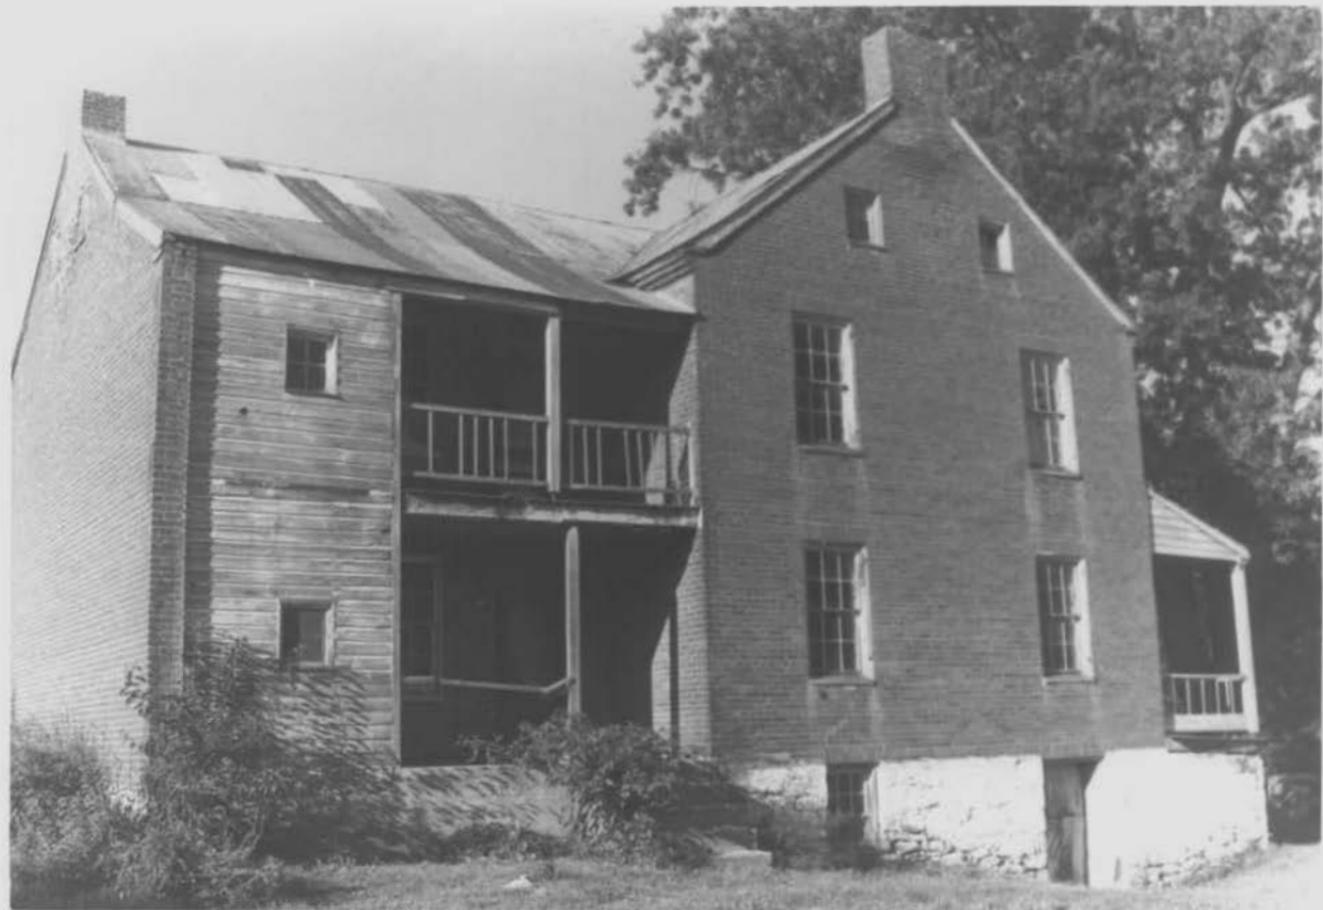
1. CARR-816 Francis L. Shipley House
2. Carroll County, Maryland
3. Joe Getty
4. July 1985
5. Md. Hist. Trust, Annapolis, Md.
6. south and west elevation

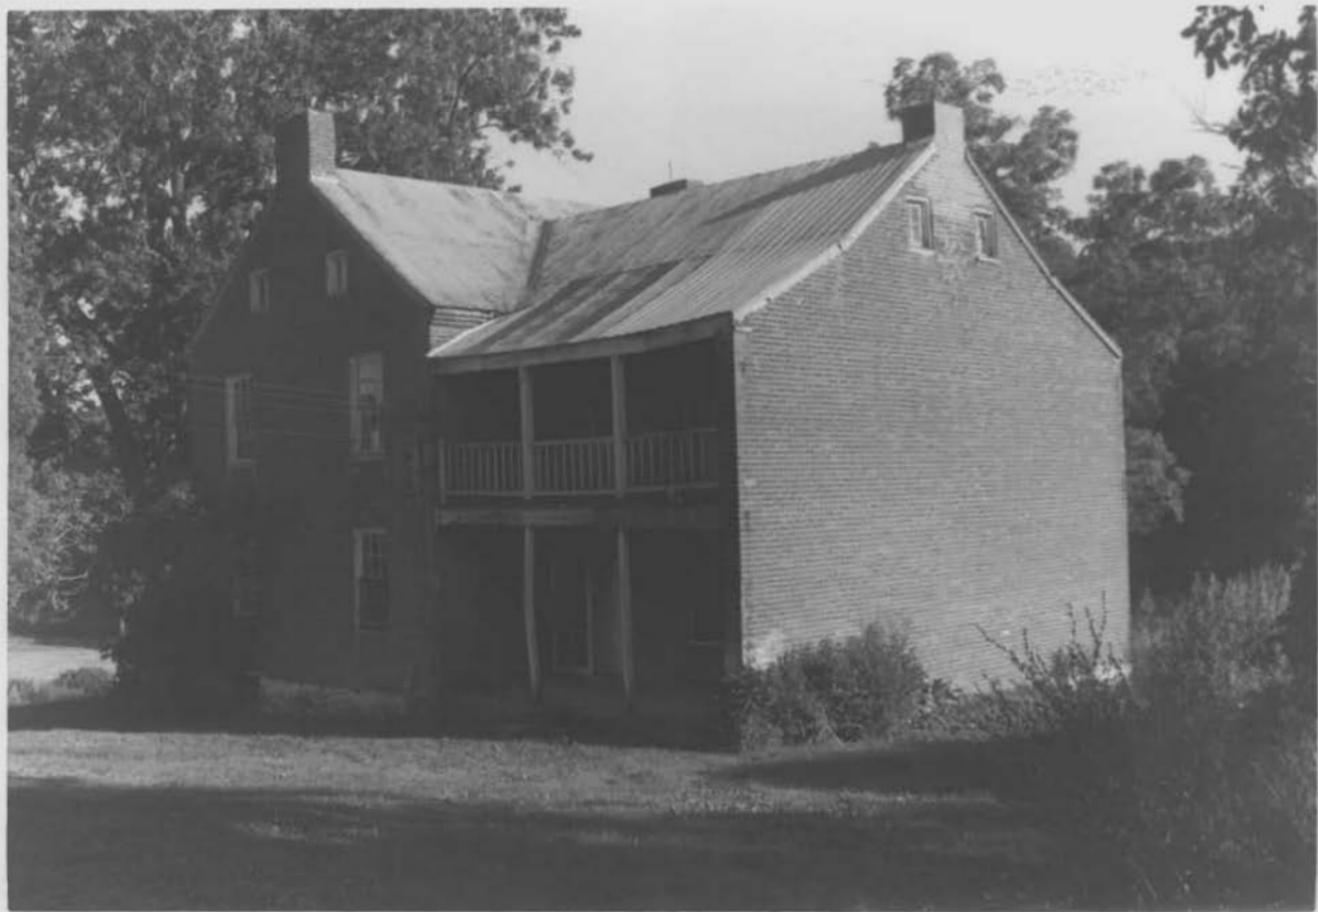
1. CARR-816 Francis L. Shipley House
2. Carroll County, Maryland
3. Joe Getty
4. July 1985
5. Md. Hist. Trust, Annapolis, Md.
6. north and west elevation

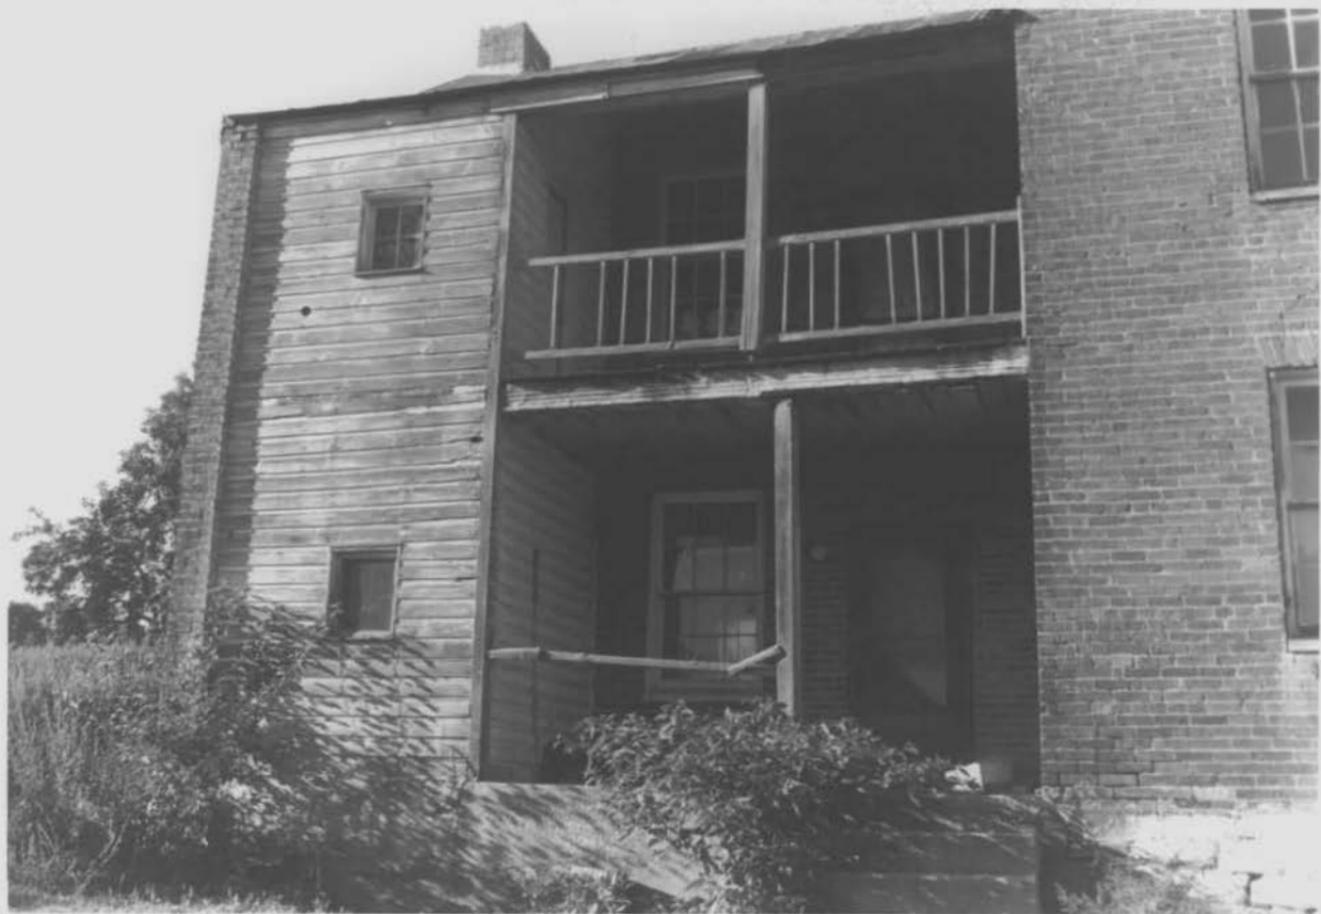
1. CARR-816 Francis L. Shipley House
2. Carroll County, Maryland
3. Joe Getty
4. July 1985
5. Md. Hist. Trust, Annapolis, Md.
6. south elevation--double-tiered porch

The wing is constructed with a solid brick wall across the west gable end that allows for the inset, double-tiered porches on both the north and south elevations. The westernmost bay of the south porch is enclosed in frame on both stories to provide small service rooms that were popular in farmhouses in this region. Following the regional pattern, the entrance to the first story framed-in room is located in the brick partition wall so that it serves as a kitchen pantry. On the second story, the room is accessible only by an entrance outside on the porch. On the first story, the easternmost bay on both the north and south brick walls contains an entrance forming a cross-passage in the kitchen. On the second story, doors are located in the easternmost bay of the south wall and the westernmost bay of the north wall. Six-over-six sash windows are located in the other bays on these elevations. The brick wall on the west gable end has two four-pane windows in the gable.

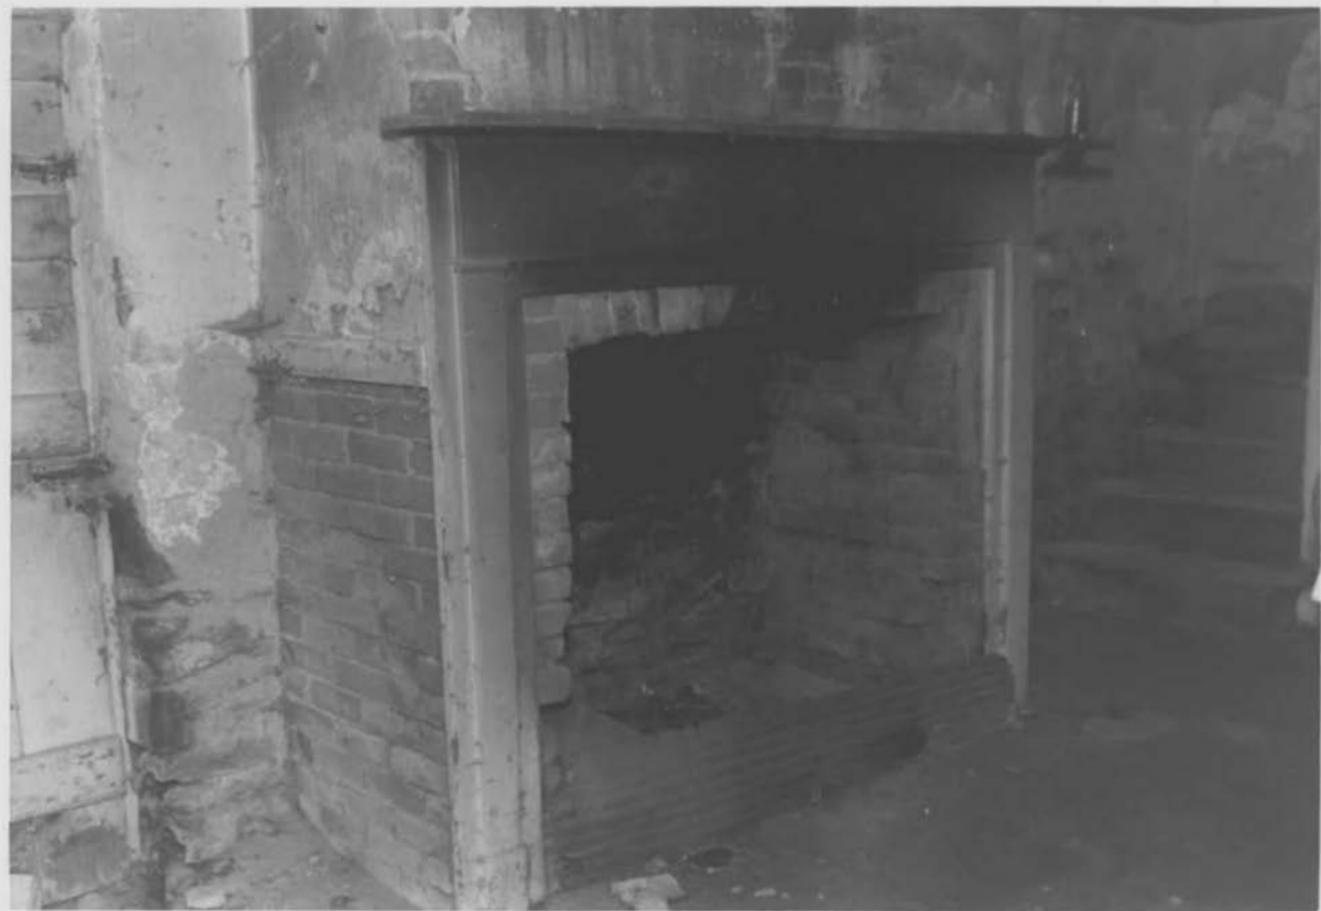
1. CARR-816 Francis L. Shipley House
2. Carroll County, Maryland
3. Joe Getty
4. July 1985
5. Md. Hist. Trust, Annapolis, Md.
6. basement fireplace

The attic contains a common rafter roof with the rafters pegged at the peak. It appears from the roof structure that standing seam sheet metal was the original roof covering as there is no evidence for wooden shingles. The basement is excavated under the main block with a two-room plan. The walls and ceilings are plastered and whitewashed indicating that the basement was used in the traditional manner of a cold cellar in the northern room and a summer kitchen in the southern room. The southern room contains a fireplace and the entrance at ground level to the outside.

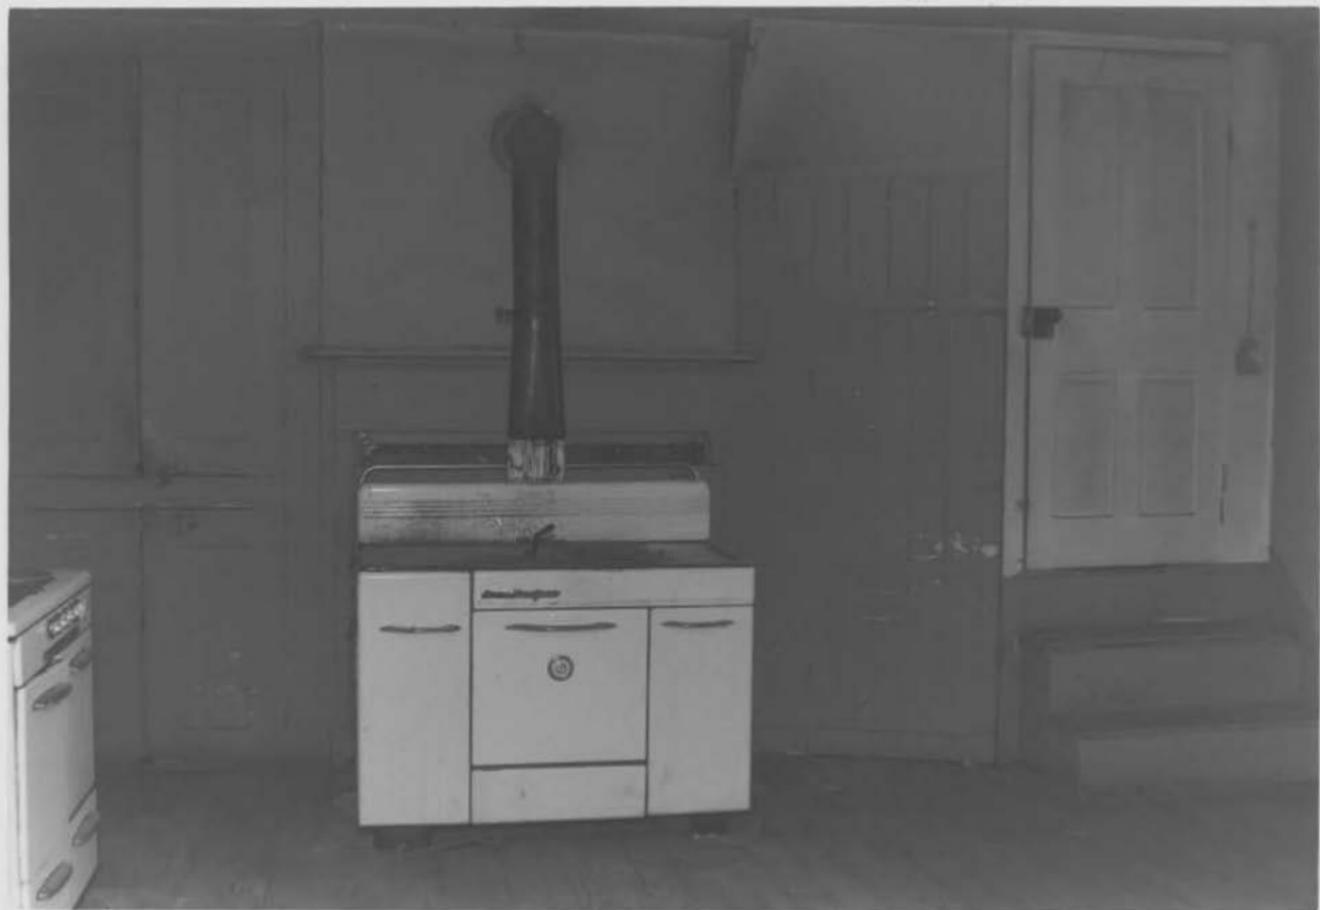
1. CARR-816 Francis L. Shipley House
2. Carroll County, Maryland
3. Joe Getty
4. July 1985
5. Md. Hist. Trust, Annapolis, Md.
6. 1st floor kitchen-north wall

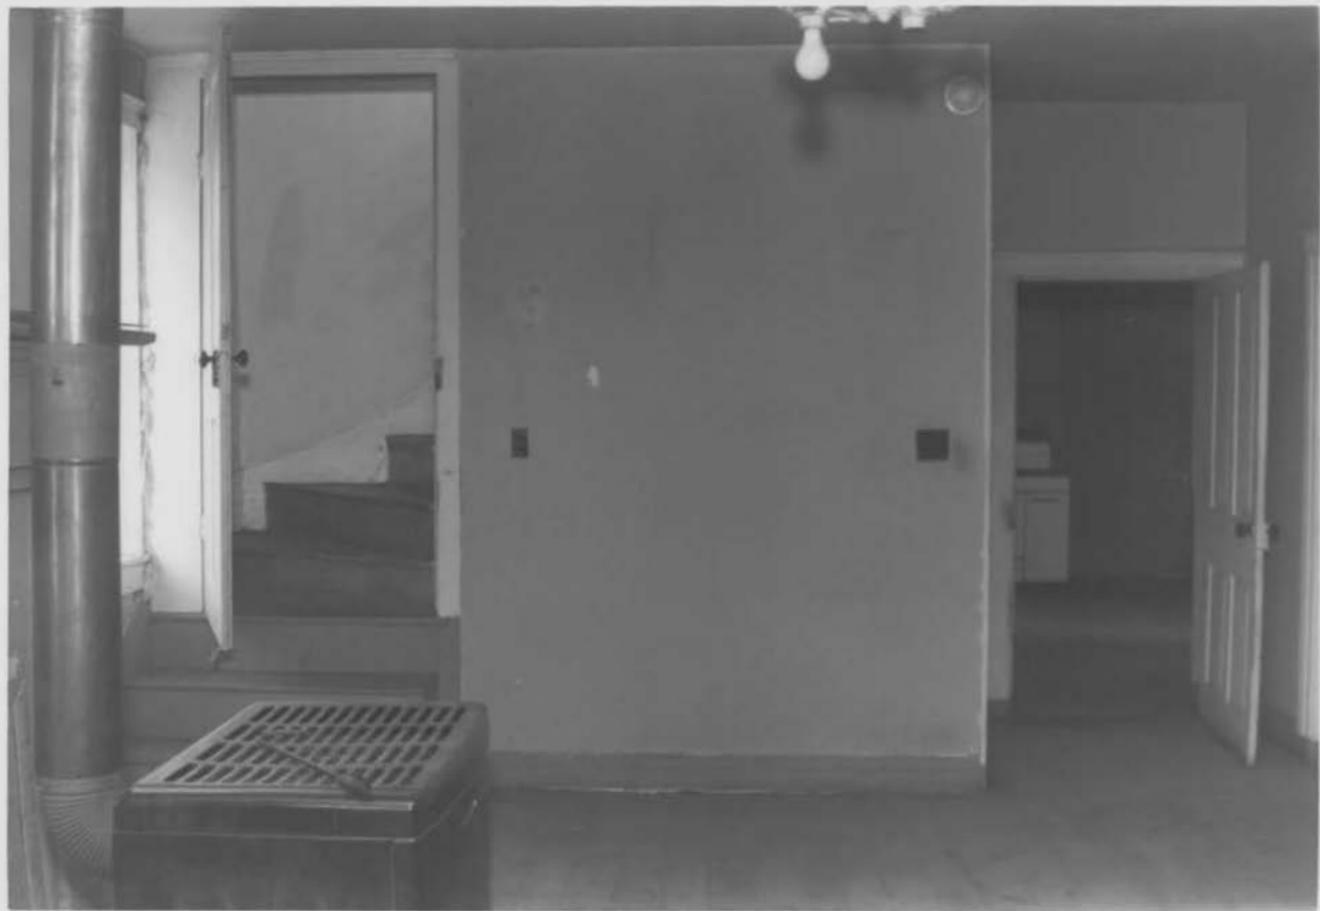
1. CARR-816 Francis L. Shipley House
2. Carroll County, Maryland
3. Joe Getty
4. July 1985
5. Md. Hist. Trust, Annapolis, Md.
6. 1st floor staircase

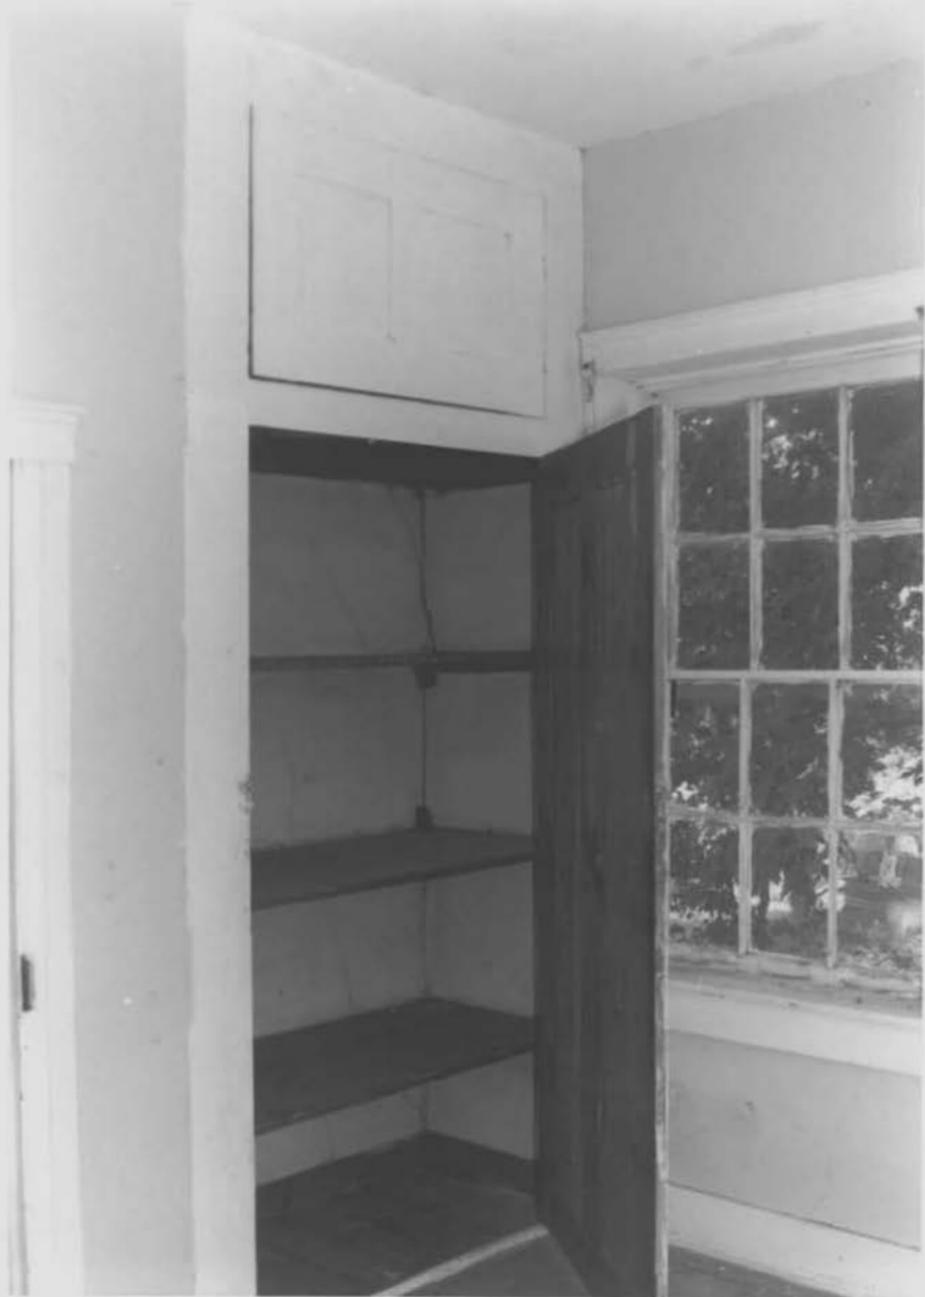
1. CARR-816 Francis L. Shipley House
2. Carroll County, Maryland
3. Joe Getty
4. July 1985
5. Md. Hist. Trust, Annapolis, Md.
6. 2nd floor ~~cupboards~~ built-in cupboards

On the second story, the main block has a four-room plan with one room containing the stairway. An unusual feature is the set of built-in cupboards serving the two front bedrooms built in the front portion of the hallway that appear from their construction to be original. The wing contains one large open room with a corner stairway to the attic.
