Property/District Name: Thomas Jones Farm Complex Survey Number: CARR-841

Project: Replace Bridge #6024, MD 140 over Piney Creek Agency: FHWA/SHA

Maryland Historical Trust
State Historic Sites Inventory Form

historic Thomas Jones Farm

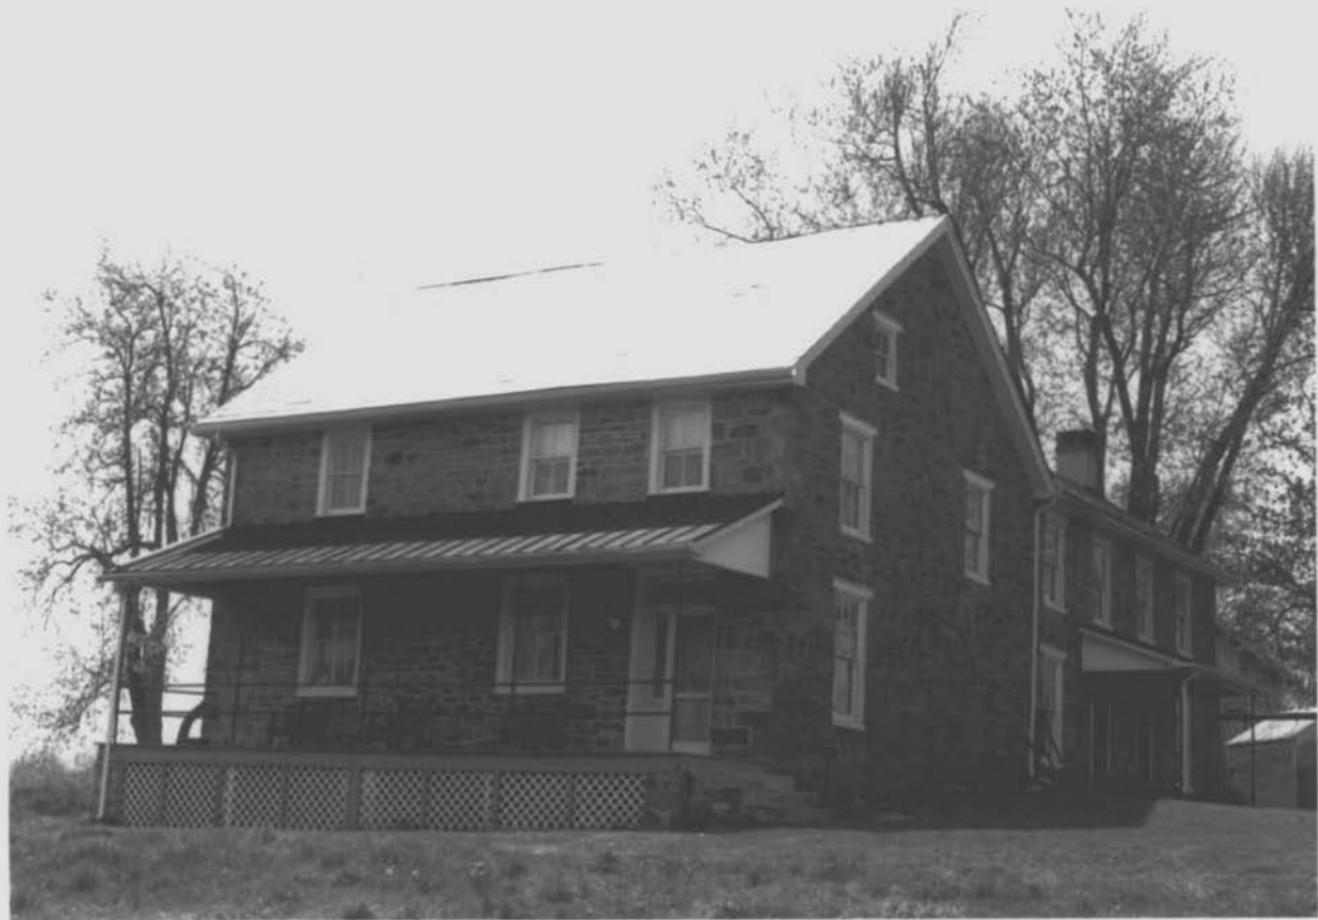
1/5

Neg. Loc.: Maryland Historical Trust
house - east & north elevations

The house is a two-story, three-bay by two-bay rubble fieldstone structure with a slate gable roof that has a north-south ridge, and it faces east. It has a four-bay ell addition on the west that has a slate gable roof and an east-west ridge. Much of the stone has been repointed, but evidence of striping survives. The east elevation in the south bay of the foundation has a beaded-edge vertical-board door on interior strap hinges in a mortised and tenoned and pegged frame with a beaded interior edge. There is a wood vent with diamond-in-section louvers in a mortised and tenoned and pegged frame set south of center in the foundation. The first story south and center bays have 2/2 sash in mortised and tenoned and pegged frames with an ovolo back band, a wood sill, and no lintel. The center bay is set north of center. The north bay has a one-light over two-lying-panel door, with sunk fields and a cavetto and ovolo panel mould. There is a sidelight to the south, with one light over one panel, and a one-light transom. The soffit has two panels and the jambs have one panel at the transom and two panels below the headrail. They are sunk, flat panels with ovolo moulds. The frame has a cavetto moulding on it. The sill is concrete and the wood lintel has an ogee moulding across the top and down both sides. There is a one-story, three-bay raised porch with three stone piers that are not tied into the house foundation. The porch has a shed roof with inverted-V-seam metal, a new deck, and iron pipe columns and railings. This and all the other porches are built of circular-sawn lumber and are bolted to the stone walls. The second story has three 2/2 sash, each with an architrave that has a beaded interior edge, is mitered at the corners, and appears to be applied over the window frame. The window openings are smaller than those on the first story. There is a wood box cornice.

The north elevation has a boarded-up opening in the east bay of the foundation. The first story east bay has a 6/6 sash in a narrow frame that has a beaded interior edge and is mitered at the corners. It has a wood sill and a wood lintel with ogee mouldings like the east door. There is no opening in the west bay. The second story has two 6/6 like that on the first story. The gable end has a four-light sash with the same details as the first-story window, set east of center. Painted on a stone near the peak is "1876".

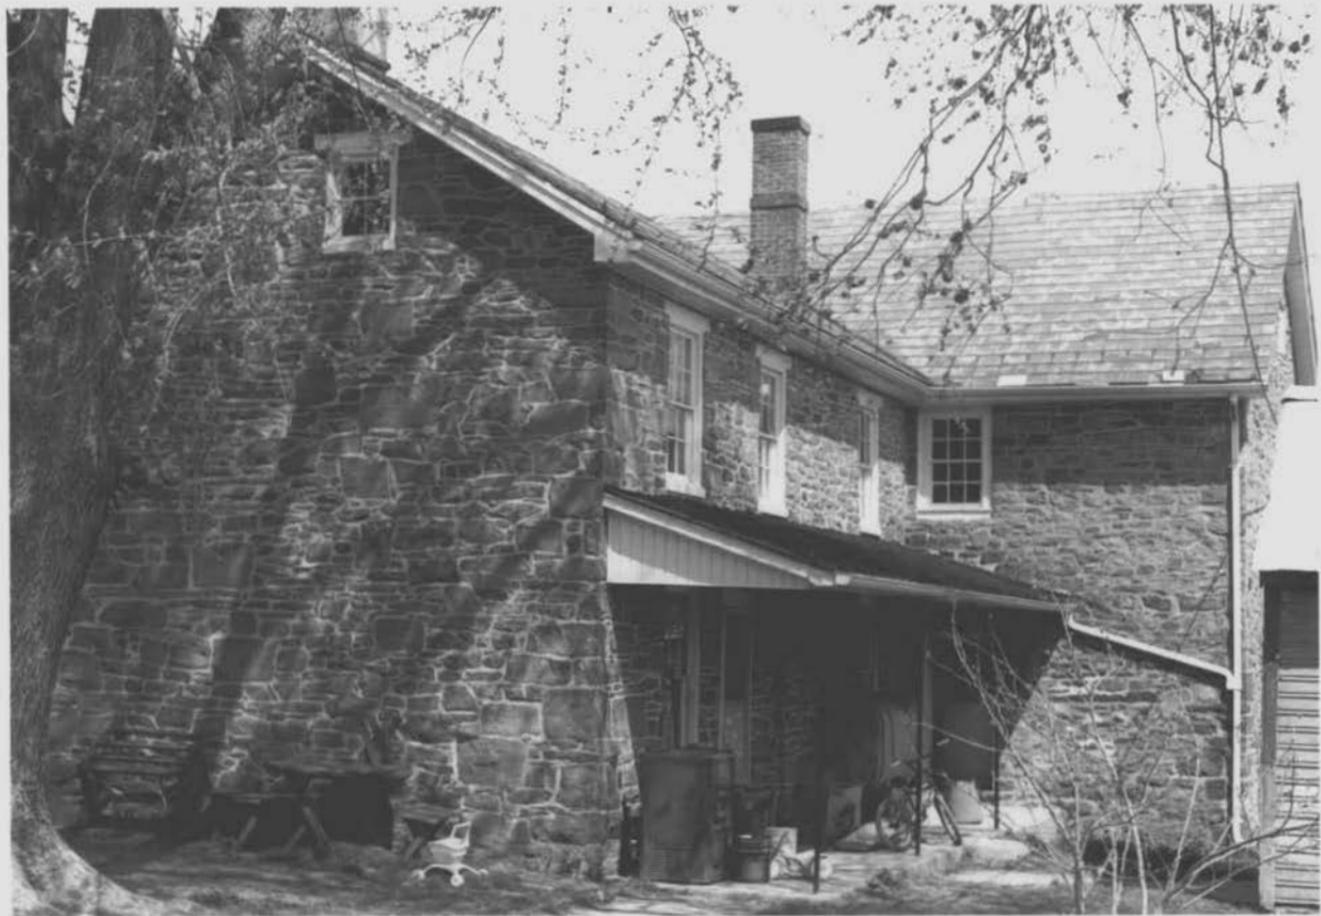
2/5

house - west & south elevations

The west elevation of the main block is one bay. The first story has a six-light-over-two-panel door, with a one-light transom. The frame is narrow, with a beaded interior edge, and is mitered at the corners. The soffit and jambs are plain. There is a stone sill, but the wood lintel has been replaced or altered. The second story has a 6/6 sash in a mortised and tenoned and pegged frame with an ovolo back band and a wood sill.

The south elevation of the main block, in the foundation, has a wood vent with diamond-in-section louvers, in the east bay. The mortised and tenoned and pegged frame has chamfered interior corners. The first story has no opening in the west bay and a 2/2 sash in the east bay with a wood sill, a beaded interior-edge frame that is mitered, and no lintel. The second story is identical to the first, but the window opening is smaller. The gable end has a four-light sash in a mortised and tenoned and pegged frame with a wood sill and no lintel. It is set east of center.

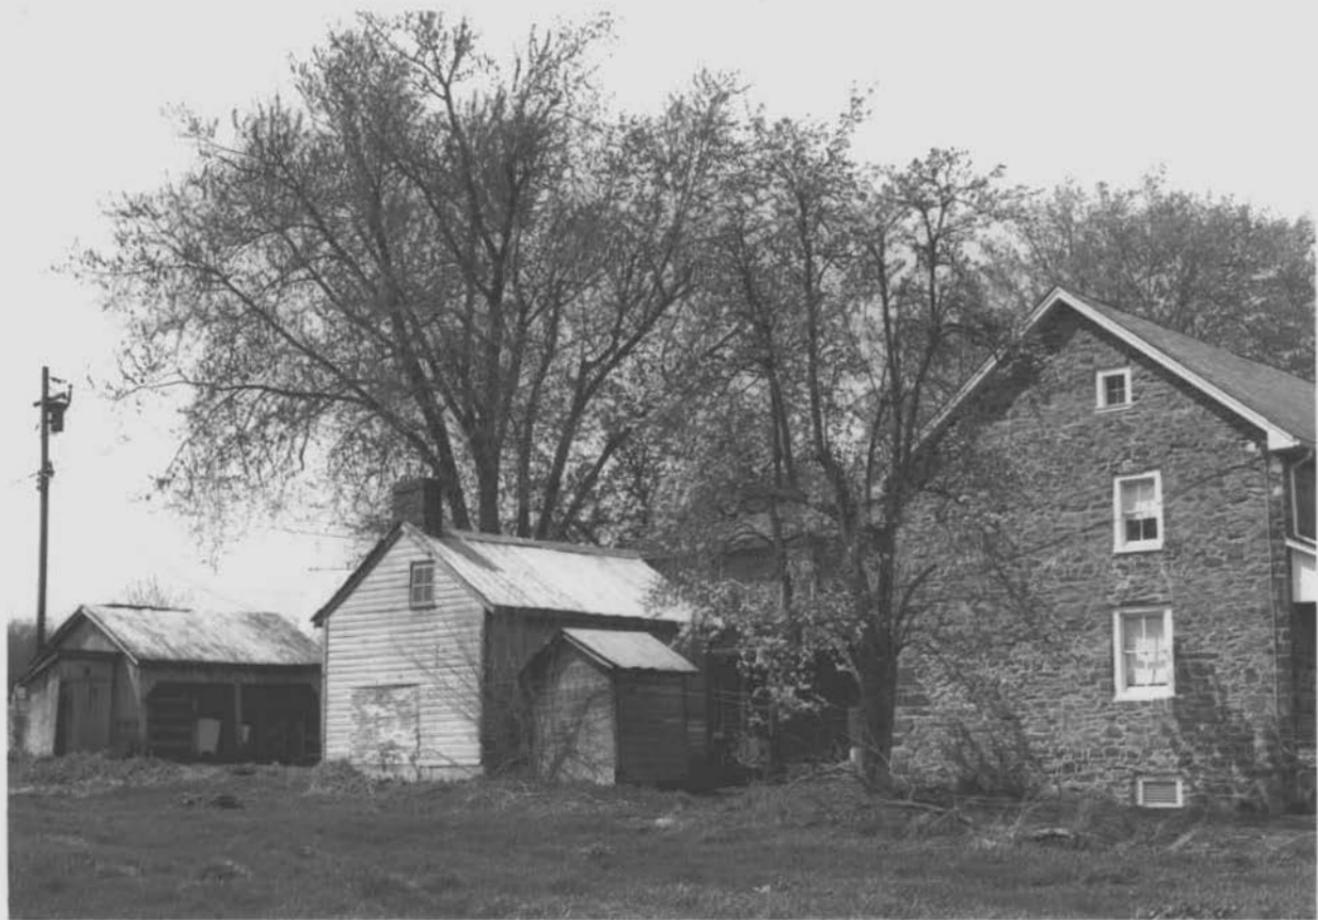
3/5

Privy, shed, summer kitchen, smokehouse,

house - south & east elevation

About 10 feet south of the house is a smokehouse with horizontal flush board siding that has a "V" cut in the center and edge of each board. There are corner boards and a gable roof of corrugated metal with a north-south ridge. The north elevation has a door to the west with vertical boards like the siding. It is built of circular-sawn 2 x 4 construction. The rafters are mitered at the ridge, but with no ridge beam.

There is a summer kitchen about 6 feet south of the house and just west of the smokehouse. It is one story and two bays by one bay. It has a concrete foundation, clapboards with an ogee moulded bottom edge, and corner boards of the same material. The gable roof has corrugated metal and a north-south ridge. There is an interior brick chimney centered on the south gable end. The north elevation has a 6/6 double-hung sash in the east bay and a vertical-board door in the west bay. The east and west elevations have a 6/6 sash in the center. The south elevation has the brick of the fireplace exposed, with a four-light sash in the gable end, set east of center. There is a large brick fireplace on the south wall that has straight jambs and a wood mantel tree. To the east of the fireplace is a straight run of stairs along the south wall. The floor is concrete. The studs are 2 inches by 3 $\frac{3}{4}$ to 4 inches. The joists are 2 $\frac{1}{2}$ by 6 inches, run east-west, and are spaced 22 $\frac{1}{2}$ to 26 $\frac{1}{2}$ inches on centers. They are nailed to the sides of the studs. The rafters are 1 $\frac{3}{4}$ to 2 $\frac{1}{4}$ inches by 3 $\frac{3}{4}$ inches, spaced 23 $\frac{1}{2}$ to 24 $\frac{1}{2}$ inches on center and use a raised plate and a ridge beam. They support lath and circular-sawn shingles. The roof was partly damaged by fire at one time, along the ridge just north of the chimney.

About 15 feet southwest of the house is a small shed with vertical-board siding and a corrugated metal gable roof with a north-south ridge. It is built of 2 by 4 construction with 4 by 4 corner posts, and is open on the east. Just south of it is a privy with beaded-edge vertical-board siding, and a door of like material on the east. The shed roof slopes to the west. It is a two-seater of 2 by 4 construction, and has a clean-out of concrete on the west elevation.

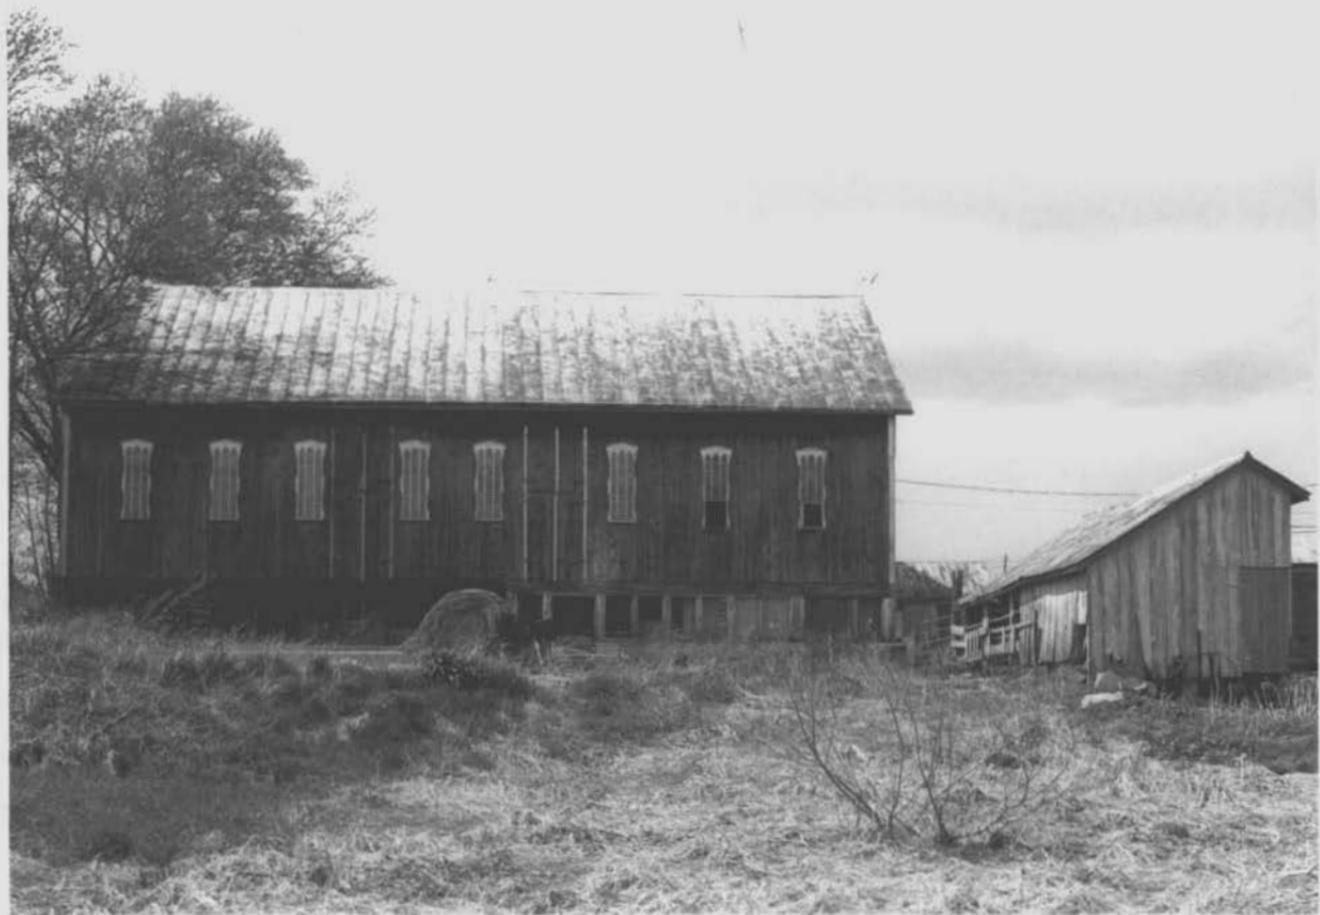
4/5

barn - SE elevation & hog pen - sw : SE elevs.

There is a hog pen about 15 feet southwest of the shed that has vertical-board siding and a salt-box gable roof of inverted-V-seam metal. The ridge runs northwest-southeast and the long slope is on the southwest. The southwest elevation is now basically open. The northwest elevation has a door opening to the north and an opening west of it. There are two openings on the northeast, with a door on strap hinges set between them, just under the eave. The building has a hewn heavy-timber frame with pegged mortise and tenon joints. It has been added on to on the southeast end. The rafters are about 2 by 4 to 3 by 5, are circular sawn, and are mitered at the ridge with no pole. The south corner post is only one story tall and has a tenon on top of it, and the southwest plate is mortised and set on top of the tenon, and pegged. The northeast wall is taller, but has not been added to, suggesting the salt-box profile is original. The southwest faces of the north and east posts have a mortise near the top of the post that is cut straight, not angled, suggesting some sort of top girt was here, not a brace. It was presumably removed when the roof framing was renewed.

There is a bank barn about 40 feet southwest of the corn crib; it has a southeast facing forebay. The gable roof has standing-seam metal and a northeast-southwest ridge. The lower story has rubble fieldstone and the upper story vertical-board siding, except for the southeast elevation. The lower story of the southeast elevation has narrow, horizontal, beaded-edge-and-center board siding. There is a wide new opening to the south, then a door opening, a $4/4$ sash, a door opening, a window opening, and a CMU wall under the east half of the forebay. The upper story of this elevation has beaded-edge-and-center vertical-boards. From south to east there are three vents, double doors over double doors, a vent, and two vents with a four-light sash in the bottom of each. The vents are tall, tripartite, and pedimented. The northeast elevation has a beaded-edge-and-center vertical-board door on rollers under the forebay. To the north in the lower story are two 20-light sash with stone infill below them; there were originally doors

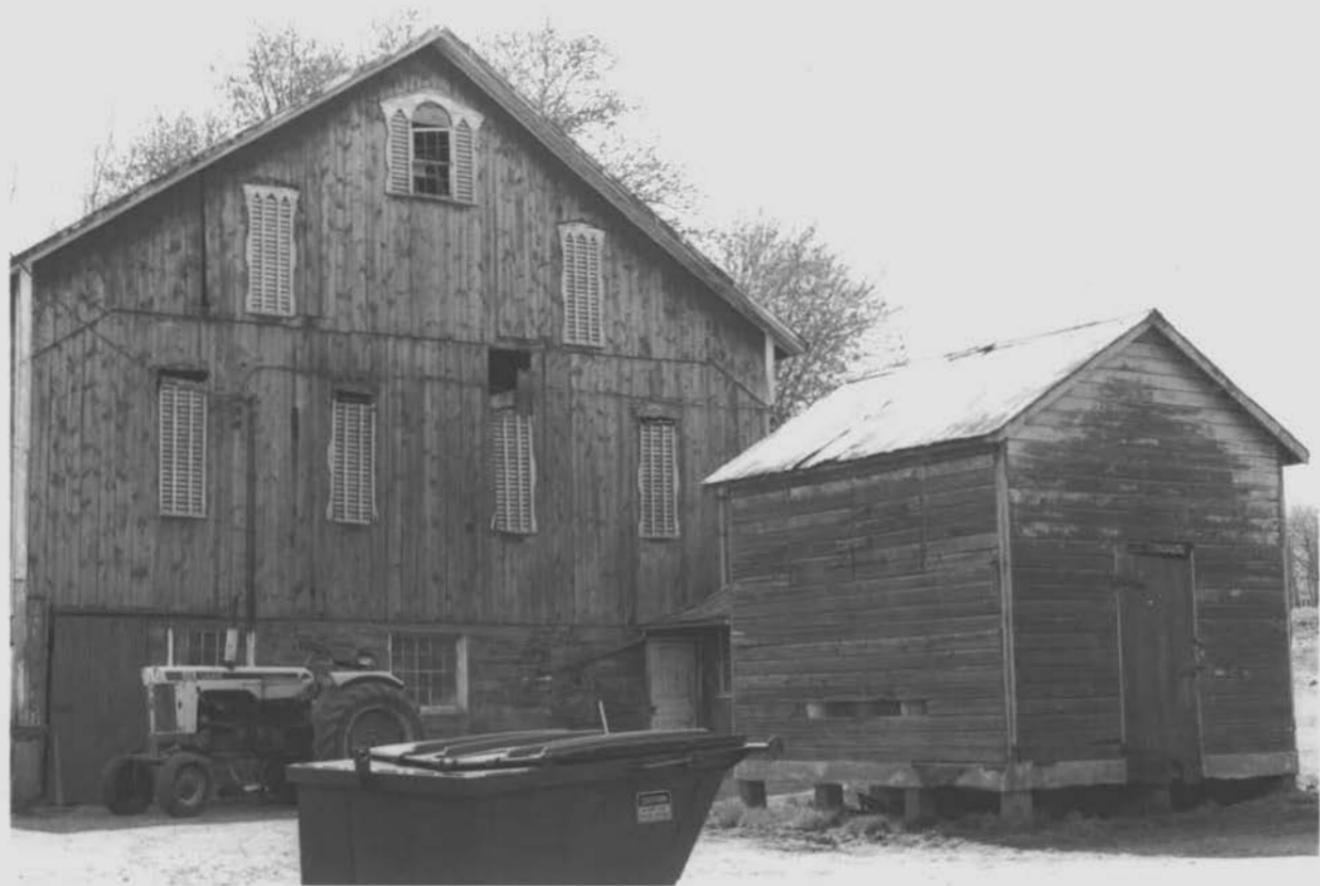
5/5

barn - NE elev. & corn crib - SE & NE elevs.

About 35 feet to the southwest of the wagon shed is a corn crib on concrete piers. It has clapboard siding set with gaps between the boards, and a gable roof with

here. The north bay has a five-panel door, with a lying panel in the center. The upper story has four typical vents, with two more in the gable end. In the peak is a 6/6 pedimented sash with a vent to each side. There is a CMU milk room attached to the north corner. There is a granary door on the upper story of the barn at the north corner. It has now been altered, with the bottom half closed off where the milk room roof connects and interferes with it.
