CARR-919

John Payne Farm
2810 Hoffman Mill Rd

c. 1858-1868

Maryland Historical Trust State Historic Sites Inventory Form

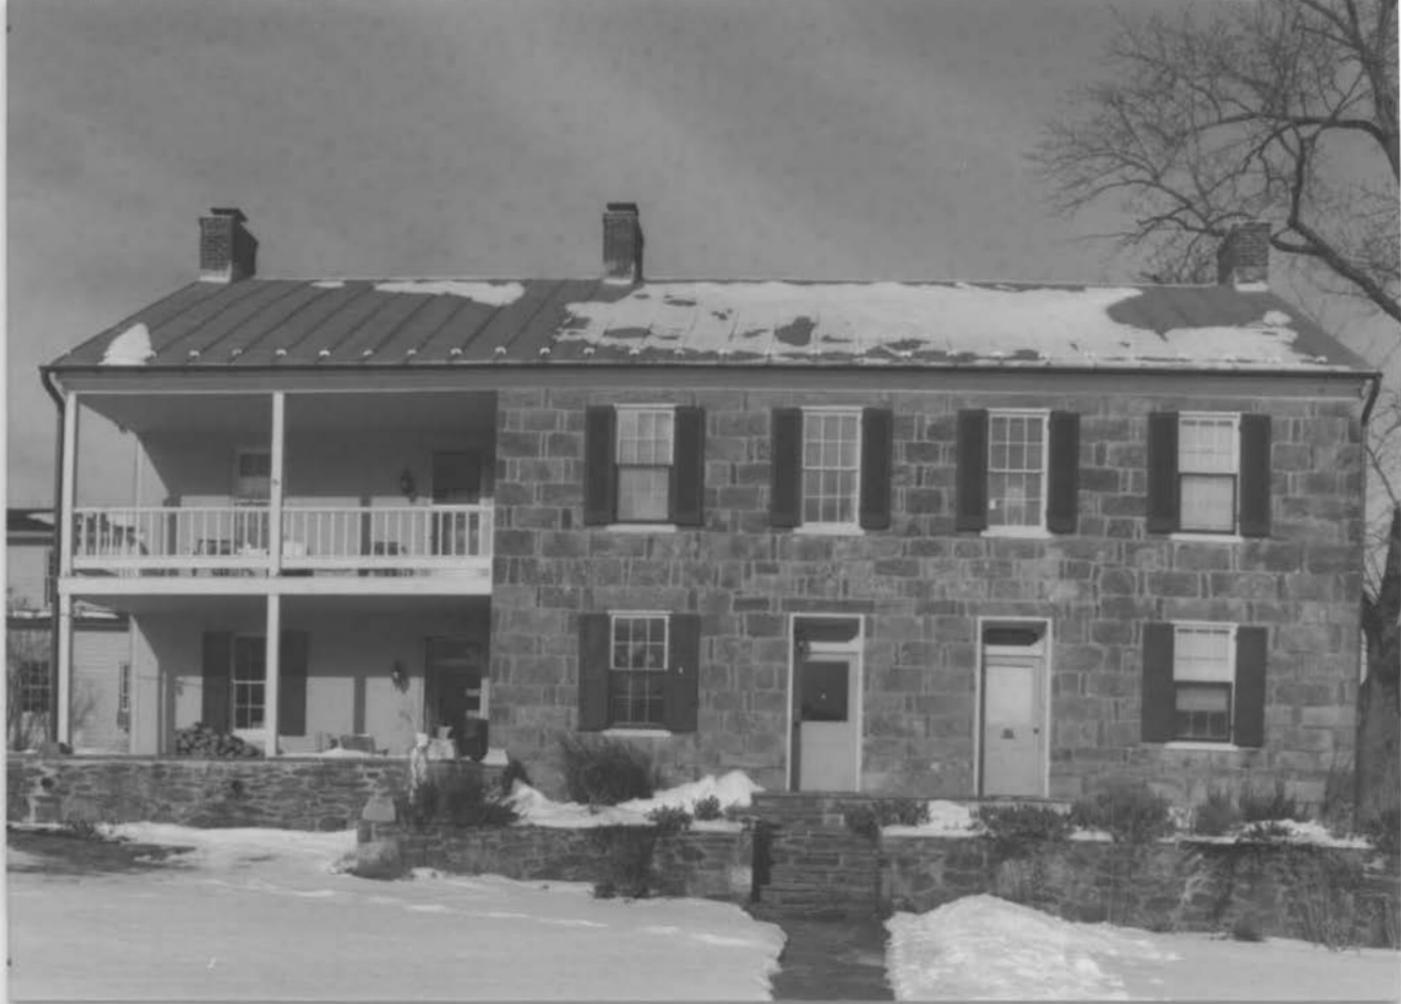
1/5

House - SW elev.

The main block of the southwest elevation has Flemish bond ashlar stone. The first story has two center doors, each with one light over two panels. The jambs have three panels each, with one panel set at transom level, and there are two panels on the soffit. The panels have sunk fields and no panel moulds. The doors have beaded-interior-edge frames, and the transoms have oval lights. According to the owner, the house had a wood beam set in the wall over the doors which the porch rafters were connected to. This beam has been removed and replaced with stone to match the original pattern. There is one 6/6 sash on each side of the doors; they have wood sills, large stone lintels, and beaded-interior-edge frames. The windows each have two three-panel shutters with a small panel set in the center of each shutter. Behind the southern-most shutter the initials "E.M.L.?" are carved in the stone. The second story of the southwest elevation has four 6/6 sash with blinds, and a wood box cornice.

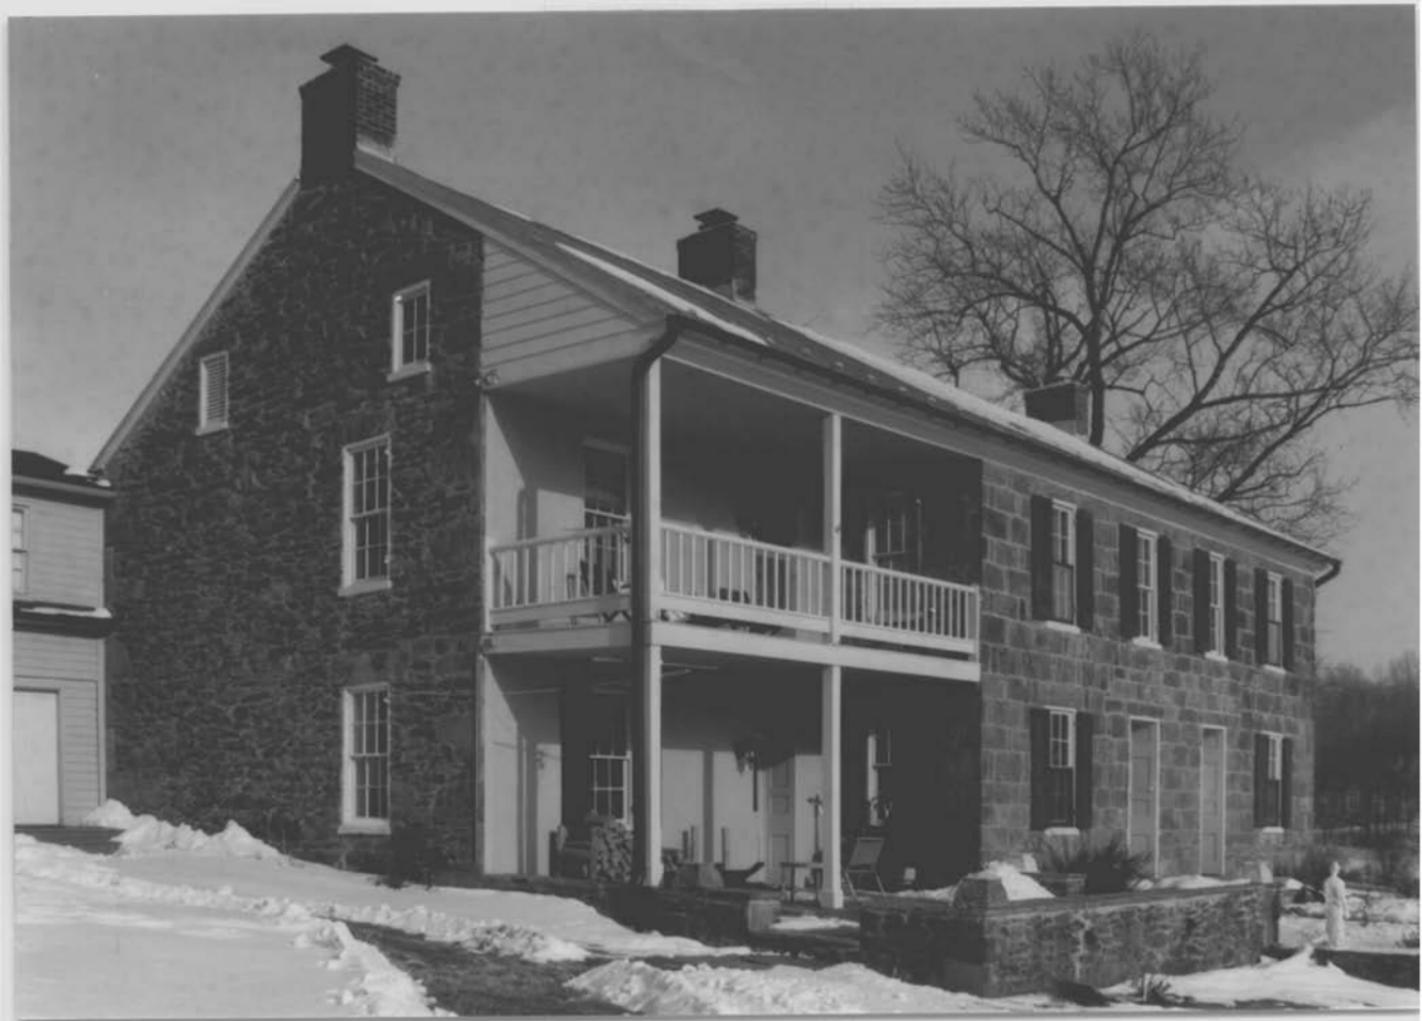
Neg. Loc.: Maryland Historical Trust
NW & SW elevs.
2/5

The northwest elevation of the wing has rubble stone with large quoins and large lintels. The first and second stories each have a 6/6 sash in the west bay. There is a new vent in the north bay of the gable end and a four-light sash in the west bay of this gable.

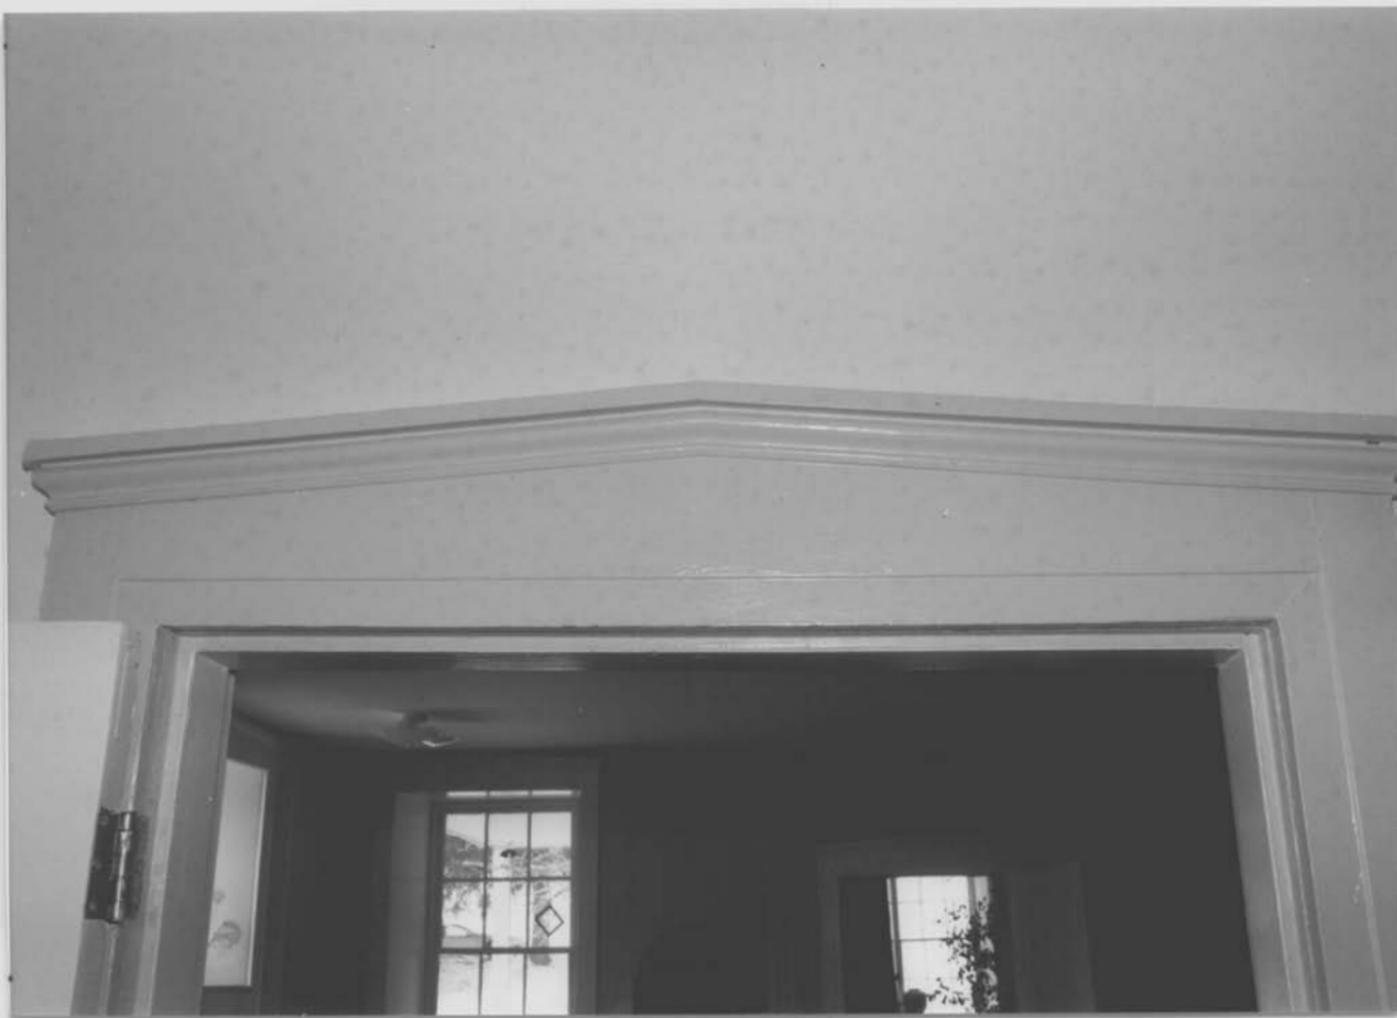
FEB 1996
3/5

Neg. loc.: Maryland Historical Trust
interior - pedimented architrave

The west room has a broken field architrave with a pediment above each opening that has an ogee and bevel cornice moulding. This moulding can also be found in the south room. New copies of this molding have been added to the east room and the hallway, which were otherwise just broken field architraves. The window openings throughout have splayed jambs of wood with broken field architraves and no spring latches.

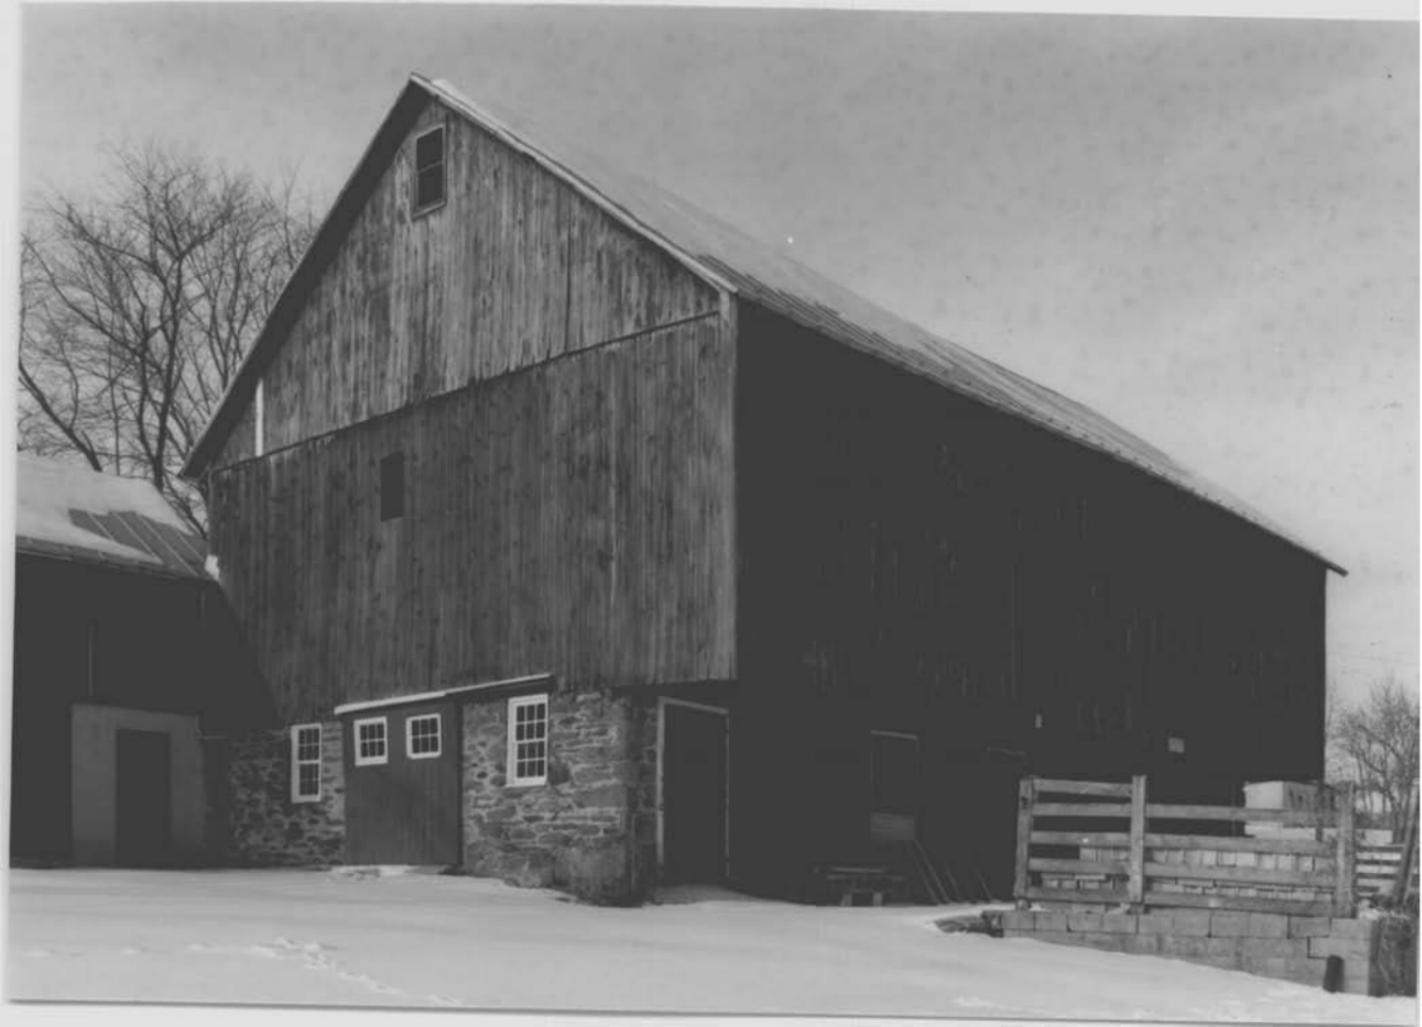
John Payne Farm
2810 Hoffman Mill Rd.
Carroll County, Maryland
Photo: Kenneth M. Short
Date: Feb. 1996
Neg. Loc.: Maryland Historical Trust
barn - SW & SE elevs.
4/5

On the southeast elevation, the lower story has five Dutch doors on machine-cut strap hinges. The upper story has two doors that match the siding and are hung on rollers. The southwest elevation has a door on rollers in the center with a 6/6 sash to either side. There are vertical metal bars behind these sash. The upper story has one opening plus a four-light sash in the gable end.

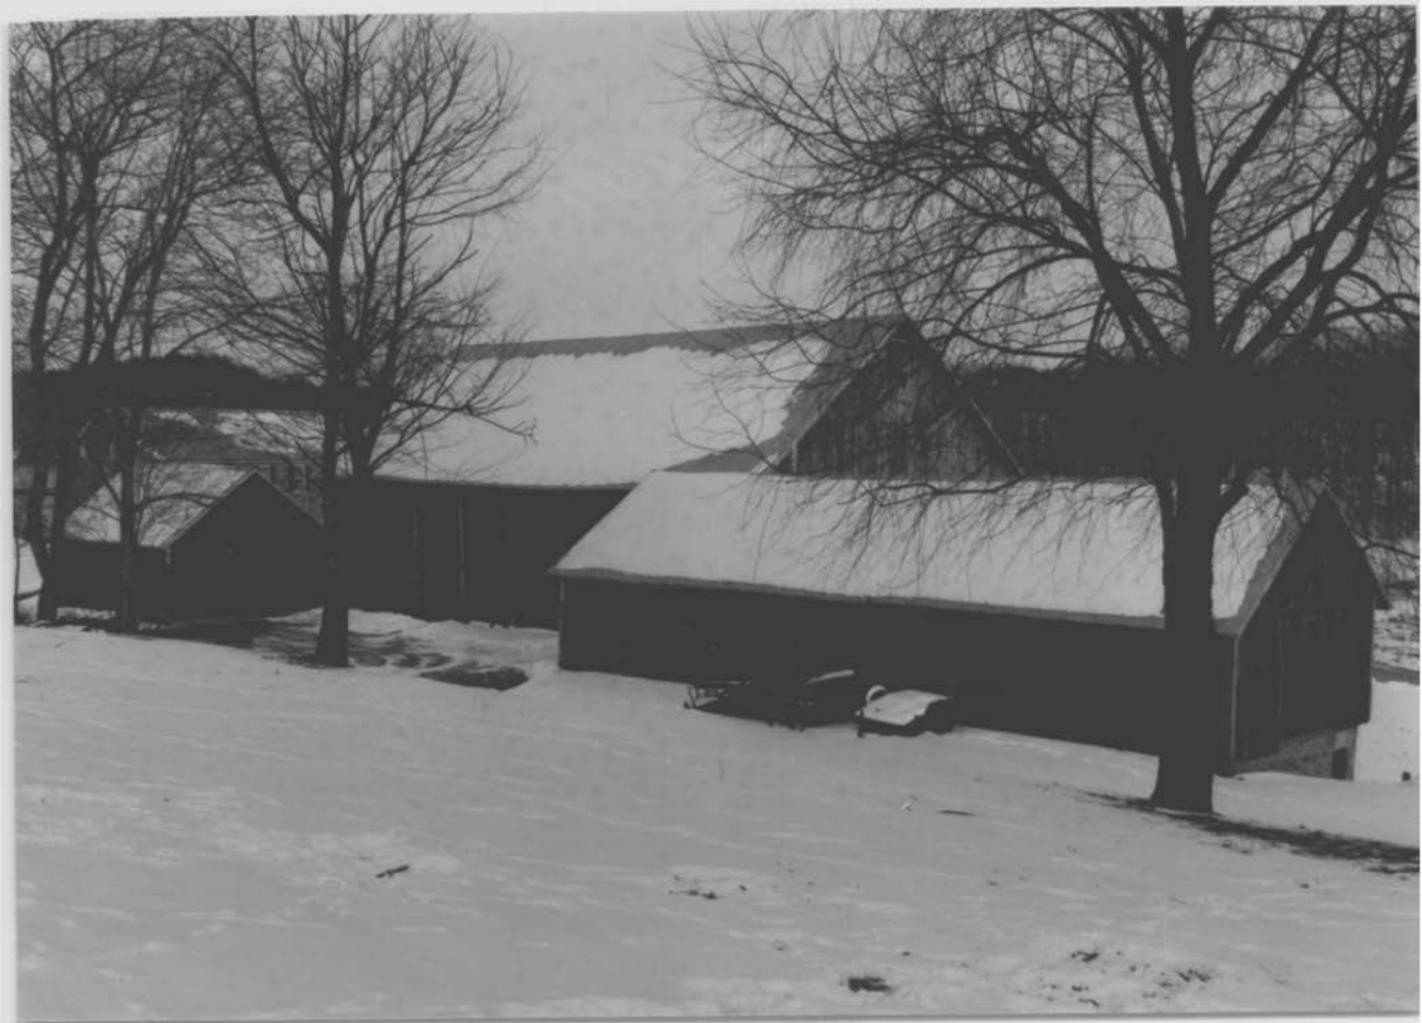
5/5

barn - NW: SW elevs.

The barn is located about 150 feet southwest of the house. It is a bank barn with a forebay that faces southeast toward the road. The barn has vertical-board siding on the northwest elevation and beaded-edge-and-center vertical boards on the other three elevations of the upper story. The lower story has rubble stone on the northeast, northwest, and southwest elevations, and horizontal beaded-edge-and-center boards on the southeast elevation. The gable roof has a northeast to southwest ridge, and is covered in standing-seam metal. The northwest elevation has two pair of wagon doors made of beaded-edge-and-center vertical boards and hung on rollers. The northeast elevation, on the lower story, has an altered opening, with a door on rollers set to the east, and a 6/6 sash to the north. The upper story has only a four-light sash in the gable end.
