~~Bayard Farm~~ CHESAPEAKE FARMS
CE-1049
Near Cayots Corner
Private

C. 1830, 1860

INVENTORY FORM FOR STATE HISTORIC SITES SURVEY

CHESAPEAKE FARMS

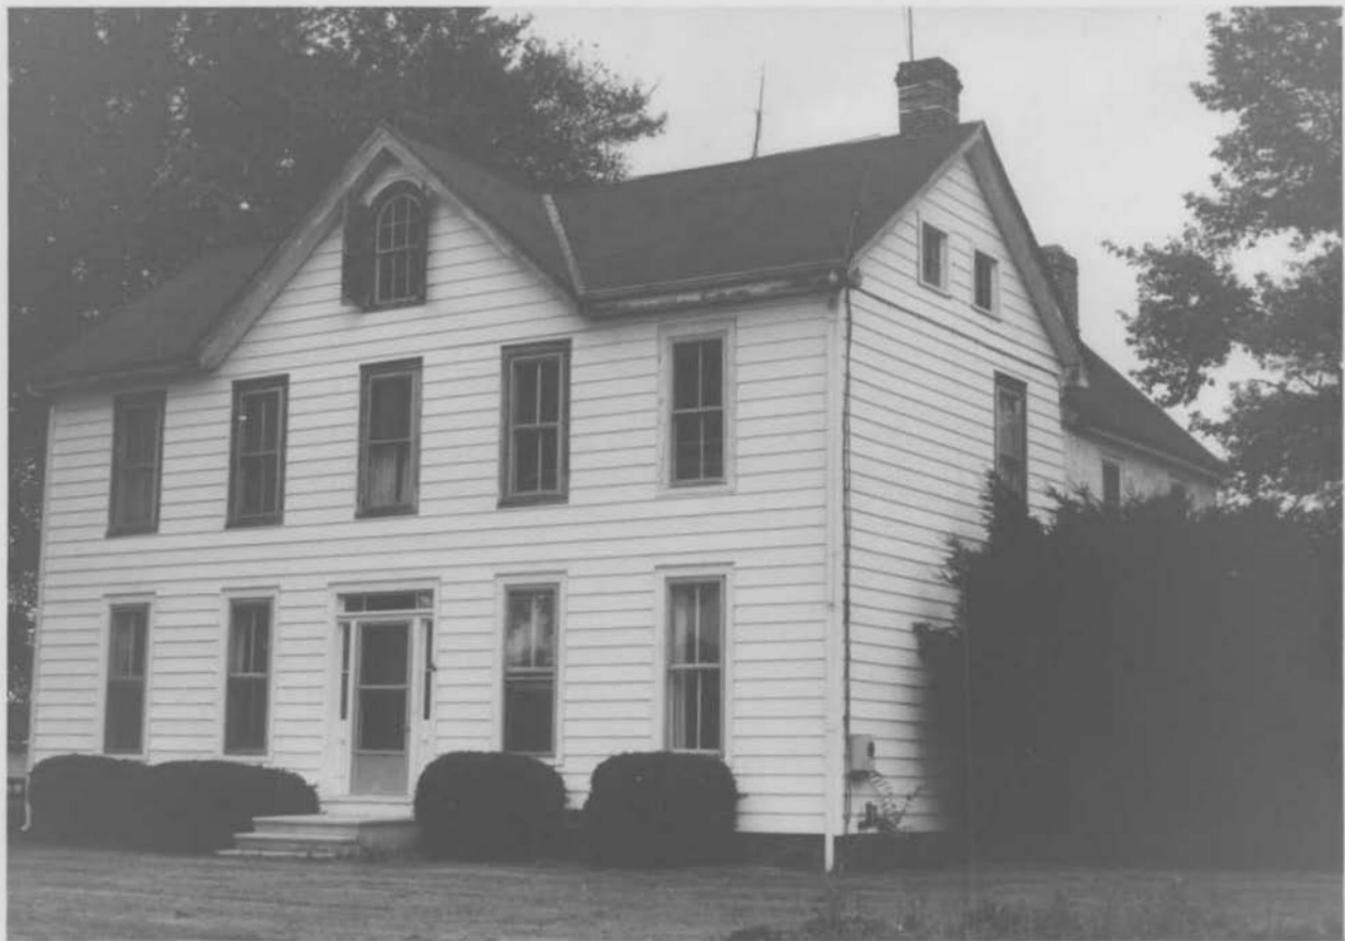
EAST ELEVATION

The east facade is five bays across with a central entrance and corresponding 2/2 sash windows. The four panel front door has arched top panels. It is bordered by two light sidelights and a three light transom. The window surrounds have been covered with aluminum. Five 2/2 sash windows illuminate the second floor and a arched 6/6 light with louvered shutters lights the cross gable. The eaves are typically extended with soffits sloped.

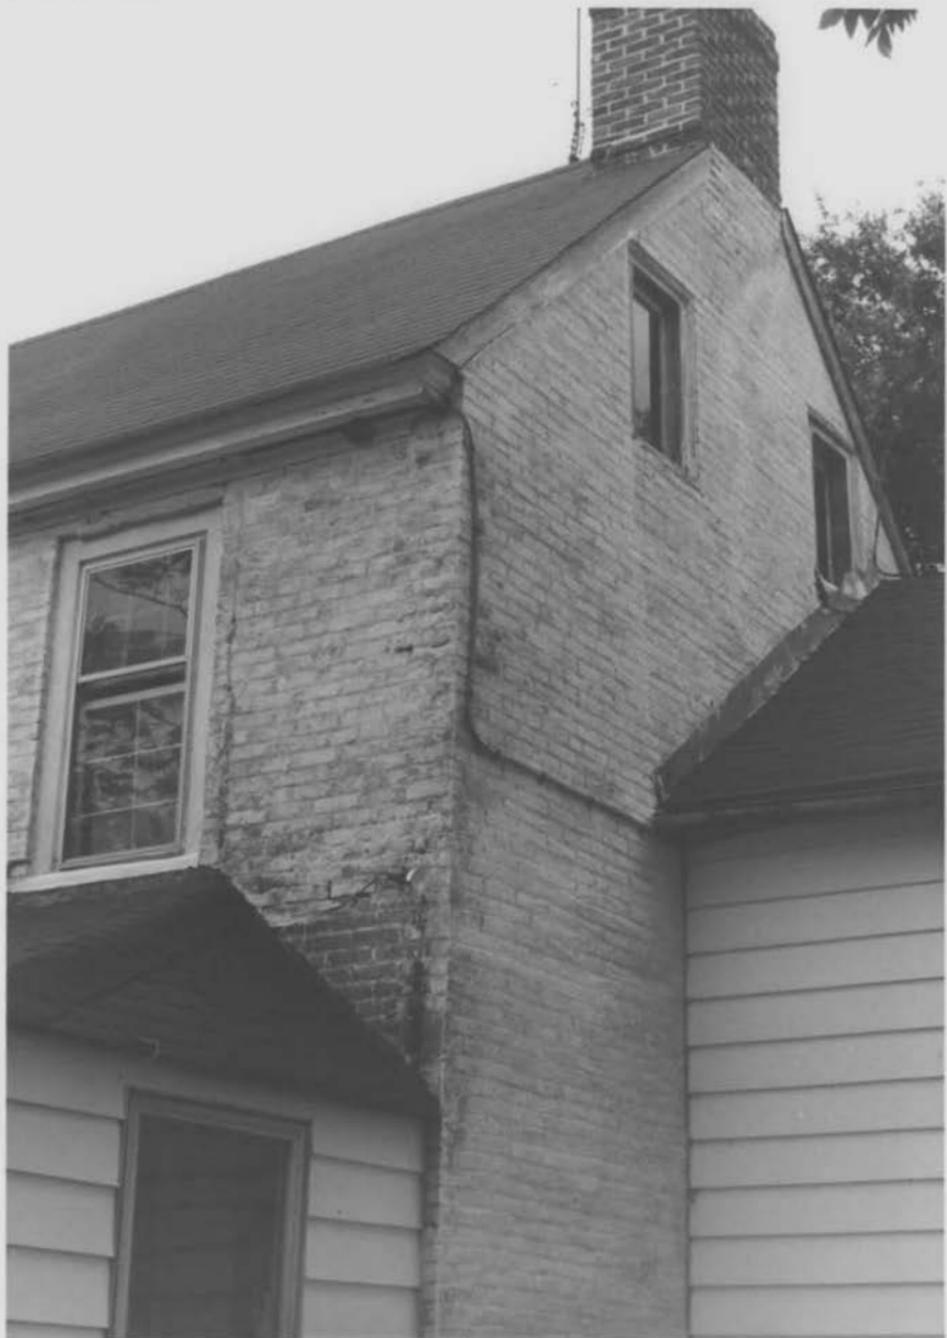
NORTH ELEVATION OF REAR WING

The west side is obviously covered primarily by the earlier rear section. The common bond structure is two bays across with an entrance in between the two 6/9 sash windows. 6/9 sash are also found to light the second floor with an thumb and astragal backband. The window frames are of mortise and tenon construction. A boxed cornice covers the rafter ends above the second floor windows and is embellished with a cymarecta curve crown molding and a bed molding as well.

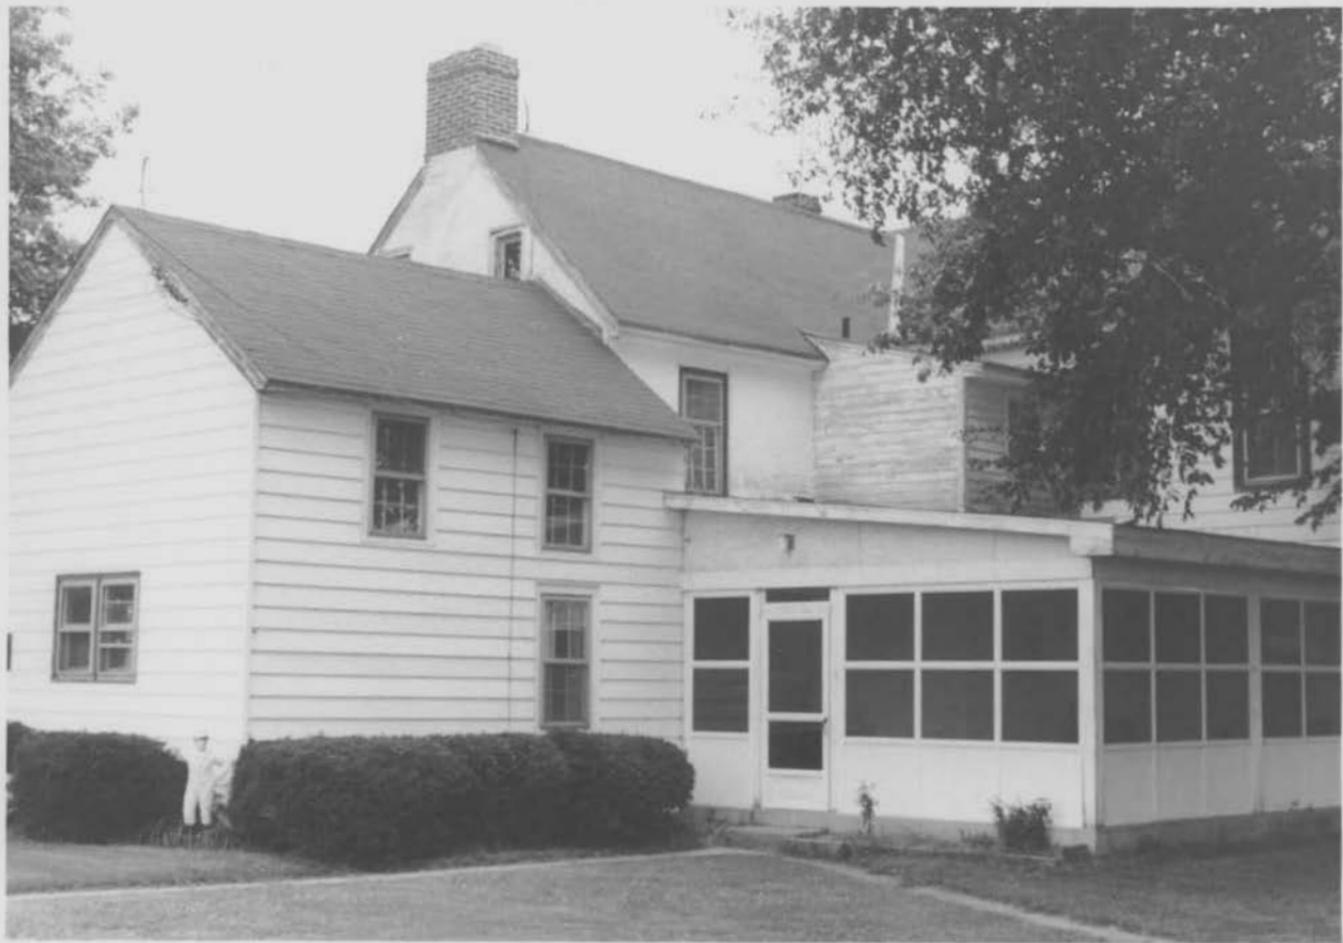
SOUTHWEST ELEVATION

The west gable end is partially covered with a later 1½ story frame addition. Two attic windows do flank the interior brick stack but have lost their moveable sash and are presently single pane. A backband with thumb and astragal molding does remain.

The south side is also predominantly covered with later frame additions. The first floor door between the two windows has been partially closed. Similar molding are also found on these openings.

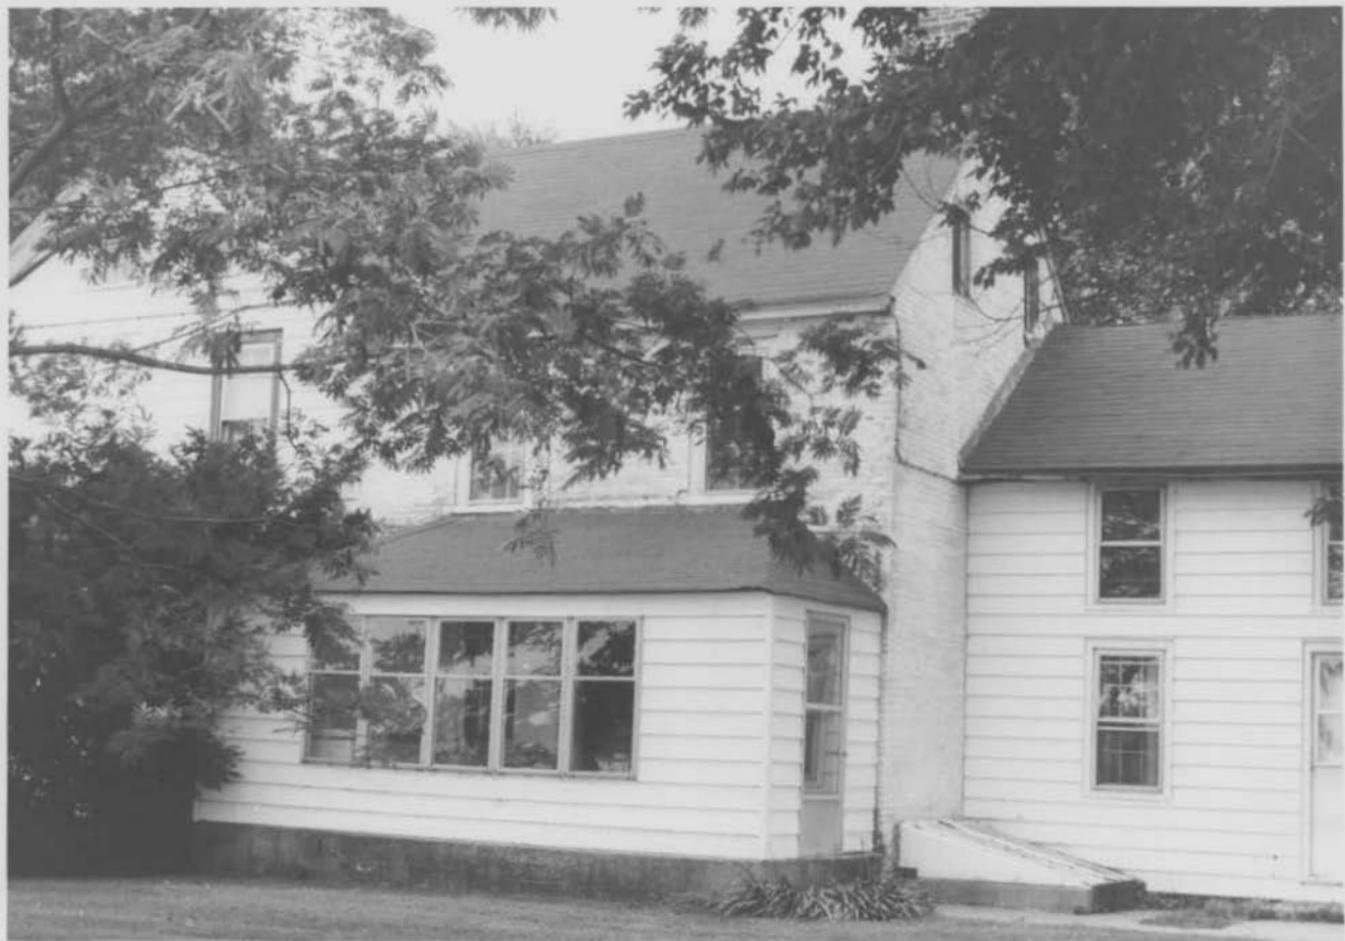
NORTH ELEVATION

The north and south gable end have single 2/2 sash windows on each floor and two four pane attic lights that flank the interior end brick stove stacks.
