CE-1220

INVENTORY FORM FOR STATE HISTORIC SITES SURVEY

Beaven Log House

Rowland Road east of Liberty Grove road

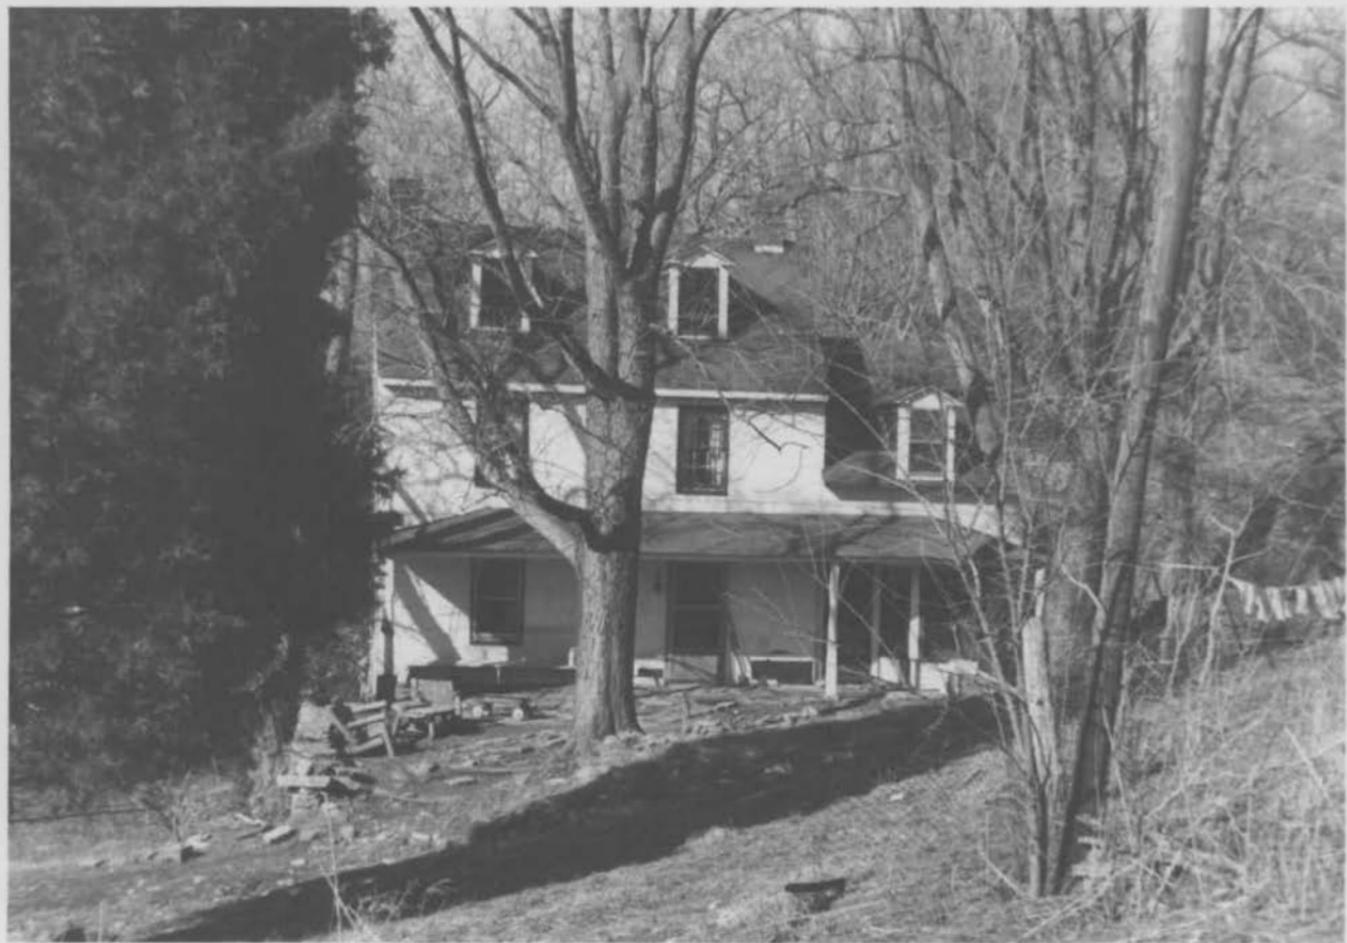
SOUTH ELEV.

The south facade of the log section is two bays across with an entrance in the eastern bay. The door has been replaced. 6/6 sash windows occupy the other openings. A corner bead on the surround serves as decorative window trim. Two identical sash light the second floor. A hip roofed porch covers the first floor and is supported by partially chamfered posts. A boxed cornice stretches across at the base of the roof and two gabled 6/6 sash dormers light the attic. The south side of the stone wing is two bays across with an entrance in the western of the two openings. A three sided bay window occupies the other bay and the shed roof porch covers the first floor of the wing. The south roof slope of the 1 1/2 story wing has a single 6/6 sash dormer.

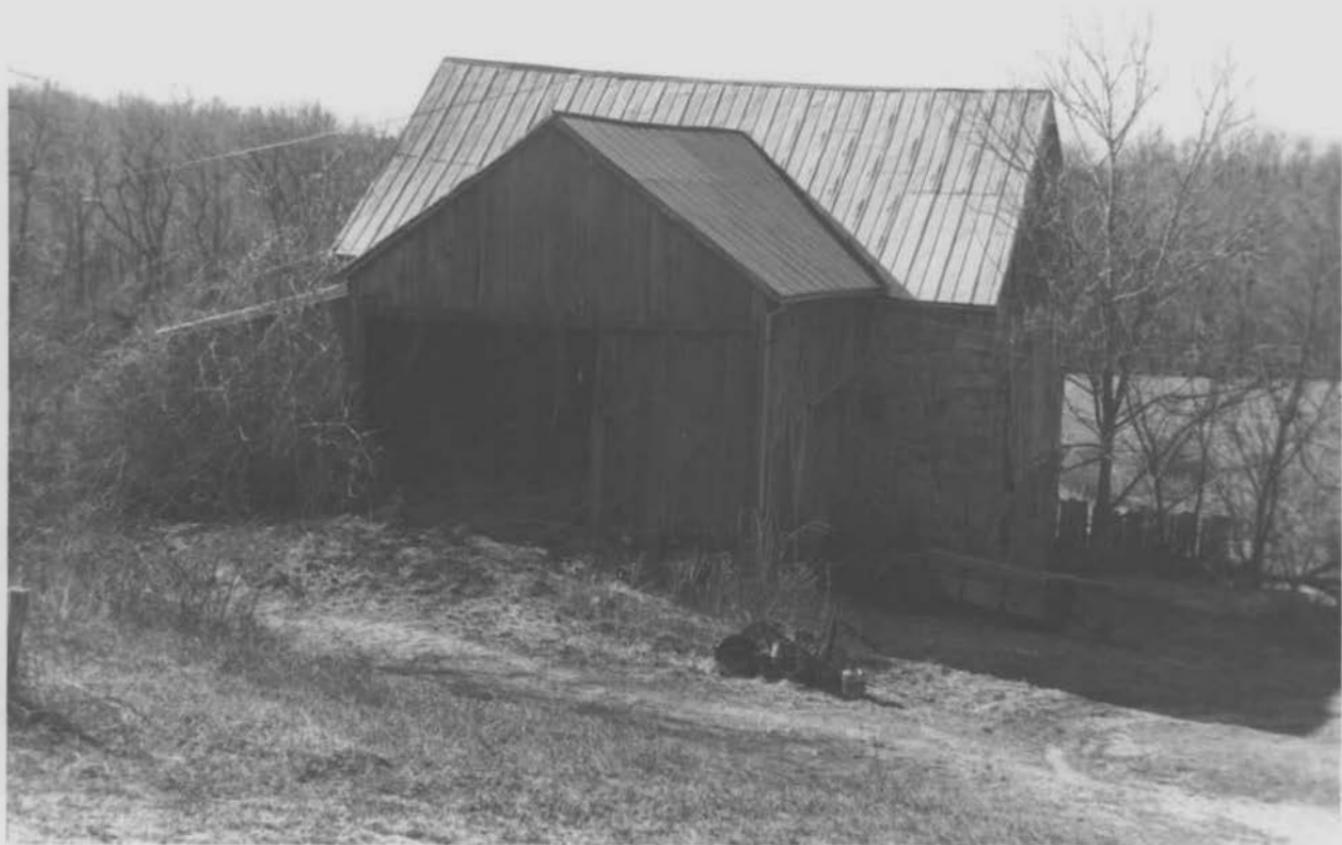
NORTH ELEV. OF BARN

A two story timber frame ^{and stone} barn stands to the south and west of the house and rests on a fieldstone foundation. It is set into a bank with a projecting entrance bay on the east side. The stone is nicely shaped and laid in courses. A later shed addition to house a dairy is attached to the south side and a shed addition off the back end.
